# 1 THE ROCK, BURY

## POST FIRE DECONSTRUCTION - SITE VISIT 2

Thursday, 22 January 2026

Prepared For Broad Property Ltd

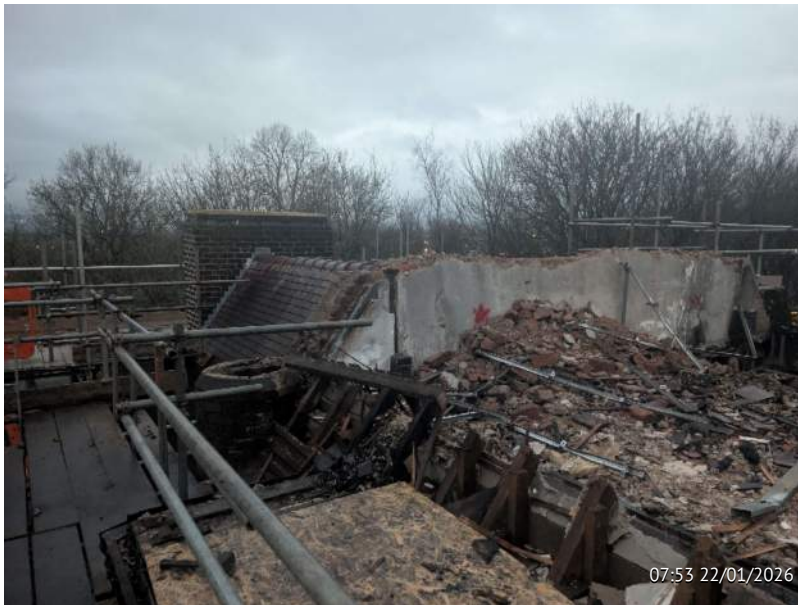
### Observation 1

View On Rear Left

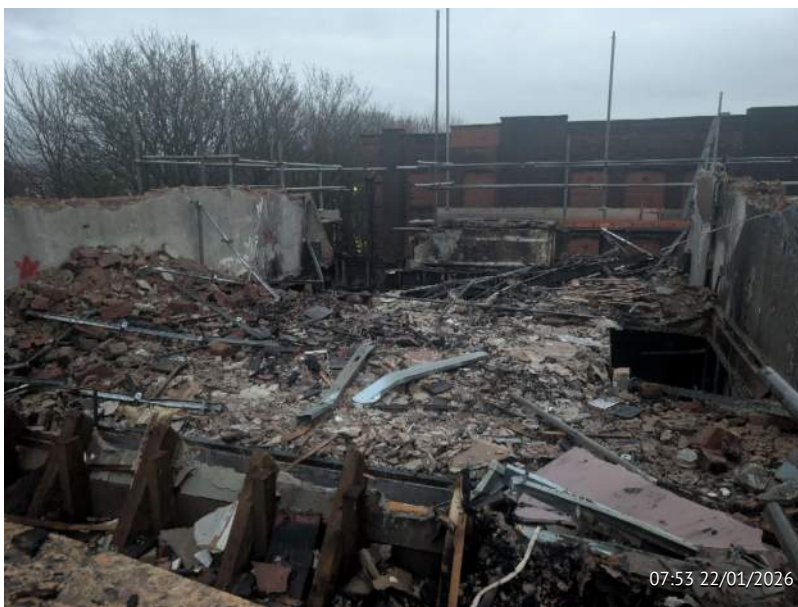
### Observation 2

View On Rear Left

They advised that they had reached the limit of what was feasible using the current baskets.

The demolition contractor is to develop a safe method of work to facilitate removal of debris on the floor.

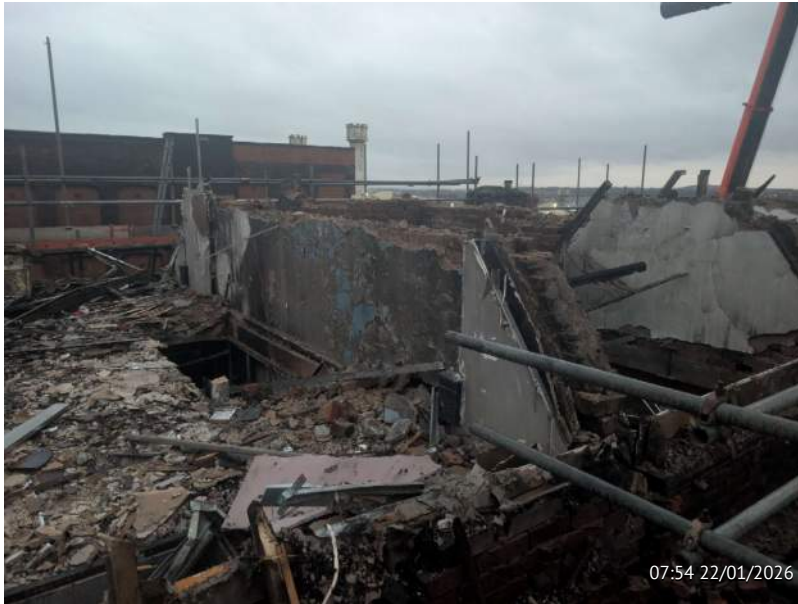
### Observation 3

View On Rear Cross Wall

The demolition contractor reported that the masonry was very loose.

Deconstruction to continue down to floor level as planned.

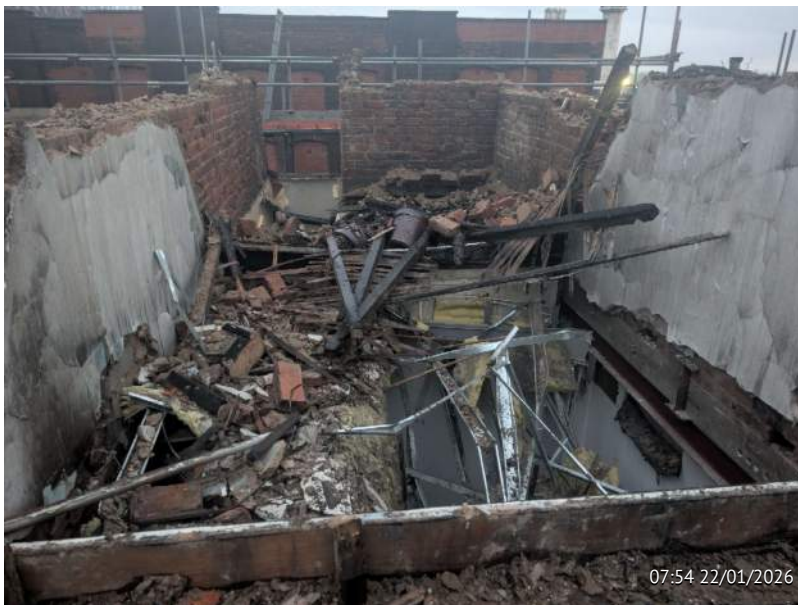
### Observation 4

Central Stairwell Area

See observation 3.

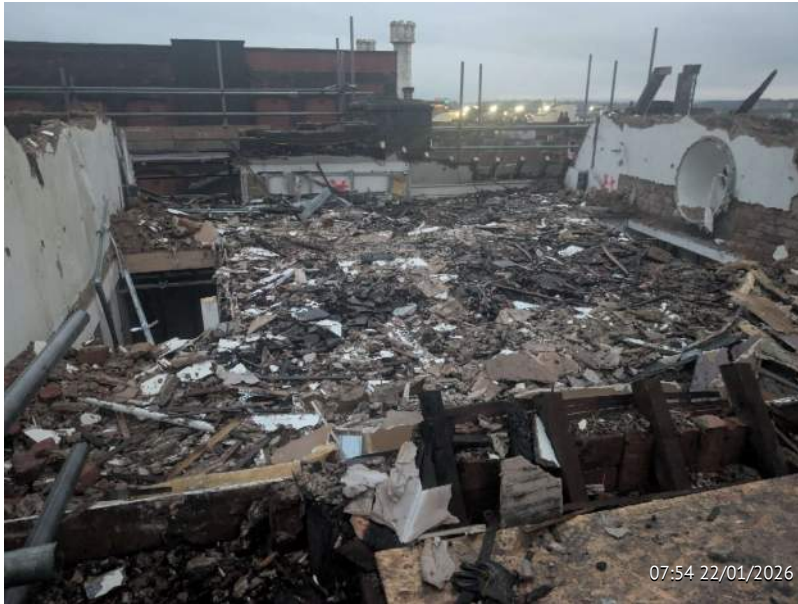
### Observation 5

Front Section

See observation 3.

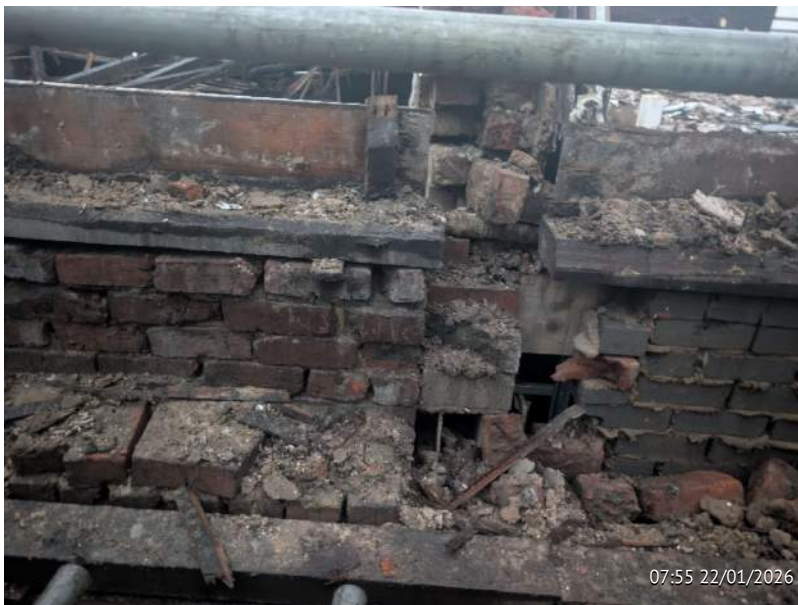
### Observation 6

Eaves At Front Cross Wall  
Interface On West Elevation

Brickwork in poor condition under  
wall plate.

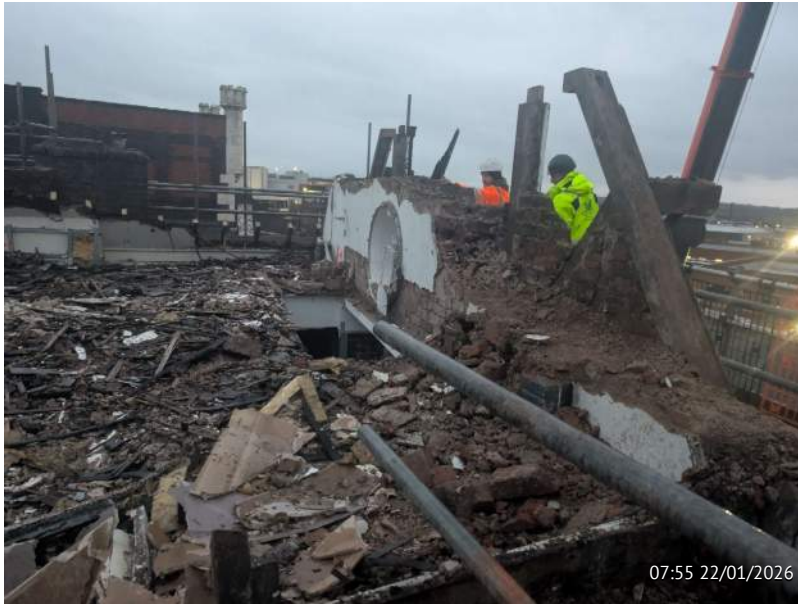
### Observation 7

Front Gable

Still to be demolished down to floor level.

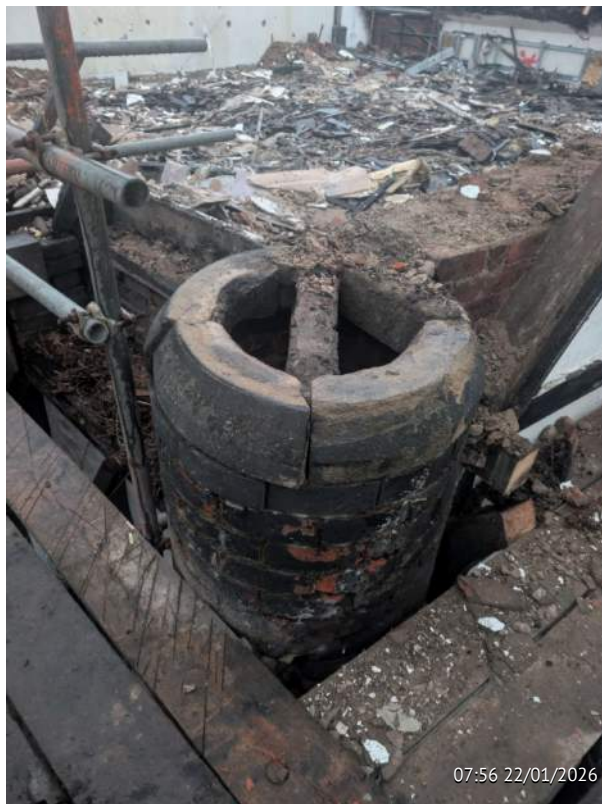
### Observation 8

Front Left Chimney Stack

Stringer course loose.

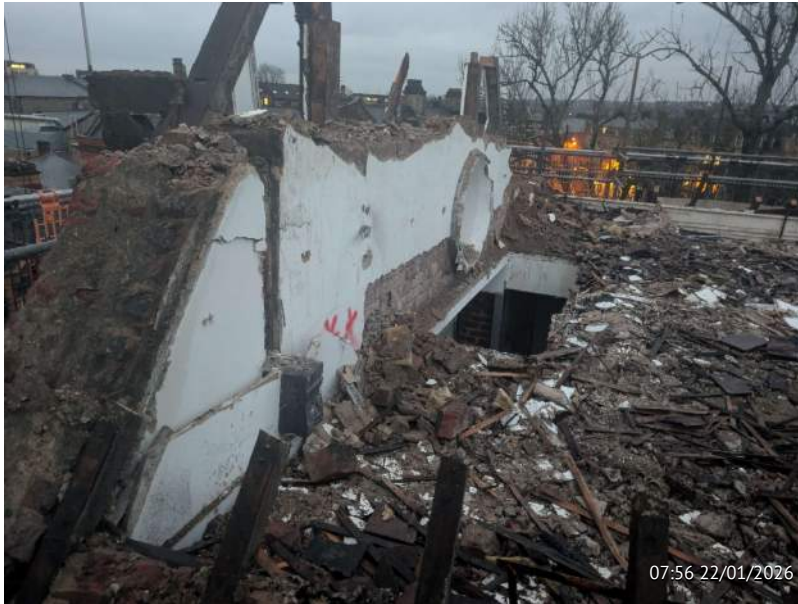
## Observation 9

Front Gable

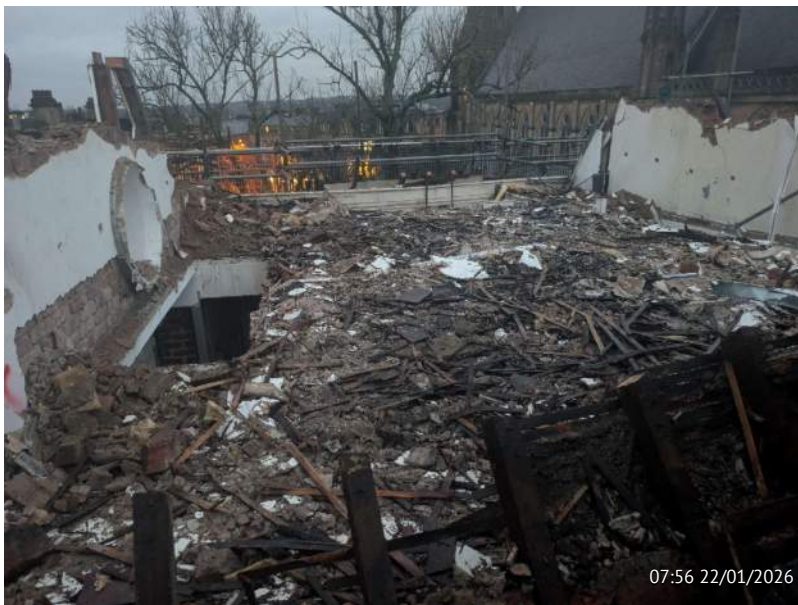
## Observation 10

Front Section

See observation 3.

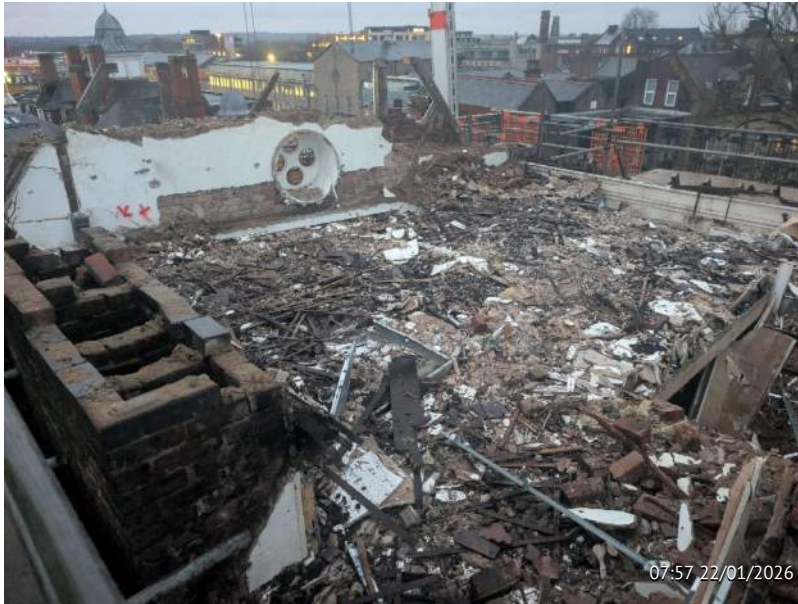
## Observation 11

Front Section

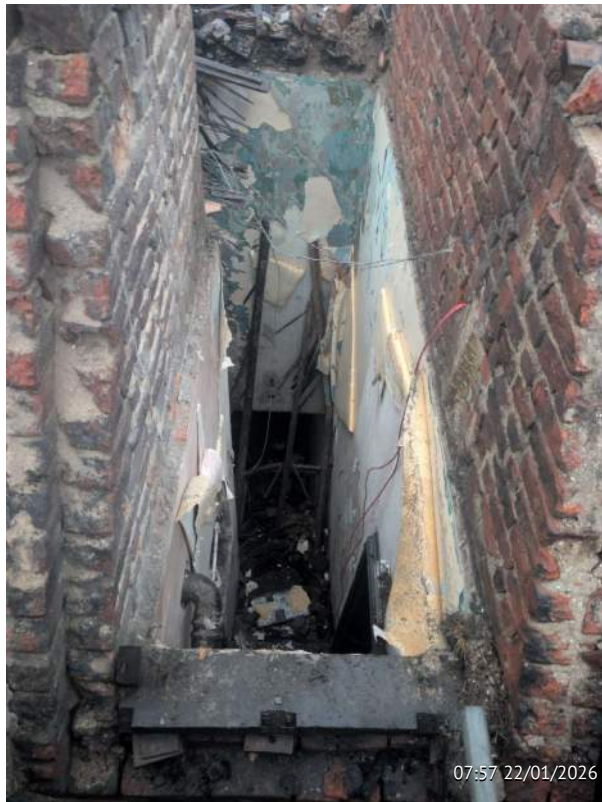
## Observation 12

Central Stairwell

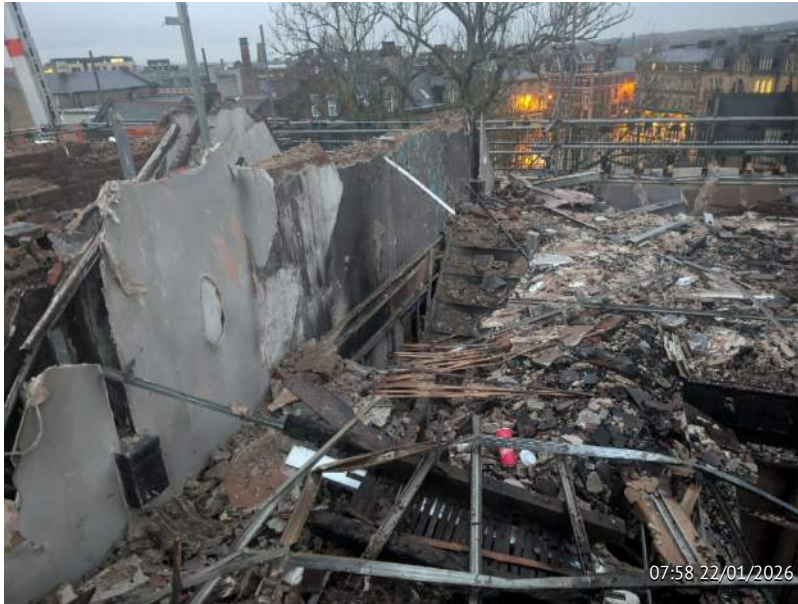
### Observation 13

Rear Central Cross Wall

See observation 4.

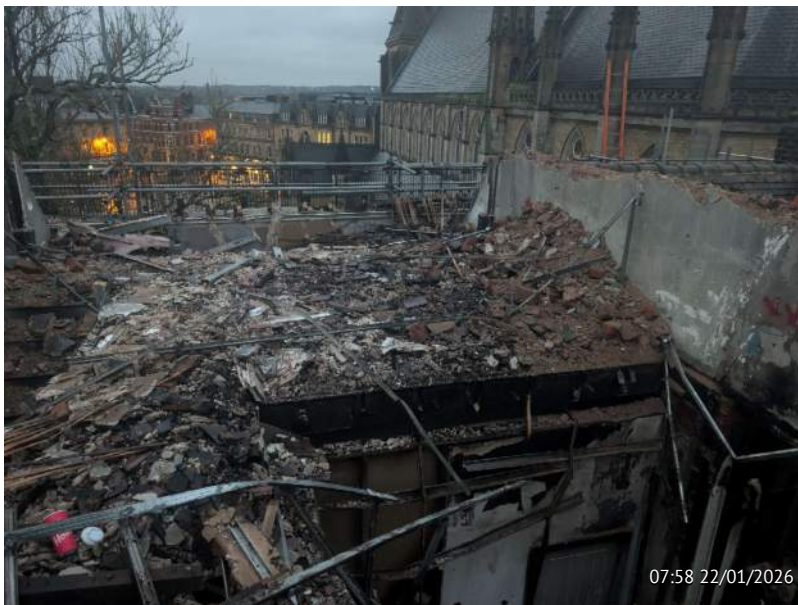
### Observation 14

Rear Section

See observation 3.

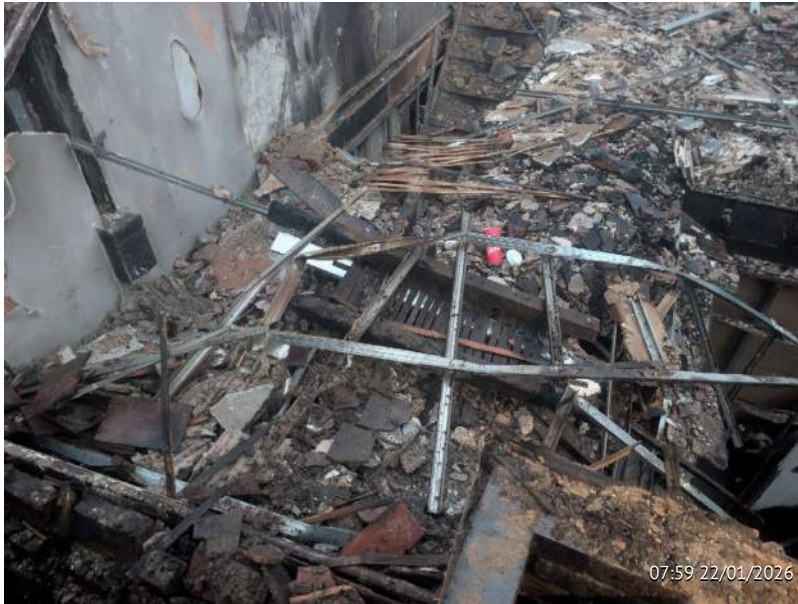
### Observation 15

Rear Section

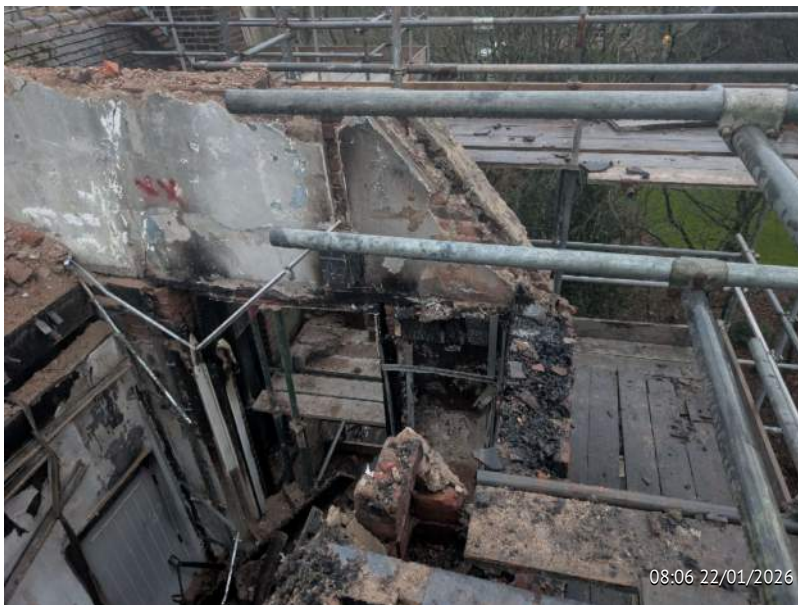
### Observation 16

Rear Left Corner

Closer inspection required to assess structural integrity of the rear left corner.

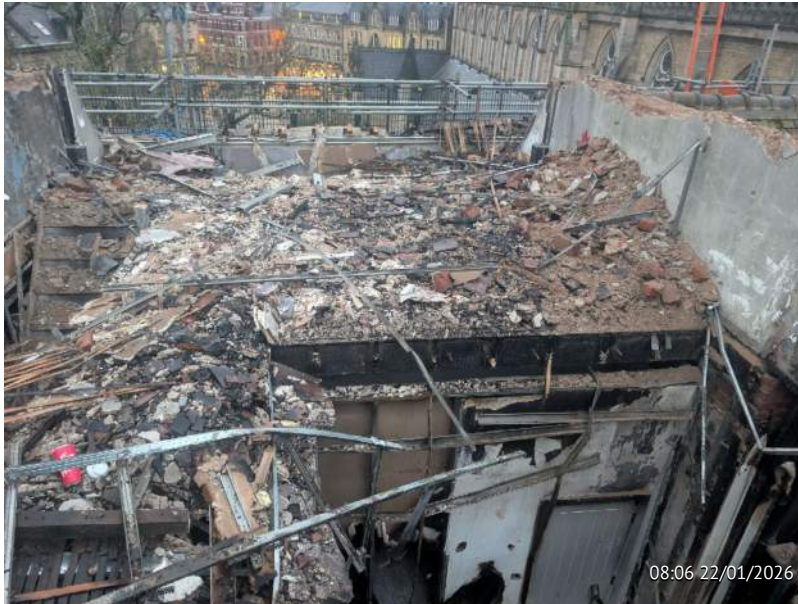
## Observation 17

Rear Section

See observation 3.

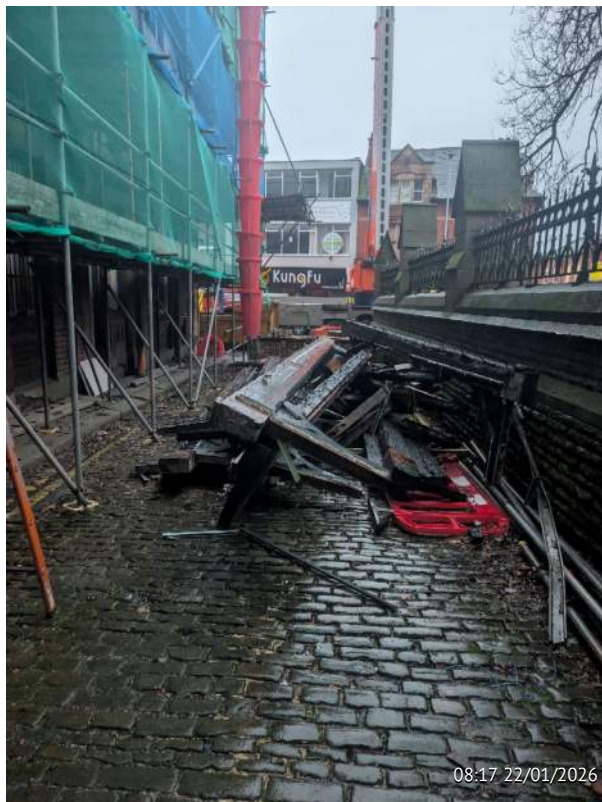
## Observation 18

Salvaged Timbers

M&G to consider next stage of assessment for reuse.

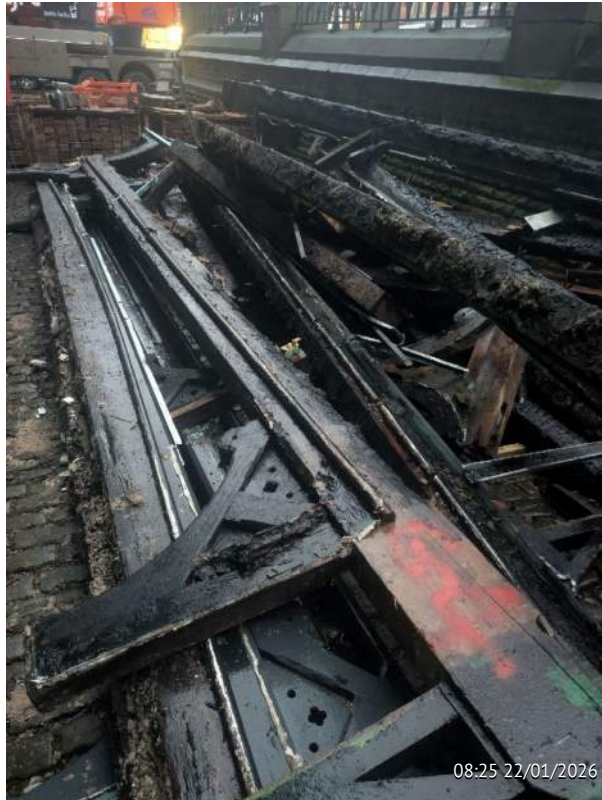
### Observation 19

Salvaged Timbers

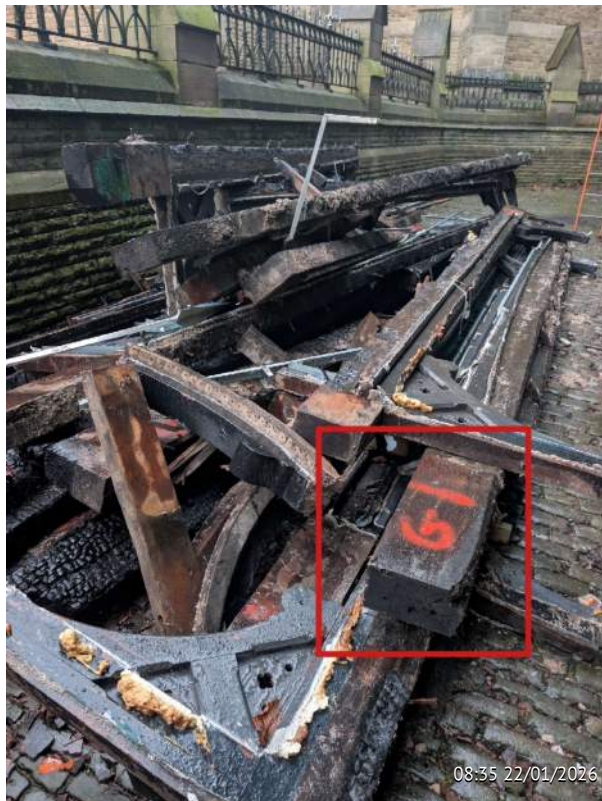
### Observation 20

Salvaged Timbers

End of purlin highlighted in poor condition.
