# 1 THE ROCK, BURY

**POST FIRE DECONSTRUCTION - SITE VISIT 3**

**Friday, 30 January 2026**

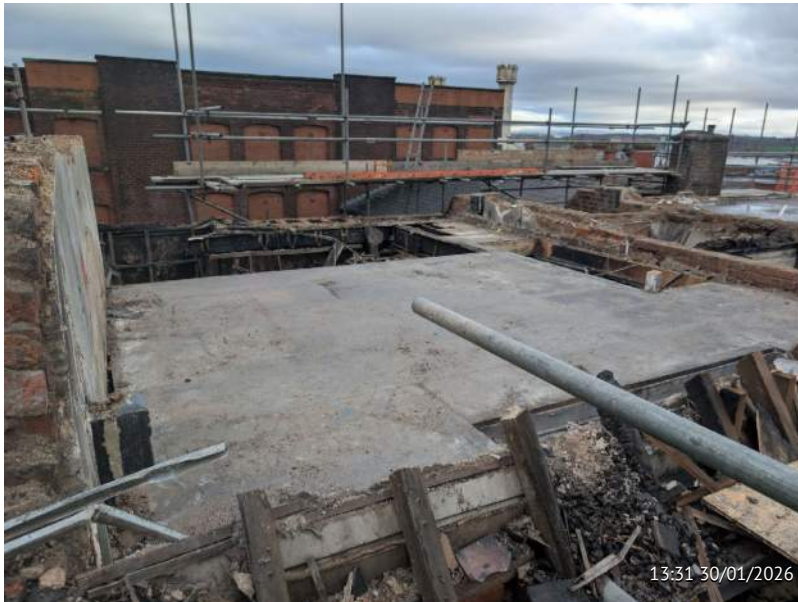
## Observation 1

View On Rear Section

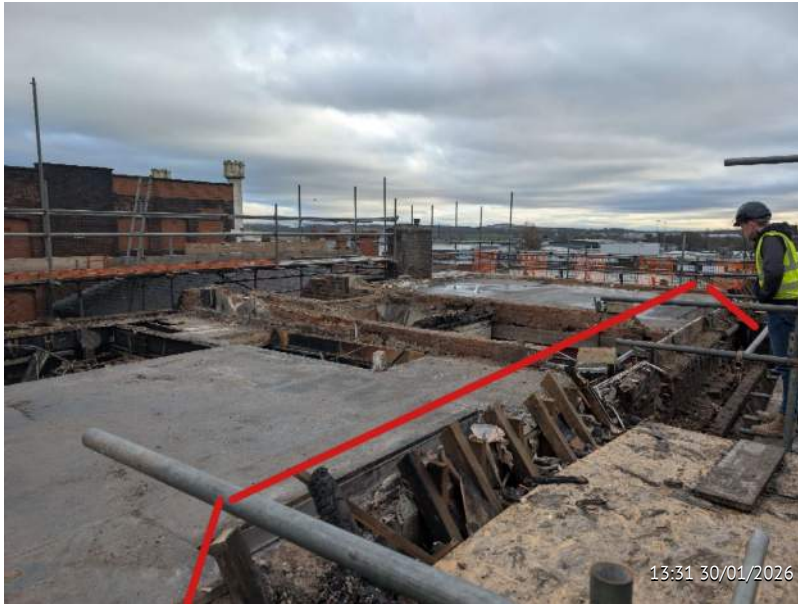
## Observation 2

View From Rear Left Looking  
Towards Front

Rafters and loose masonry yet to  
be removed.

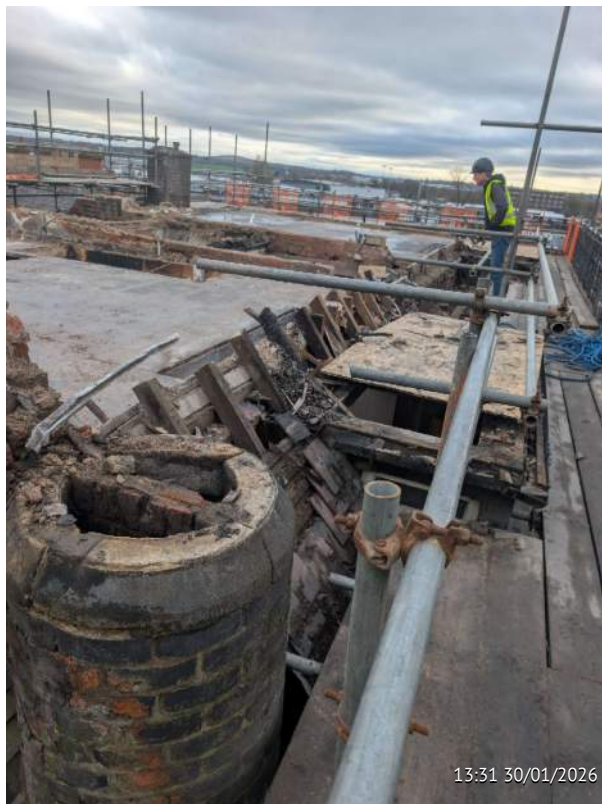
## Observation 3

View Along Left Hand Eaves

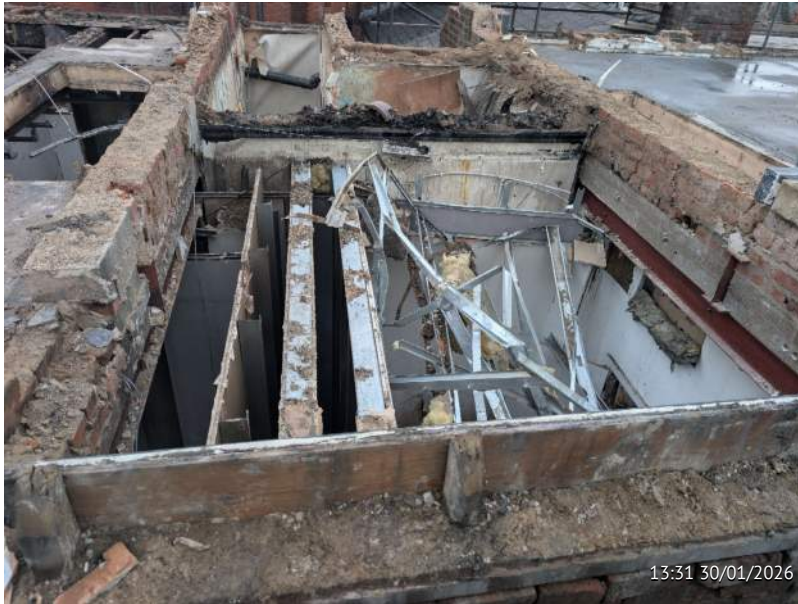
#### Observation 4

Central Left Section

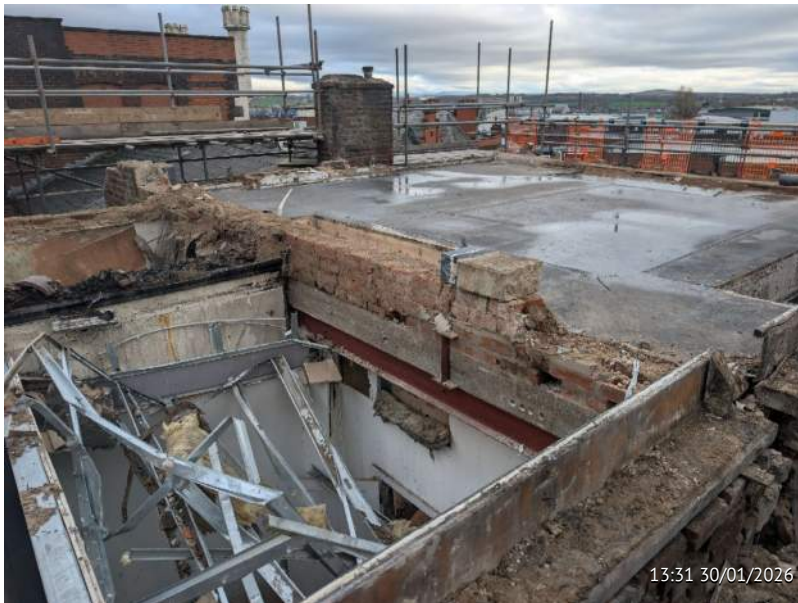
#### Observation 5

View On Front Section

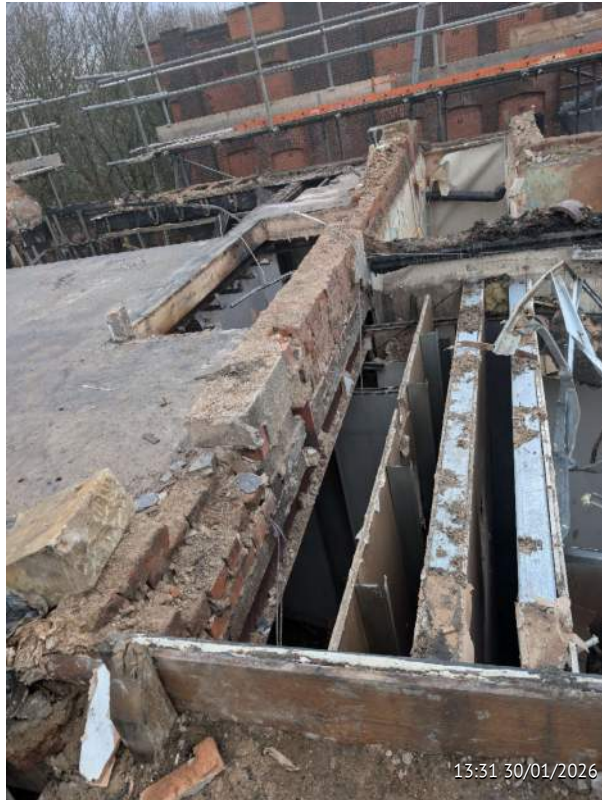
### Observation 6

Rear Cross Wall

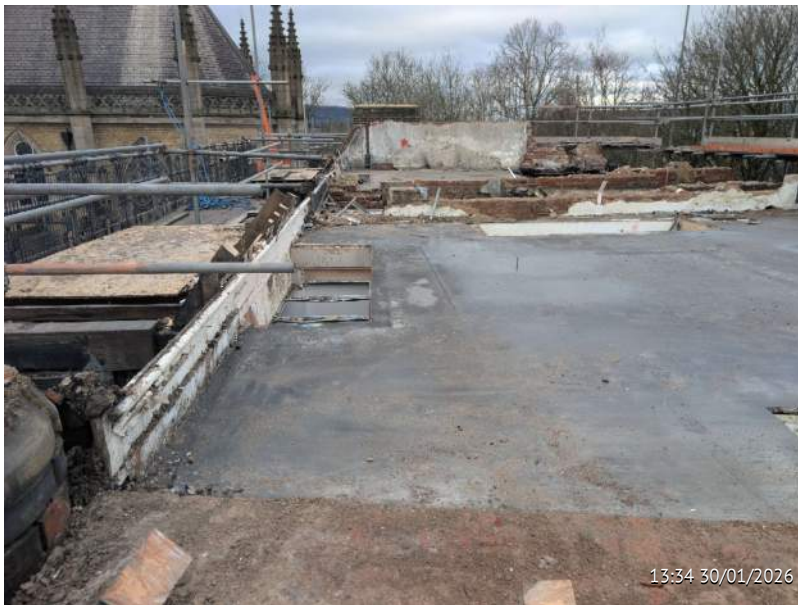
### Observation 7

View Towards Rear From Front  
Left Corner

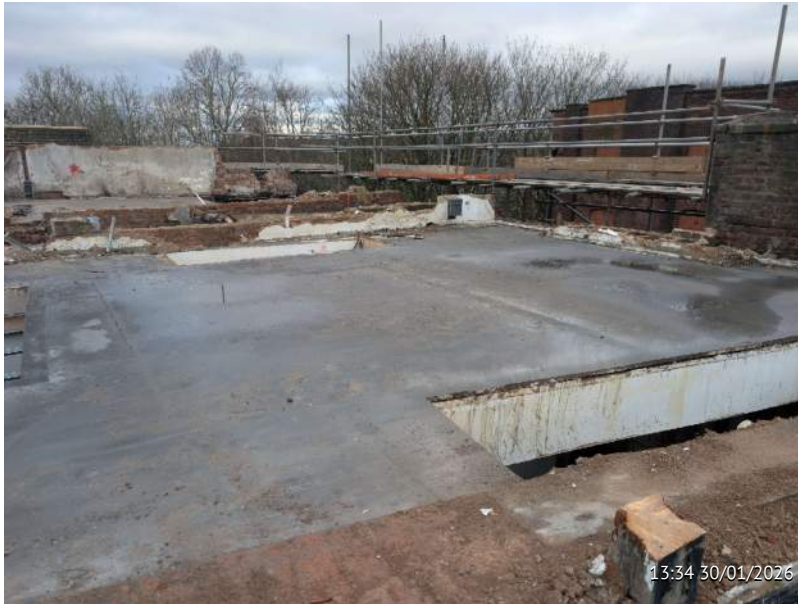
### Observation 8

View Towards Rear From Front  
Left Corner

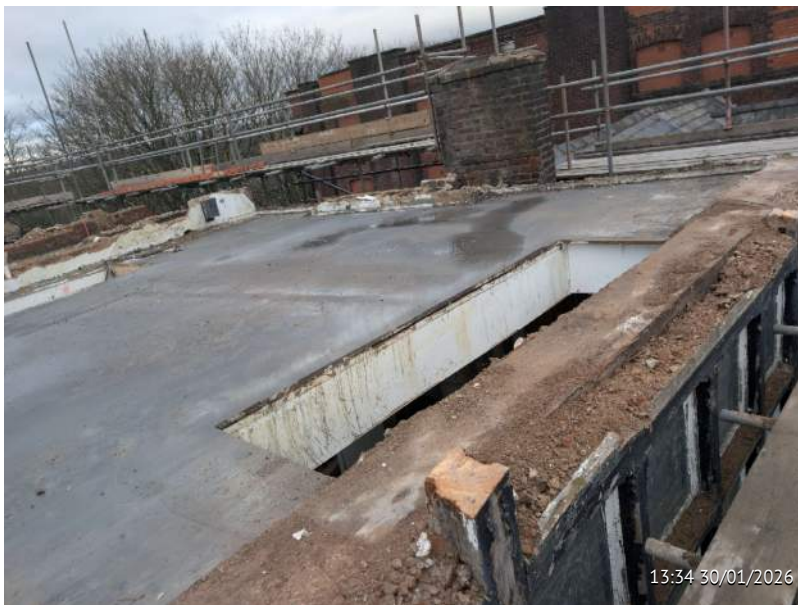
### Observation 9

View On Front Section

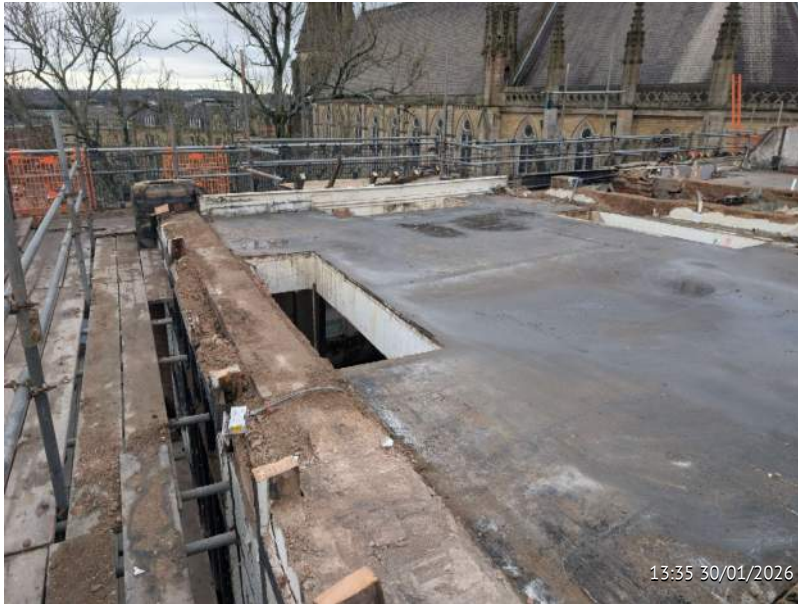
### Observation 10

View On Front Section

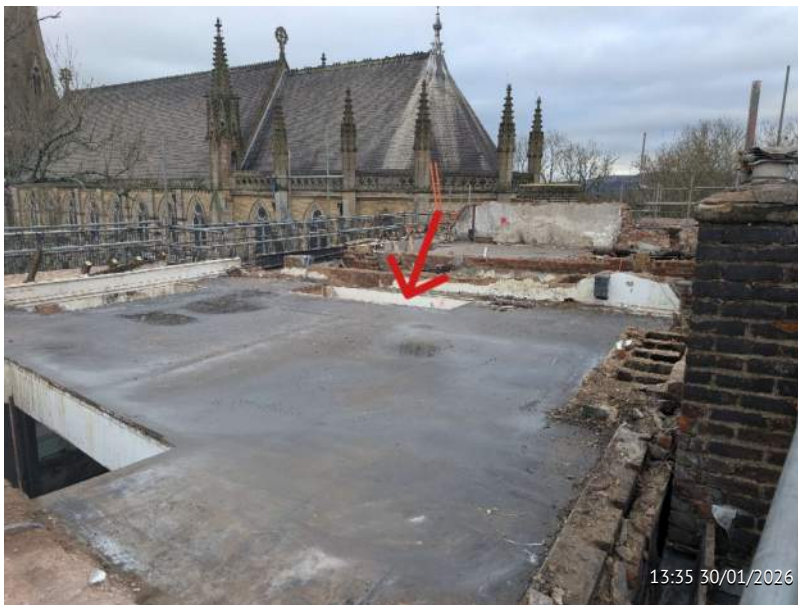
### Observation 11

View Towards Rear From Front  
Right Corner

Stairs up from 3rd floor have  
collapsed.

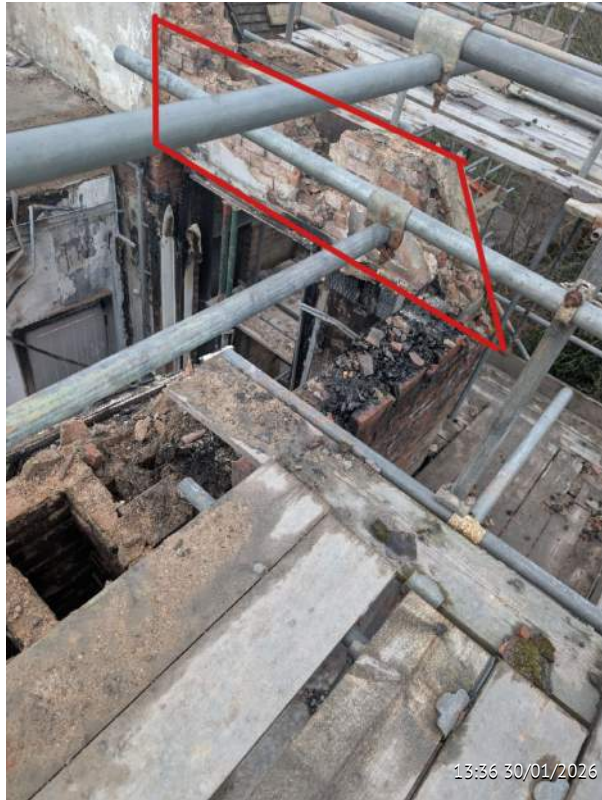
### Observation 12

Rear Right Corner

M&G were asked to consider whether the brickwork above the rear right window (currently propped) could be removed to facilitate further debris removal activities – M&G to advise.

M&G to advise if the section of brickwork highlighted can be removed to facilitate further clean up works.

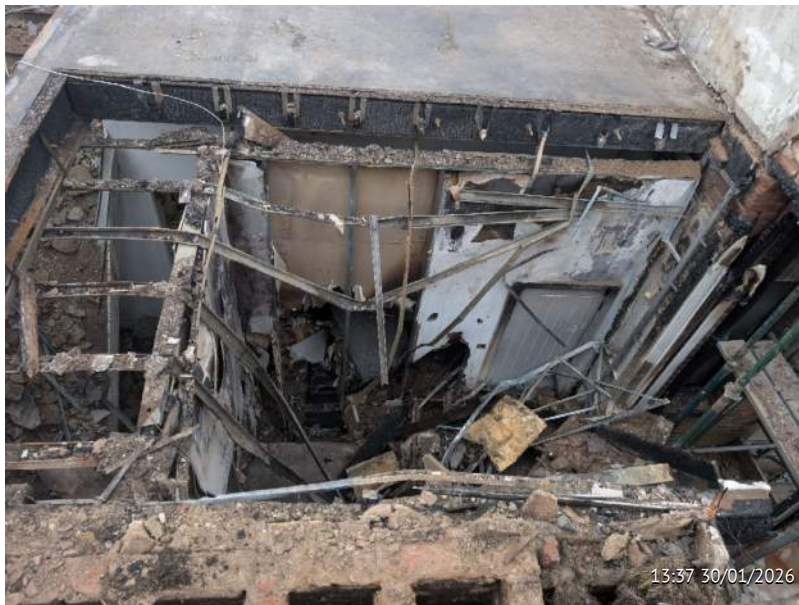
### Observation 13

Rear Right Section

Significant build up of debris on floor.

Contractor unable to remove with current demolition methods.

The next phase is to remove debris internally. Due to the amount of debris on the upper floors, this should be done in a bottom-up sequencing, allowing propping of the floors and central staircase to be installed as the clean-up progresses upwards. Propping should extend through the ground floor and into the basement.

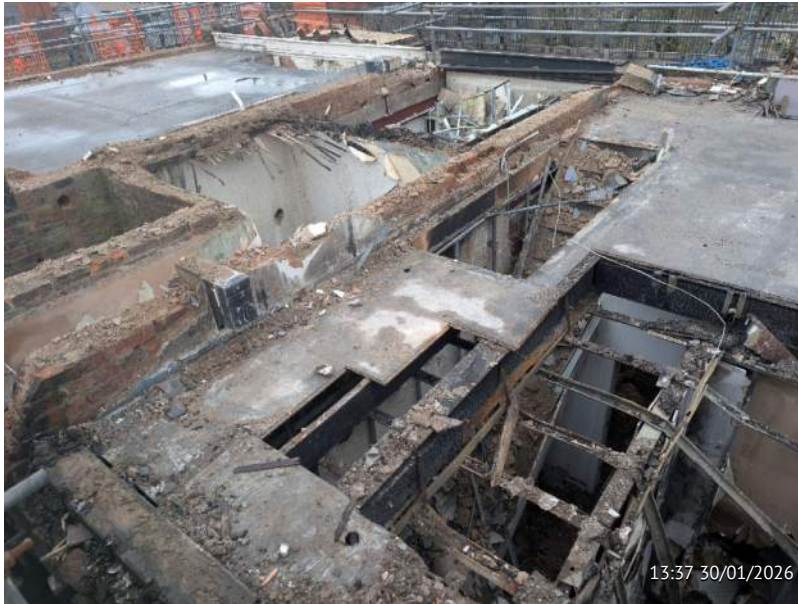
#### Observation 14

View On Rear Central Section

Significant build up

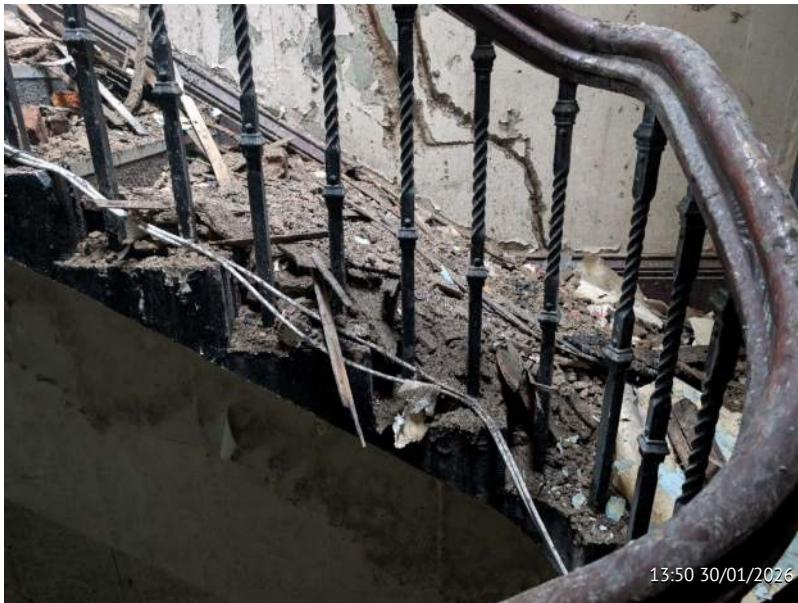
#### Observation 15

Central Staircase At 2nd Floor  
Half Landing

Significant build up of debris on  
stair - not considered to be safe to  
walk on.
