# **POST FIRE PRELIMINARY INSPECTION REPORT**

**1 The Rock, Bury**

**Broad Property Ltd**

| <b>Title</b> | Post Fire Preliminary Inspection Report | | |

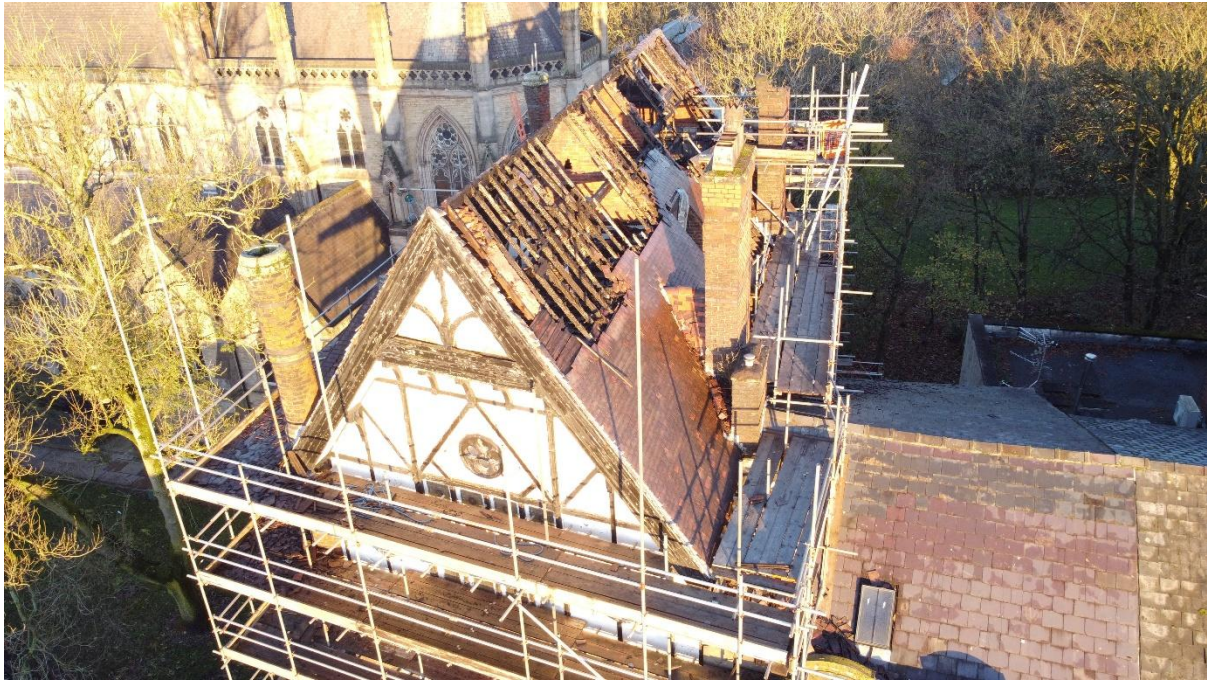
- 3.3 The roof timbers have, in the most part, been destroyed with only larger sections (predominantly purlins) remaining insitu but these are heavily charred and considered to be structurally unsound.

*Picture 1 View On Roof*

1. Remove the timber roof overhangs on the front and rear elevations.
  2. Take the remainder of the roof structure down to eaves level.
  3. Dismantle the gables and transvers cross walls down to eaves level.

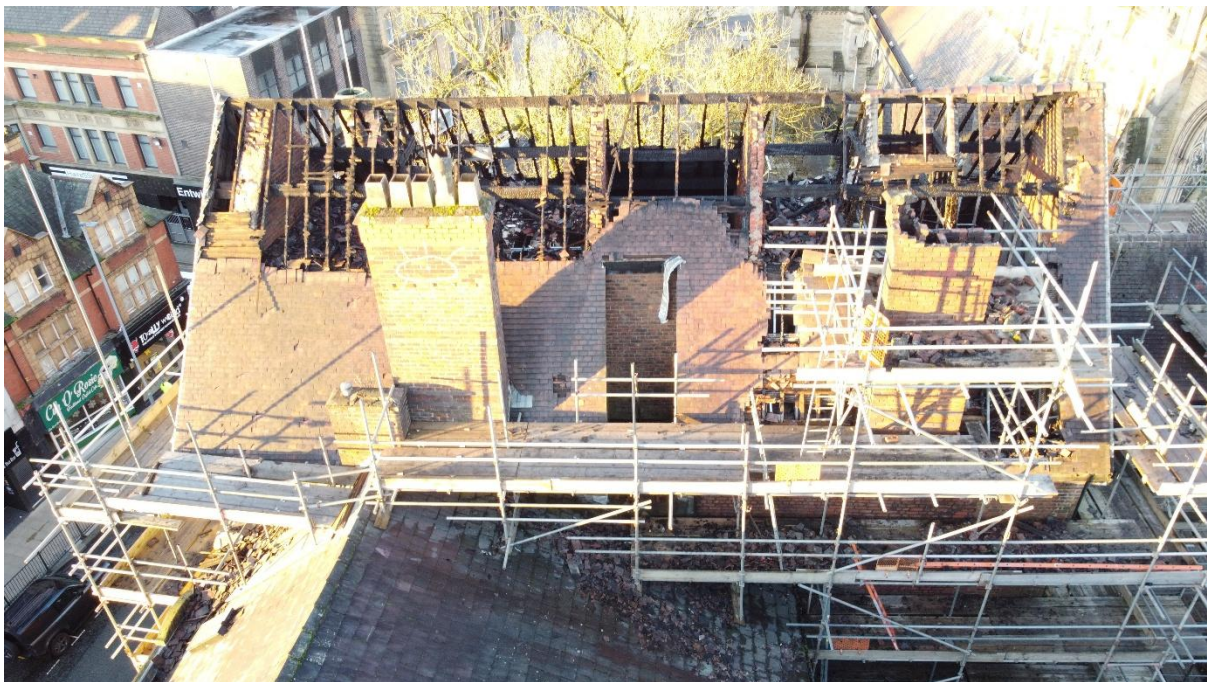
*Picture 2 View On Roof*

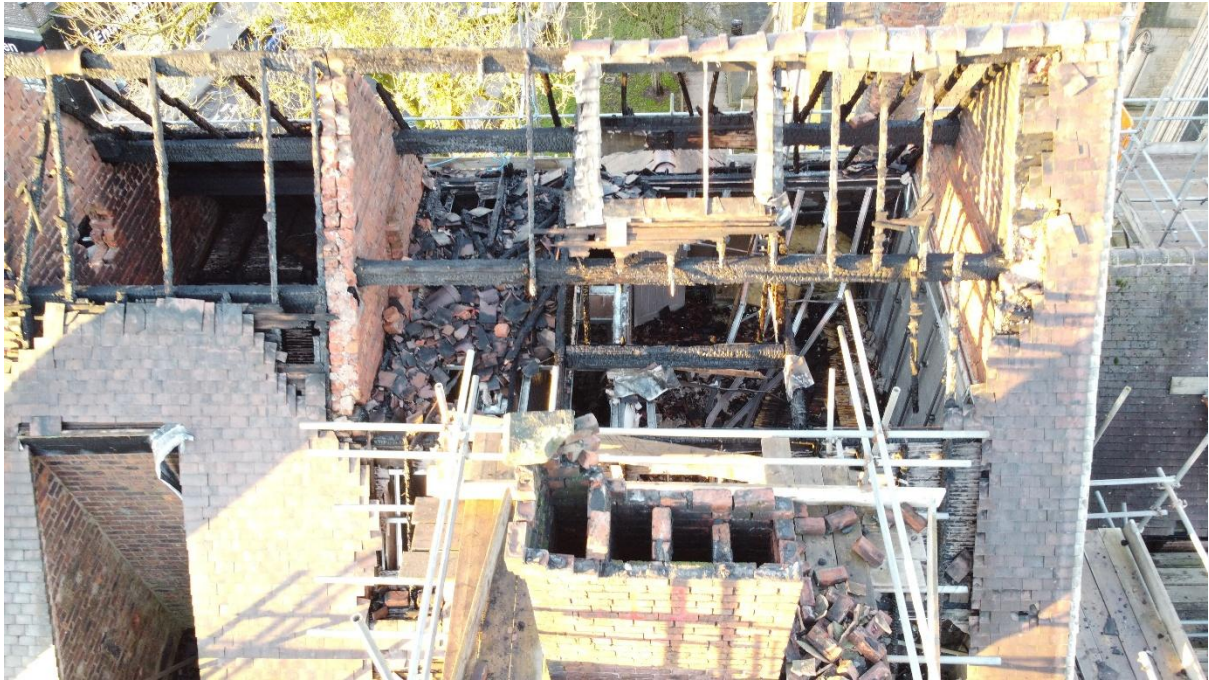
*Picture 3 View On Roof - Rear Section*

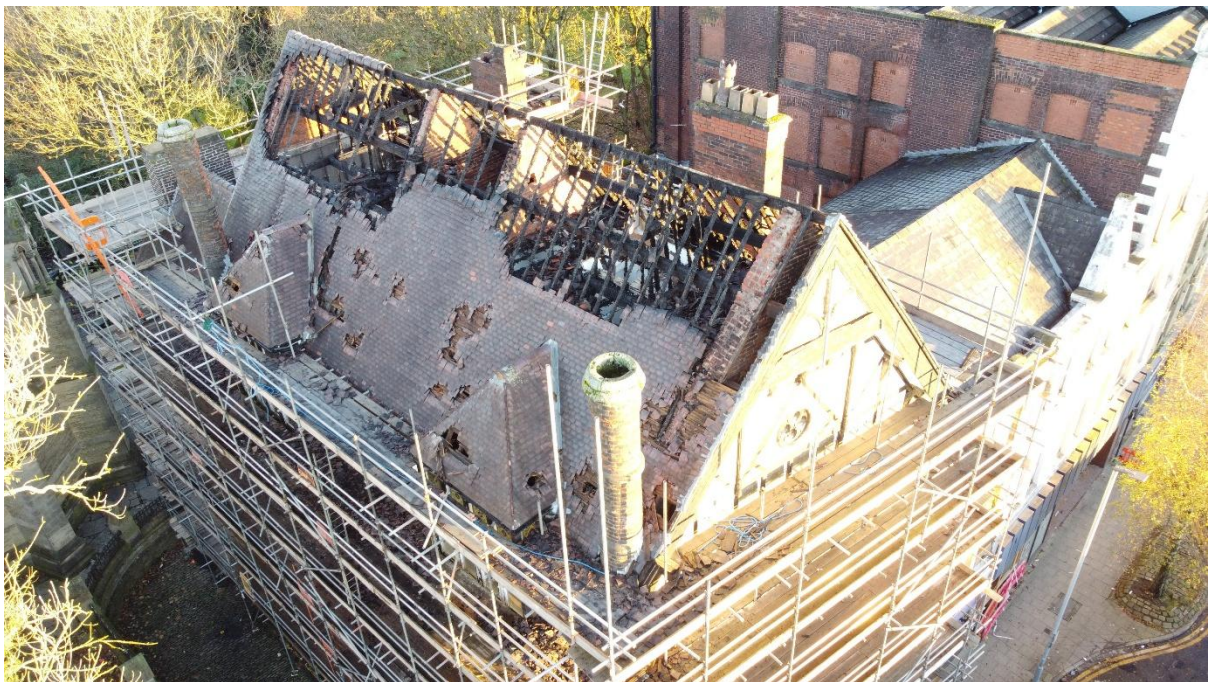
*Picture 4 View On Roof*

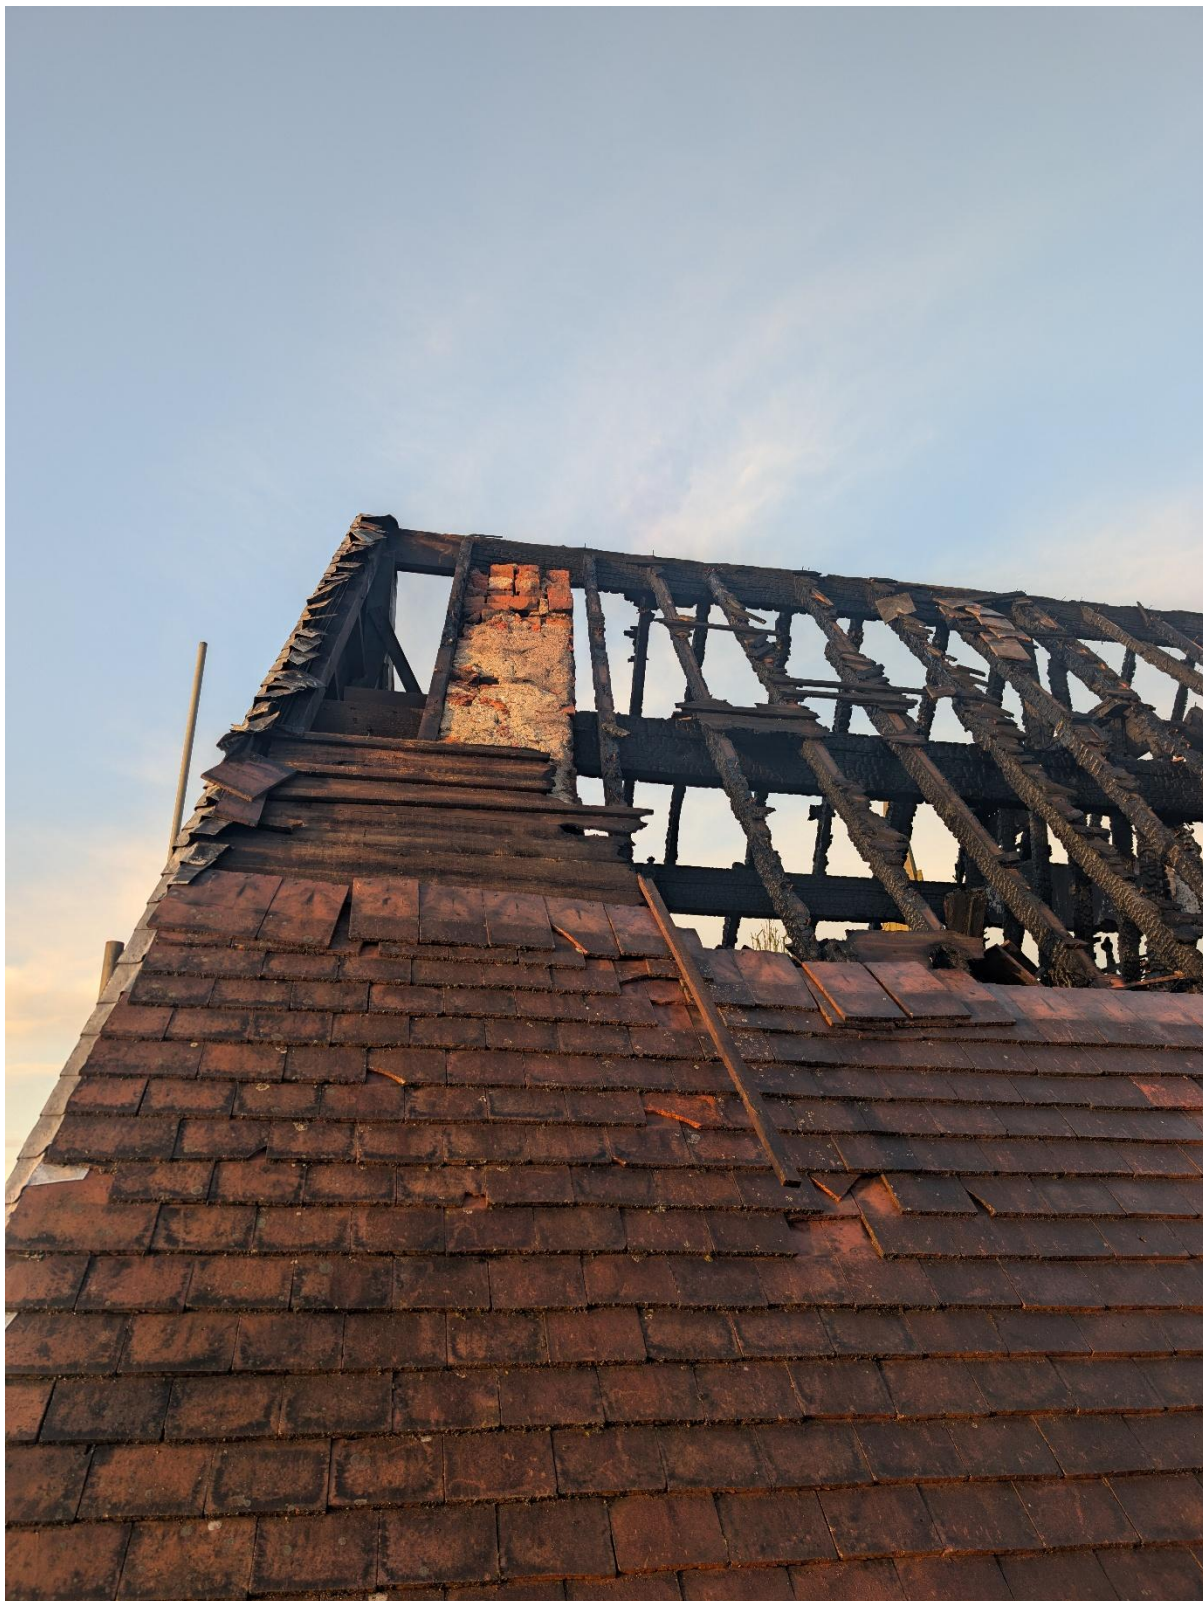
- 3.5 The purlins extend through the front and rear gables and provide support to the roof overhangs, barge and soffit boards. Consequently, the structural stability of these elements is now compromised and indeed the front timber panelling appears to be displaced outwards and its integrity of significant concern.

- 3.6 There is also a slight inwards lean of the front gable wall towards the peak.
- 3.7 The internal cross walls at roof level are in very poor condition and could collapse without warning, particularly if wind speeds become elevated.

*Picture 5 View on Front Gable - Slight Inwards Lean at Peak – Localised Outwards Displacement of Roof Overhang*

- 4.4 Whilst in theory it may be possible to provide temporary lateral support to the front and rear gables, there will be a period of time during removal of fire damage structures when they will be unrestrained. As the structural stability of these gables can not be guaranteed, even in the short term, and given the consequence of collapse would be catastrophic, we are of the opinion that the gables should also be dismantled down to approximately eaves level as well.

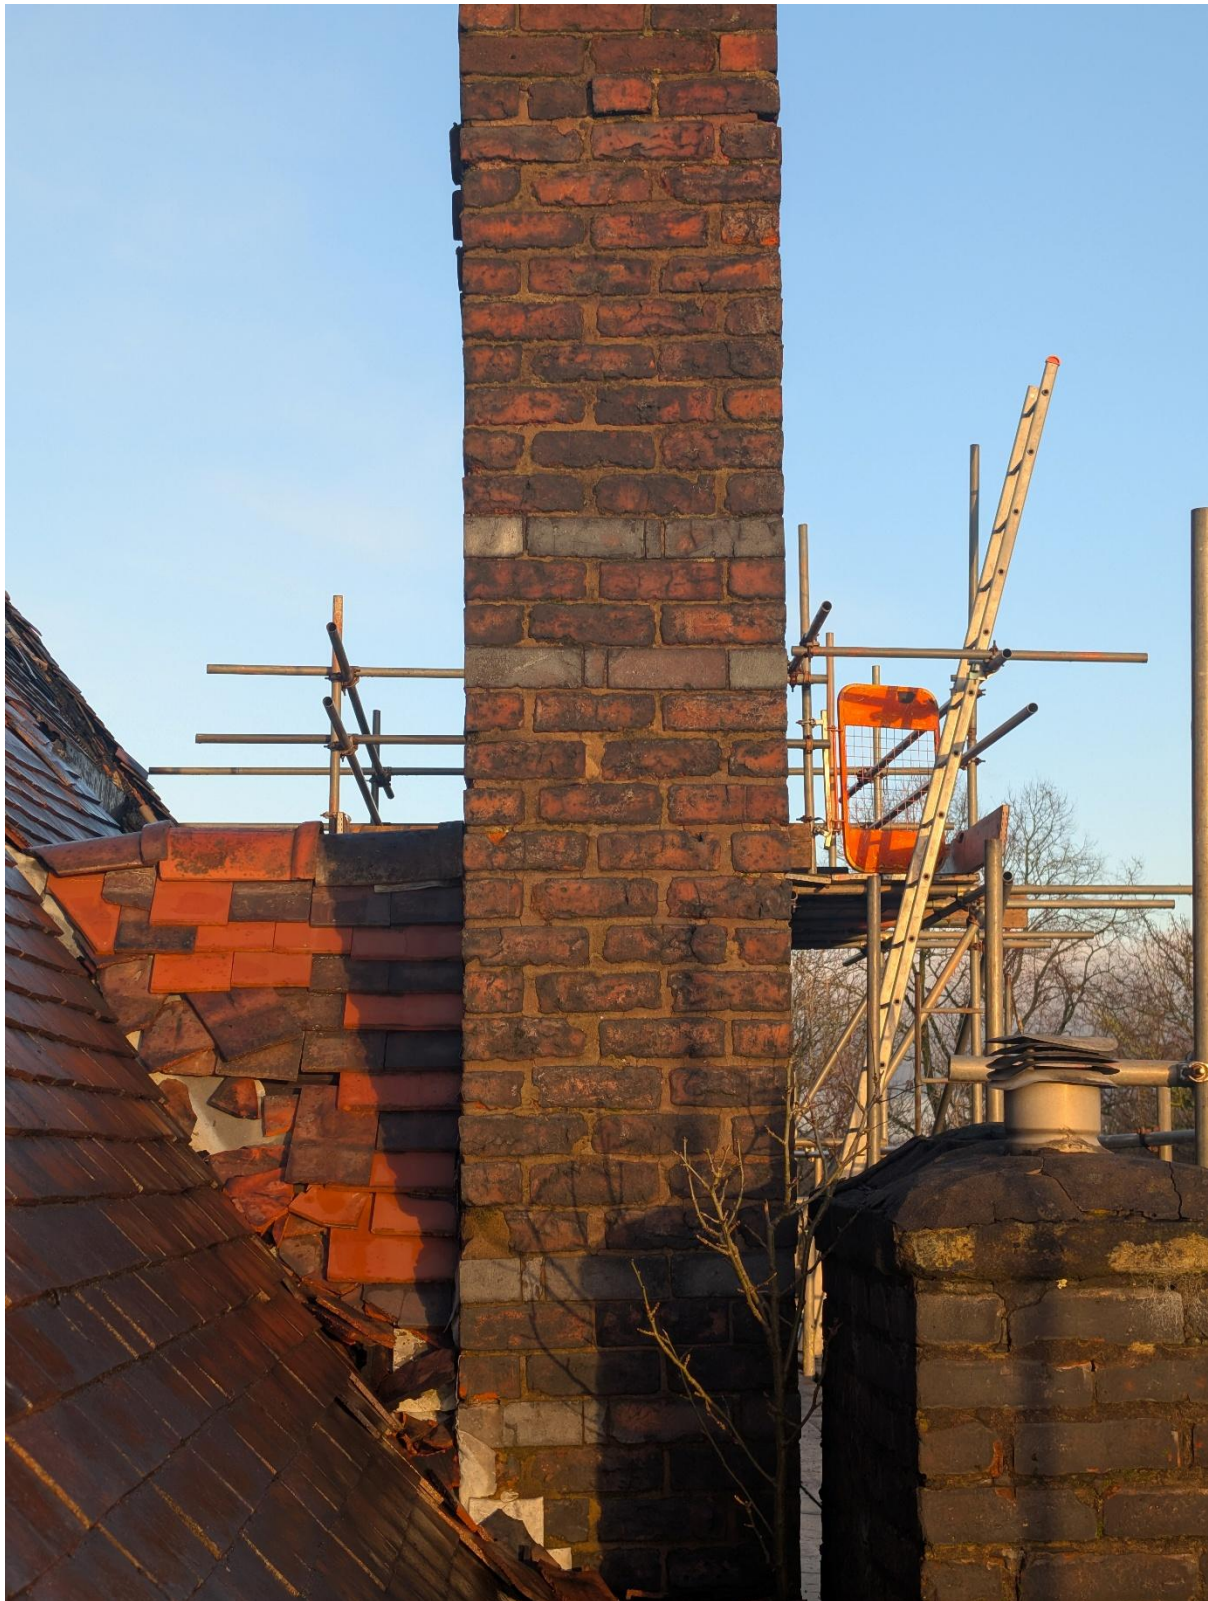
- 3.8 The rear left chimney stack is damaged and the others are considered to be in poor condition. Whilst the damage on the rear left stack is as result of the fire, the condition of the others cannot be attributed to this cause. They do however rely, partially, towards their base, on restraint from the roof which has now been compromised.

*Picture 6 View on Front Left Chimney Stack - Slight Inwards Lean*

- 4.5 Finally, due to the restraint to the chimney stacks being compromised, and due to their poor condition, we are also of the opinion that these should be dismantled down to eaves level.

4. Dismantle chimney stacks down to eaves level.
  5. Prop fractured lintel on rear elevation.
  6. Prop remainder of 4<sup>th</sup> floor on the rear left section.

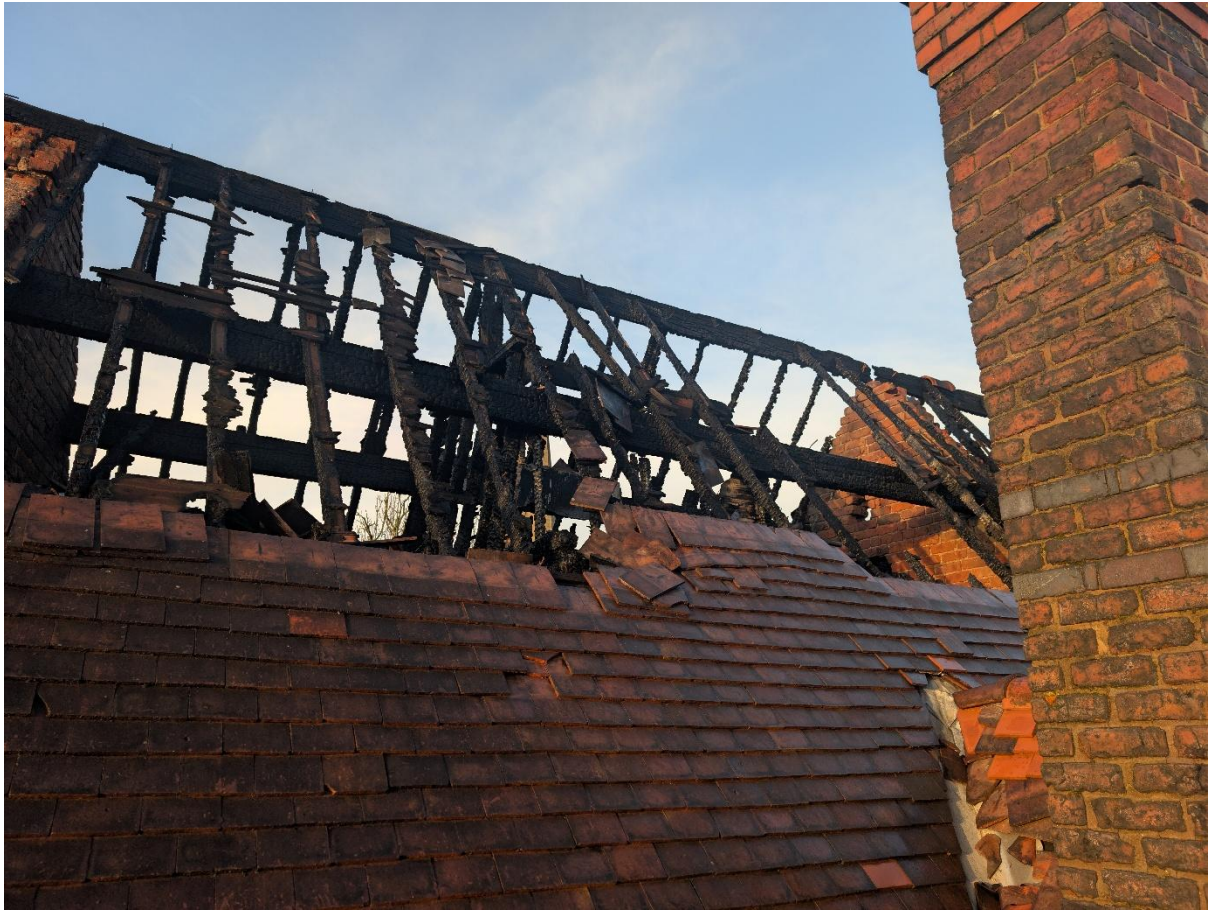
*Picture 7 View On Roof*

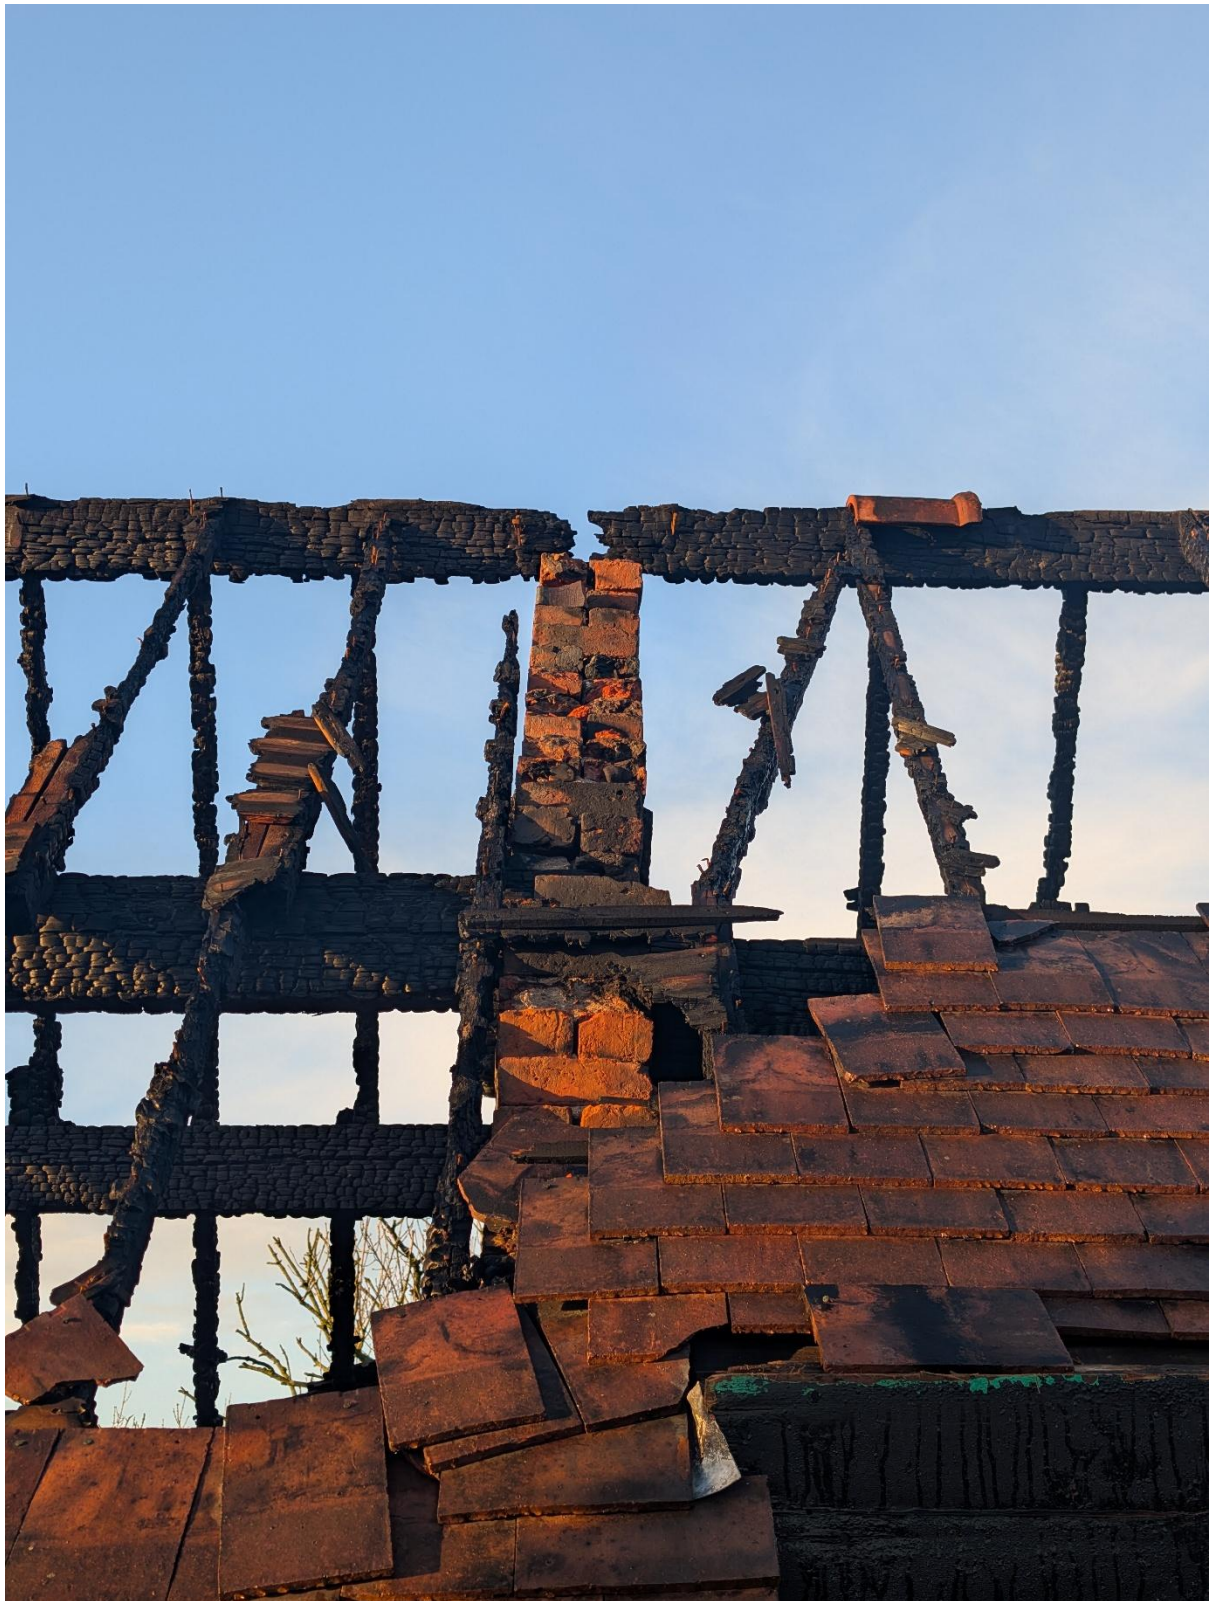
*Picture 8 View On Internal Transverse Cross Wall*

- 4.3 As the internal transverse walls at roof level are in poor condition there is no other option but to take these down to approximately eaves level.

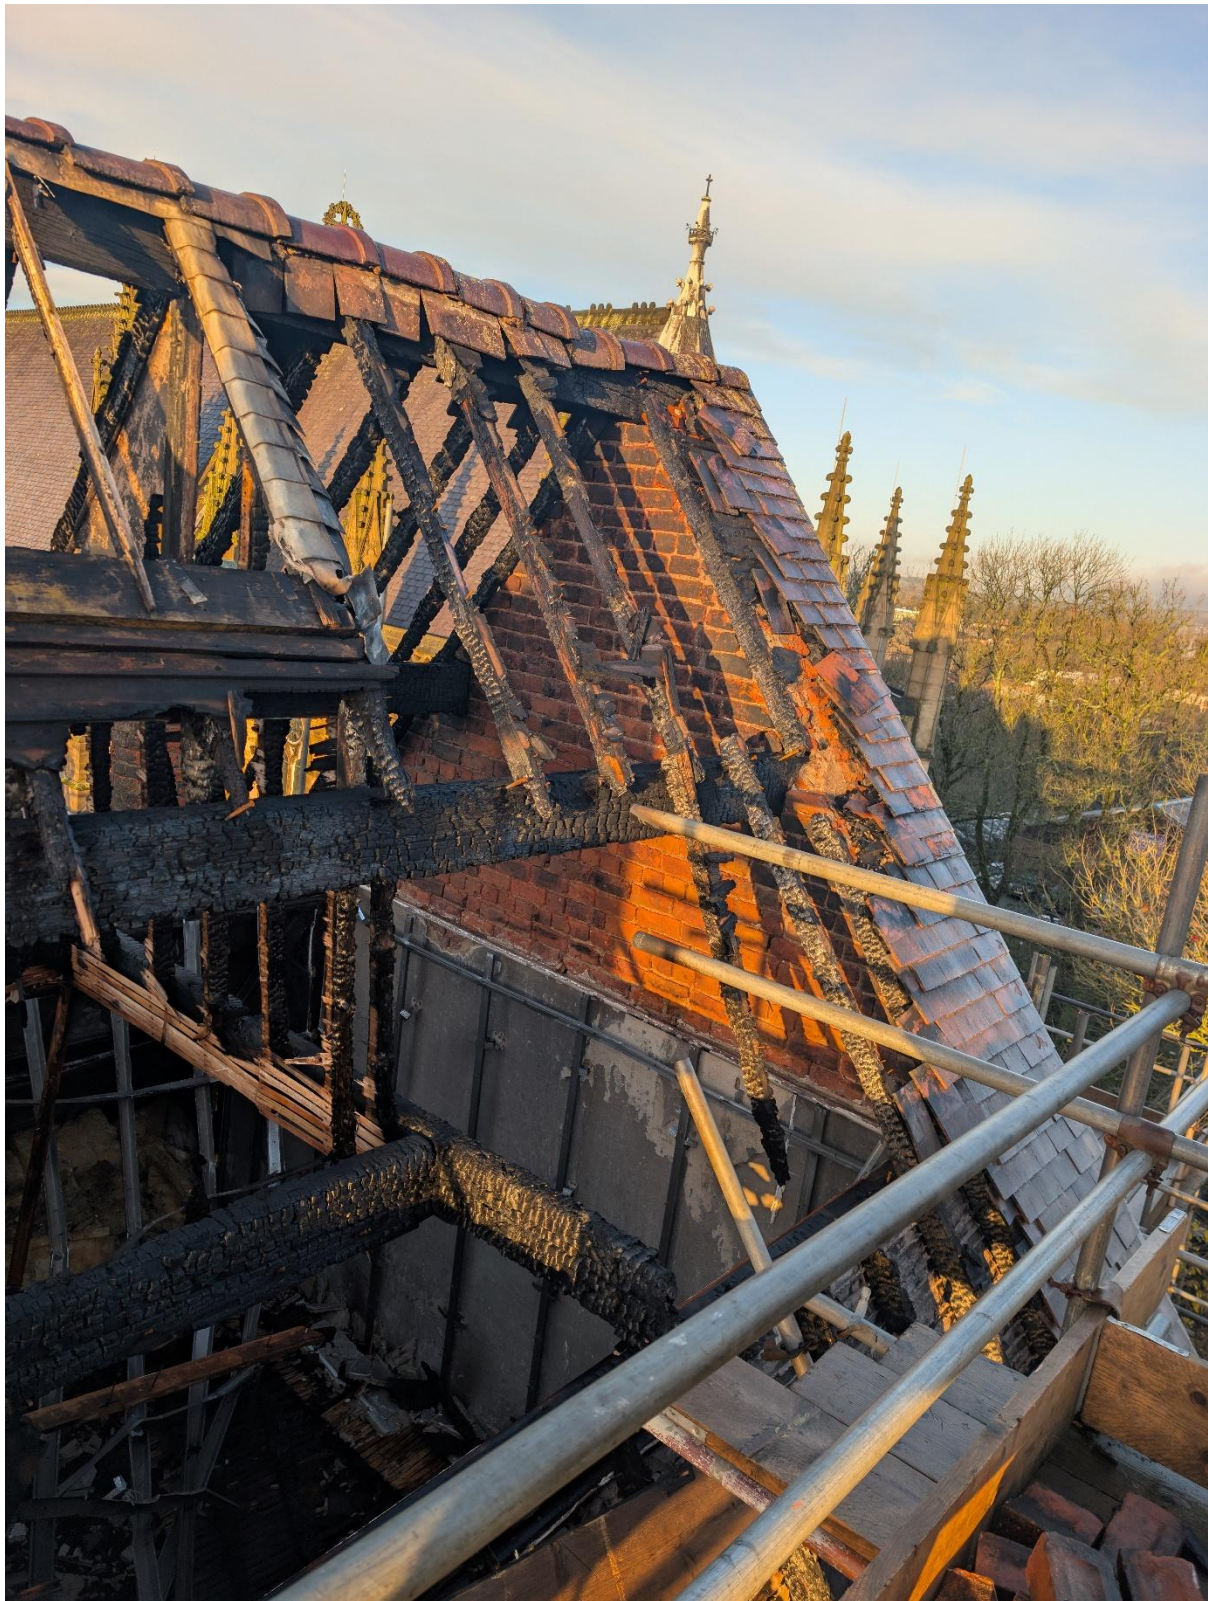
*Picture 9 View on Rear Gable - Restraint from 4th Floor Lost*

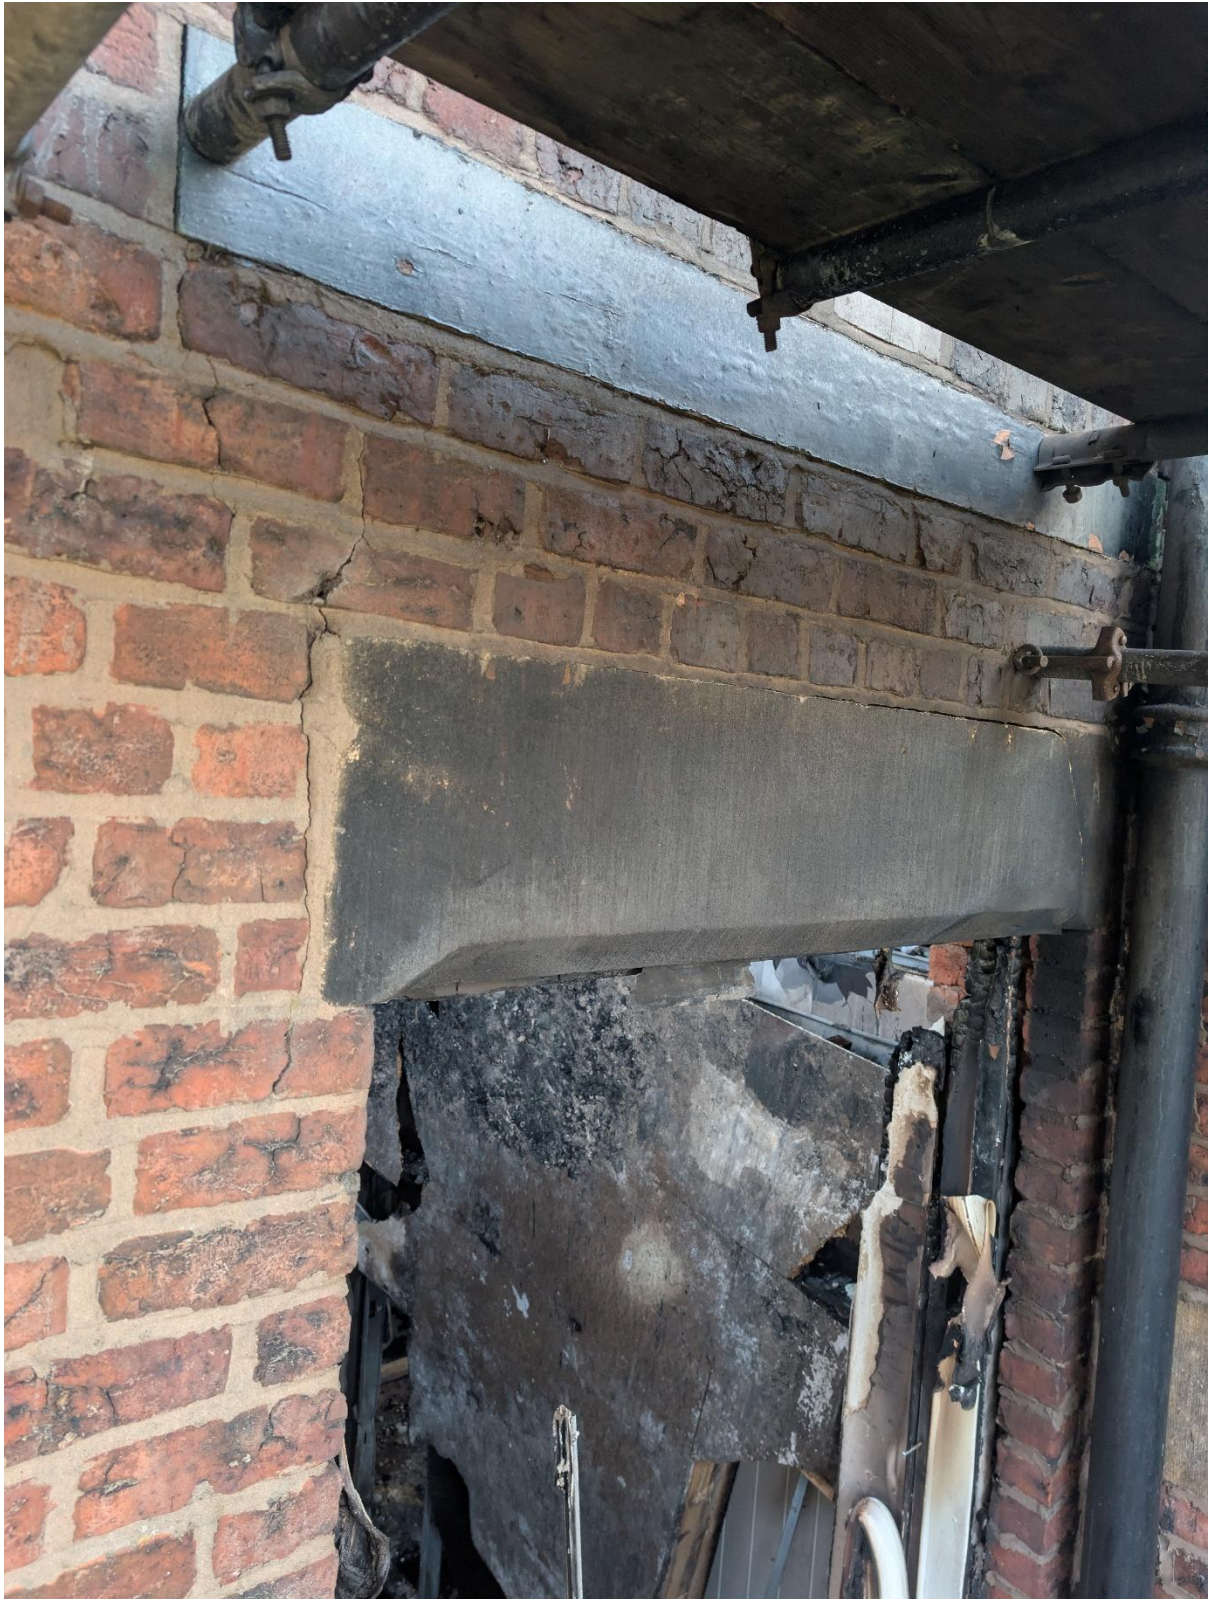
- 3.12 Below the 3<sup>rd</sup> floor the damage is primarily as a result of smoke and fire fighting activities.
- 3.13 Finally, there is a fractured lintel above a 3<sup>rd</sup> floor rear window, possibly due to thermal effects and could collapse without warning.

*Picture 10 Fractured Lintel On Rear Elevation at 3rd Floor*

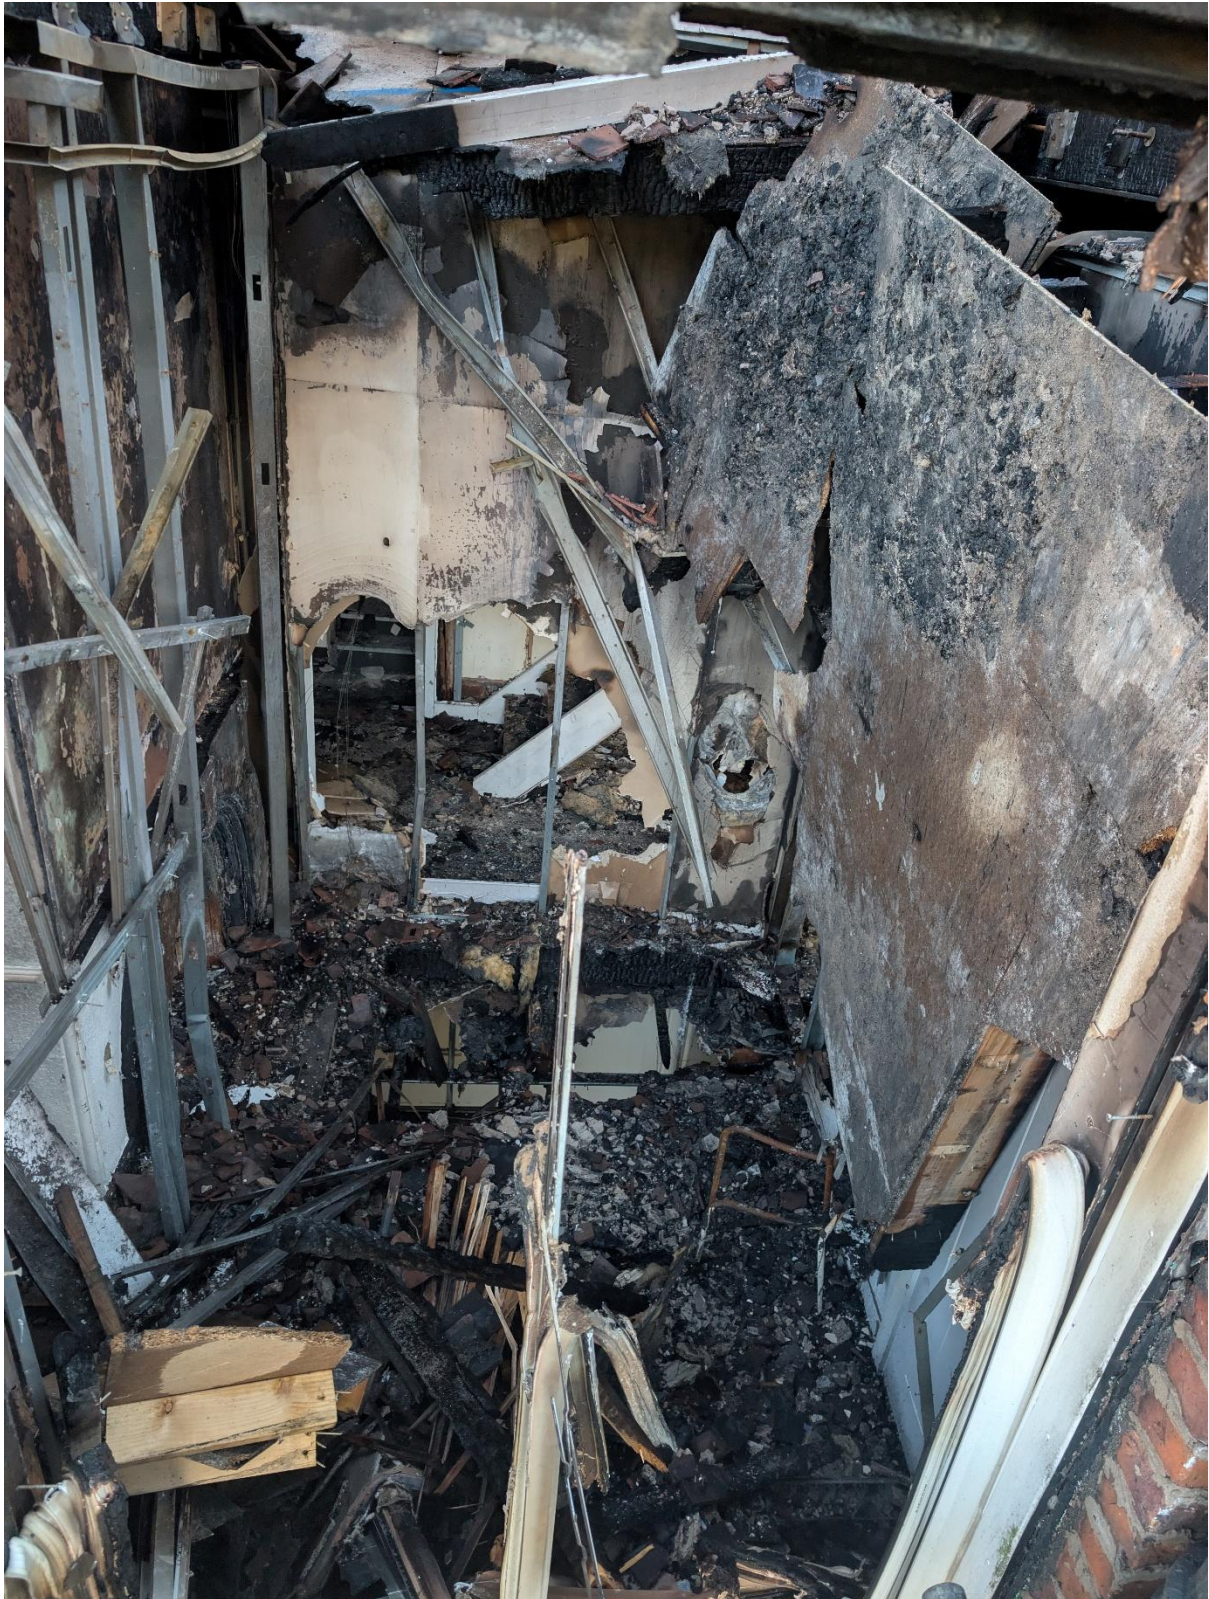
- 3.9 The 4<sup>th</sup> floor in the rear right section of the building has collapsed, and whilst the rear left section is still in place, it has not been possible to inspect this area due to unsafe access conditions. Until this can be done the floor should be considered unsafe to access.

*Picture 11 View Into 3rd Floor - 4th Floor Collapsed*

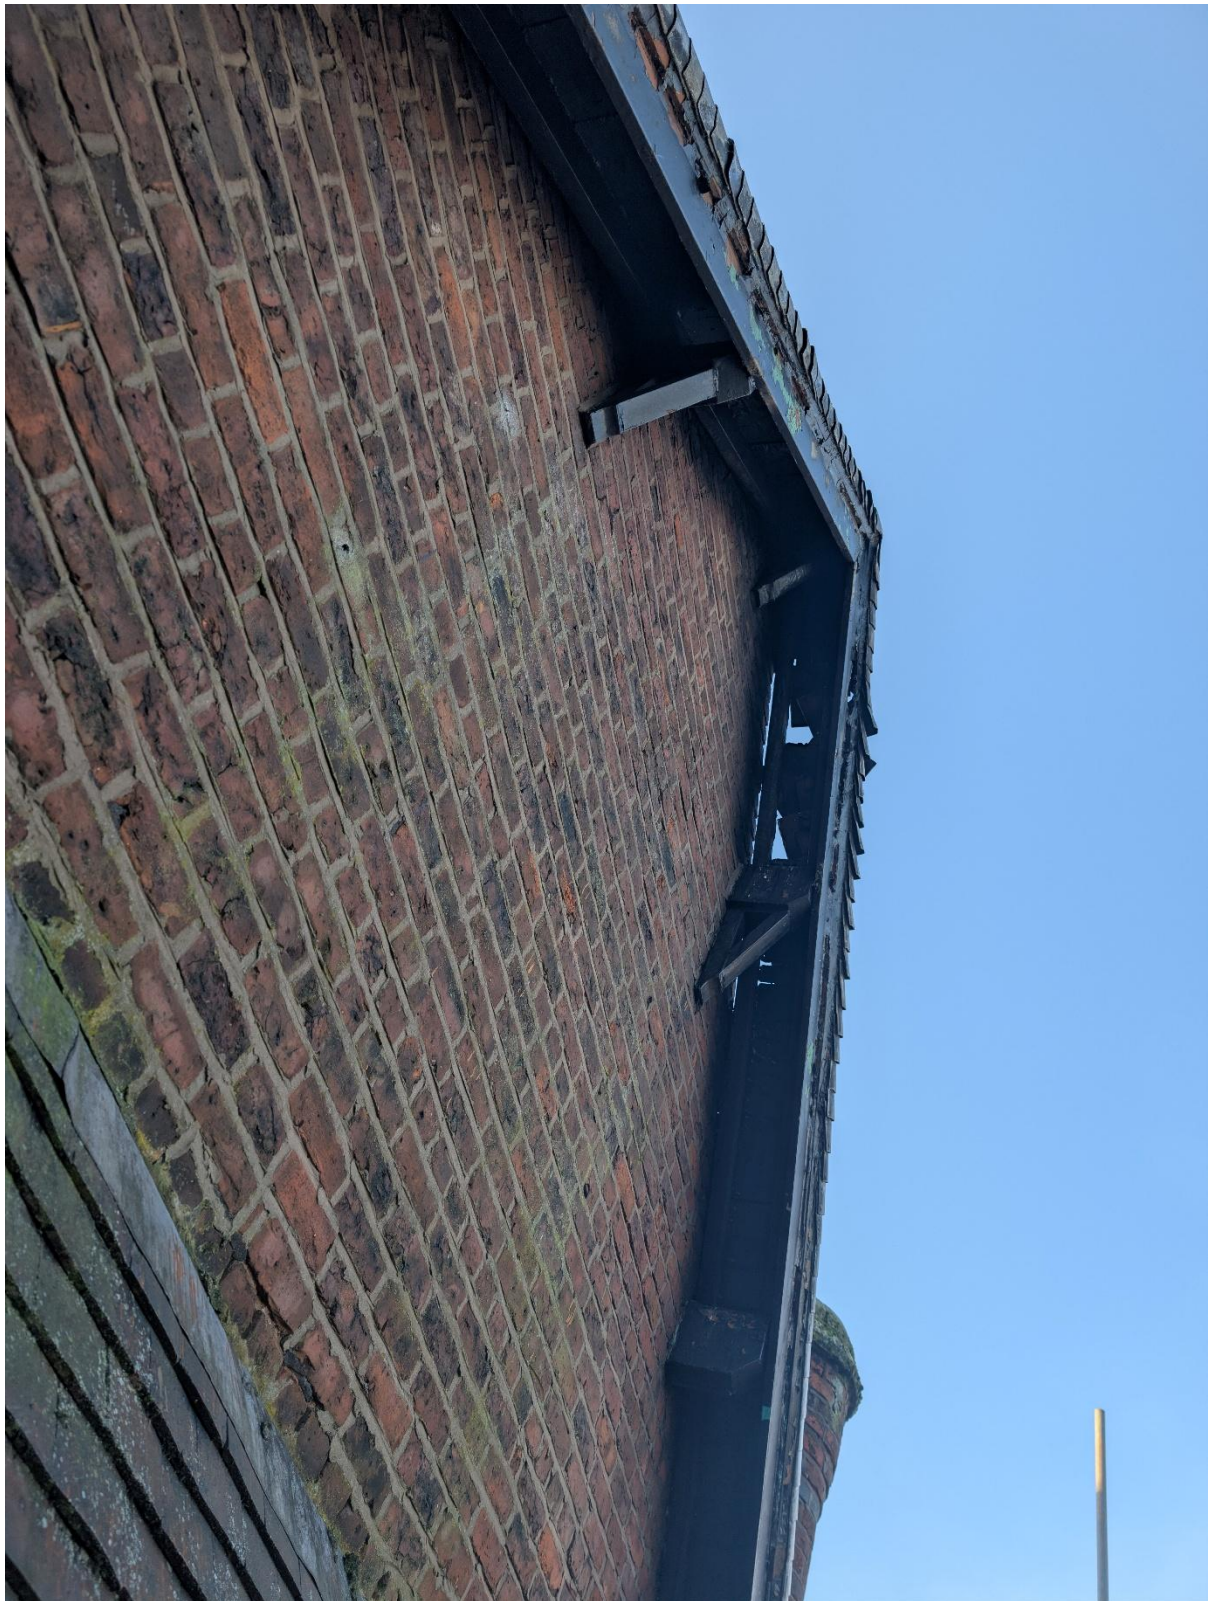
*Picture 12 Rear Roof Overhang*

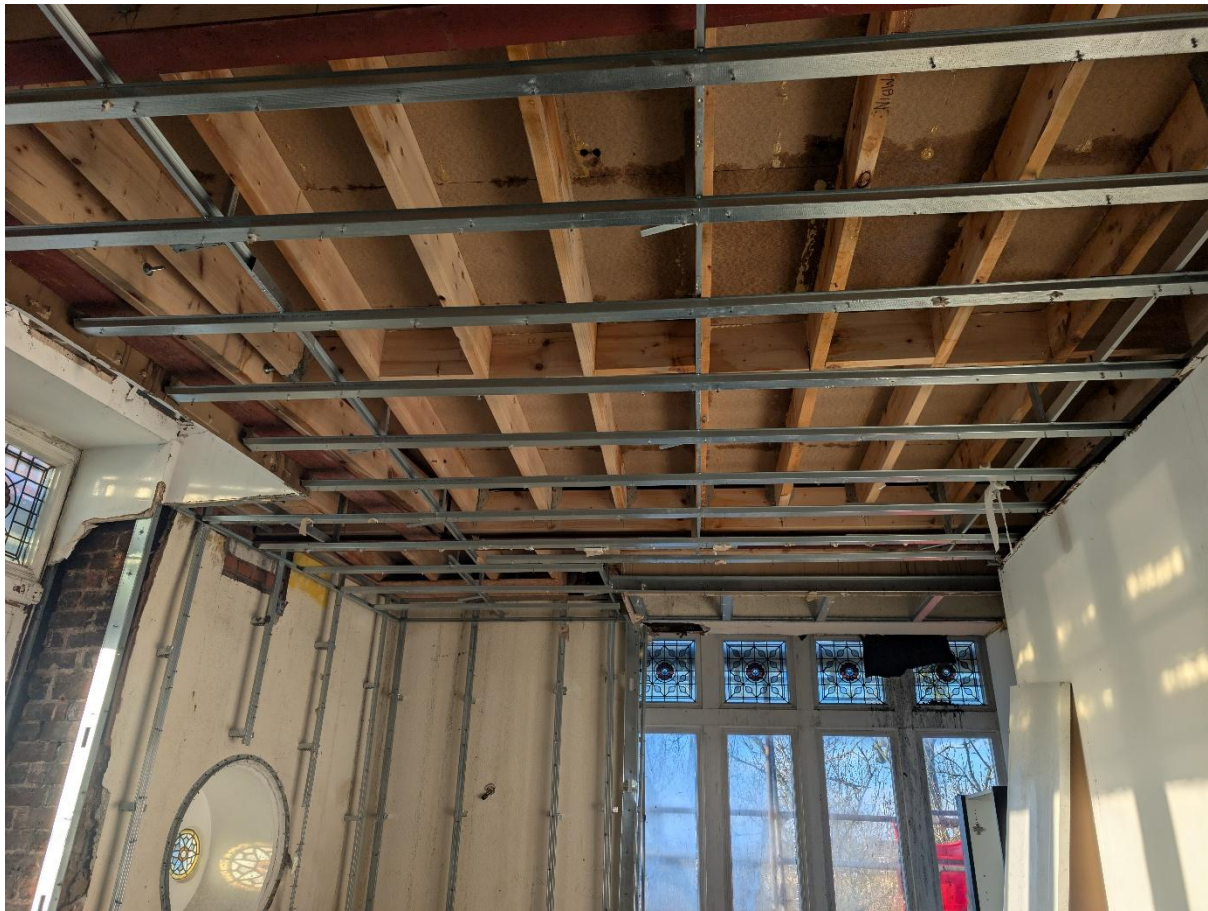
- 3.10 The 4<sup>th</sup> floor in the front section only appears to have been affected by smoke and fire fighting activities.
- 3.11 There is localised damaged to the 3<sup>rd</sup> floor, particularly in the rear section of the building. Floor boarding has locally burned away and supporting joists are heavily charred,

*Picture 13 Soffit of 4th Floor In Front Section*

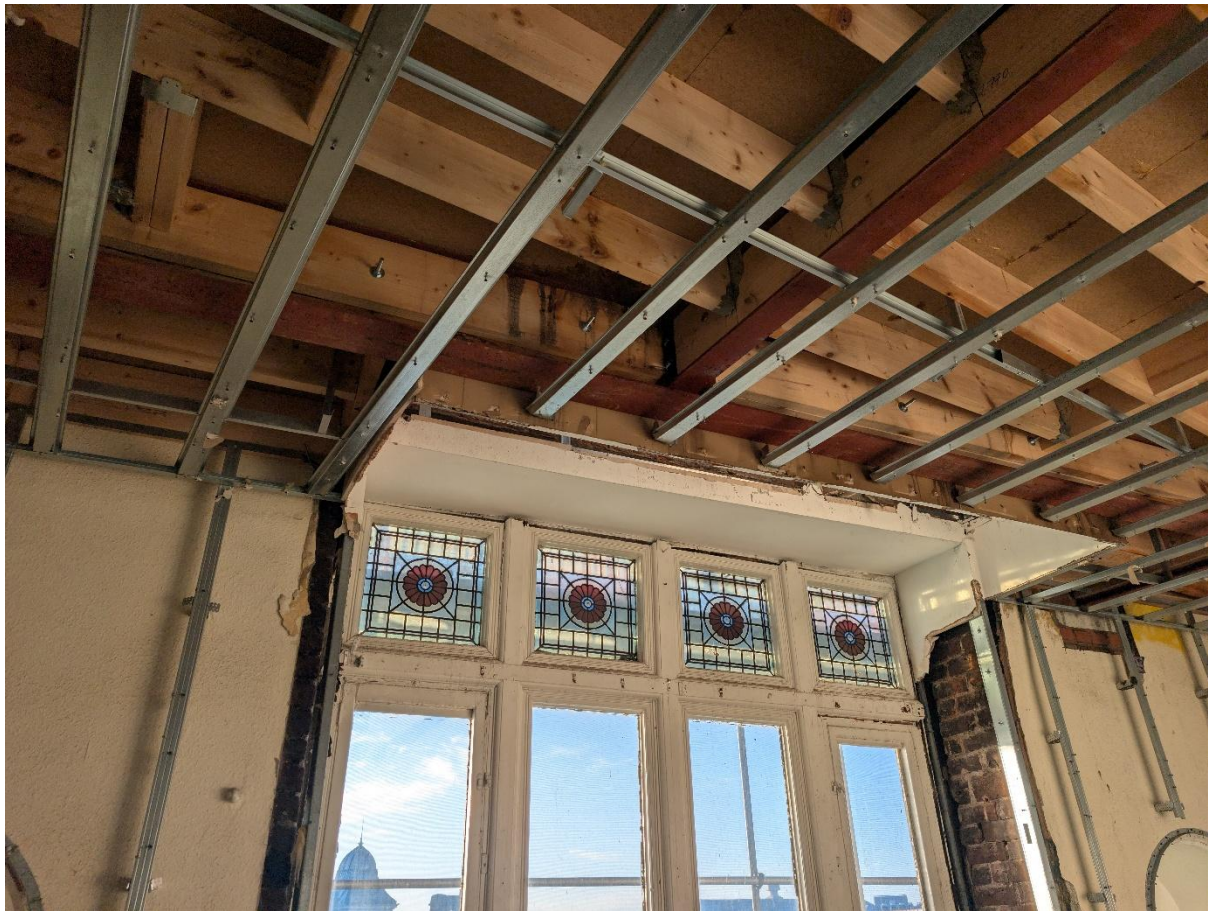
*Picture 14 Soffit of 4th Floor In Front Section*

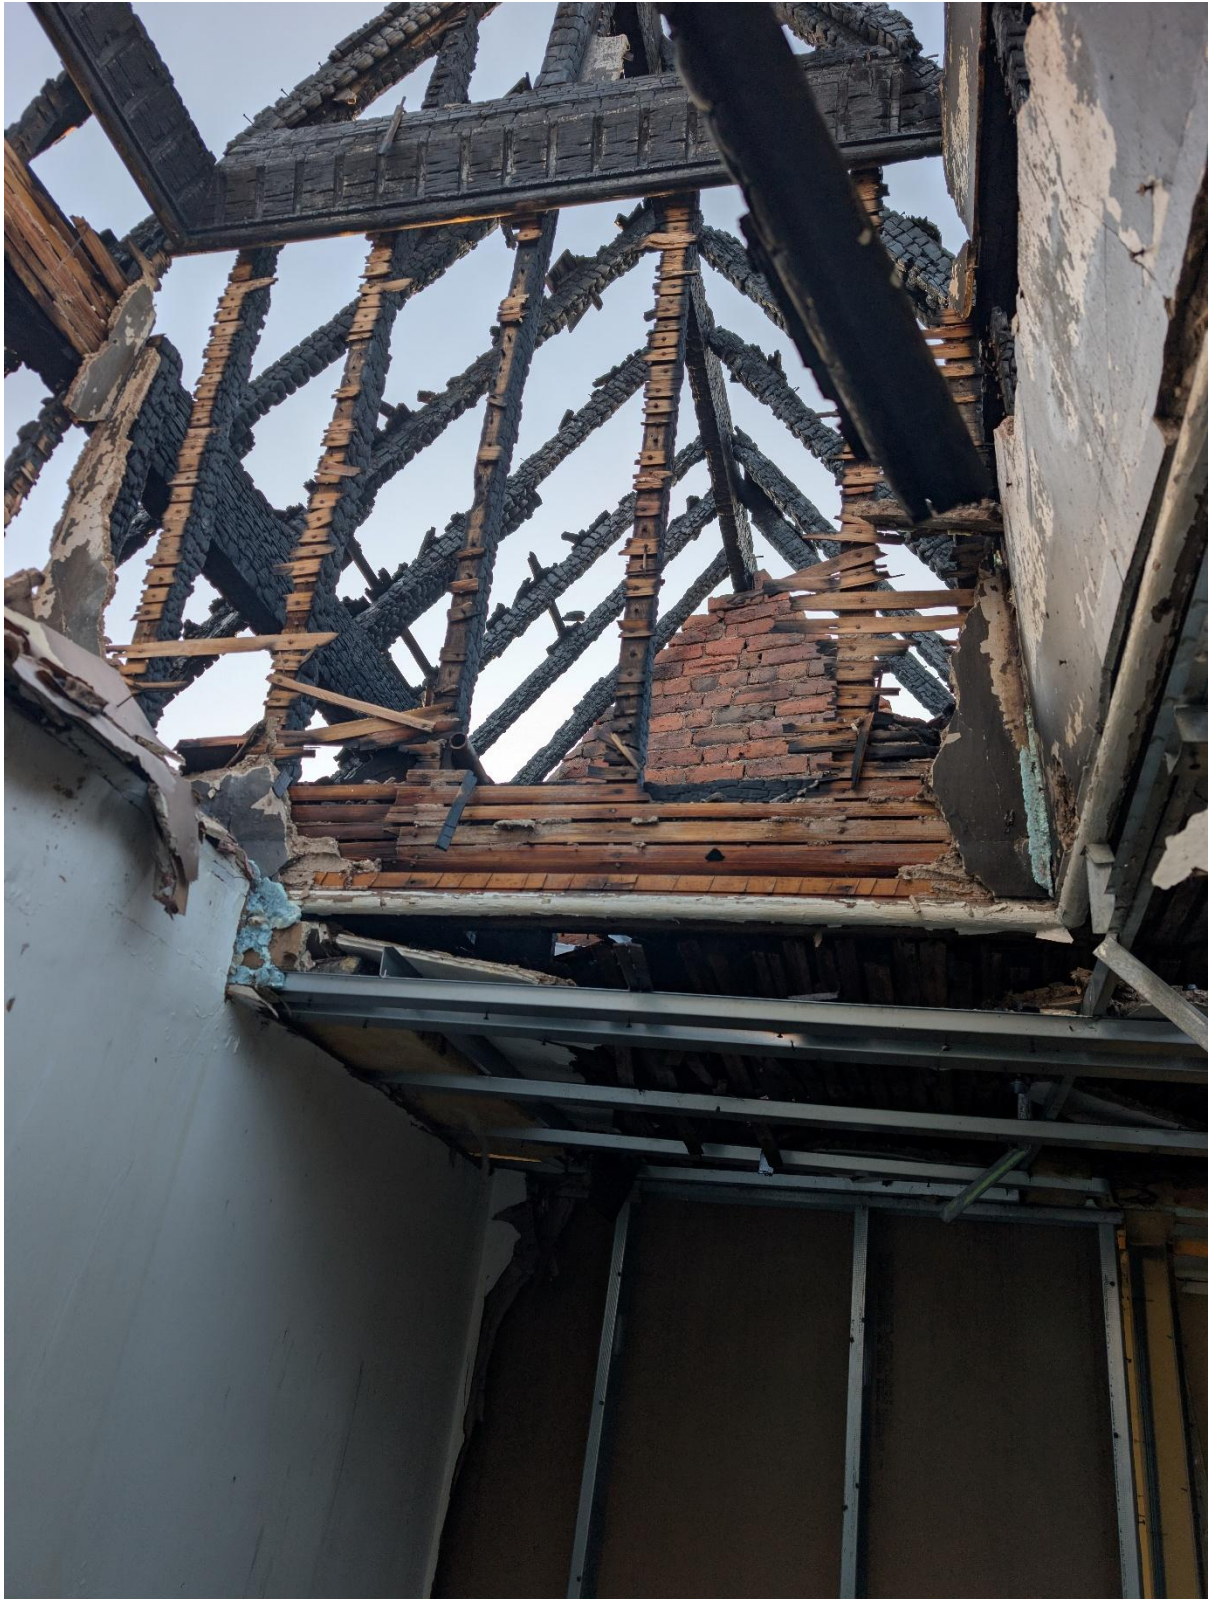
*Picture 15 View In Roof From 4th Floor*
