# **POST FIRE PRELIMINARY INSPECTION REPORT**

**1 The Rock, Bury**

**Broad Property Ltd**

| <b>Title</b> | Post Fire Preliminary Inspection Report | | |

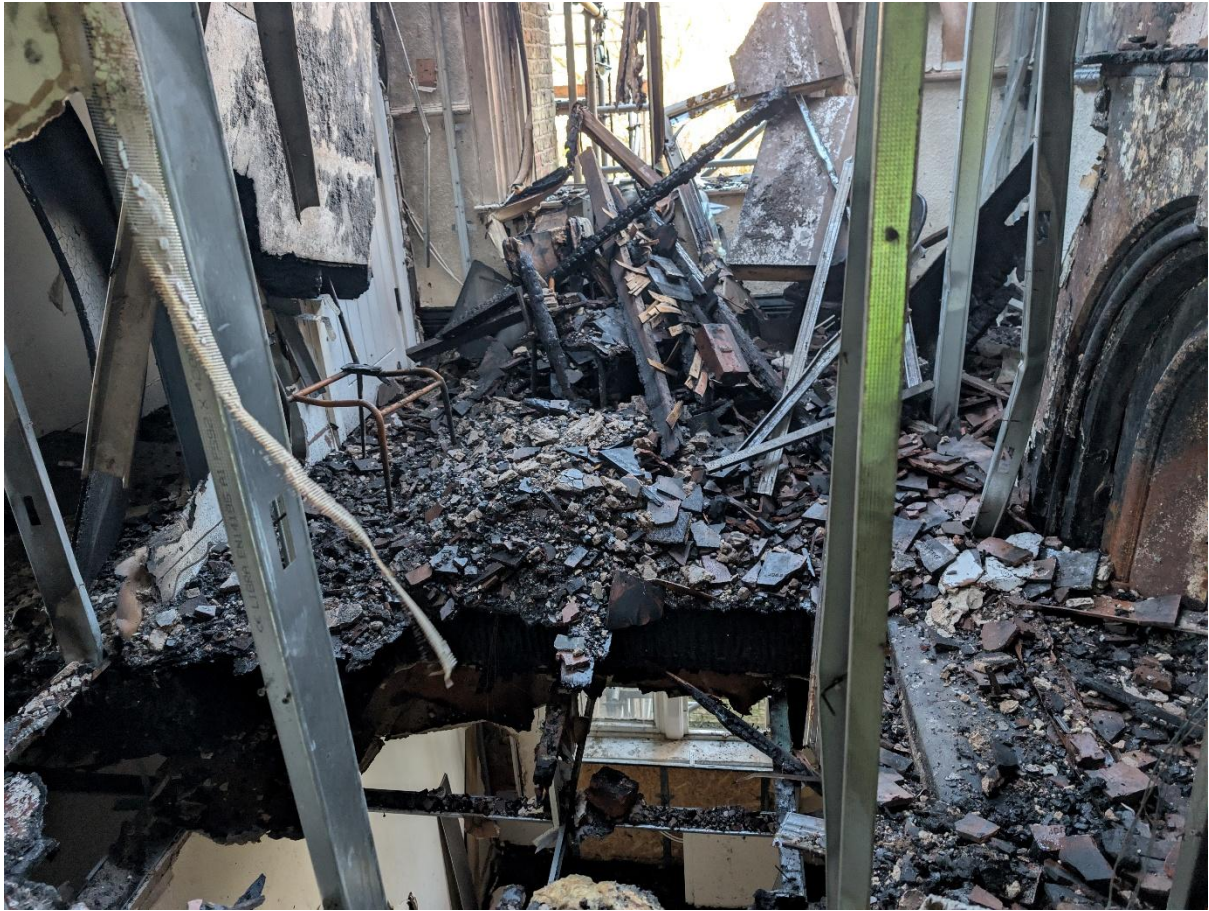
- 3.1 It is understood that the fire started on the 3<sup>rd</sup> floor in the rear right apartment which spread upwards to the 4<sup>th</sup> floor and finally into the roof.

*Picture 16 3rd Floor Rear Right - Possible Seat of Fire*

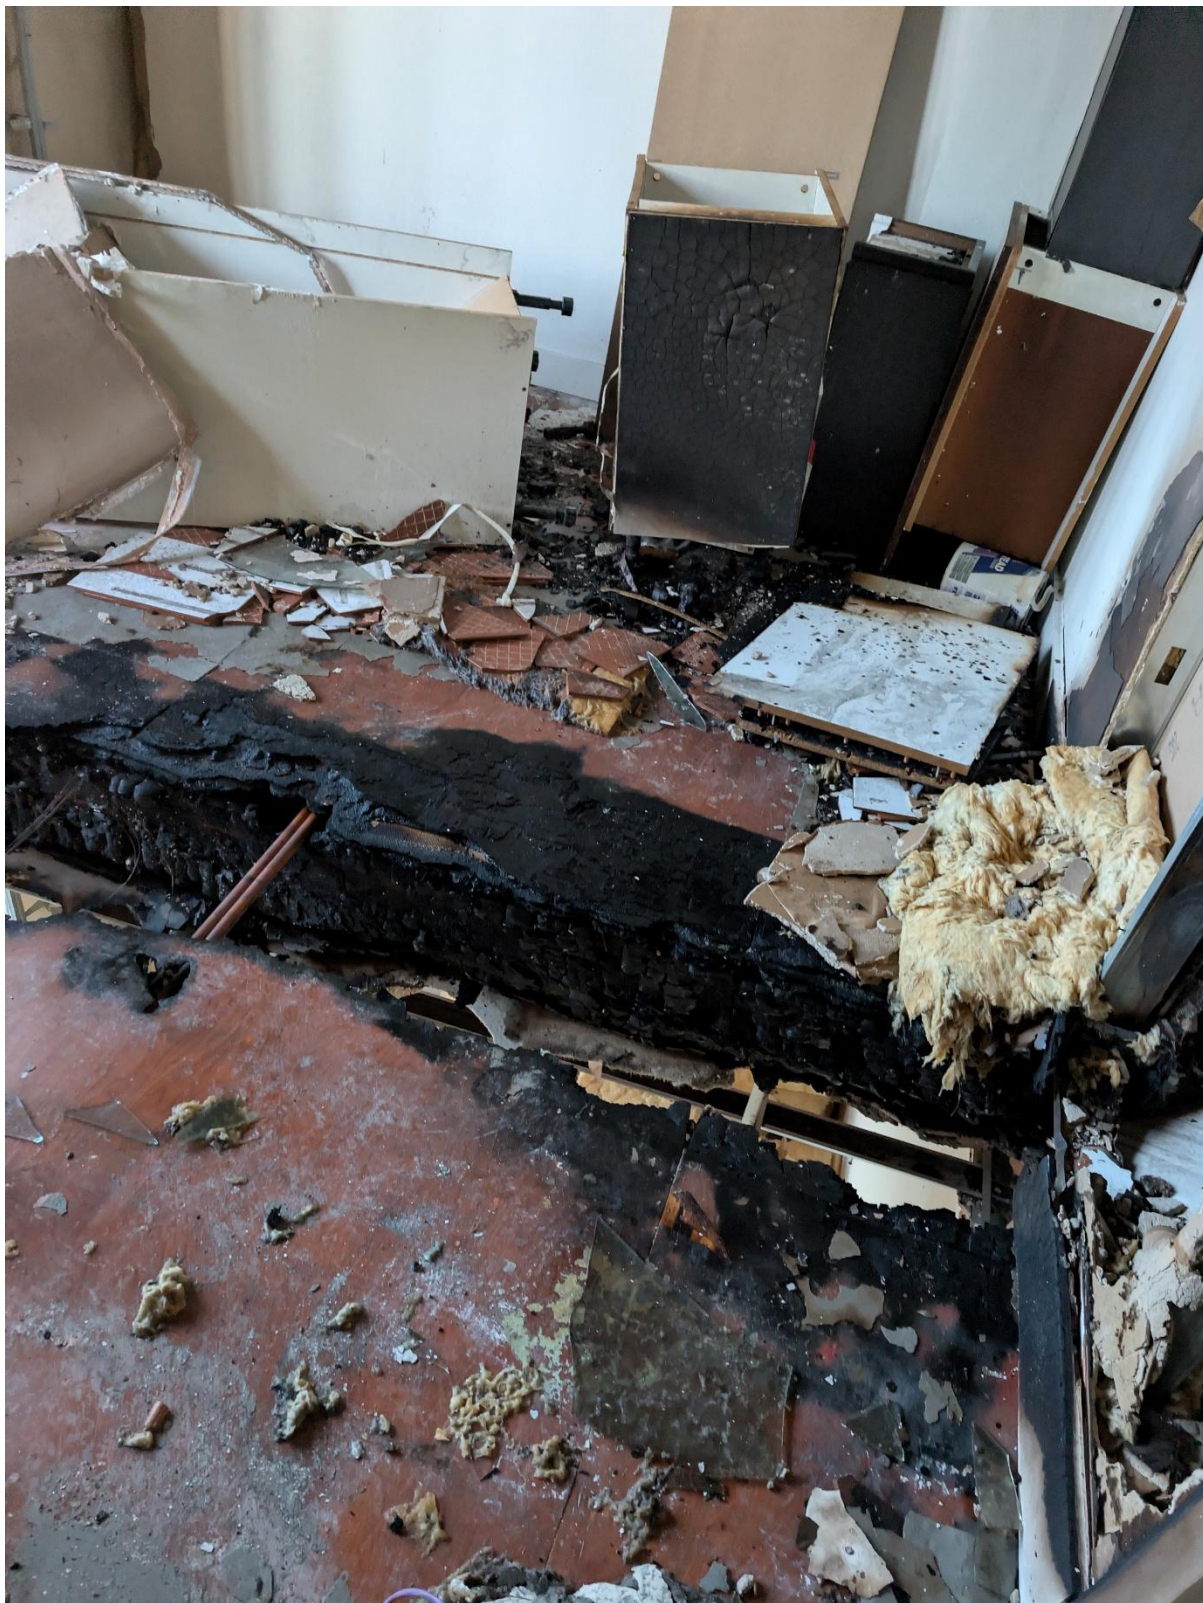
- 3.10 The 4<sup>th</sup> floor in the front section only appears to have been affected by smoke and fire fighting activities.
- 3.11 There is localised damaged to the 3<sup>rd</sup> floor, particularly in the rear section of the building. Floor boarding has locally burned away and supporting joists are heavily charred,

*Picture 17 3rd Floor Rear Left Section*

7. Prop damaged areas of the 3<sup>rd</sup> floor in the rear section.
  8. Remove debris from floors.
- 5.2. This is not an exhaustive list and indeed there may be other areas that require urgent attention as the work progresses, and unseen areas of structure are uncovered and become safe to inspect.

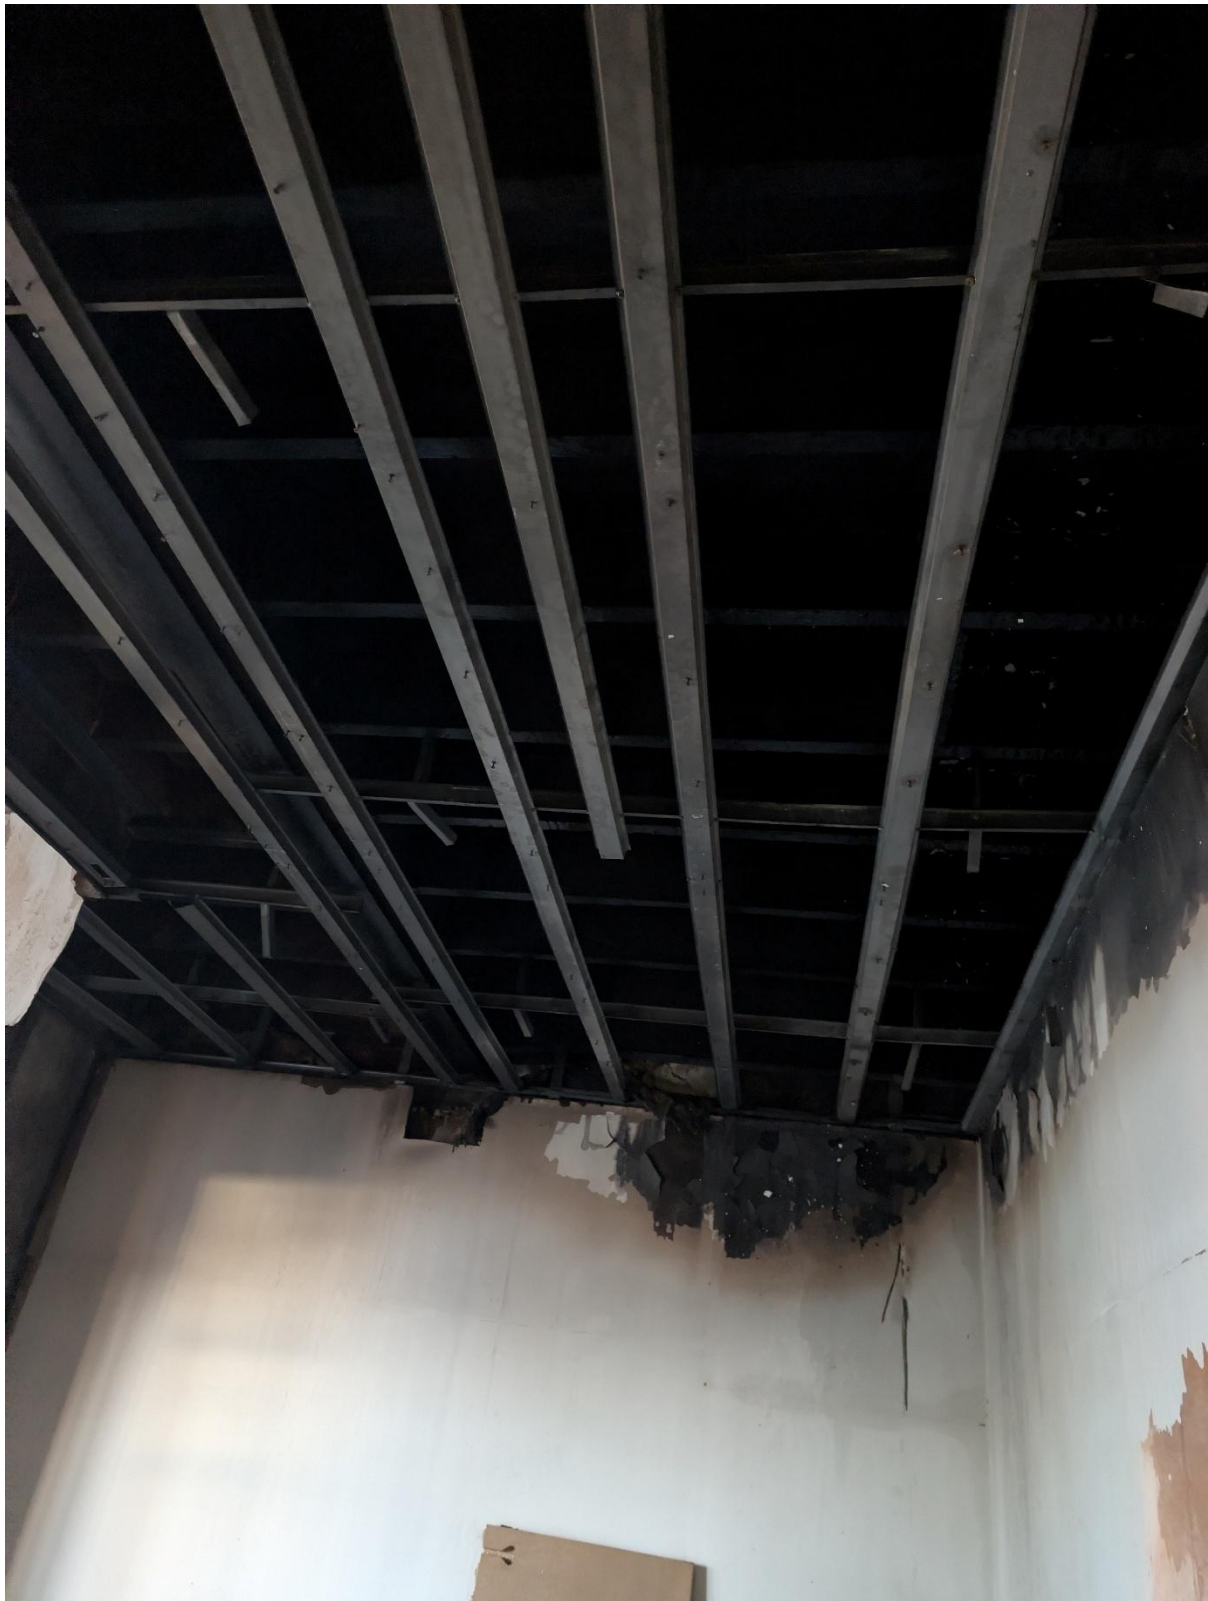
- 3.9 The 4<sup>th</sup> floor in the rear right section of the building has collapsed, and whilst the rear left section is still in place, it has not been possible to inspect this area due to unsafe access conditions. Until this can be done the floor should be considered unsafe to access.

*Picture 18 Soffit of 4th Floor Rear Left Section*

4. Dismantle chimney stacks down to eaves level.
  5. Prop fractured lintel on rear elevation.
  6. Prop remainder of 4<sup>th</sup> floor on the rear left section.

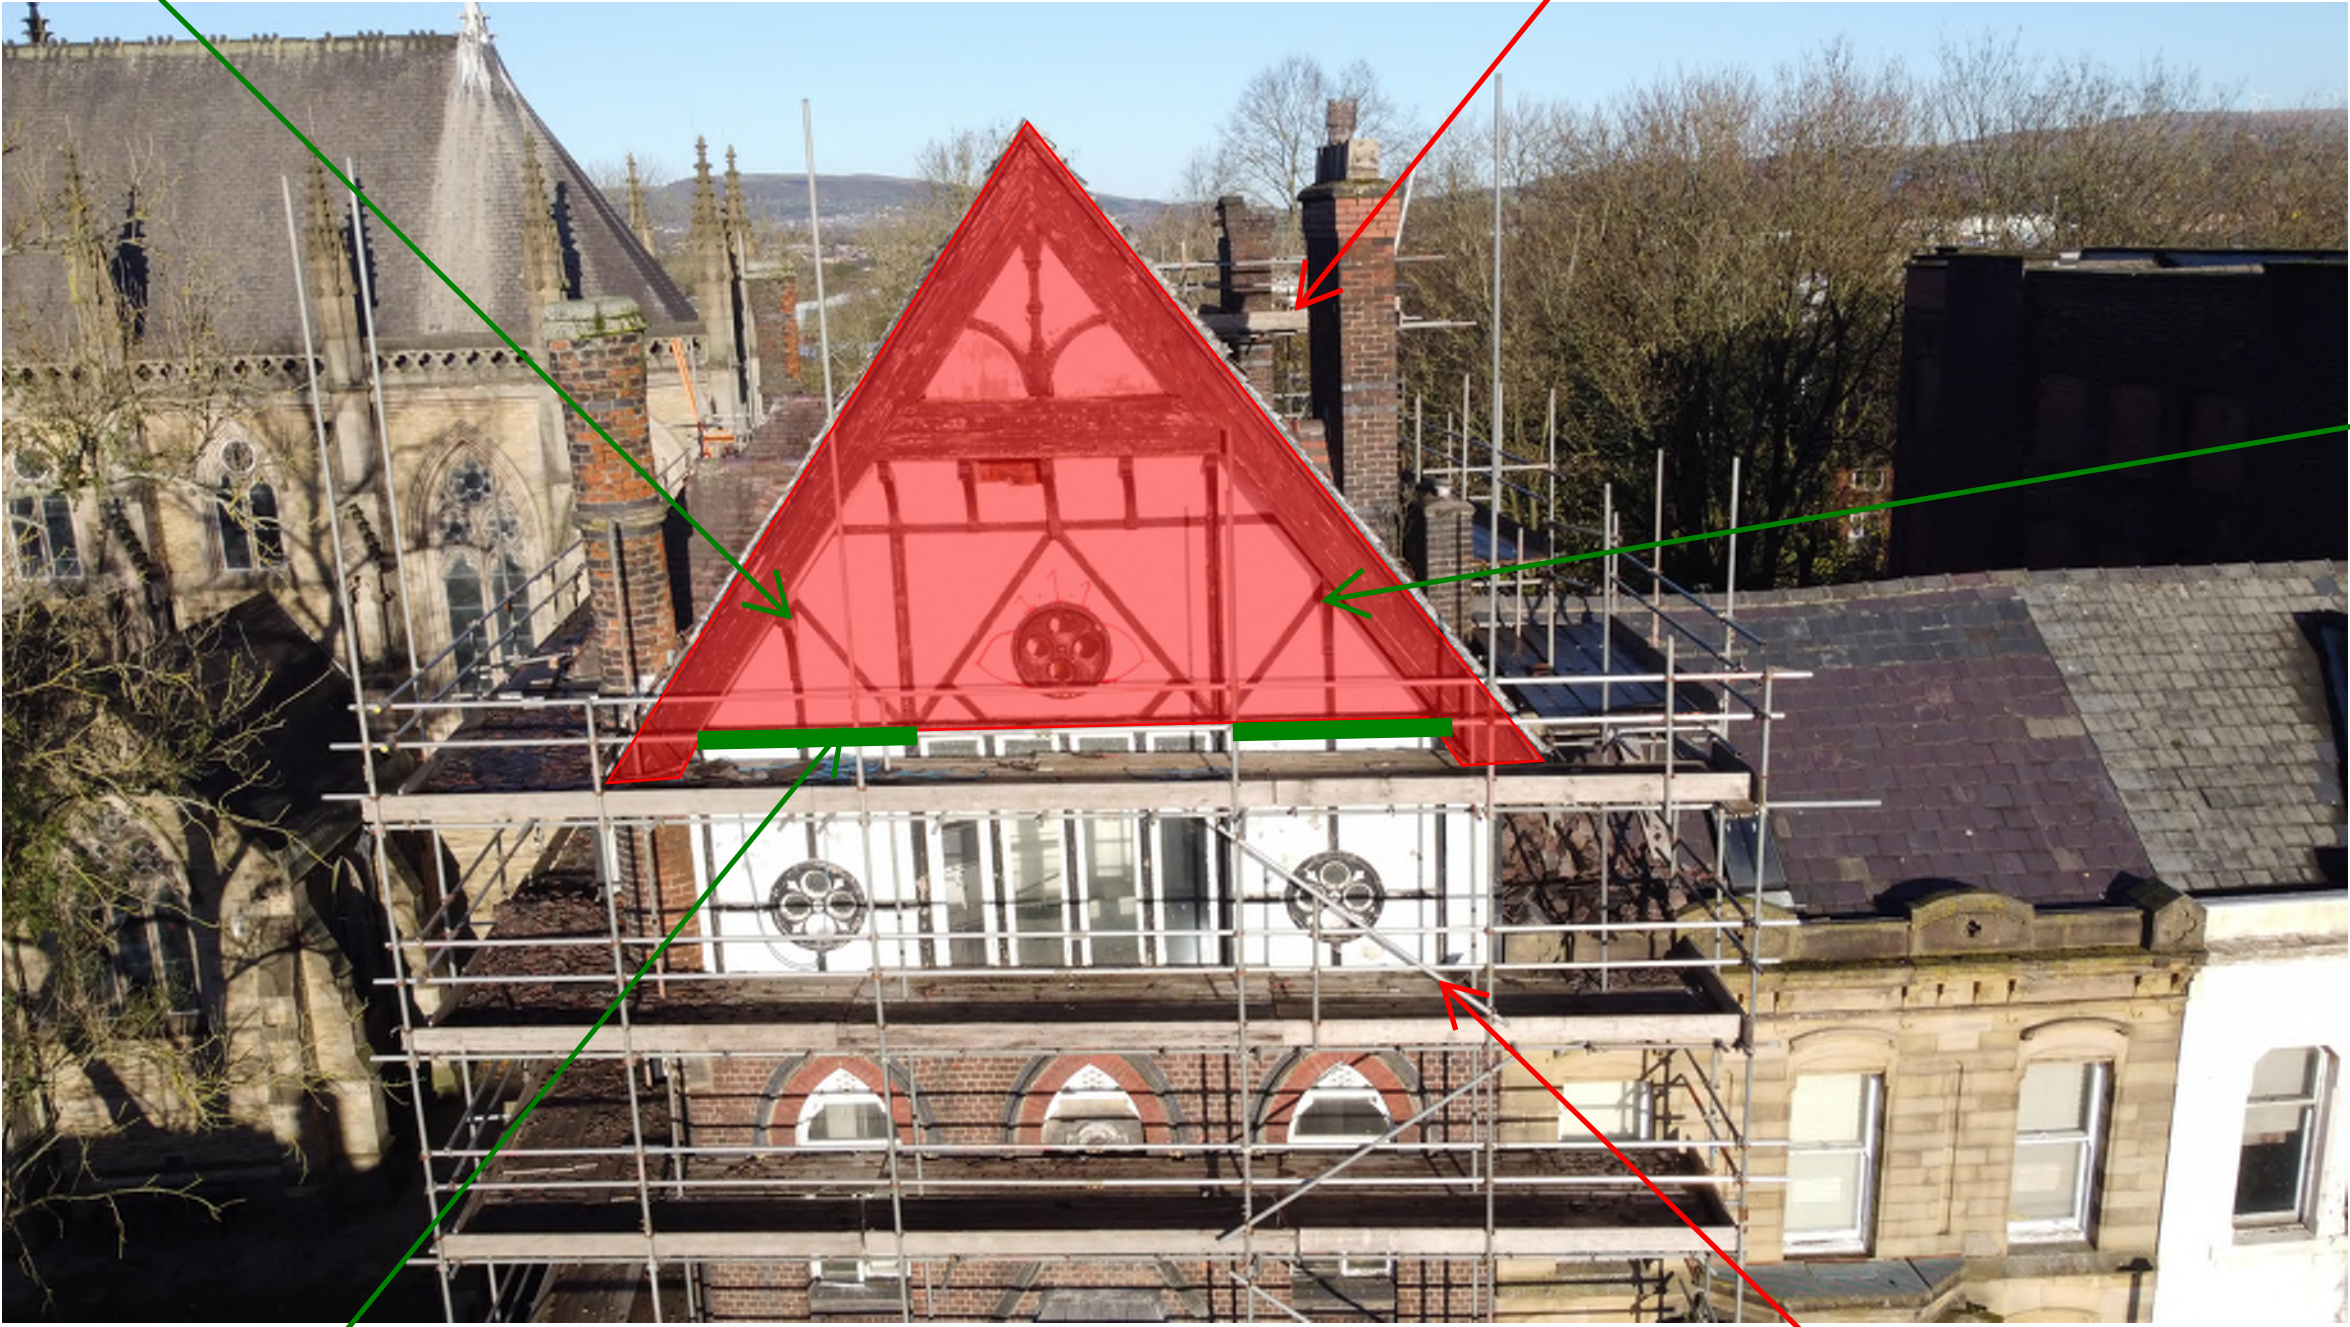
Purlin at this level  
possibly  
salvageable.

Gable appears to  
lean inwards slightly.

Purlins and ridge  
board not  
salvageable.

- 1. Remove timber  
barge boards and  
supporting structure.
- 2. Remove gable  
down 5th floor  
window head.

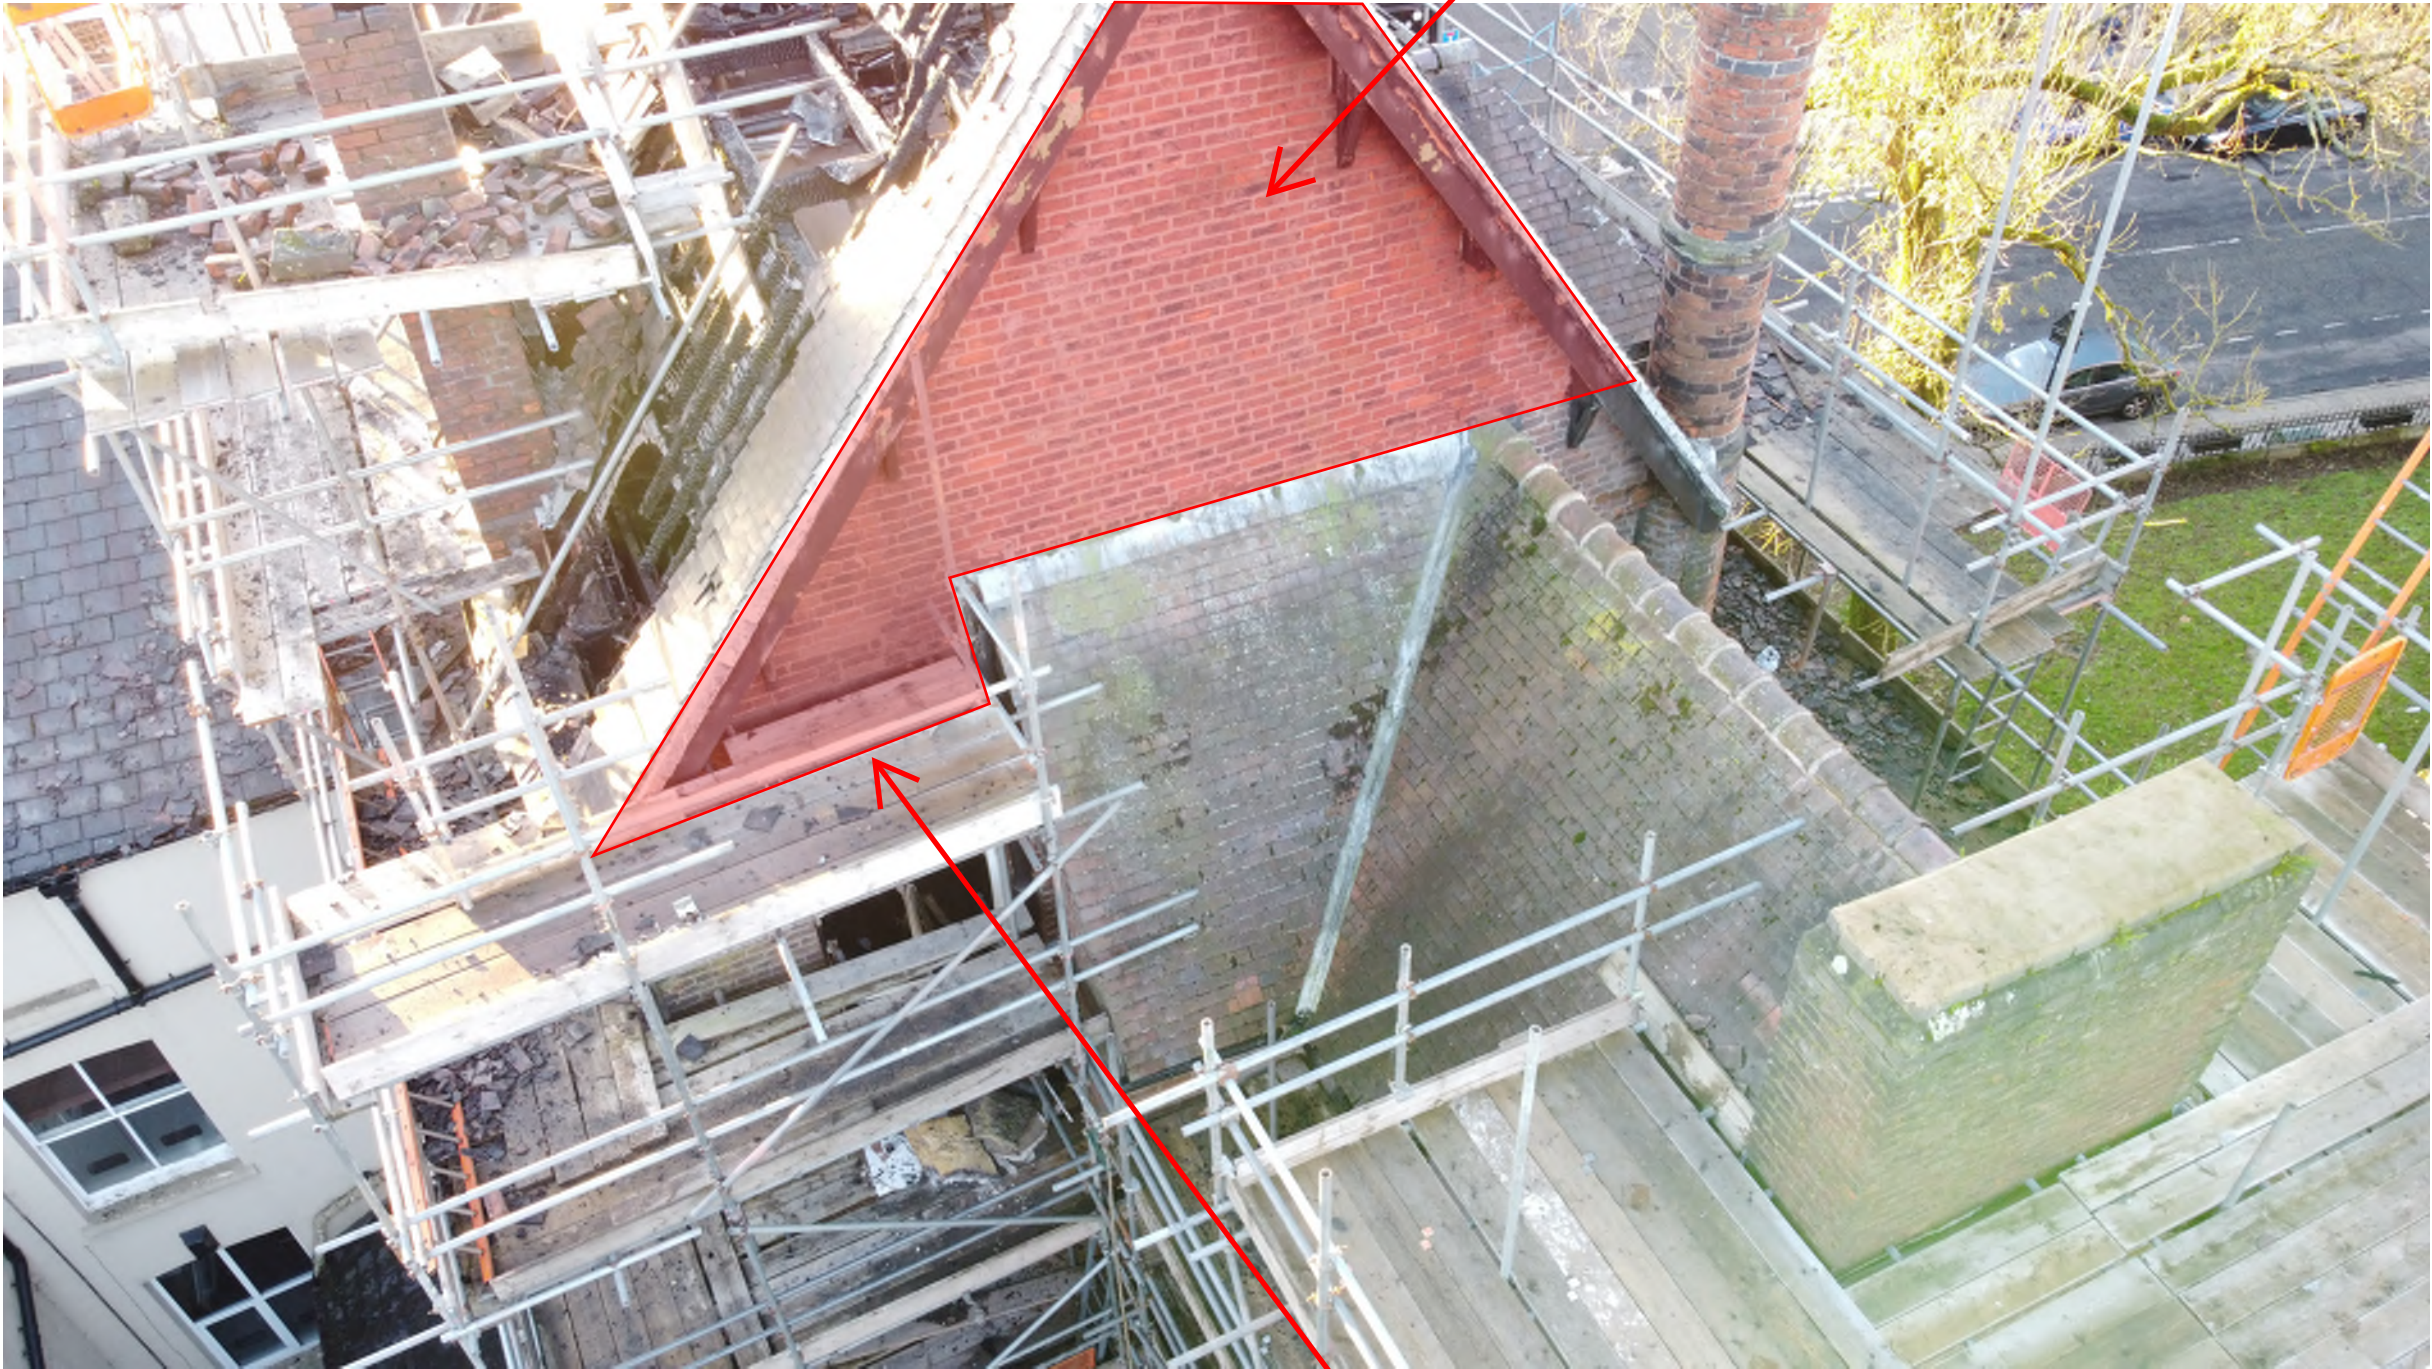
Fractured stone  
lintel.  
To be propped ASAP

Take cantilevered  
barge boards and  
gable down.

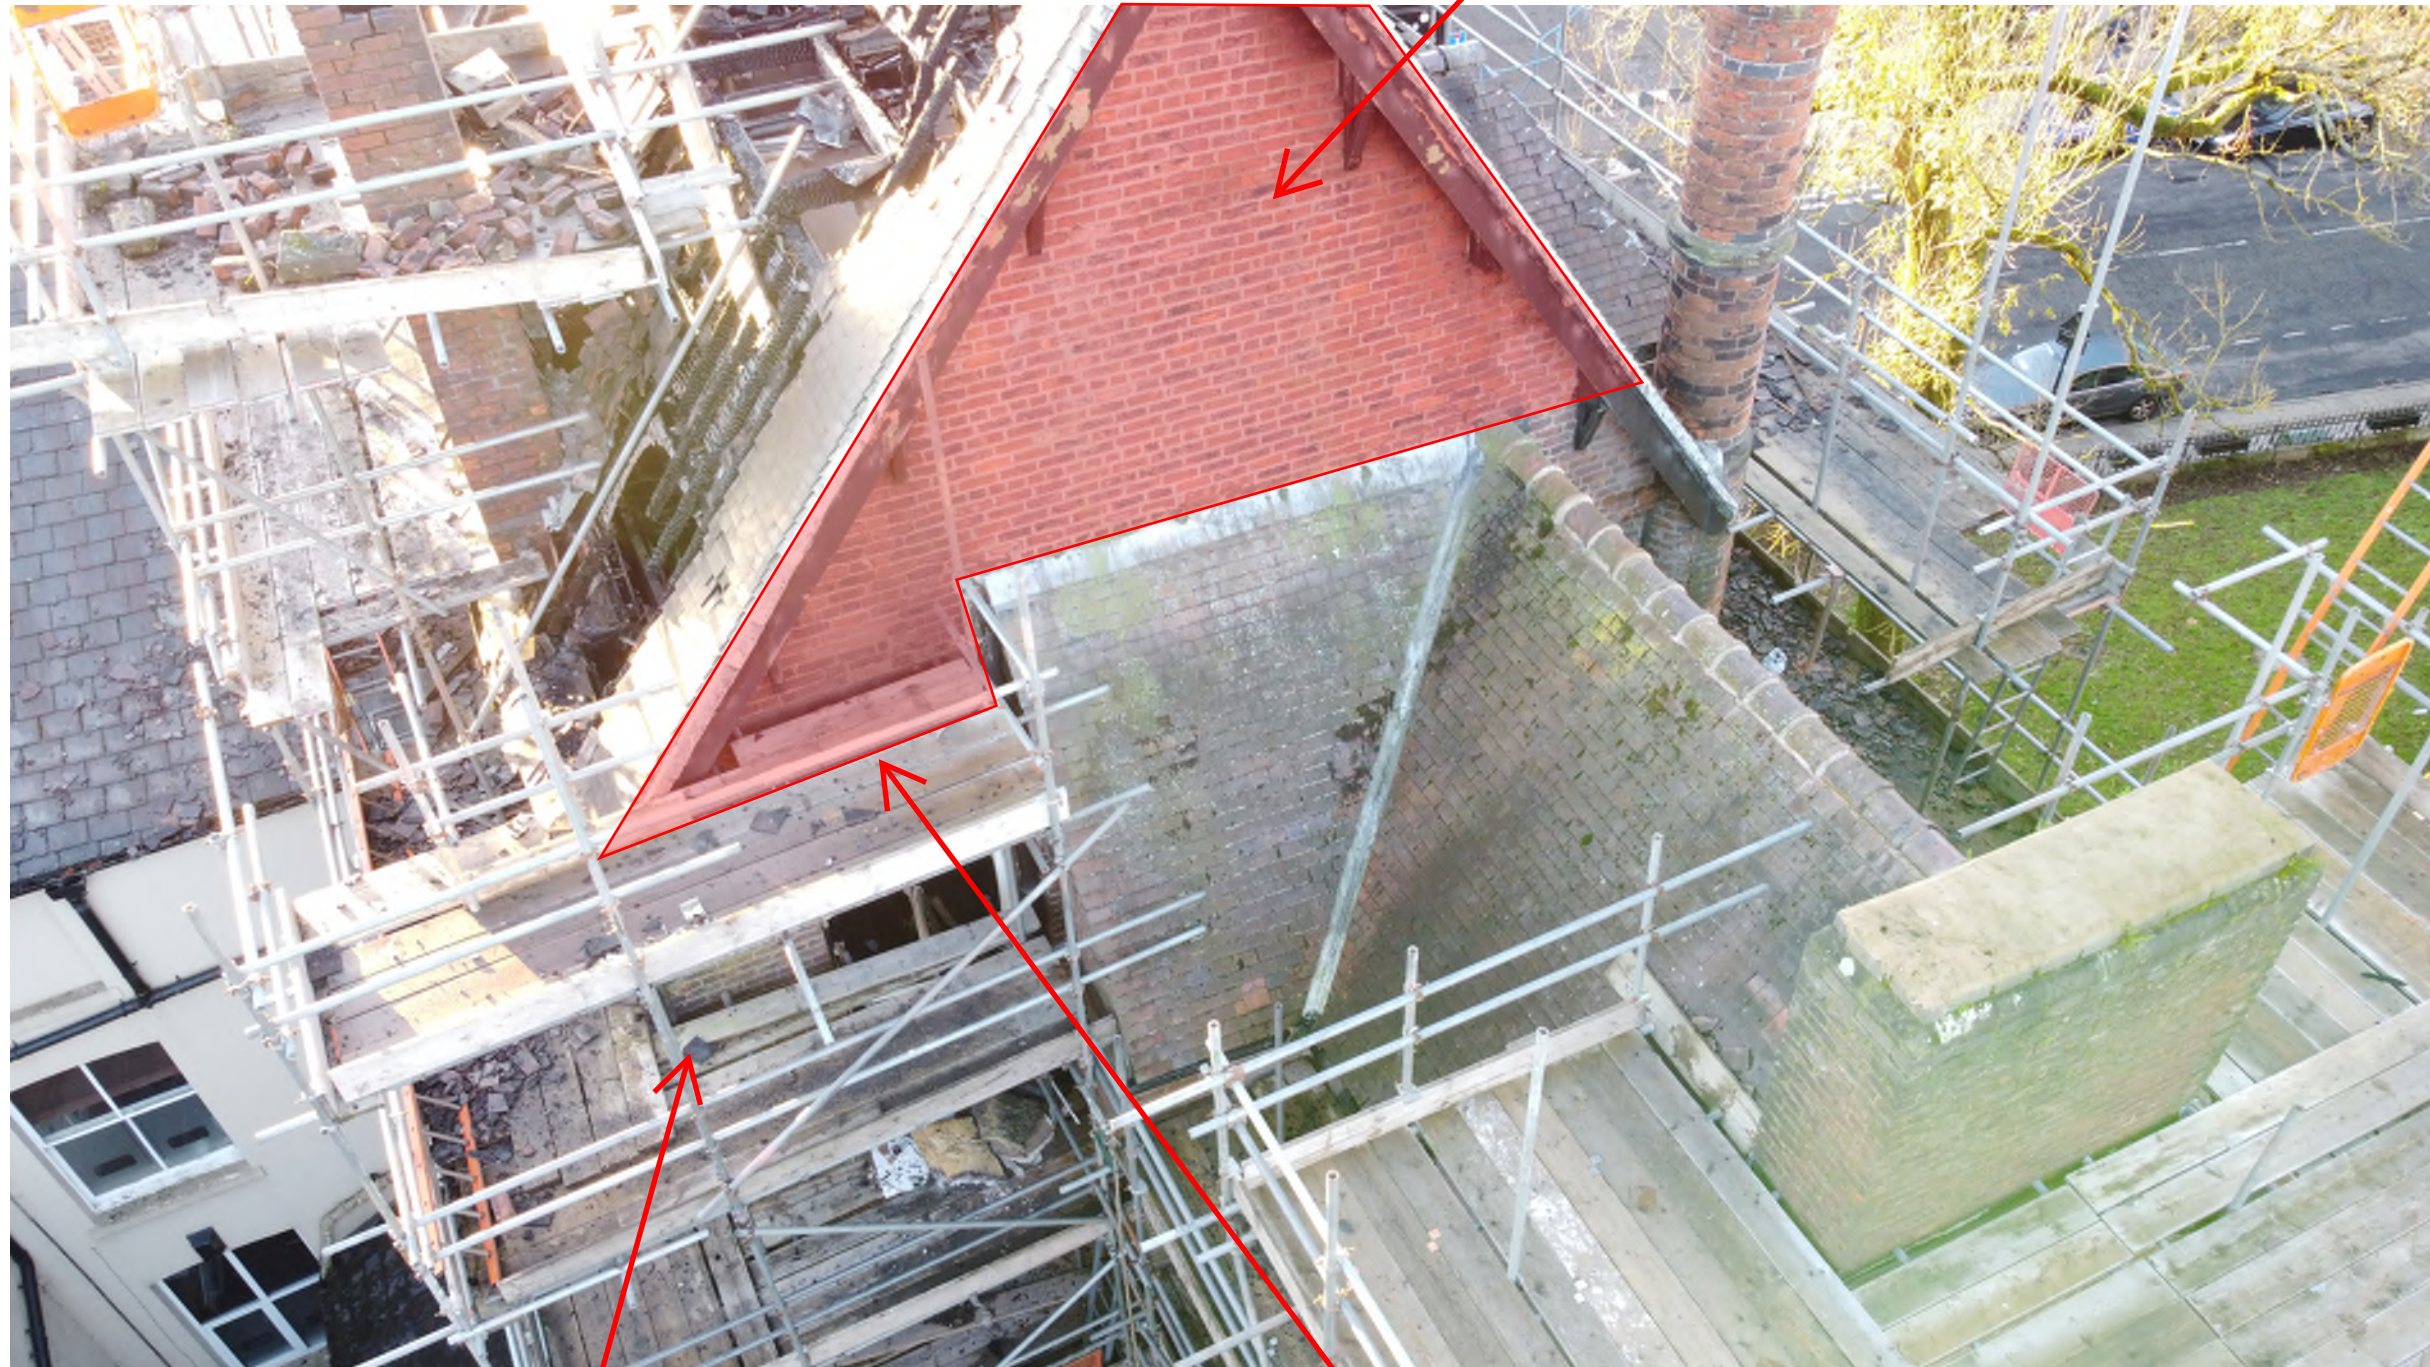
Fractured stone  
lintel.  
To be propped ASAP

Install temporary  
strapping to corner.
