1.1 The following Heritage Impact Assessment (HIA) has been prepared to support a retrospective application for Listed Building Consent in relation to no.1 The Rock, Bury, BL9 0JP.

1.2 No.1 The Rock dates from 1874 and is a four storey end of terrace building. It is Grade II listed and situated in the Bury Town Centre Conservation Area.

1.3 A fire broke out in the building on 23 November 2025 and caused extensive structural damage to the uppermost floor and roof structure. Following a post fire inspection, emergency works to stabilise and support the building were undertaken in line with the provisions of section 9(3) of the Planning (Listed Buildings and Conservation Areas) Act 1990.

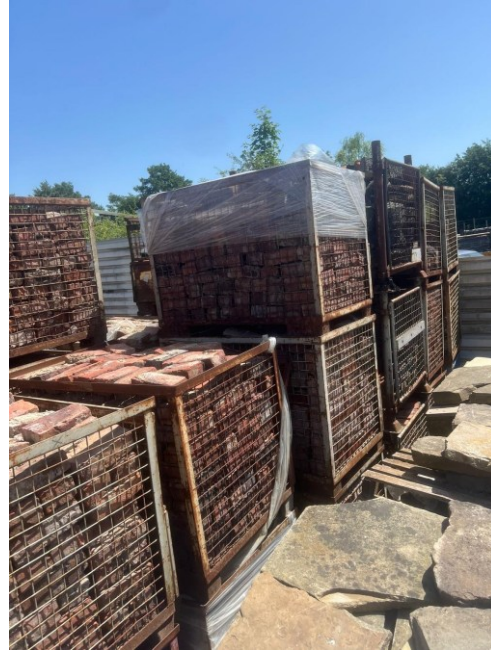
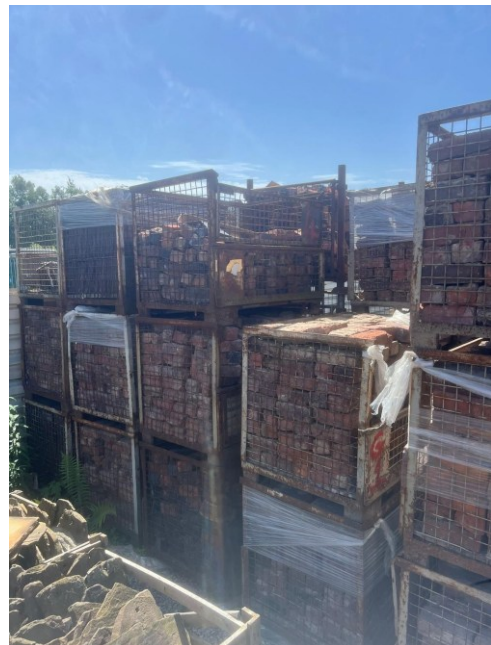
*Figure 10 & 11: Salvaged bricks and other historic fabric have been catalogued and stored safely off site, awaiting reinstatement where possible.*

5.13 A Strategy for Re-Use of Salvaged Structural Elements (**R4**) has been prepared by Marston & Grundy Consulting Engineers in relation to salvaged roof tiles, masonry and timber elements. This outlines the conditions under which salvaged materials will be suitable and safe for reuse. Dismantling was undertaken carefully and salvaged elements were recorded, and are now stored safely off site, allowing for reconstruction and reinstatement in due course.
