# Site Inspection Record

Address: The Rock, Bury

Project Ref: MJC25/11/449

Issue Date: 25/11/2025

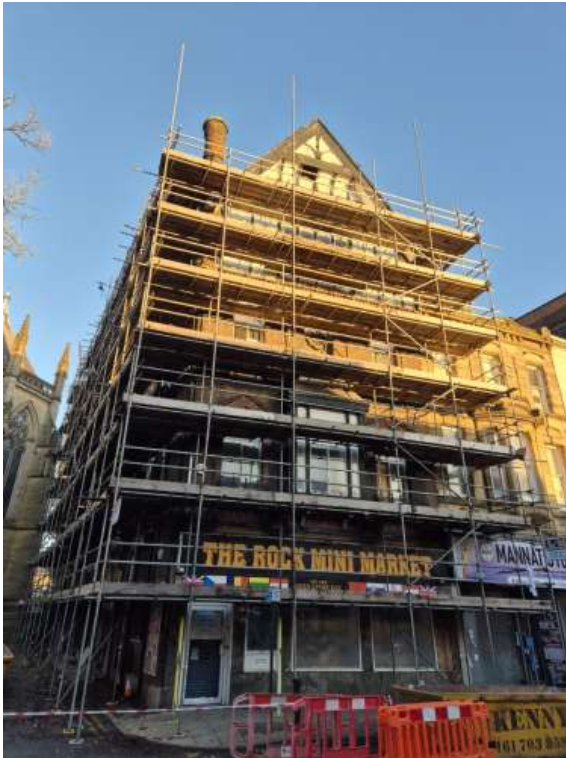
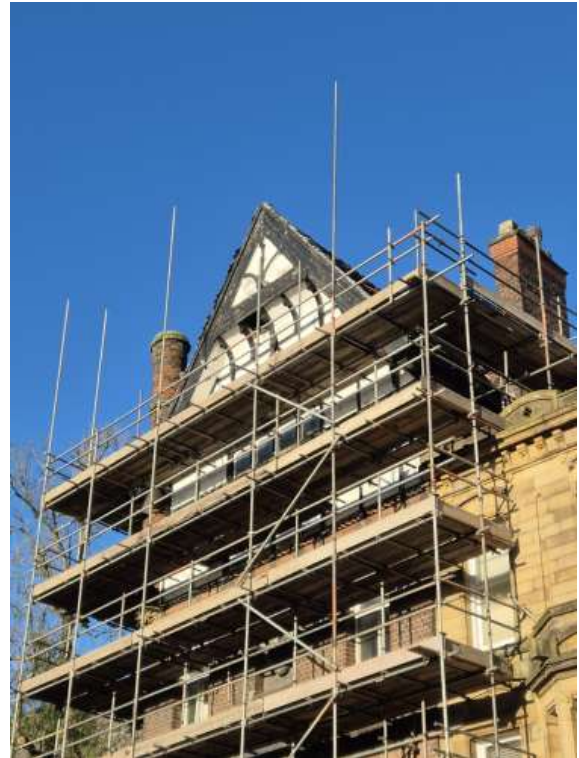
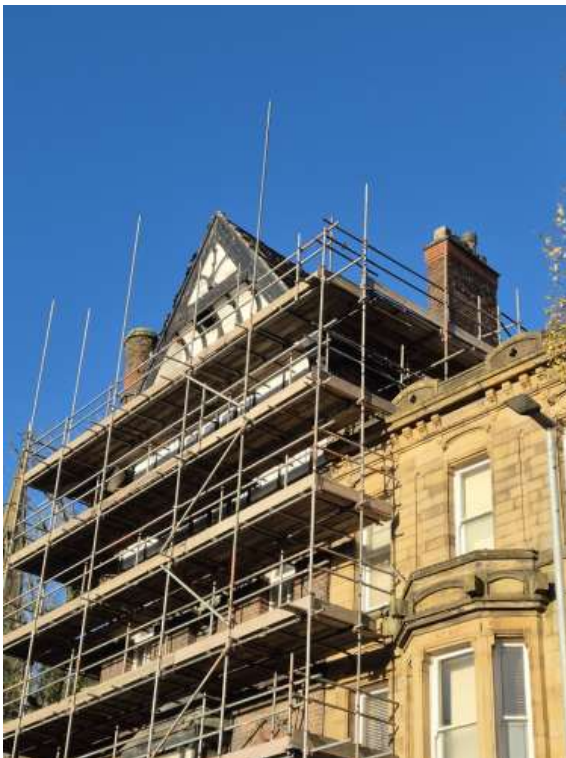
External - Front Elevation (General)

A fire has recently occurred to the upper levels of the structure. The roof structure is almost completely burnt out leaving unrestrained gable masonry, the gable masonry is currently restrained by remaining purling and ridge members which are severely charred.

This is applicable to the front gable, the rear gable and internal gables.

By review of drone imagery the front gable appears to be leaning inwards significantly and may require rebuilding under the permanent works. The extent of the lean should be fully surveyed once safe access is available.

The gable masonry should be secured as soon as possible; this could be achieved by either dismantling the gable masonry or providing shoring to restrain the gable masonry in position. The property is Grade II listed and demolition of gables may require consent prior to undertaking, therefore shoring is likely the most suitable option, at least in the short term to secure the structure.

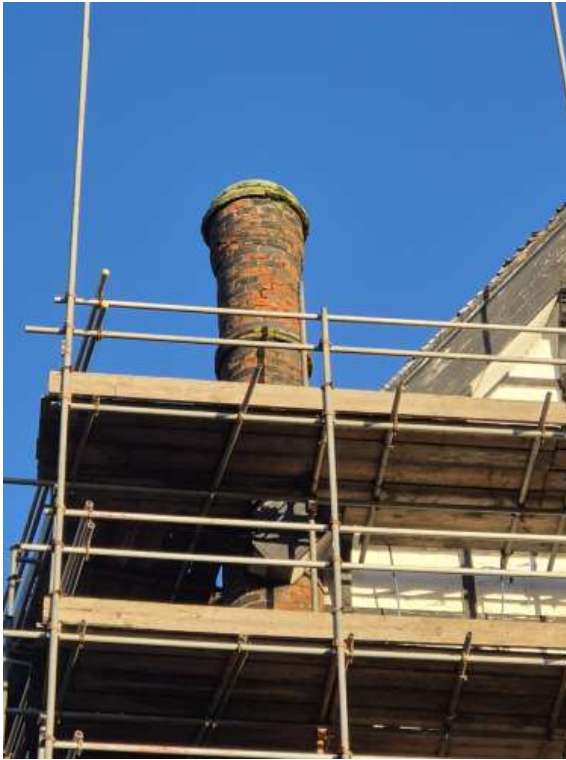
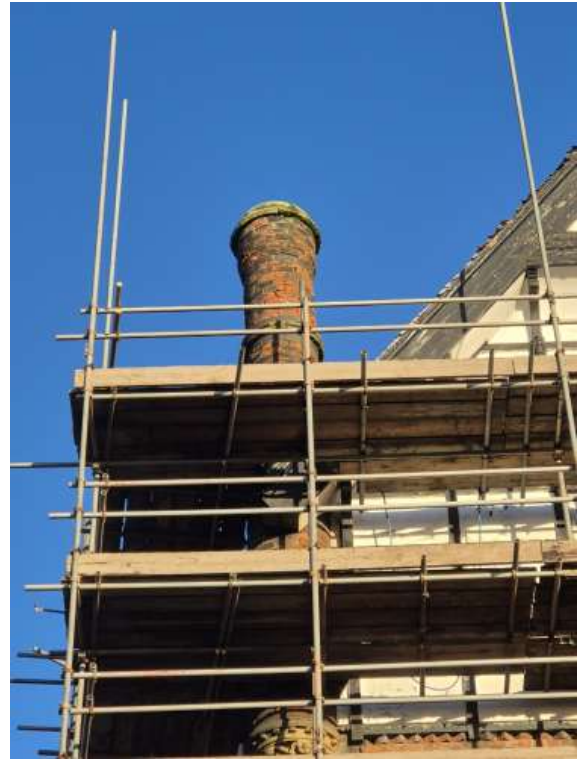
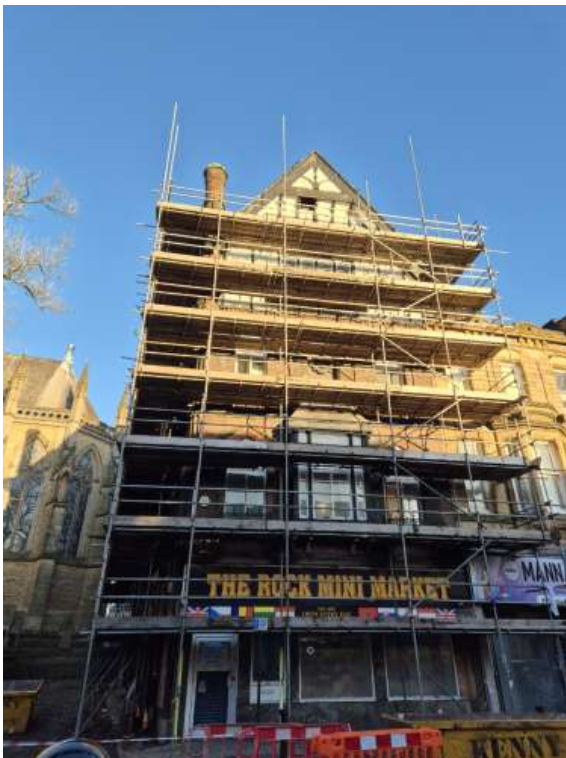
External - Front Elevation (Front corner chimney stack)

The circular chimney stack to the front corner appears to be leaning away from the building as viewed from ground level at the front of the property. It is unclear whether this observed movement is historic or recent, it was reported that some lean had been observed prior to the fire although it is unclear if this has been exasperated due to the fire event.

The chimney masonry should be secured as soon as possible; this could be achieved by either dismantling the gable masonry or providing shoring to restrain the gable masonry in position.

The property is Grade II listed and demolition of the chimney may require consent prior to undertaking, therefore shoring is likely the most suitable option, at least in the short term to secure the structure.

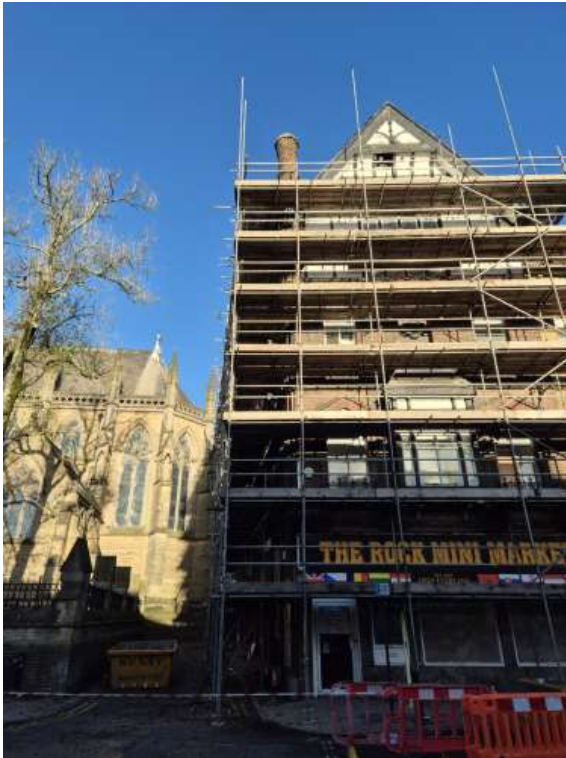
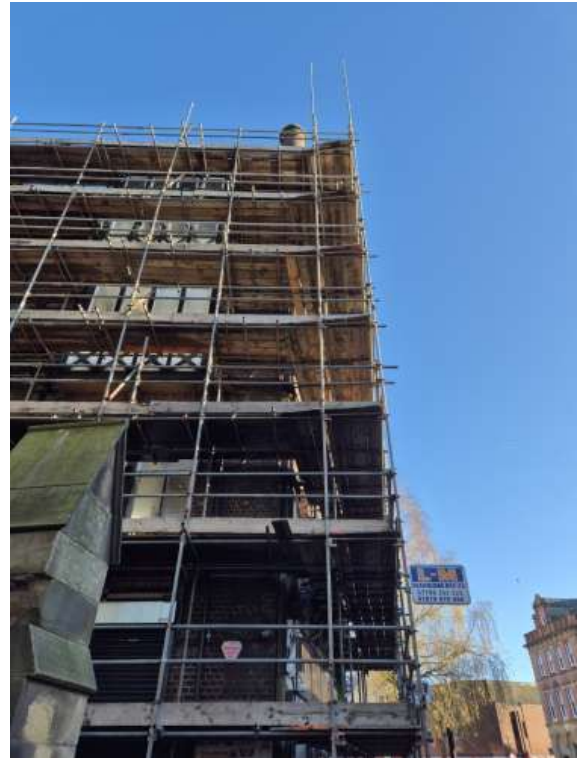
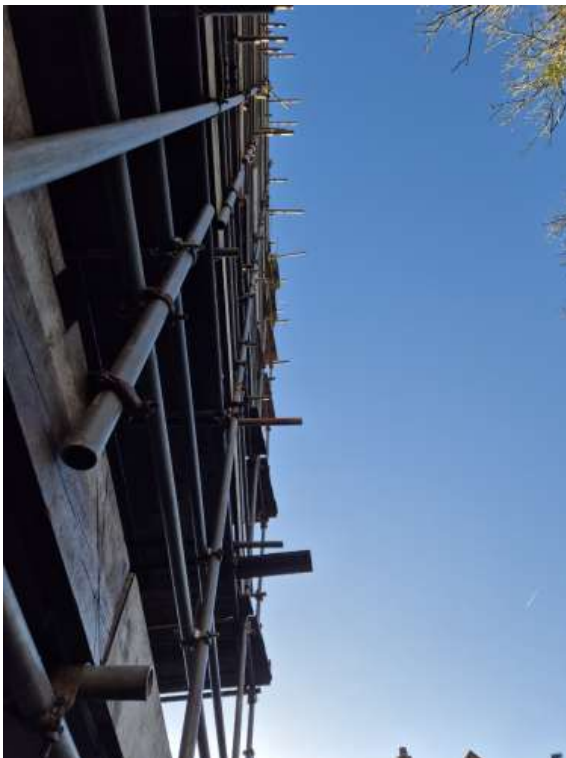
External - Other (Scaffolding)

The existing scaffolding appears to be designed for access only and has not to provide restraint to the structure, the scaffold appears to be tied to the masonry façade of the main structure with the main structure providing lateral restraint to the scaffold.

Due to the fire, which has burnt out the upper floor and roof structures the masonry façade is now partially unrestrained and therefore unsuitable to provide support to the scaffold structure.

Masonry and roofing slate debris has fallen onto the scaffold as part of the fire event, this appears to be beyond the scaffolding design allowances. The scaffold appears to have a visible twist within its arrangement to the upper levels front corner of the building; it is in this general area where debris has accumulated. It is unclear if this twist is a result of the recent removal of the upper level of scaffolding above, overloading due to accumulated debris or interaction with the fire event (thermal loading or water pressure). One or more of these factors may have/be impacting the scaffold in its current condition.

1. Remove accumulated debris from the scaffold structure using a MEWP to provide safe access.
2. Scaffolding contractor/engineer to review scaffold and make any required improvements to ensure stability in the short term.

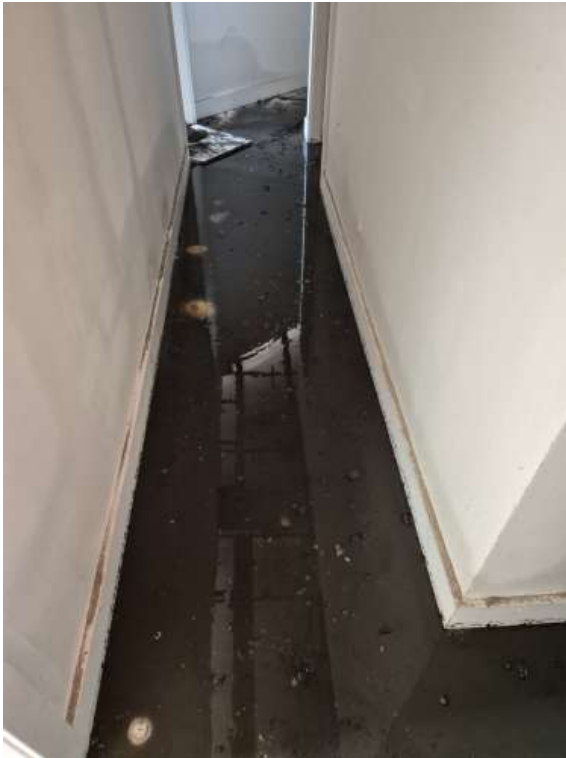
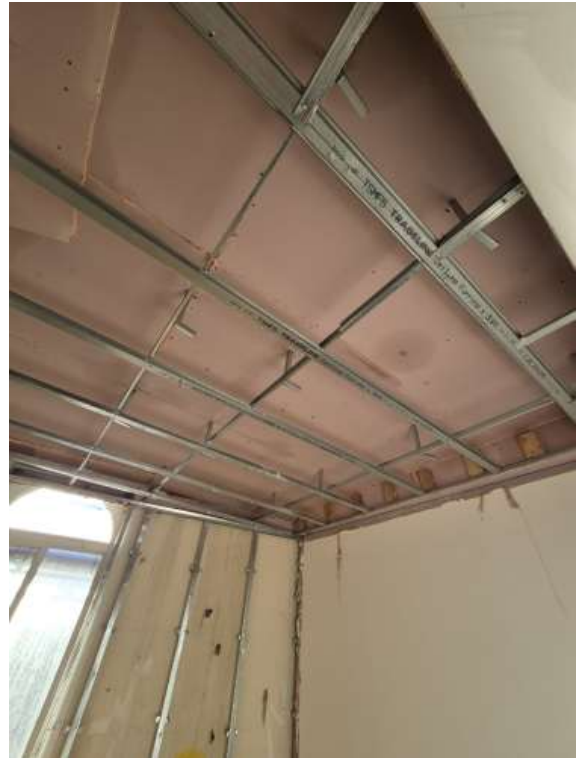
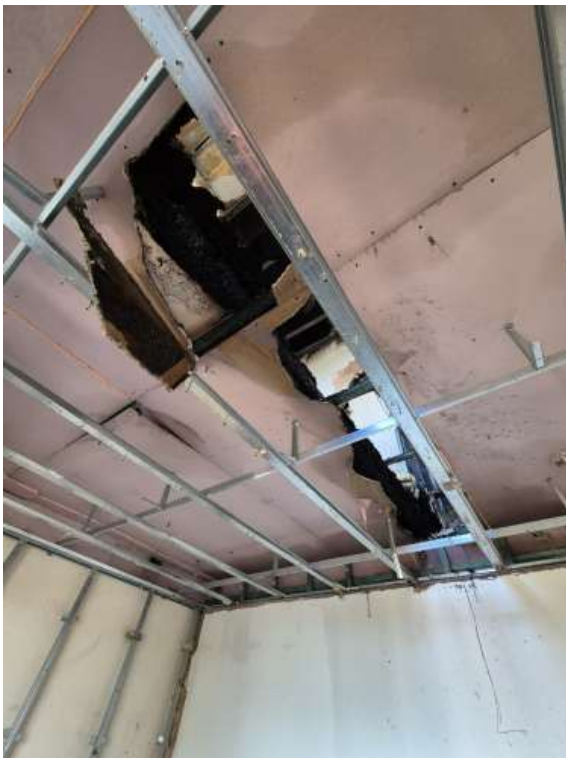
Internal - Second Floor (General)

Structures appear to be generally unaffected by the fire at Second Floor Level. Standing water was present to the floor structure underfoot and a slight slope is observed to the floor structure within the front of the property.

Overhead, the Third-Floor structure to the rear of the building appears to have been fire damaged above the fire compartmentation as seen via a penetration that has been formed in the boarding likely due to water damage.

No actions required for short term stability.

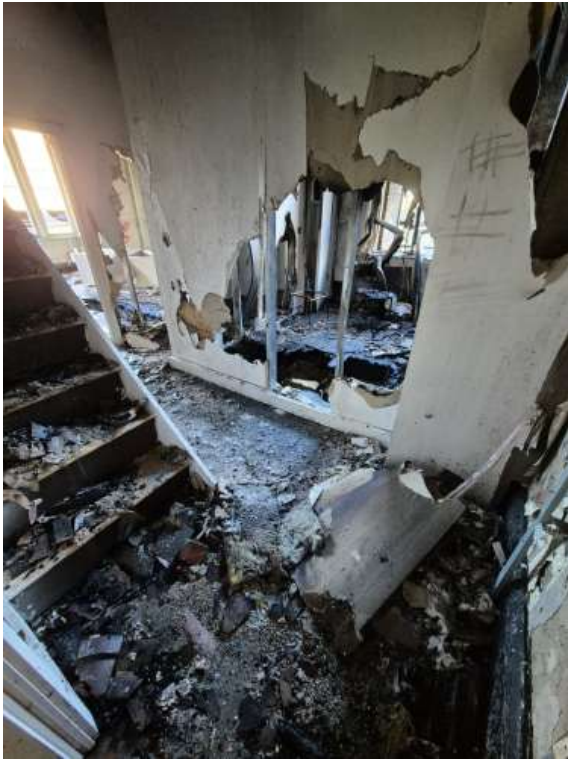
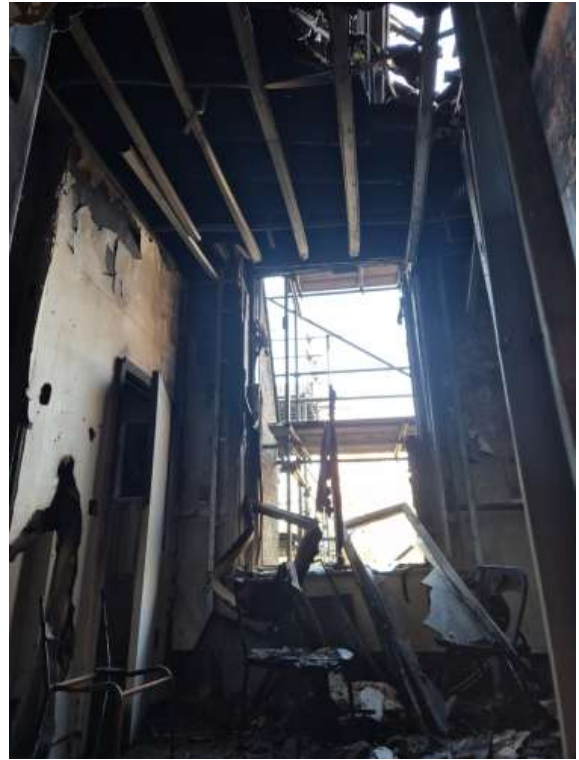
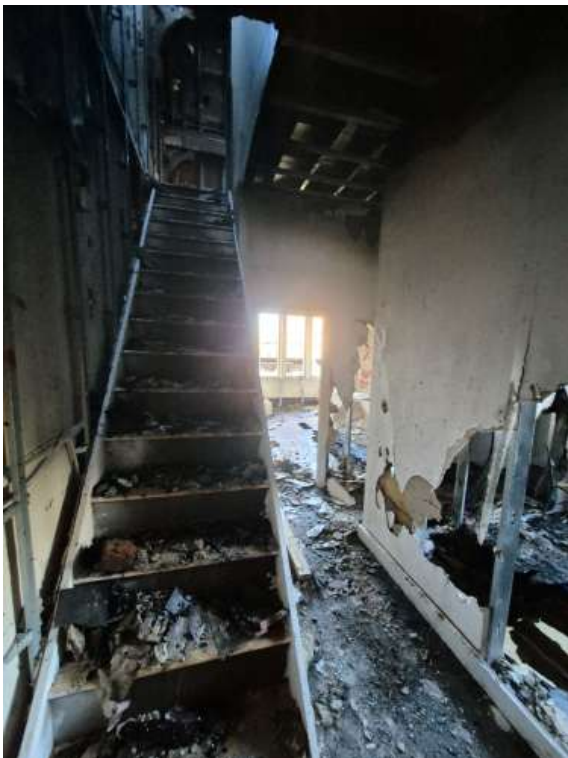
Internal - Third Floor (Rear of structure)

Significant damage has occurred to the rear of the building which appears to be the primary location of the fire. The floor structure underfoot was significantly charred with penetrations through, and similarly structures overhead were in the same condition.

It was not deemed to be safe to enter this area of the structure at this level or above in its current condition.

Inspection was limited from the threshold of the hallway doorway but based on observations from this area and from drone imagery it is expected that floor structures have been significantly damaged in this area so as that they no longer provide sufficient restraint to the perimeter masonry.

Implement temporary shoring by the installation of dedicated façade retention system.

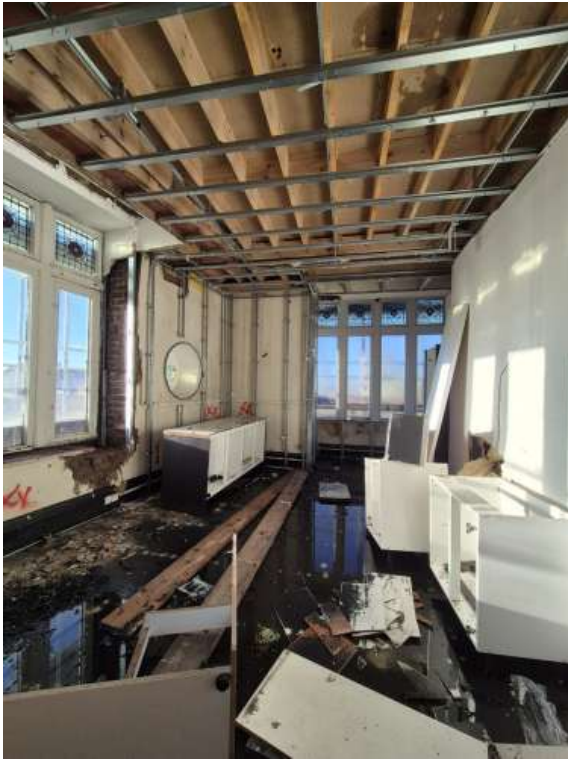
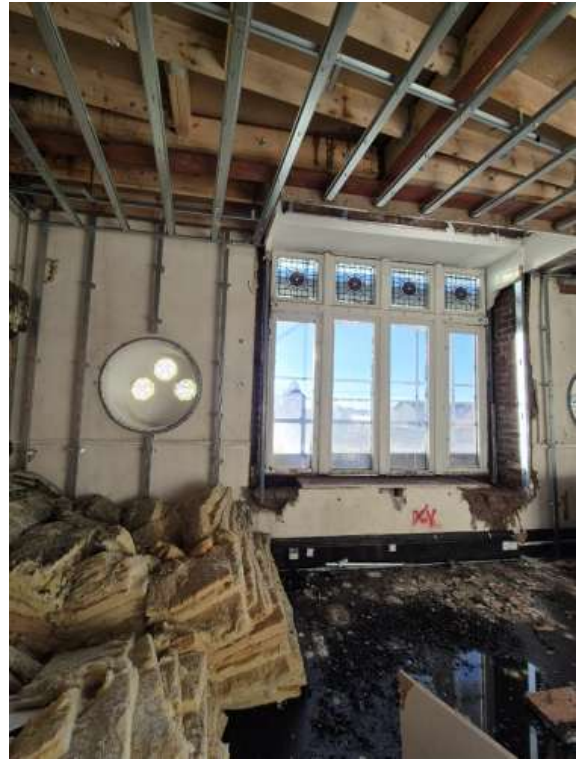
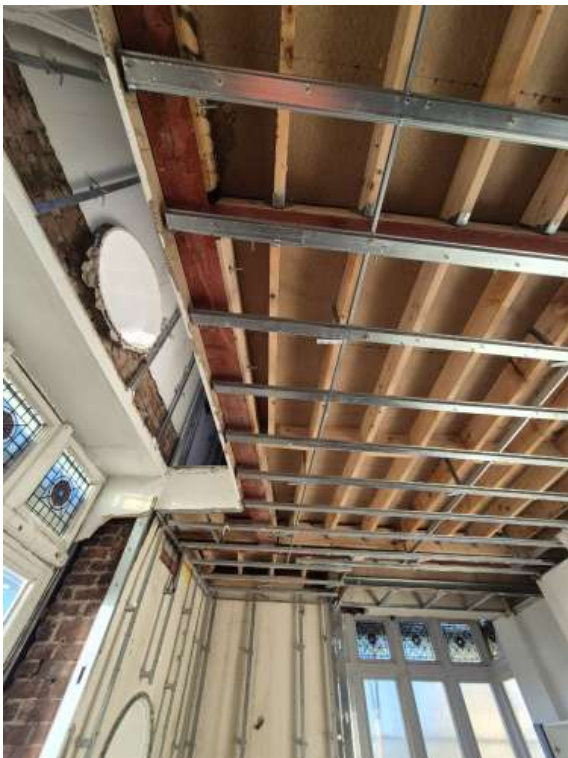
Internal - Third Floor (Front of building)

The Fourth Floor over appears to be in a good condition (from the underside) and does not appear to be impacted by the fire. It appears that the fire at this level was generally to the rear of the building.

No actions required for short term stability.

The façade retention system described elsewhere will provide restraint to this level and above.

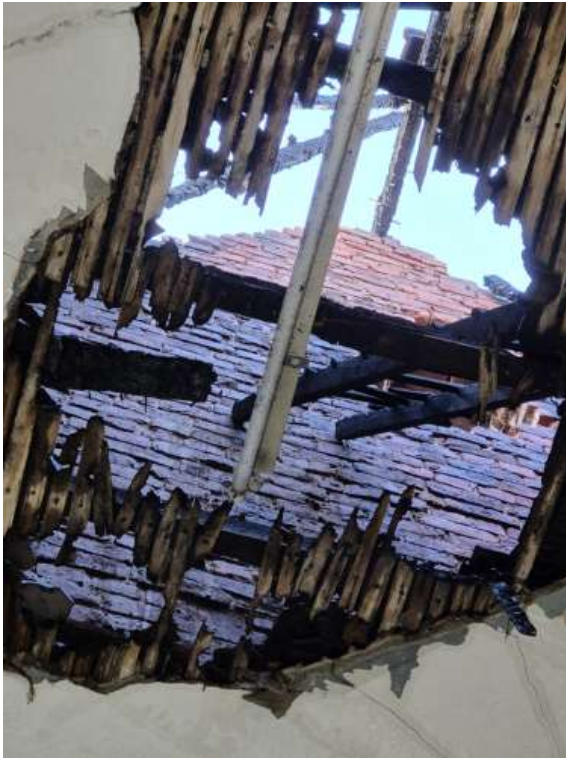
Internal - Roof Void (Internal gables)

An internal gable was viewed from below by a penetration over the stairwell, it could be seen that the internal gable was unrestrained due to the combustion of the original timber roof structure.

The internal gable masonry should be secured as soon as possible.

It has been previously recommended that a façade retention system is installed to the perimeter of the building to secure the perimeter masonry and the front and rear gables, once this system is in place the internal gables can be shored internally against the front and rear gables by shoring props spanning between the gables from front to back.

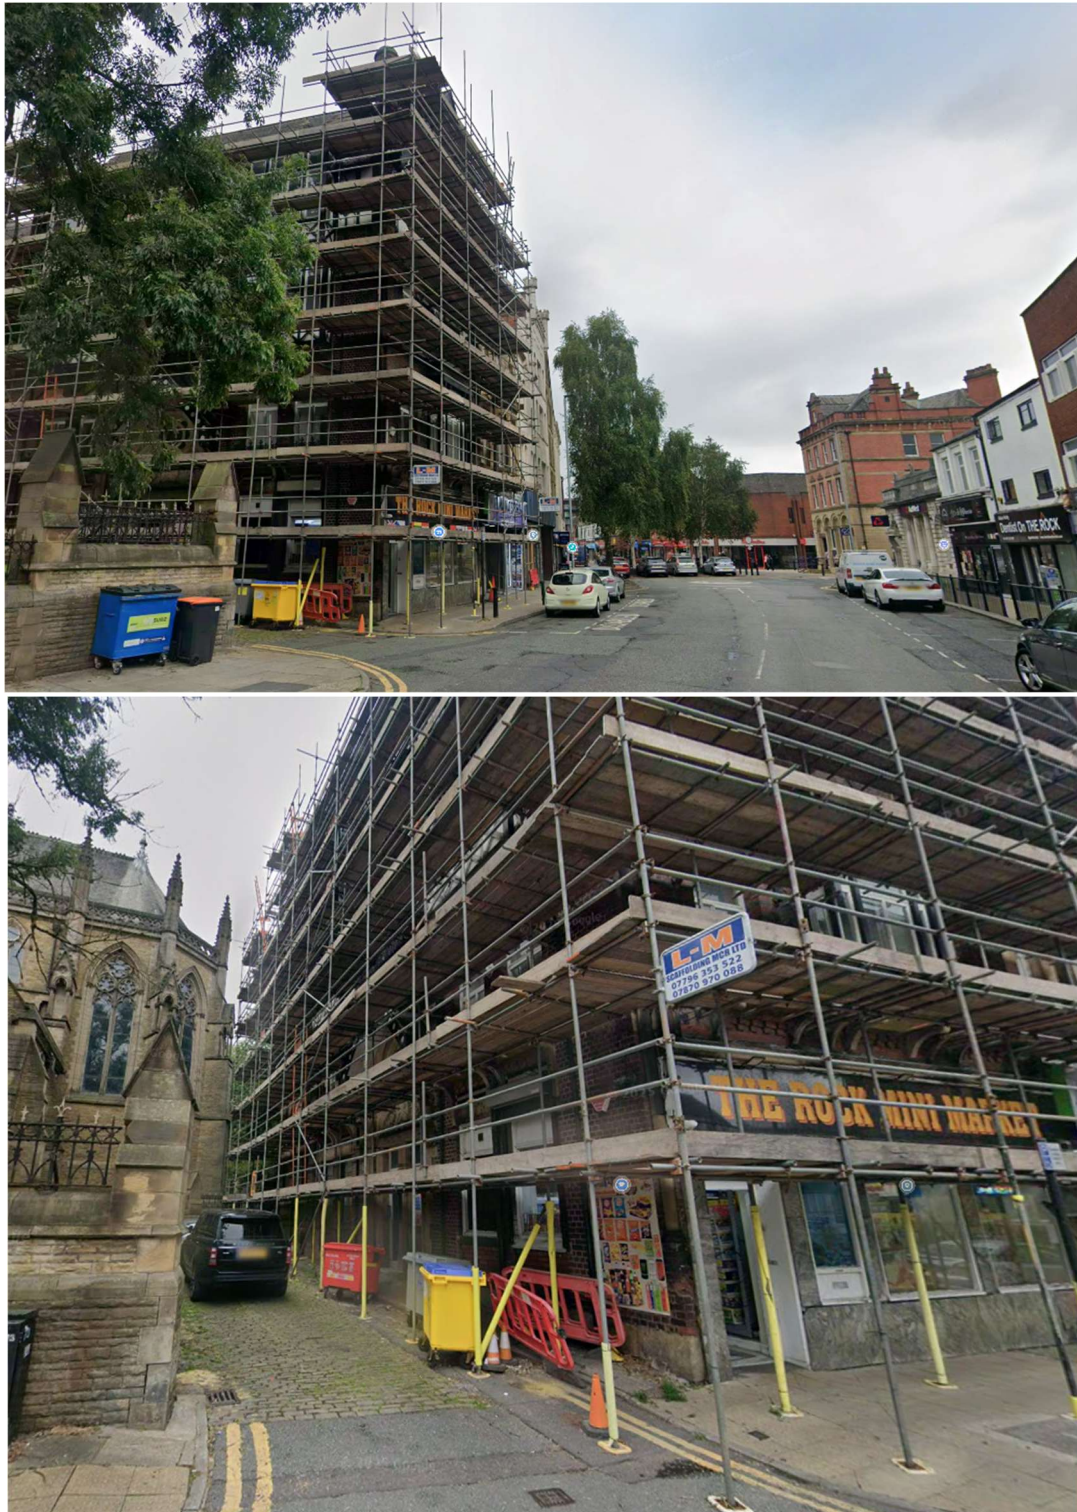
External – Public Highways and Access  
(Historic Images)

A public highway is present to the front of the building which is currently closed off for access.

Access is required to the side of the structure to access properties to the rear.

These areas should remain closed off to the public until such a time that the building is deemed to be secure. In order for the building to be deemed secure, the façade retention system and internal propping between gables must be installed.

A crash deck should be installed above areas where the public will need to access following the stabilisation works. This would generally be expected to be along the side elevation if rear access is required and outside of the neighbouring commercial premises.

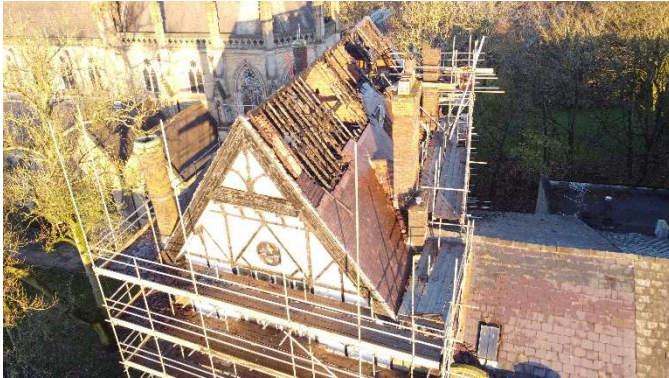
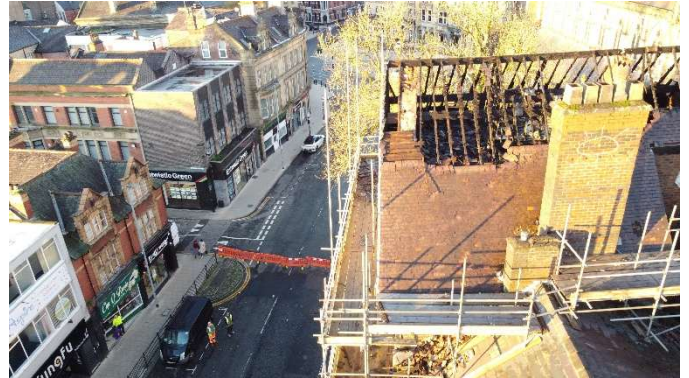
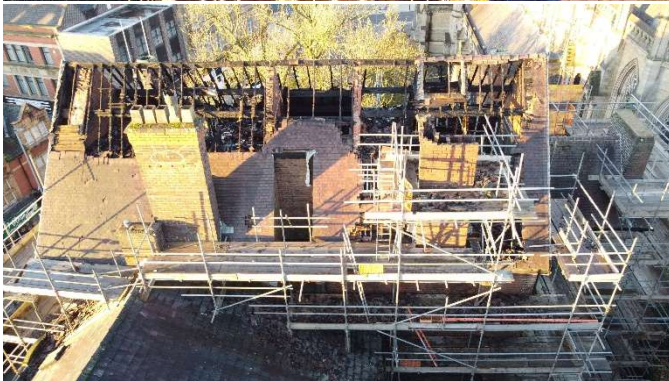
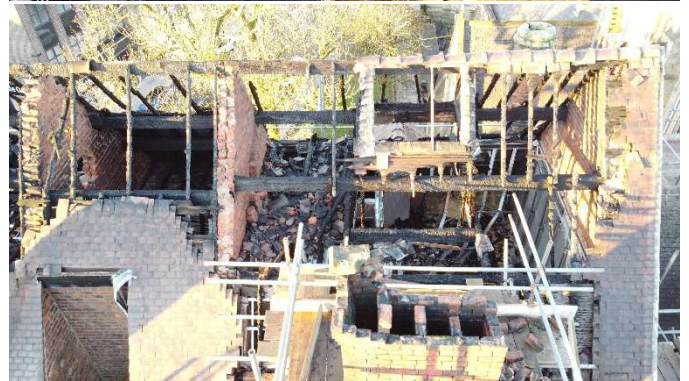
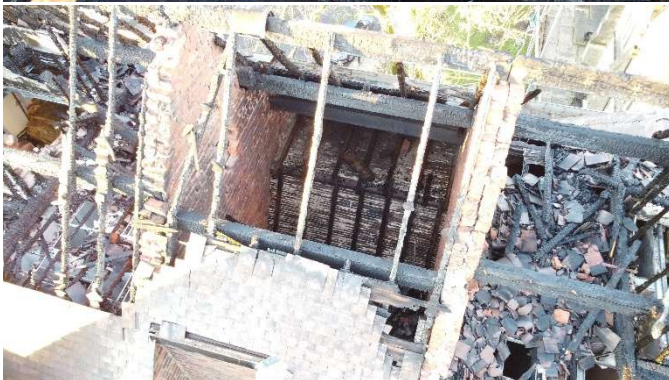
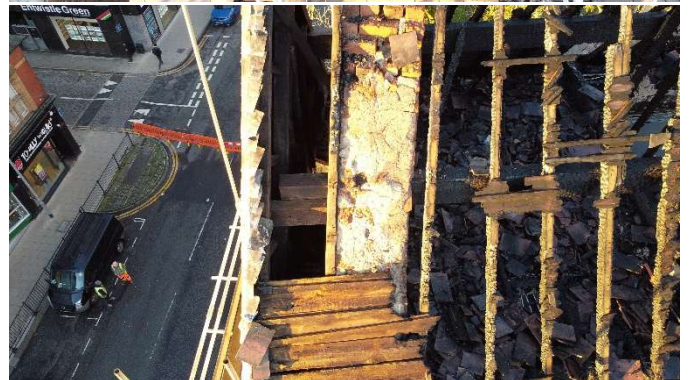
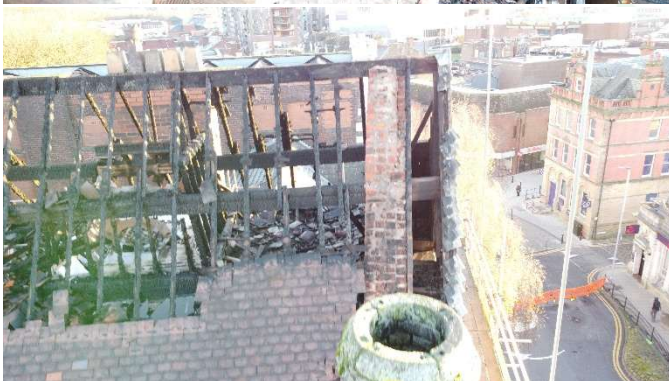
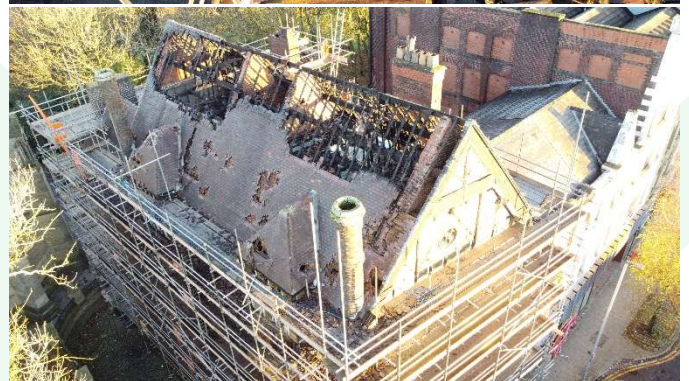
External – Upper Levels by Drone Survey  
*(Images provided by Dewsridge)*

The drone survey shows the extent of the damage to the roof structure. The fire damage has caused extensive damage to the whole roof structure, the fire appears to have been concentrated to the rear where in some areas the roof rafters are completely absent. Elsewhere the roof structure is fire damaged beyond repair and provides very little in way of lateral restraint to the gable masonry as it once did. This essentially renders the gable masonry as freestanding structures, as the remaining timber purlins and rafters cannot be relied upon to provide effective tie in the long term, which leaves the gables at risk of future collapse due to lateral forces imposed by wind.

The front elevation gable appears to be leaning inwards as can be observed when comparing it to the remaining rafters to its rear.

Restrain masonry gables by temporary shoring as previously described.

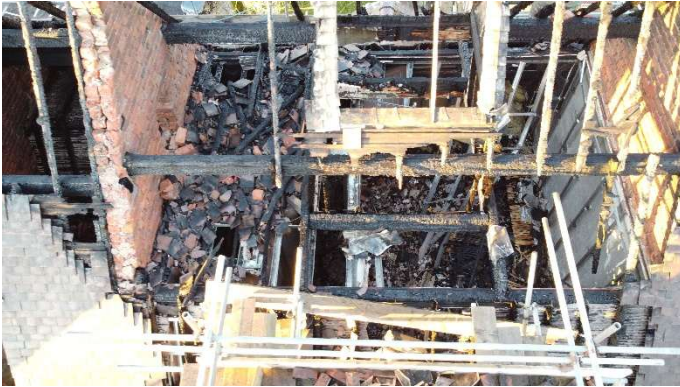
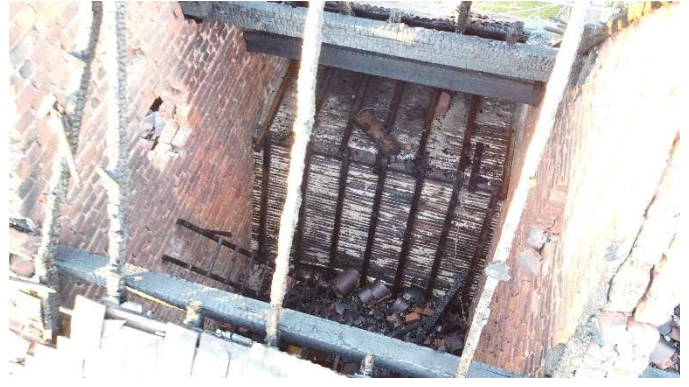
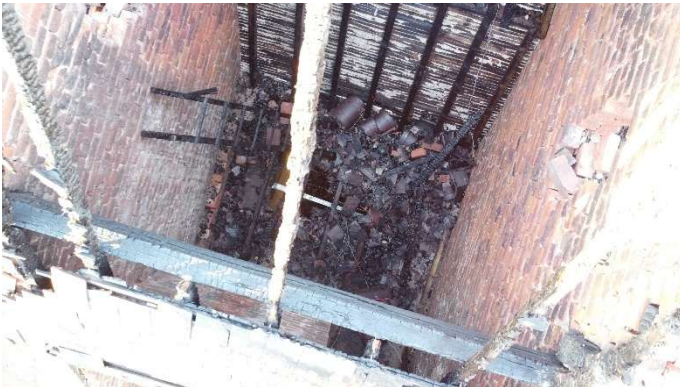
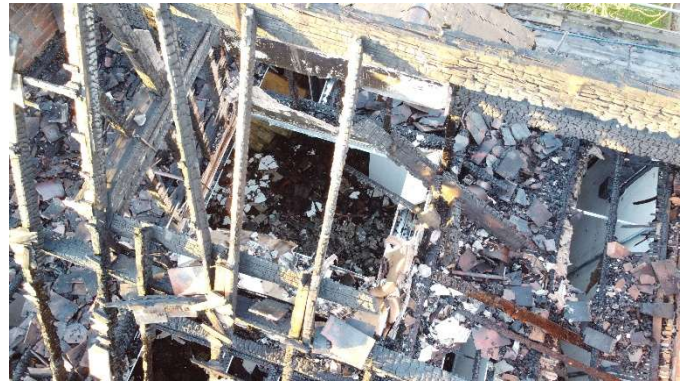
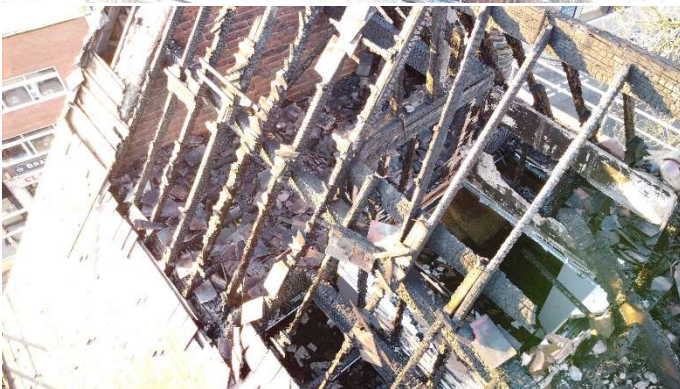
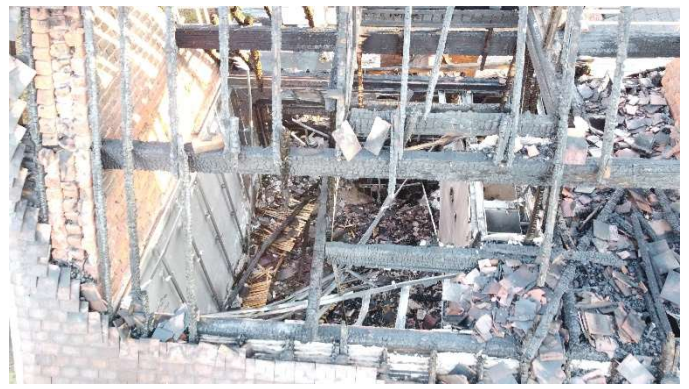
External – Upper Levels by Drone Survey  
*(Images provided by Dewesridge)*

The drone survey shows the extent of the damage to the upper floor and ceiling structures. Suspended timber floor and ceiling structures are partially collapsed, overloaded with debris and subject to extensive fire damage that leaves them at risk of collapse where overloaded and leaves masonry elevations unrestrained.

External façade to be shored by independent scaffold and internal gables to be shored internally as previously described. Once this has been undertaken then removal of fallen debris overloading remaining floor structures should be undertaken and removal of the floor structures themselves should follow. This should be undertaken from top down as the risk of falling debris from above is high.

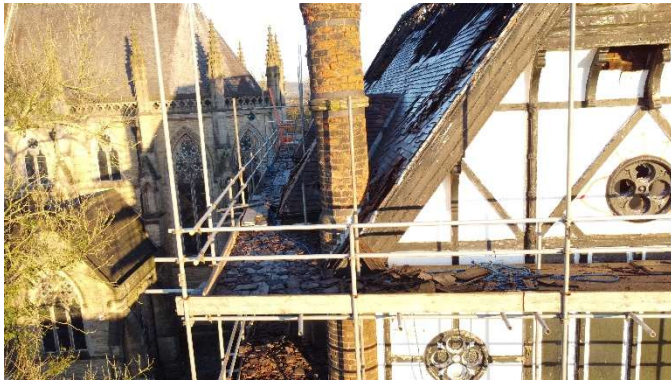
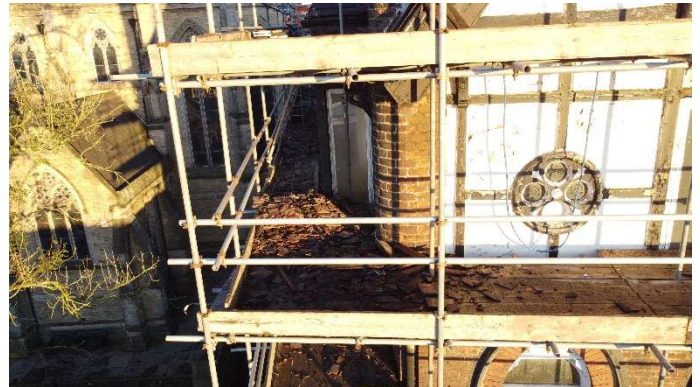
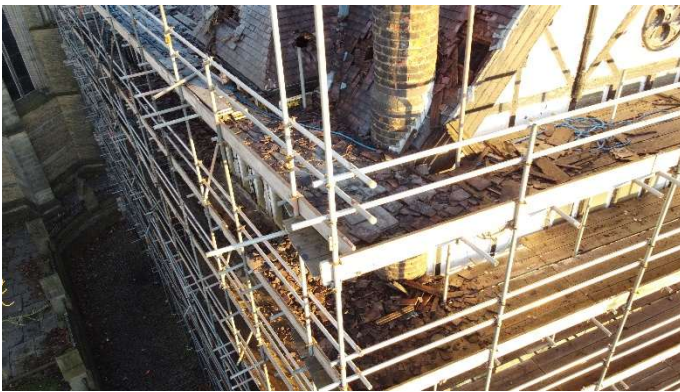
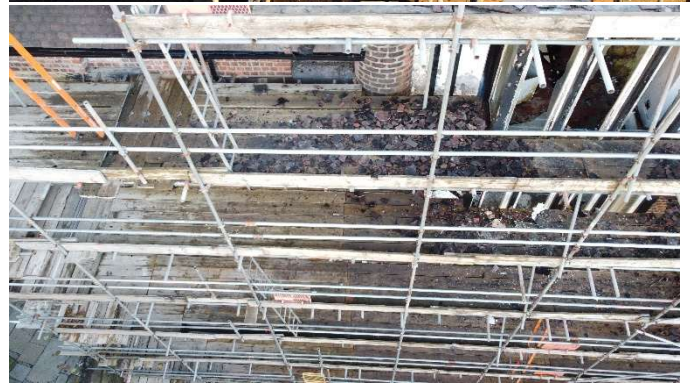
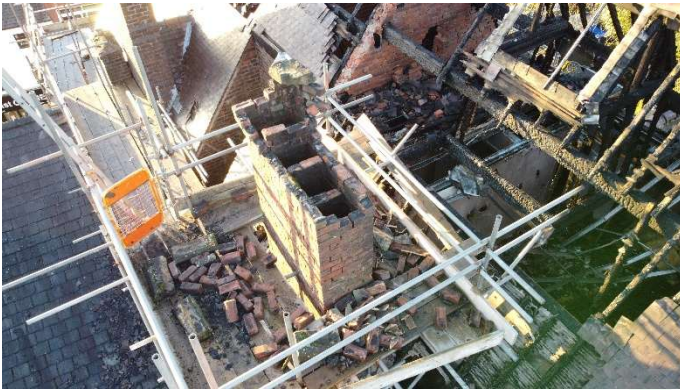
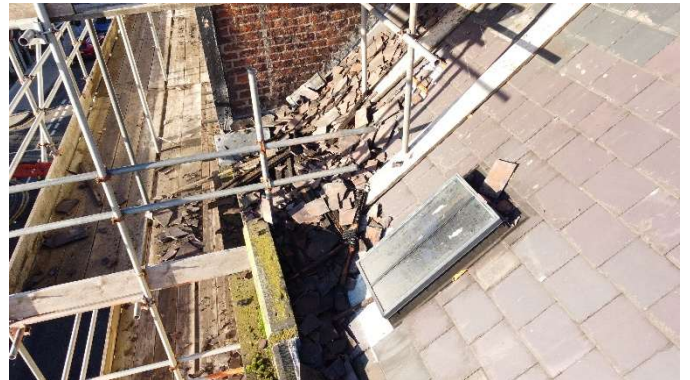
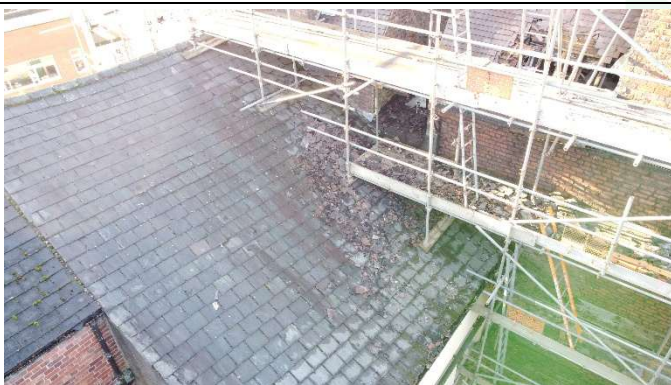
External – Upper Levels by Drone Survey  
*(Images provided by Dewstridge)*

The drone survey shows that debris has fallen onto the scaffold structure which is likely overloading the scaffold beyond its current design limits. Similarly, debris has fallen onto the roofs of neighbouring structures.

Removal all fallen debris from scaffold structures and neighbouring roof structures as soon as possible, access should be undertaken by MEWP until such a time that the scaffold structure is deemed to be secure by the scaffolding designer.

Structures and finishes to roofs should be inspected for damage following removal of debris and repairs undertaken immediately to prevent water ingress.
