## BURY FUSILIERS MUSEUM

Addendum to Condition Survey  
Chambers Conservation Ltd, October 2022 ISSUE 1.

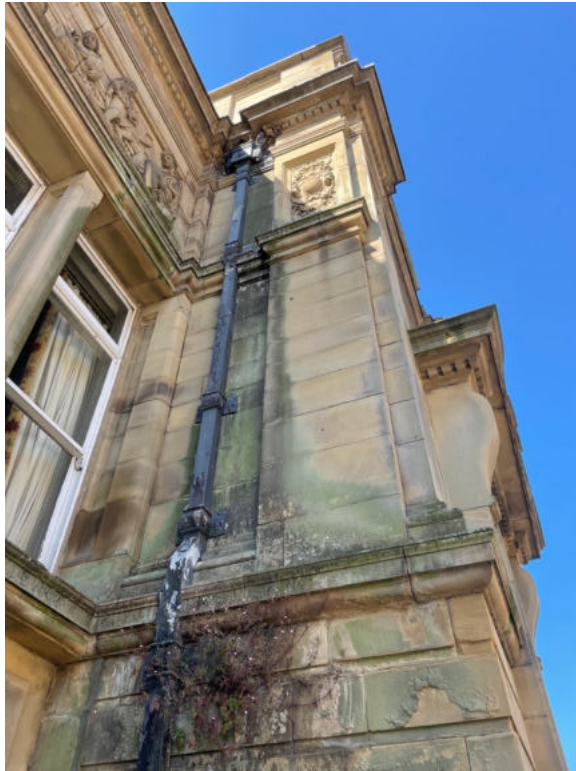
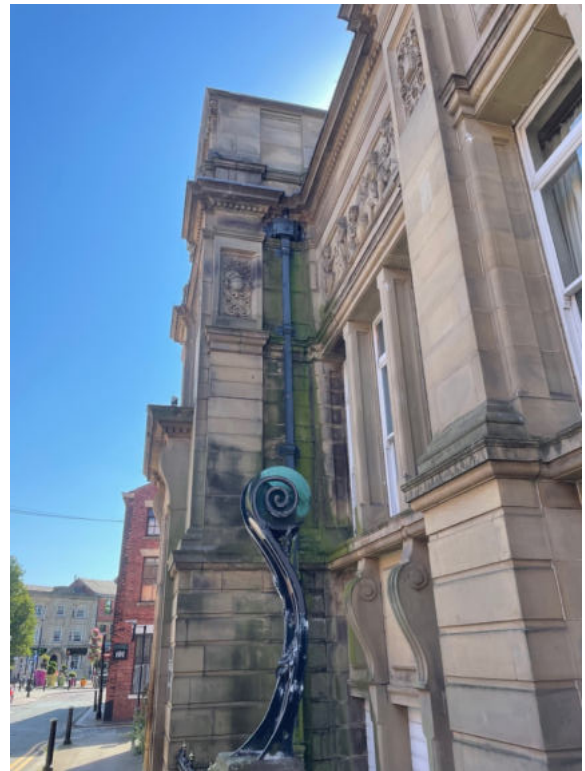
In particular the outlets to Broad Street (see Fig 01) are regularly over-flowing down the external stonework which is starting to cause significant damage to the stonework externally and finishes and joinery internally. Without address this also could result in substantial rot taking hold.

**01** (Area A, right and B, left). Outlets and downpipes to Broad Street. Surcharging and discharging down the face of the ashlar. Causing damage to the stonework (externally) and damp internally. A combined cause of complex discharge arrangements at cornice level, lack of capacity and blockages can be identified as the causes.

There is a need to consider providing additional capacity to the area around the chute, and increased capacity into the hopper and pipe. The hopper and pipe are integrated into the stonework and façade, so increasing the pipe and hopper capacity would be very damaging to the appearance of the listed building. Improved access for maintenance is, however, required.

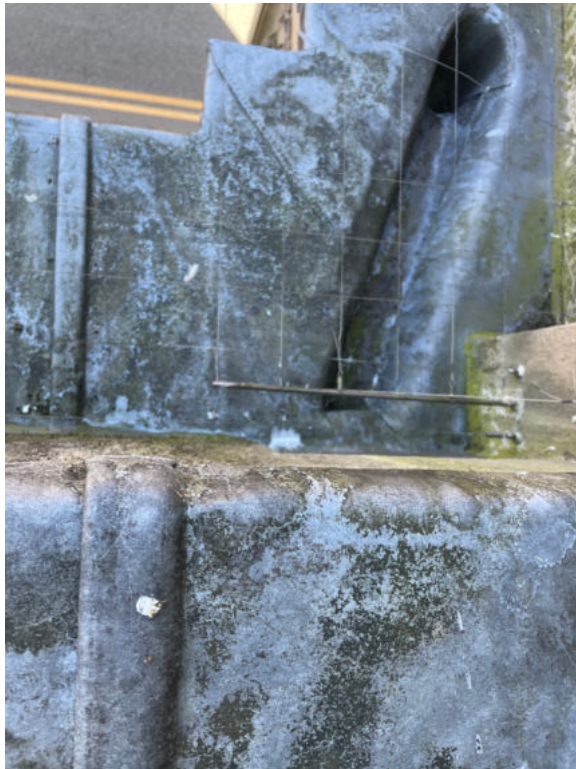
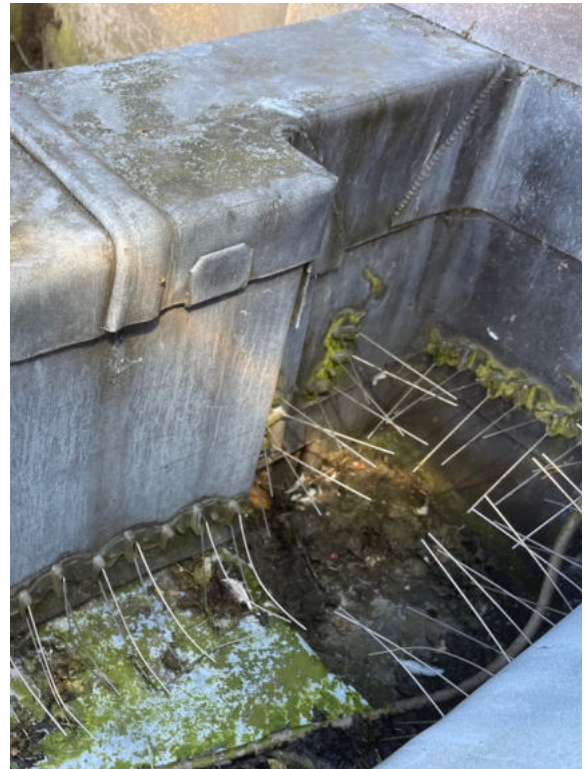
Inspection from above (see Fig 02) shows that the gutter (a fairly standard lead, stepped, parapet gutter) discharges through the blocking course into a very small channel cut into the sky-face of the cornice. Lined in lead, this only provides a very limited capacity and there is no catch-pit or sump to assist in storm conditions. The end result is water discharging over the top of the cornice. The pipes also are vulnerable to blockage, especially as pigeons can gain access to the hoppers. The general evidence of saturation to the stonework suggests the pipe is currently blocked and leaking. It needs to be removed to inspect for cracking to the rear.

**02** Area A (Note, Area B same but mirrored). Lead gutter discharges onto cornice, through channel cut into stone and lined in lead. Capacity is very limited and there is in effect no catch-pit or sump.

The rainwater pipes discharge onto the surface of the concrete in the light-wells to Broad St. There are gullies in the light-wells but not in direct proximity to the pipes. It is suggested that the below-ground drainage is investigated further and a survey commissioned to ensure that the water is being effectively dealt-with.

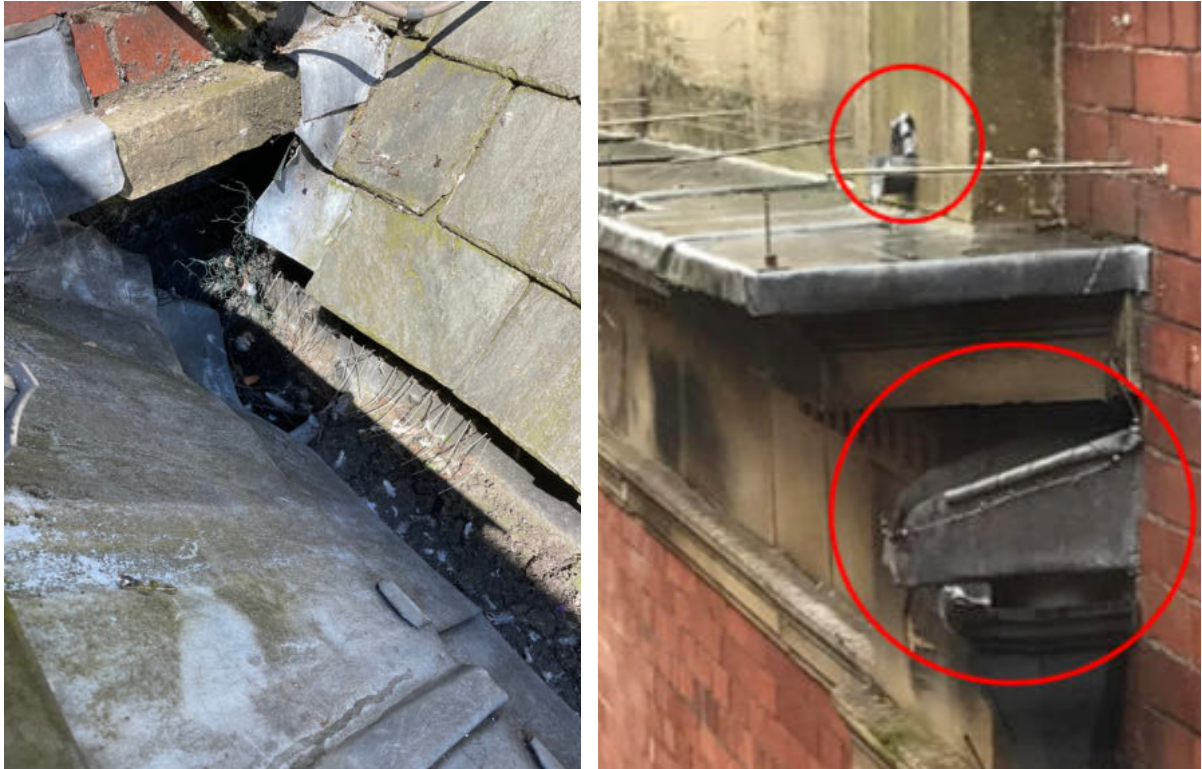
Area C is the discharge point for Gutter 3. This outlet takes a substantial amount of water from two adjacent roof slopes. Identified in AY report, but the outlet configuration was not fully understood, (see illustration 14/15 of AY summary). Water ingress is very evident below the outlet.

Currently the gutter drops into a very small catch-pit with (blocked) overflow. The pipe is then routed internally (concealed) with an off-set to a chute and hopper below. (see Fig03). This is currently very difficult to maintain without external scaffold.

03 (Area C). View from the gutter above. View from the north-west showing the overflow and hopper (circled).

There is very limited over-flow capacity and the outlet is vulnerable to blockage. It should be possible to increase the catch-pit capacity, with some reconfiguration, and improve access for maintenance to reduce risks to the fabric.

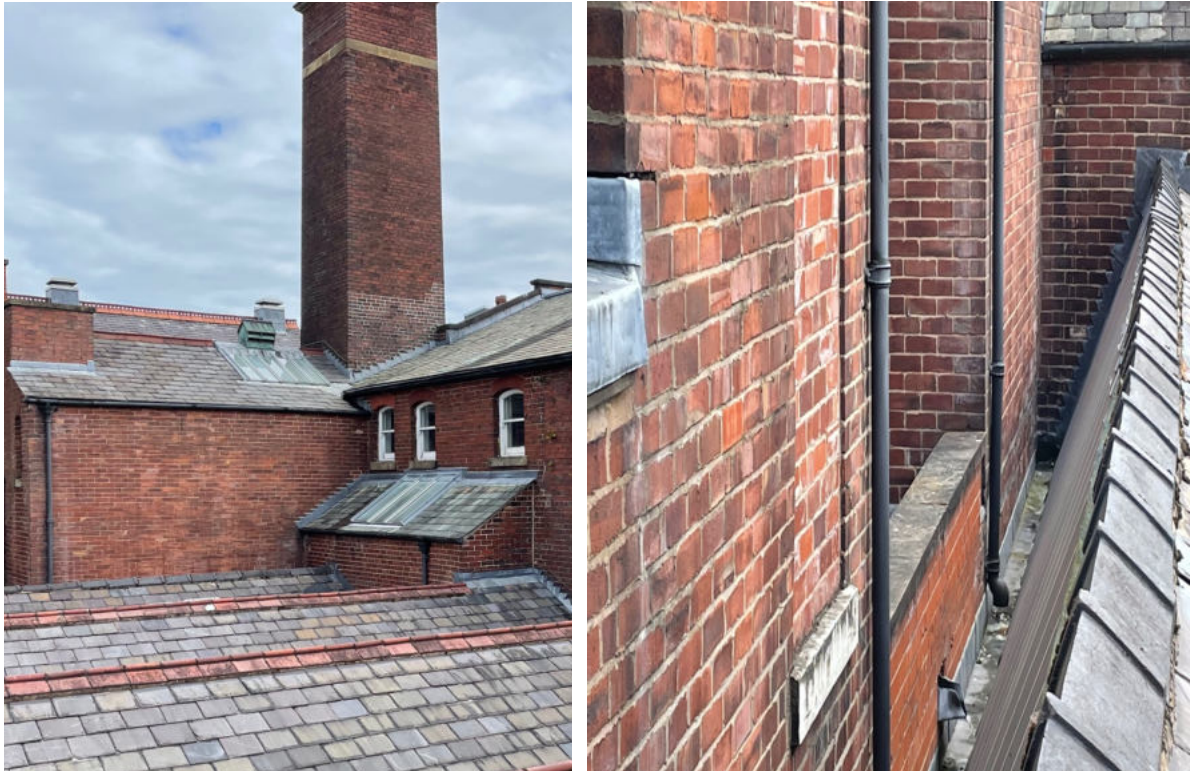
Further areas of water ingress were identified, (above the WC corridor and mezzanine stair S06). This was identified in the AY report (item 4.15, p19), but has noticeably deteriorated subsequently. Gutter 6 and 7 are both misaligned and there is failure in the gutter joints, with consequent saturation of the walls below. A section of rainwater pipe is also missing where gutter 7 discharges into valley gutter 13.

Lead valley gutter (15) has limited capacity (it also takes water from roof 11 via a chute), and inadequate height flashings. There is also misaligned and poor quality brickwork above (this appears to be historic and resulting from the varied dates of construction in this area), this has open joints and is potentially contributing to the damp masonry and plasterwork failure below. This area is identified as Area G on drawing BUFM.01-001.

04 (Area G). General view (left). Close up of view of lead gutter, outlet from roof 11 (left).

The iron gutters need dismantling, joints repairing and re-aligning properly. The lead valley gutter (15) should have increased depth flashings, which could be extended also to protect the brickwork above.

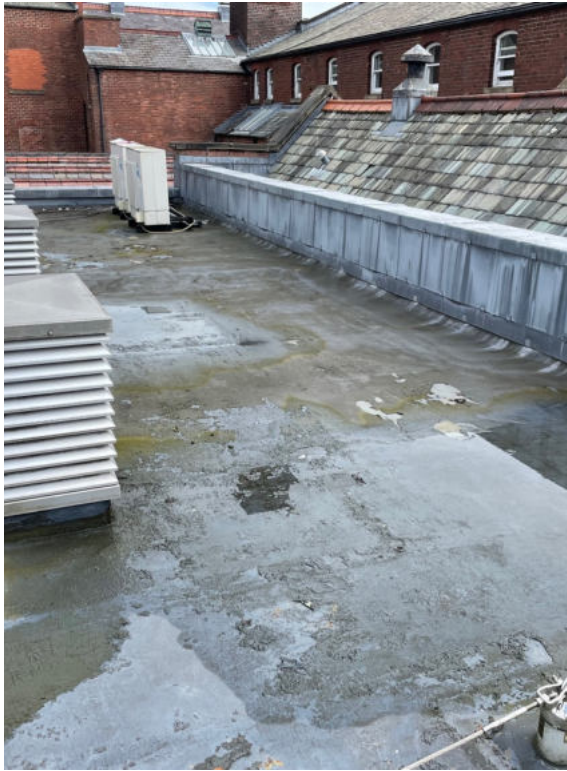
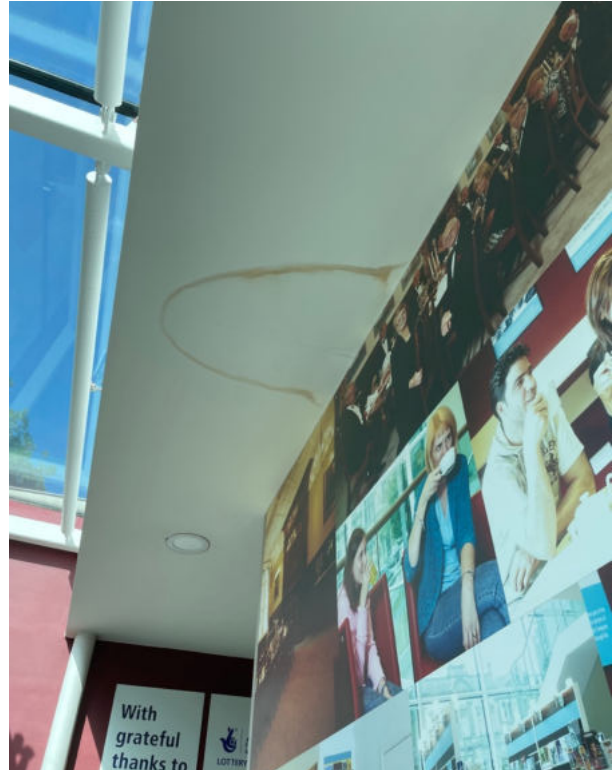
The AY report noted the failure of the modern roofing over the entrance and café. On inspection in August 2022, the roof covering has further failed, and there was widespread evidence of ponding to the surface (through staining as conditions were dry). Water ingress was also evident internally and consequently there is failure in the internal finishes.

The ponding suggests that the roof is not falling properly to the outlets (see Fig 05). The original specification and drawings show a decothane liquid membrane on cut-to-falls insulation. There is widespread evidence of failure in the coating and it is consequently possible the insulation has become wet below, therefore potentially affecting both performance and the falls to the outlets. Patching has been undertaken in a number of locations.

There is also cracking where the liquid extends over the coping to the south-western corner. This isn't currently protected by a flashing, which would significantly improve the detail.

05 (Area F). Evidence of ponding to the flat roof, extensive coating failure and patching. Right, internal water ingress and damage to finishes.

The whole roof is now in need of renewal before significant internal damage occurs. This should preferably be in a membrane rather than liquid applied system, which should offer improved longevity and a more robust finish. Flashings would provide a more robust detail to the south-western parapet.

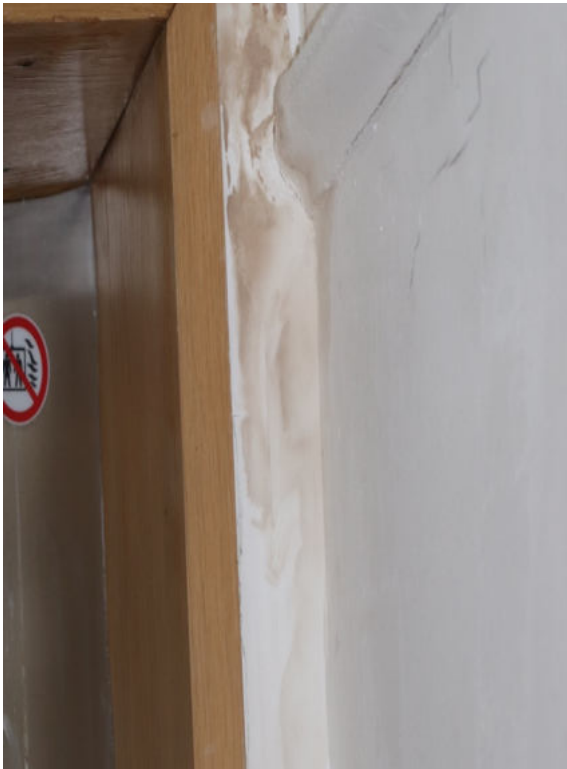
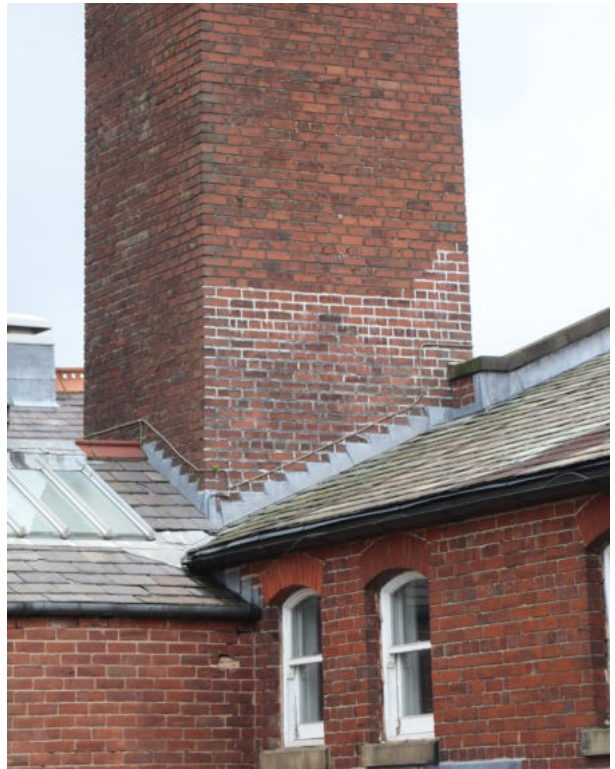
At the time of inspection it was not possible to safely access the interior of the lift shaft to determine the extent of water in the shaft (lift 1), but there remains evidence of some on-going water ingress which is causing damage to finishes (see Fig 06).

06 & 07 (Area D). Damage to finishes from water ingress above lift shaft (lift 1) and recent repointing works, which have made an improvement to the water ingress.

The lift is within a historic ventilation shaft, Some repointing work has been undertaken (see Fig 06), which has (anecdotally) made a difference to the water ingress. It is however evident that the problem remains, and in order to properly determine the cause, a proper high-level inspection, probably using rope access is required, together with a lift-engineer to facilitate the internal inspection. This may determine further high-level works or additional pointing requirements.
