# Preliminary Roost Assessment

The Stables

41 Arthur Lane

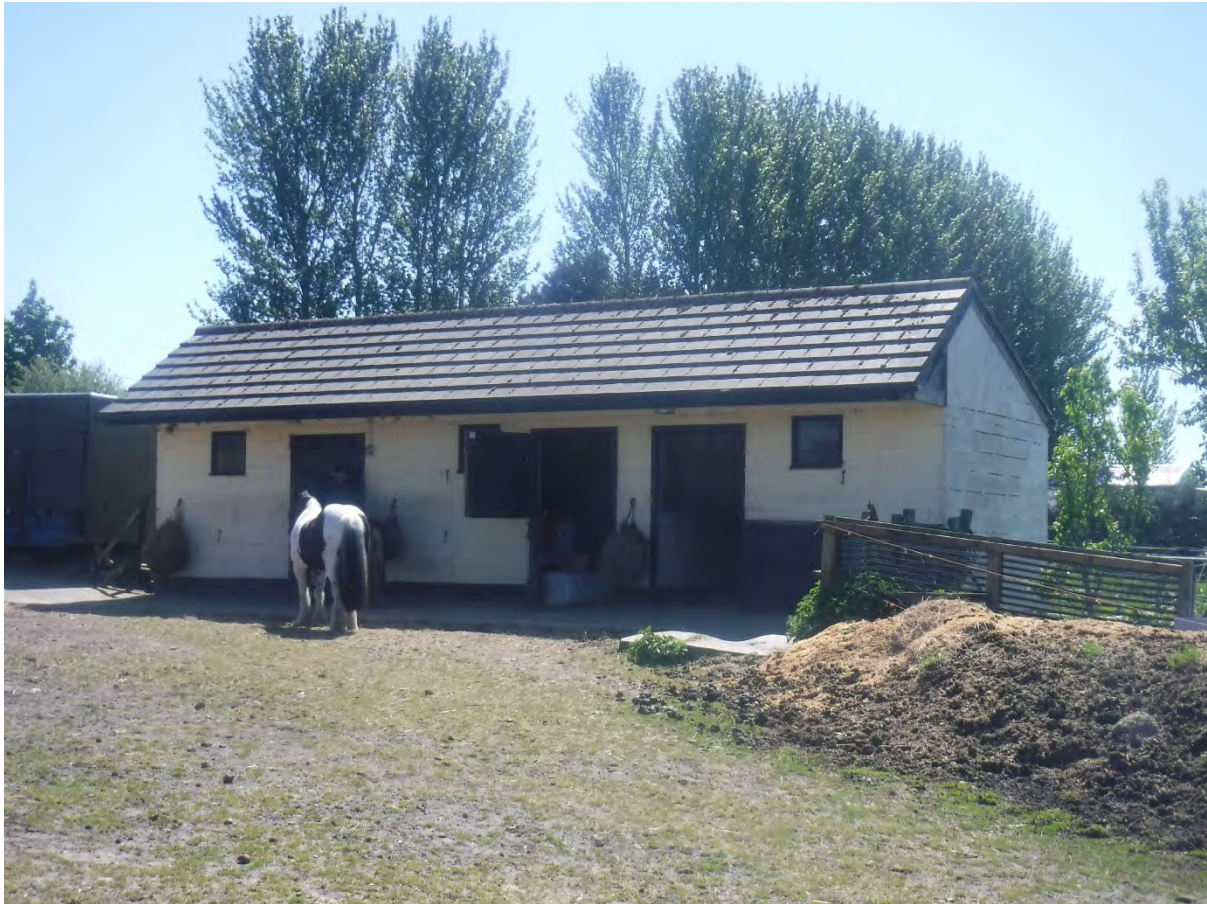
3.1a – The front of the stables.

The building is a detached stable block, it was built approximately 20 years ago, and is used daily. It has an unequally pitched roof, covered with Marley concrete roof & ridge tiles; roof pitches face north & south, gables face east & west. End tiles at the verges are sealed with cement. Wooden fascia boards are fitted at the eaves and gable ends.

The building is well maintained, and in good condition. Roof tiles are tightly fitted with no damaged, missing, or slipped tiles. Ridge tiles are fitted tightly, and fixed in place with cement. End tiles at the verges are sealed with cement. There are no gaps between roofing materials. Wooden fascia boards are fixed tightly against walls with no suitable gaps. Walls are in good condition with no gaps or cracks, and no missing mortar.

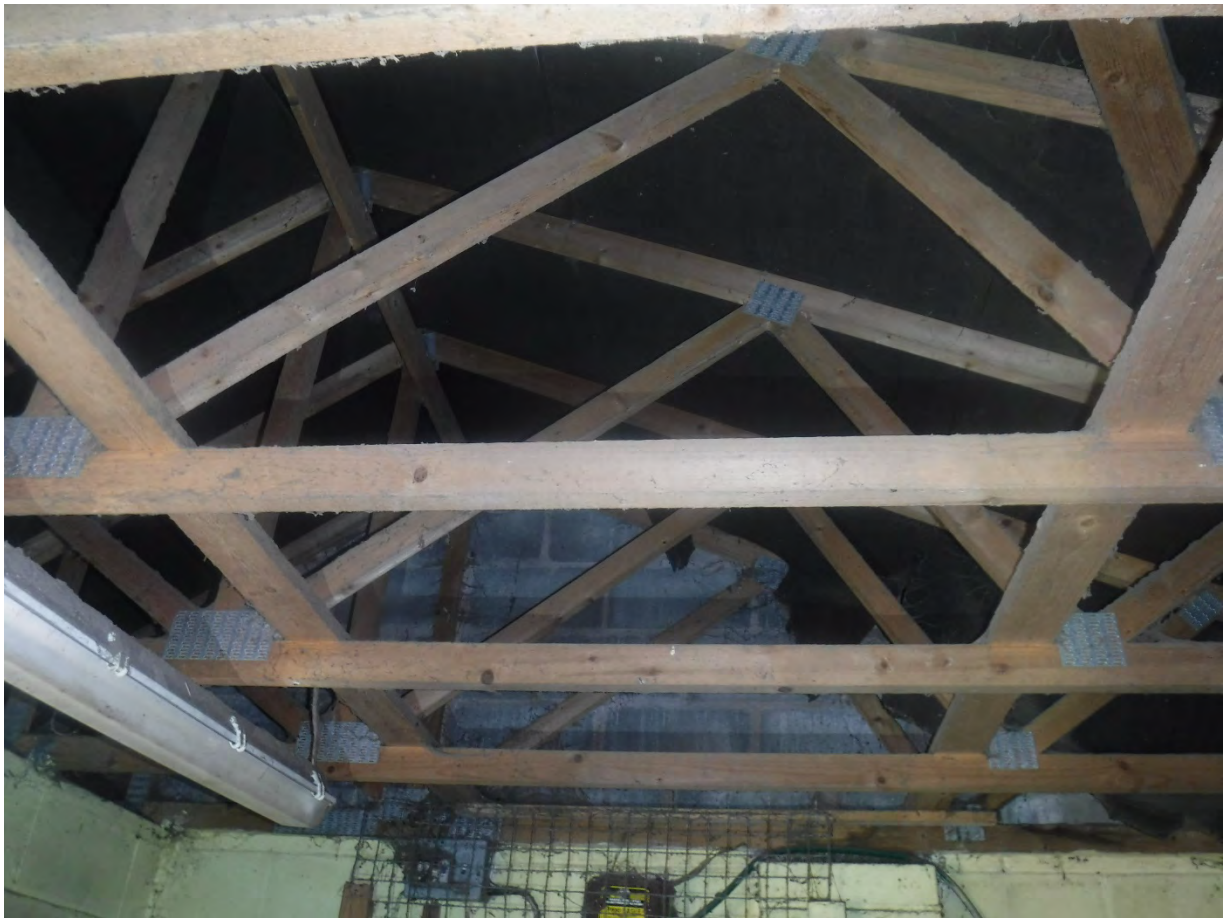
3.2a – The roof structure.

Internally, the building is split into two stables and a storage room. There is no internal roof void and the roof structure and underside of roofing materials is exposed. The building has a trussed timber roof structure, lined with bitumen felt. Walls are single layered concrete blockwork and are not lined. Floors are concrete.

Roof timbers are fixed tightly against the inside of the gable end walls with no suitable gaps, and fixed to the top of blockwork at the wall-plate. Timbers are dusty and cobwebbed. The roof lining is intact with no tears or gaps, and there are no holes or gaps in the roof which could give access to roosting bats.

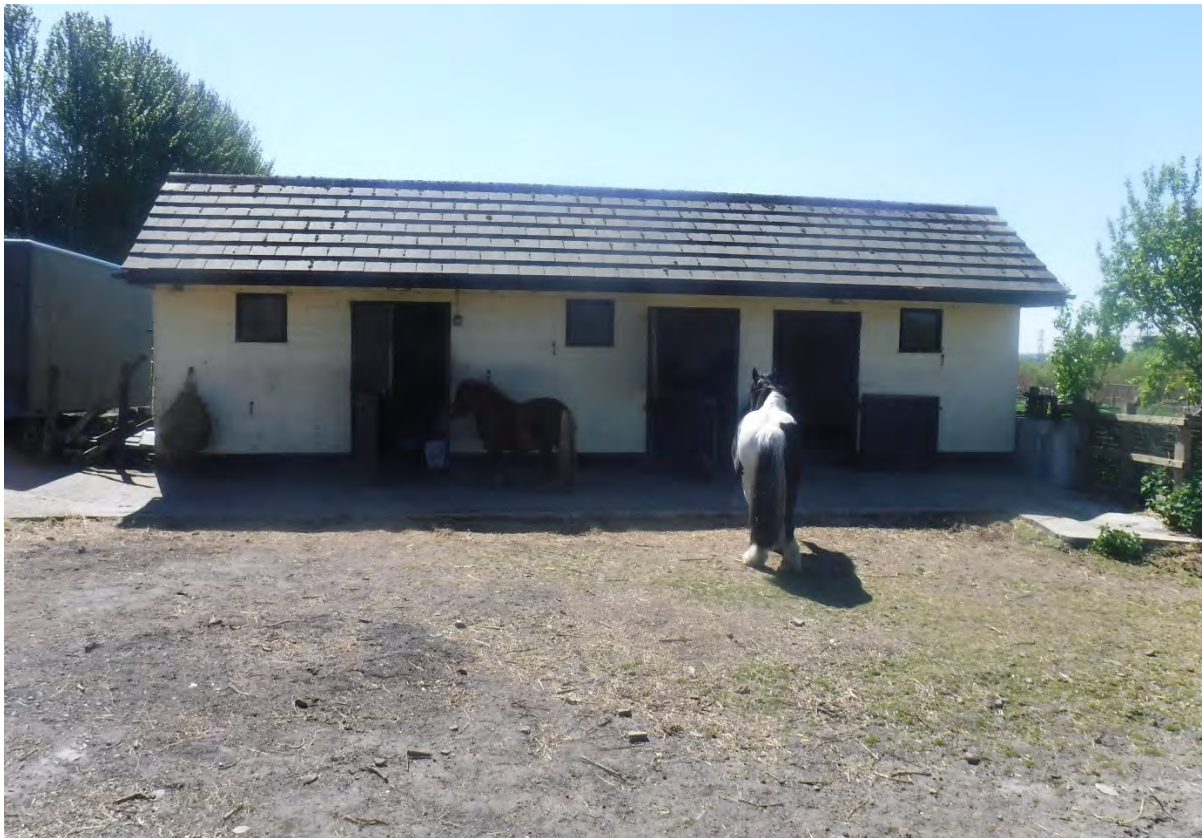
1 – The north facing front of the stable block.

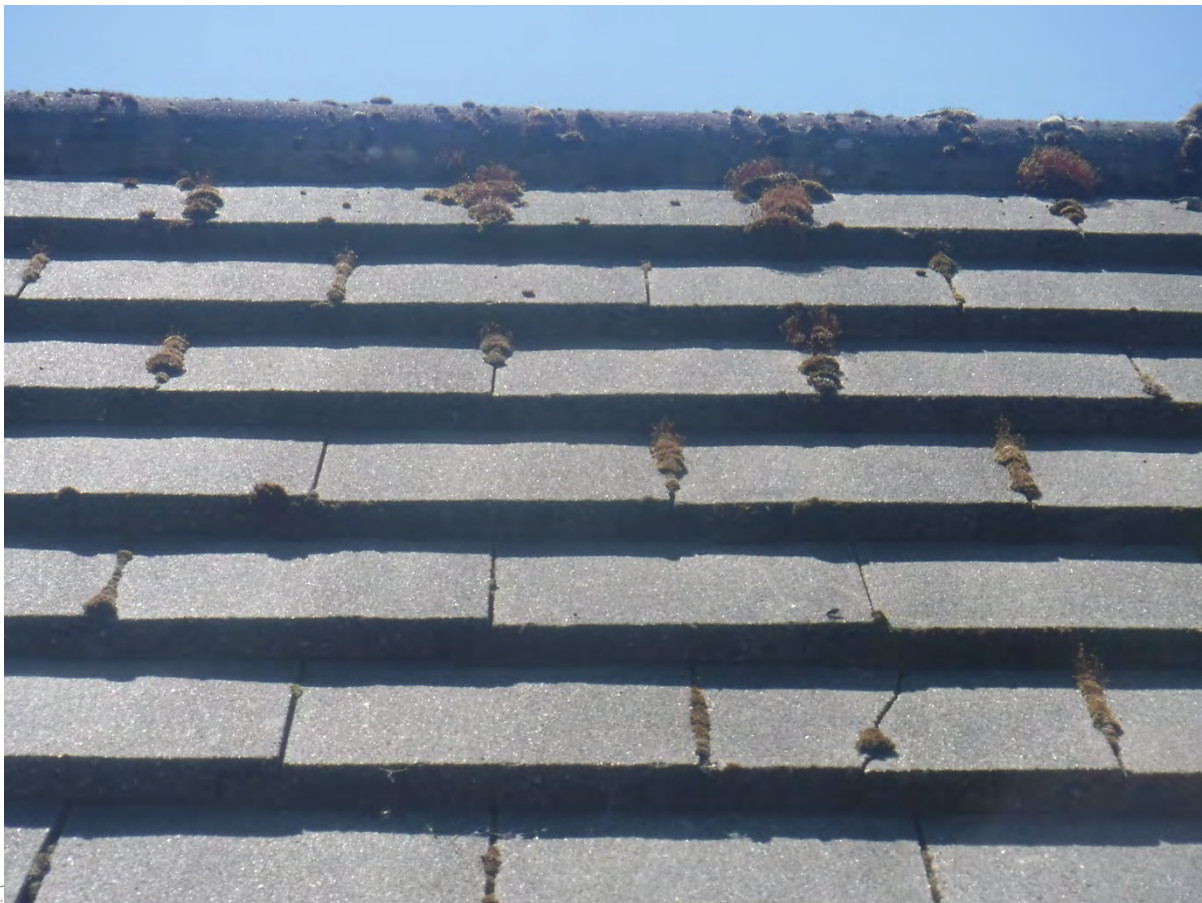
2 – Roof tiles are in good condition with no suitable gaps.

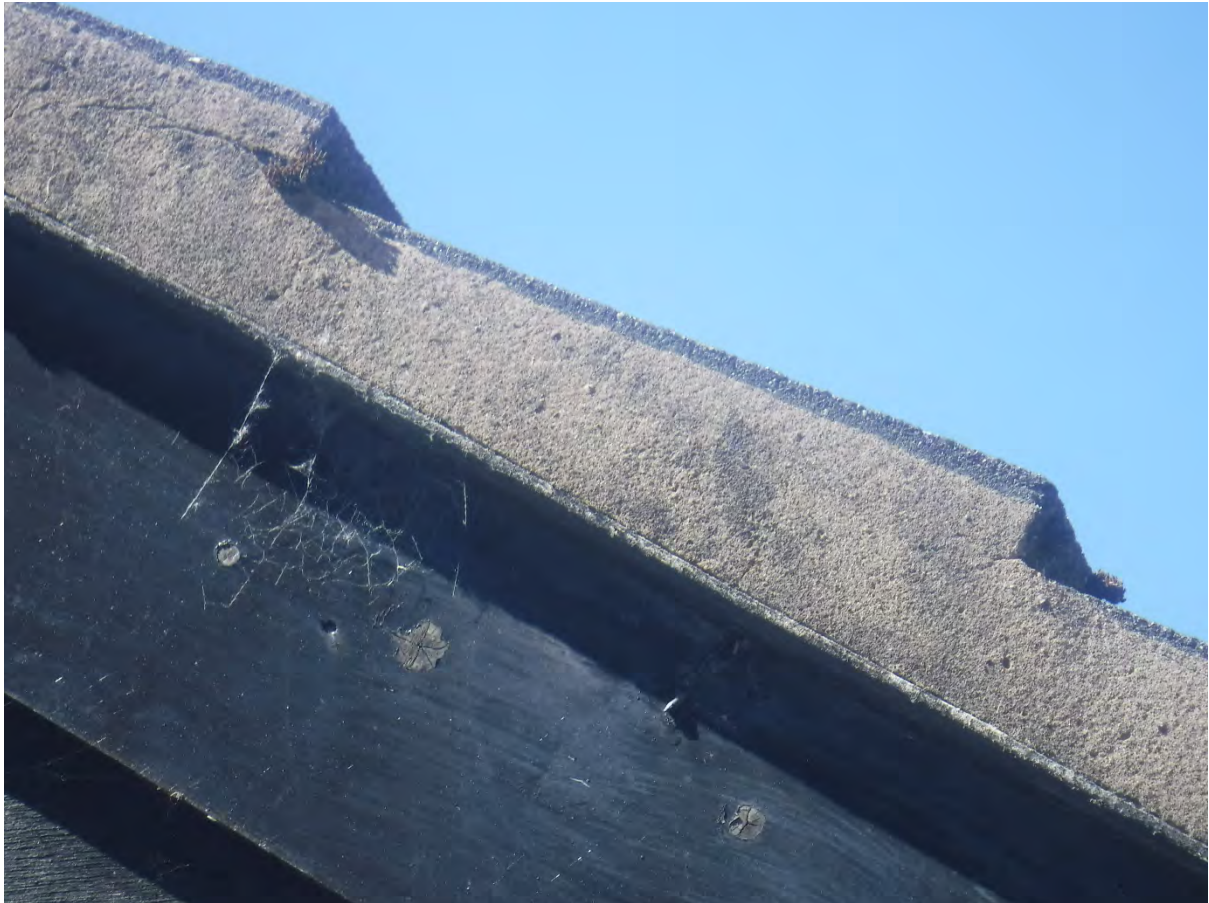
3 – Cement at the gable end verges is intact with no suitable gaps.

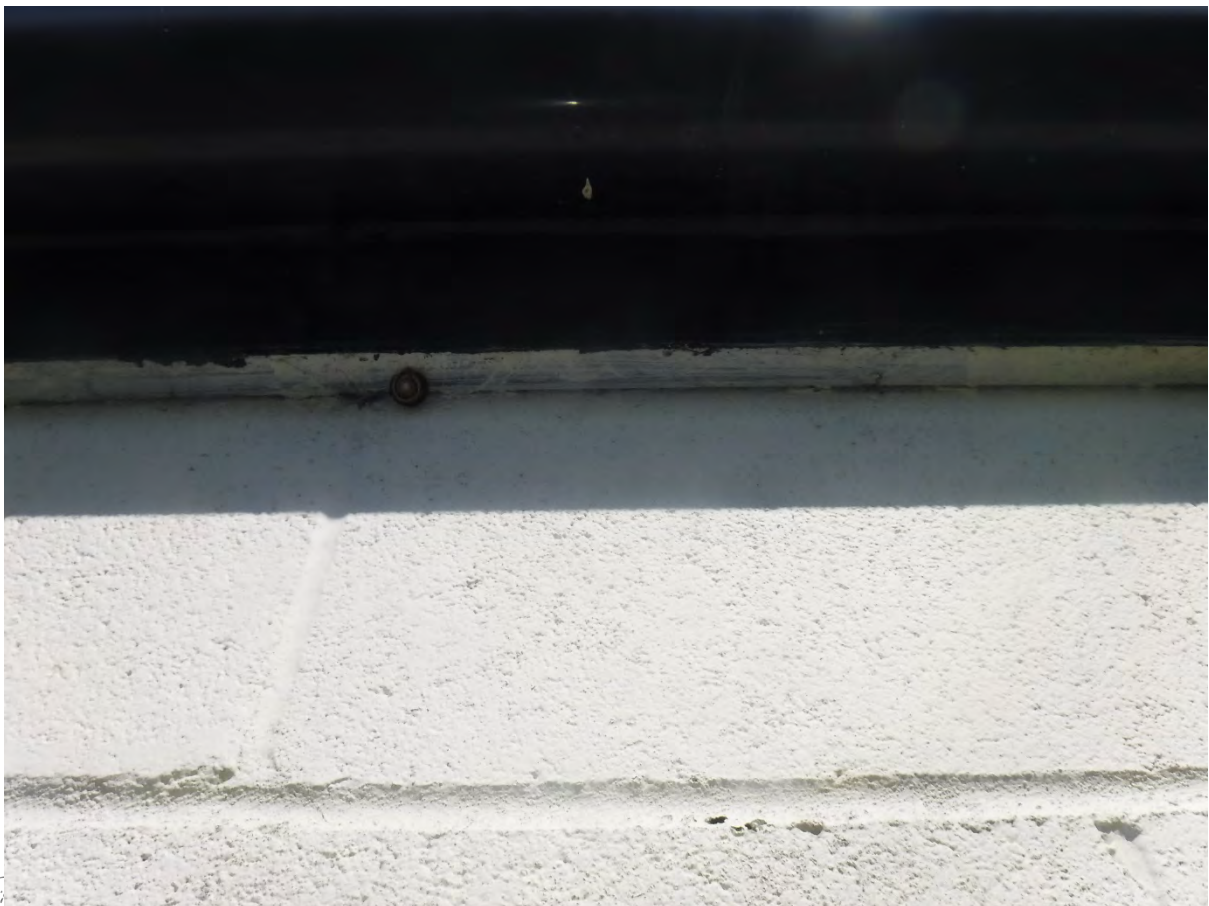
4 – Wooden fascia boards are fixed tightly against blockwork with no suitable gaps.

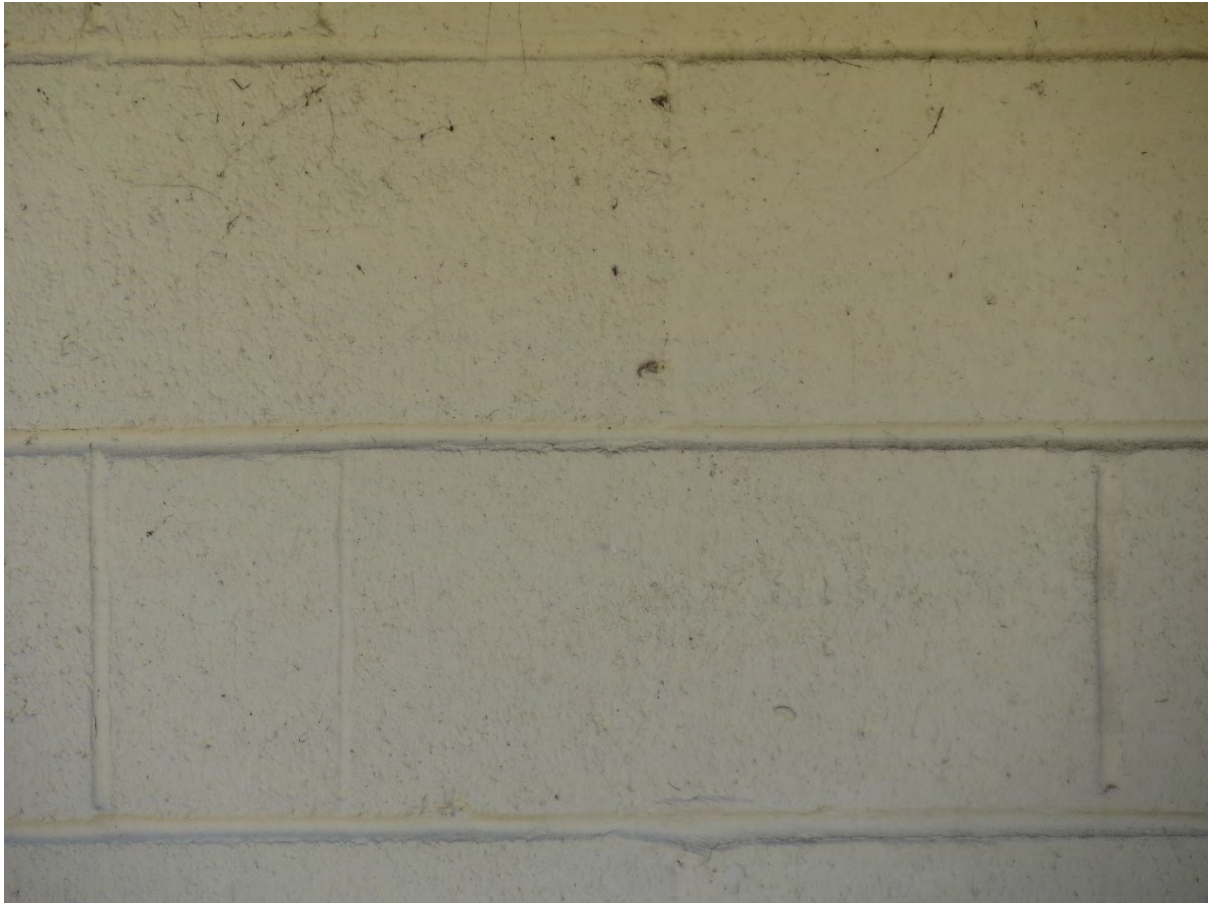
5 – Walls are in good condition with no gaps or cracks.

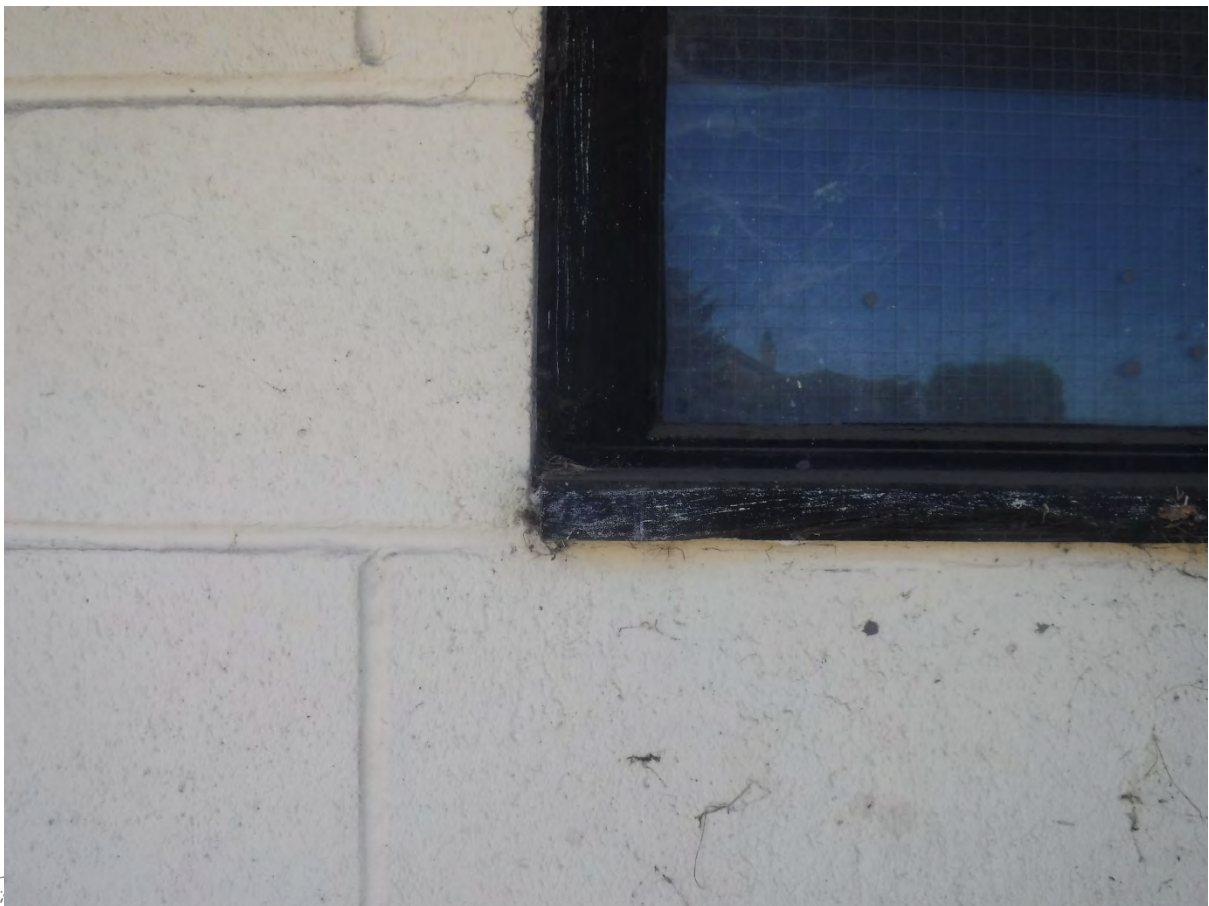
6 – Window and door frames are sealed into the walls with no suitable gaps.

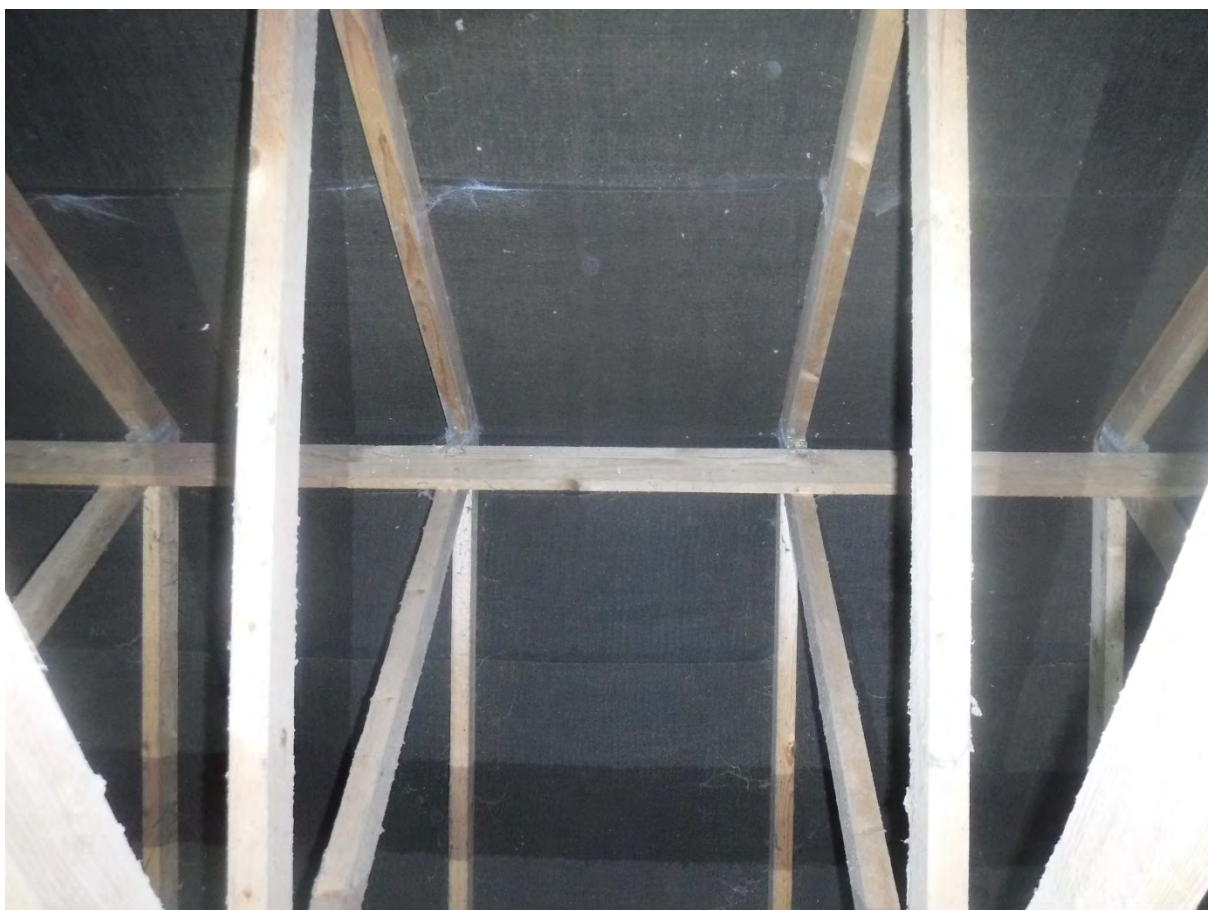
7 – The building has no enclosed roof void, and has a timber trussed roof structure.

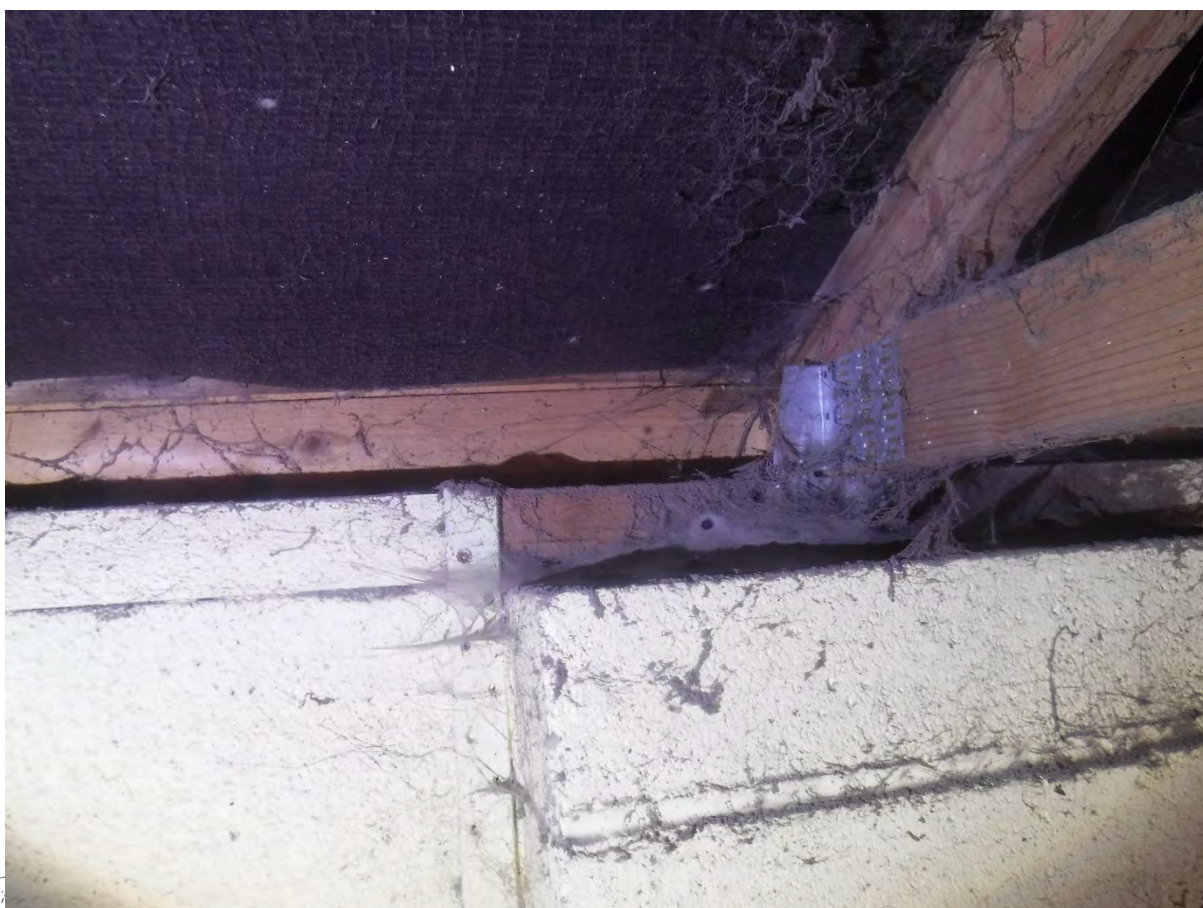
8 – Timbers are covered in dusty cobwebs with no gaps between timbers and blockwork.
