# ASBESTOS SURVEY REPORT

## REFURBISHMENT/DEMOLITION ASBESTOS SURVEY

SPECIFIC AREAS, 41 ARTHUR LANE, AINSWORTH, BOLTON, BL2 5PR

REPORT NUMBER: R-17322

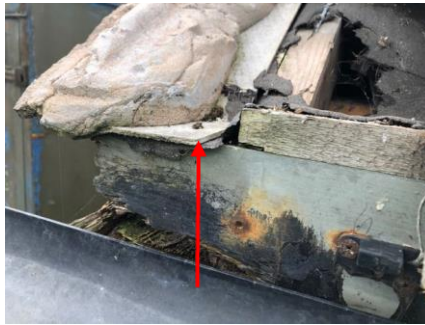
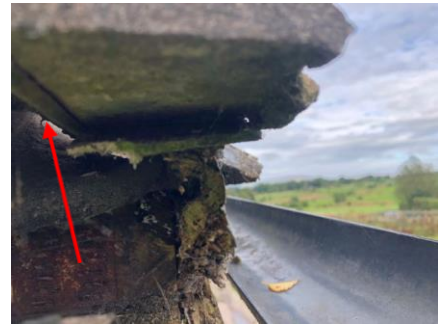
Chrysotile asbestos cement (AC) undercloaking is present to the apex of the roof and the lip as the undercloaking coating corners around the front and rear. These should be removed by a trained contractor under CAR 2012.

| Location | Sample No. | Risk Ass't No. | Product | Approx. Quantity | Condition | Surface Treatment | Accessibility | Asbestos Type | MRS | PRS | Actions/Comments |
|---|---|---|---|---|---|---|---|---|---|---|---|
| External | R-17322/003 | 401639 | Lip to underside of corner of roof - Asbestos cement (AC) | 1 l/m | Medium damage | Unsealed | Medium | Chrysotile | 6 | N/A | Remove (T): Trained contractor to complete any remedial or removal works under CAR 2012. |

| ACTION | | |
|---|---|---|
| Inspection Cycle | N/A | <b>Comments/Recommendations</b><br>Trained contractor to complete any remedial or removal works under CAR 2012. |

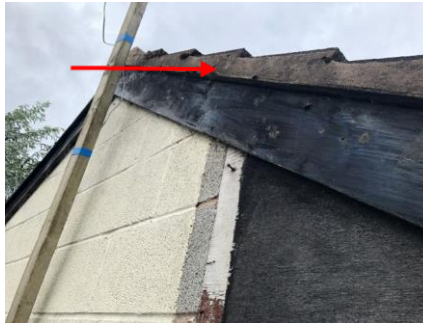
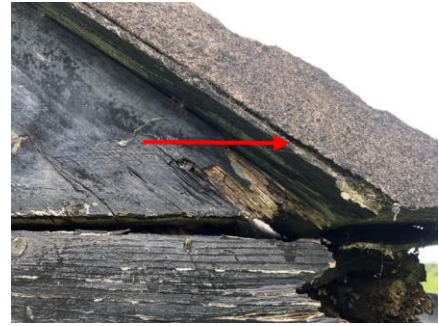
| Location | Sample No. | Risk Ass't No. | Product | Approx. Quantity | Condition | Surface Treatment | Accessibility | Asbestos Type | MRS | PRS | Actions/Comments |
|---|---|---|---|---|---|---|---|---|---|---|---|
| External | R-17322/004 | 401636 | Undercloaking - Asbestos cement (AC) | 12 l/m | Medium damage | Unsealed | Medium | Chrysotile | 6 | N/A | Remove (T): Trained contractor to complete any remedial or removal works under CAR 2012. |

| ACTION | | |
|---|---|---|
| Inspection Cycle | N/A | <b>Comments/Recommendations</b><br>Trained contractor to complete any remedial or removal works under CAR 2012. |
