## Preliminary Roost Assessment

Substation 3 - Fairfield General Hospital

Proposed development to convert an existing estates store into substation.

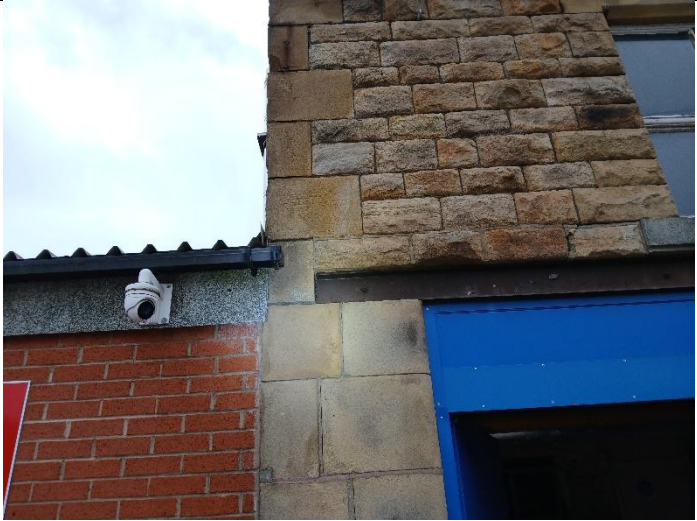
| Feature | Materials | Condition/description/suitability | Photograph(s) |
|---|---|---|---|
| Walls | Brick and mortar construction | <p><b>Condition/description</b><br/>All brick and mortared walls on all elevations are in good condition overall. Two single gaps are present adjacent to the door lintel of <b>B1a</b> above the access door. Additional small gaps are present on the eastern elevation where, pipework exits the building.</p> <p><b>Suitability/access/evidence of bats</b><br/>Overall, the exterior wall construction is well sealed with no missing mortar present. The two gaps present above the access door into <b>B1a</b> extend inwards above and below the steelwork, however, do not extend into the buildings internal space. These gaps are exposed to the elements and are considered unsuitable for roosting bats due to their shallow extent.</p> <p>Gaps in the walls where pipework exits the building allow external light to enter the internal space, however these features are cluttered with cables and pipework and would not offer suitable access for bats to enter into the internal space. No evidence of bats or bat roosting within the external walls was observed.</p> | <p>Gap above steel lintel at entrance to B1a</p> |

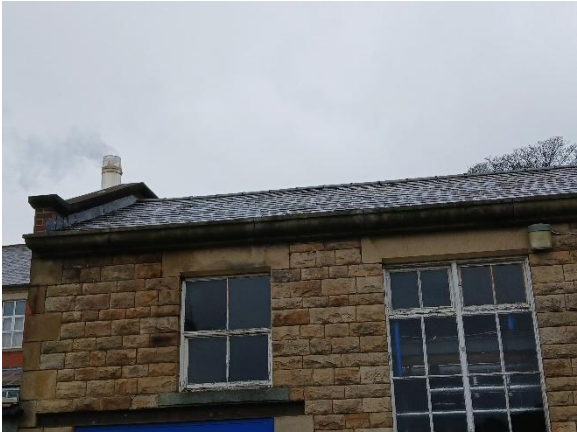
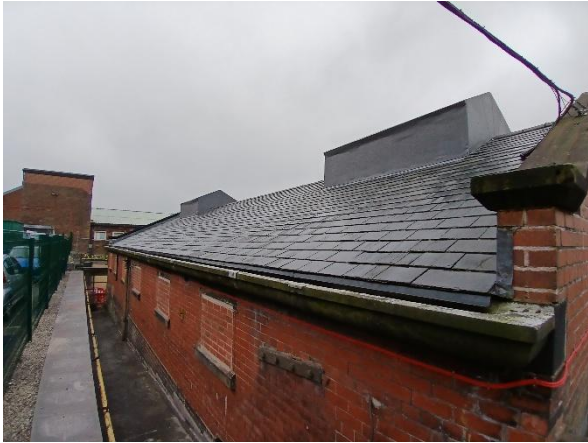
| Roof | Slate tiles on pitched sections. | <p><b>Condition/description</b></p> <p>All roof tiles on all roof elevations are tightfitting and in good condition, where present. Two tiles are missing from the roof of section <b>B1b</b> on the southern sloping aspect; however the above tiles are tightfitting with no significant gap present due to missing tiles.</p> <p><b>Suitability/access/evidence of bats</b></p> <p>No gaps suitable for bats to enter into the buildings internal space or access between the tiles and any roof lining present have been recorded. No evidence of bats or bat roosting within the roof was observed.</p> | <p>B1a roof tiles</p> <p>B1b roof tiles northern elevation</p> |

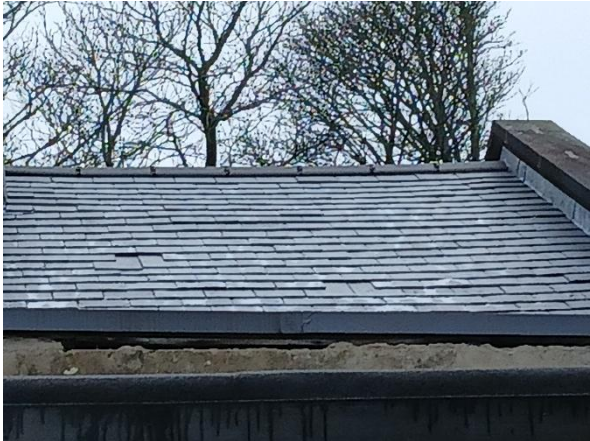
| | | | <p>Missing tiles in B1b southern elevation</p> |

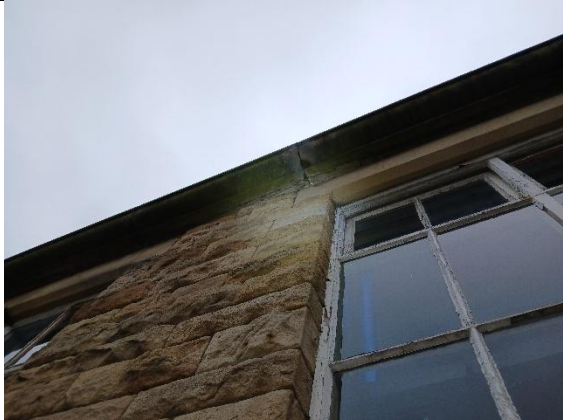
| Eaves | Overhanging | <p><b>Condition/description</b><br/>All roof eaves are sealed with mortar on all roof aspects, with capping stones present along the northern elevation.</p> <p><b>Suitability/access/evidence of bats</b><br/>No access points into eaves or capping stones are possible.</p> | <p>Mortared eaves of B1a and B1c</p> |

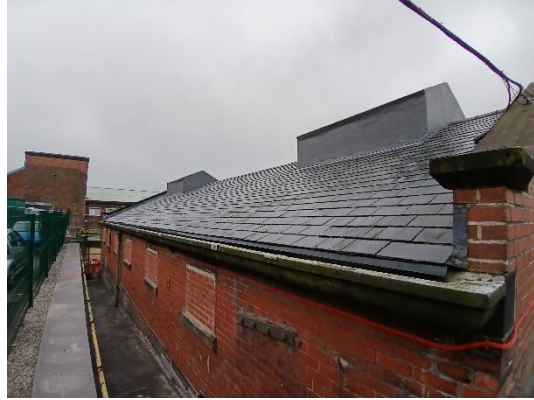
| | | | <p>Mortared capping stones on northern elevation of B1b</p> |

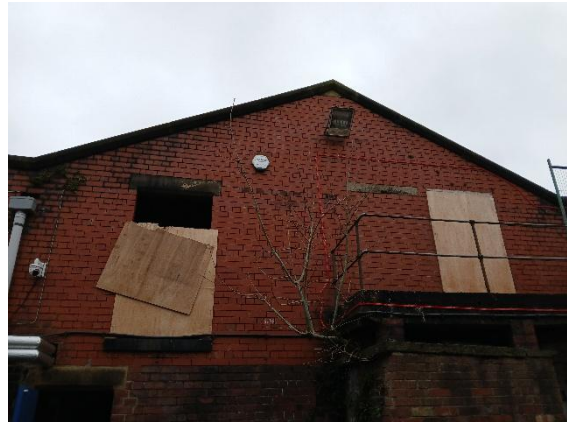
| Window/doors/<br>frames | UPVC | <p><b>Condition/description</b></p> <p>All windows, doors and door frames are in good condition and well-sealed where present. External doors on the eastern elevation of <b>B1b</b> have been boarded over, however, a section of the boarding has broken off, giving access into the internal space of the building.</p> <p><b>Suitability/access/evidence of bats</b></p> <p>The missing boarding on the eastern elevation would give bats access into the buildings internal space.</p> | <p>Missing boarding at second storey doorway of B1b</p> |

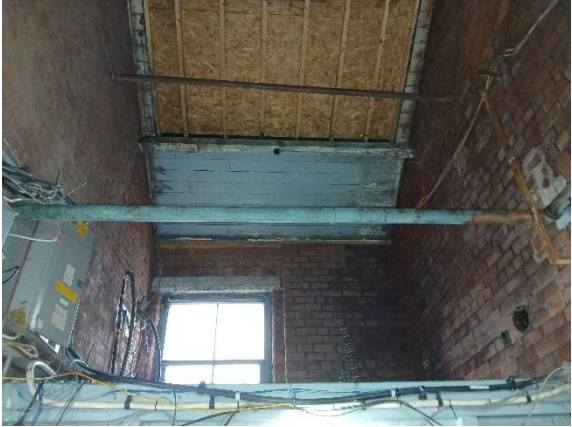
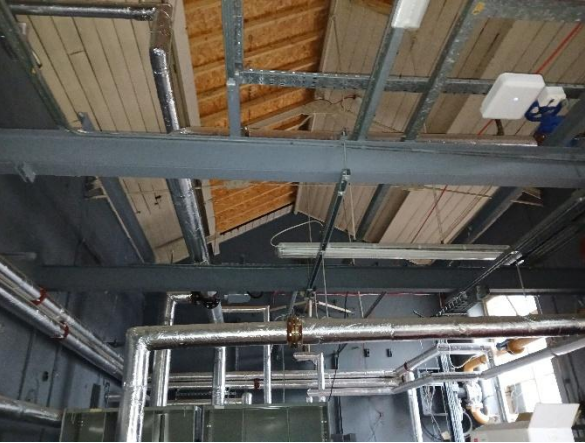
| Internal voids | <p>Timber rafters and ridge beam. Open floor to ridge, sloping to eaves. Wooden OSB and sarking boarded lining present.</p> <p>Exposed brick walls</p> | <p><b>Condition/description</b></p> <p>The internal space of B1 is split into multiple sections, relative to the previous building sections discussed externally.</p> <p><b>B1a</b> comprises of two sections and two-storeys, with a mezzanine second floor present above the access door. Internally the porch section of B1a extends directly into B1b. This section is open to the ridge with exposed OSB boarded roof lining and brick wall construction present. The boiler room section of B1a is separated by a locked internal door with no direct connectivity between the two sections of B1a. This section is also open to the ridge with OBS boarding and wooded sarking present, the walls of the boiler room are well sealed, however gaps extend from the boiler room into B1b where pipes have been removed. No gaps are present within the brick wall construction of B1a.</p> <p>The internal spaces of B1a measure approx. 6m from floor to ridge, with the mezzanine floor present at approx. 2m within the porch section, with a width of 5.8m. The porch extends 2.8m west to east, transitioning into the boiler room which extends a further 9.5m. The boiler room section of B1a is cluttered, housing heating infrastructure and stored materials. Both sections are well lit by external windows.</p> <p>Internal climatic conditions within B1a were 13°C 65% RH for the boiler room and 10.5°C 72% RH for the porch.</p> | <p>Internal porch section of B1a</p> <p>Boiler Roof section of B1a</p> |

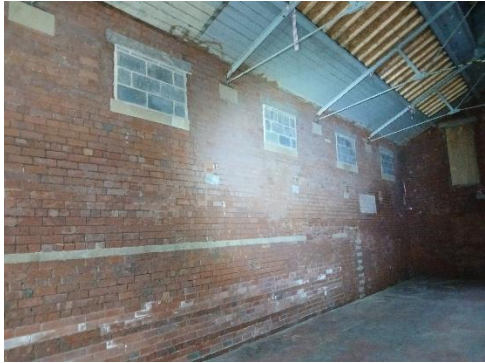
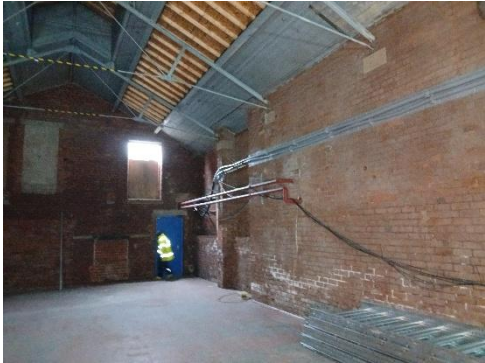
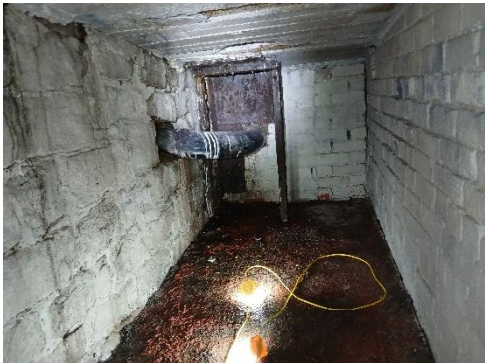
| | | <p><b>Suitability/access/evidence of bats</b></p> <p>Access points into B1a are available internally from B1b, however no suitable roosting features for bats were observed within B1a.</p> <p><b>B1b:</b> Section B1b is a large open building which has been subject to recent soft stripping and asbestos removal (October 2024 – January 2024). The main section of B1b is open to the ridge with exposed OSB boarded roof lining and brick wall construction present. There is a small subterranean annex to the rear of B1b, which extends under an access ramp to the rear of the building. This section comprises exposed brick with a concrete ceiling which slopes from west to east. No gaps are present within the internal roof construction of B1b.</p> <p>Gaps are present within the internal wall construction of B1b, due to the removal of storage infrastructure and asbestos containing materials. These gaps vary in extent with some gaps present leading into B1a where pipework has been removed (PRF1), whilst others extend from the first to the second row of bricks within the external English Bond wall construction on the northern and eastern elevation (PRF2). No cavity wall is present, however a cavity is present between blockwork installed on the northern elevation, where previous louvres were present (PRF3). All PRFs were inspected via torch and endoscope during the inspection.</p> <p>The subterranean section of B1b is well sealed with no suitable gaps present.</p> | <p>Northern elevation of B2b</p> <p>Southern and eastern elevations of B1b</p> <p>Subterranean section of B1b</p> |

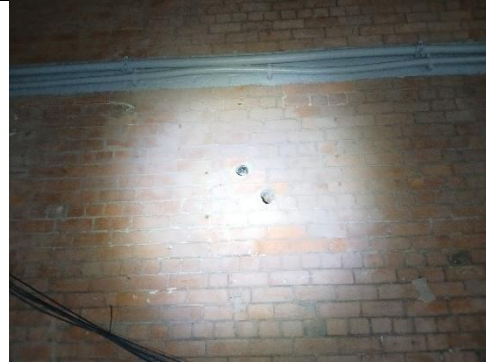
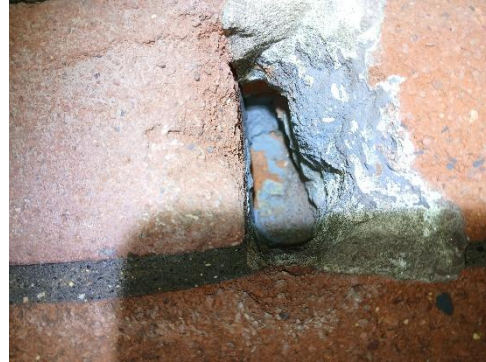
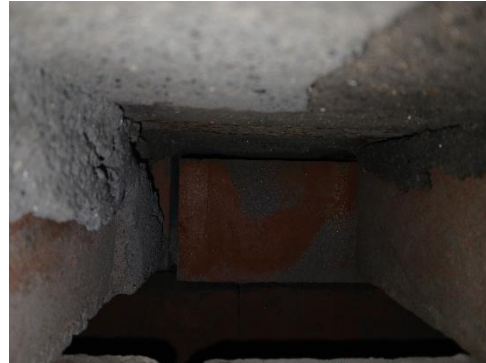
| | <p>The internal spaces of B1b measure approx. 6m from floor to ridge with a height of 7.5m at roof dormers. The central room width is approx. 8.5m. The subterranean annex measures approx. 14m in length, with a width of 3m narrowing to 1.5m west to east. The height of this section is approx. 2m decreasing to approx. 1m.</p> <p>Internal climatic conditions within B1b were 10.5°C 72% RH within the main internal space and 12.3°C 77% RH for the subterranean section.</p> <p>No bats or evidence of roosting bats was observed within B2b.</p> <p><b>Suitability/access/evidence of bats</b></p> <p>Access into the building is available via the missing boarding at the second storey doorway on the eastern elevation. The identified PRFs (1,2 and 3) may offer suitability for crevice dwelling bats species, with the overall construction of B1b offering suitable roosting habitat for void dwelling species. These features could offer a maximum of Low suitability for roosting bats due to their extent and condition.</p> <p>However, having reviewed the programme of works undertaken at B1b to date including the removal of storage and heating infrastructure and asbestos containing materials (including paintwork and pipe lagging) it is considered that no PRFs or access for bats into the building was available prior to October 2024.</p> <p>On this basis it is considered that section B1b offers <b>Negligible</b> suitability for roosting bats throughout the</p> | <p>Example of PRF1</p> <p>Example of PRF2</p> <p>PRF3</p> |

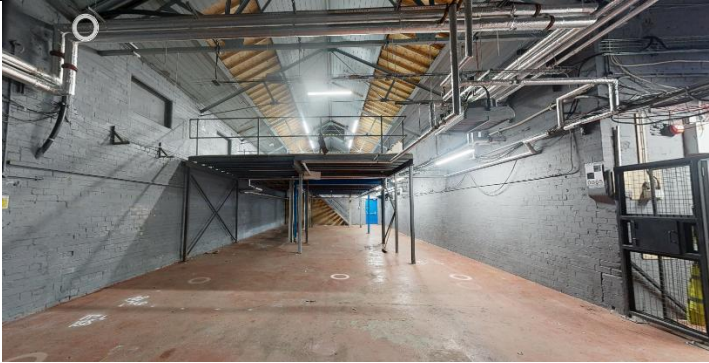
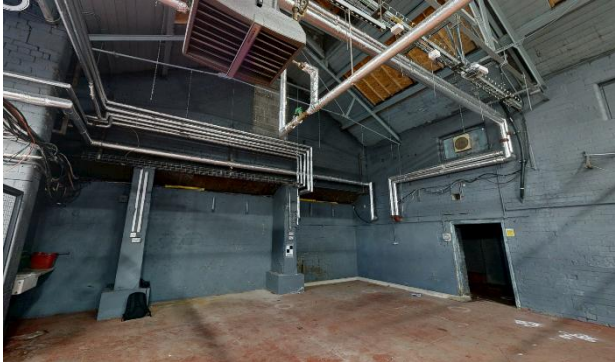
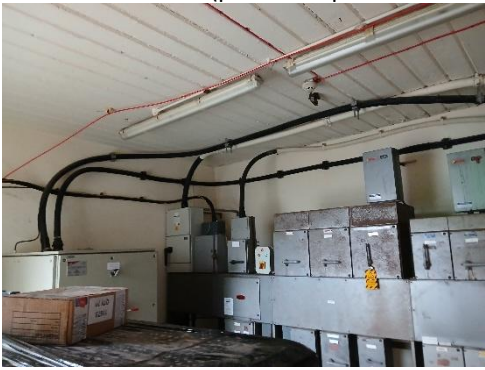
| | | <p>summer roosting period, and that all PRFs and access points are newly created, resulting in an increase in suitability encountered during the survey.</p> <p>Due to the nature of the building and connectivity to the adjacent boiler room, with copper pipework running through B1b to other areas of the hospital grounds, the building is considered unsuitable for hibernating bats due to its heated nature throughout the winter and fluctuating climatic conditions compared to external temperatures.</p> <p><b>B1c</b> is a single storey switch room, which is well sealed on all elevations and not directly connected to B1a or B1c.</p> <p>The internal space of B1c measure approx. 3m from floor to wooden sarking below the flat concrete roof. No void above the sarking is present. B1c. It extends approx. 6m in length and 4m in width.</p> <p>Internal climatic conditions within B1c were 8°C 65% RH.</p> <p><b>Suitability/access/evidence of bats</b></p> <p>B1c offers <b>no</b> access or suitability for roosting bats.</p> | <p>Internal structure of B1b (prior to September 2024) east</p> <p>Internal structure of B1b (prior to September 2024) west</p> <p>B1c</p> |

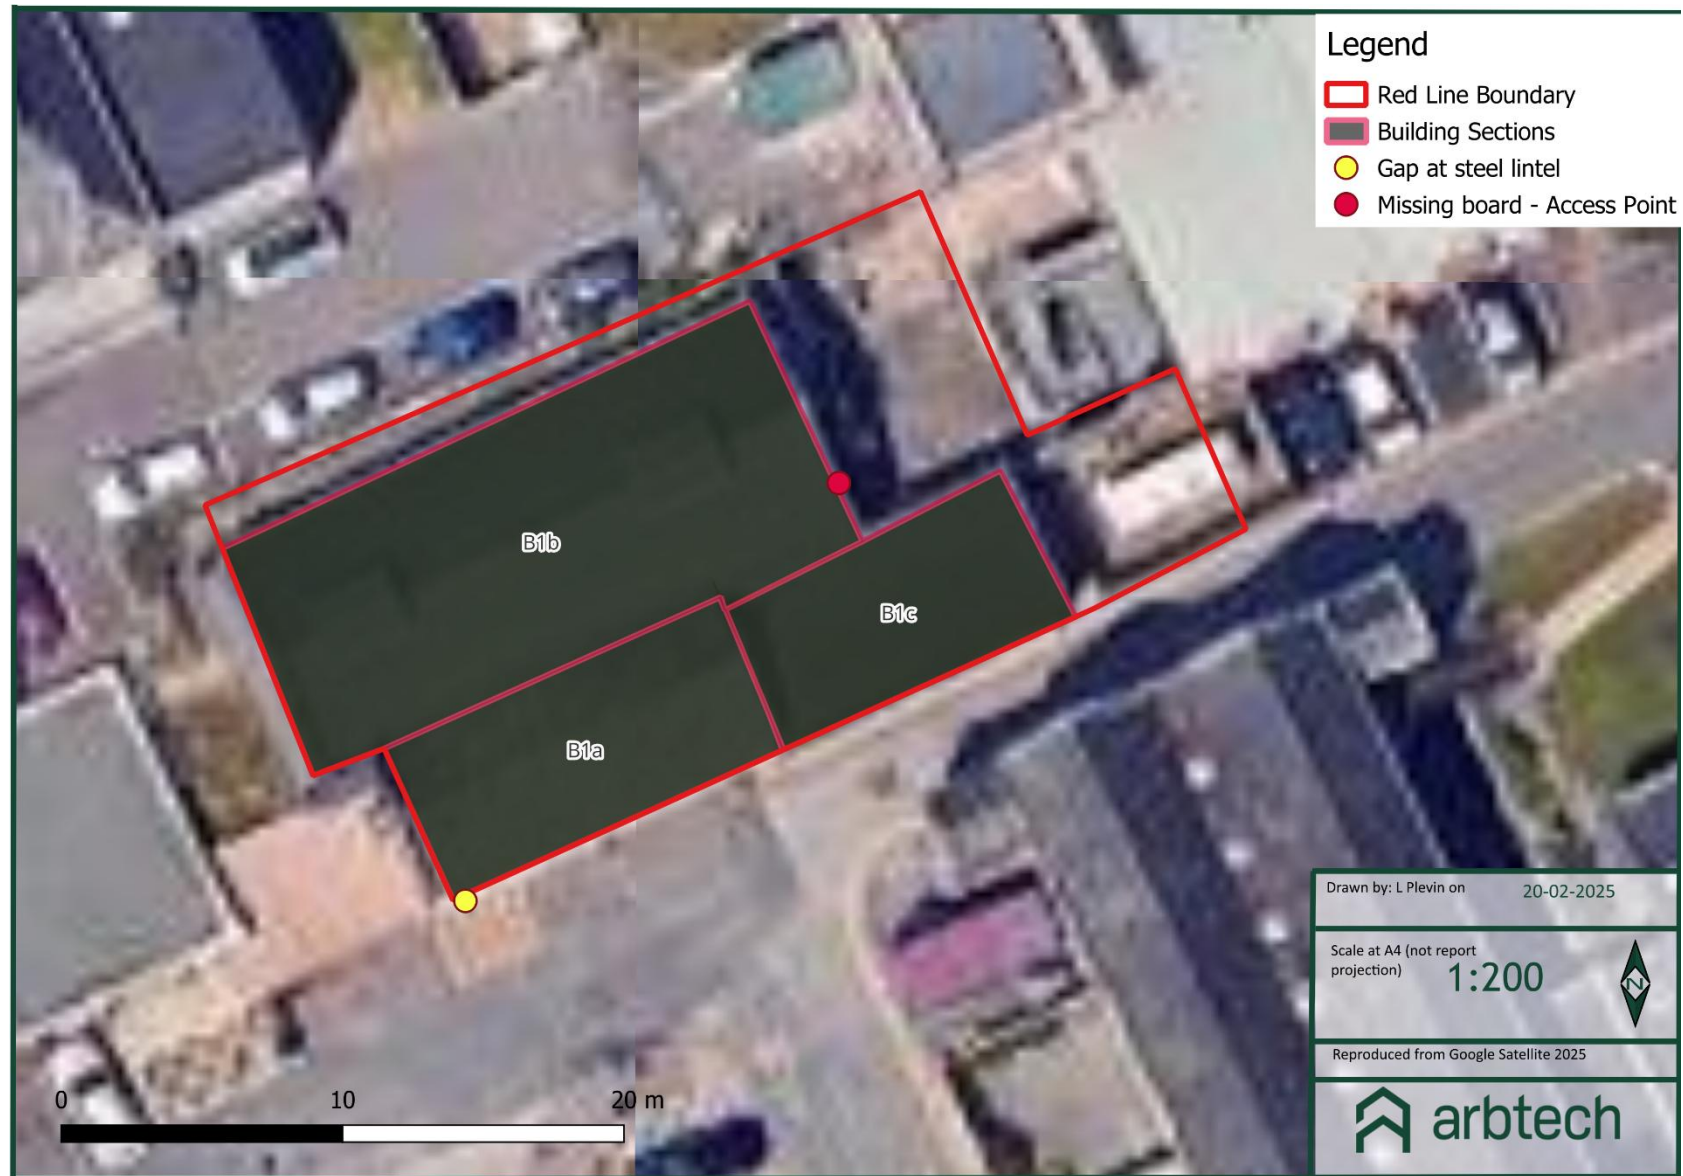
## Appendix 1: PRA plan

| | EPSL reference | Bat species affected | Distance from site | Impacts allowed by licence |
|---|---|---|---|---|
| | <b>Roosting habitat</b><br>Buildings to be impacted by the proposed development are assessed for their suitability to support roosting bats below. Only one building is present within the site (B1), this building will be impacted by the proposed development. No evidence of roosting bats was identified on or within B1. | | | |

| <i>Recommendations</i> | <p><b>Roosting habitat [Buildings]</b></p> <p>No further surveys or mitigation is required for the proposed development to proceed.</p> <p><b>Foraging and commuting habitat</b></p> <p>No further surveys or mitigation are required.</p> <p><b>Artificial lighting</b></p> <p>None required.</p> <p><b>Enhancements</b></p> <p>Due to the well-lit nature of the site by existing lighting associated with the Fairfield General Hospital site, no enhancements for bats are considered appropriate to be installed onto the building.</p> |
