# Preliminary Roost Assessment

2 Windsor Road  
Prestwich  
Manchester  
M25 0DZ

For  
Northedge Architecture

# Gritstone Ecology

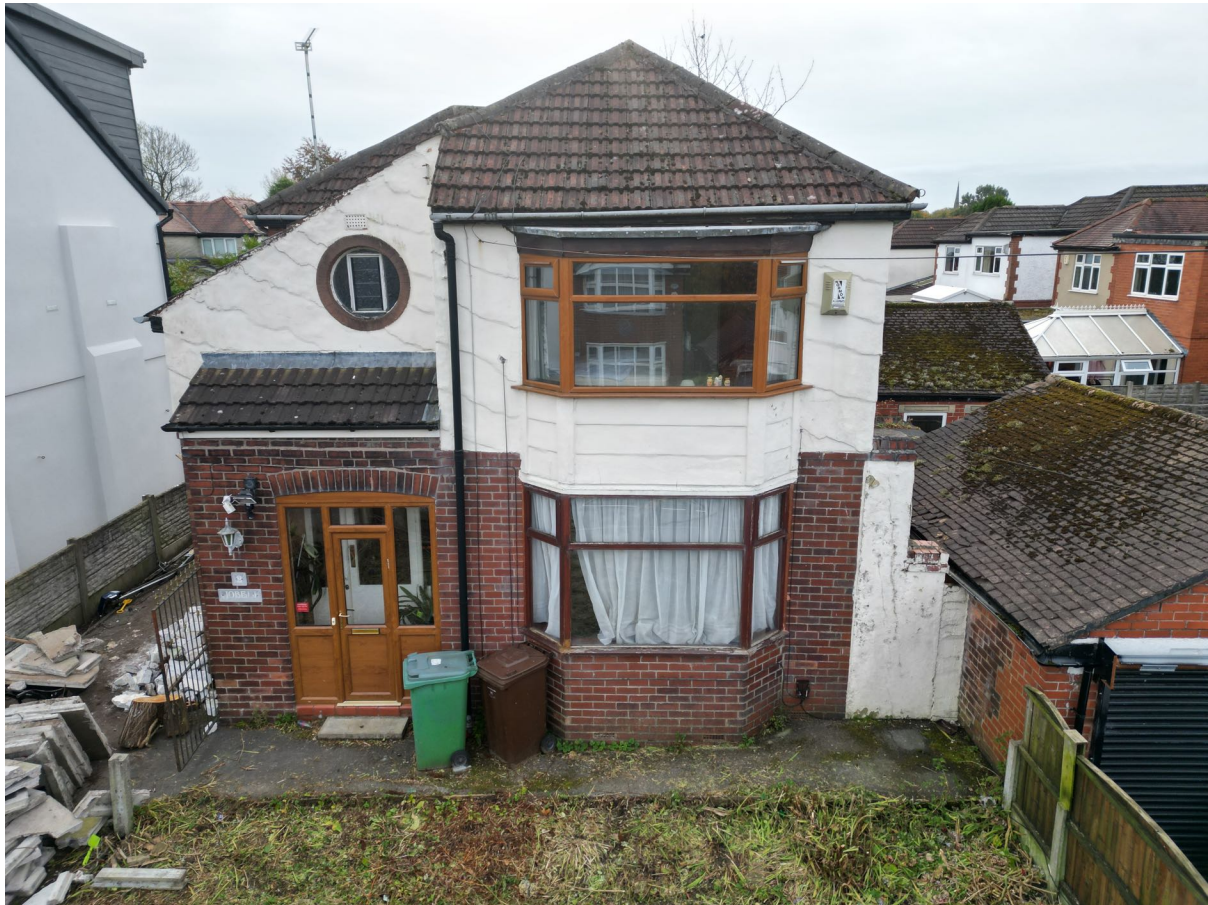
3.1a – The front of the house.

The building is in poor cosmetic and structural condition. However, ridge tiles are fixed tightly, there are no damaged or missing ridge tiles. There are no damaged, slipped, or missing roof tiles. Roof tiles are tightly fitted, with no gaps between tiles.

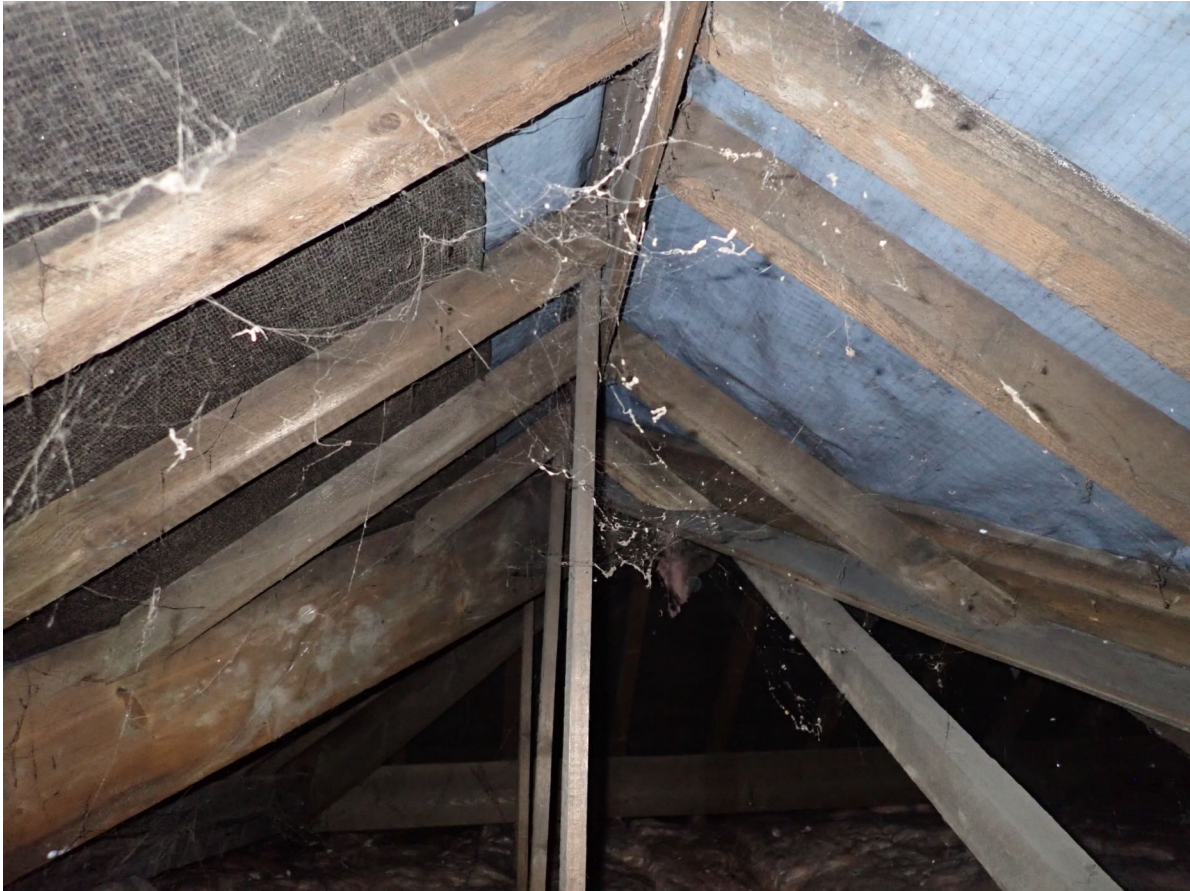
3.2a – The roof void.

The roof has a timber rafter and purlin structure, lined with a mixture of bitumen felt and a modern non-breathable membrane, and insulated with mineral wool between the ceiling joists. The roof lining is in good condition with no tears, or gaps. Roof timbers are covered in dusty cobwebs.

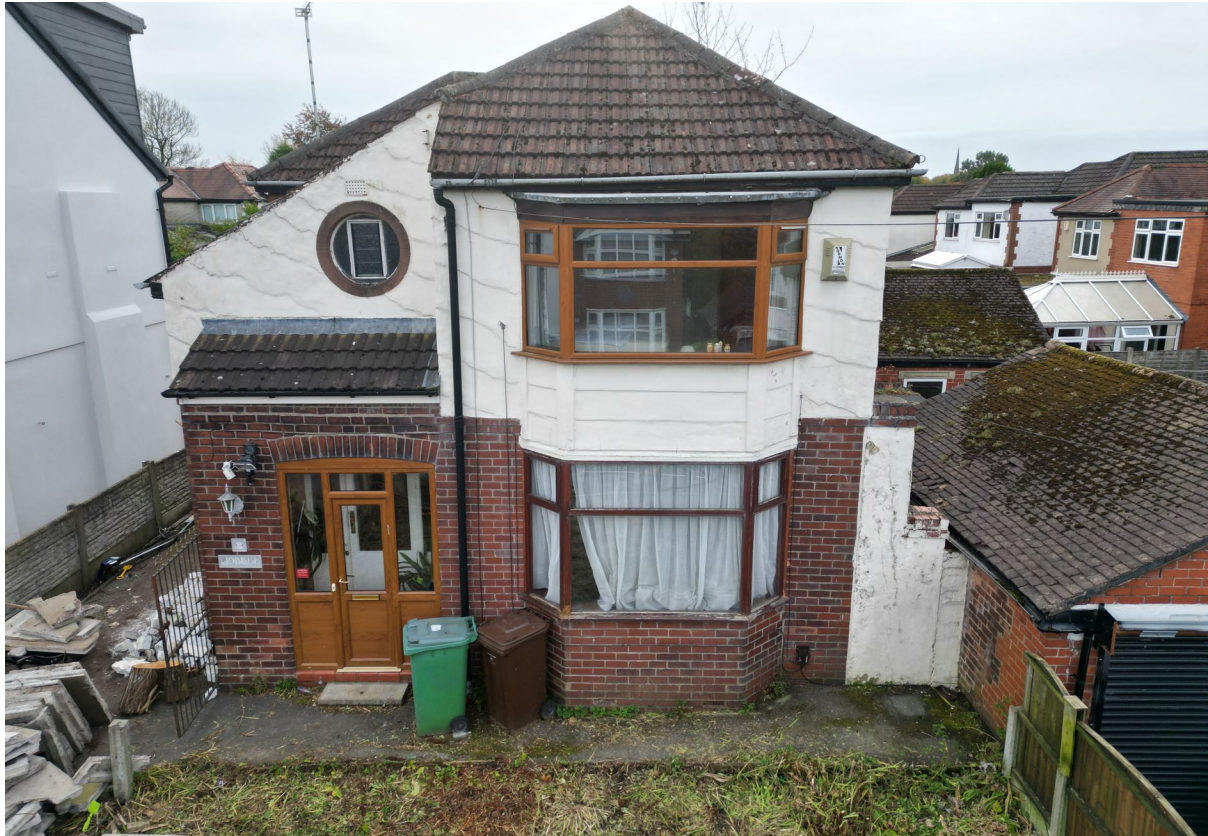
1 – The front of the house.

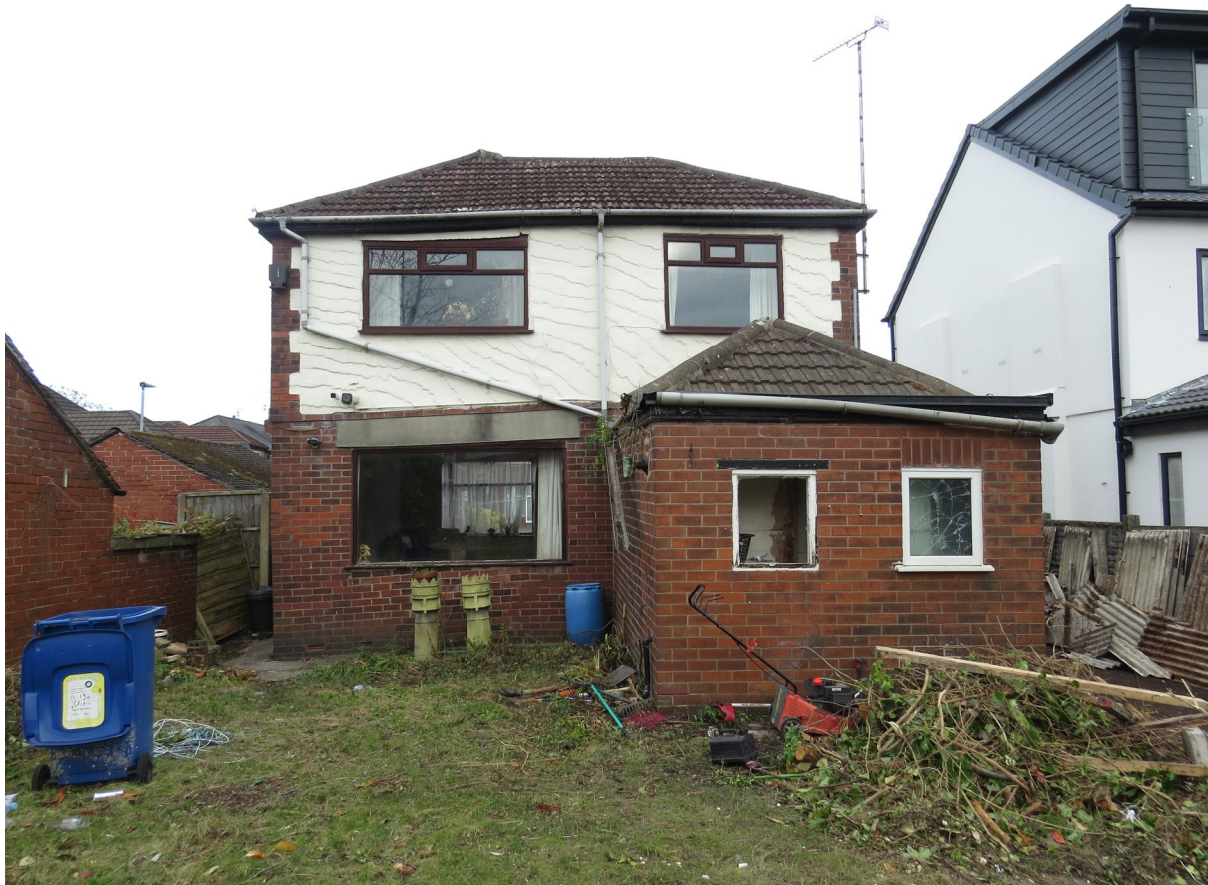
2 – The rear of the house and rear extension.

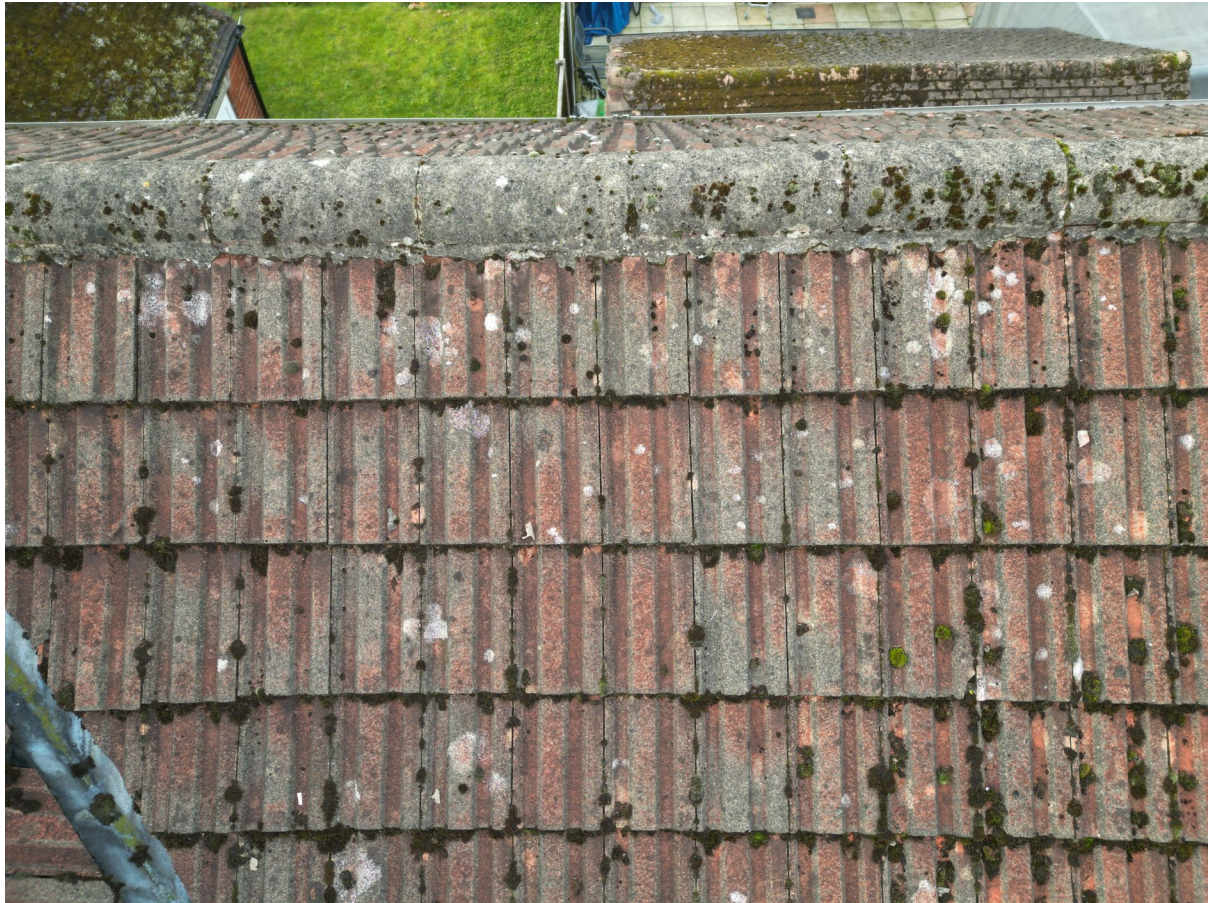
Roof and ridge tiles are in good condition; ridge tiles are sealed with cement. There are no gaps between roofing materials which could be used by roosting bats.

3 – Roof and ridge tiles are in good condition with no suitable gaps.

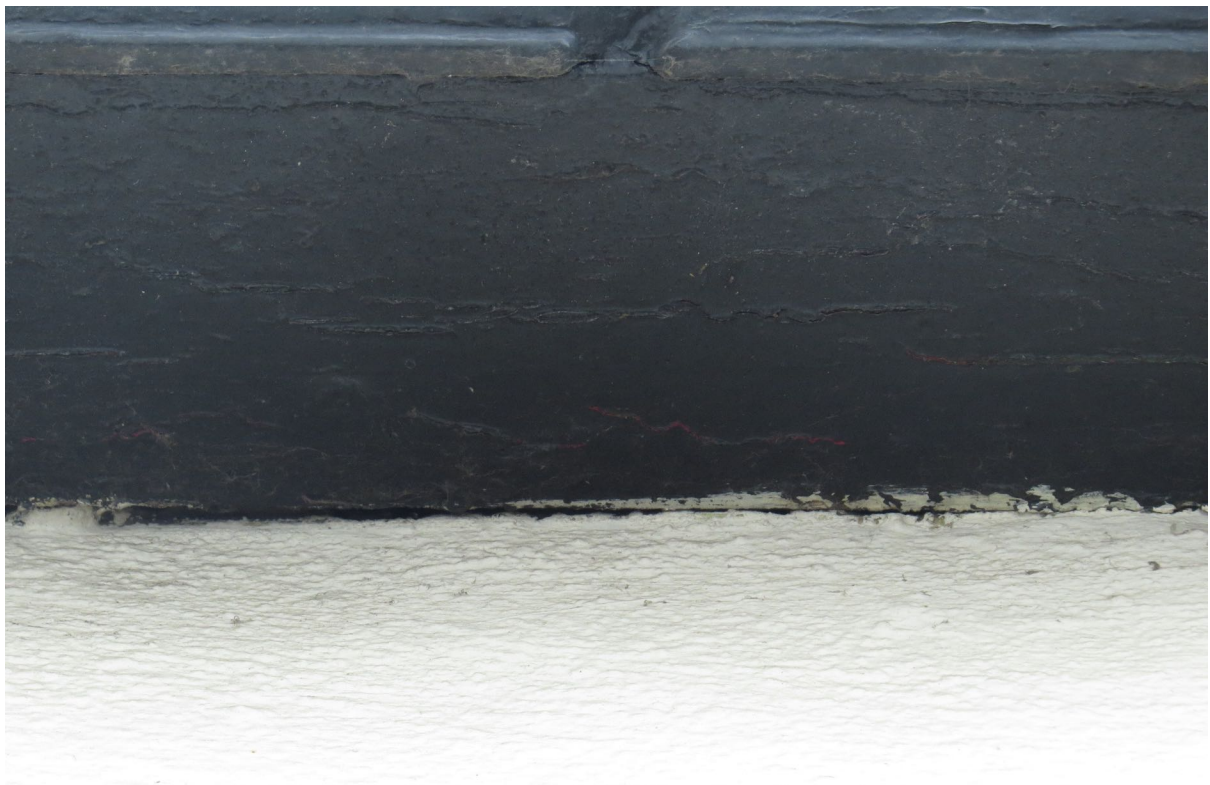
Fascia boards and boxed soffits at the eaves are fixed tightly against brickwork, with no suitable gaps; wall cavities and boxed soffits open into the roof void, and were inspected from above.

4 – Fascia boards and soffits are fixed tightly against brickwork with minimal gaps (<5mm).

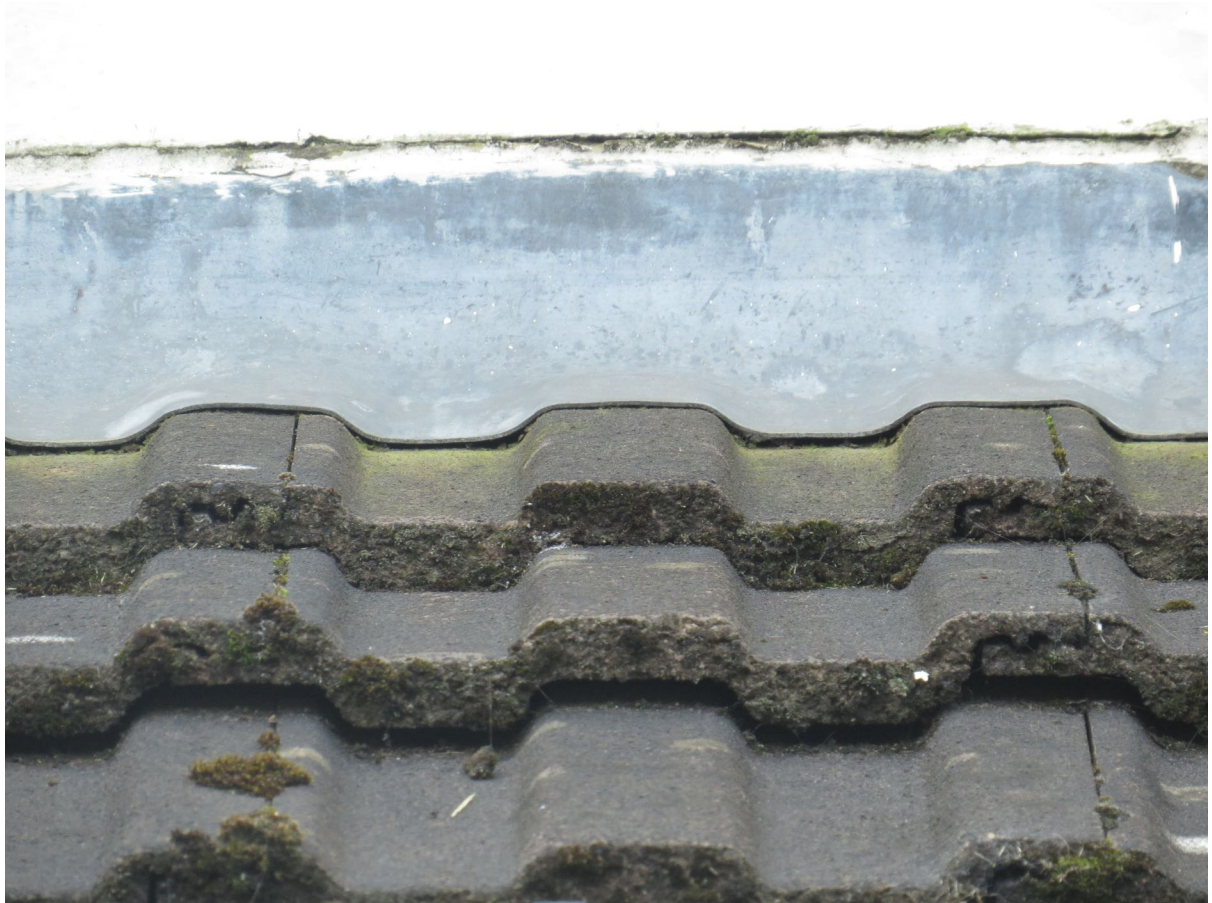
5 – Lead flashing is fitted tightly with no suitable gaps.

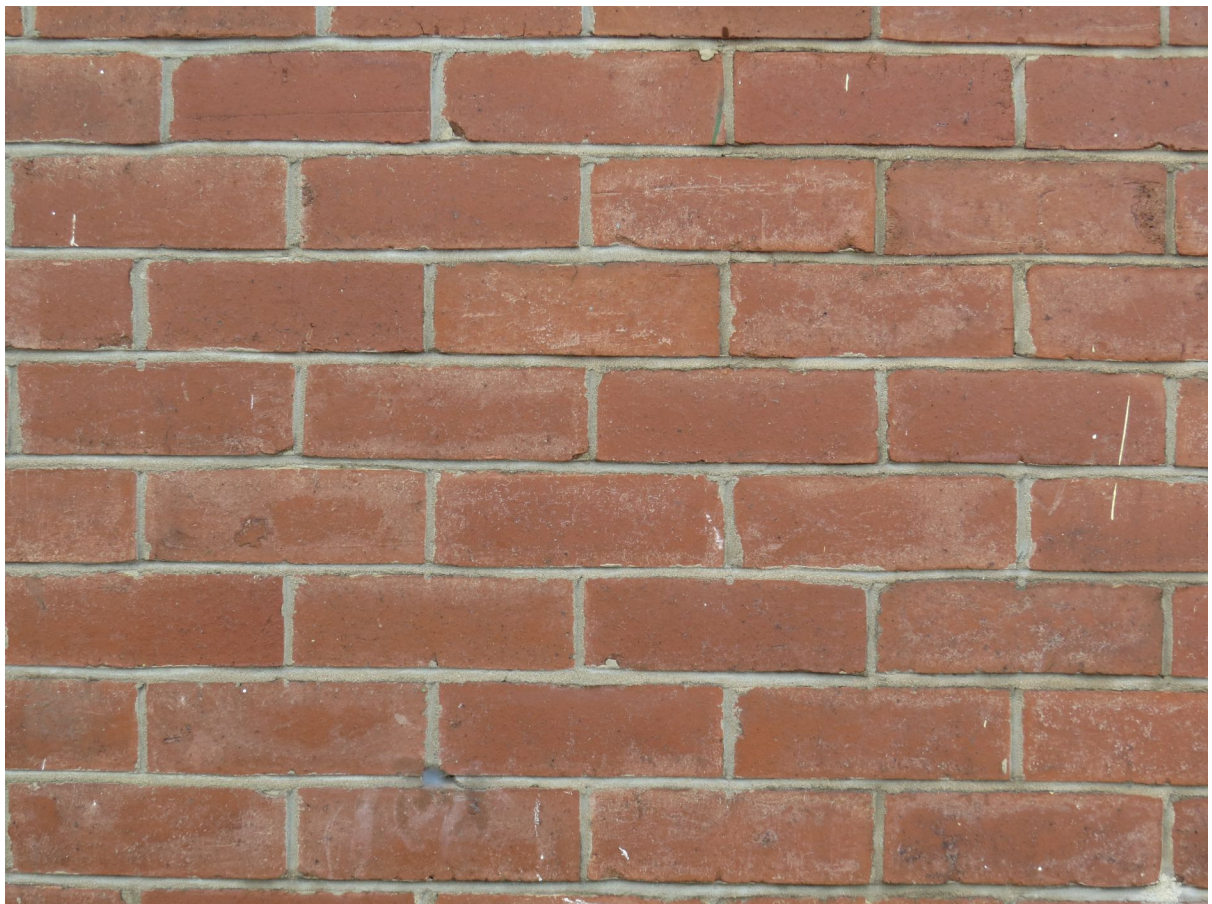
Walls are brick with an insulating cavity. Walls are in good condition, with no cracks, or missing mortar which could be used by crevice dwelling bats.

6 – Brickwork and mortar are in good condition with no suitable gaps.

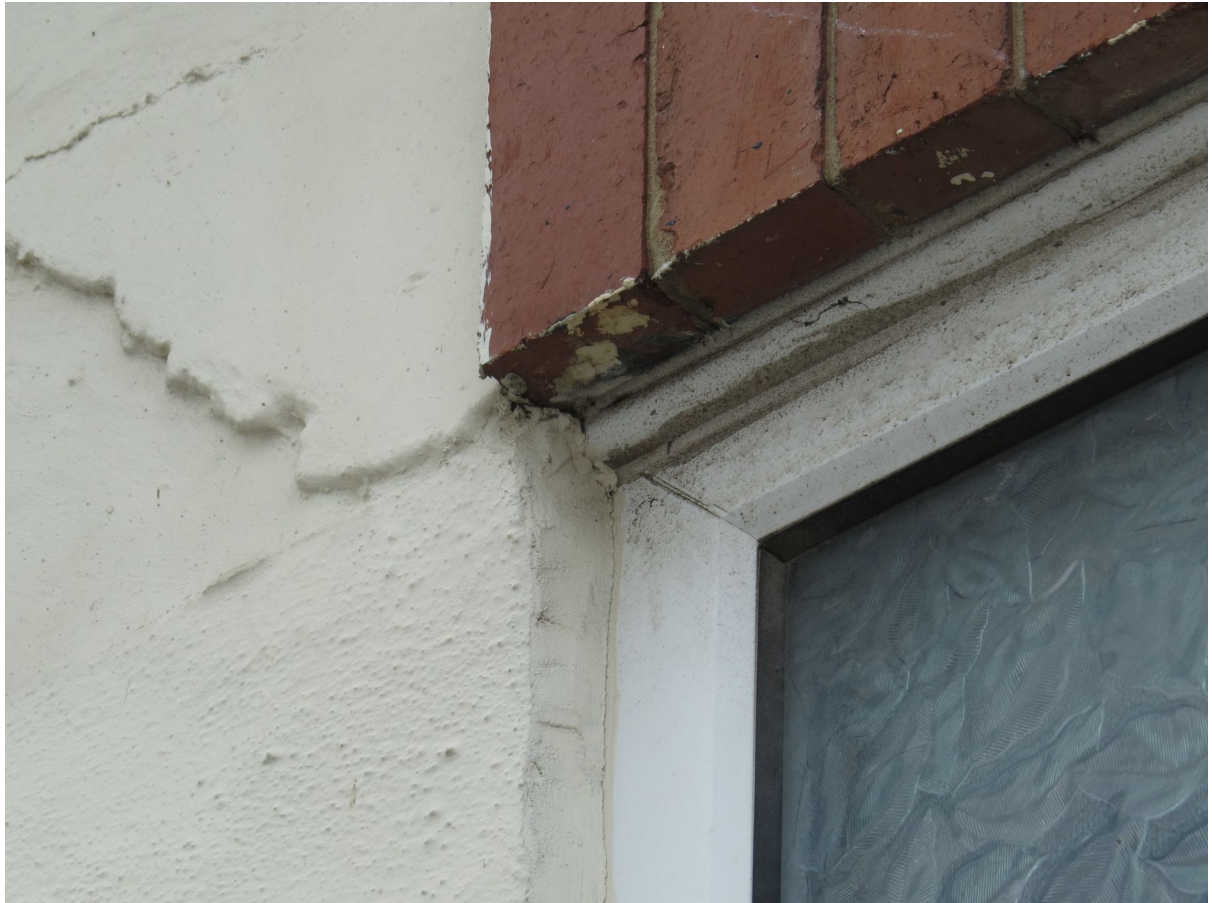
Window and door frames are fixed into the brickwork, gaps are filled with sealant, and offer no suitable roosting opportunities.

7 – Window and door frames are tightly sealed into brickwork with no suitable gaps.

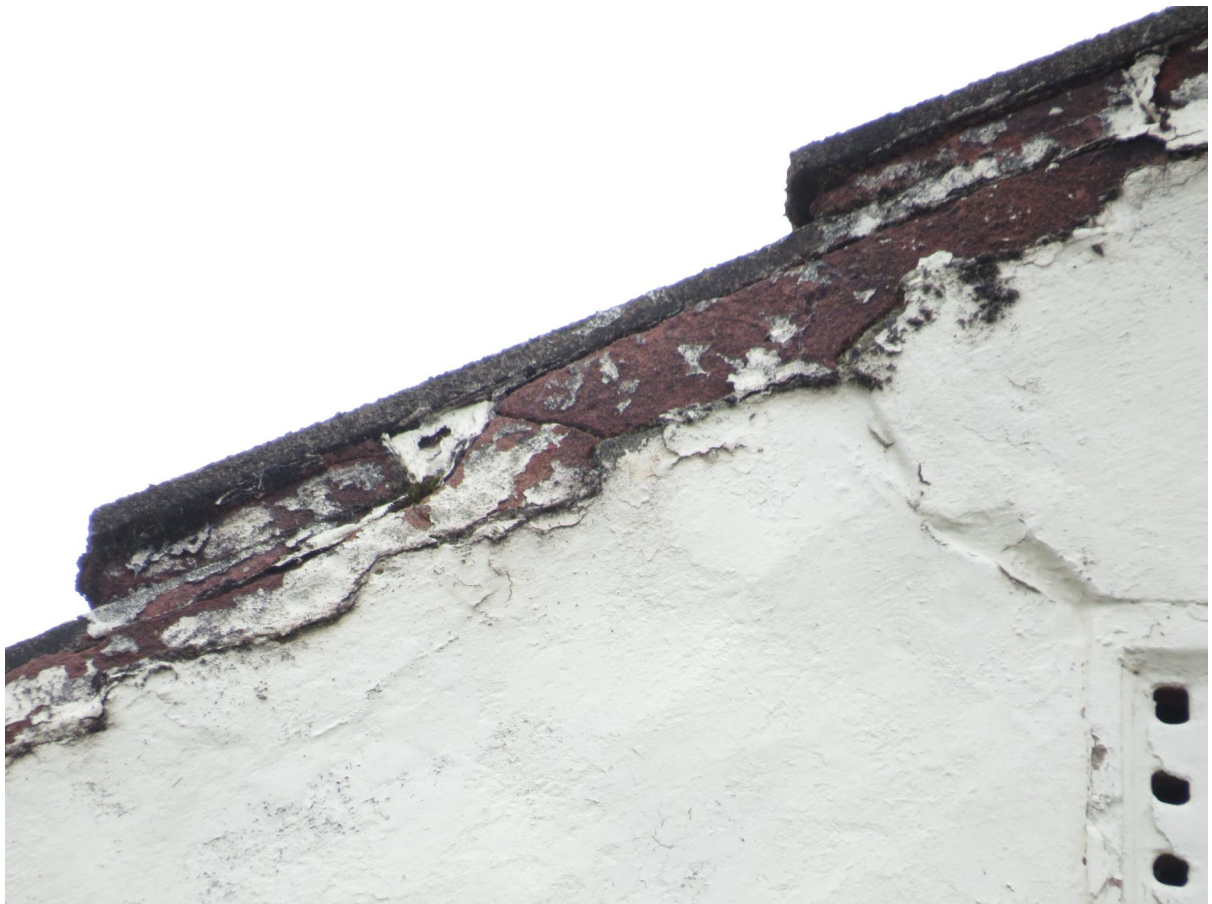
8 – Cement at the verges is intact with no suitable gaps.

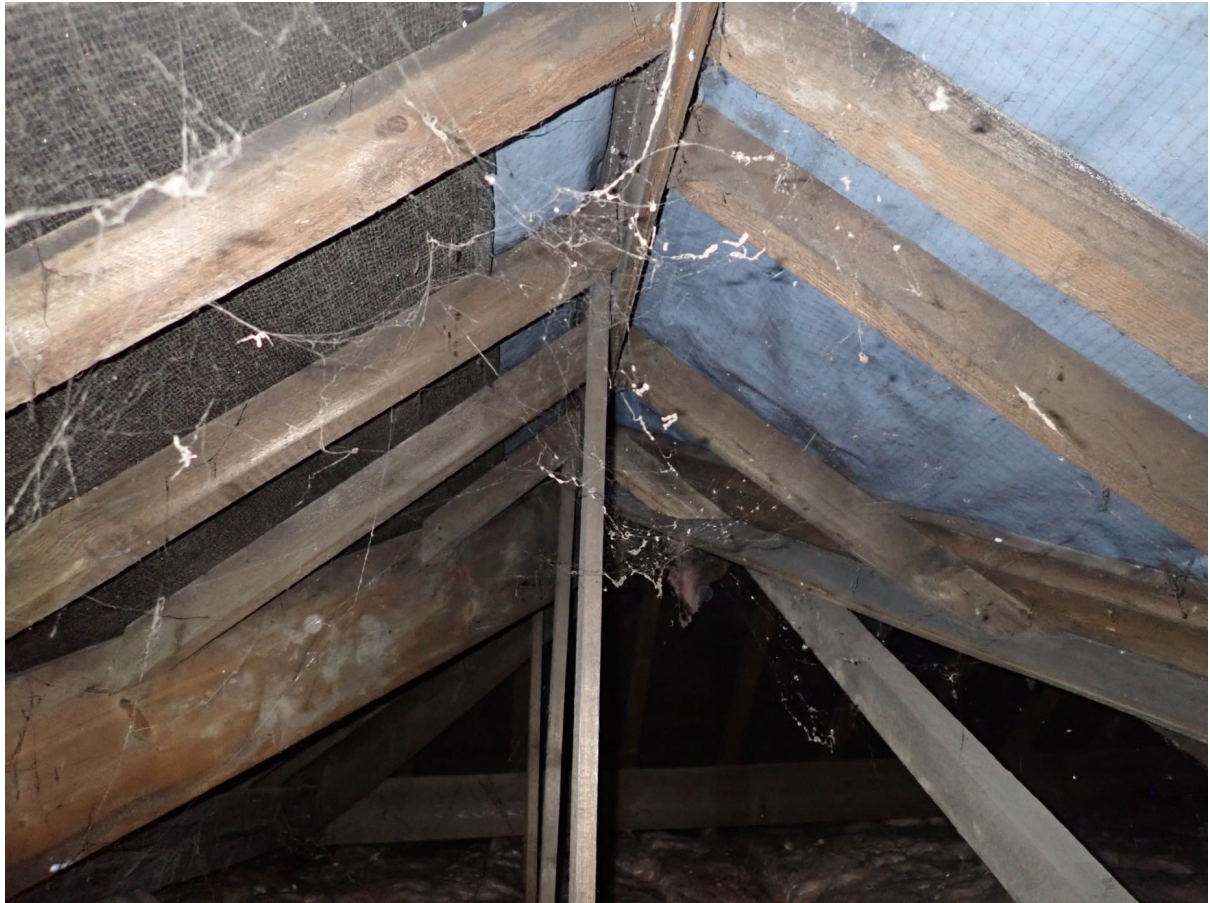
9 – Roof timbers are covered in dusty cobwebs.

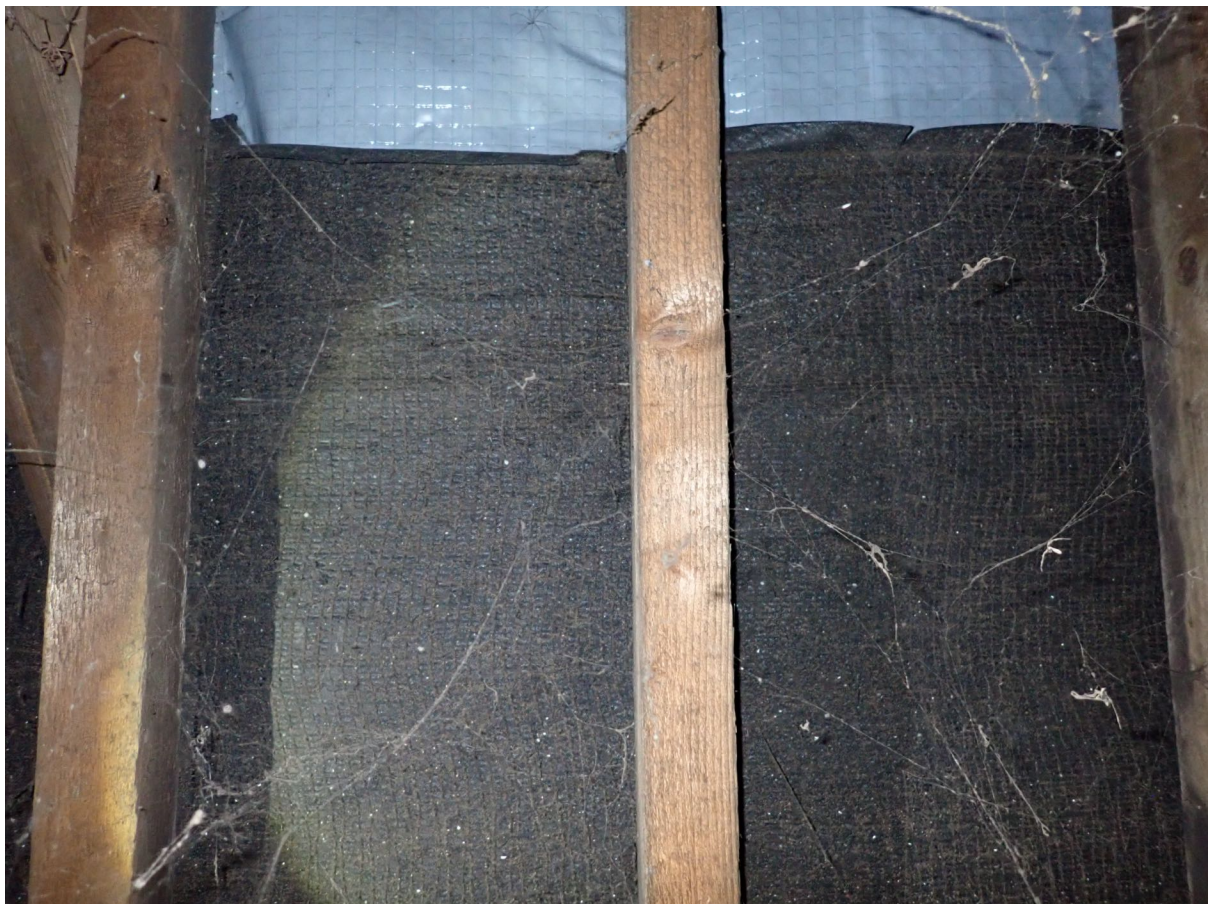
10 – Roof lining is in good condition with no gaps or tears.
