## **Land South of Warth Road, Bury**

### **Outline Phase 1 and Phase 2 Geo- Environmental Investigation Report**

For: GFIC Properties Ltd

| <b>Date:</b> | <b>April 2025</b> | |

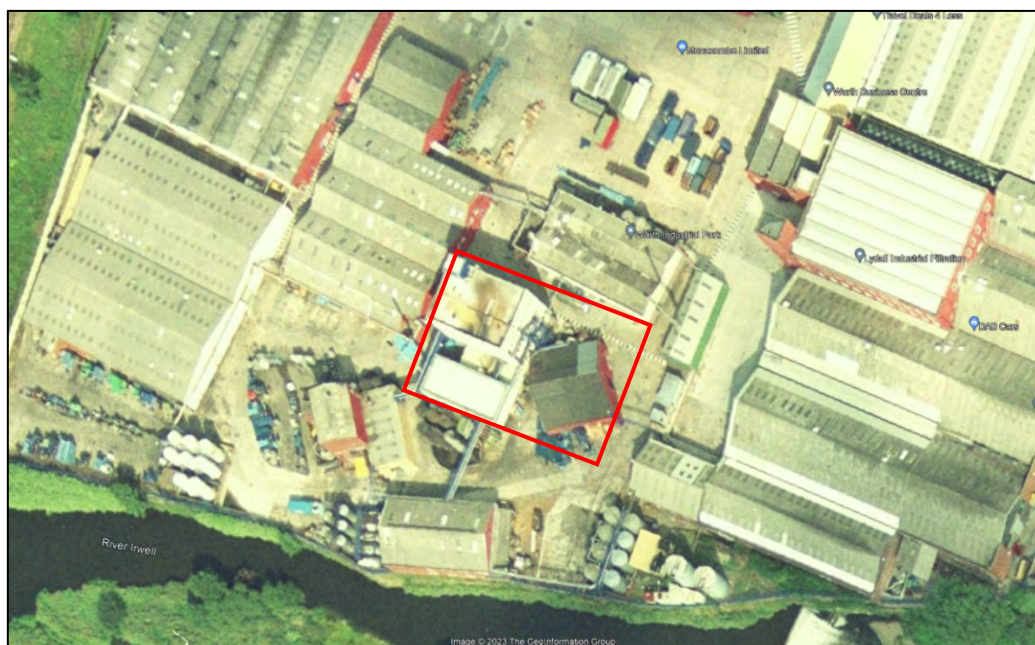
*Figure 4 – Google Earth image from December 2020 showing numerous tanks and large buildings in the southern site section that are no longer present. Units 43, 49 and 50 are noted within the red box.*

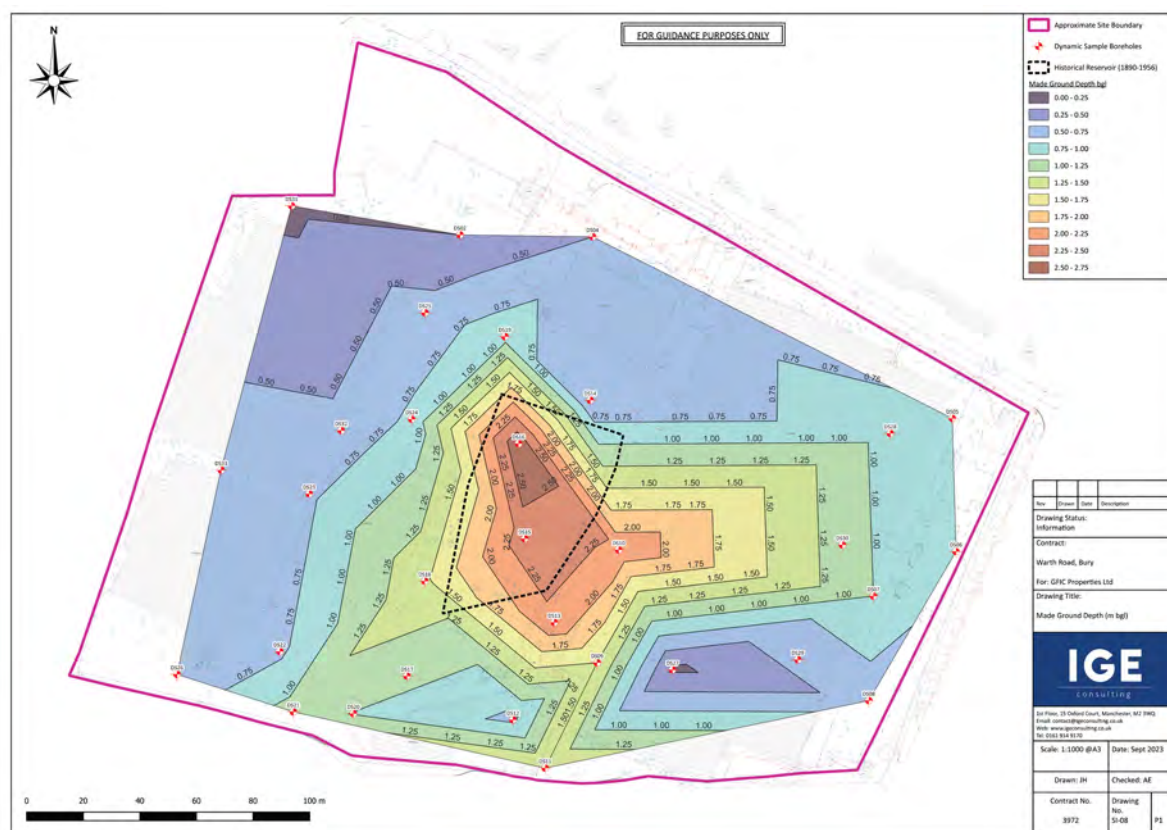
Figure 8 – SI-08 Made Ground Depth Plan (m bgl).

- DS15 and DS16 were undertaken within the area of the historical infilled reservoir. Deeper **Made Ground** comprising medium dense, dark brownish grey, sandy, angular to subangular, fine to coarse GRAVEL of concrete, sandstone, red brick, clinker, limestone and glass was encountered to a depth of between 2.40m and 2.70m bgl (68.68m – 67.75m AOD).

Any deep Made Ground encountered outside of the reservoir is inferred to be associated with historical buildings on site. An extract of the Made Ground depth plan (SI-08) showing depth to base of Made Ground in bgl is included below:

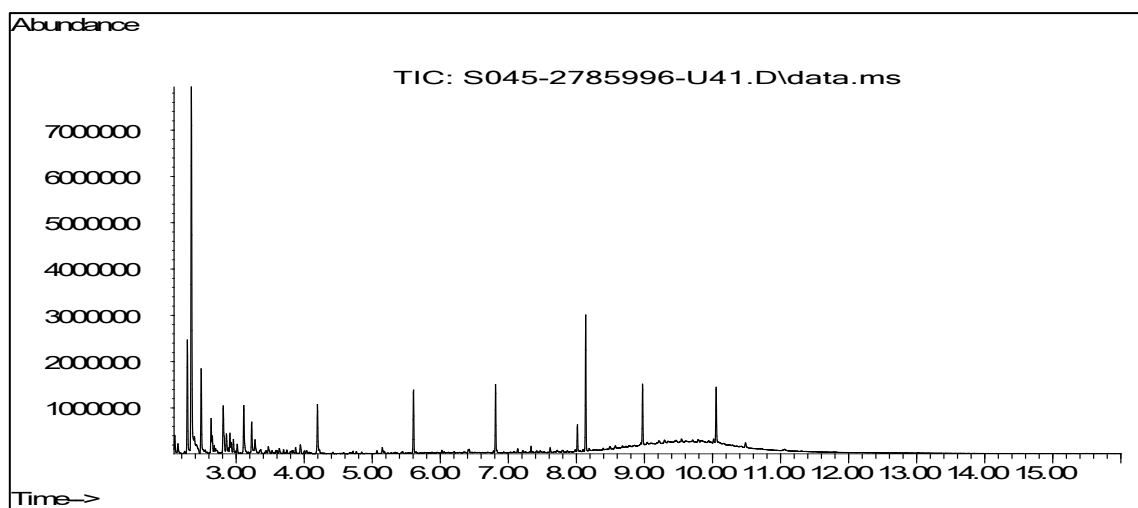
Figure 12 – Chromatograph for the sample in DS18 at 2.50m bgl.

The total ion count (TIC) for the sample from DS18 at 2.50m bgl shows a carbon range from C10 to C35. The TIC trace is complex, showing aliphatic and aromatic product sources. The trace does not match the standard product profiles.

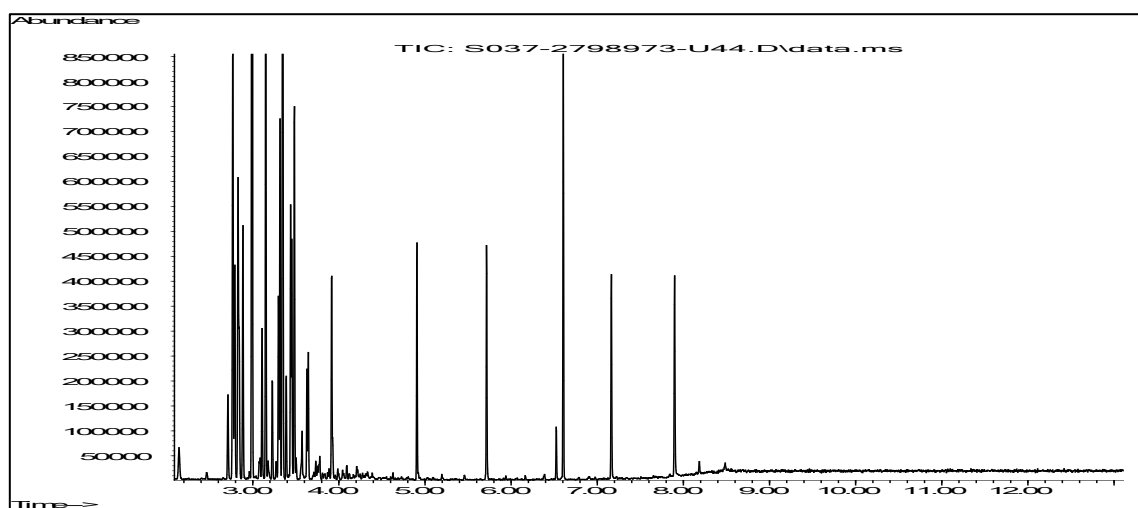
Figure 13 – Chromatograph for the sample in DS33 at 1.30m bgl.

GAC exceedances and elevated concentrations of contaminants have been recorded within both the Made Ground and the underlying natural superficial deposits. The levels of BTEX are elevated, as well as their equivalent VOCs, which relates to the high PID readings recorded during sampling. The exceedances and elevated concentrations were generally recorded within exploratory holes within the southern site section, particularly in the areas of the historical tanks and buildings in this area associated with the paints and varnishes factory. The depth of the 'contamination' was noted to be at or around the groundwater level, generally within 1m of the measured standing water level. This suggests that the contamination is "sat" on top of the groundwater, indicating the possible presence of LNAPL (light non-aqueous phase liquid). It is therefore inferred that as the water level rises and falls due to seasonal variations / flood events, the contamination is spread / smeared over the site soils. Odours noted during exploratory hole construction and groundwater sampling consistently referenced a 'white spirit' odour. TPH identification and a chromatograph was produced for 2 No. samples: DS18 at 2.50m bgl and DS33 at 1.30m bgl. These chromatographs are included below.

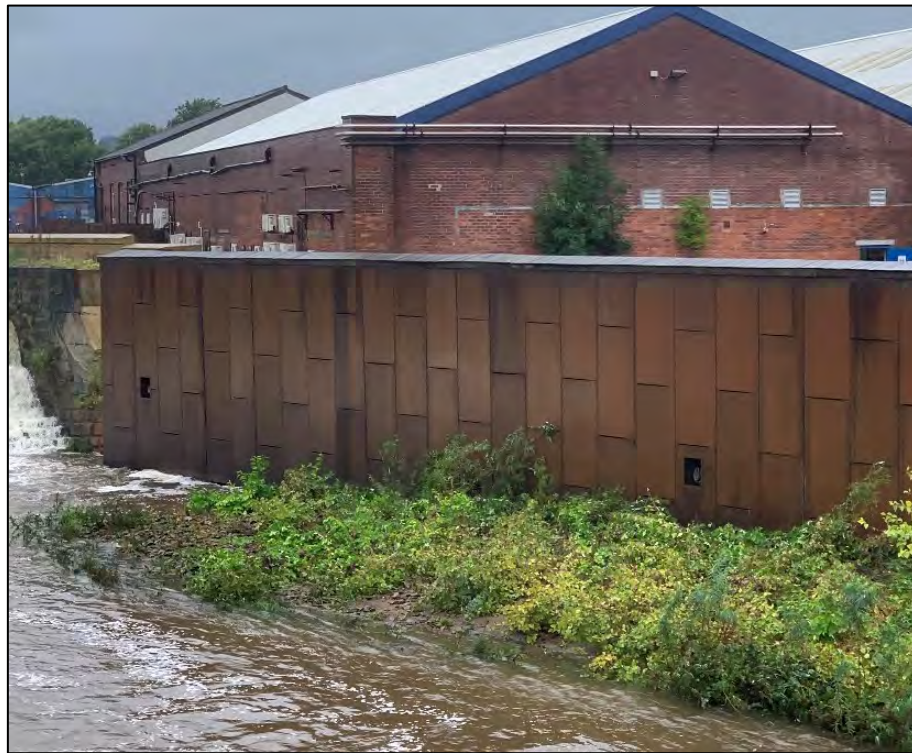
No flow of water from the outfalls was noted when observed from the river side, a photo taken during the visit of the retaining wall from the river side is included in Figure 14 below.

*Figure 14 – Photo taken from off site to the south east looking north west back onto site at the recently installed retaining wall.  
2 No. outfalls can be seen, neither of which appear to have any water flowing from them. Photo taken 20<sup>th</sup> September 2023.*

As noted on the conceptual site model, although significant contamination (predominantly BTEX and VOCs) is present in the shallow site soils, continuity with the adjacent river is significantly reduced / eliminated by the sheet piled retaining wall installed to c. 12-15m. However, due to the risk posed by flood events or drainage failure, together with the significant concentrations of contamination recorded within the site soils, remedial works are required in order to achieve significant betterment.
