D0372 - 104 - PLANNING

## Existing Photographs

Barwood House,  
Grants Lane,  
Ramsbottom ,  
BL0 9AX

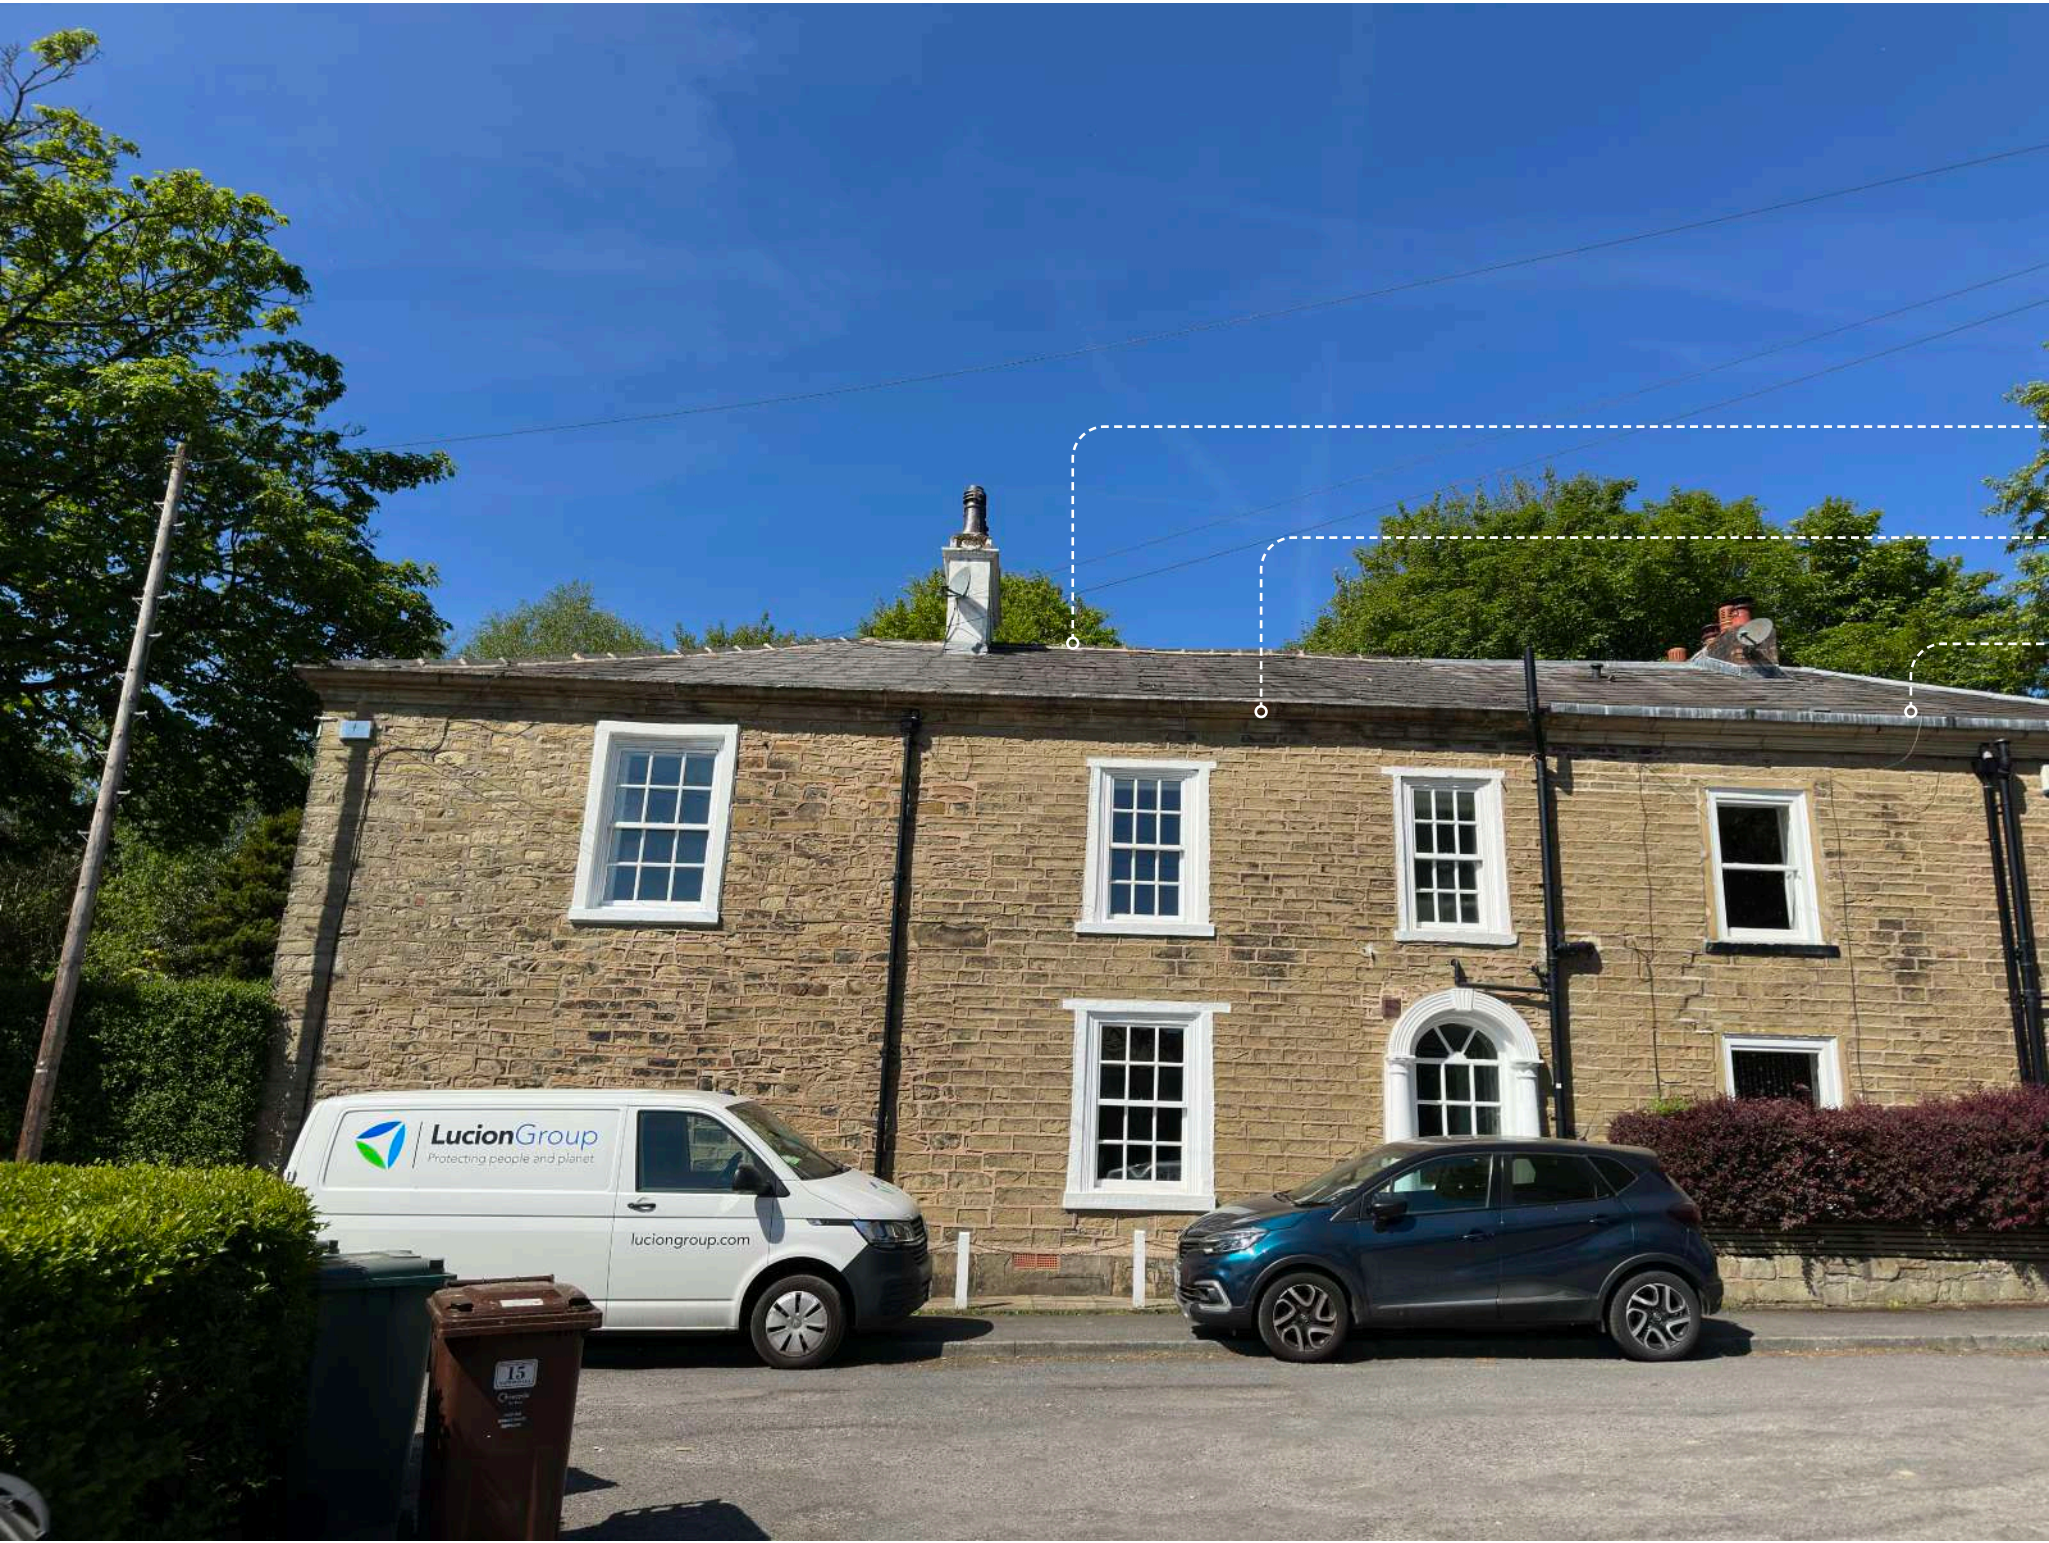
Figure 1A: Photo taken from Grants Lane looking towards Barwood House

- Existing property has a slate roof with mortared hip & ridge tiles.
- Inset stone gutter with moulded cornice.
- Neighbouring property No.19 has large lead flashing along eaves, ridge & hips.

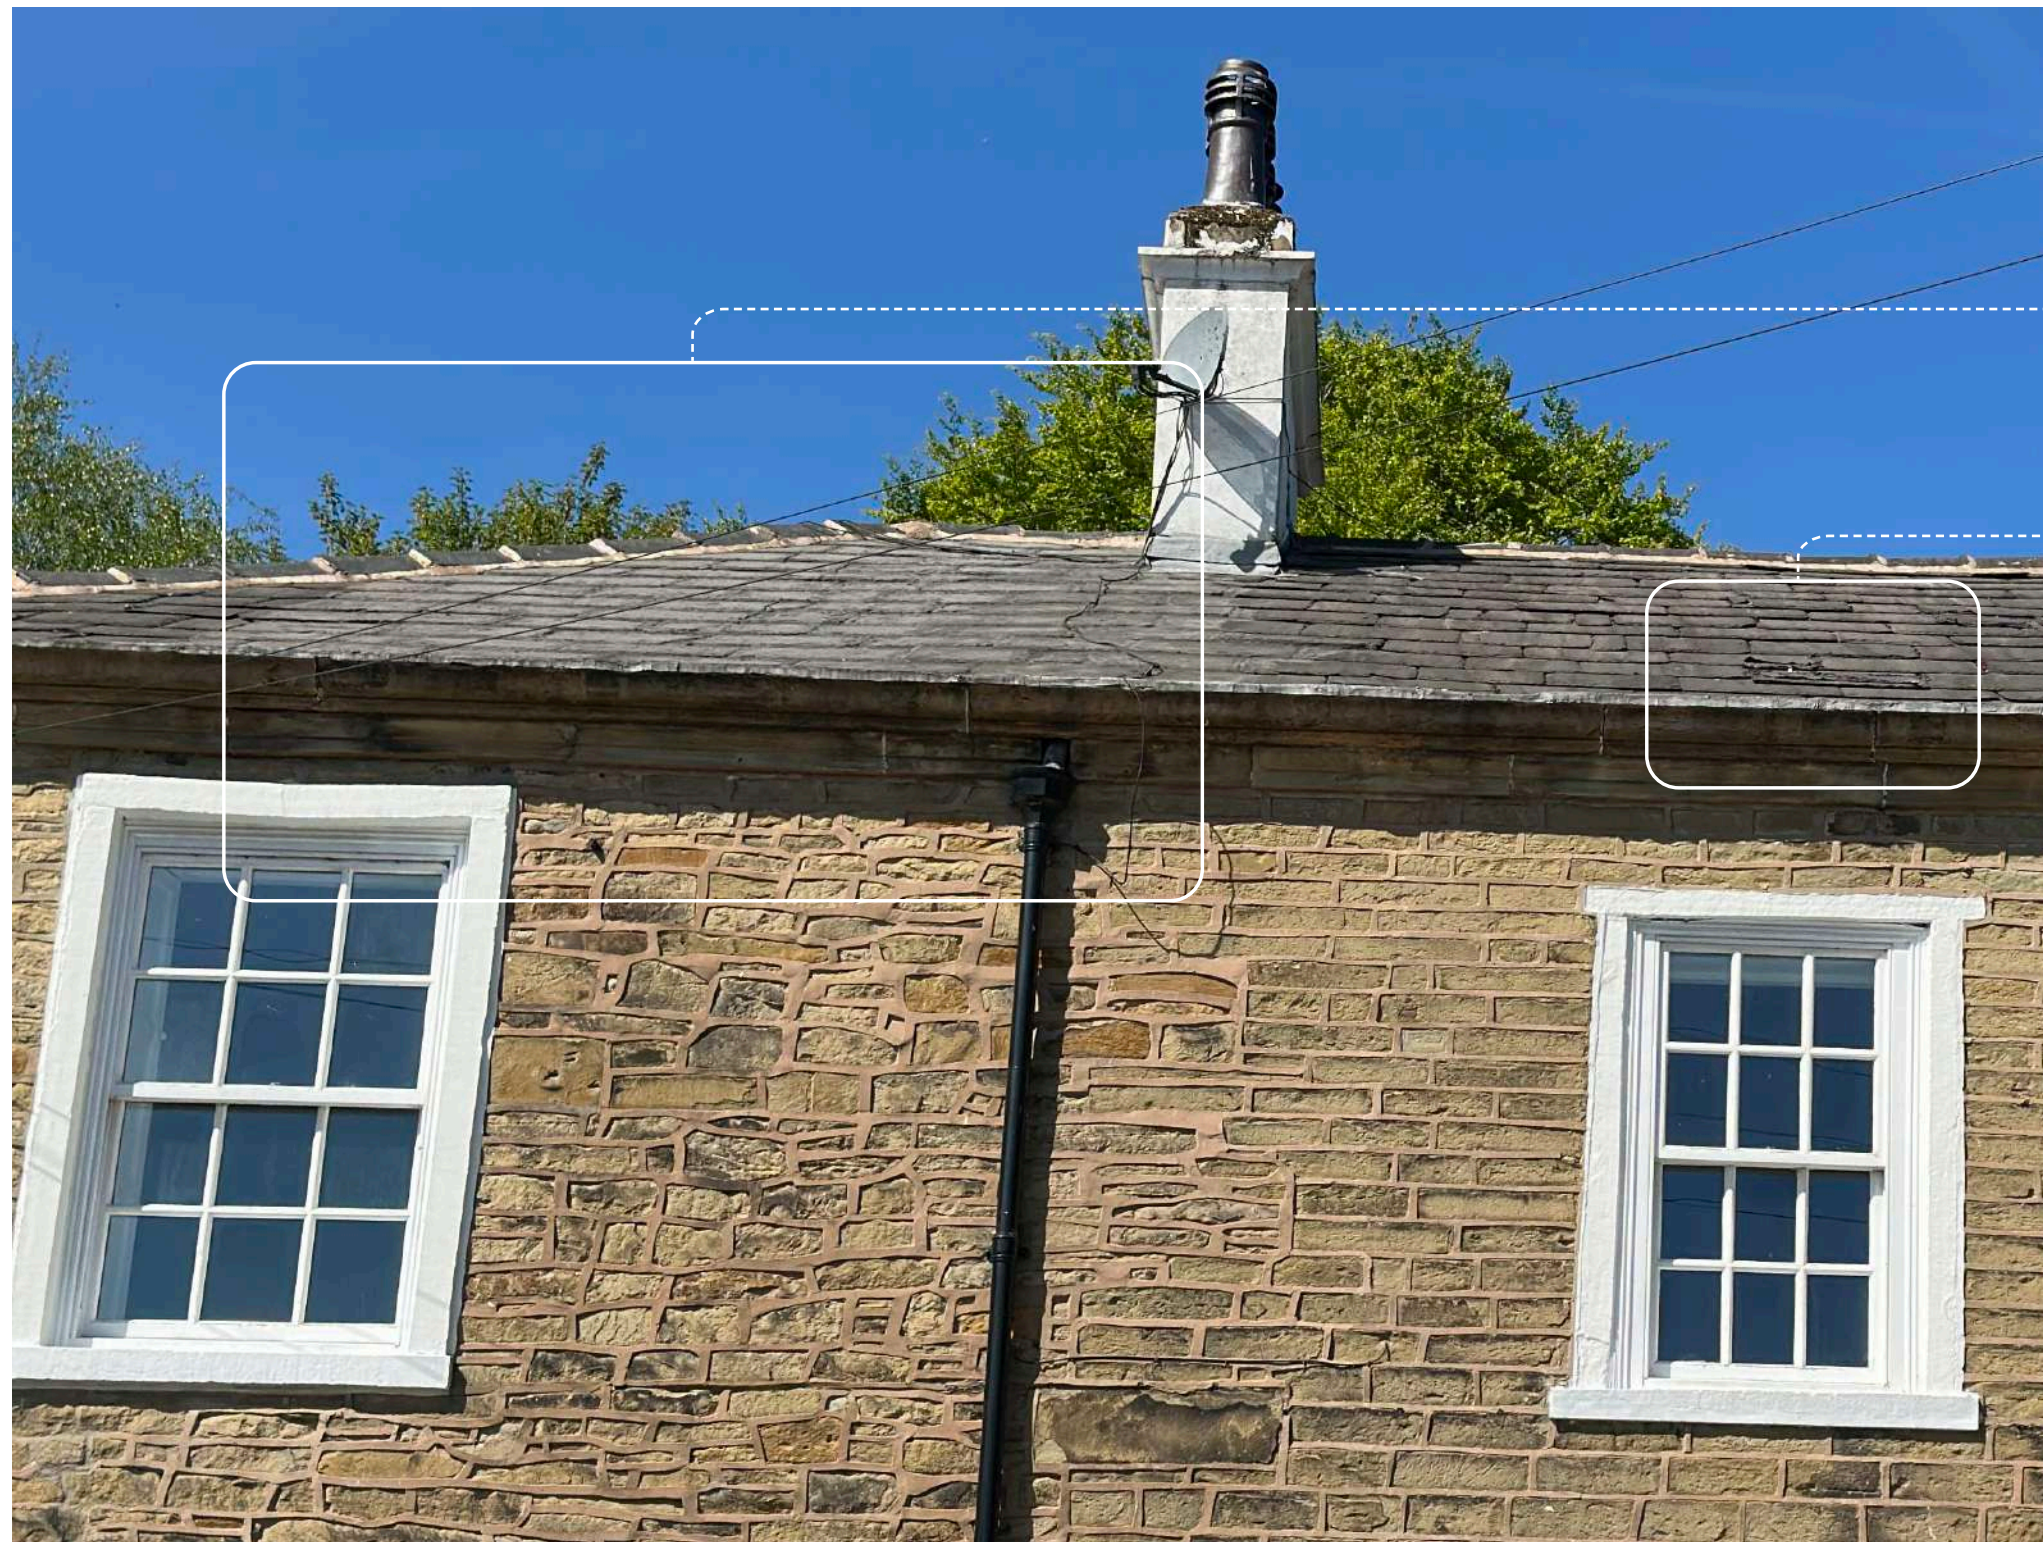
Figure 1B: Close-up area of side elevation roof.

----- Damaged roof tiles. Probably from a previous roof repair using hot bitumen, which has since been removed.

----- Evidence of previous Bitumen & felt roof repair. These quick fix roof repairs have now failed.

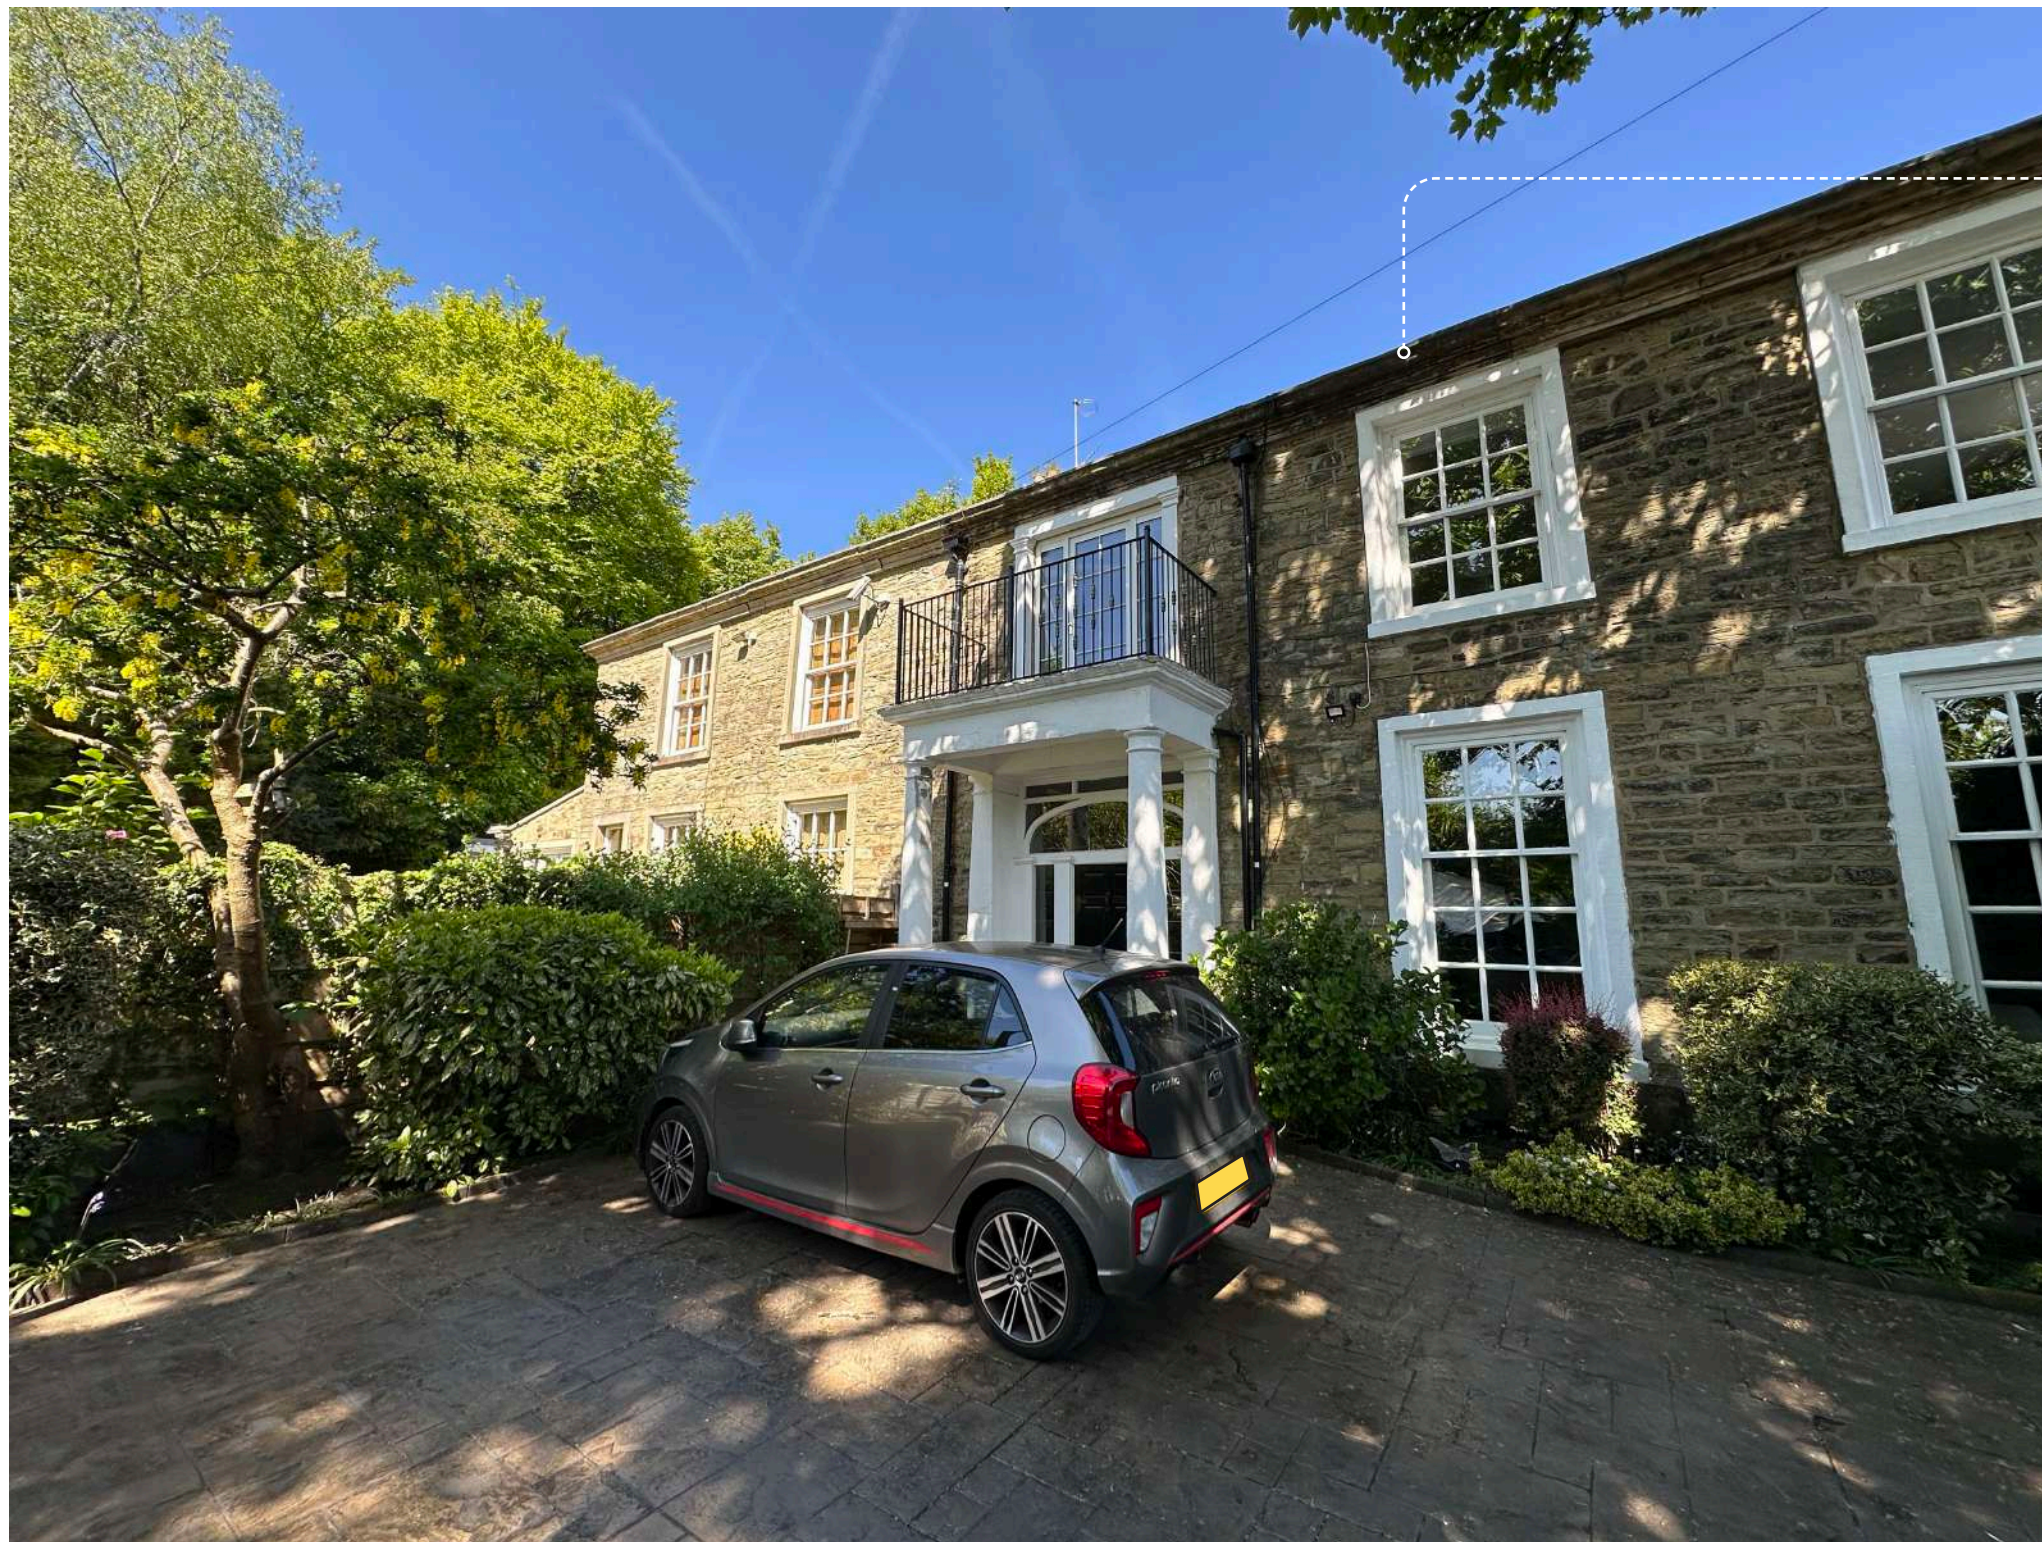
Figure 2: Photo of the front elevation of Barwood House

Inset stone gutter with moulded cornice runs along entire front elevation (including neighbouring property No.17)

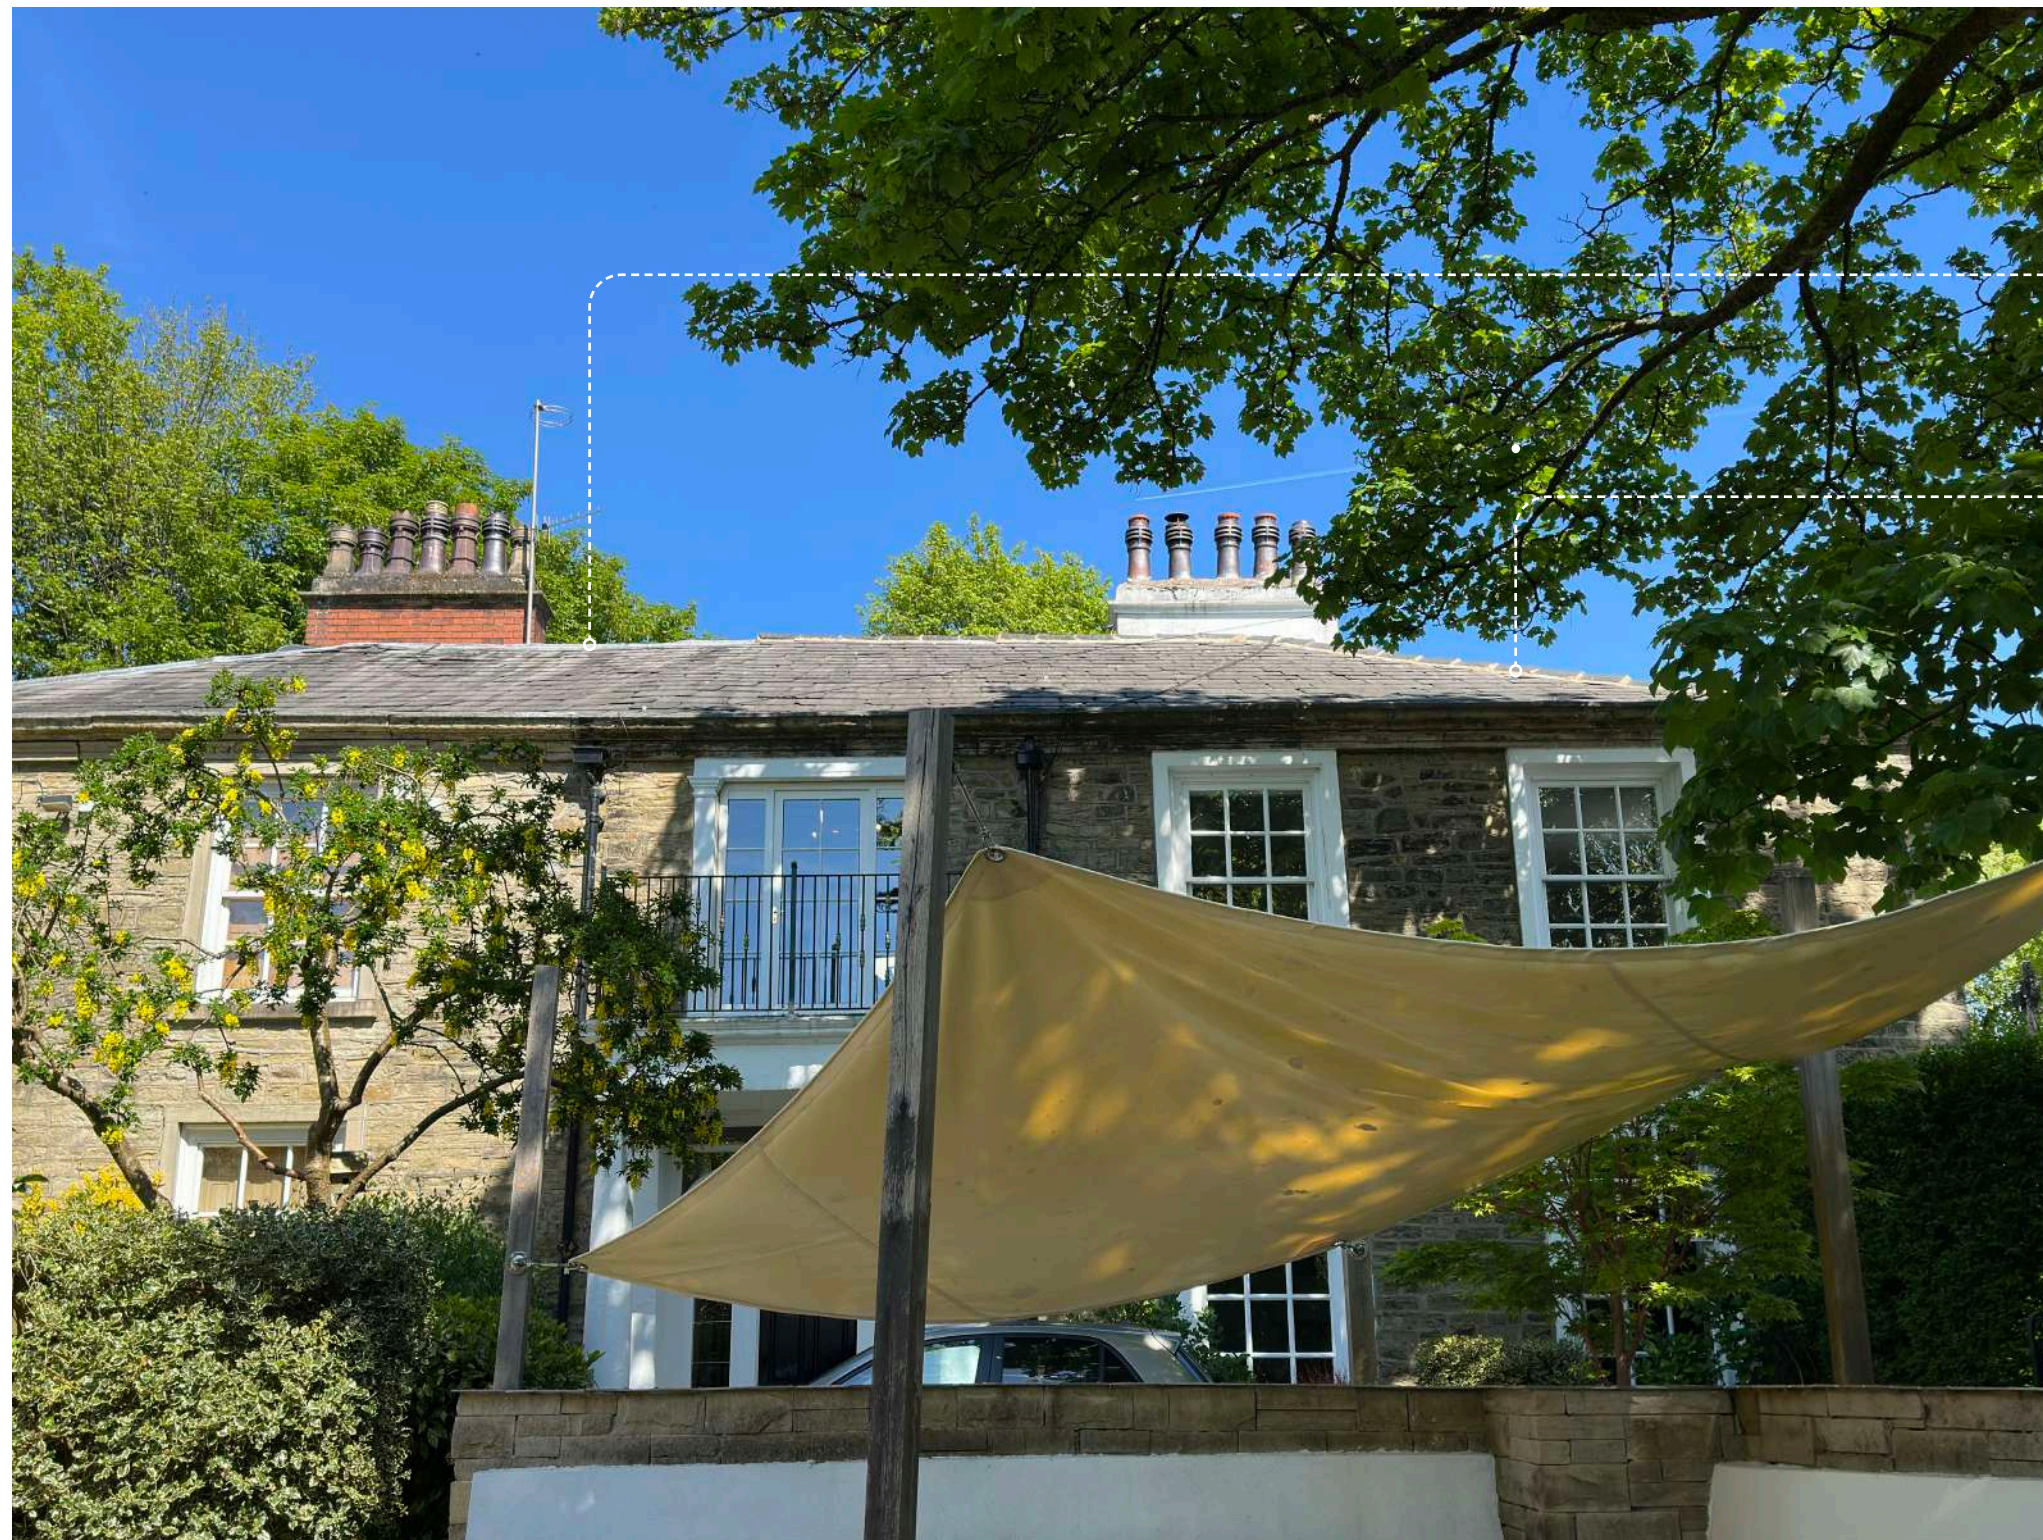
Figure 3: Photo taken from the garden looking towards Barwood House.  
Photo shows the state of the existing roof.

Neighbouring property No.17  
has lead flashing along the roof  
ridge & hips.

Existing mortared ridge & hip  
tiles.

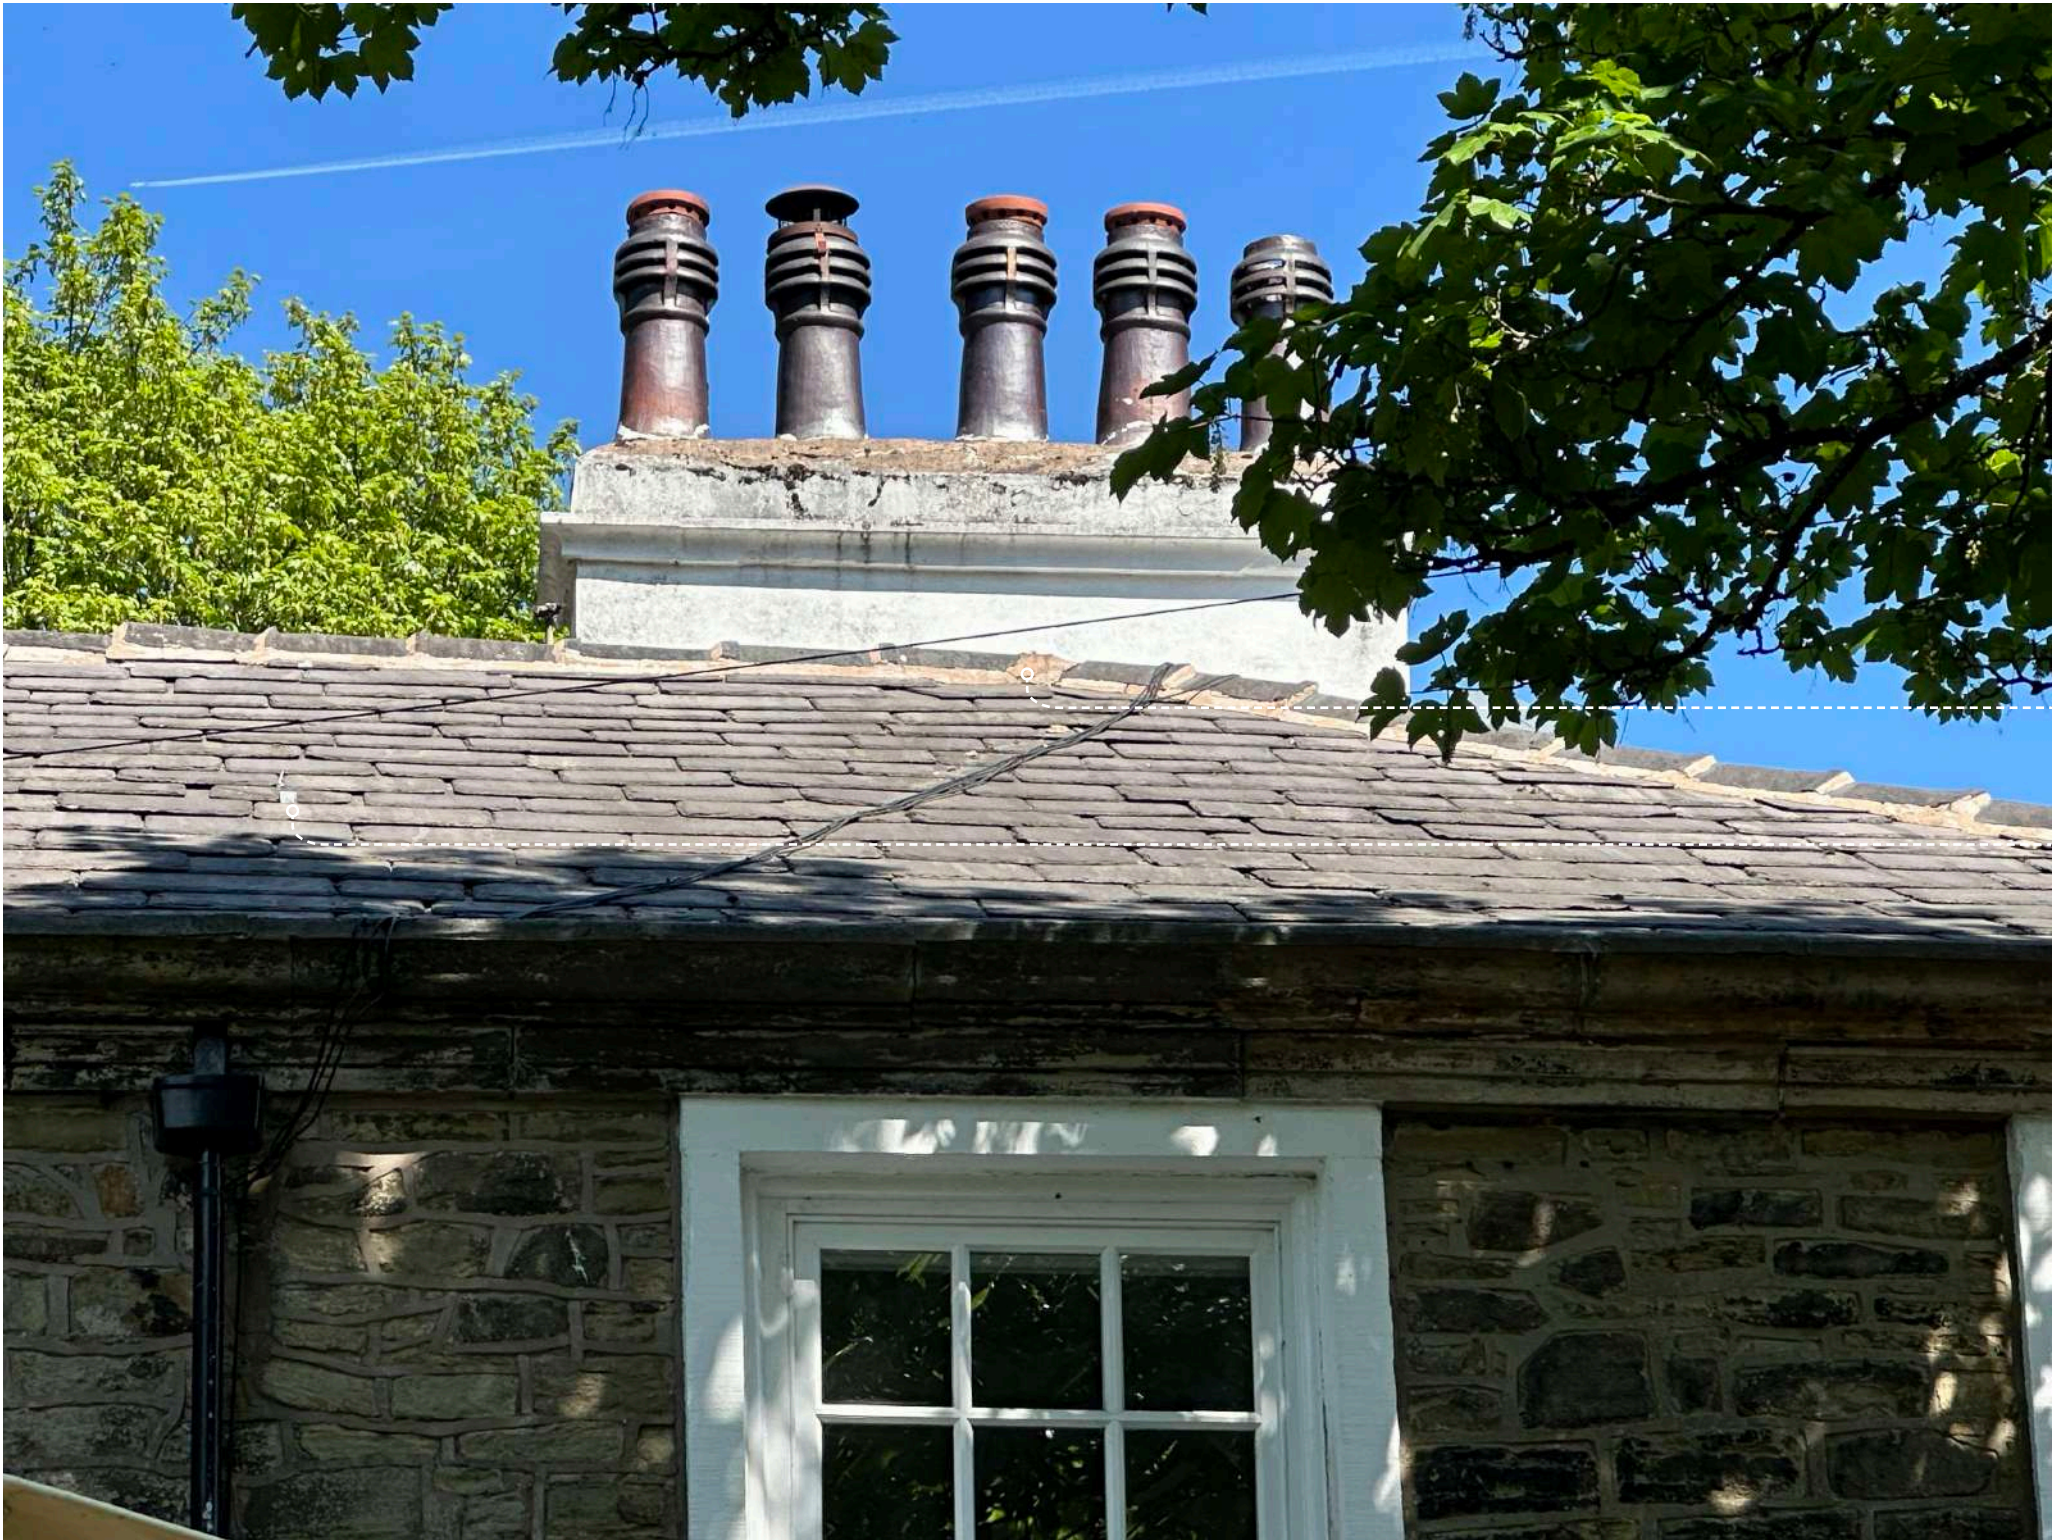
Figure 4: Close-up photo of front elevation. Showing the state of the existing roof.

Cracks in the mortar along the ridge & hip tiles.

Lead straps used to replace rusting/failing nails in the slate roof.

Inset Stone gutter with moulded cornice.
