## BURY FUSILIERS MUSEUM

Design, Access & Heritage Impact Statement.  
Chambers Conservation Ltd, January 2023 ISSUE 1.

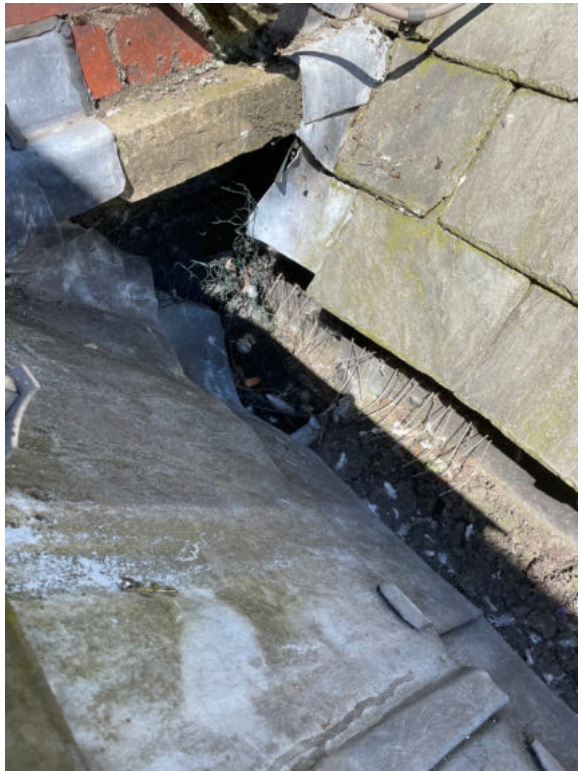
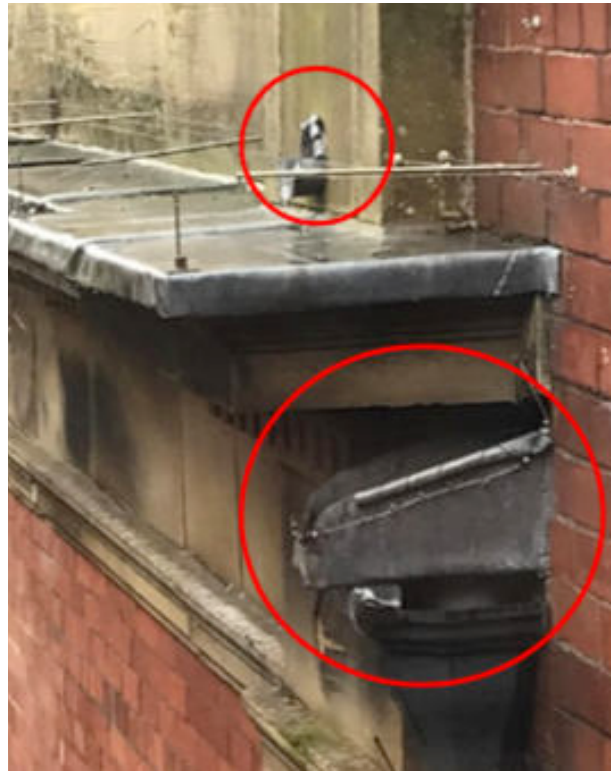
These are primarily focussed to the Broad Street and service area elevations, with a further area above the WC corridor and mezzanine stair). Inadequate capacity, detailing and difficult maintenance have resulted in water discharging down the ashlar, causing widespread staining, algal growth and some internal

03 (Area C). View from the gutter above. View from the north-west showing the overflow and hopper (circled).

The area collects water from Roof 1 and 2. The rainwater drains into a valley between the two roofs, then discharges through a sump, running internally to a chute into a hopper.

The proposals look to create an enlarged sump and overflow, which increases capacity. The overflow and eases maintenance (from the parapet gutter above) and will alert the museum to any blockages. Refer to drawing 001, A101 and C101 for details.

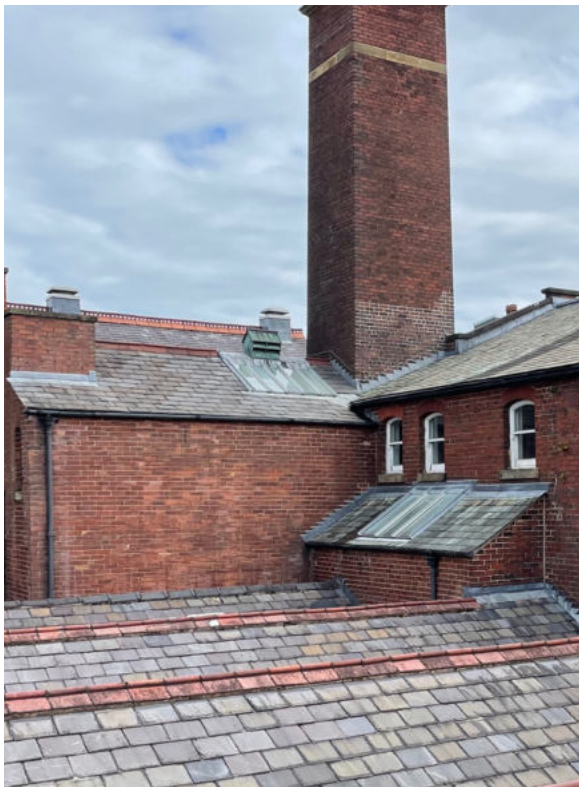
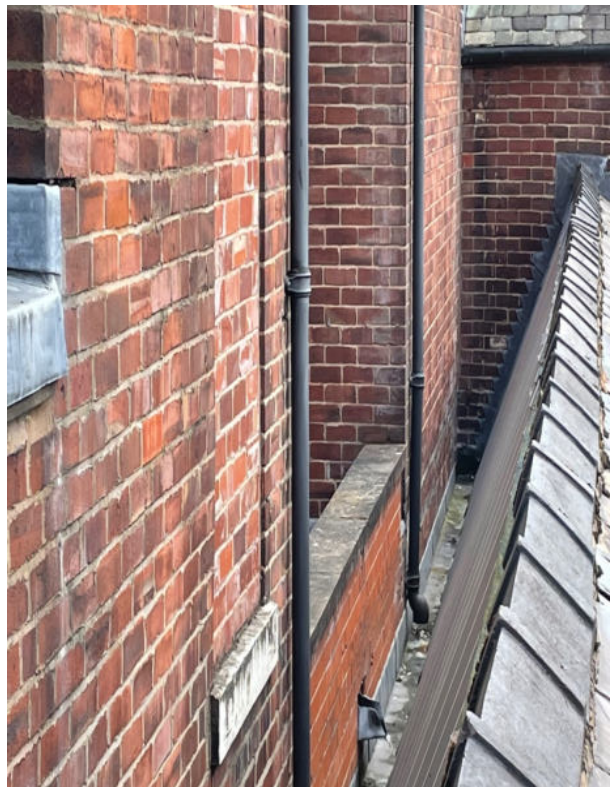
04 (Area G). General view (left). Close up of view of lead gutter, outlet from roof 11 (left).

deterioration. Revised details are needed to ensure that the system can cope with current rainfall and to make maintenance more realistic. Refer to Areas A, B, C & G on drawing BUFM.01-001.

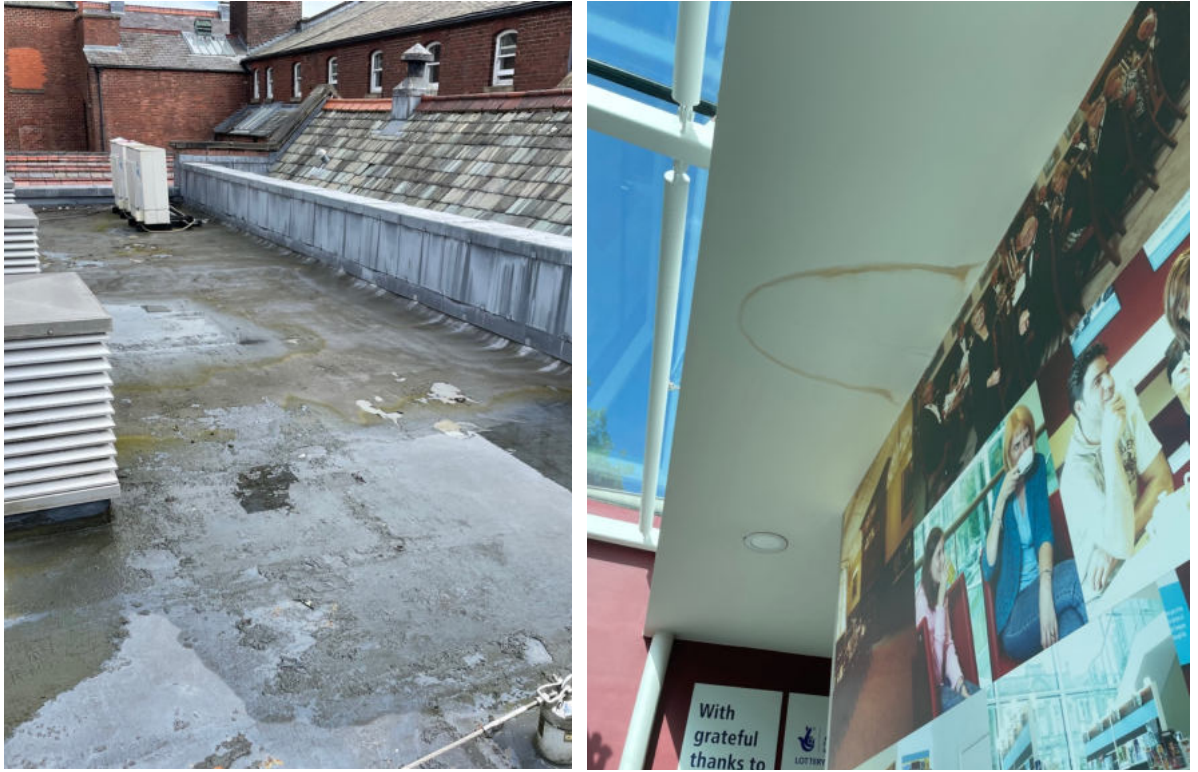
The roofing membrane/coating over the modern (2007-9) entrance area shows significant signs of deterioration and blistering. The original drawings show this to be a decothane liquid membrane on cut-to falls insulation. There is now extensive ponding and issues to the perimeter. The roofing membrane needs to be replaced and laid properly to falls, with better detailing around the perimeter. Refer to Area F on drawing BUFM.01-001

05 (Area F). Evidence of ponding to the flat roof, extensive coating failure and patching. Right, internal water ingress and damage to finishes.

Water ingress has been occurring into the modern entrance area. Whilst this does not, specifically, affect the historic fabric, it affects the overall significance through detriment to visitor experience (communal value). The works propose

renewing the membrane with an equivalent with better longevity and to renew the perimeter flashings to an improved detail
