## BH0045 - Radcliffe Civic Hub Project

### Method Statement for the protection of United Utilities 375mm diameter Combined Sewer laid within the site boundary.

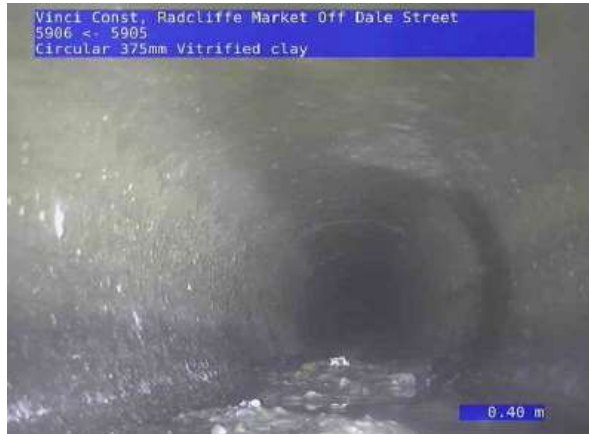
The report identifies no structural defects, but does identify some serviceability issues such as some standing water (10% of vertical dimension), and some settled deposits with 15% cross sectional area loss in 2 locations.

0.4m – Water level at 10%

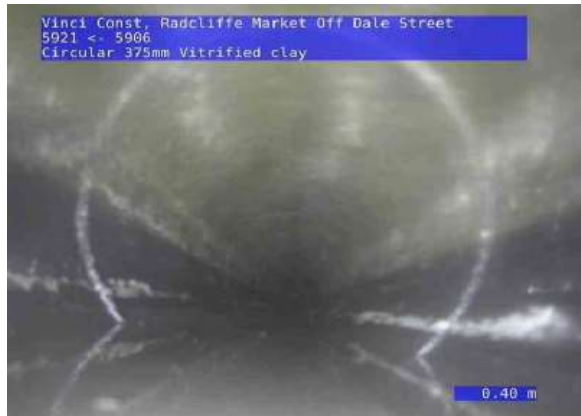
The report identifies no structural defect, but does note some serviceability issues such as some standing water (10% of vertical dimension), one defective connection, and some hard/compacted settled deposits, with 15% cross sectional area loss.

0.0m – Water level at 10%

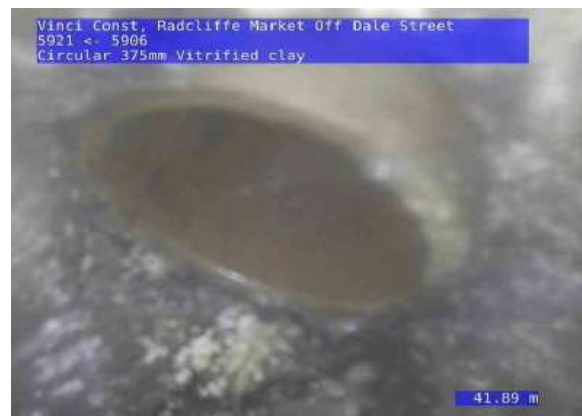
41.89m – Intruding connection of 150mm pipe

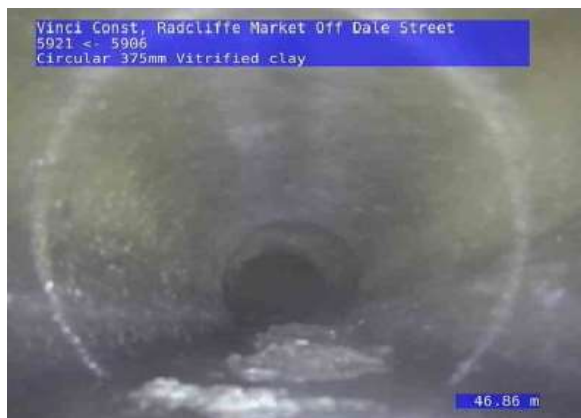
46.86 – Hard or compacted settled deposits

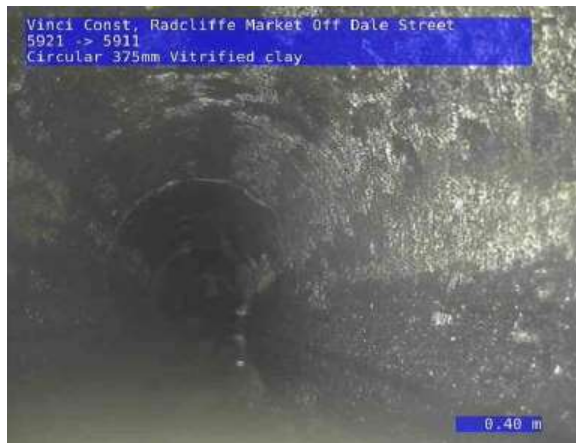
The report identifies no structural defects, but does note some serviceability issues such as some standing water (15% of vertical dimension), and some attached deposits, with 15% cross sectional area loss.

0.4m – Water level at 15%

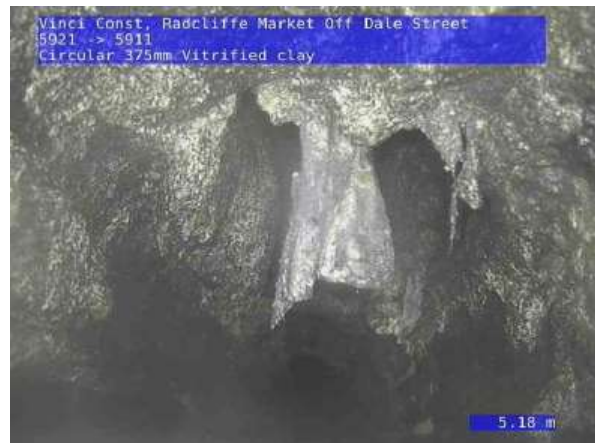
5.18 – attached deposits (encrustation)

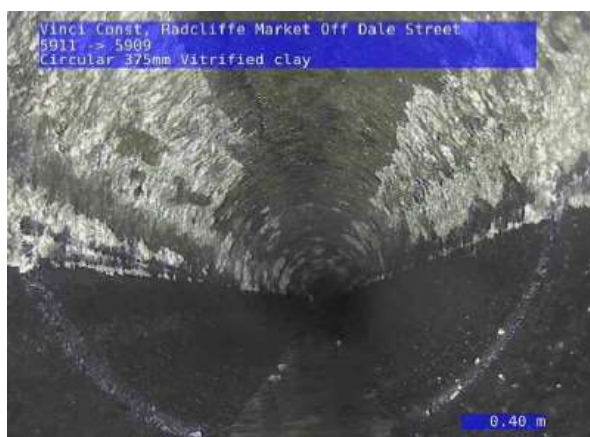
The report identifies no structural defects, but does note some serviceability issues such as some standing water (10% of vertical dimension), and some attached deposits, with 20% cross sectional area loss.

0.0m – Water level at 10%

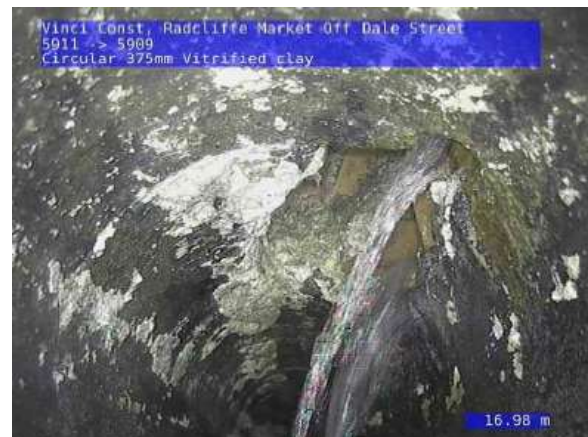
16.98m – defective connection (part blocked)

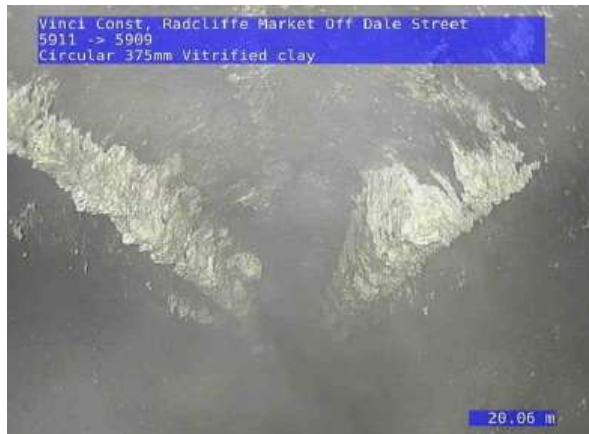
20.06m – Encrustacion (20% cross section loss)

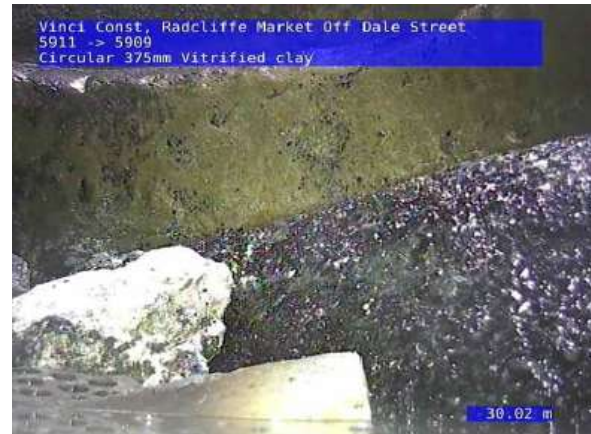
30.02m – Encrustacion (20% cross section loss)
