## Technical Advice Note

**Project:** Bury Fusilier Museum

**Subject:** Ventilation Tower

### Tower - Repairs

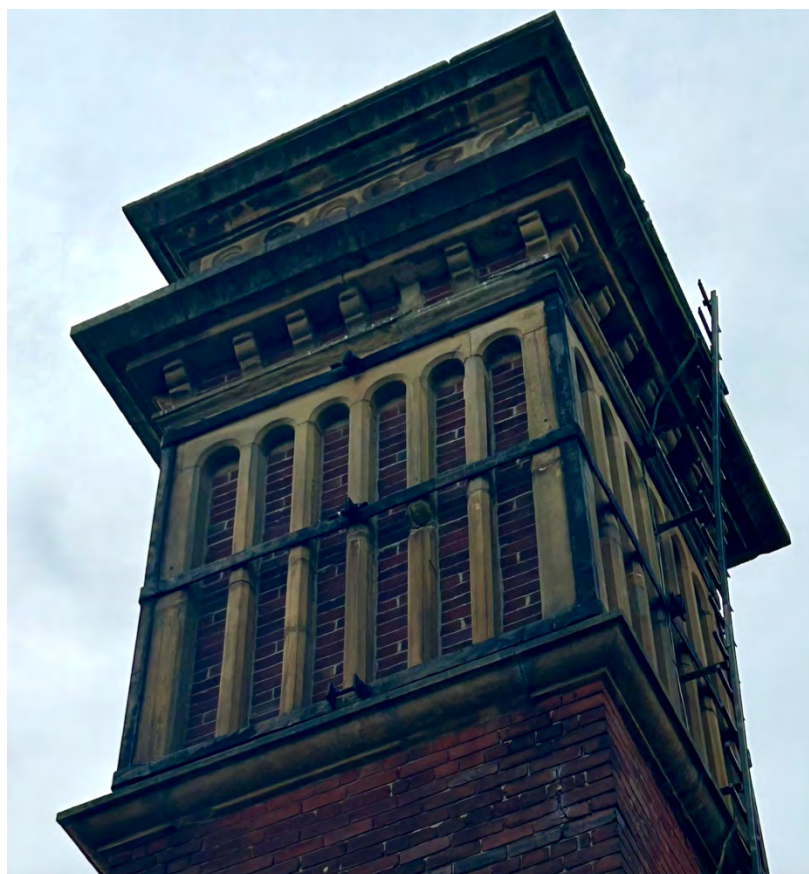
Photo 1 - East elevation of ventilation tower

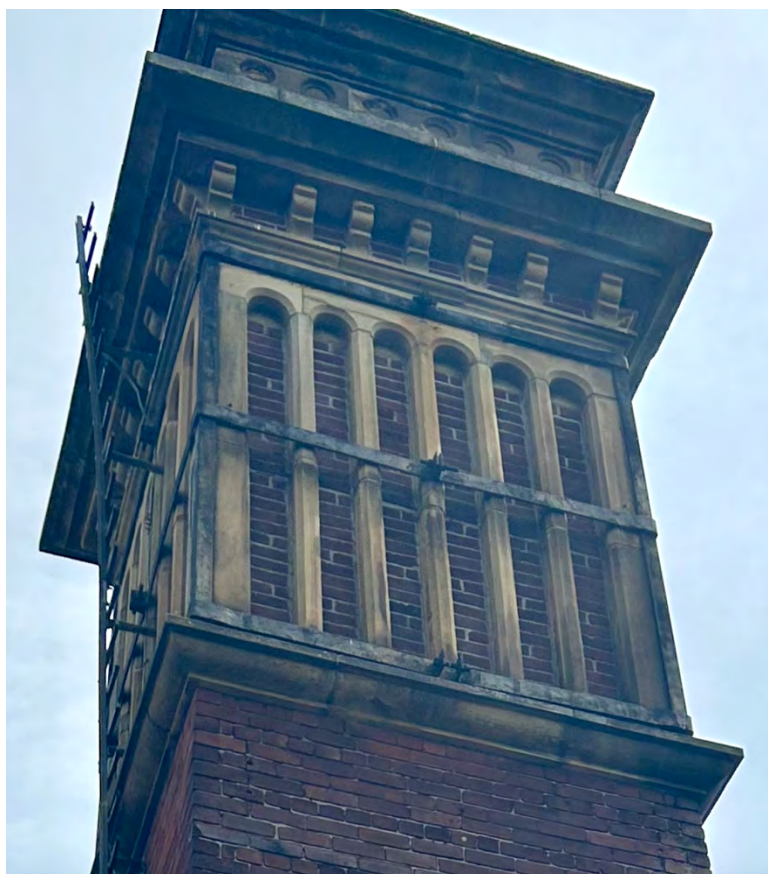
Photo 2 - West elevation of ventilation tower

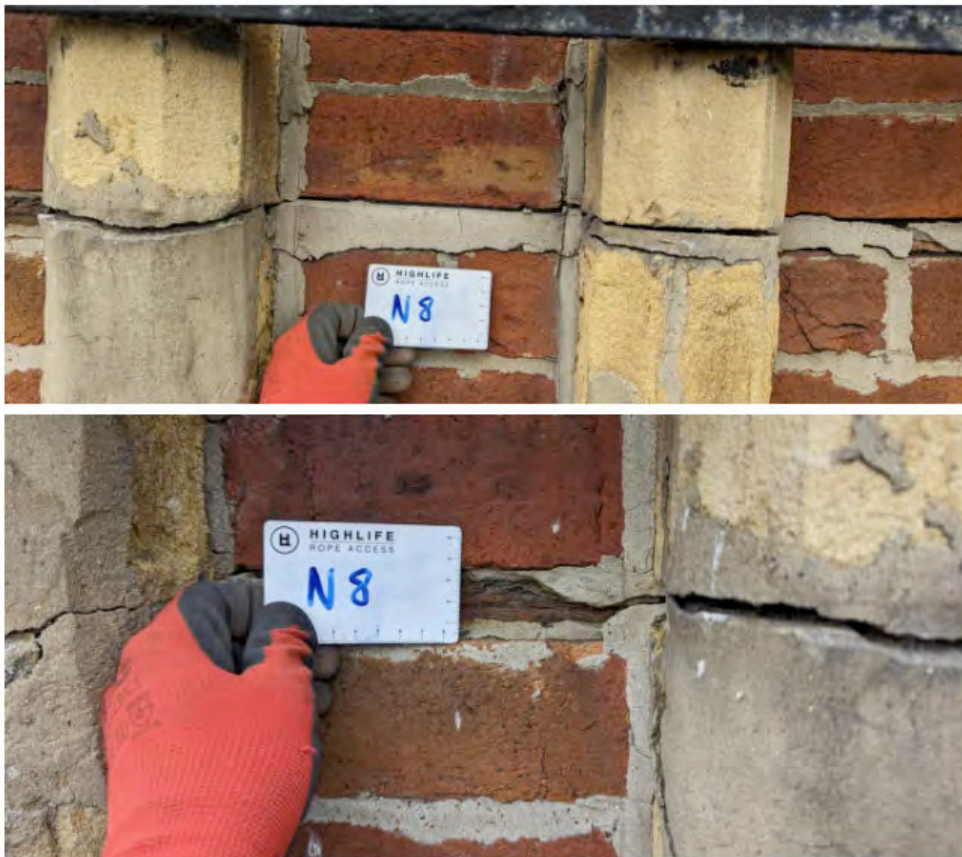
There is an embedded iron band in the brickwork approximately halfway up the sandstone mullions, approximately 1 no. brick course below the external horizontal strapping. The iron band is 60mm wide and is corroding causing jacking to the stonework, greater than 10mm on the north, east and west side. There is localised spalling to the stone. The wide bed joint has been pointed in cement mortar.

Photo 3 – Significant corrosion to embedded iron band in mortar joint (extract *Highlife Rope Access Report*)

We would recommend that the corroding embedded iron band is removed. The course of brickwork above the band should be removed in sections, setting aside any sound bricks for reinstatement. The iron band can then be cut out and the bricks rebbed in an appropriate lime mortar. This should be repeated around the full perimeter of the tower. The band doesn't require replacement.

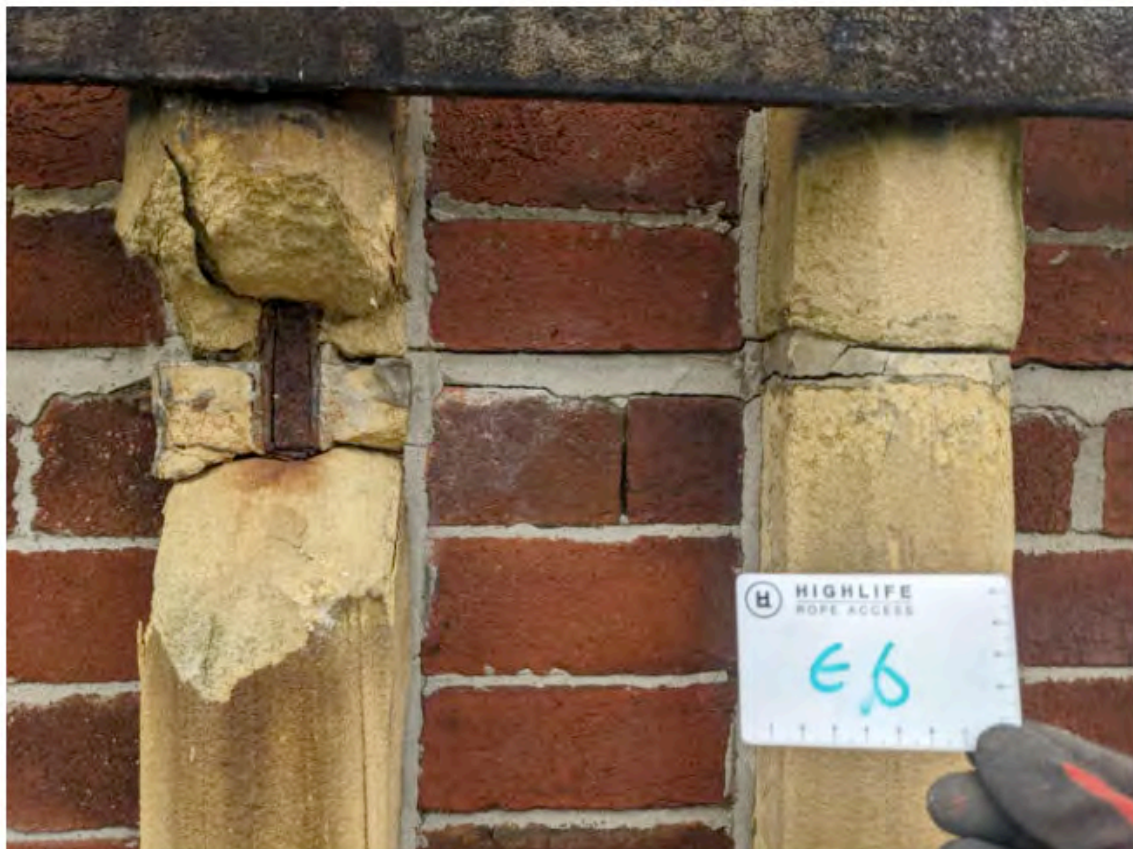
There are ferrous dowels within the sandstone mullions, in line with the embedded iron band, it's unclear if the dowels and band are connected. The dowels are corroding

causing 1 no. stone mullion to spall on the east side. There are mortar repairs to the stone mullions in this location which may be concealing ferrous dowels.

Photo 4 – Significant corrosion to ferrous dowel between stone mullions (extract *Highlife Rope Access Report*)

The ferrous dowels within the mullions in line with the embedded iron band should be removed and replaced as the iron band is being removed. We would recommend that a section of the stone mullion is cut out to enable the vertical dowel to be removed. A new piece of stone can be indented into the mullion, and tied back to the brickwork at the bottom bed joint. The tie could be a proprietary stainless steel cramp, from Ancon or similar. The head of the cramp would be bent up and secured to the brickwork using stainless steel threaded bar set in 2pt epoxy resin. The tail of the cramp would be bent down into a slot in the top of the existing stone mullion and secured in lime mortar.

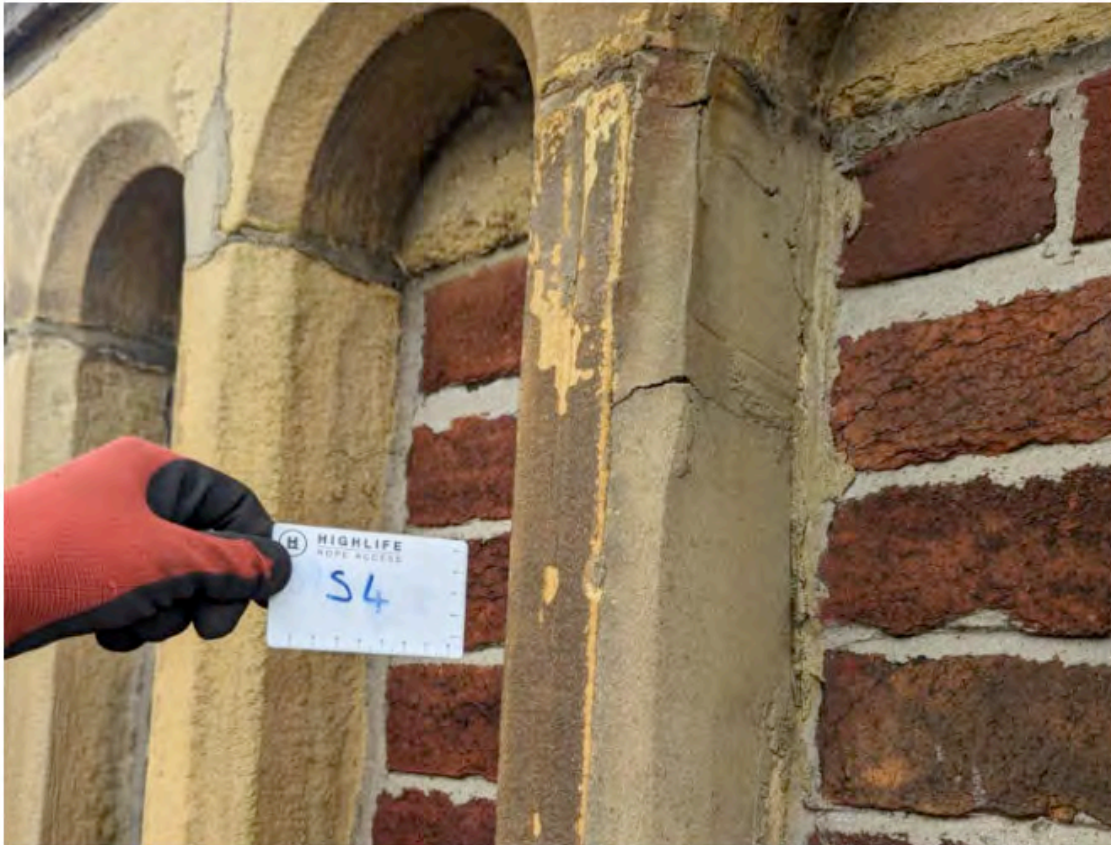
At the top of the stone mullions there are diagonal fractures indicative of corroding ferrous dowels. In some locations the mullion has been refaced with a mortar repair, which may be in response to spalling stone from ferrous fixings, or from erosion of the sandstone.

Photo 5 – Previous mortar repair to upper section of stone mullion (*extract Highlife Rope Access Report*)

It is likely that there are ferrous dowels at the top of the stone mullions where they meet the arch stone. We would recommend that further investigations are carried out to determine the location and detail of any dowels. The failing mortar repair could be removed from the top of the stone mullion near the joint, and any remaining cement mortar from the bed joints.

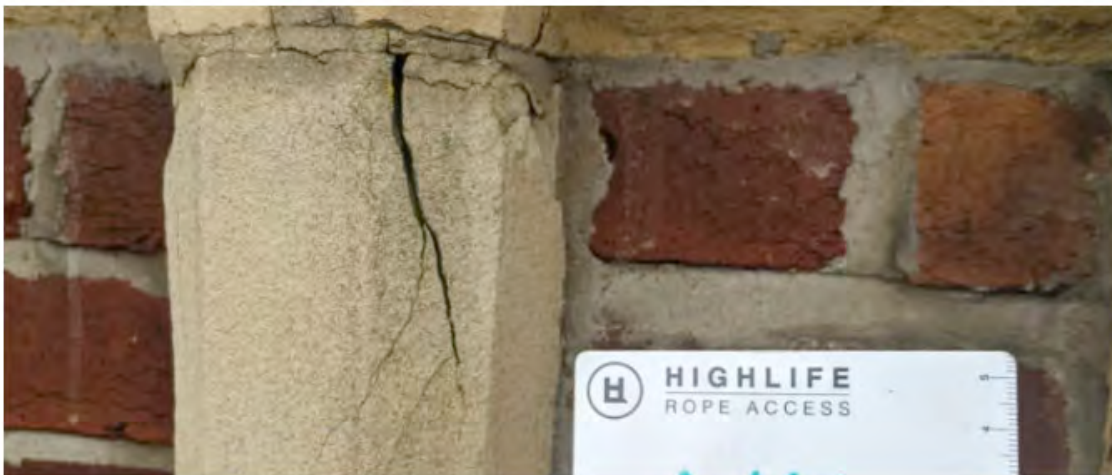
Photo 6 – Diagonal fracture in upper section of stone mullion, likely from corroding ferrous fixing (*extract Highlife Rope Access Report*)

As there are signs of embedded ferrous dowels beginning to corrode with diagonal fractures and localised spalling, this will continue to progress given the age of the building and the environmental exposure. We would recommend that all dowels in these locations are removed and replaced, if necessary, whilst access is available. The repair would involve locally removing the ferrous dowel, replacing in stainless steel and indenting a new piece of stone, carefully matched to the existing.

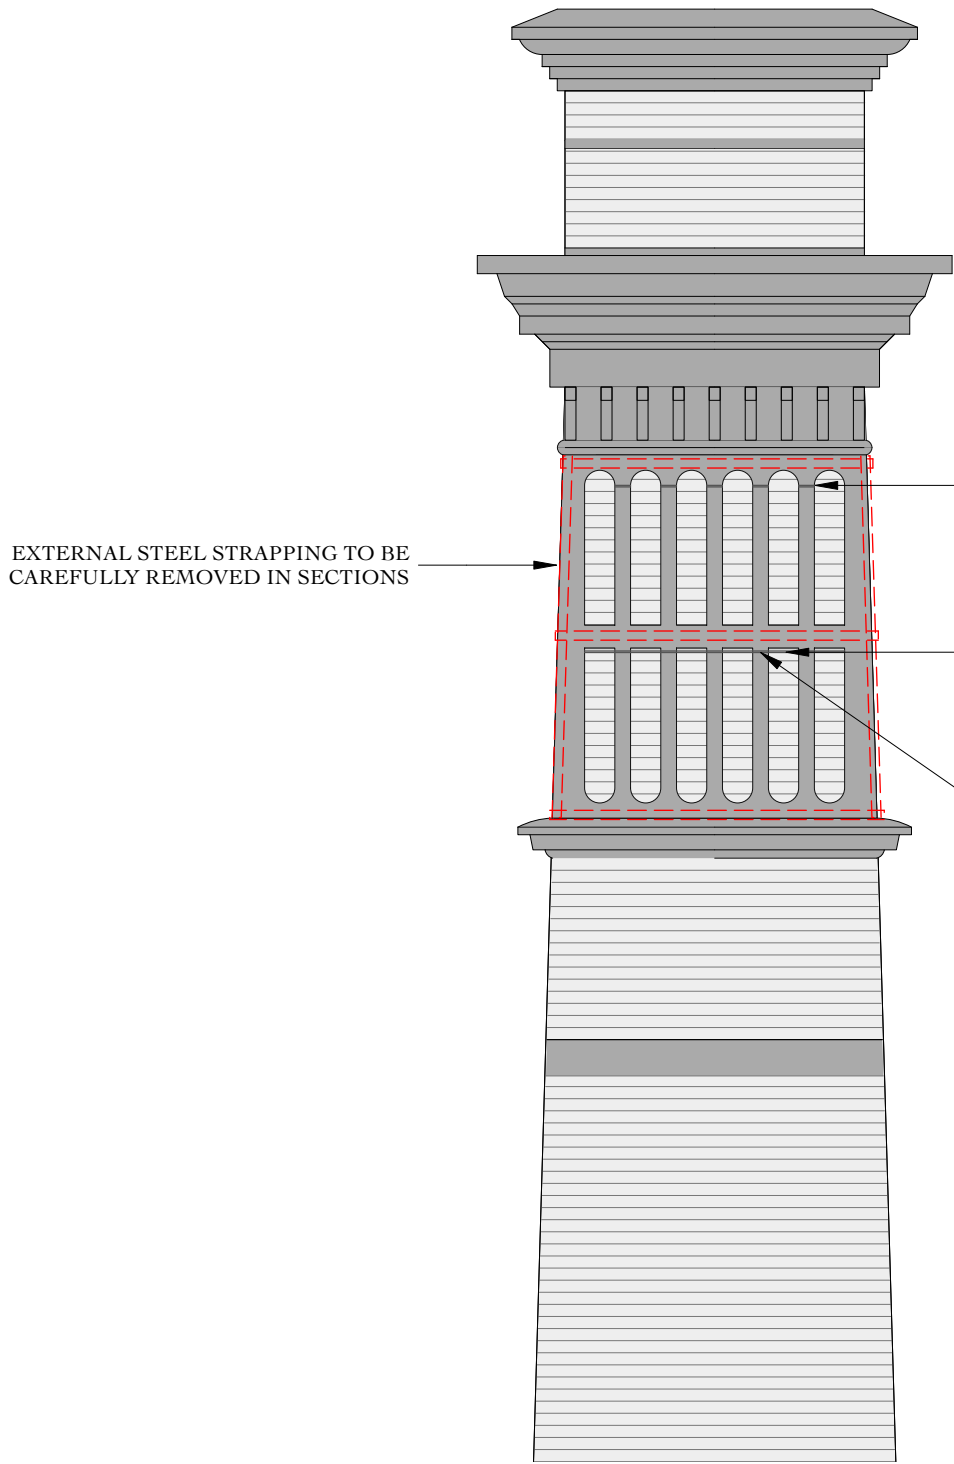
EMBEDDED IRON BAND, 60mm WIDE, IN BED JOINT OF BRICKWORK. BAND IS CORRODING AND CAUSING RUST JACKING TO MASONRY REPAIR - REMOVE SHORT LENGTH OF BRICK COURSE ABOVE IRON BAND, CUT OUT IRON BAND AND REBED BRICK. REPEAT REPAIR AROUND FULL PERIMETER OF TOWER.

EXTERNAL STEEL STRAPPING TO BE CAREFULLY REMOVED IN SECTIONS

LIKELY LOCATION OF FERROUS DOWEL BETWEEN STONE MULLION AND ARCH STONE  
FURTHER INVESTIGATION - LOCALLY REMOVE PREVIOUS MORTAR REPAIR FROM STONE MULLION TO DETERMINE CONDITION OF REMAINING STONE AND LOCATION OF FERROUS METALWORK

EMBEDDED VERTICAL FERROUS DOWEL THROUGH BED JOINT OF STONE MULLIONS  
REPAIR - CUT OUT SECTION OF STONE MULLION AND REMOVE DOWEL. NEW STONE INDENT WITH PROPRIETARY STAINLESS STEEL CRAMP, REFER TO DETAIL A
