## Protected Tree Assessment, Site next to 8 Haslam Brow

FINAL version 08/11/2022

Dominic Rigby MCIEEM, Senior Ecologist

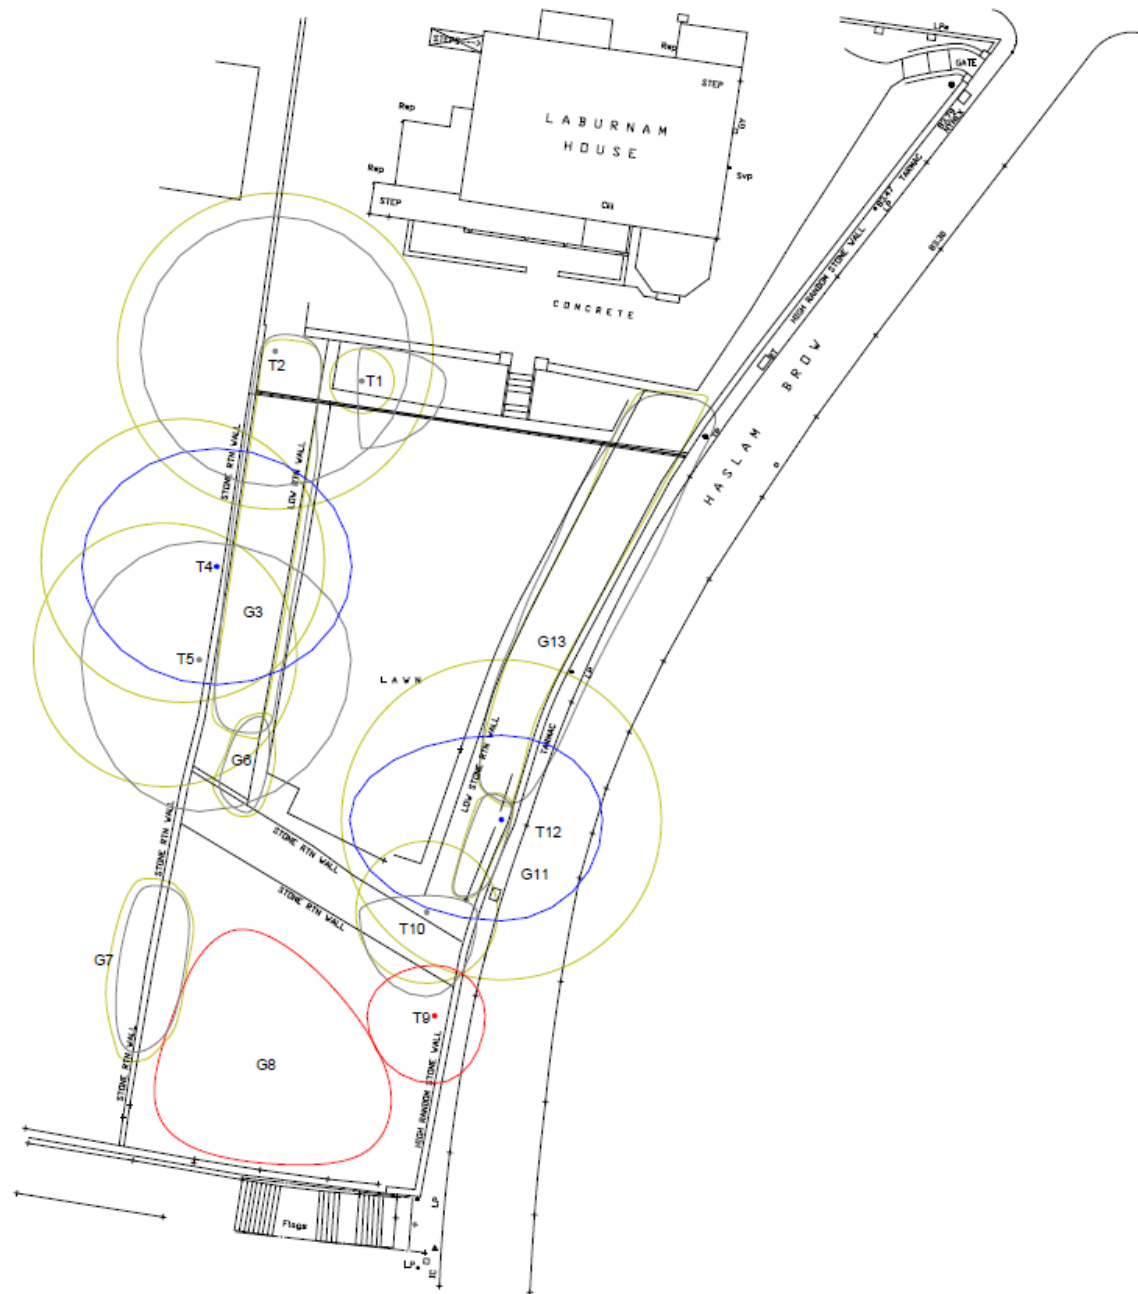
Figure Two: 2013 Arboriculture Impact Plan (reproduced from Godwin Arboricultural's 2013 Report)

- T12 was a mature lime, protected by a TPO. This would not be affected by the development; its root protection zone (RPA) fell outside the development. Furthermore, the ground level for almost all the RPA was 1m higher than the proposed development site, separated by a retaining stone wall. It was quite likely that the RPA was terminated by the retaining wall.

- T9 was a semi mature sycamore. Its crown overhung the adjacent footpath, it was multi-stemmed at ground level with a slightly unbalanced crown and contained bark wounds and cavities at its base. It had been assessed as having a poor vitality and removal for arboricultural reasons had been recommended in the 2013 report. The tree was still present in October 2022 but was targeted for removal.

- T10 was a mature sycamore, protected by a TPO. As with T12, the tree was on the far side of a retaining wall which was to remain. There was no plan to interfere with this tree however the root zone (yellow contour in Figure 2, not considering the wall and drop in height) overlapped slightly with a proposed patio/terrace area.

The finish of the patio/terrace surface within the RPA of **T10** should be porous to ensure that any roots present are able to access oxygen, water and nutrients once the building is complete.

- It was recommended that the tree surgeon should be aware of bats and the law and that should bats be encountered or suspected works must stop immediately and an experienced licensed bat ecologists be alerted.
- Tree works should be planned for autumn/winter. Although this was outside the nesting bird season it should be considered that some birds – pigeons especially – can nest at any time of year and thus visual checks should be made prior to works to working the tree.
- Should works be planned between March and September, a bat potential roost features survey would need to be undertaken and a thorough nesting birds check would be required.

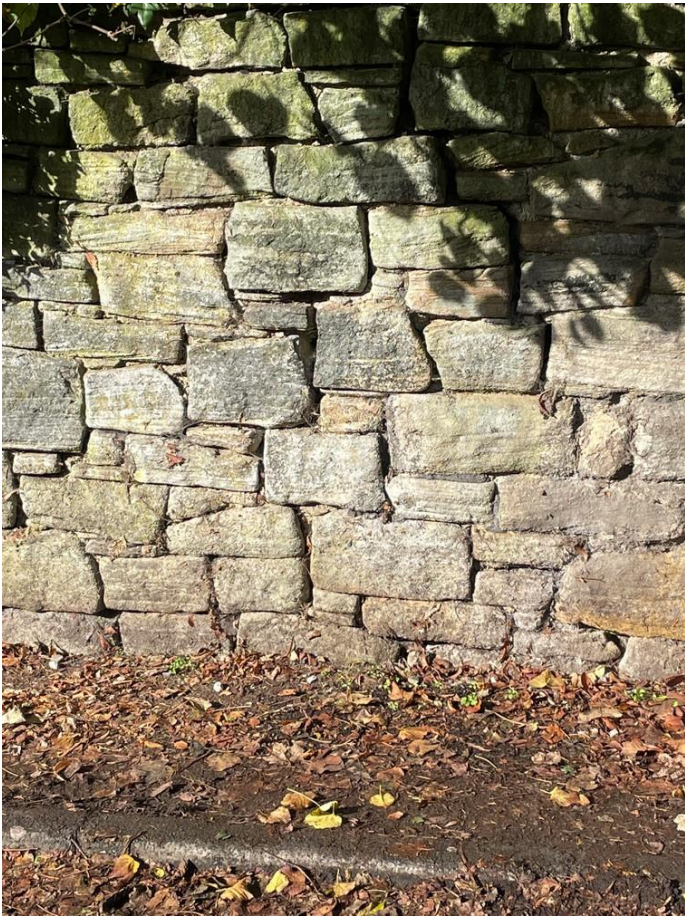
Although the lime tree T12 (with TPO) was unaffected by the development, it was noted that the roots of the tree were expanding through the retaining wall along Haslam Brow footway. The crown also contained limbs that were overhanging the property opposite.

**Photograph One: Footway wall bowing in response to lime tree roots**

- Specialist advice regarding the tree's protected status and the likelihood of the wall failing should be sought.
- A crown reduction should be considered, this would require prior approval from the local authority tree officer.

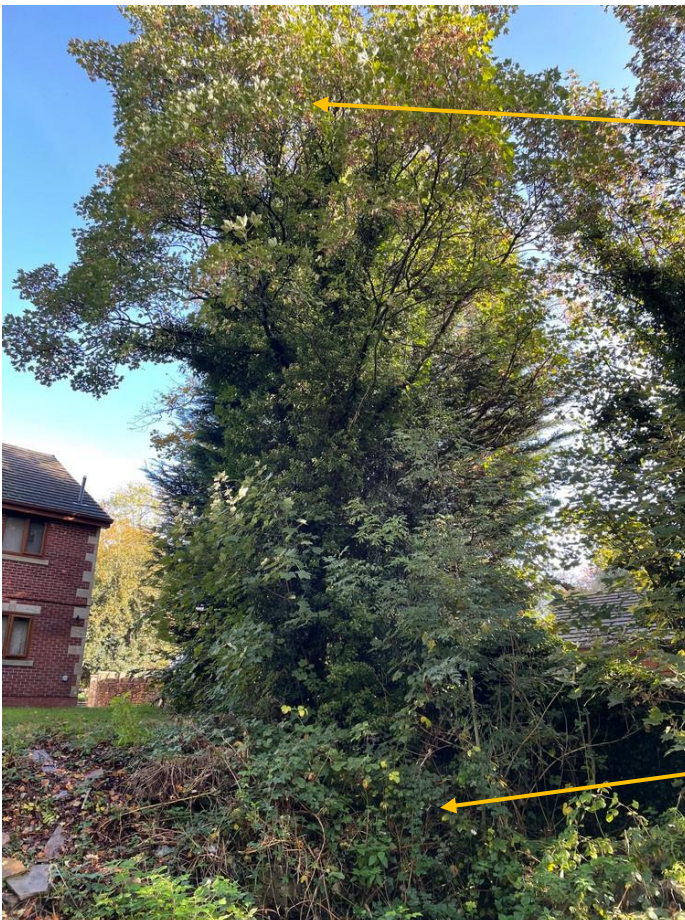
**Photograph Two: Drop in land height between the two plots**

T10 in background

Retaining wall emphasising  
different land levels between
