**Window and door repair and refurbishment methodology for change of use of existing offices (Use Class B1) to 9 apartments (Use Class C3) with internal and external alterations at 18-20 St Mary's Place, Bury, BL9 0DZ**

Ref; 22/1289/305 – Window and door methodology

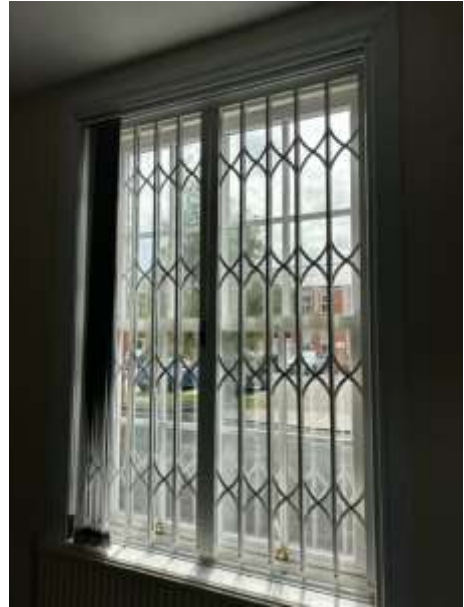
Internal view of Type 1 window  
– WT1

- In general the windows to the front elevations are sliding sash operation with opening lights to the bottom sash.
- Units are modern day replacement for sliding sash windows (circa 2003). Bottom sash is opener, top sash is fixed.
- Timber frame painted white with double glazed units (16mm air gap between units). 8 and 8 glazing pane pattern. No blown double glazed units & double glazed units appear to be satisfactory for continued use.
- Brass plated D rings and sash catches.
- Internal timber beadings to glazed units.
- Plastic architrave to window reveals (to windows W1, W4, W21, W22, W23, W24).
- Internal timbers are in a sound condition with no significant defects. Opener is seized or fixed shut. Windows require redecoration and servicing.
- Cill boards are timber bull nose profile painted white.

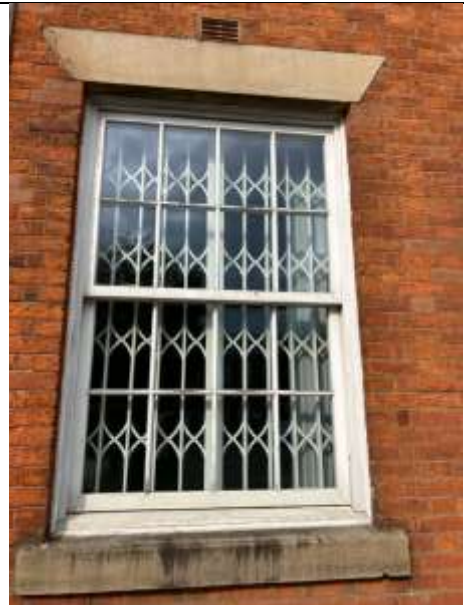
External view of Type 1 window –  
WT1

- Externally the timbers are generally in a sound condition but there is some minor softness to the window cills and timber glazing beads. Sealant is applied to glazed units and timber glazing beads are painted (white).

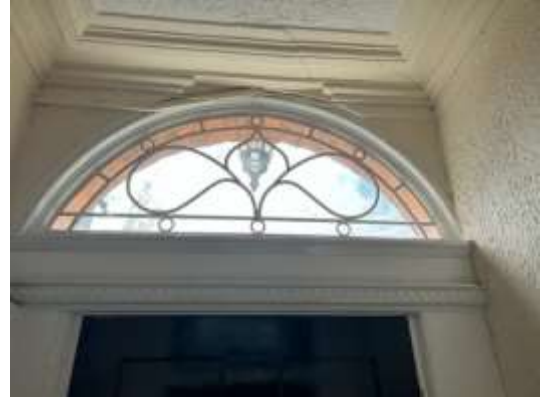
Internal view of fanlight – WT2

- Single glazed fanlights located above the main entrance door (No.20), and redundant entrance door (No.18). Timber frame painted (white) incorporating single glazed leaded glass.
- Internal timbers in satisfactory condition, no signs of rot.
- Internal timber beadings to glazed units painted (white).
- Internal timbers are in a sound condition with no significant defects.

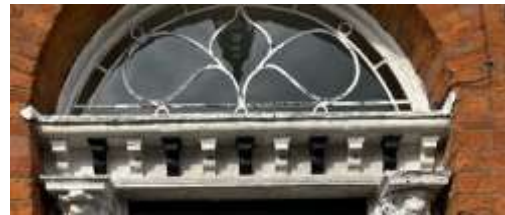
External view of fanlight – WT2

Externally the timbers are generally in a sound condition but now require redecoration to prevent deterioration. Sealant is applied to glazed units and timber glazing beads are painted (white).

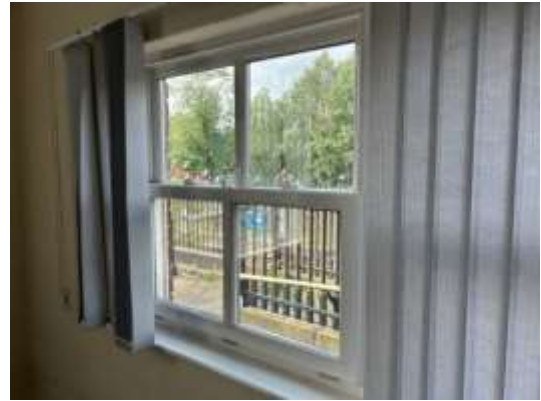
Internal view of Type 3 window  
– WT3

- To the side and rear elevations the opening lights are to the bottom sash and are bottom hinged.
- Units are modern day replacement for sliding sash windows (circa 2003).
- Bottom sash is opener, and are hinged at the base of the window frame.
- Timber frame painted white with double glazed units (16mm air gap between units). 2 and 2 glazing pane pattern.
- No blown double glazed units & double glazed units appear to be satisfactory for continued use.
- Nickel sash catches and stays.
- Internal timber beadings to glazed units painted (white).
- No architraves or lining boards to window reveals (plaster wall finish – painted).
- Internal timbers are in a sound condition with no significant defects. Openers are seized or fixed shut. Windows require redecoration and servicing.

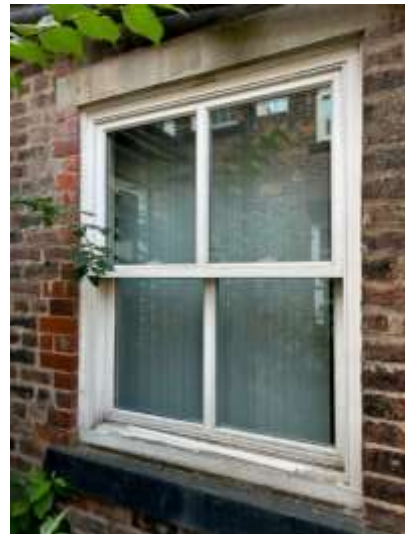
External view of type 3 window – WT3

- Externally the timbers are generally in a sound condition but there is some minor softness to the window cills and timber glazing beads. Sealant is applied to glazed units and timber glazing beads are painted (white).

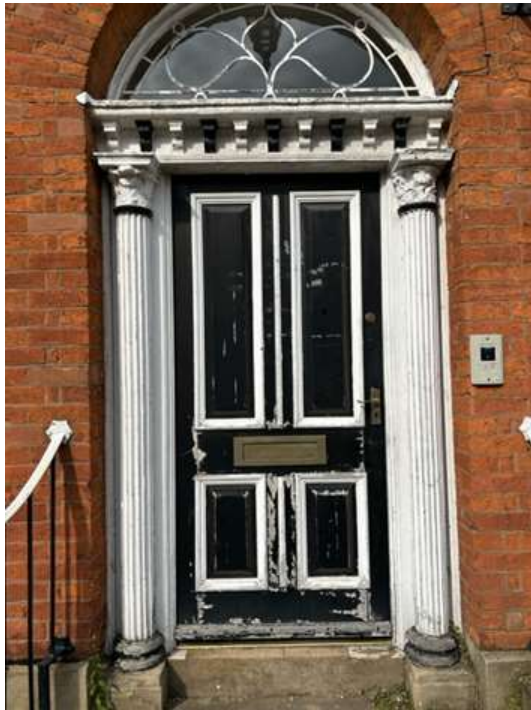
External view of communal  
entrance door (D1)

- Timber door panel and frame are generally in a good condition.
- Some impact damage to edges.
- Existing paint finish is deteriorating with fracture cracks and peeling paint.

| Door ref: | Function: | Construction: | Comments: |
|---|---|---|---|
| D1 | Redundant entrance (No.18) | Timber frame and panel. | Requires repair to timbers and complete redecoration. |

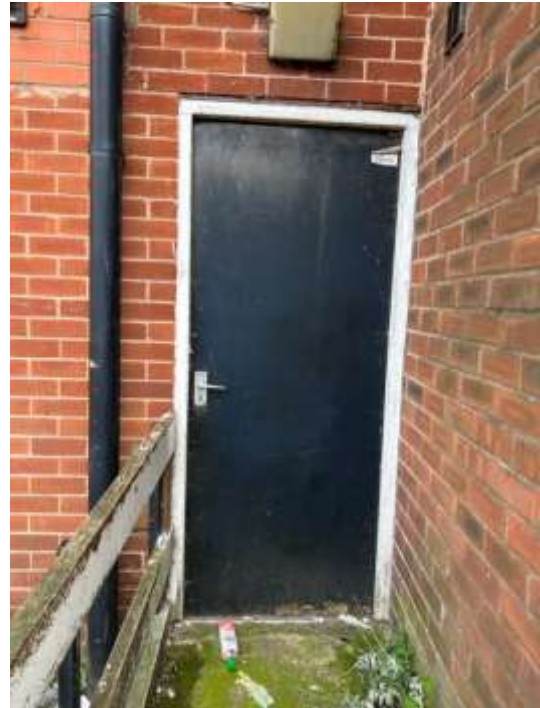
Timber door and frame (D3)

- Timber door panels and frames are generally satisfactory and without significant areas of rot. Painted finish to doors (black) and frames (white).
- Areas of fracture cracks to paint finish and flaking paint.
- Door D6 is half glazed and is proposed to be replaced with new moulded 4 panel hardwood door.

| Door ref: | Function: | Construction: | Comments: |
|---|---|---|---|
| D3 | Former fire escape | Timber panel & frame. | Door panel & frame to be removed. Lower part of opening infilled with brick to match adjacent brickwork.<br>New sliding sash timber window to be installed to upper part of opening. |
