## CCTV SURVEY INSPECTION REPORT

| <b>Location:</b> | Radcliffe Hub (Next to the Bridge Tavern Pub) |

**Project Name:** CONSTRUCTICON BLACKBURN STREET RADCLIFFE 060624  
**Project Date:** 06/06/2024  
**Inspection Standard:** MSCC5 Sewers & Drainage GB (SRM5 Scoring)

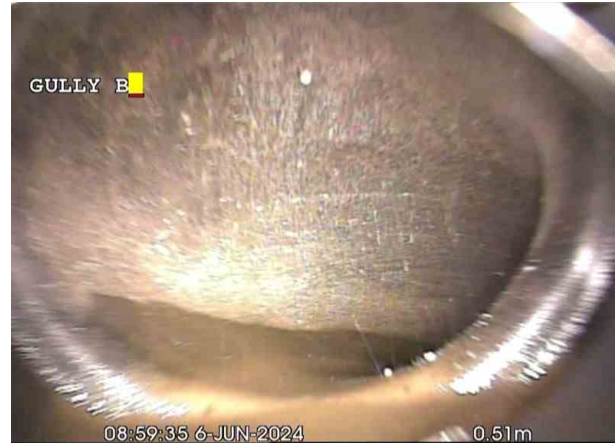
| Scale: | 1:50 | Position [m] | Code | Observation | MPEG | Photo | Grade |
|---|---|---|---|---|---|---|---|
| | | 0.51 | LR | Line deviates right: SLIGHT | 00:00:03 | GULLY BX_9d17f683-b9d7- | |

GULLY  
 BX\_9d17f683-b9d7-482b-b9dc-d7c99259cbd4\_20240606\_130  
 150\_613.jpg, 00:00:03, 0.51 m  
 Line deviates right, SLIGHT

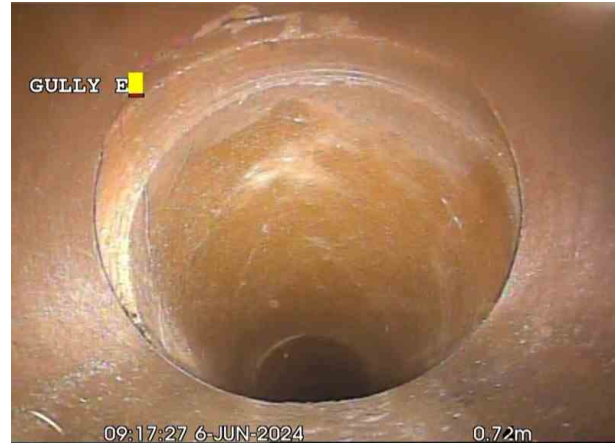
| Scale: | 1:50 | Position [m] | Code | Observation | MPEG | Photo | Grade |
|---|---|---|---|---|---|---|---|
| | | 0.72 | JDM | Joint displaced, medium: WHERE LINE IS DROPPING DOWN TO MIAN | 00:00:05 | GULLY EX_fbda3 13f-64ec-4 | 1 / 3 |

GULLY  
 EX\_fbda313f-64ec-4726-b4be-b0d7f1e4c4aa\_20240606\_130  
 736\_835.jpg, 00:00:05, 0.72 m  
 Joint displaced, medium, WHERE LINE IS DROPPING DOWN  
 TO MIAN

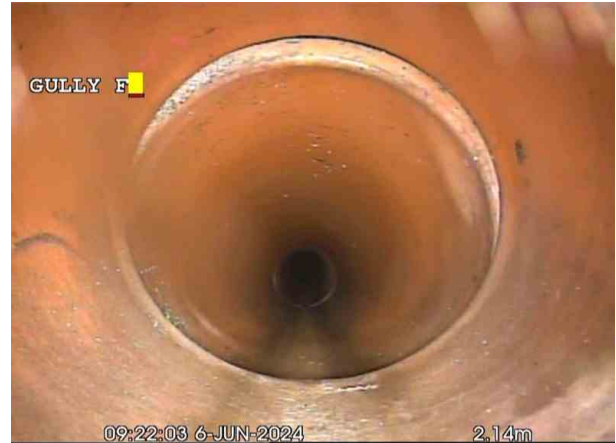
| Scale: | 1:92 | Position [m] | Code | Observation | MPEG | Photo | Grade |
|---|---|---|---|---|---|---|---|
| | | 2.14 | JD | Joint displaced, 5mm displacement, 1 - 1.5 x pipe wall thickness: SLIGHT | 00:00:16 | GULLY<br>FX_0ec81<br>767-8013- | 1 / 1 |

GULLY  
 FX\_0ec81767-8013-4ce2-a69b-a74791e86684\_20240606\_13  
 1037\_436.jpg, 00:00:16, 2.14 m  
 Joint displaced, 5mm displacement, 1 - 1.5 x pipe wall  
 thickness, SLIGHT

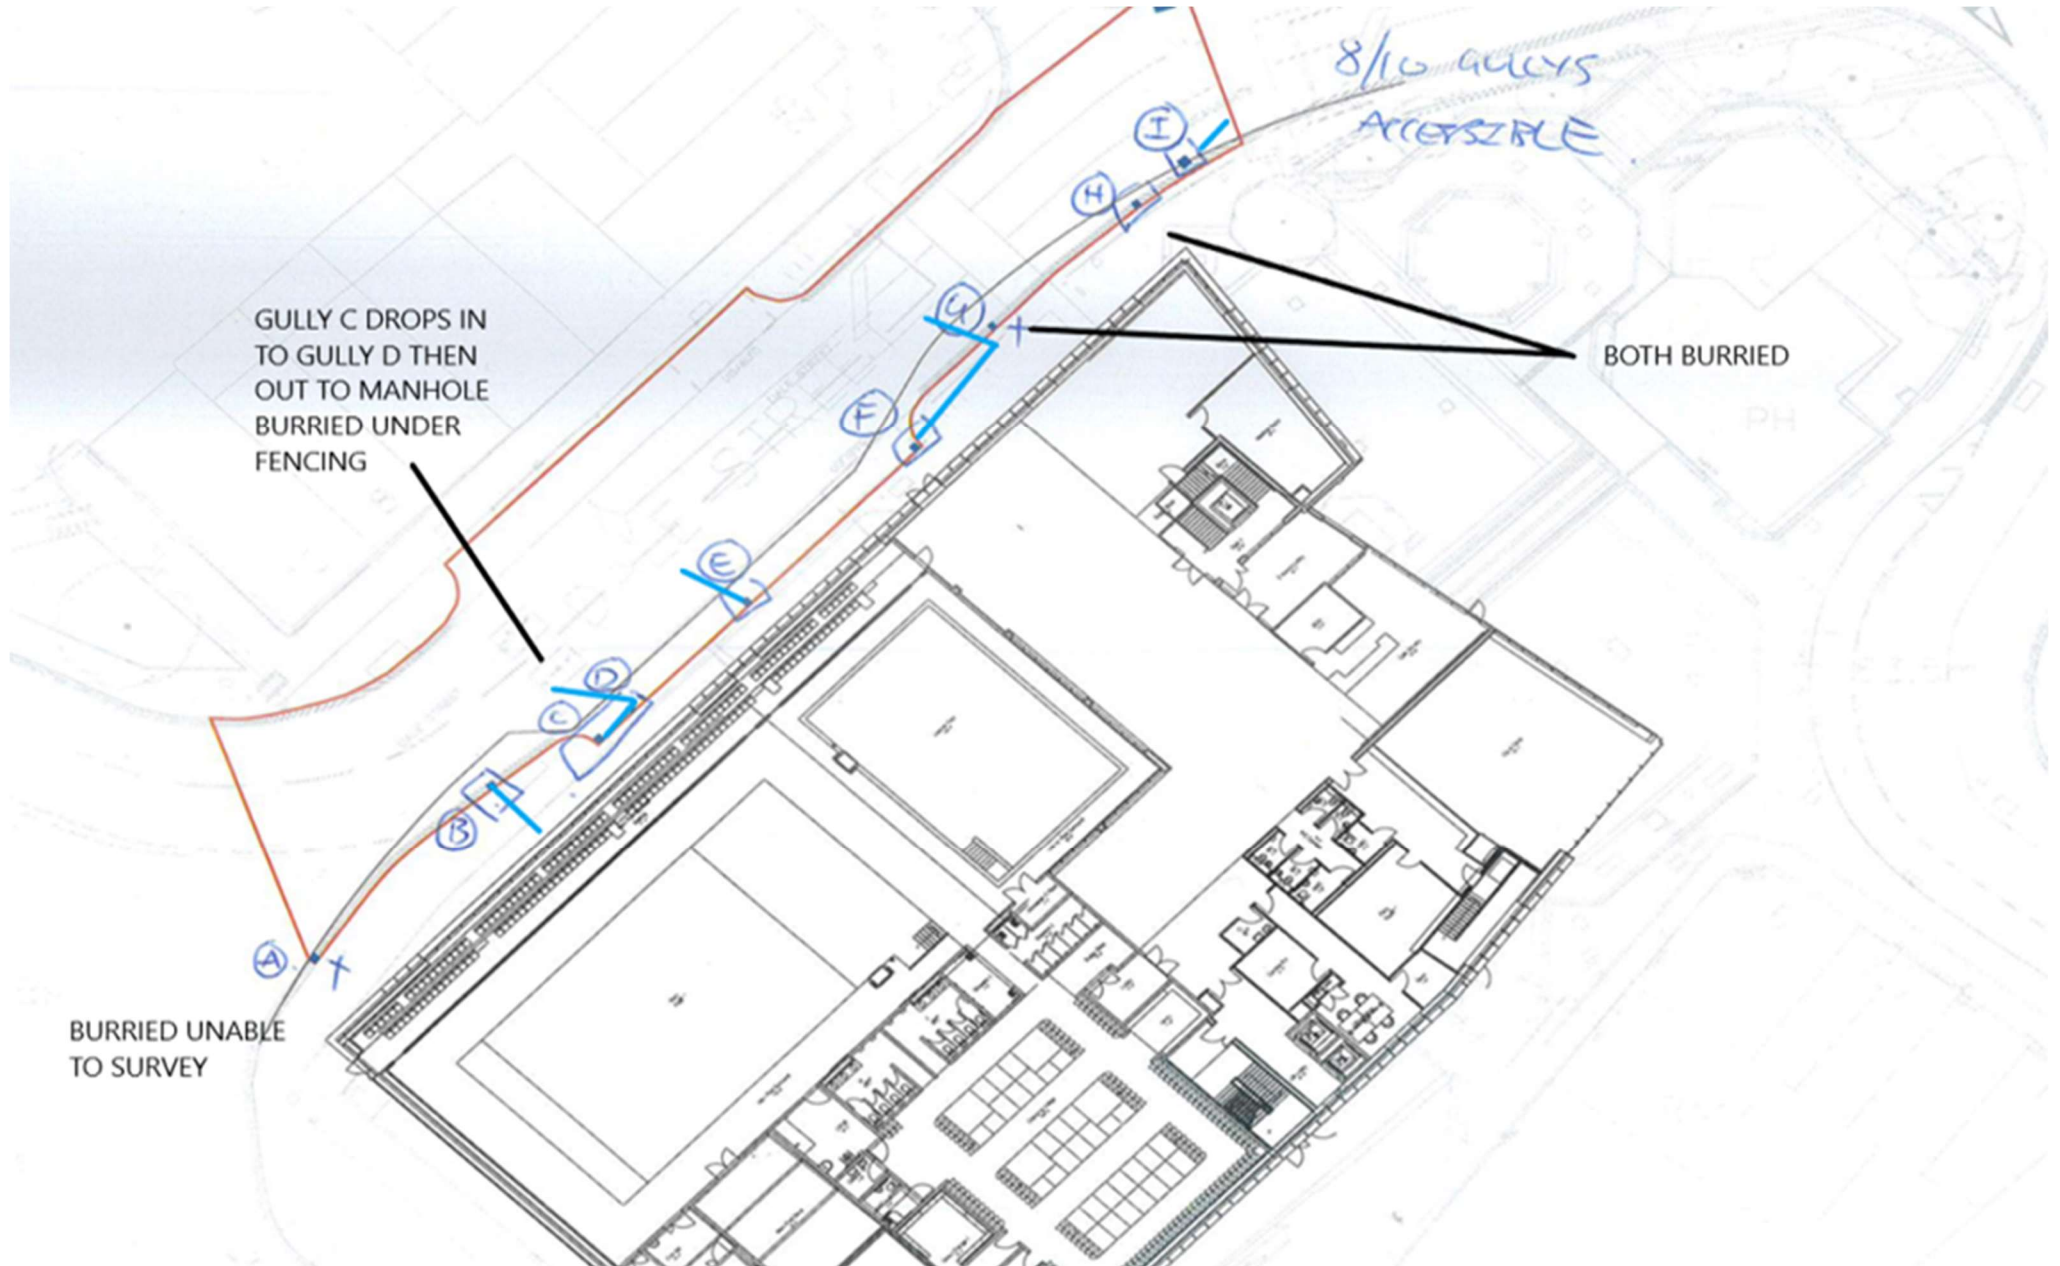
| IWJS | | <b>IWJS Work Record</b> | | | | Work Order | | | |
|---|---|---|---|---|---|---|---|---|---|
| 07:30 | 13:00 | <p>Arrived on to site and liased with Luke Murphy our site contact. Advised site induction wasn't untill 08:30. Sat induction and then carried out a site walk over. Works finally began on site @ 10:00. We are instructed to CCTV condition Survey off 09 in number road gullies as per site drawings. Gully A/G AND H are burried and unable to survey. Carried out cctv of the remaining gullies and mapped on to plans. Spoke with Luke with findings and walked over the site to explain, job complete and luke happy. Gully B drops straight out in to a carrier see plans. Gully C drops into Gully D. Gully D drops into manhole burried under site fencing. Gully E drops to main carrier. Gully F drops to main carrier via dog leg see plan. Gully i drops in to main.</p> | | | | | | 4 | 30 |
