## Appendix E - CCTV Survey

| Reference | Title |
|---|---|
| LITTLE LEVEL - RADCLIFFE 000518 | CCTV Survey Report |

Project name :  
**LITTLE LEVER - RADCLIFFE 00051**

Date :  
**08-Sep-20**

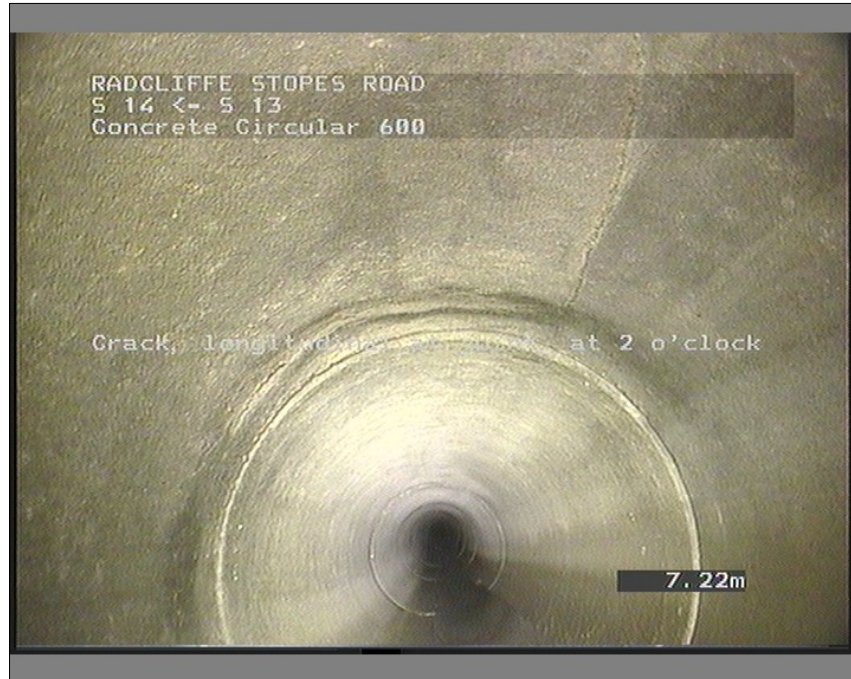
Crack, longitudinal at joint, at 2 o'clock

Photo: 1\_1\_3\_A.JPG  
7.22m, Crack, longitudinal at joint, at 2 o'clock

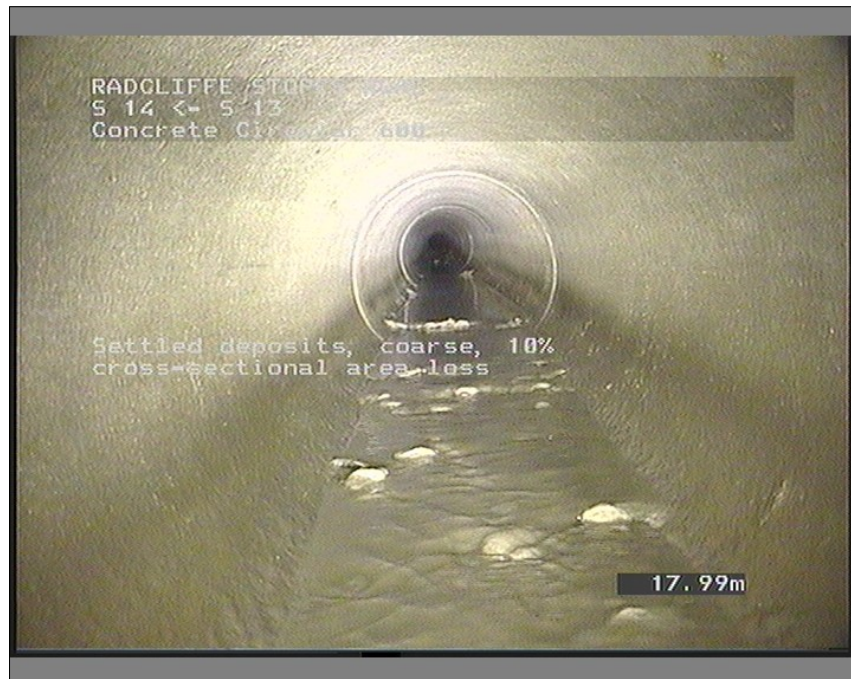
Settled deposits, coarse, 10% cross-sectional area loss

Photo: 1\_1\_4\_A.JPG  
17.99m, Settled deposits, coarse, 10% cross-sectional area loss

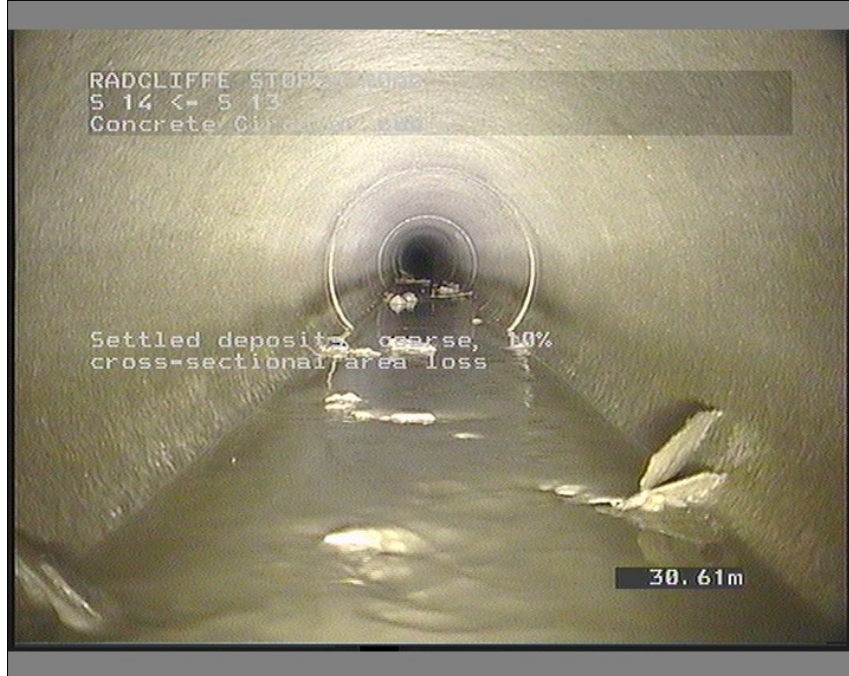
Photo: 1\_1\_5\_A.JPG

30.61m, Settled deposits, coarse, 10% cross-sectional area loss

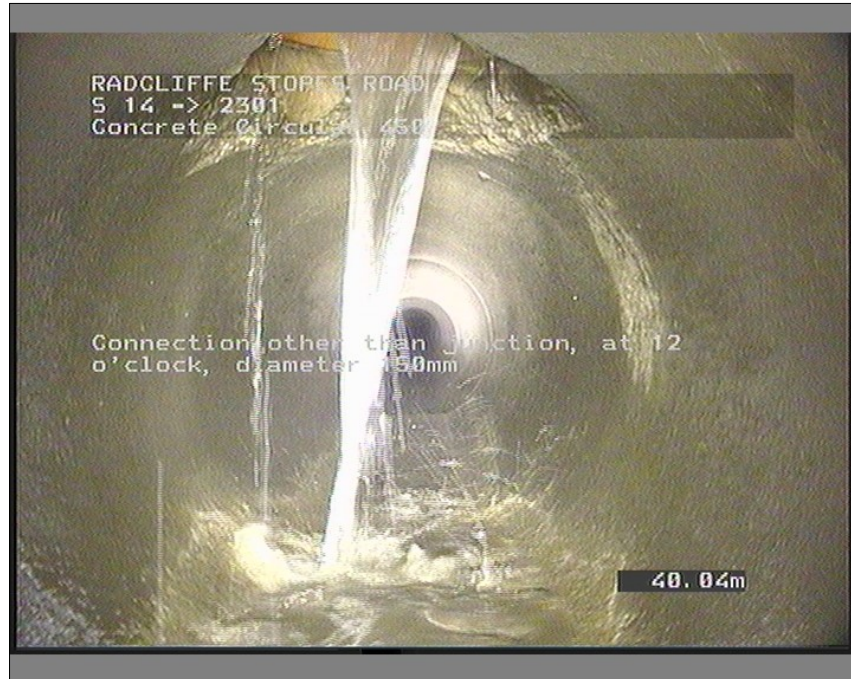
Photo: 3\_3\_8\_A.JPG

40.04m, Connection other than junction, at 12 o'clock, diameter 150mm

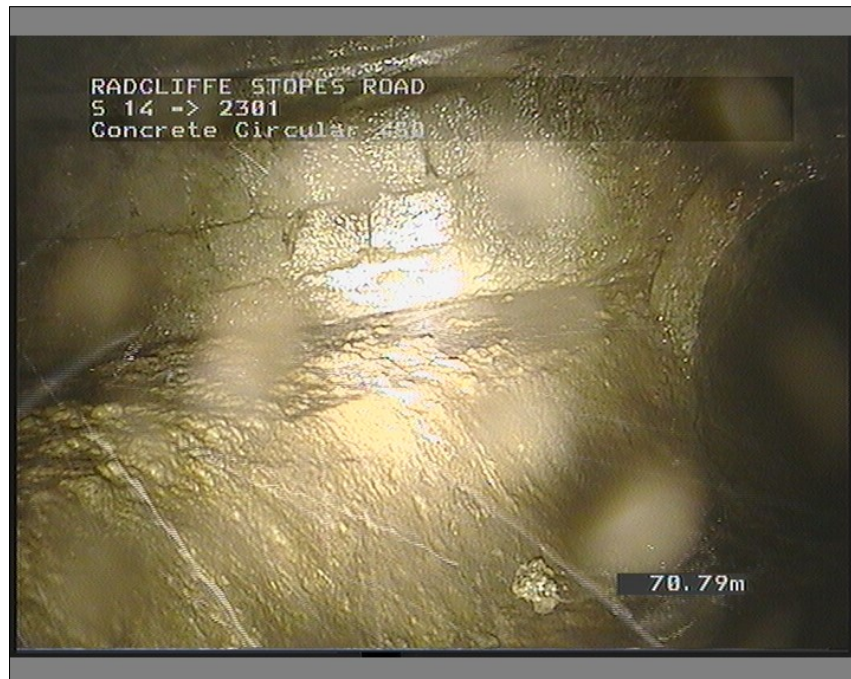
Photo: 3\_3\_9\_A.JPG

70.79m, Finish node type, manhole reference number: S 15

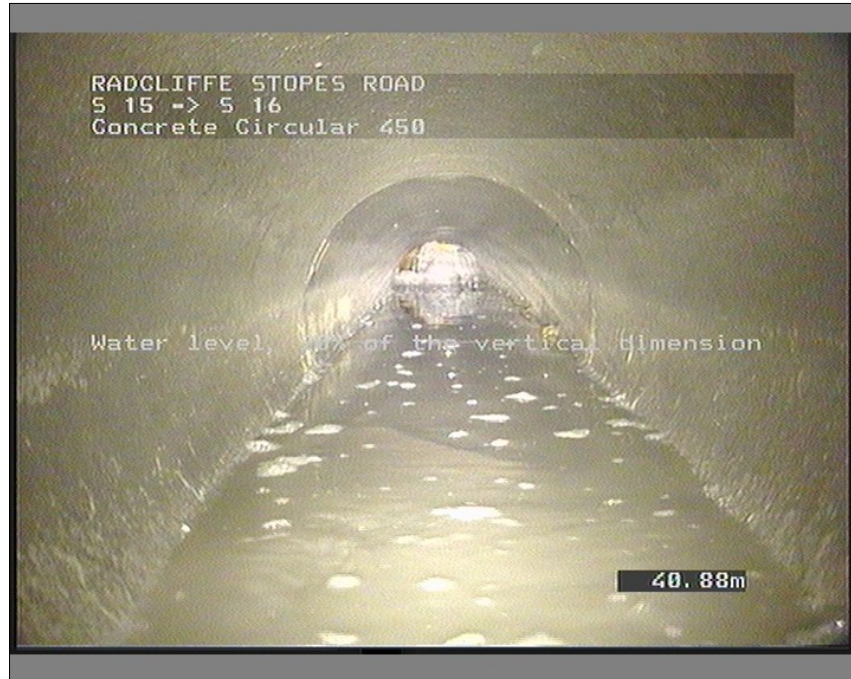
Photo: 4\_4\_11\_A.JPG  
40.88m, Water level, 20% of the vertical dimension

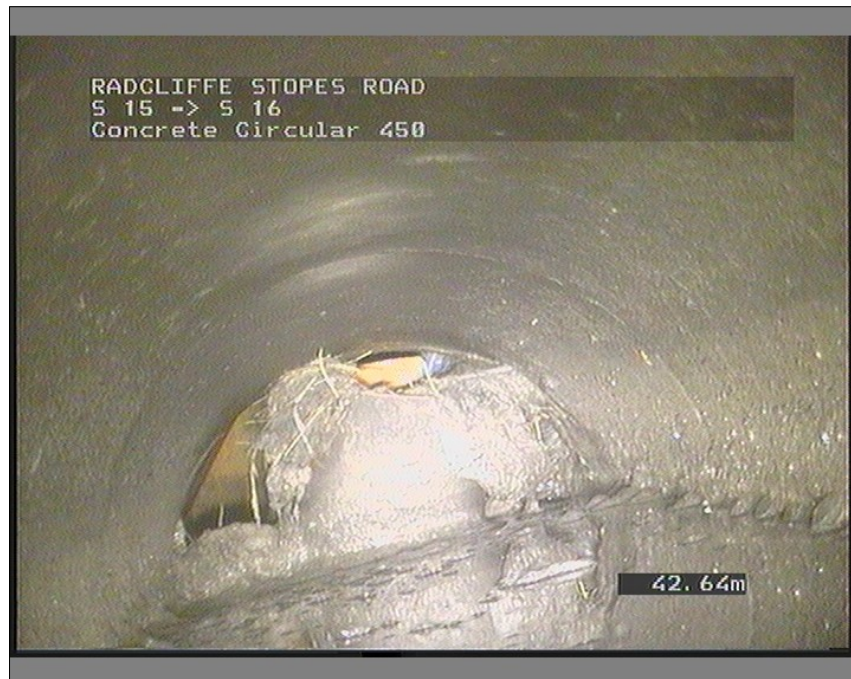
Other obstacles, brick or masonry in invert, from 12 to 12 o'clock, 80% cross-sectional area loss

Photo: 4\_4\_13\_A.JPG  
42.64m, Other obstacles, brick or masonry in invert, from 12 to 12 o'clock, 80% cross-sectional area loss

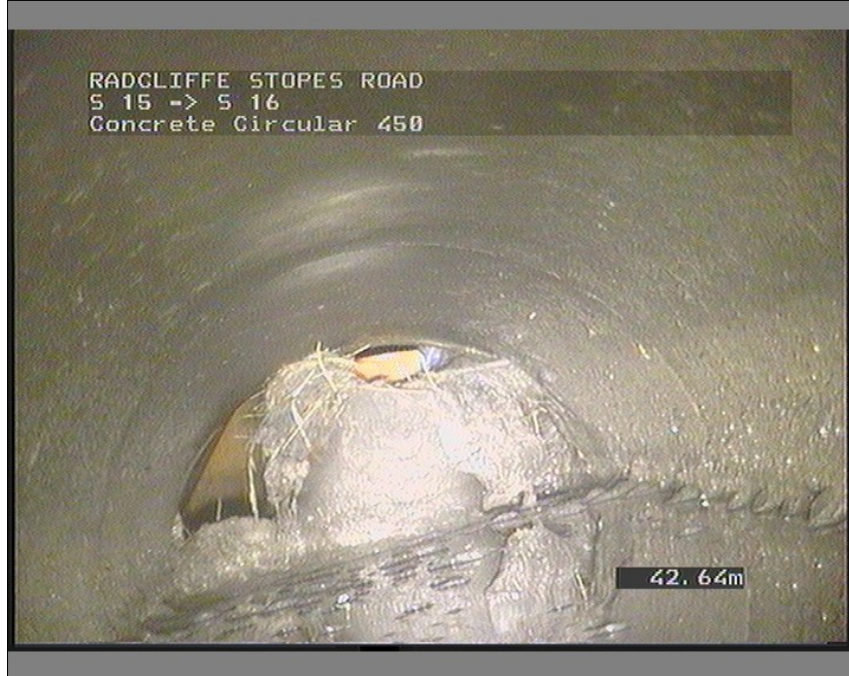
Photo: 4\_4\_14\_A.JPG  
42.64m, Survey abandoned

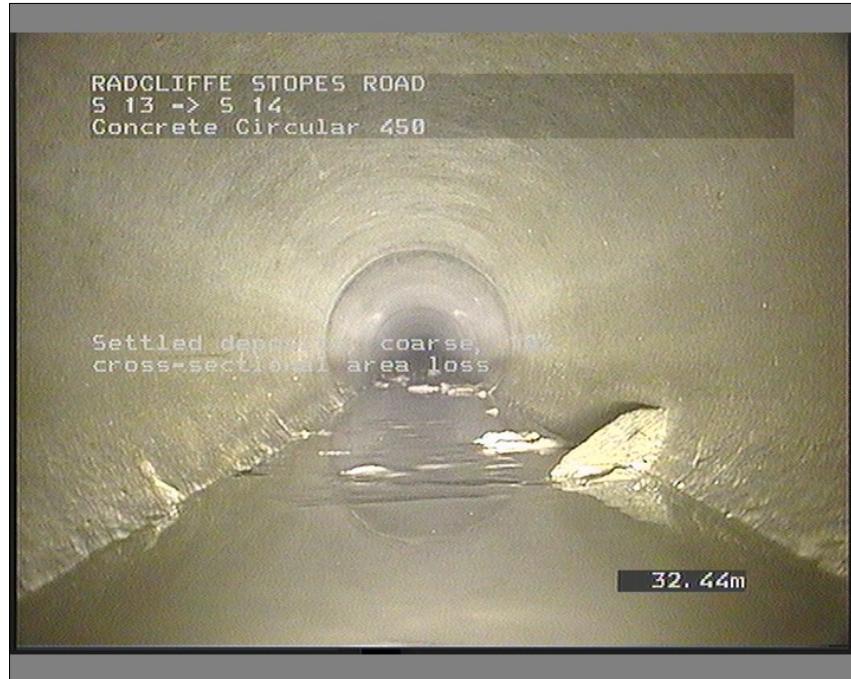
Photo: 5\_5\_16\_A.JPG

32.44m, Settled deposits, coarse, 10% cross-sectional area loss

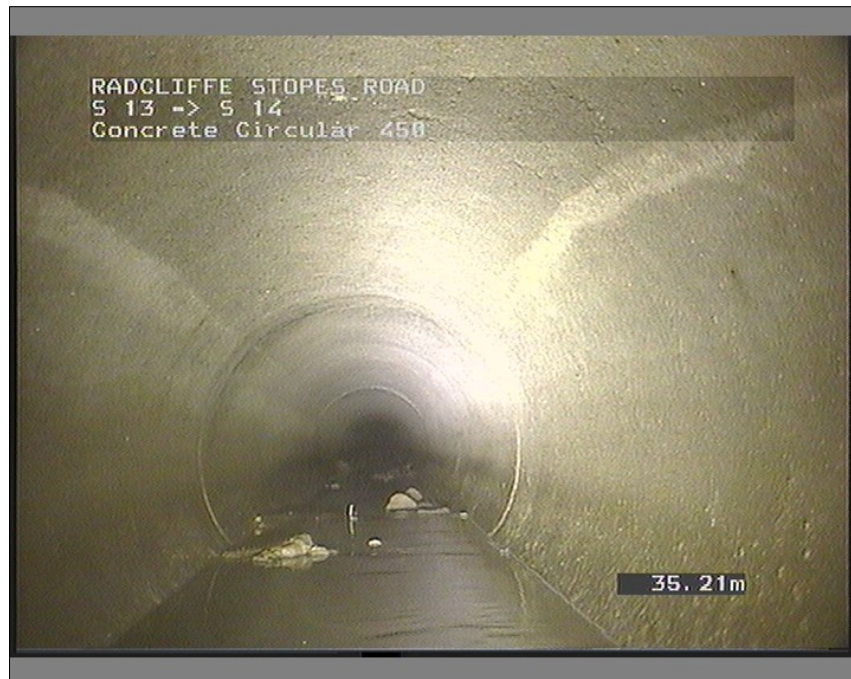
Photo: 5\_5\_17\_A.JPG

35.21m, Finish node type, other special chamber reference number: S 14

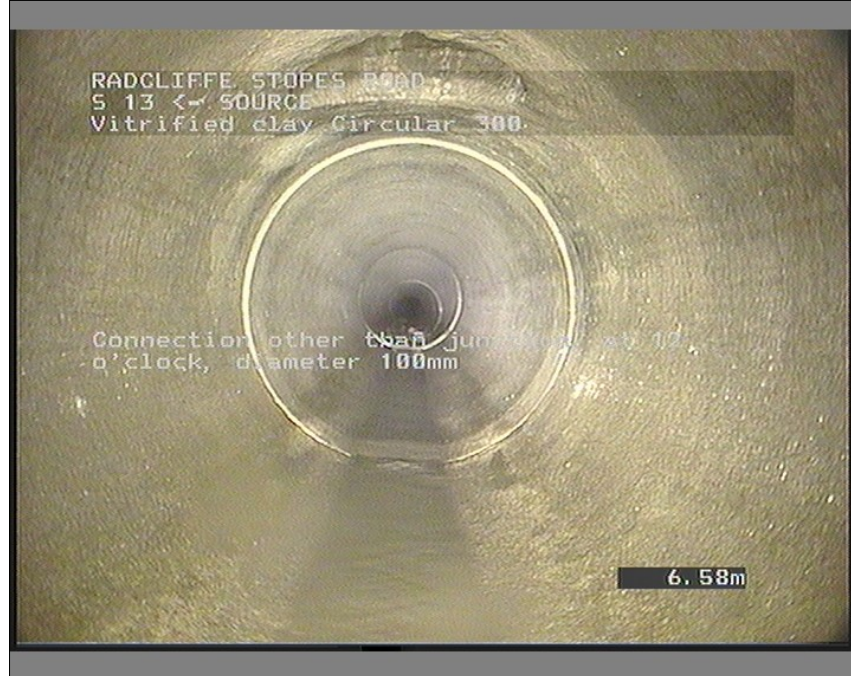
Photo: 6\_6\_19\_A.JPG

6.58m, Connection other than junction, at 12 o'clock, diameter 100mm

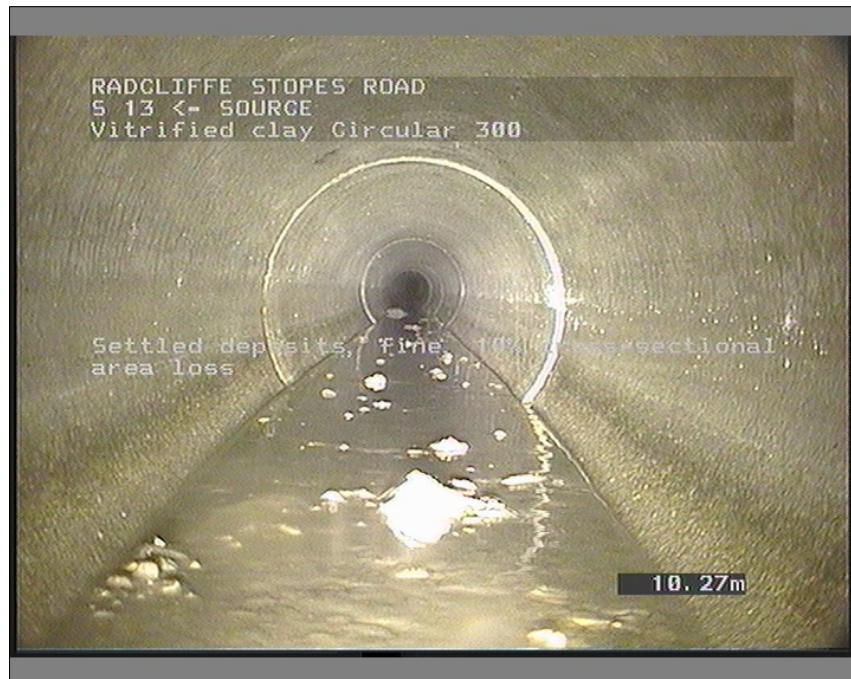
Photo: 6\_6\_20\_A.JPG

10.27m, Settled deposits, fine, 10% cross-sectional area loss

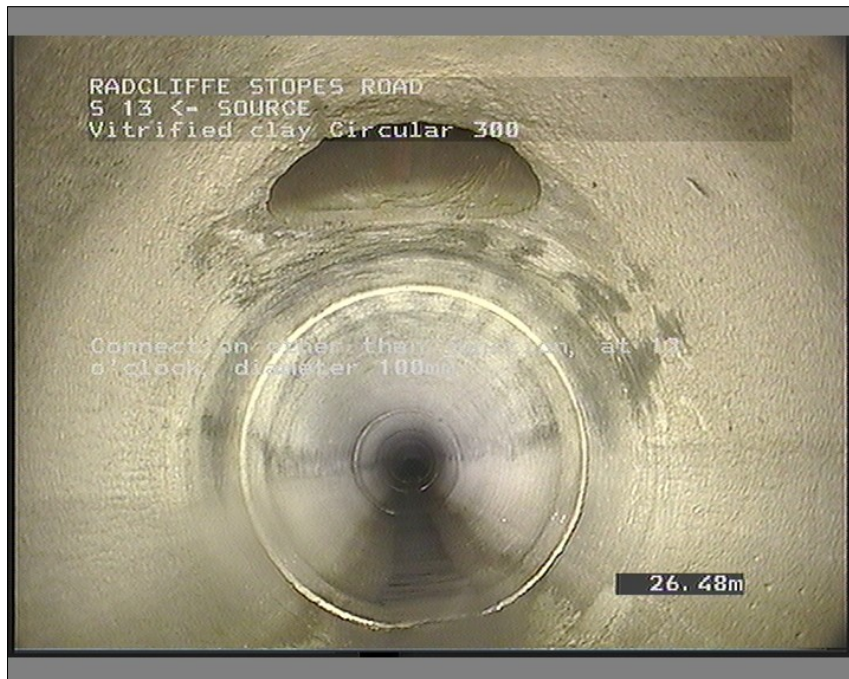
Photo: 6\_6\_22\_A.JPG

26.48m, Connection other than junction, at 12 o'clock, diameter 100mm

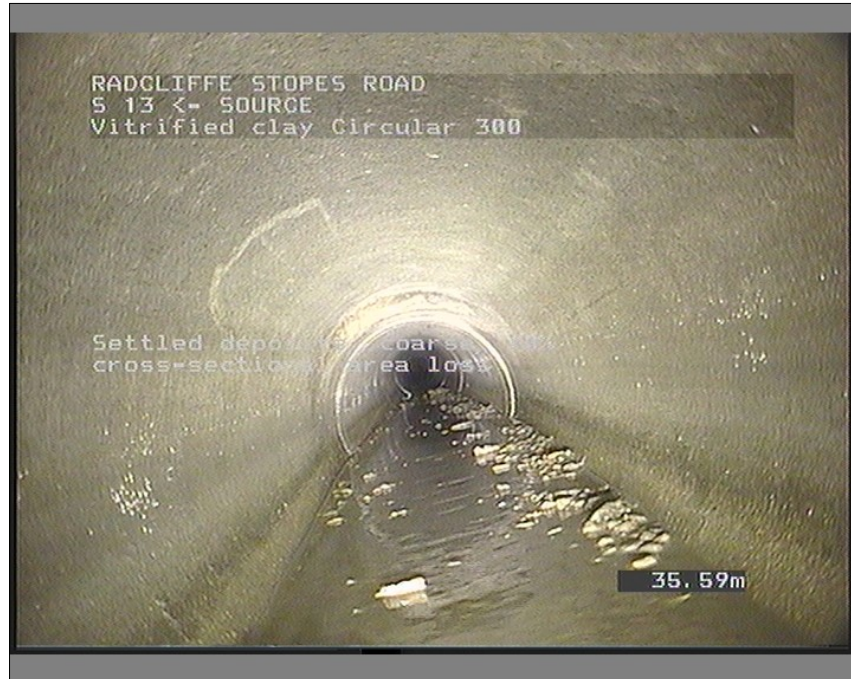
Photo: 6\_6\_23\_A.JPG

35.59m, Settled deposits, coarse, 10% cross-sectional area loss

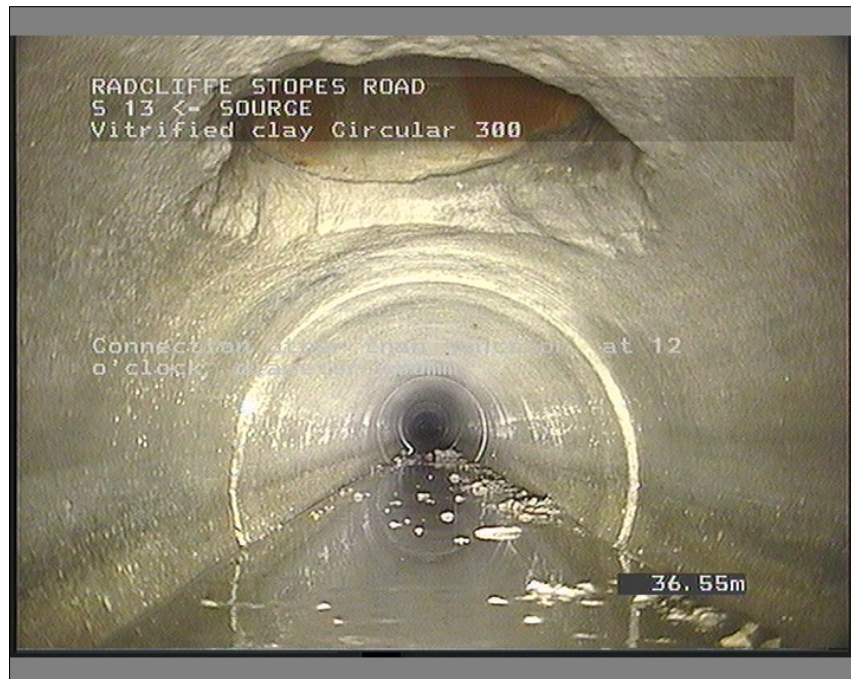
Photo: 6\_6\_24\_A.JPG

36.55m, Connection other than junction, at 12 o'clock, diameter 100mm

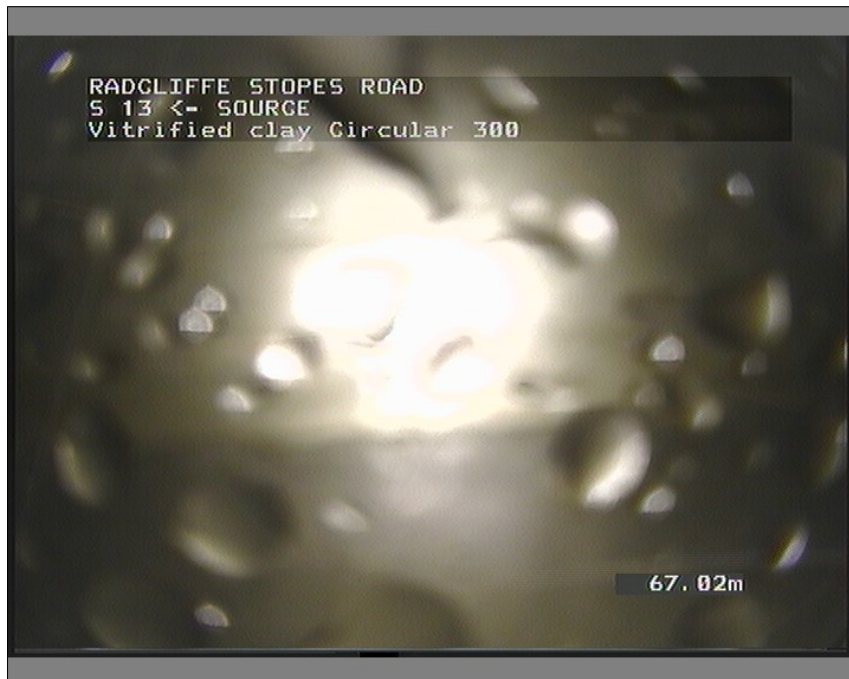
Photo: 6\_6\_26\_A.JPG

67.02m, Finish node type, manhole reference number: SOURCE

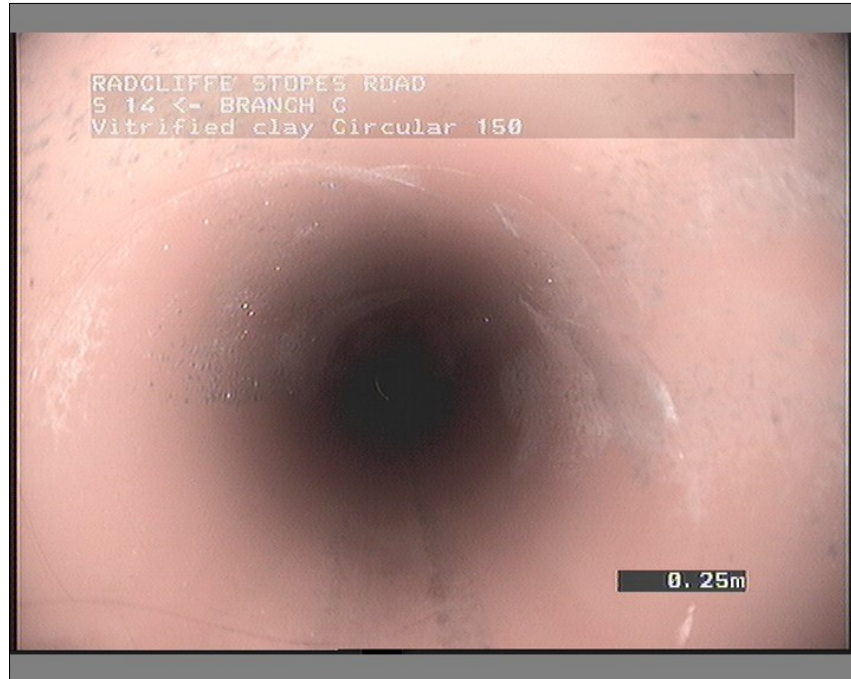
Crack, circumferential, from 12 to 12 o'clock

Photo: 7\_7\_28\_A.JPG  
0.25m, Crack, circumferential, from 12 to 12 o'clock

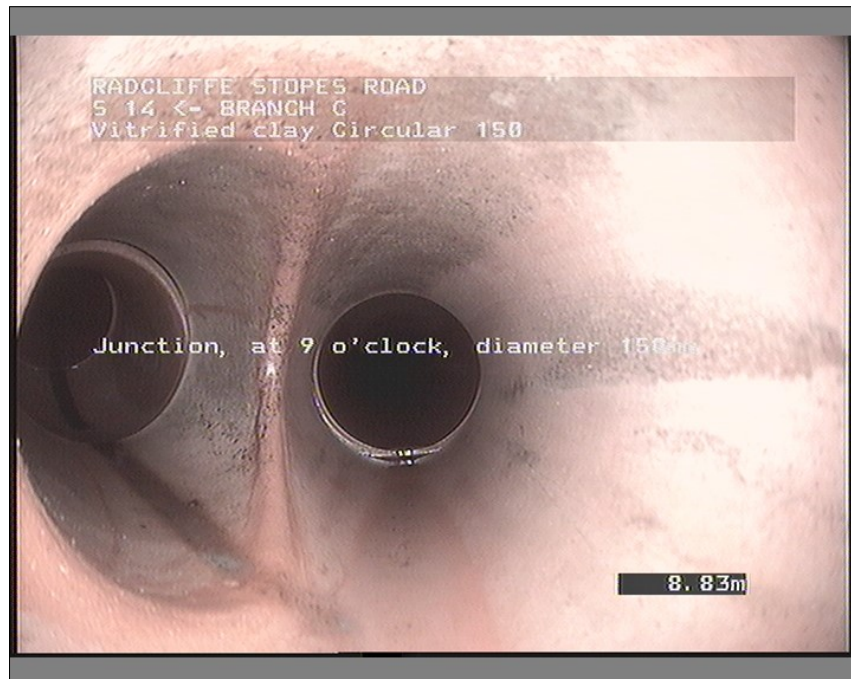
Photo: 7\_7\_29\_A.JPG  
8.83m, Junction, at 9 o'clock, diameter 150mm

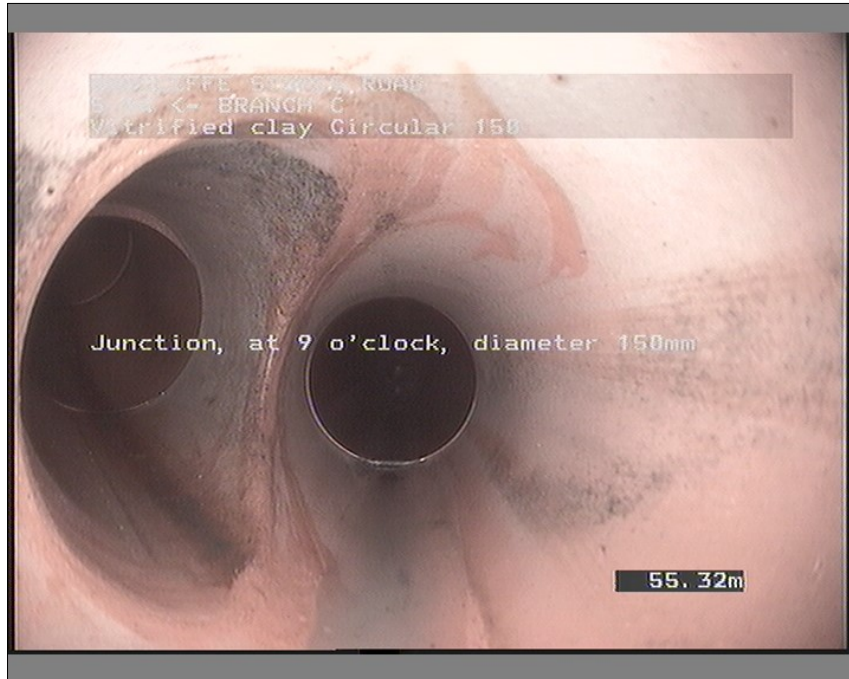
Photo: 7\_7\_30\_A.JPG  
55.32m, Junction, at 9 o'clock, diameter 150mm

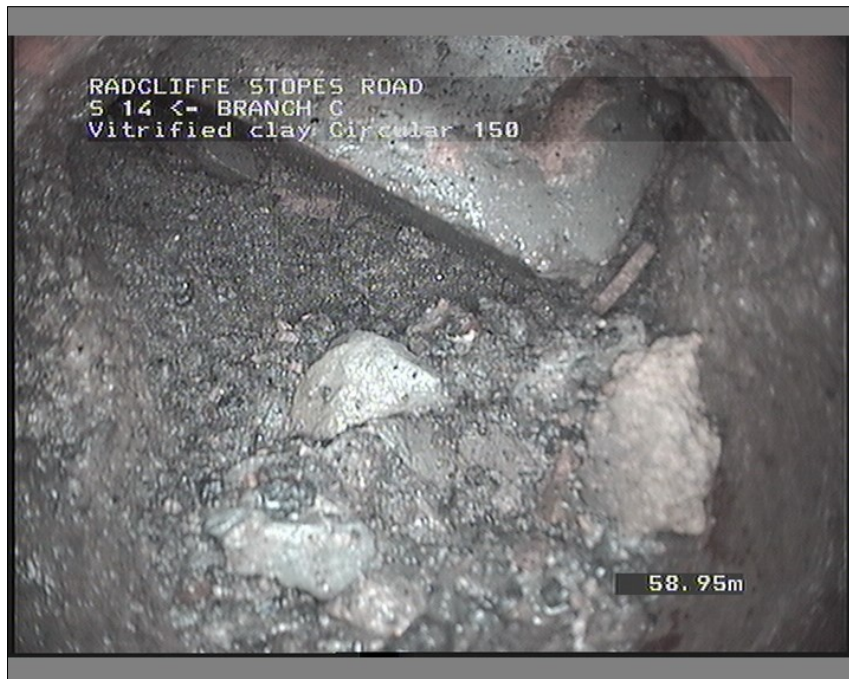
Photo: 7\_7\_31\_A.JPG  
58.95m, Finish node type, other special chamber reference number: BRANCH C

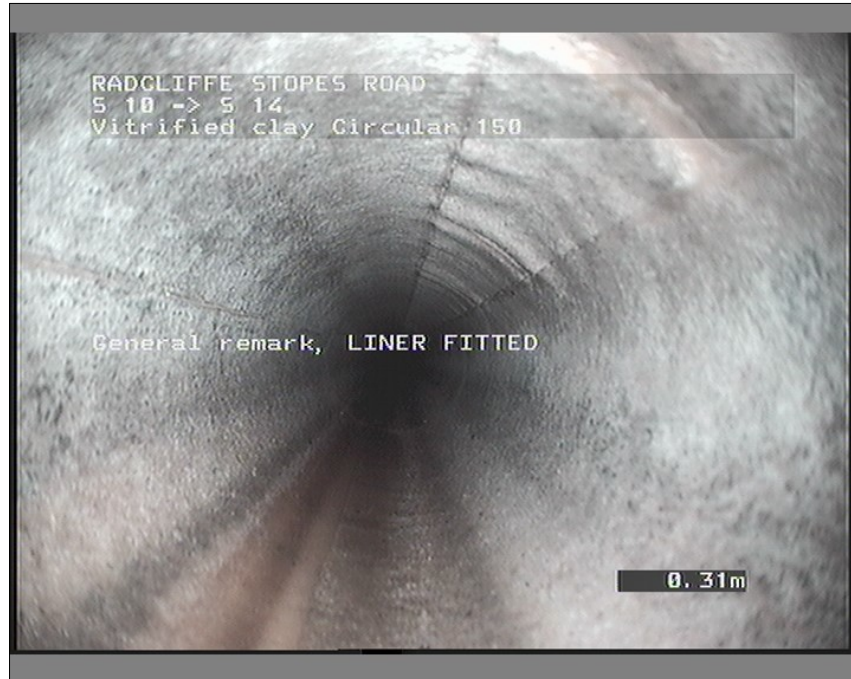
Photo: 8\_8\_33\_A.JPG  
0.31m, General remark

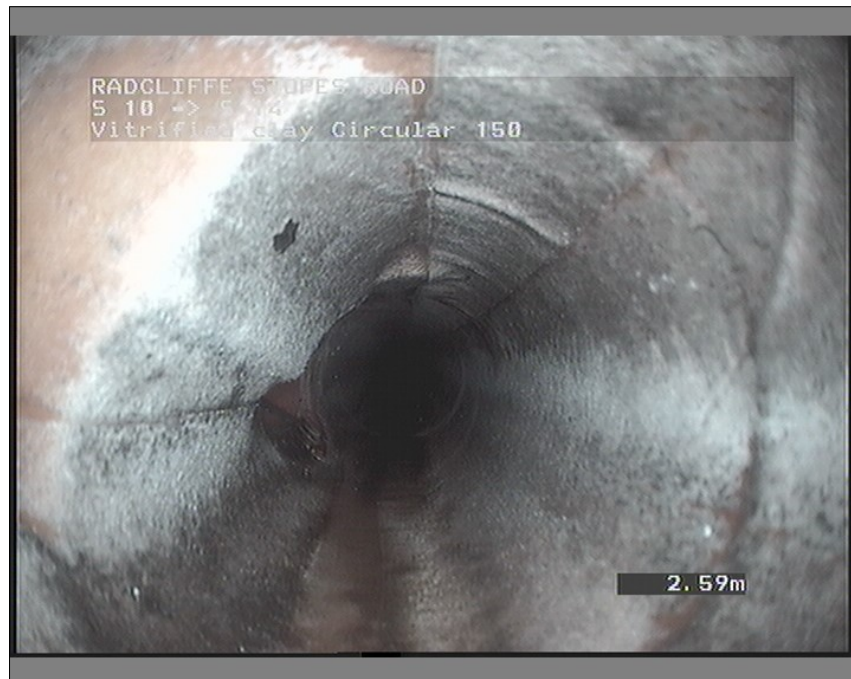
Photo: 8\_8\_34\_A.JPG  
2.59m, Deformed sewer/drain, 10%

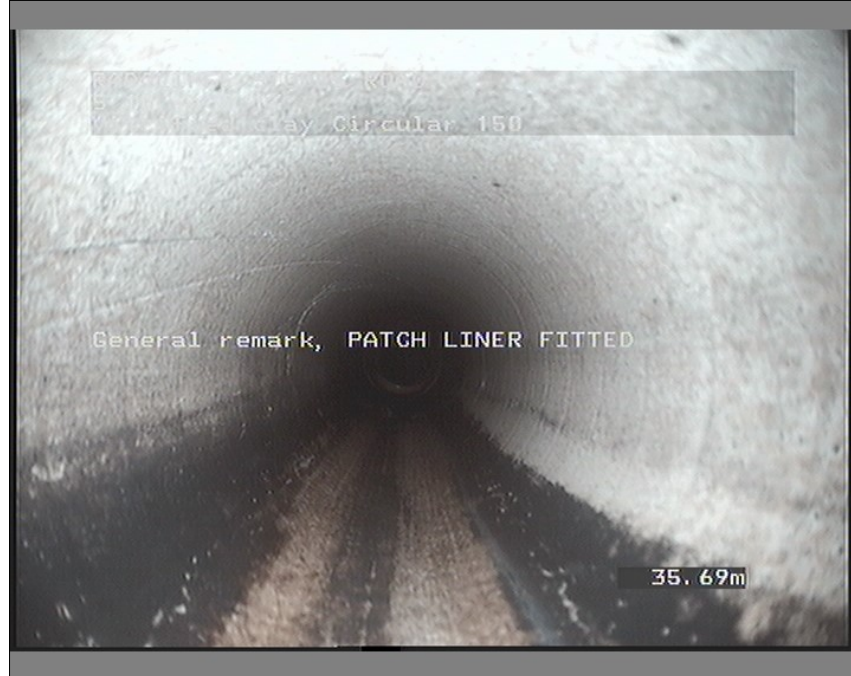
Photo: 8\_8\_37\_A.JPG  
35.69m, General remark

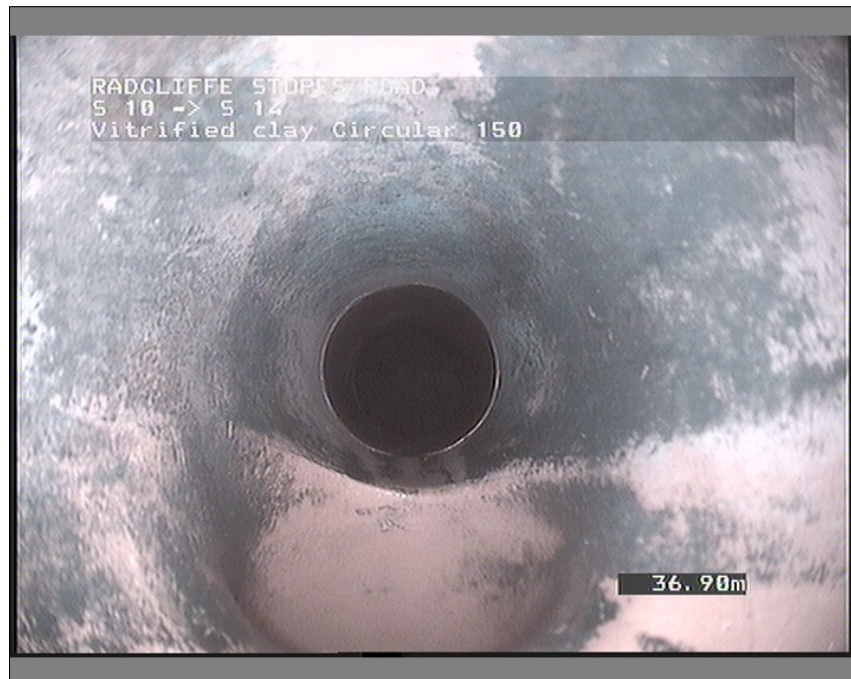
Photo: 8\_8\_39\_A.JPG  
36.9m, Finish node type, manhole reference number: S 14

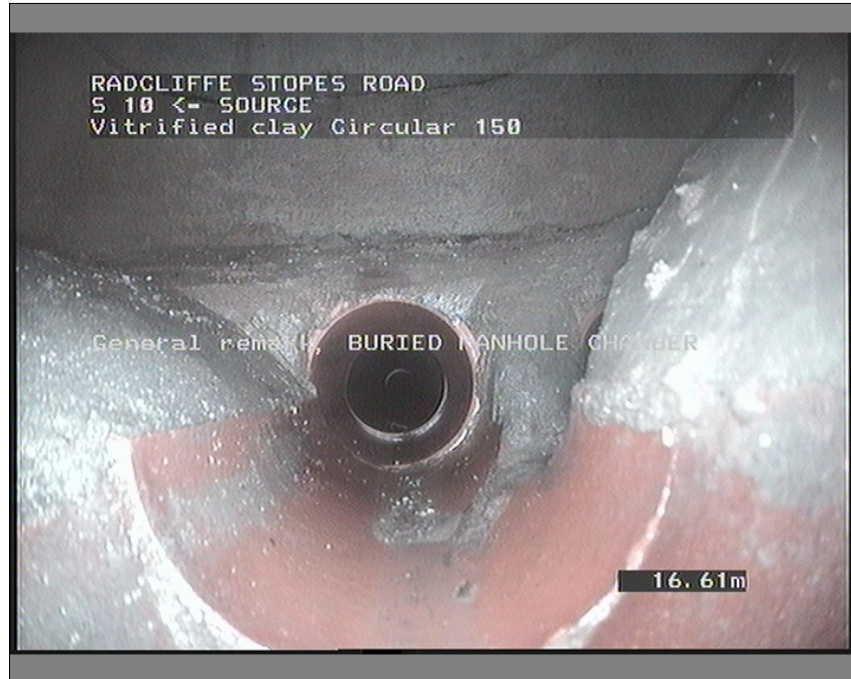
Photo: 9\_9\_41\_A.JPG  
16.61m, General remark

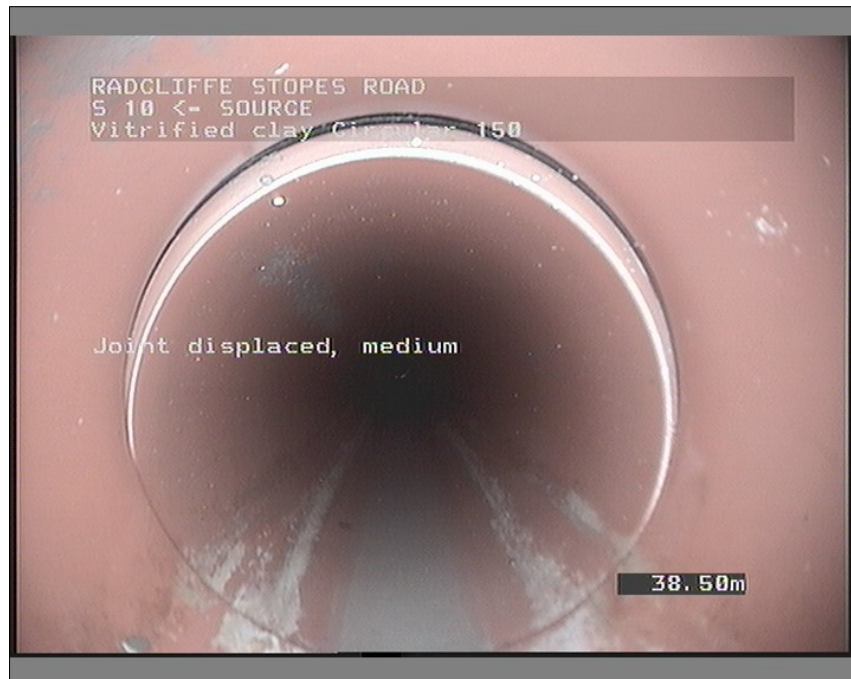
Photo: 9\_9\_42\_A.JPG  
38.5m, Joint displaced, medium

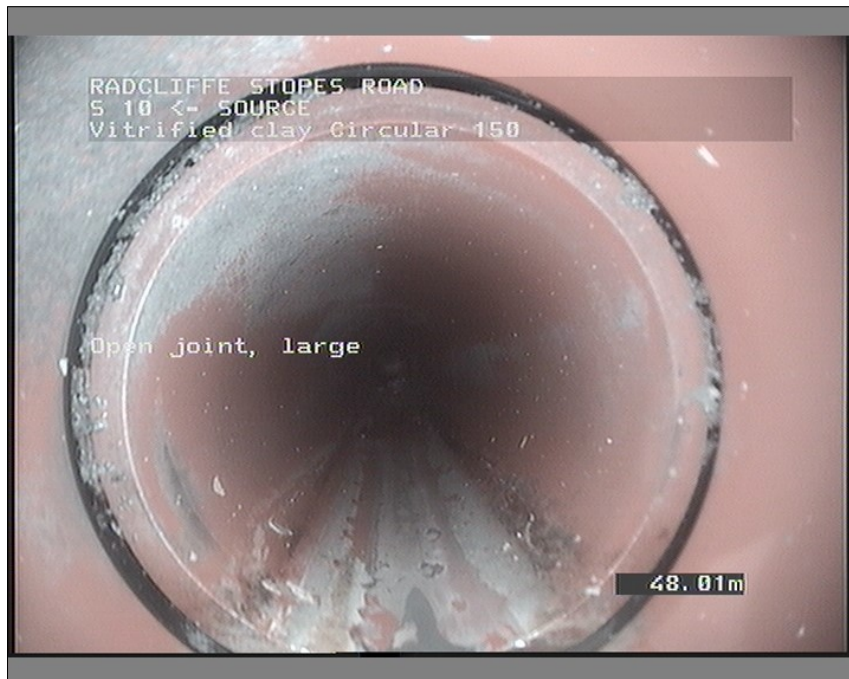
Photo: 9\_9\_45\_A.JPG  
48.01m, Open joint, large

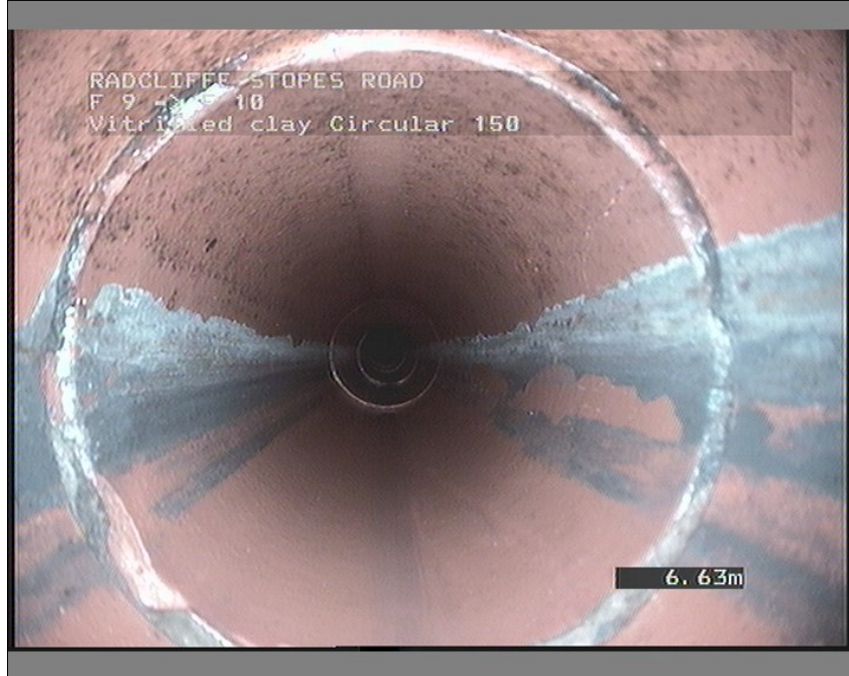
Photo: 11\_11\_53\_A.JPG  
6.63m, Crack, longitudinal at joint, at 2 o'clock

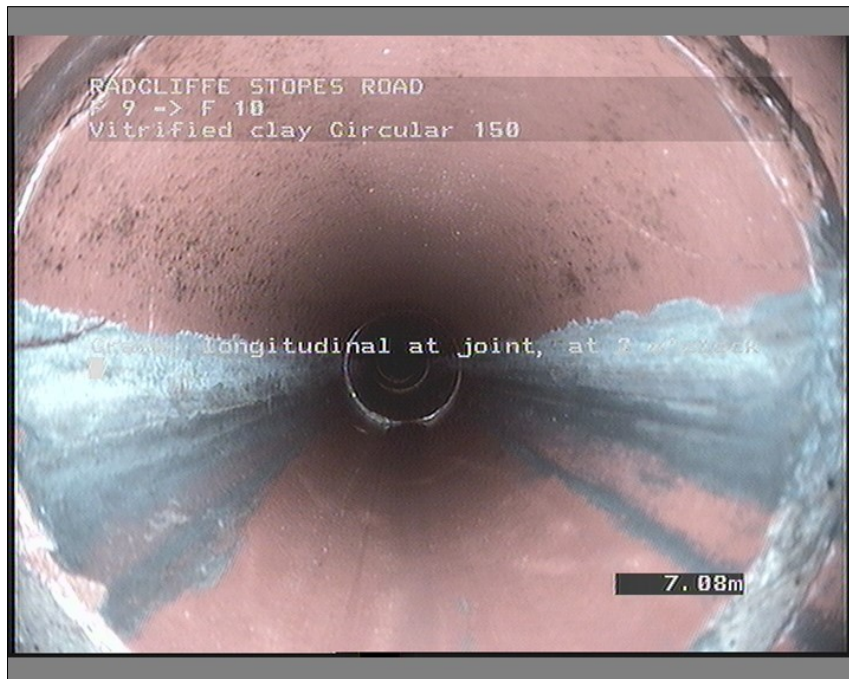
Photo: 11\_11\_54\_A.JPG  
7.08m, Crack, longitudinal at joint, at 2 o'clock

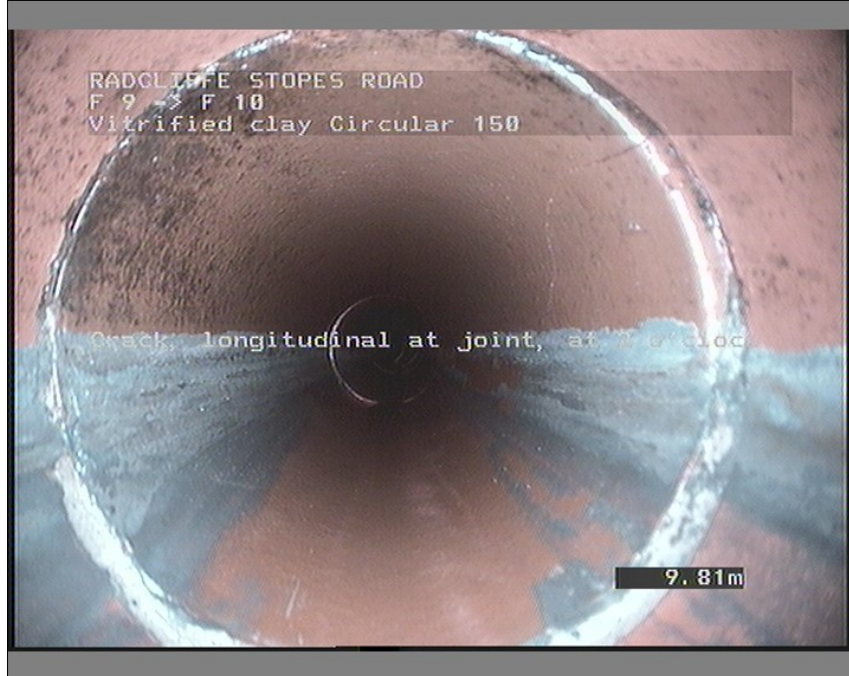
Photo: 11\_11\_55\_A.JPG  
9.81m, Crack, longitudinal at joint, at 2 o'clock

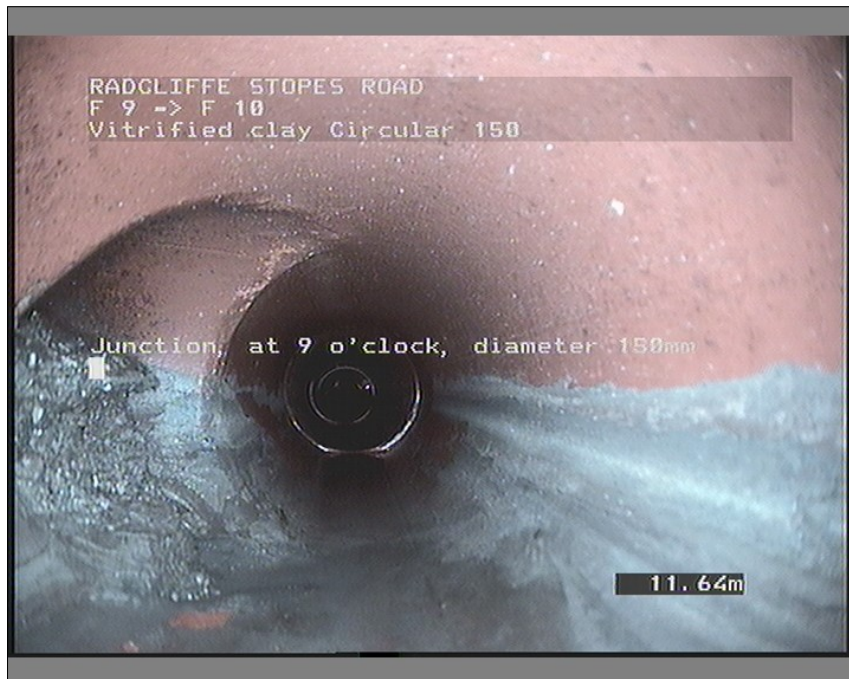
Photo: 11\_11\_56\_A.JPG  
11.64m, Junction, at 9 o'clock, diameter 150mm

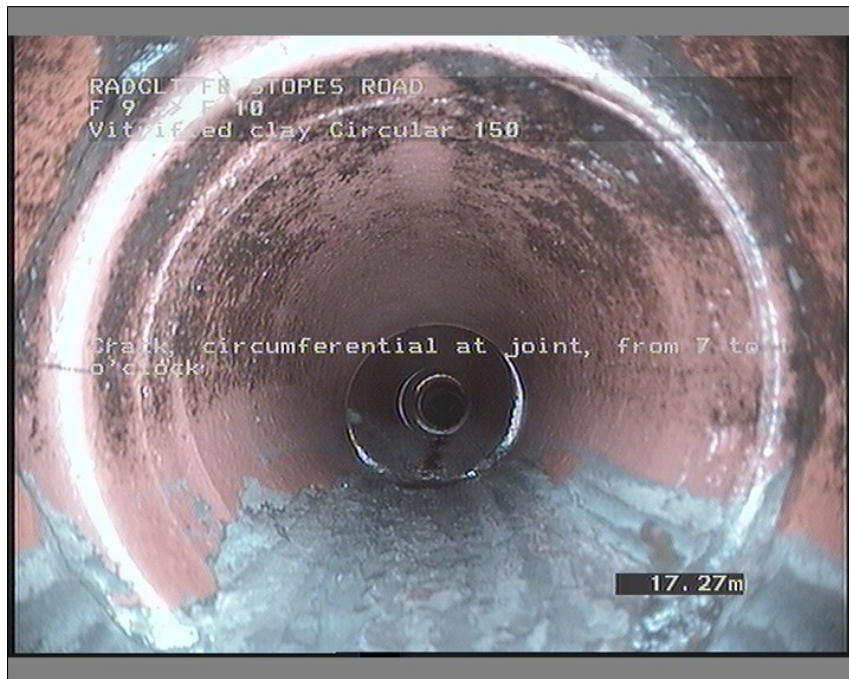
Photo: 11\_11\_59\_A.JPG  
17.27m, Crack, circumferential at joint, from 7 to 1 o'clock

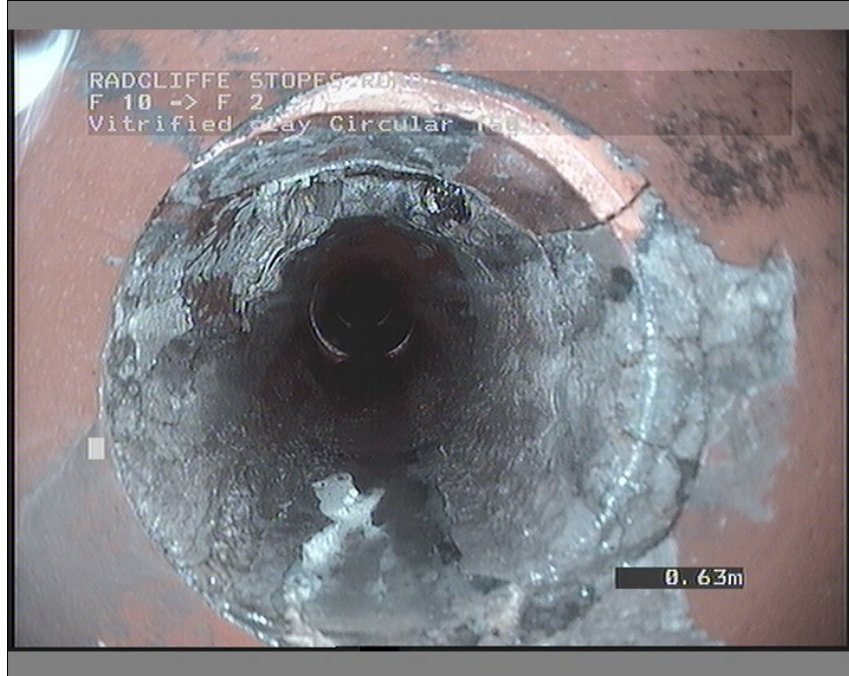
Fracture, circumferential at joint, from 10 to 4 o'clock

Photo: 12\_12\_62\_A.JPG  
0.63m, Fracture, circumferential at joint, from 10 to 4 o'clock

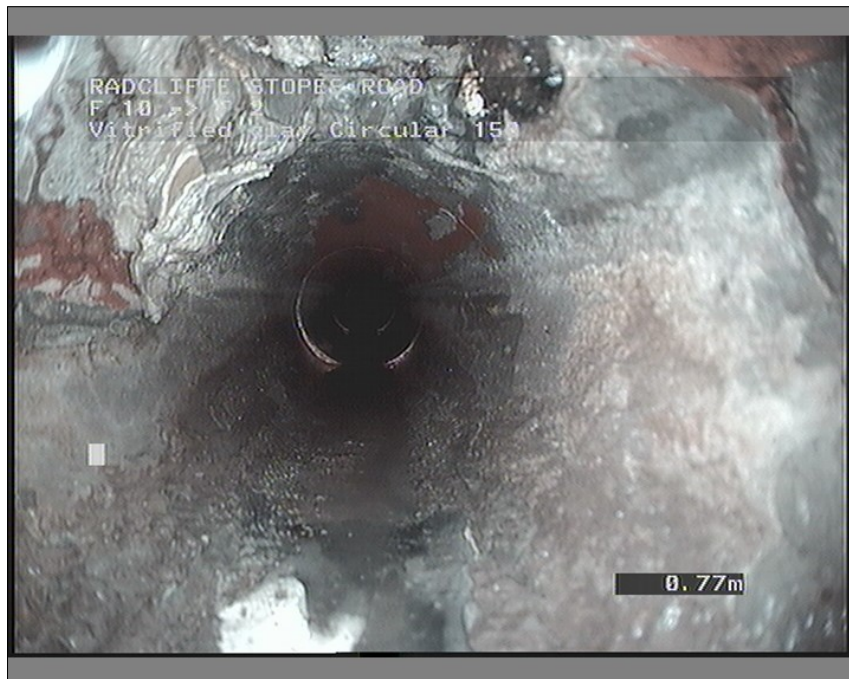
Photo: 12\_12\_63\_A.JPG  
0.77m, Connection other than junction, at 12 o'clock, diameter 100mm

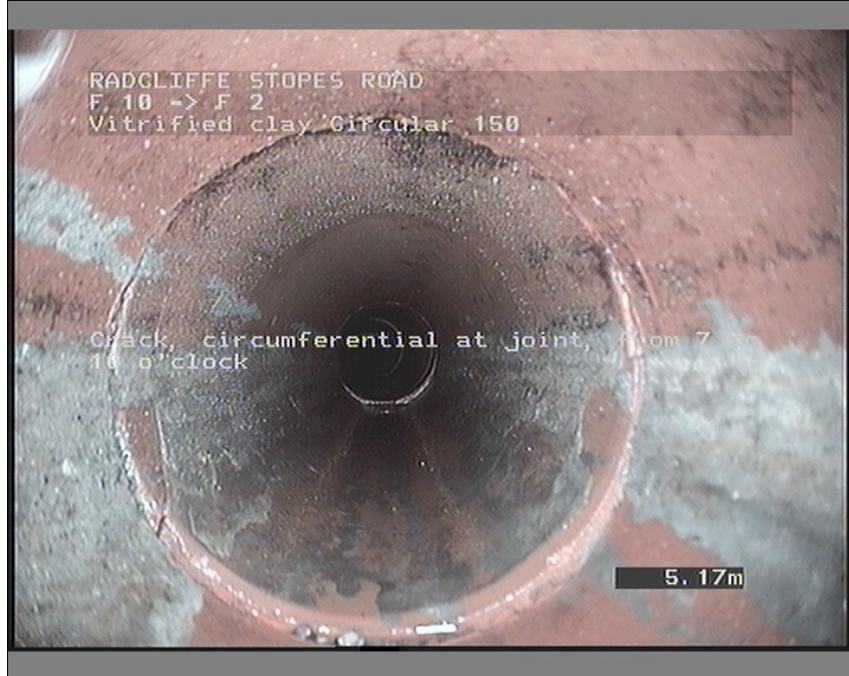
Photo: 12\_12\_64\_A.JPG

Crack, circumferential at joint, from 7 to 10 o'clock

5.17m, Crack, circumferential at joint, from 7 to 10 o'clock

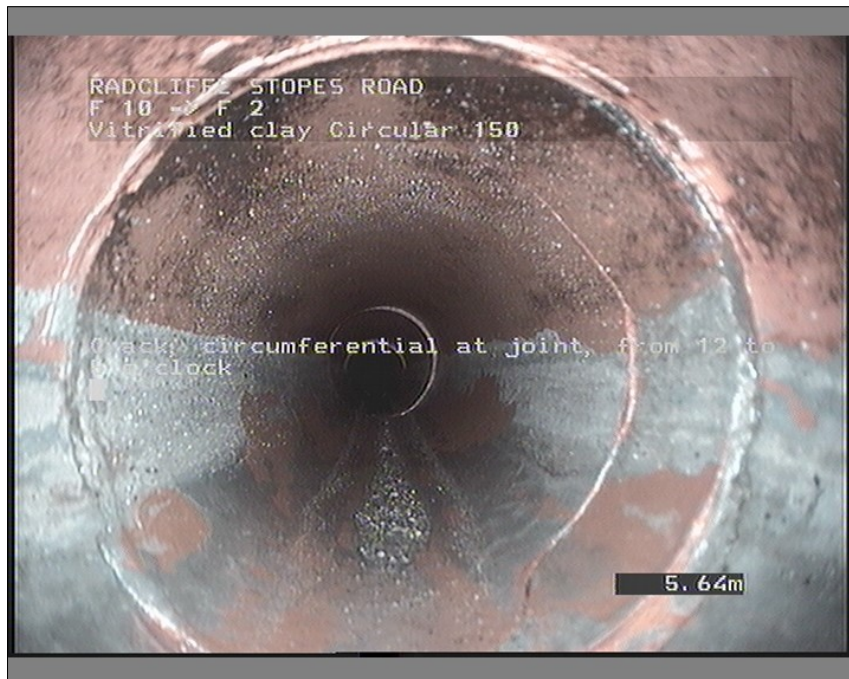
Photo: 12\_12\_65\_A.JPG

Crack, circumferential at joint, from 12 to 5 o'clock

5.64m, Crack, circumferential at joint, from 12 to 5 o'clock

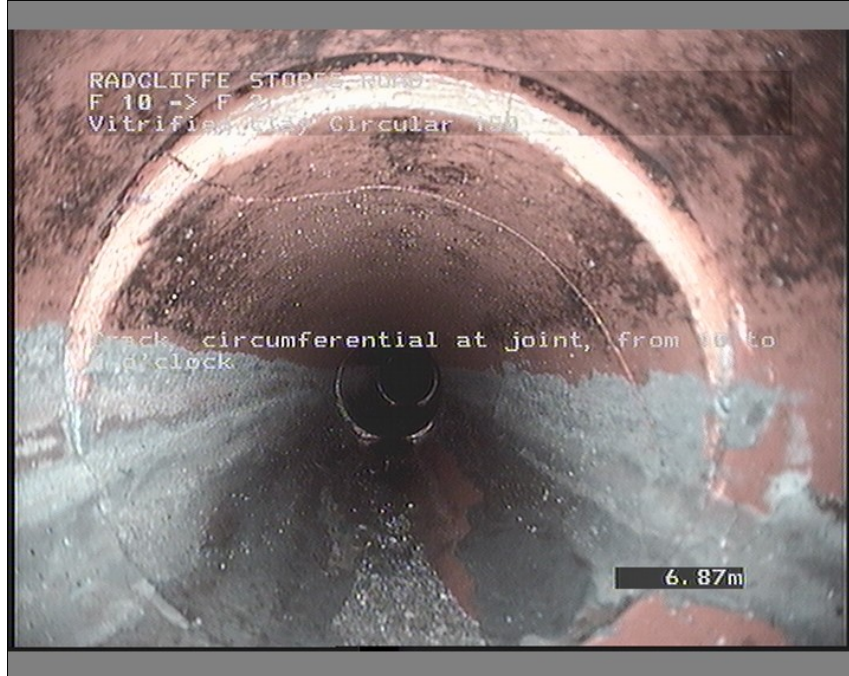
Photo: 12\_12\_66\_A.JPG

Crack, circumferential at joint, from 10 to 4 o'clock

6.87m, Crack, circumferential at joint, from 10 to 4 o'clock

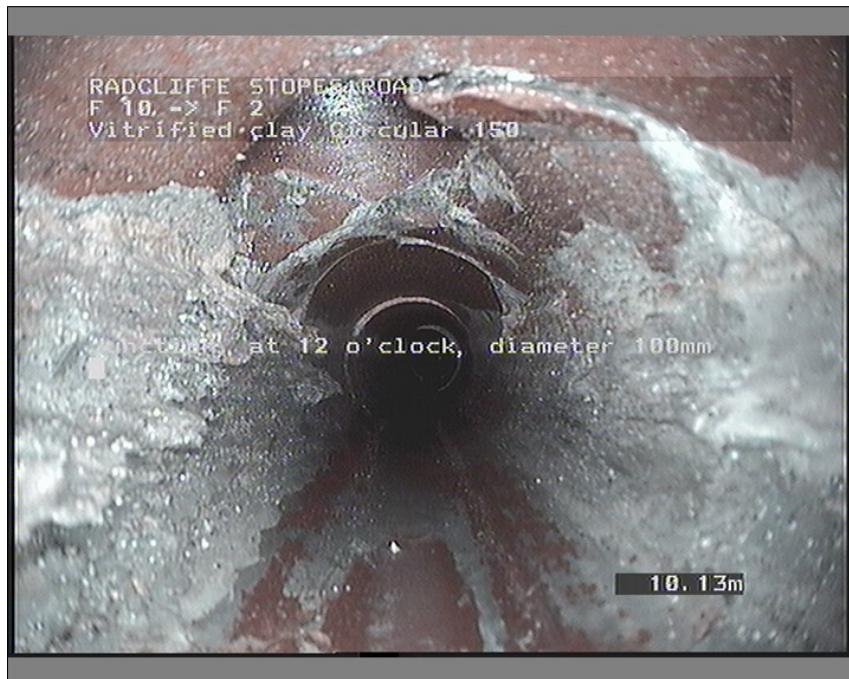
Photo: 12\_12\_67\_A.JPG

10.13m, Junction, at 12 o'clock, diameter 100mm
