## Appendix E - CCTV Survey

| Reference | Title |
|---|---|
| LITTLE LEVEL - RADCLIFFE 000518 | CCTV Survey Report |

Project name :  
**LITTLE LEVER - RADCLIFFE 00051**

Date :  
**08-Sep-20**

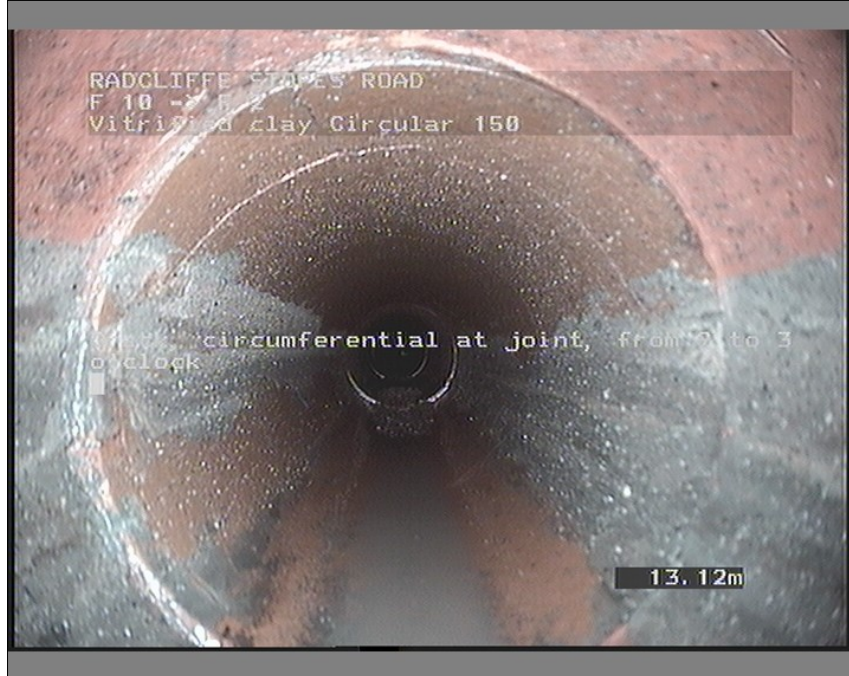
Crack, circumferential at joint, from 9 to 3 o'clock

Photo: 12\_12\_68\_A.JPG  
13.12m, Crack, circumferential at joint, from 9 to 3 o'clock

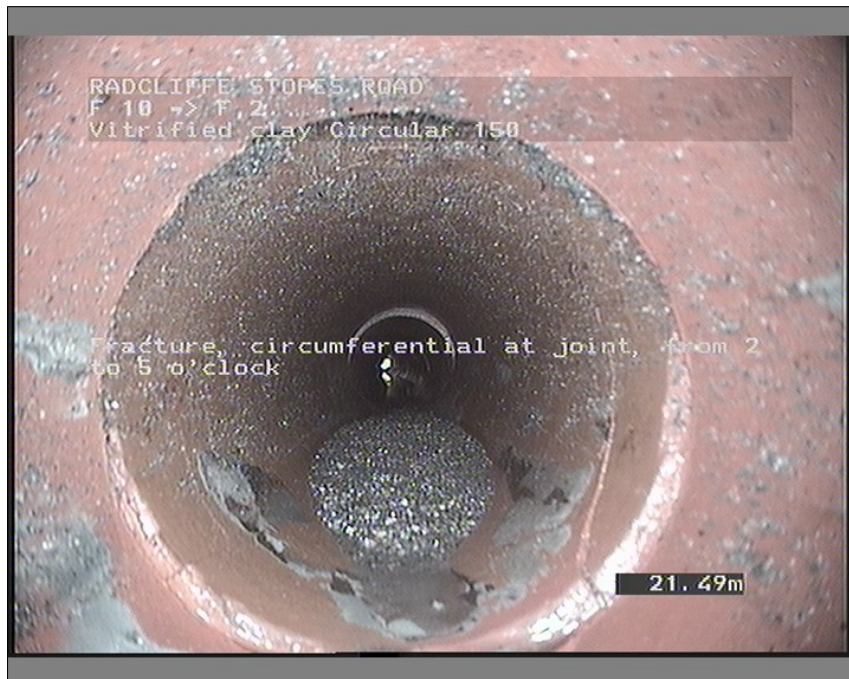
Fracture, circumferential at joint, from 2 to 5 o'clock

Photo: 12\_12\_69\_A.JPG  
21.49m, Fracture, circumferential at joint, from 2 to 5 o'clock

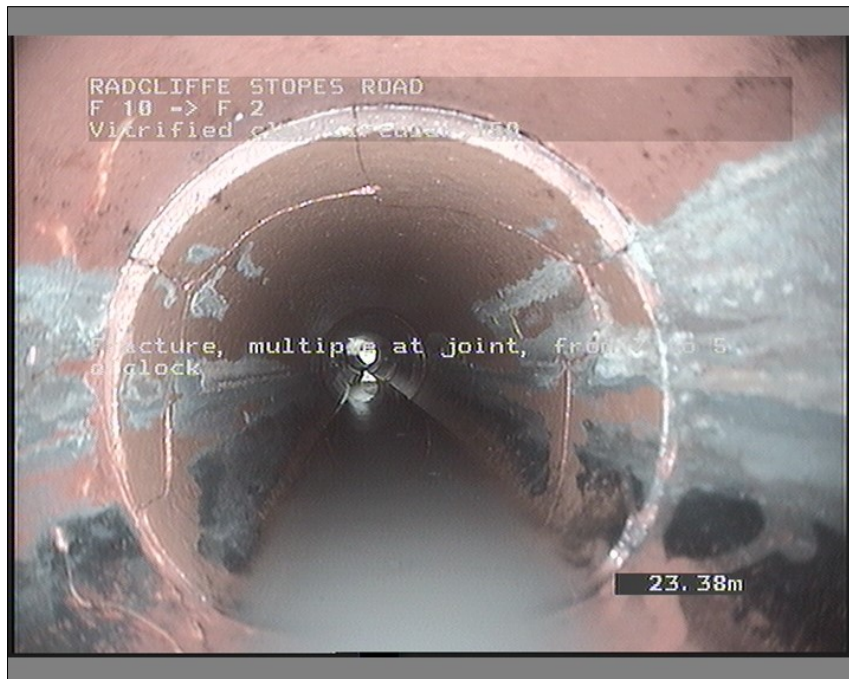
Fracture, multiple at joint, from 7 to 5 o'clock

Photo: 12\_12\_71\_A.JPG  
23.38m, Fracture, multiple at joint, from 7 to 5 o'clock

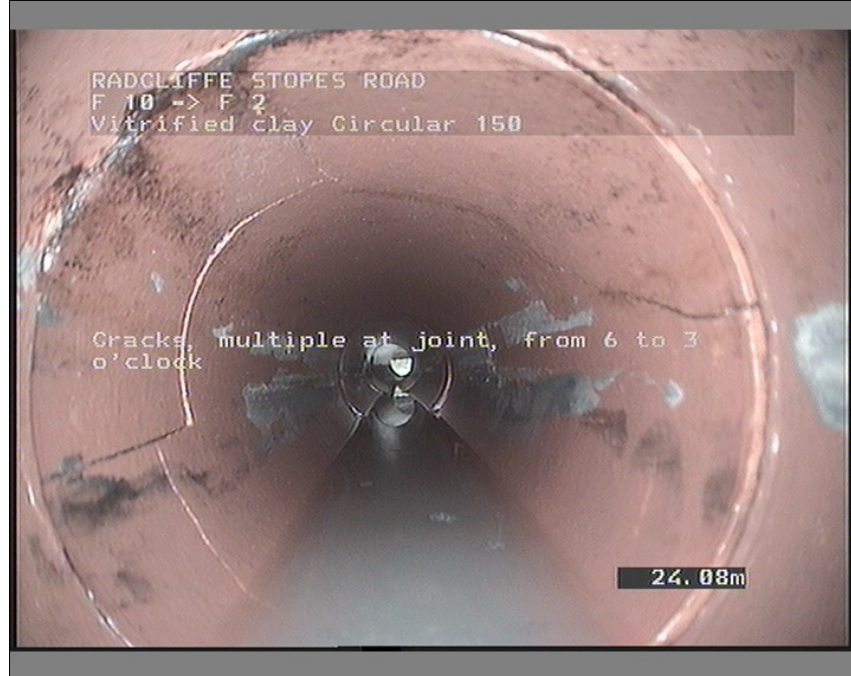
Cracks, multiple at joint, from 6 to 3 o'clock

Photo: 12\_12\_72\_A.JPG  
24.08m, Cracks, multiple at joint, from 6 to 3 o'clock

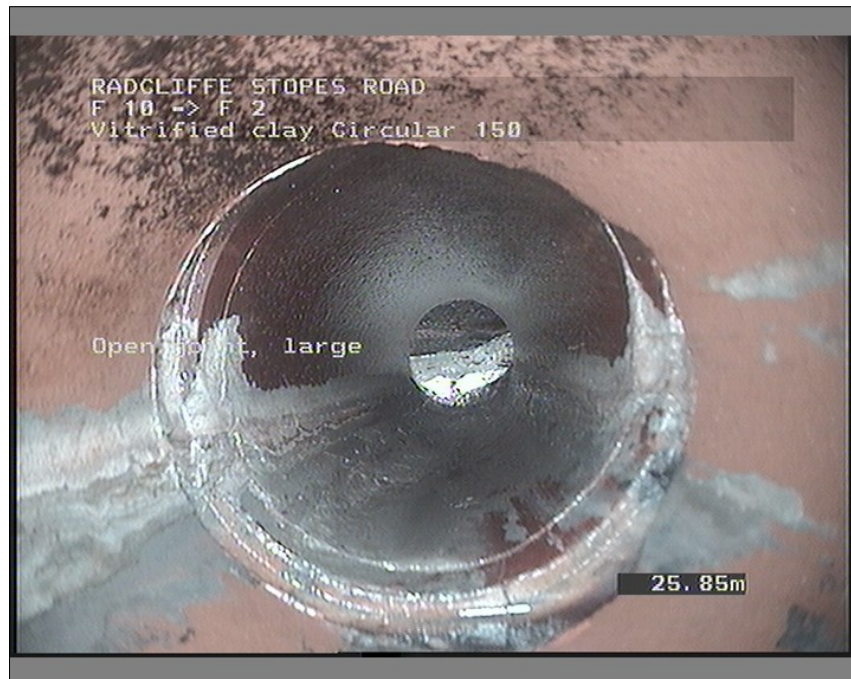
Photo: 12\_12\_73\_A.JPG  
25.85m, Open joint, large

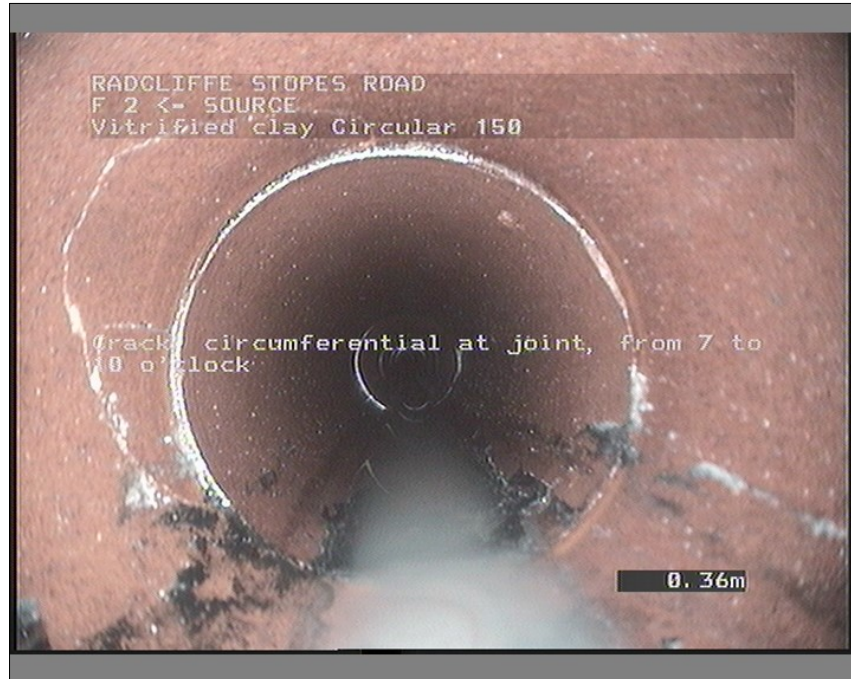
Photo: 14\_14\_80\_A.JPG

Crack, circumferential at joint, from 7 to 10 o'clock

0.36m, Crack, circumferential at joint, from 7 to 10 o'clock

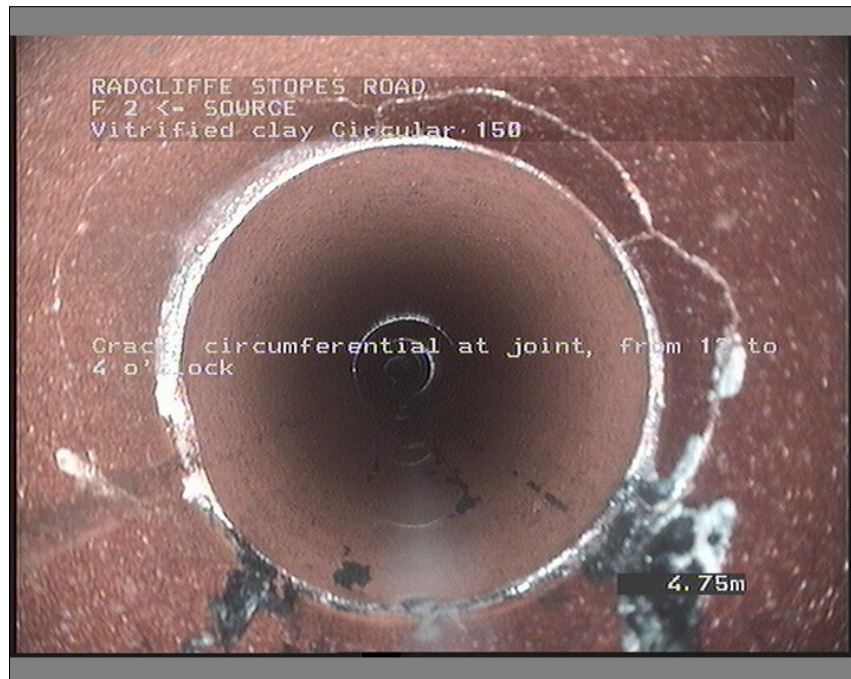
Photo: 14\_14\_81\_A.JPG

Crack, circumferential at joint, from 12 to 4 o'clock

4.75m, Crack, circumferential at joint, from 12 to 4 o'clock

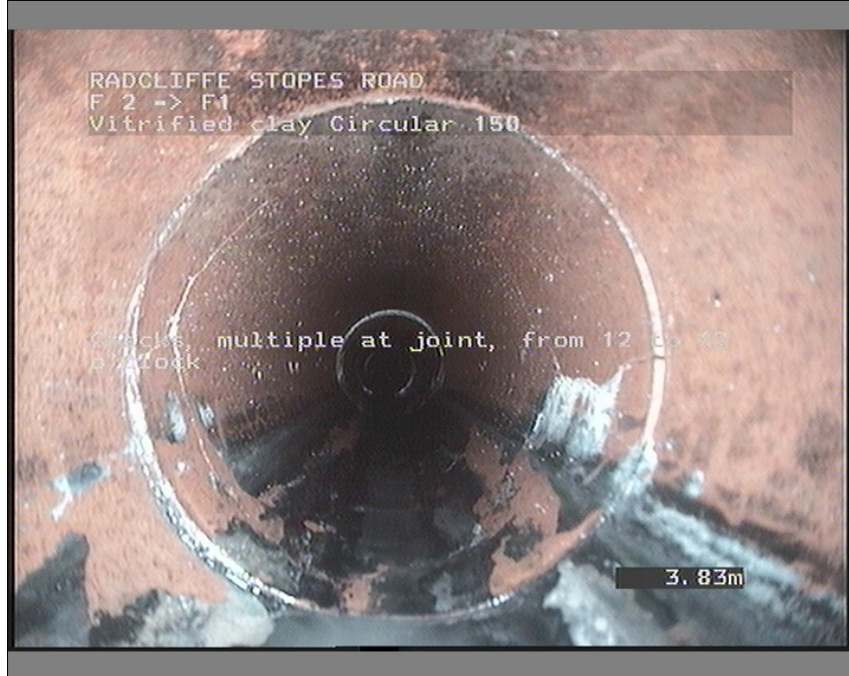
Photo: 15\_15\_85\_A.JPG  
3.83m, Cracks, multiple at joint, from 12 to 12 o'clock

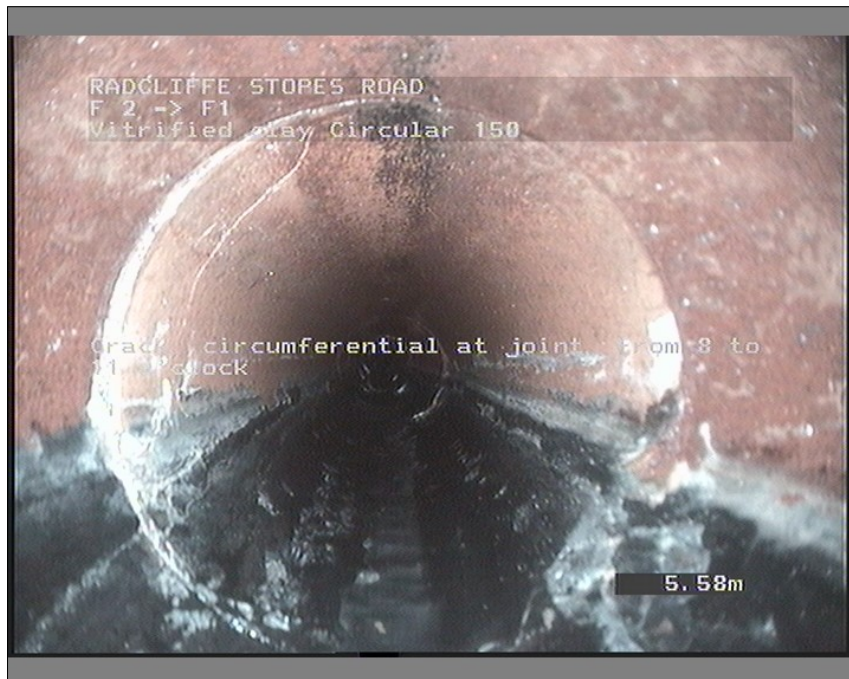
Photo: 15\_15\_86\_A.JPG  
5.58m, Crack, circumferential at joint, from 8 to 11 o'clock

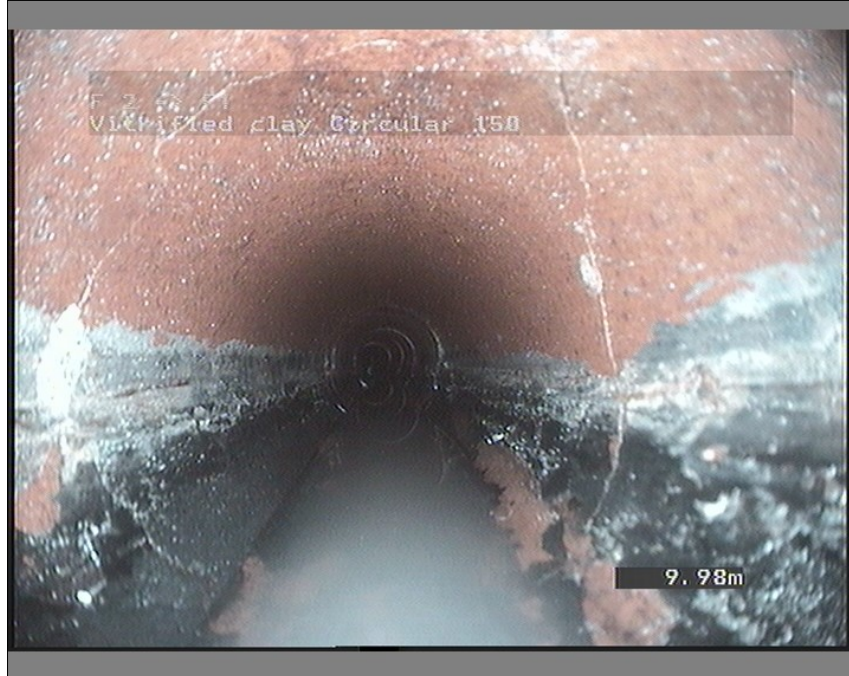
Photo: 15\_15\_87\_A.JPG

9.98m, Crack, circumferential at joint, from 12 to 12 o'clock

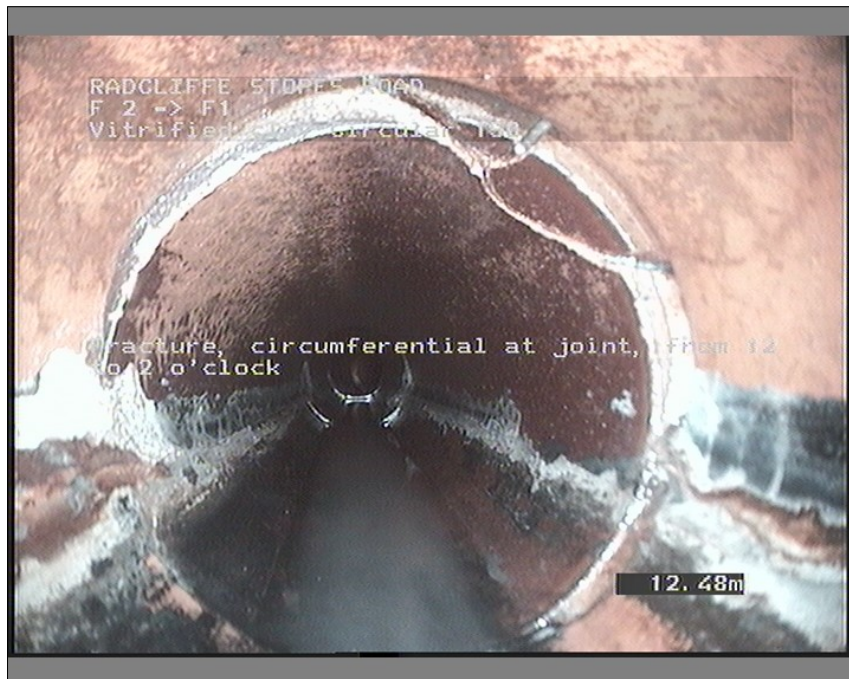
Photo: 15\_15\_88\_A.JPG

12.48m, Fracture, circumferential at joint, from 12 to 2 o'clock

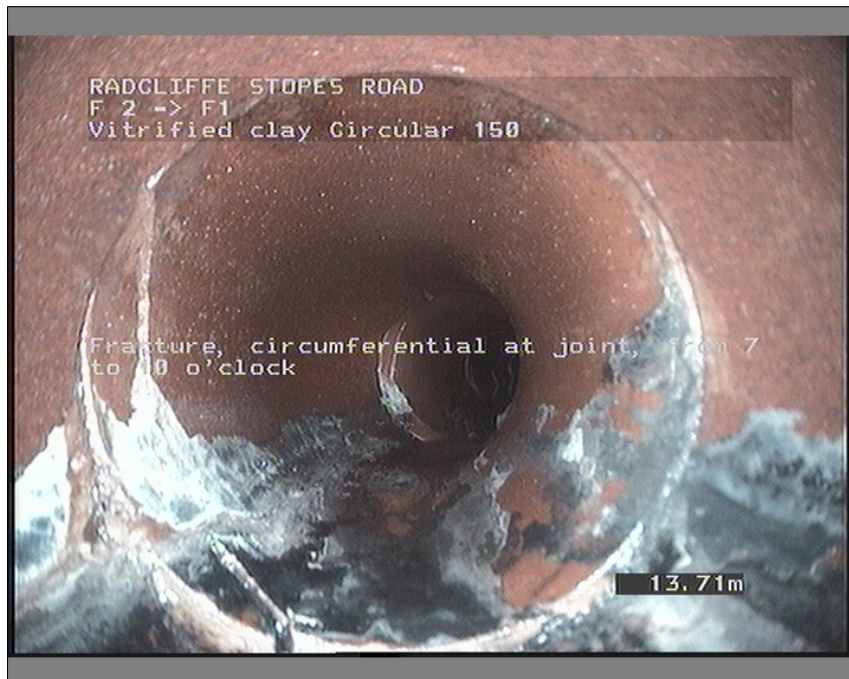
Photo: 15\_15\_90\_A.JPG

13.71m, Fracture, circumferential at joint, from 7 to 10 o'clock

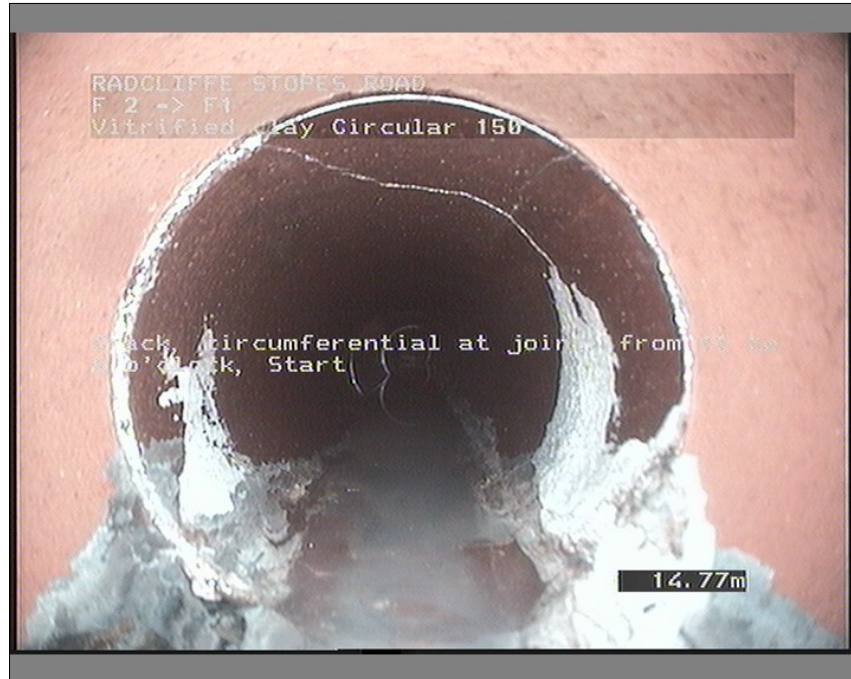
Photo: 15\_15\_91\_A.JPG

14.77m, Crack, circumferential at joint, from 11 to 5 o'clock, Start

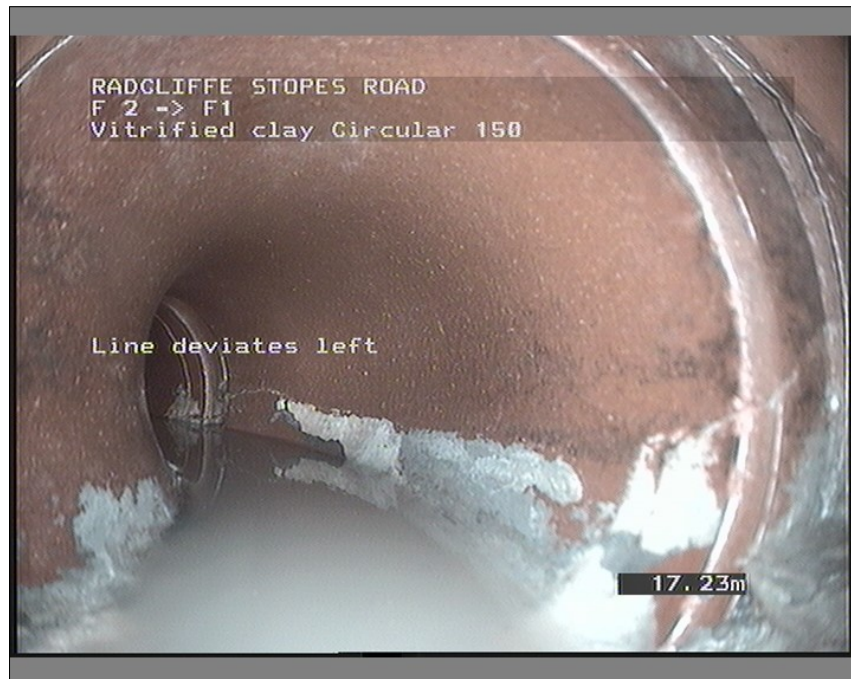
Photo: 15\_15\_92\_A.JPG

17.23m, Line deviates left

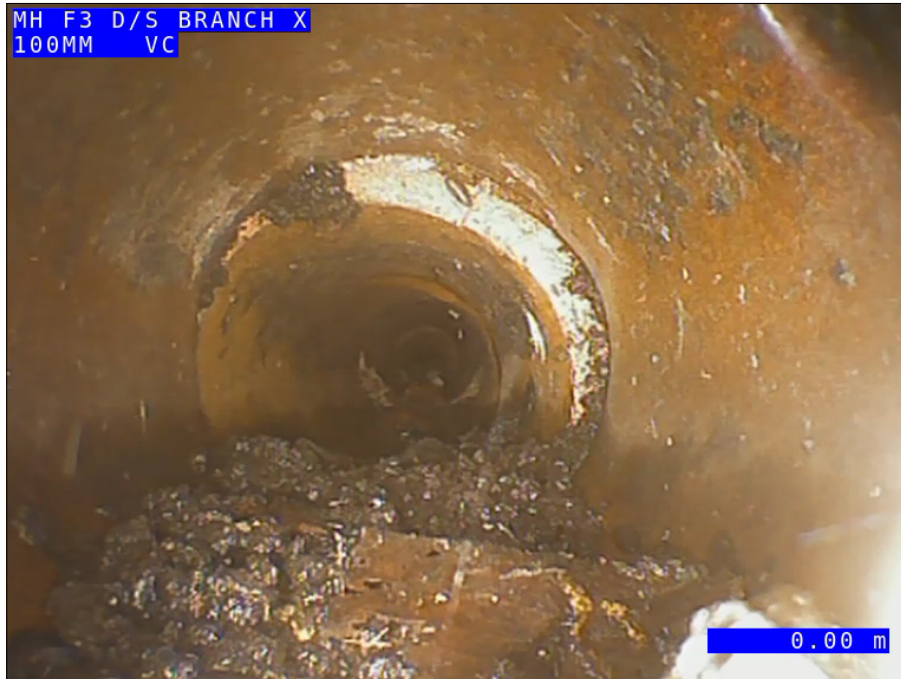
Photo: 16\_16\_97\_A.jpg  
0m, Settled deposits, coarse, 10% cross-sectional area loss

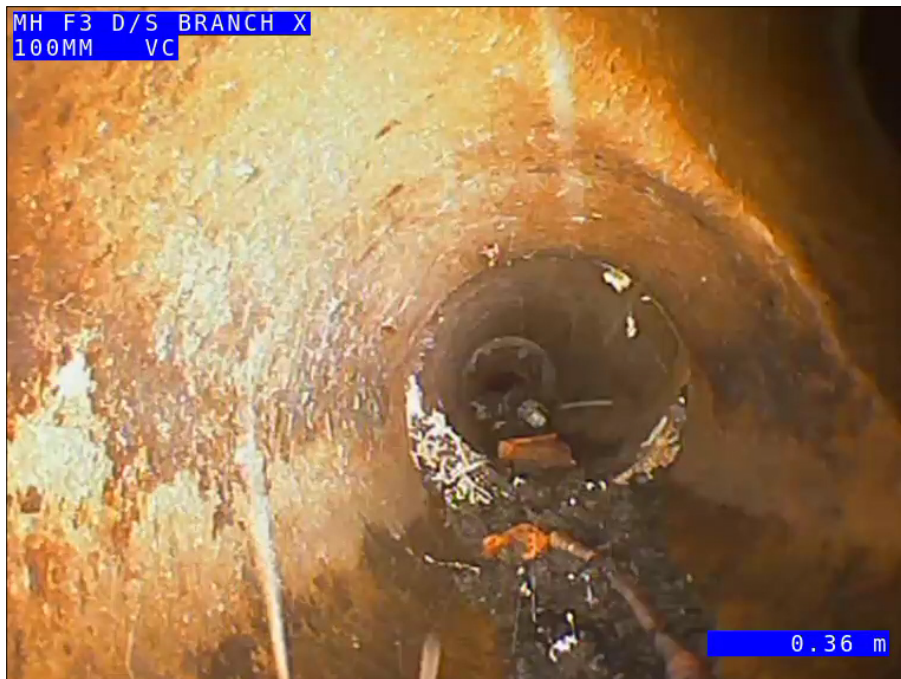
Photo: 16\_16\_98\_A.jpg  
0.36m, Junction, at 3 o'clock, diameter 100mm

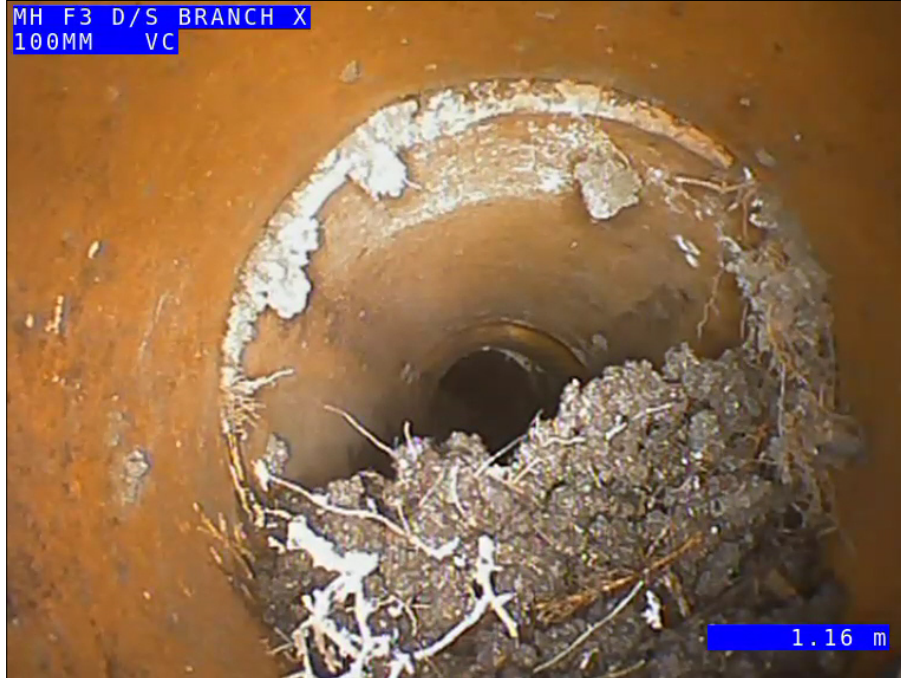
Photo: 16\_16\_99\_A.jpg

1.16m, Roots, mass at joint, 40% cross-sectional area loss

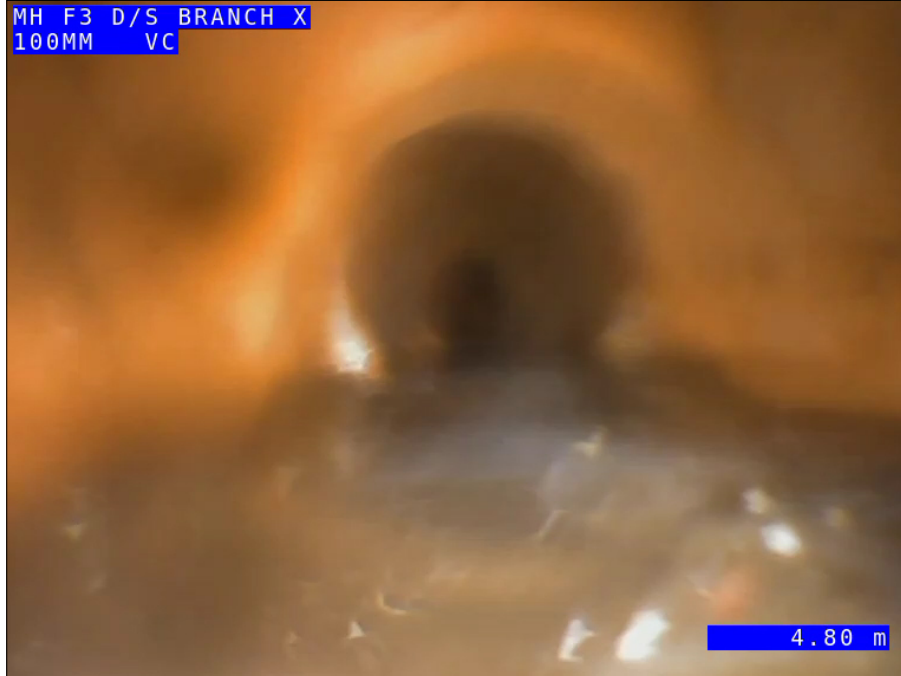
Photo: 17\_17\_103\_A.jpg  
 4.88m, Junction, at 11 o'clock, diameter 100mm

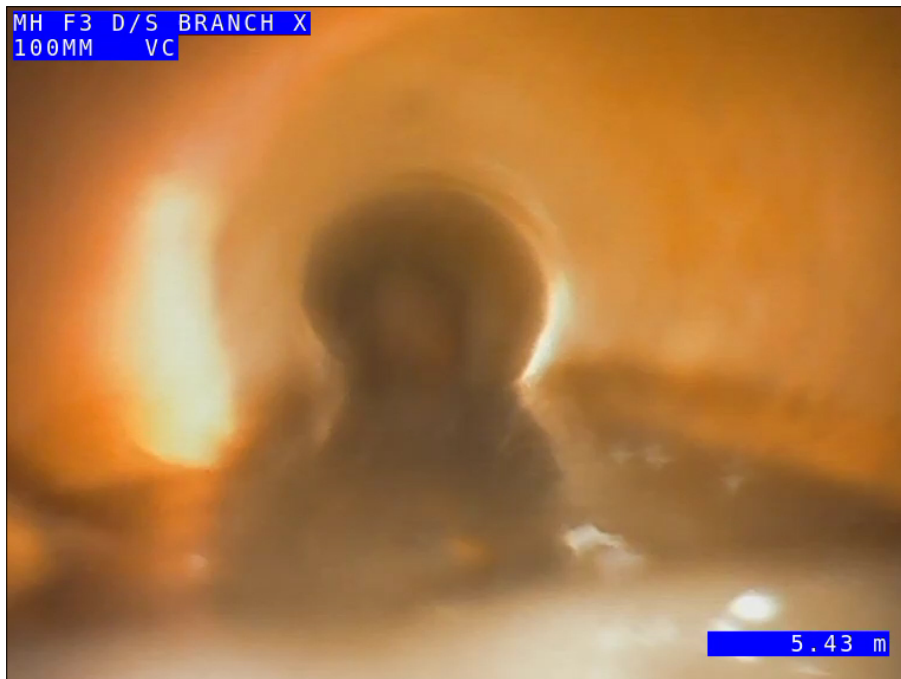
Photo: 17\_17\_104\_A.jpg  
 5.43m, Junction, at 11 o'clock, diameter 100mm

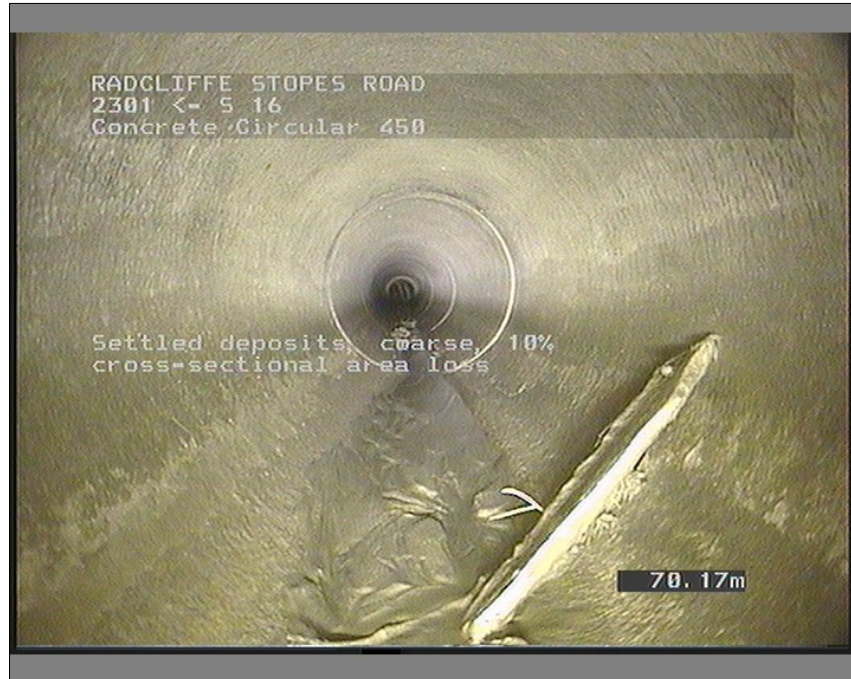
Photo: 19\_19\_110\_A.JPG

70.17m, Settled deposits, coarse, 10% cross-sectional area loss

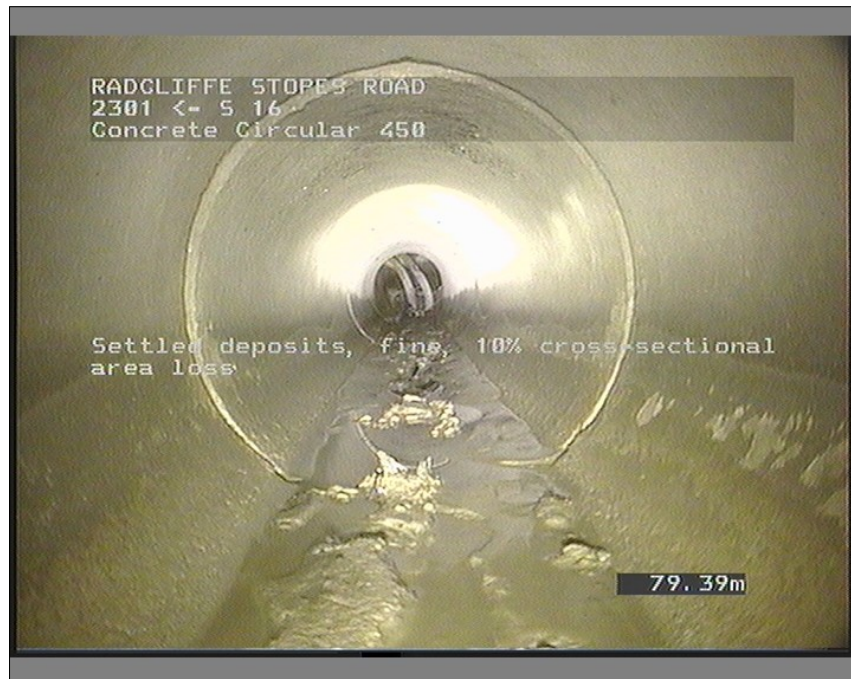
Photo: 19\_19\_111\_A.JPG

79.39m, Settled deposits, fine, 10% cross-sectional area loss

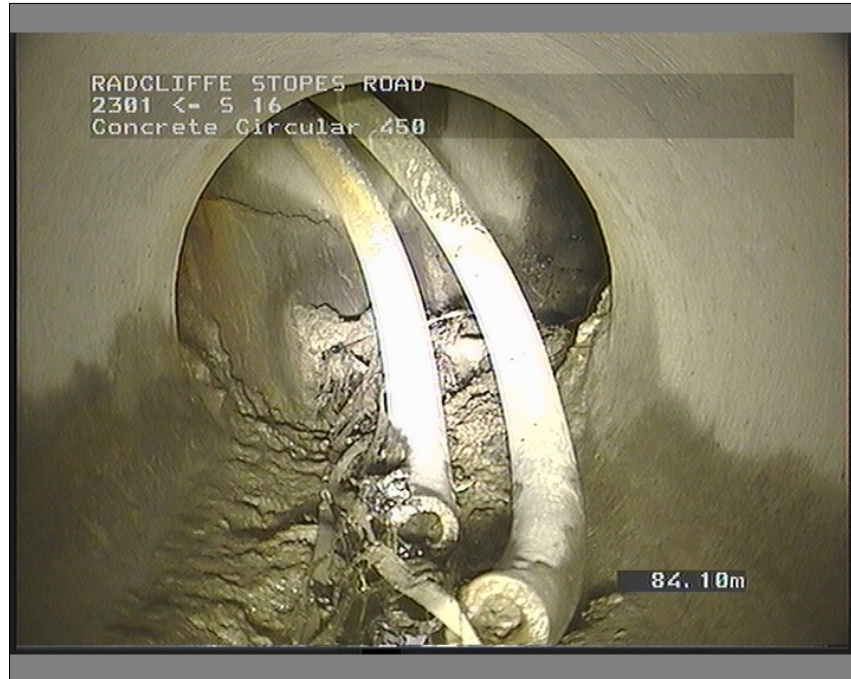
Photo: 19\_19\_112\_A.JPG

84.1m, Other obstacles, external pipe or cable, from 12 to 6 o'clock, 15% cross-sectional area loss

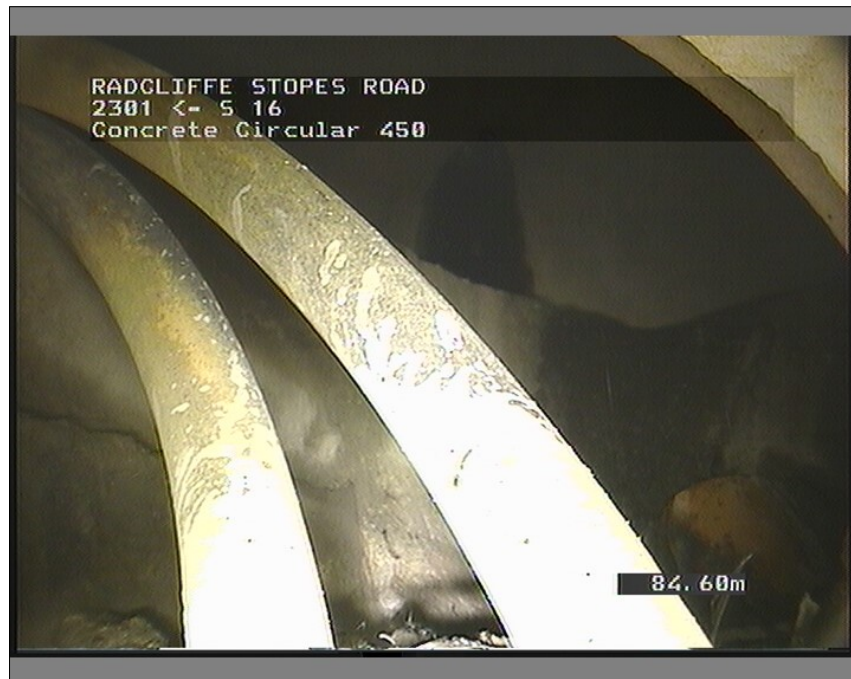
Photo: 19\_19\_113\_A.JPG

84.6m, Finish node type, manhole reference number: S 16
