Gas Membrane Installation  
Validation Report  
Darmel Construction  
10 Spring Vale Street  
Tottington  
Bury  
BL8 3RL

## Appendix 1 – Site Survey Sheets

| <b>Building Reference/Unit No:</b> | Units 1 & 2 | |

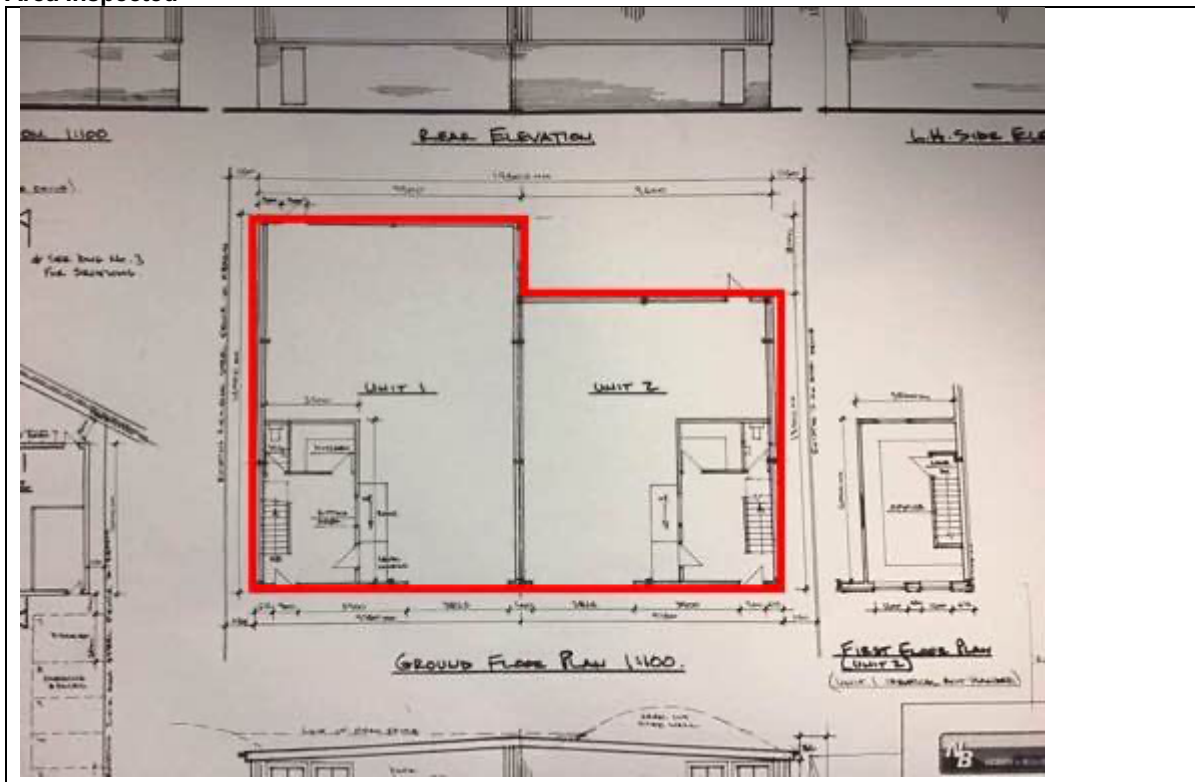
#### Area Inspected

| <b>Area Inspected:</b> | Full line out installation - See Marked Up Plan | |

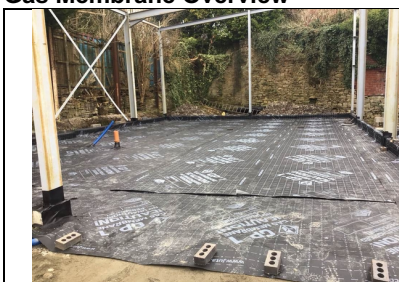
Unit 1 overview

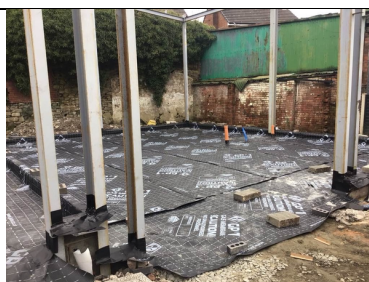
Unit 2 overview

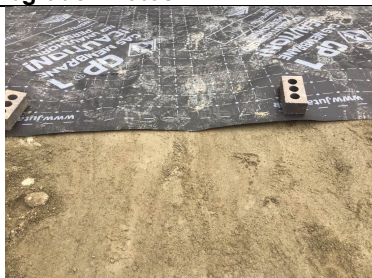
| <b>Sub-Grade Preparation:</b> | The subgrade consists of sand blinding that has been well rolled and compacted and is acceptable to lay the membrane on | |

Sand blinded substrate

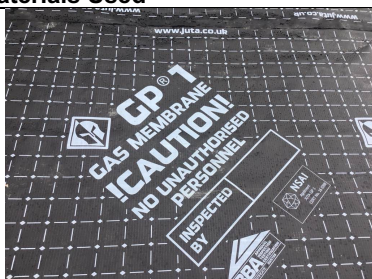
Evidence of Juta GP1 gas membrane

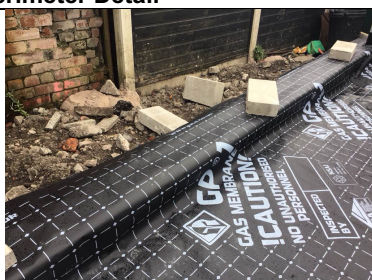
Membrane extended over the perimeter edge blockwork

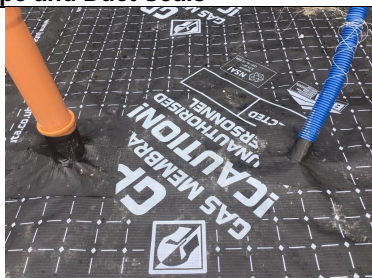
Unit 2 sealed pipe penetrations using SAGM and heat applied

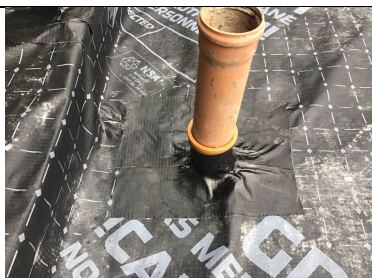
Unit 1 sealed pipe penetration using SAGM and heat applied

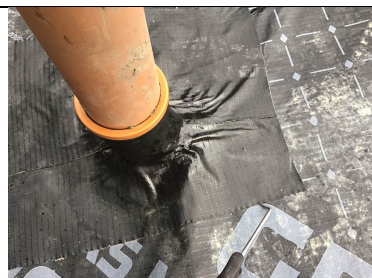
Testing to pipe detailing

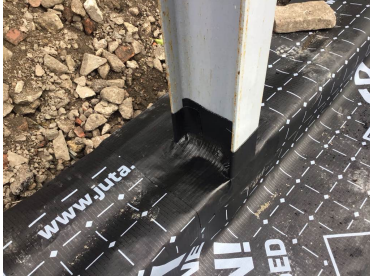
Unit 2 sealed stanchion detailing  
using SAGM and heat applied

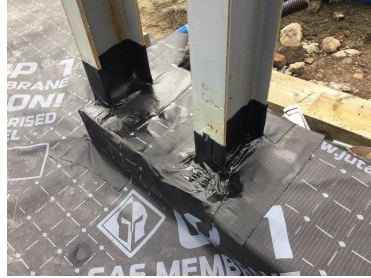
Unit 1 sealed stanchion detailing  
using SAGM and heat applied

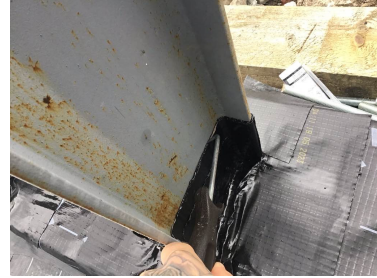
Testing to stanchion detailing

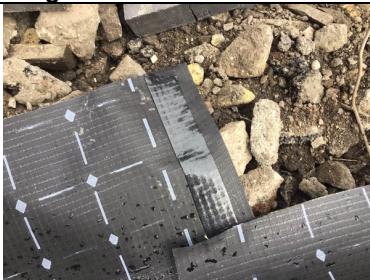
Tape used for membrane joints

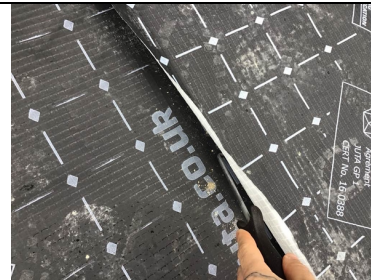
Testing of taped membrane joint

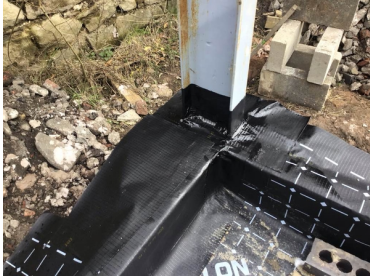
Unit 1 sealed corner detailing  
using SAGM and heat applied

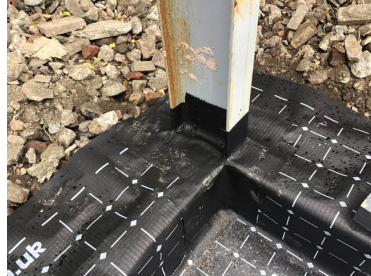
Unit 2 sealed corner detailing  
using SAGM and heat applied

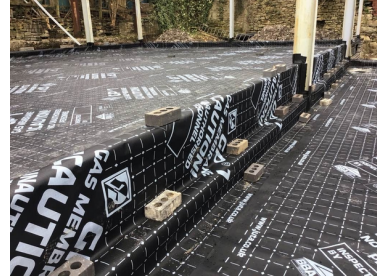
Step down detailing using Juta  
GP1 membrane

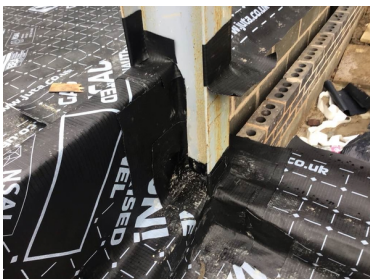
Stanchion detailing at the end of  
the step down detail
