## CCTV Inspection Report

**Stand Golf Club, Ashbourne Grove, Whitefield, Manchester M45 7NL**

**19/12/2024**

**Job Number: Site B Stand Golf Club, Ashbourne Grove, Whitefield,  
Manchester M45 7NL**

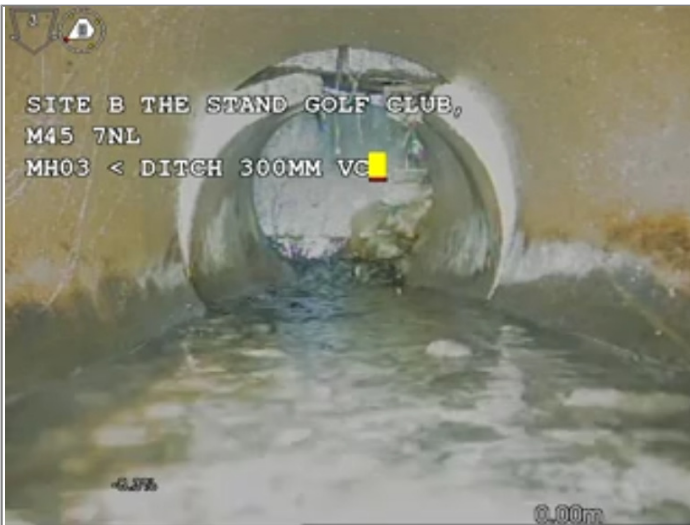
Start node type, Manhole, reference MH03

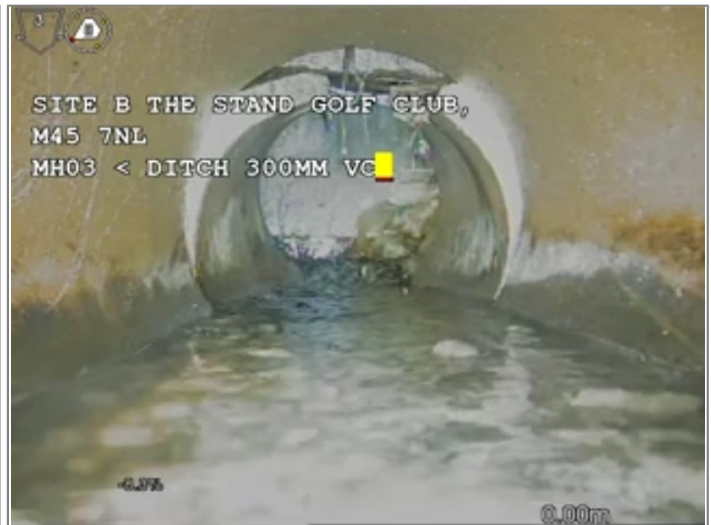
Water level 10% height/diameter

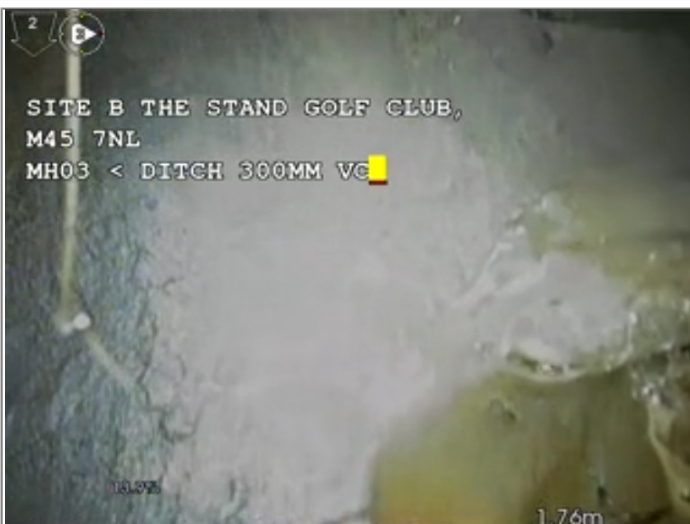
Finish node type, other special chamber, reference DITCH

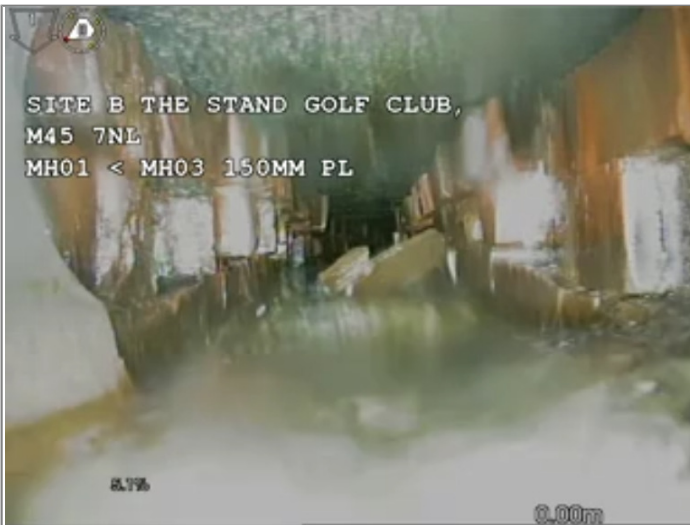
Start node type, Manhole, reference MH01

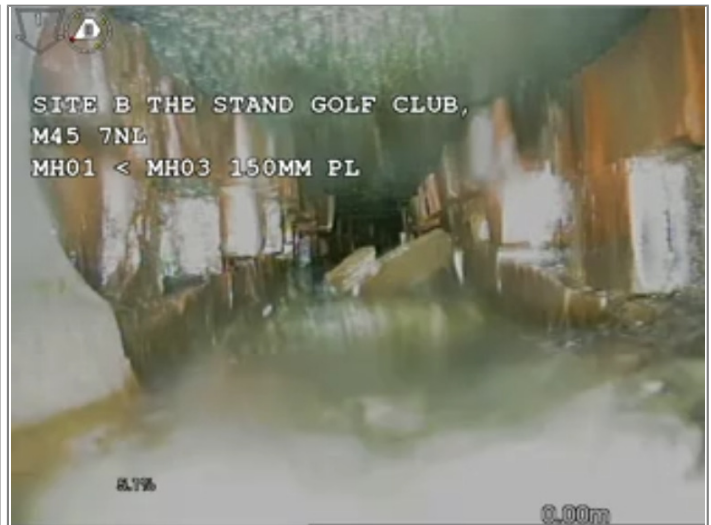
Water level 10% height/diameter

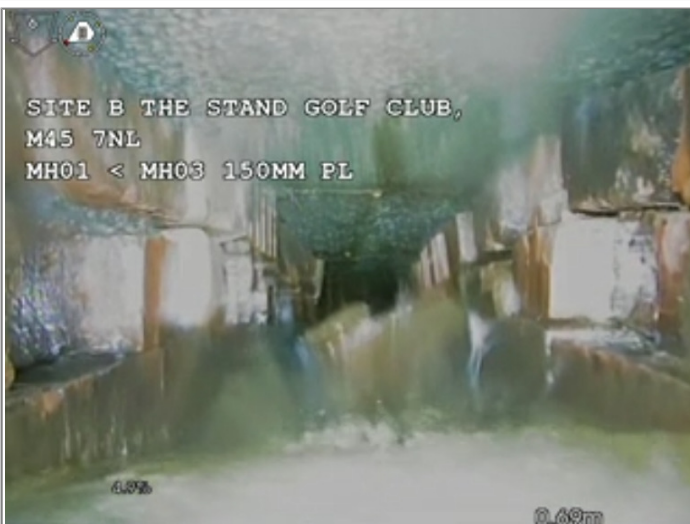
Survey abandoned - Remark: SA due to pipe size / shape change, unable to pass

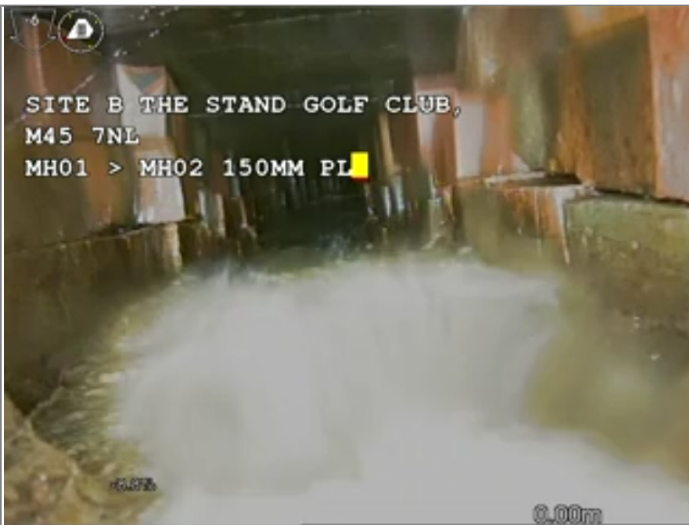
Start node type, Manhole, reference MH01

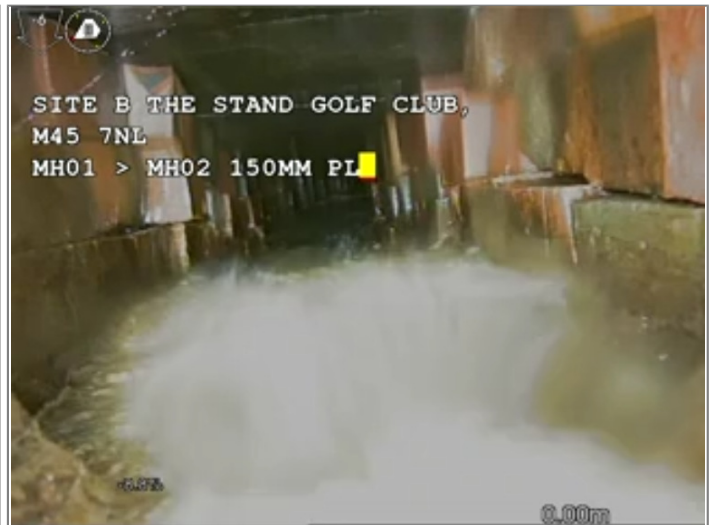
Water level 10% height/diameter

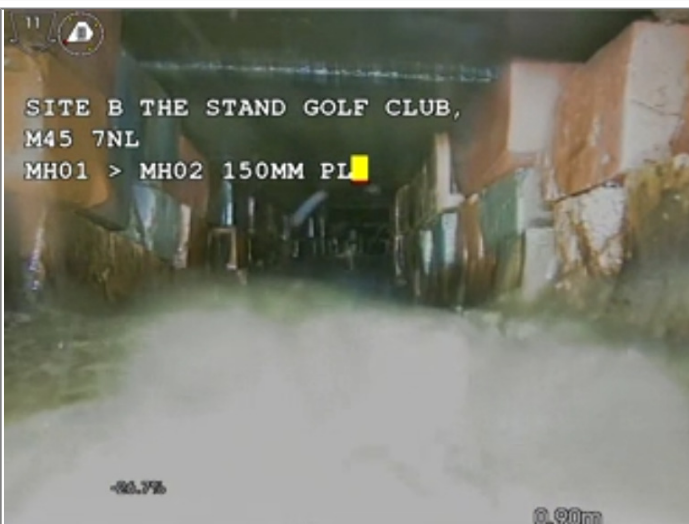
Survey abandoned - Remark: SA due to pipe size / shape change, unable to pass

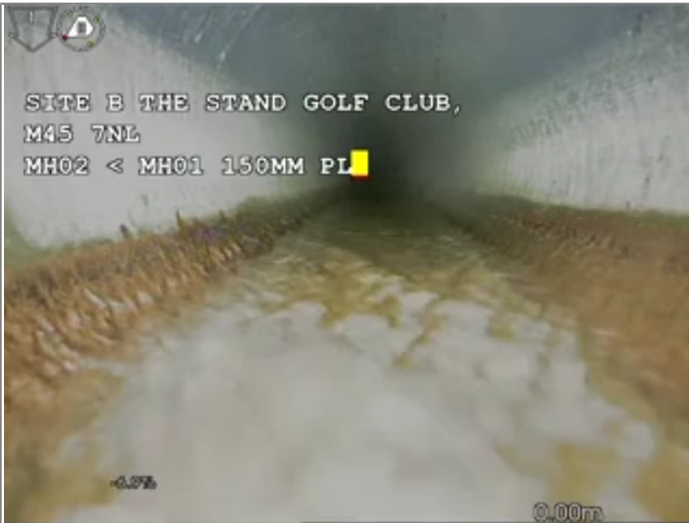
Start node type, Manhole, reference MH02

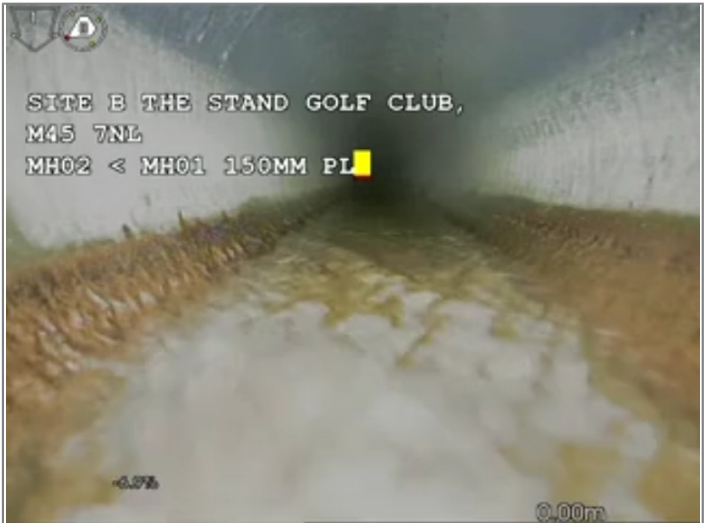
Water level 10% height/diameter

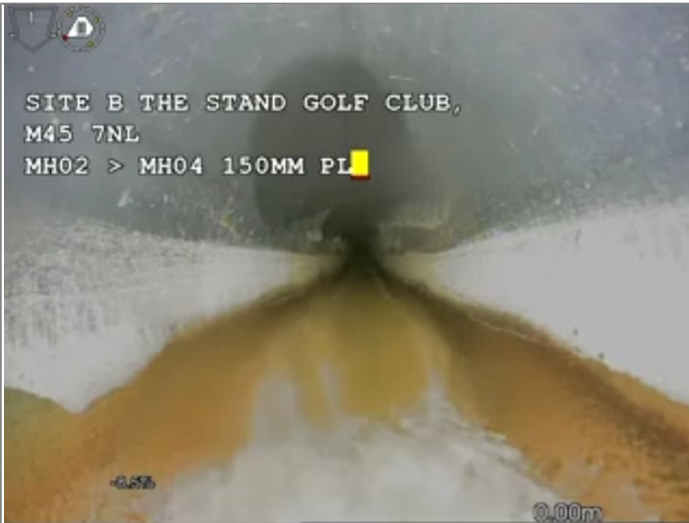
Start node type, Manhole, reference MH02

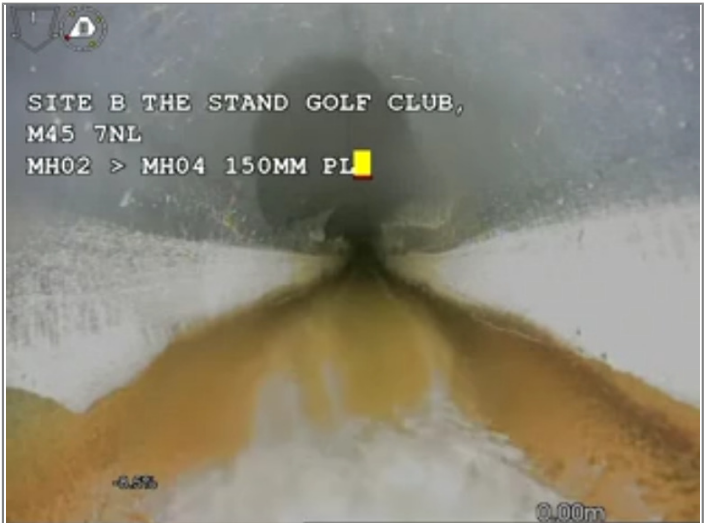
Water level 10% height/diameter

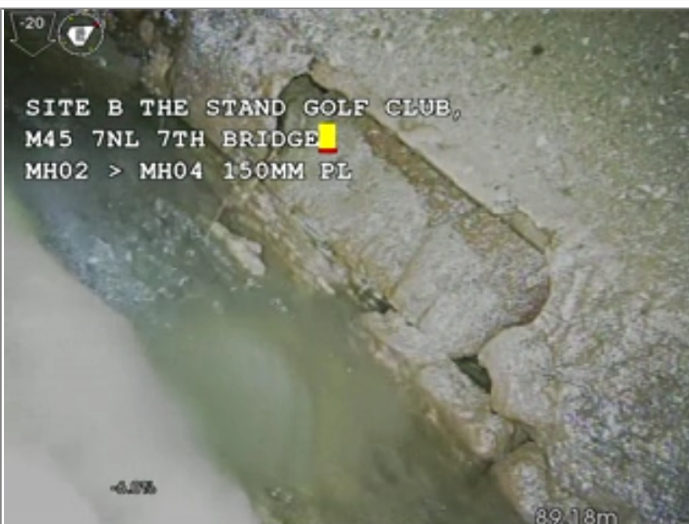
Finish node type, manhole, reference MH04

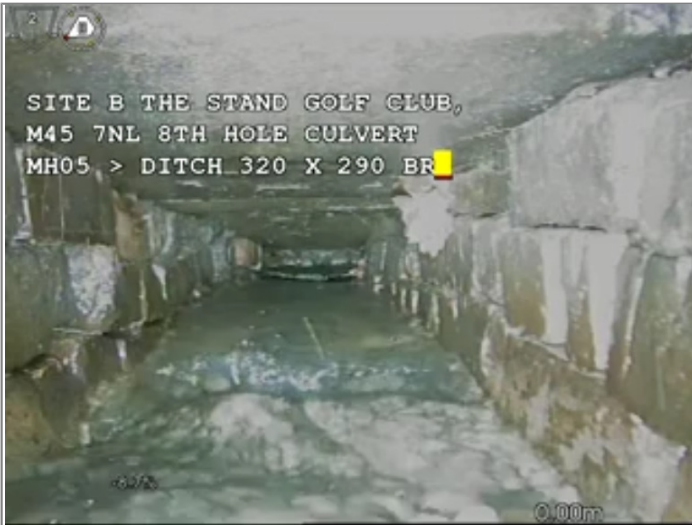
Start node type, Manhole, reference MH05

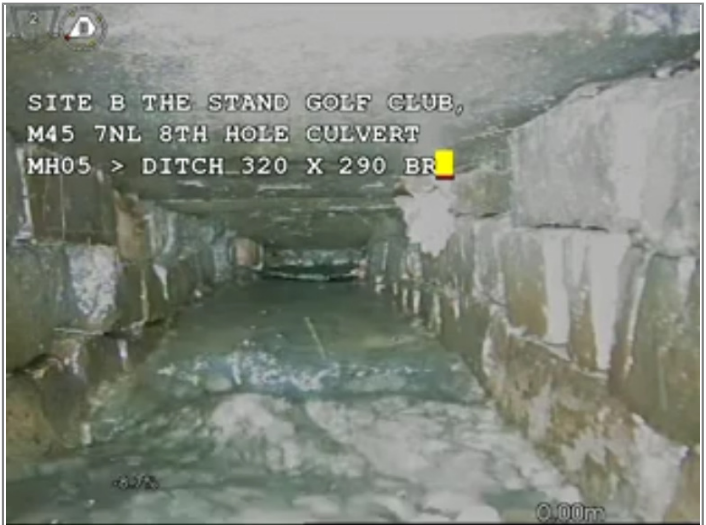
Water level 10% height/diameter

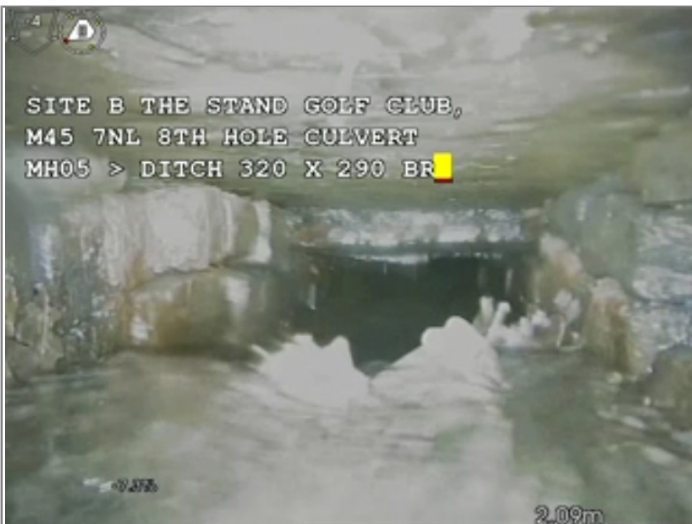
Survey abandoned - Remark: SA due to step down within culvert, unable to pass
