The visual verification inspection was undertaken by a suitably competent IDG verification engineer, in accordance with the requirements of CIRIA C735 and the site-specific Gas Protection Measures Verification Plan.

Ground Floor Lift Pits Radon Protection – Area of Installation/ Inspection for given date highlighted Yellow

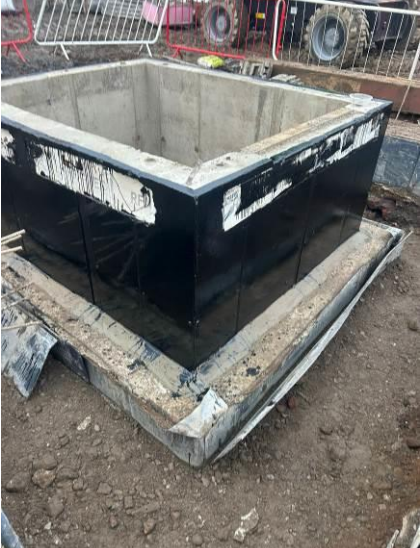
| No. | Item | Comments (see notes) |
|---|---|---|
| | | <i>Photograph showing the radon protection measures installed for the single Groundfloor lift pit. Black paint-on waterproof primer being applied prior to installation membrane.</i> |

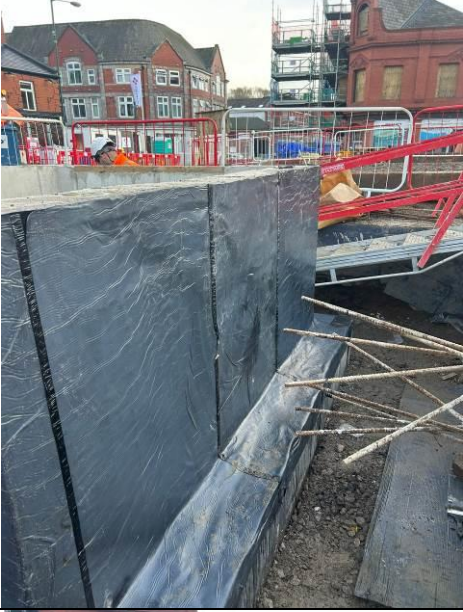
| | <p>Photograph showing the radon protection measures installed for the single Groundfloor lift pit. GR-SAM membrane applied to external faces lapping down to form continuous seal onto previously installed and validated GP TitanBond membrane on lift base base.</p> |

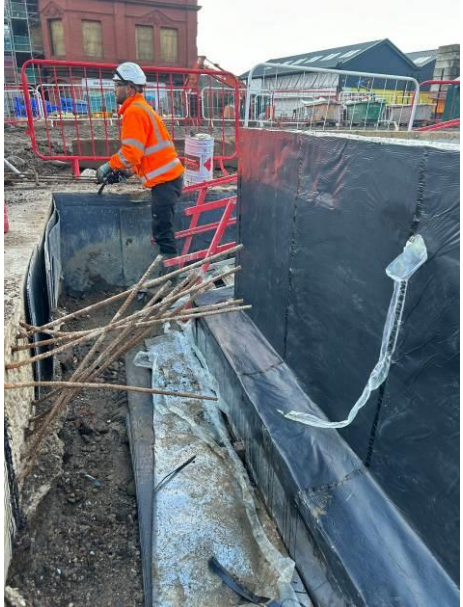
| | <p>Photograph showing the radon protection measures installed for the single Groundfloor lift pit. GR-SAM membrane applied to external faces lapping down to form continuous seal onto previously installed and validated GP TitanBond membrane on lift base base.</p> |

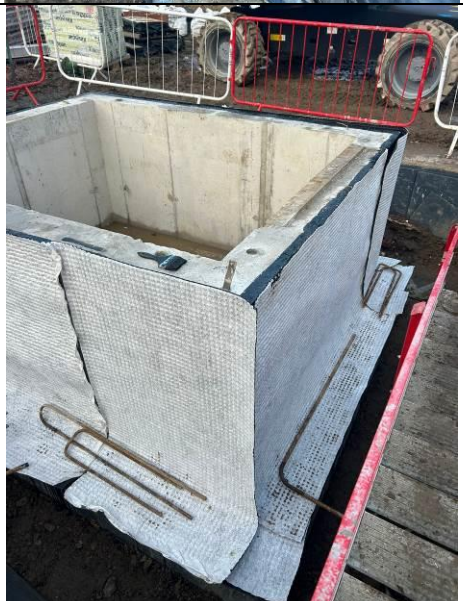
| | <p>Photograph showing the radon protection measures installed for the single Groundfloor lift pit. GR-SAM membrane applied to external faces lapping down to form continuous seal onto previously installed and validated GP TitanBond membrane on lift base base. Cavity drain membrane in place over GR-SAM ready for placement of external backfill.</p> |

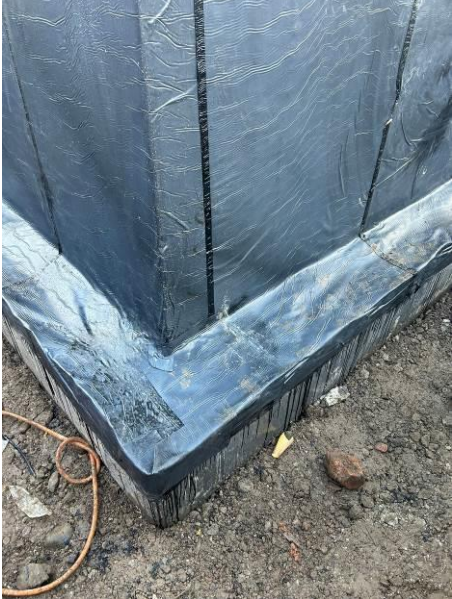
| | <p>Photograph showing the radon protection measures installed for the double Groundfloor lift pit. GR-SAM membrane applied to external faces lapping down to form continuous seal onto previously installed and validated GP TitanBond membrane on lift base base.</p> |

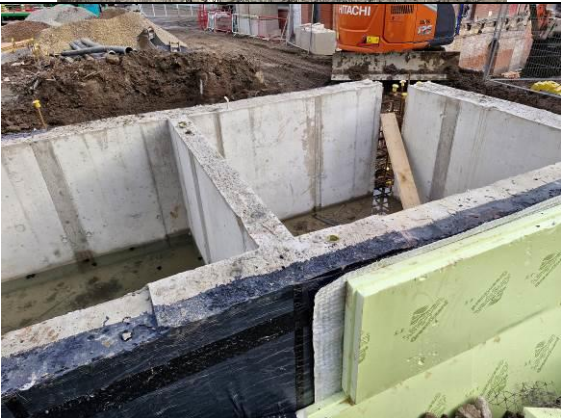
| | <p>Photograph showing the radon protection measures installed for the double Groundfloor lift pit. GR-SAM membrane applied to external faces lapping down to form continuous seal onto previously installed and validated GP TitanBond membrane on lift base base.</p> |

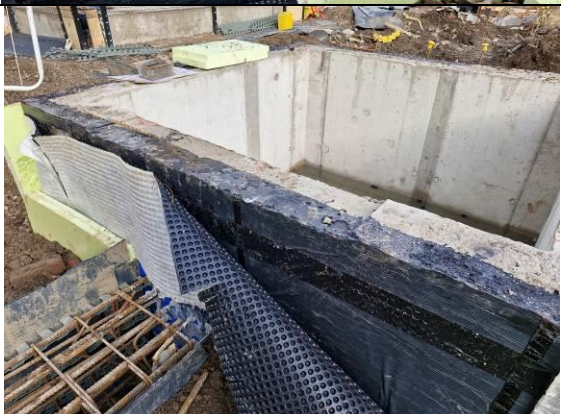
| | <p>Photograph showing the radon protection measures installed for the double Groundfloor lift pit. GR-SAM membrane applied to external faces lapping down to form continuous seal onto previously installed and validated GP TitanBond membrane on lift base base. Cavity drain membrane in place over GR-SAM ready for placement of external backfill.</p> |

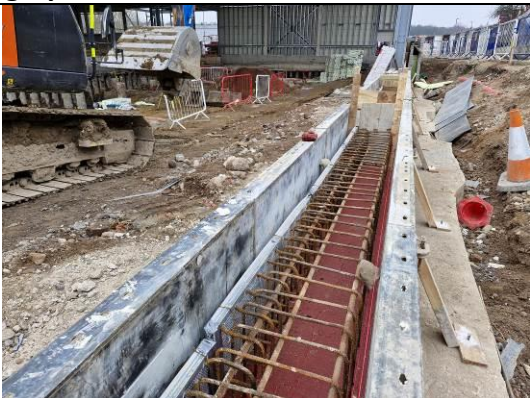
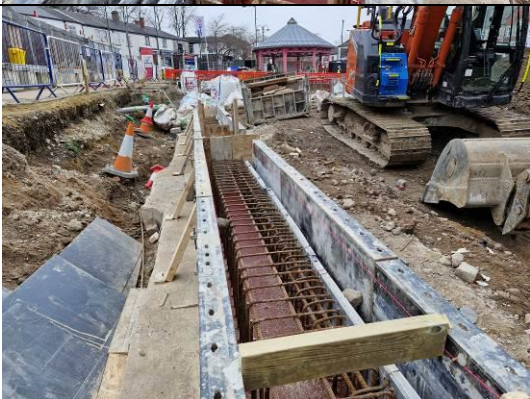
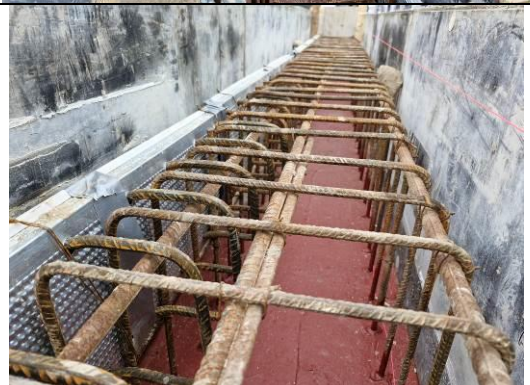
| No. | Item | Comments (see notes) |
|---|---|---|
| | | Photograph showing the GP Liquid barrier (red) applied to all substructure concrete along the northern external perimeter of the learner swimming pool area as per design ready for next phase of concrete pour. |

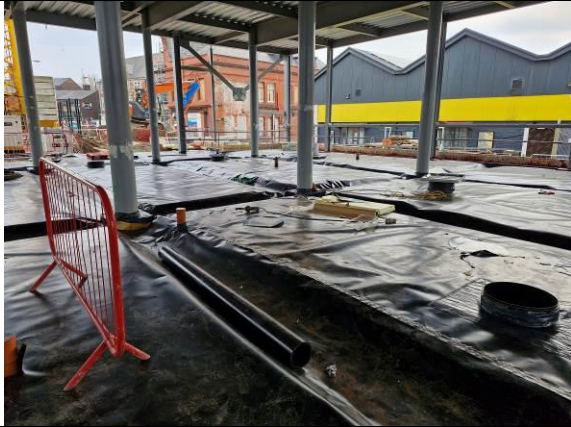
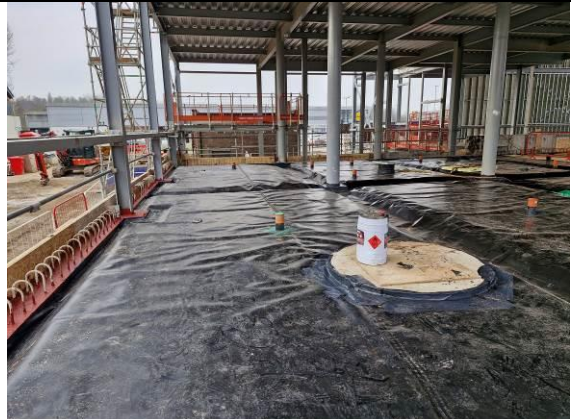
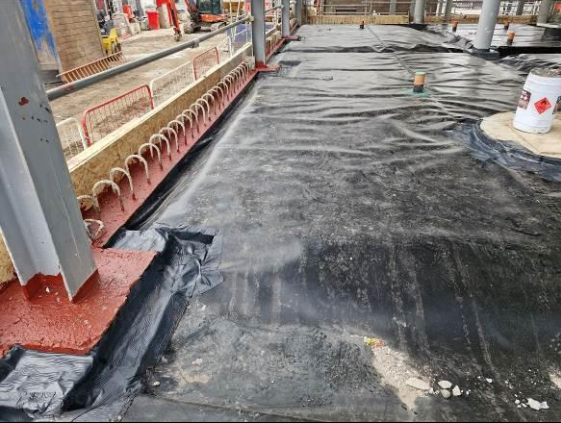
| No. | Item | Comments (see notes) |
|---|---|---|
| | | <i>Photograph showing the radon protection measures installed for the Phase 2 floor slab area. GP Liquid barrier (red) applied to all stanchion bases and substructure concrete as per design. Juta GP-H 0.6mm membrane (black) bonded to GP Liquid barrier using Titan Tape and / or GR-SAM. Membrane joints heat welded using Twinny type welder.</i> |

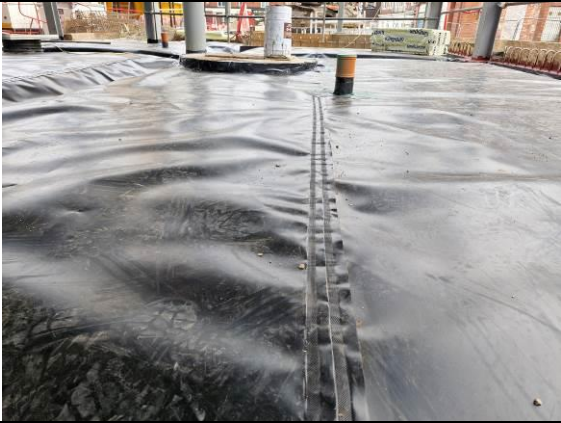
| | <p>Photograph showing the radon protection measures installed for the Phase 2 floor slab area. Juta GP-H 0.6mm membrane sheet joints heat welded using a Twinny type welder.</p> |

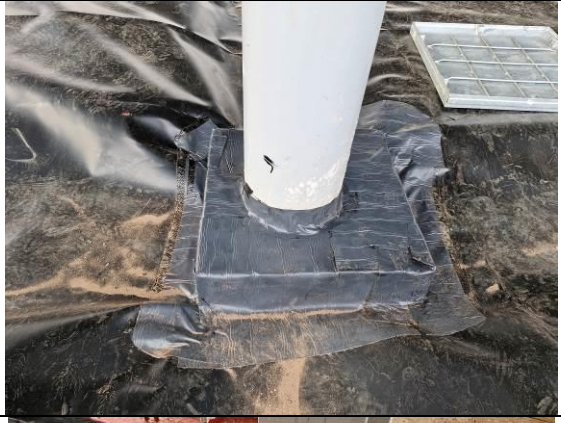
| | <p>Photograph showing the radon protection measures installed for the basement plant room. GP Titan Bond membrane (grey/black) sheet joints heat welded using a Twinny type welder.</p> |

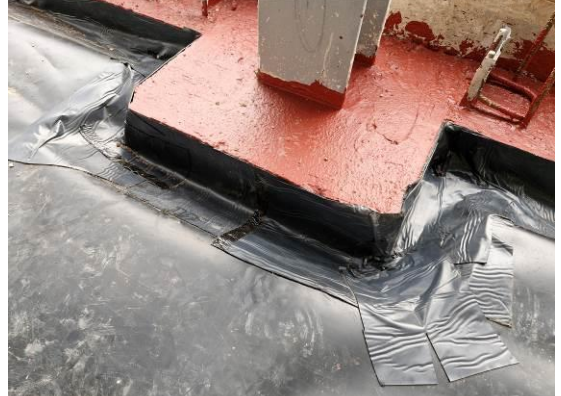
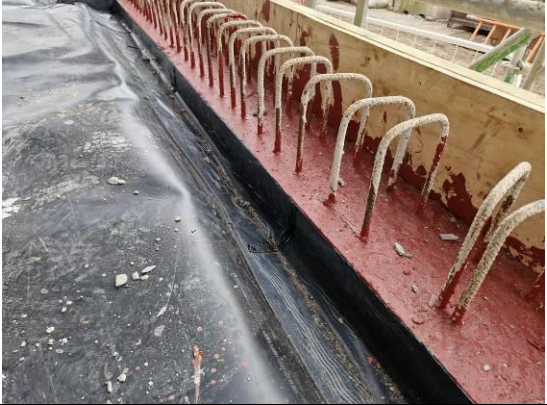
| | <p>Photograph showing the radon protection measures installed for the Phase 2 floor slab area. GP Liquid barrier (red) applied to all stanchion bases and substructure concrete as per design. Juta GP-H 0.6mm membrane (black) bonded to GP Liquid barrier using Titan Tape and / or GR-SAM.</p> |

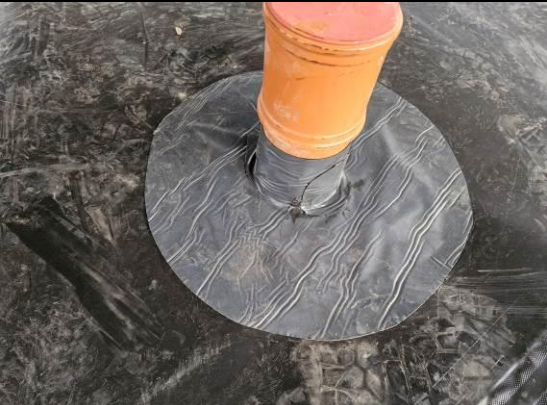
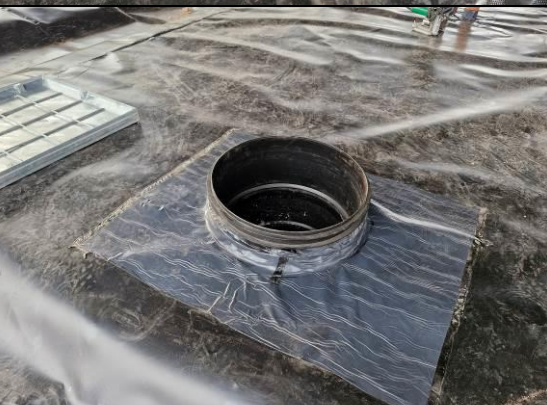
| | <p>Photograph showing the radon protection measures installed for the Phase 2 floor slab area. Service entries fully sealed to Juta GP-H 0.6mm membrane using GR-SAM.</p> |

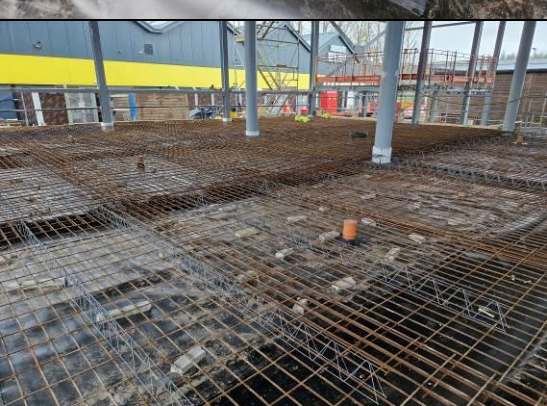
| | <p>Photograph showing the radon protection measures installed for the Phase 2 floor slab area with steel work in place post-validation ready for concrete pour.</p> |

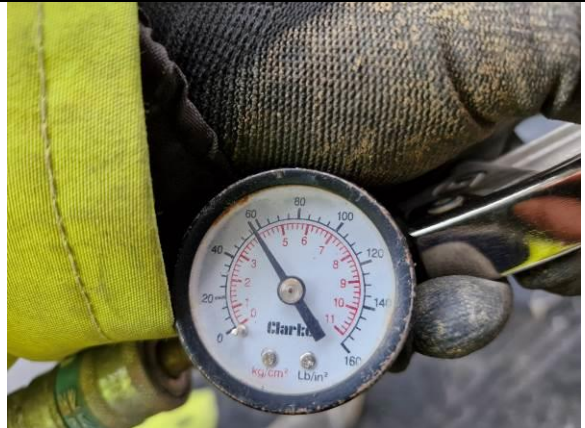
| Photograph | Description |
|---|---|
| | <p><i>Air lance testing in basement plant room, with pressure gauge showing maintained pressure above minimum of 50psi advocated by ASTM D4437-08:2013.</i></p> |

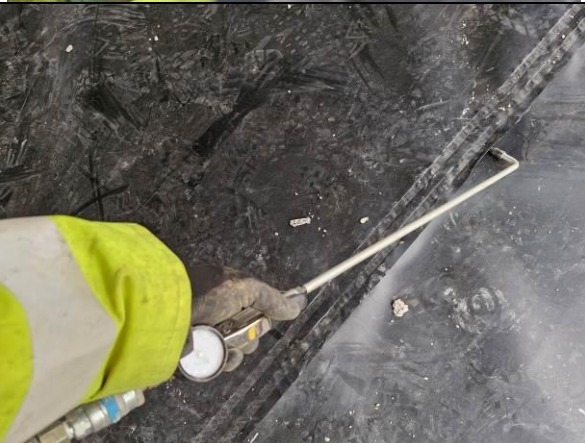
| Photograph | Description |
|---|---|
| | <p><i>Air lance testing of joint between two GP-H membrane sheets in Phase 2 floor slab area, with pressure gauge showing maintained pressure above minimum of 50psi advocated by ASTM D4437-08:2013.</i></p> |

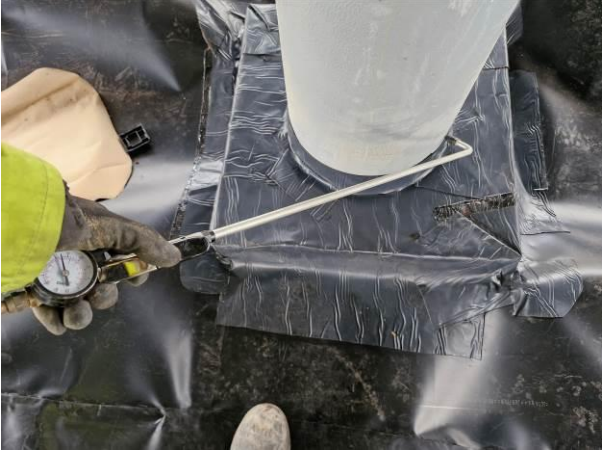
| | <p>Air lance testing of joints between GP-H membrane, GR-SAM and Liquid Barrier at stanchion base interface, with pressure gauge showing maintained pressure above minimum of 50psi advocated by ASTM D4437-08:2013.</p> |

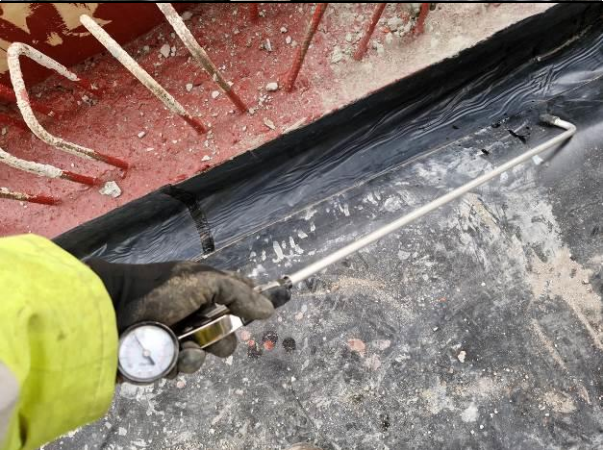
| | <p>Air lance testing of joints between GP-H membrane, GR-SAM and Liquid Barrier at ground beam interface, with pressure gauge showing maintained pressure above minimum of 50psi advocated by ASTM D4437-08:2013.</p> |

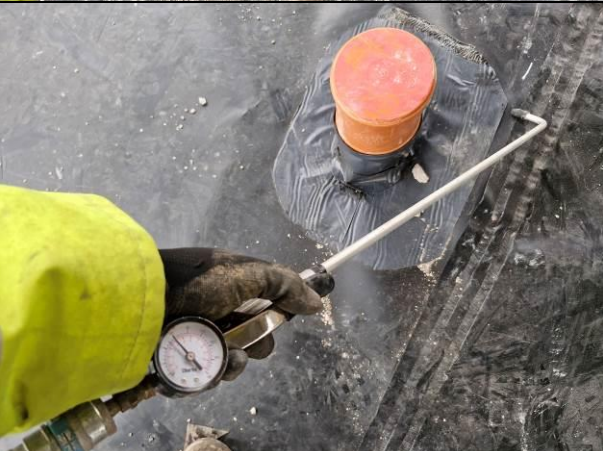
| | <p>Air lance testing of joint between GP-H membrane and GR-SAM used to seal service entries, with pressure gauge showing maintained pressure above minimum of 50psi advocated by ASTM D4437-08:2013.</p> |

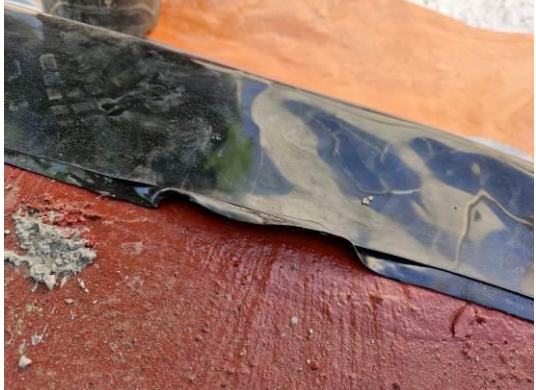
| | <p>Photograph showing small section of failure in jointing between TitanFlex membrane and liquid barrier due to moisture ingress. Rectified by SEL on site during the inspection.</p> |

Visual and mechanical point stress testing identified two localised areas where Titan Tape had not adequately bonded to the liquid membrane on the beam – subsequently repaired by SEL on site under supervision of IDG.

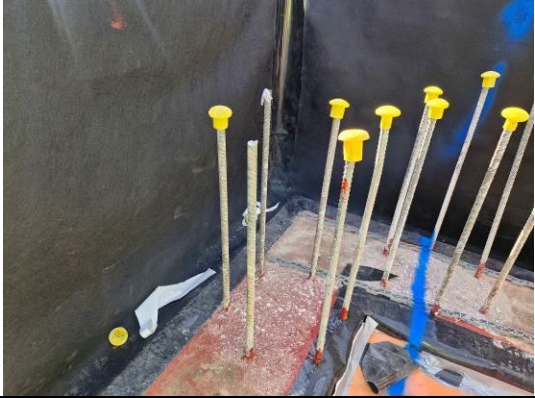
| | <p>Photograph showing the GP Liquid barrier (red) applied to all substructure concrete of Basement 2 and Stairwell as per design ahead of shuttering and next phase of concrete pour. TitanBond Membrane joined to substructure to form vertical face ahead of next concrete pour, and TitanFlex membrane joined to inner side of substructure prior to steel work and shuttering being placed. Corner detailing completed to a good standard.</p> |

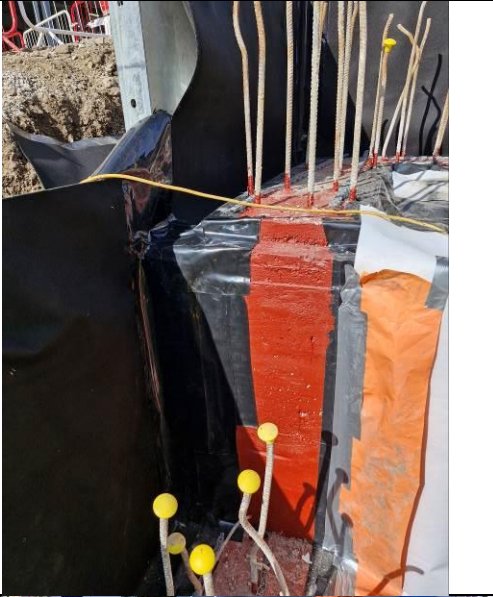
| | <p>Photograph showing the GP Liquid barrier (red) applied to all substructure concrete of Basement 2 and Stairwell as per design ahead of shuttering and next phase of concrete pour. TitanBond Membrane joined to substructure to form vertical face ahead of next concrete pour, and TitanFlex membrane joined to inner side of substructure prior to steel work and shuttering being placed. Neat detailing around level step-up completed to a good standard.</p> |

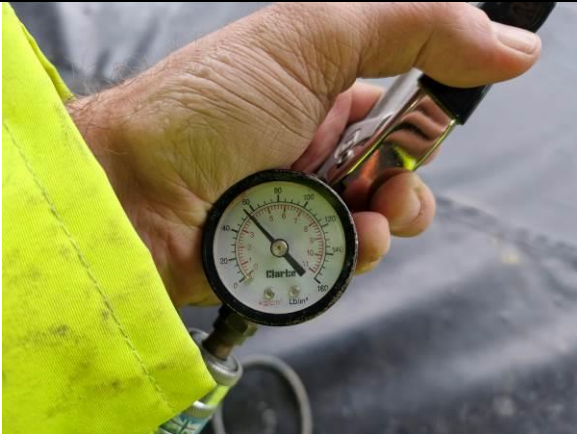
| 4 - Photographs | |
|---|---|
| | Air lance testing in main swimming pool base, with pressure gauge showing maintained pressure above minimum of 50psi advocated by ASTM D4437-08:2013. |

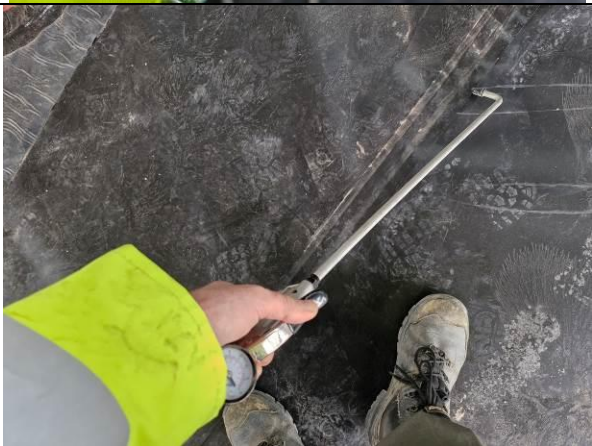
| 4 - Photographs | |
|---|---|
| | Air lance testing of joint between two GP-H membrane sheets in main swimming pool base area, with pressure gauge showing maintained pressure above minimum of 50psi advocated by ASTM D4437-08:2013. |

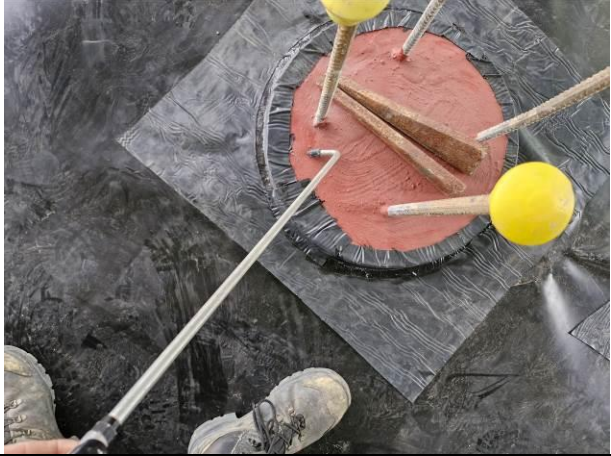
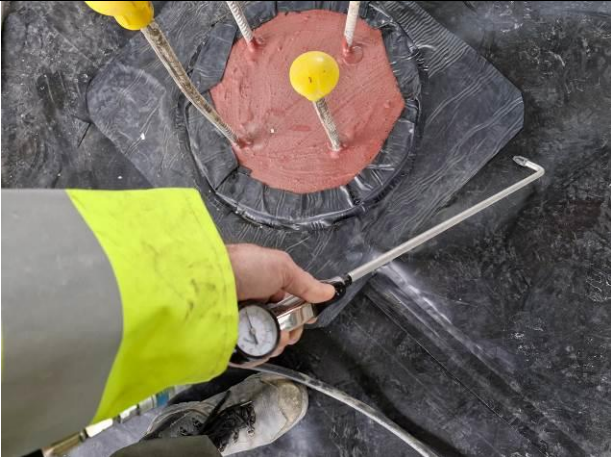
| | <p>Air lance testing of joints between GP-H membrane, GR-SAM and Liquid Barrier pile head interface, with pressure gauge showing maintained pressure above minimum of 50psi advocated by ASTM D4437-08:2013.</p> |

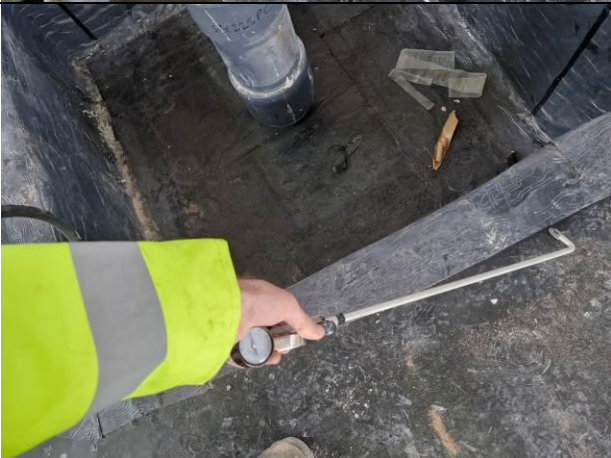
| | <p>Air lance testing of joints between GP-H membrane, and GR-SAM at water inlet sump pit, with pressure gauge showing maintained pressure above minimum of 50psi advocated by ASTM D4437-08:2013.</p> |

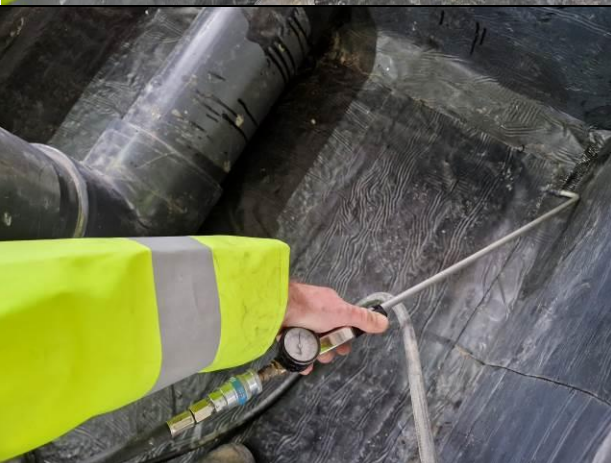
| | <p>Air lance testing of joints between GR-SAM at water inlet sump pit, with pressure gauge showing maintained pressure above minimum of 50psi advocated by ASTM D4437-08:2013.</p> |
