# GAS PROTECTION MEASURES VERIFICATION VISUAL INSPECTION RECORD

| Site Name: | Radcliffe Civic Hub | Gas Characteristic Situation: | Basic Radon Only |
| Gas Protection Components inspected: | Radon membrane installation and sealing to liquid membrane on concrete substructure using GR-SAM. | | |

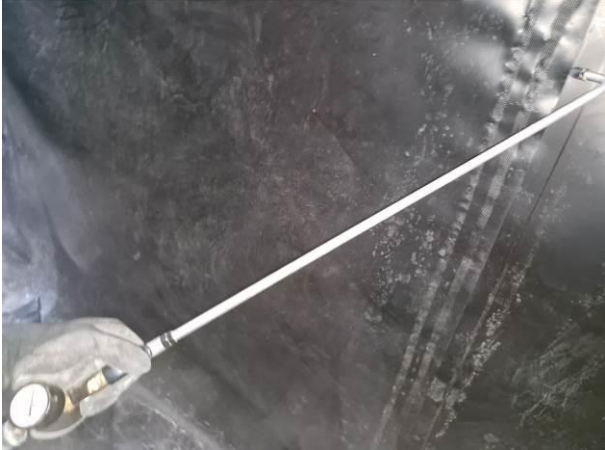
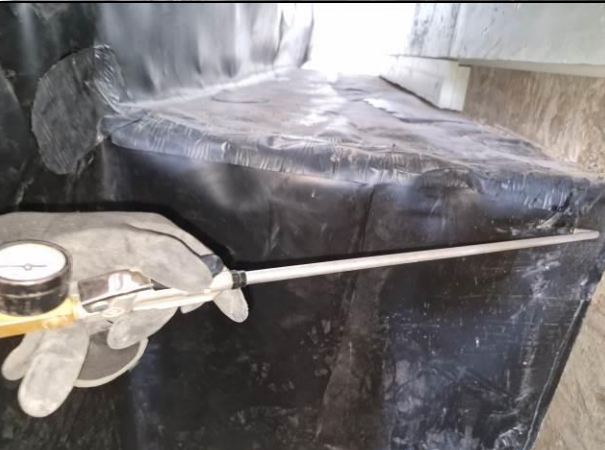
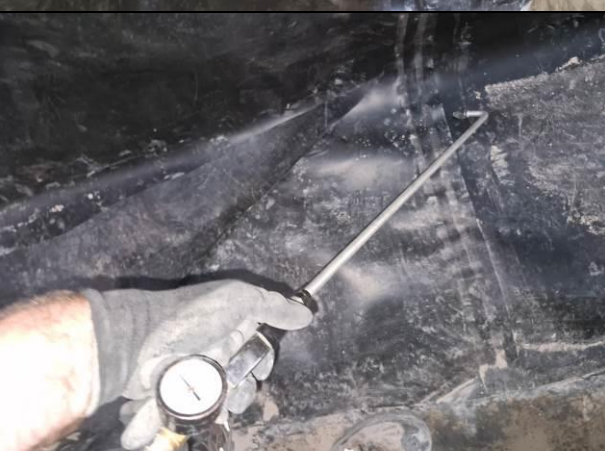
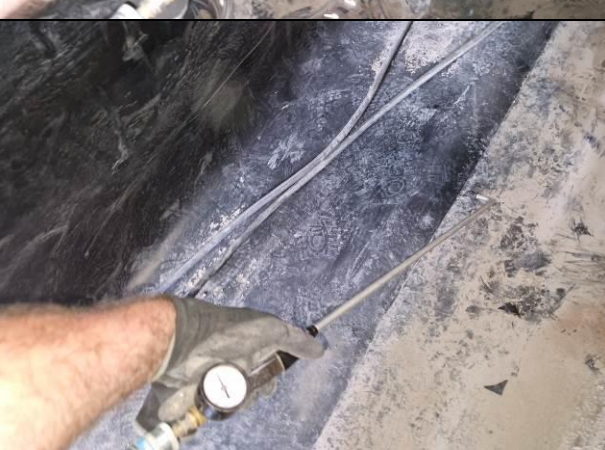
| | <p>Air lance testing of joint between two GP-H membrane sheets in the south and eastern learner pool surround area, with pressure gauge showing maintained pressure above minimum of 50psi advocated by ASTM D4437-08:2013.</p> |

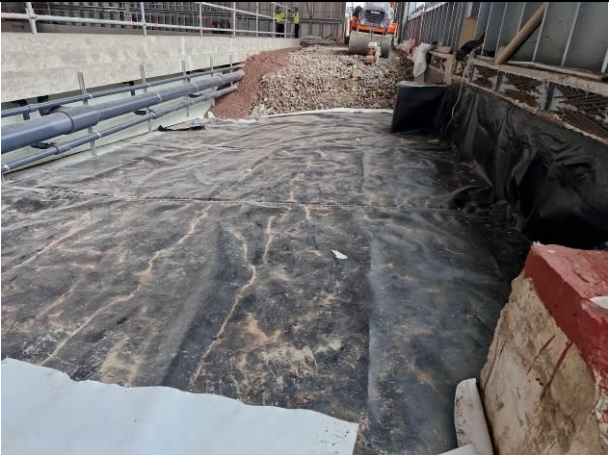
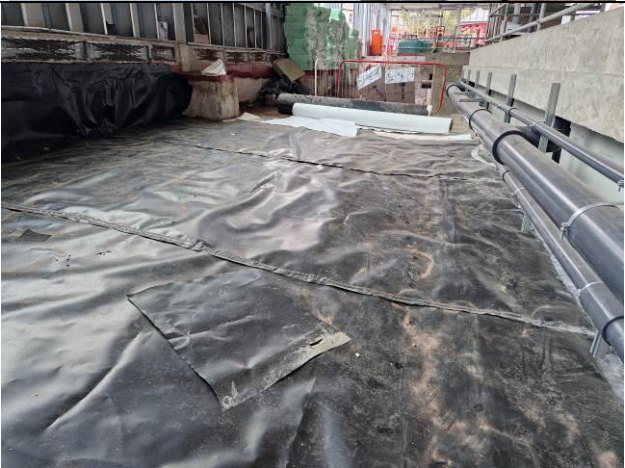
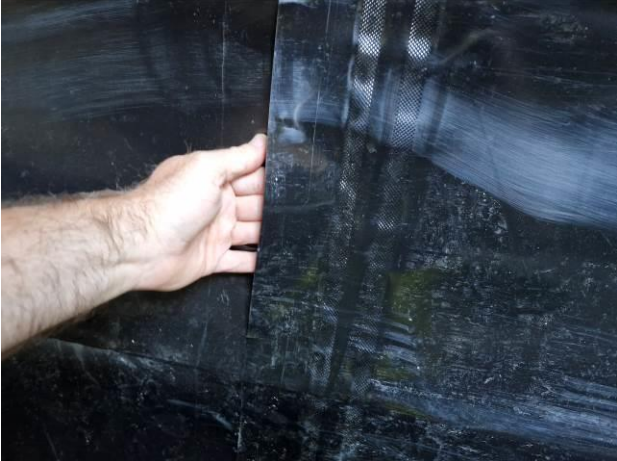
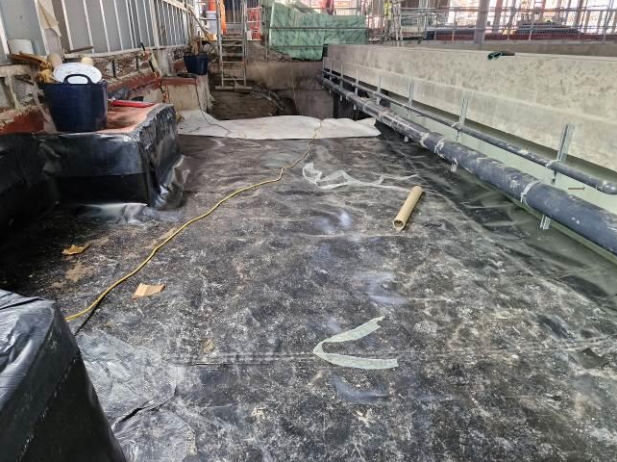
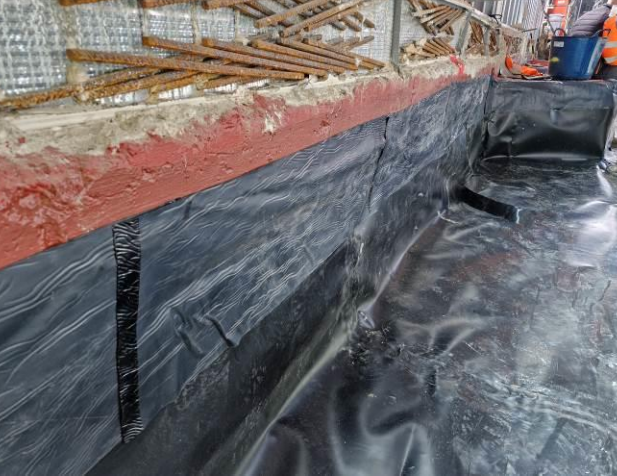
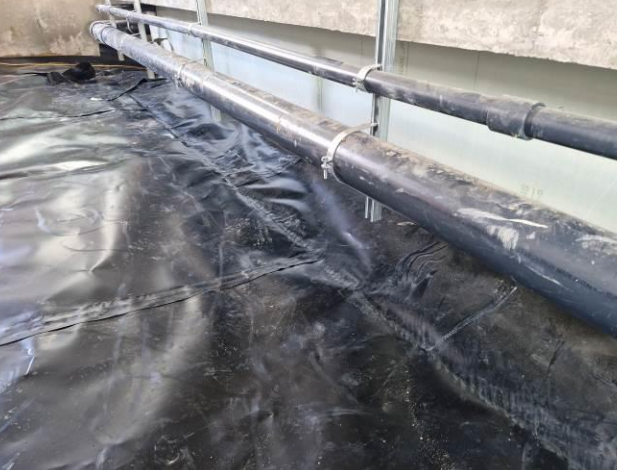
| No. | Item | Comments (see notes) |
|---|---|---|
| 3.3 | Gas membrane condition (rips/ tears/ penetrations) | <i>Generally very good. No punctures/rips or tears identified.</i> |
| | | <i>Photograph showing the radon protection measures installed for the main pool and learner pool northern surround area. GP Liquid barrier (red) applied to all substructure concrete as per design. Juta GP-H 0.6mm membrane (black) bonded to GP Liquid barrier using GR-SAM. Membrane joints heat welded using Twinny type welder.</i> |

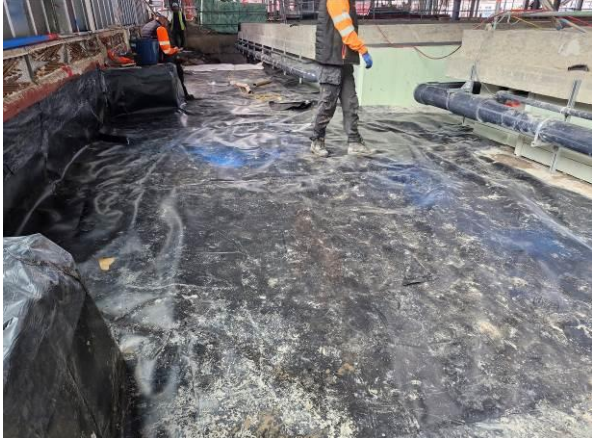
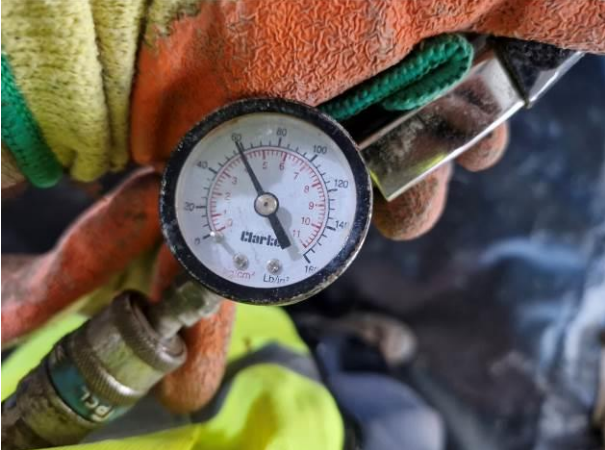
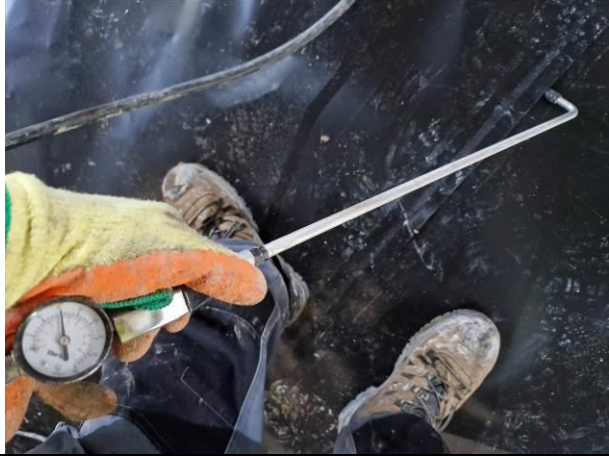
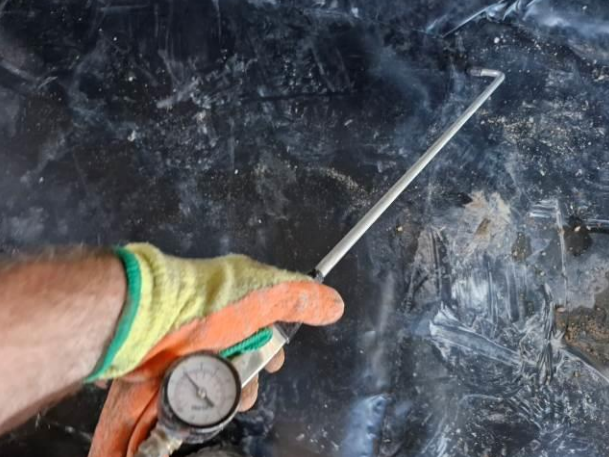
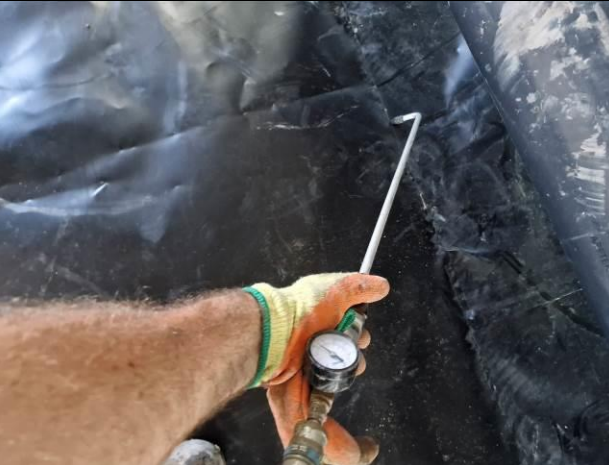
| No. | Item | Comments (see notes) |
|---|---|---|
| Membrane to membrane Joints | S | All membrane to membrane seams/join length proven to be satisfactory by IDG via ASTM D4437 air lance test. No failures recorded. |
| | Air lance testing in main pool and learner pool northern surround area, with pressure gauge showing maintained pressure above minimum of 50psi advocated by ASTM D4437-08:2013. | |

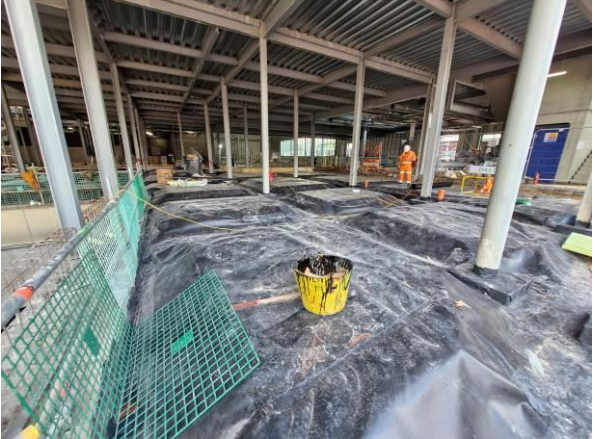
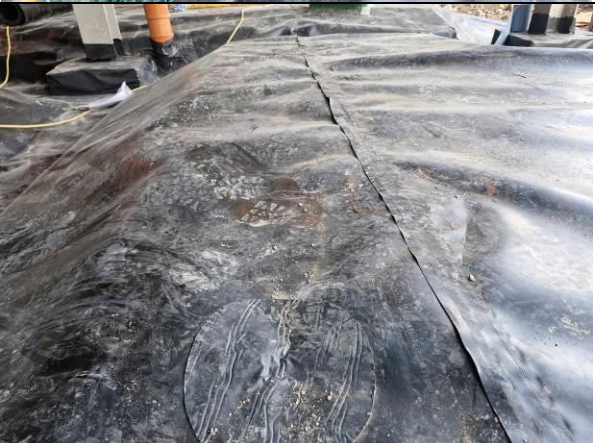
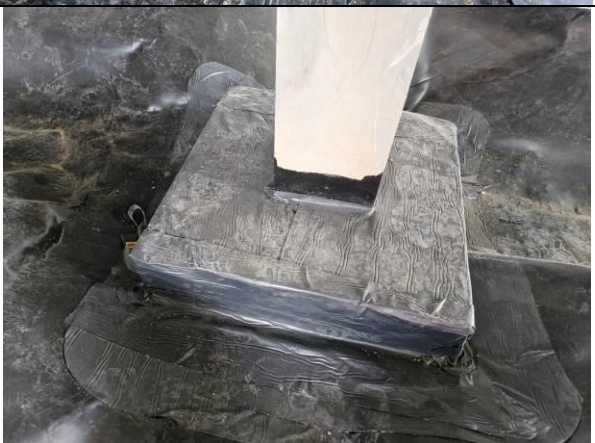
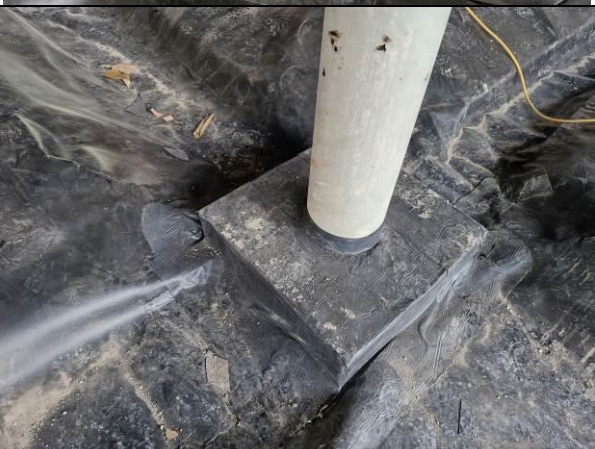
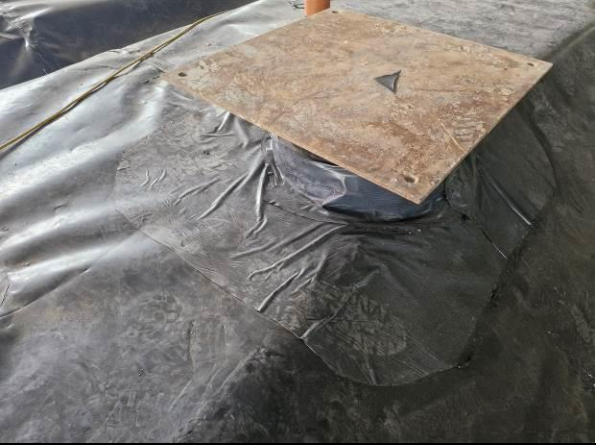
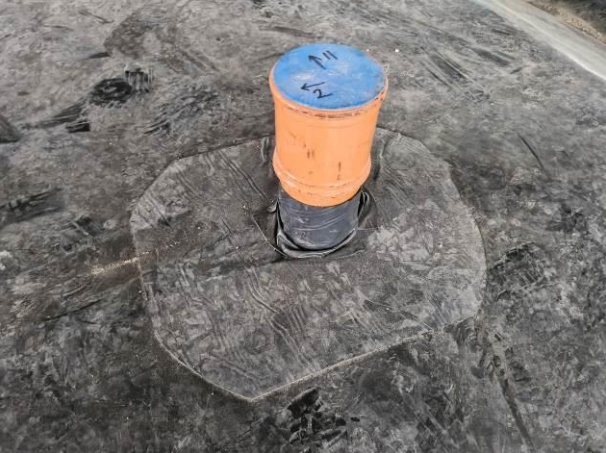
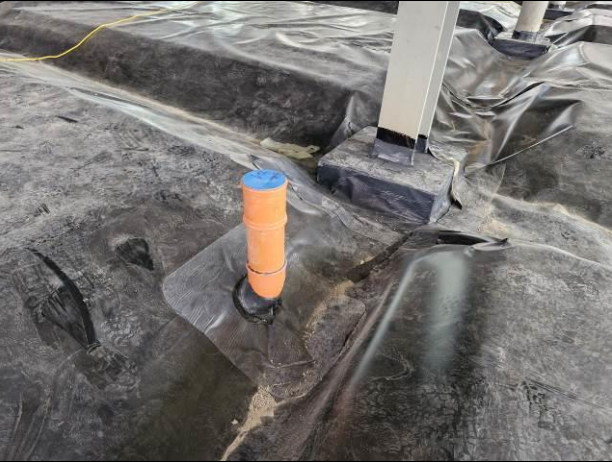
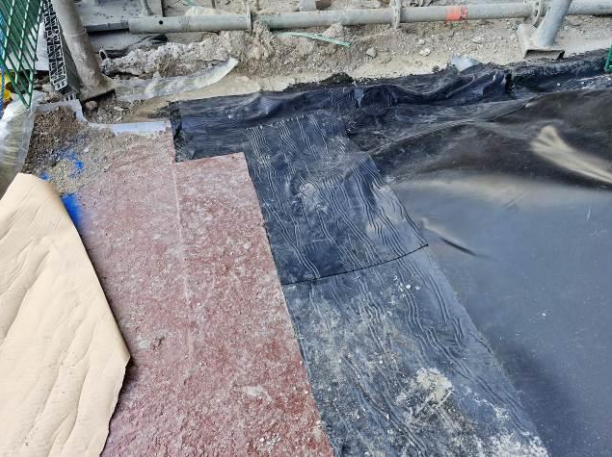
| No. | Item | Comments (see notes) |
|---|---|---|
| 3.3 | Gas membrane condition (rips/ tears/ penetrations) | <i>Generally very good.</i> |

| | <p>Photograph showing the radon protection measures installed for the Phase 3 &amp; 4 floor slab area. GP Liquid barrier (red) applied to all substructure concrete as per design. Juta GP-H 0.6mm membrane (black) bonded to GP Liquid barrier using Titan Tape and / or GR-SAM. Membrane joints heat welded using Twinny type welder.</p> |

N/A - all remedial actions completed

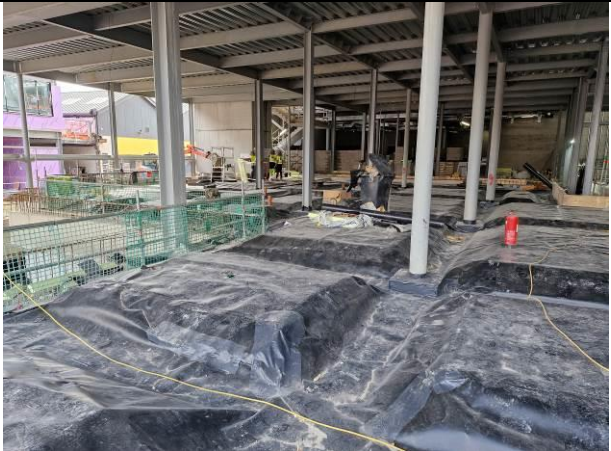
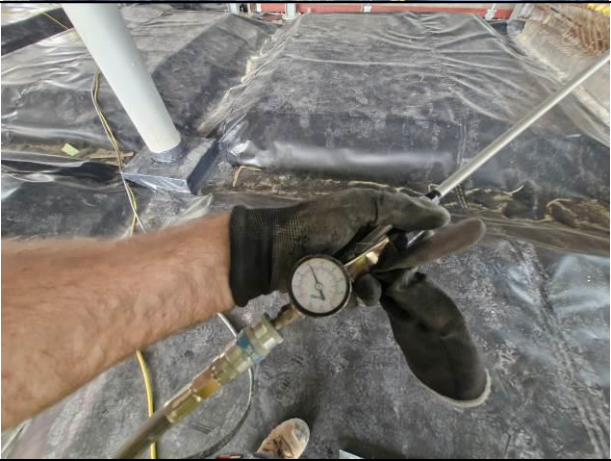
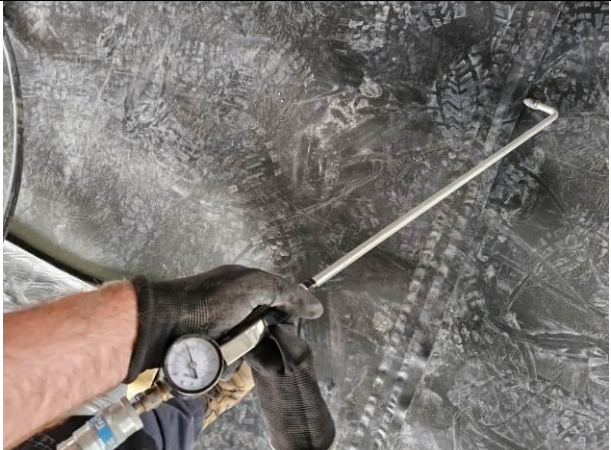
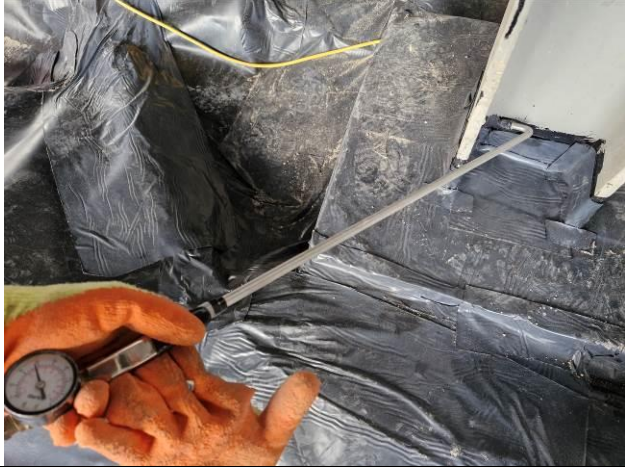
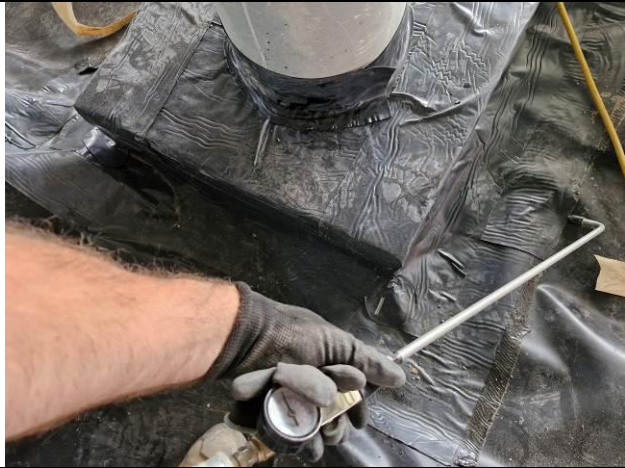
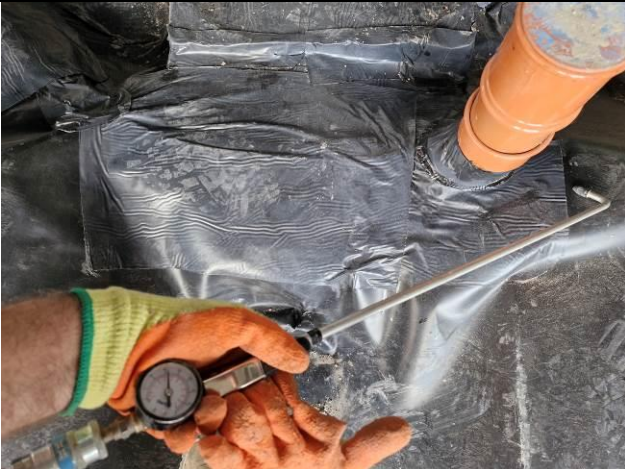
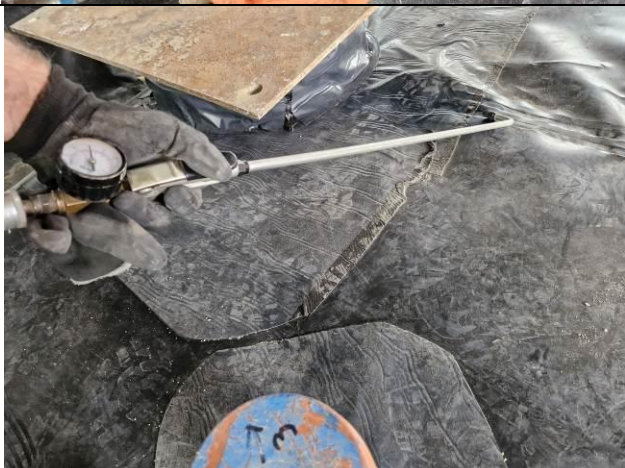
| Photograph | Description |
|---|---|
| | <p>Air lance testing of Phase 3 &amp; 4 floor slab area, with pressure gauge showing maintained pressure above minimum of 50psi advocated by ASTM D4437-08:2013.</p> |

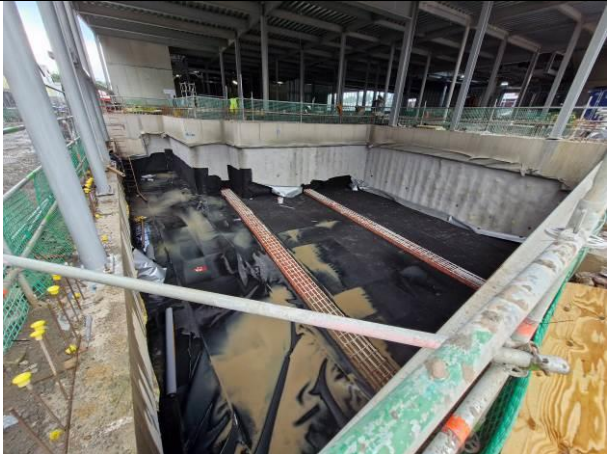
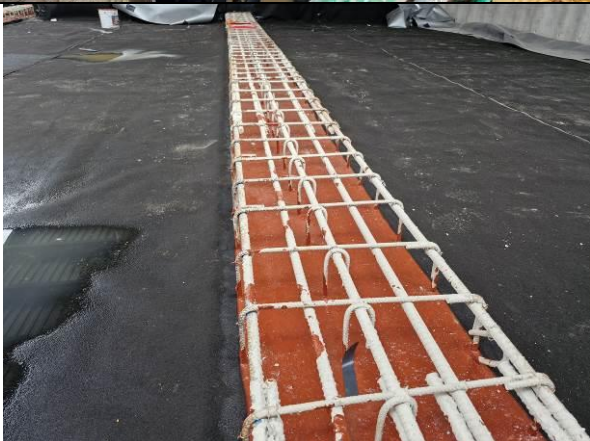
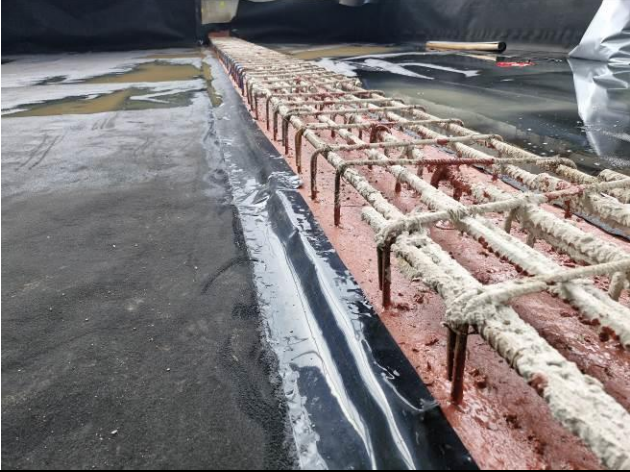
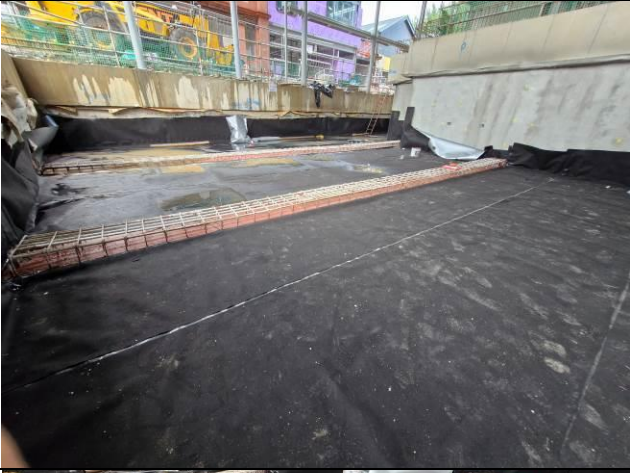
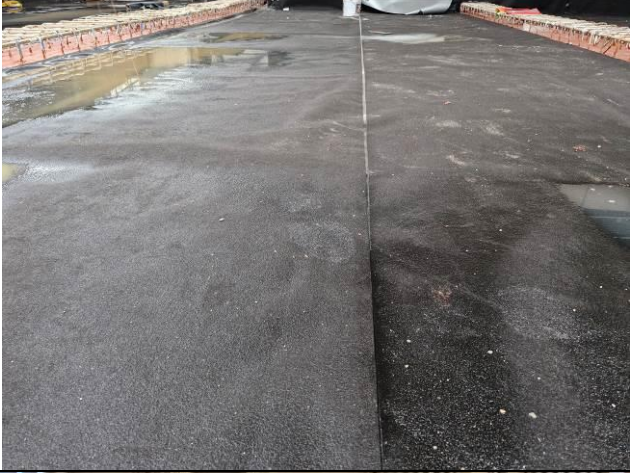
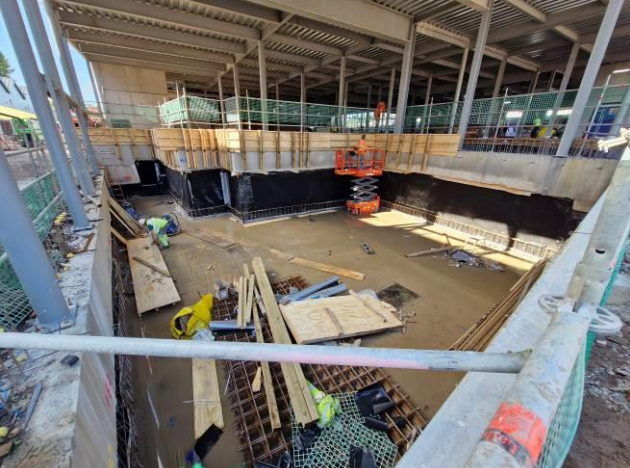
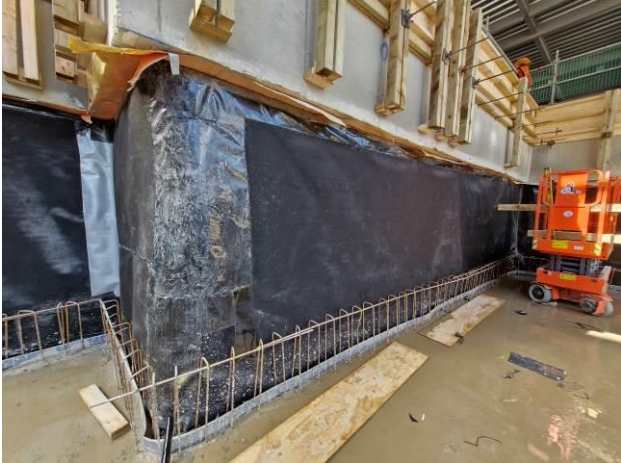
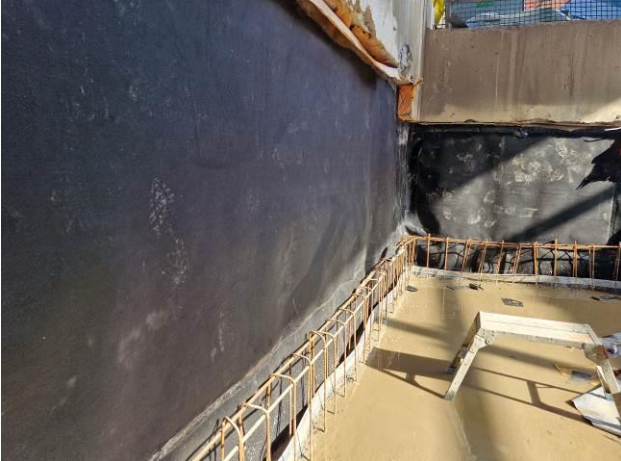
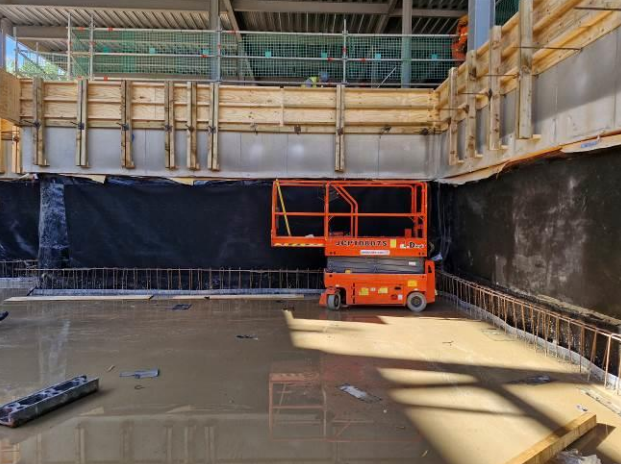
| | <p>Photograph showing the Titan bond membrane installed with heat-welded joints across the base of Basement 2 area. Membrane joined to substructure GP Liquid barrier (red) using GR-SAM.</p> |

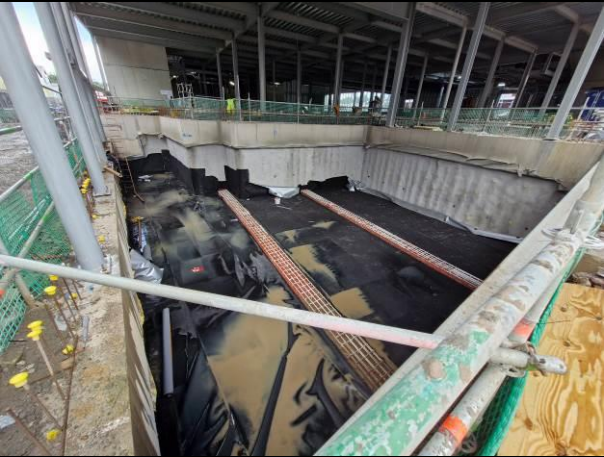
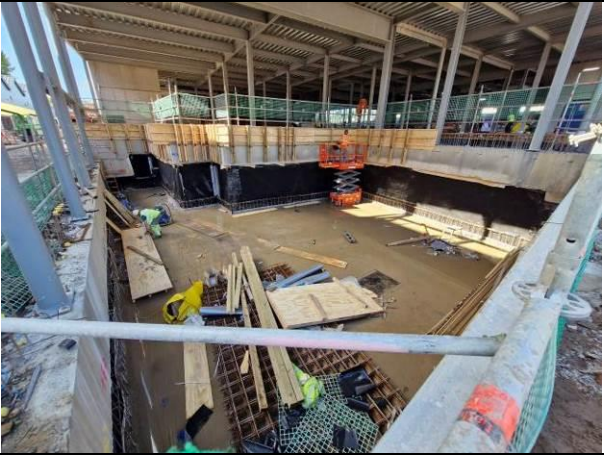
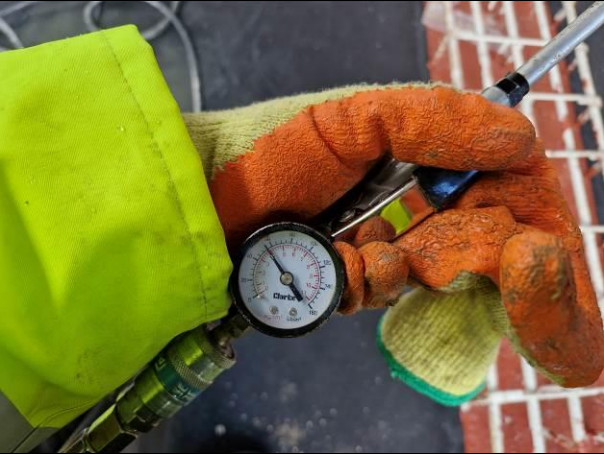
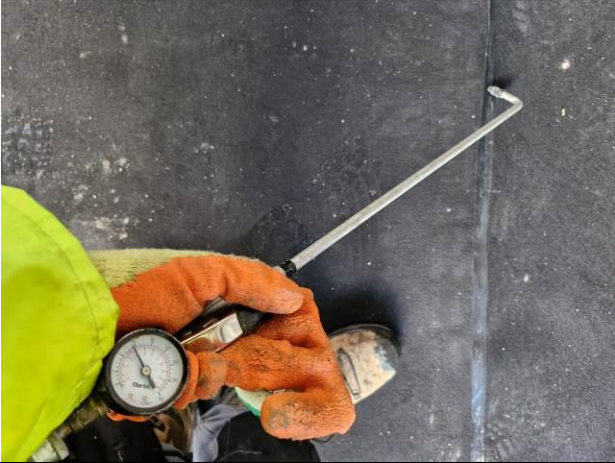
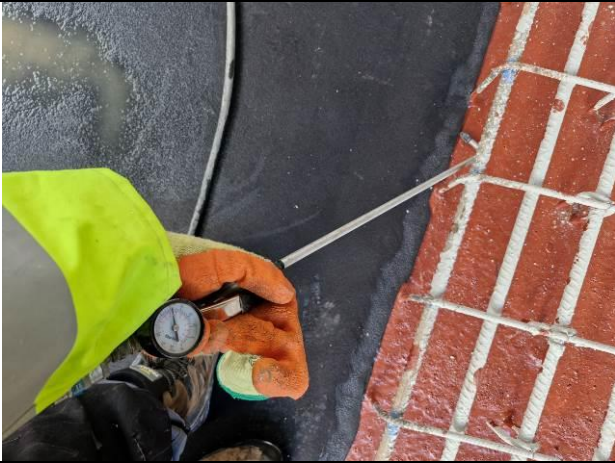
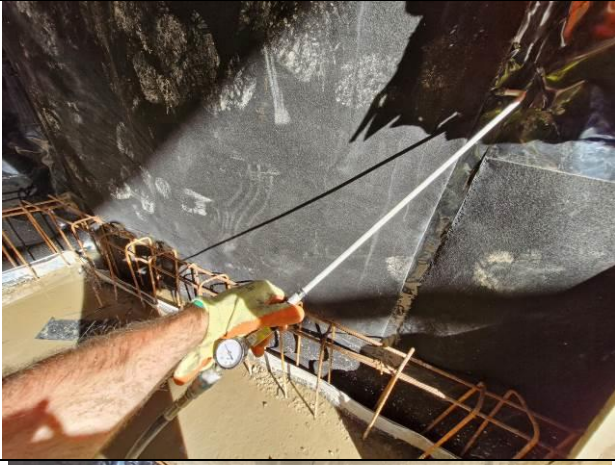
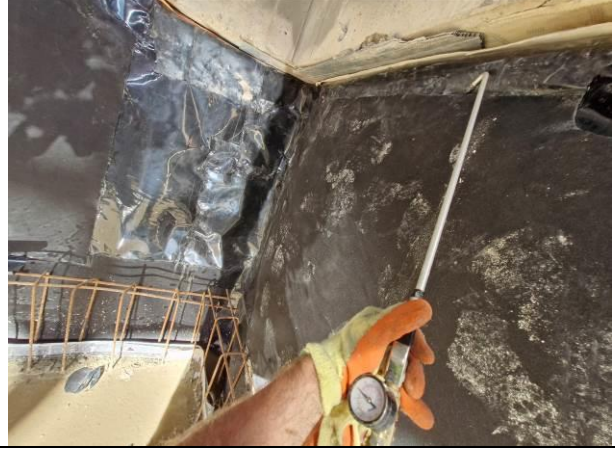
| 4 - Photographs | |
|---|---|
| | <i>Air lance testing of Basement 2 floor area, with pressure gauge showing maintained pressure above minimum of 50psi advocated by ASTM D4437-08:2013.</i> |

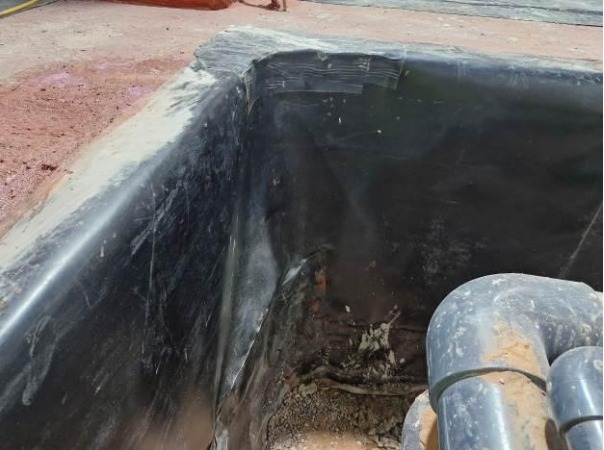
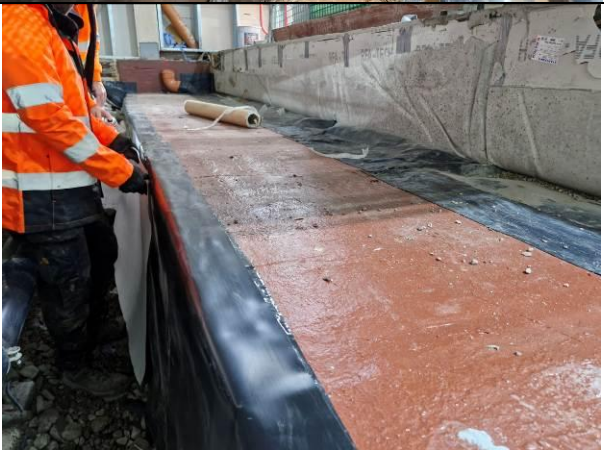
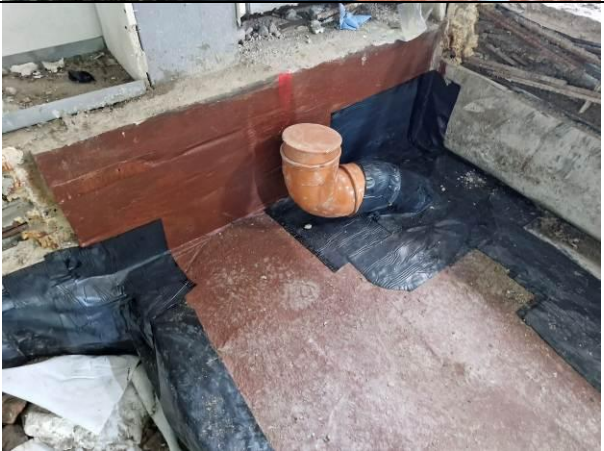
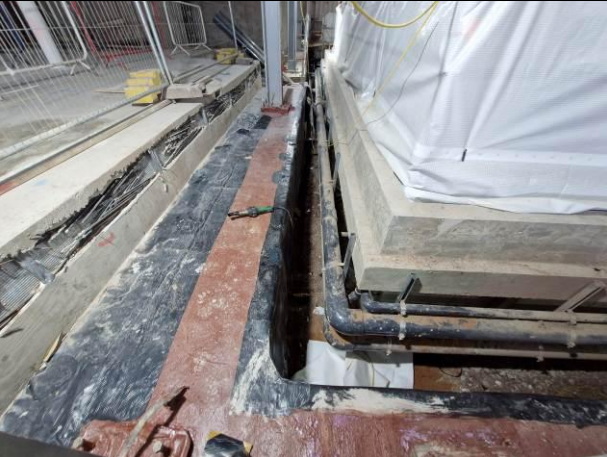
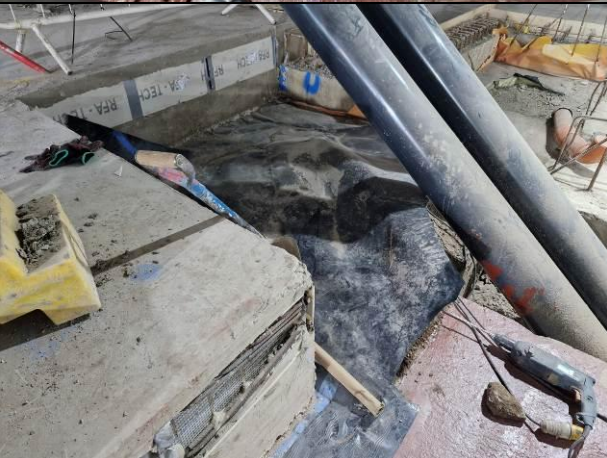
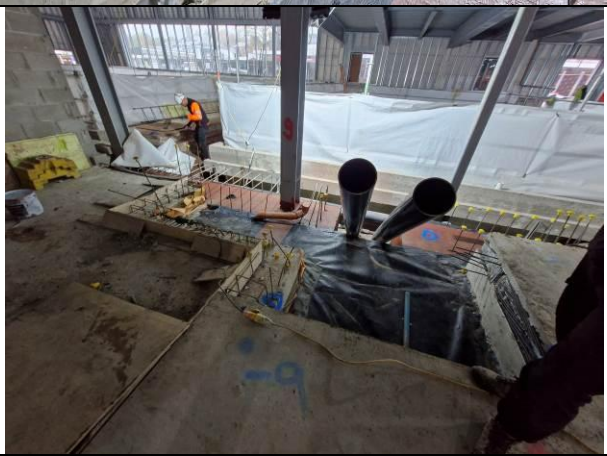
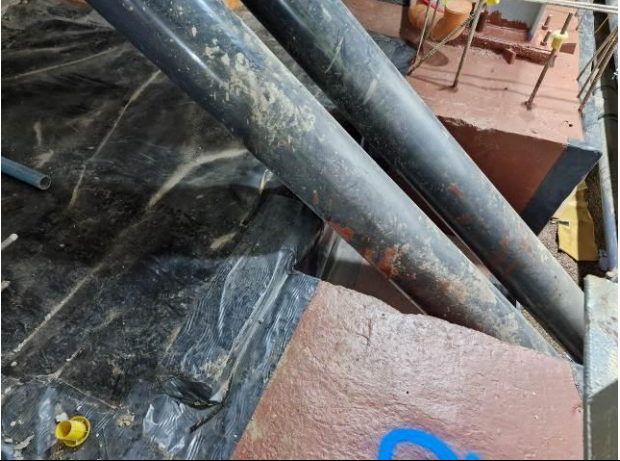
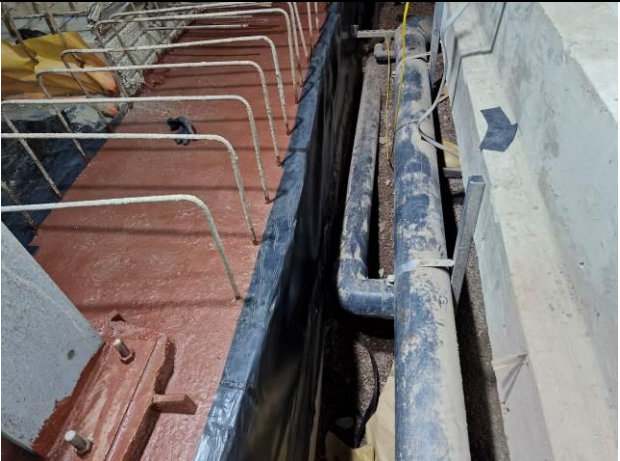
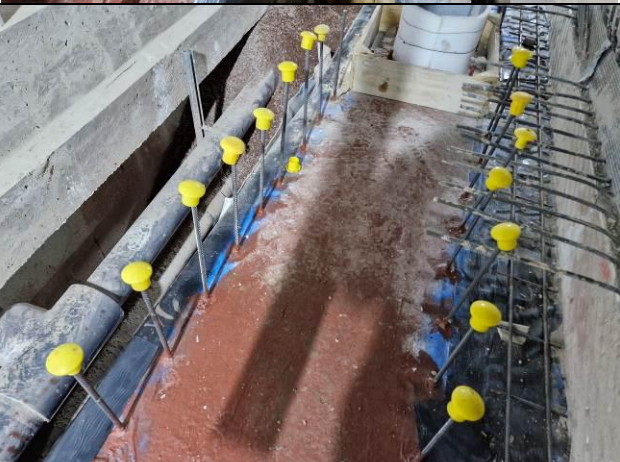
| | <p>Photograph showing the radon protection measures installed for the learner pool eastern and southern surround area vertical faces being tied into main floor slab. GP Liquid barrier (red) applied to all substructure concrete as per design. Juta GP-H 0.6mm membrane (black) bonded to GP Liquid barrier using GR-SAM. Membrane joints heat welded.</p> |

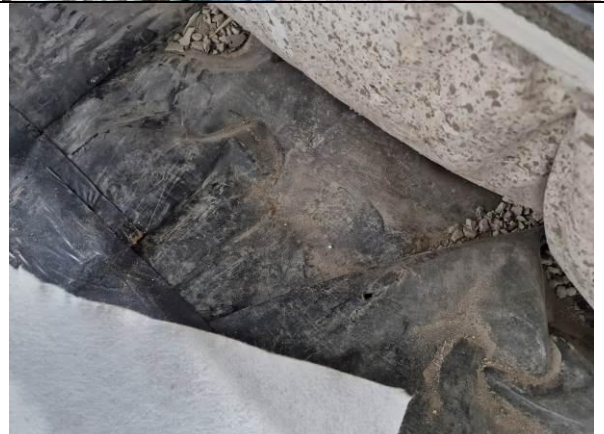
| | <p>Example of puncture damage to previously installed membrane tail requiring repair.</p> |

| | <p>Repair patches being installed to remedy puncture damage under supervision of the verification engineer.</p> |

N/A – All remedial actions relating to minor punctures repaired and checked by validation engineer.

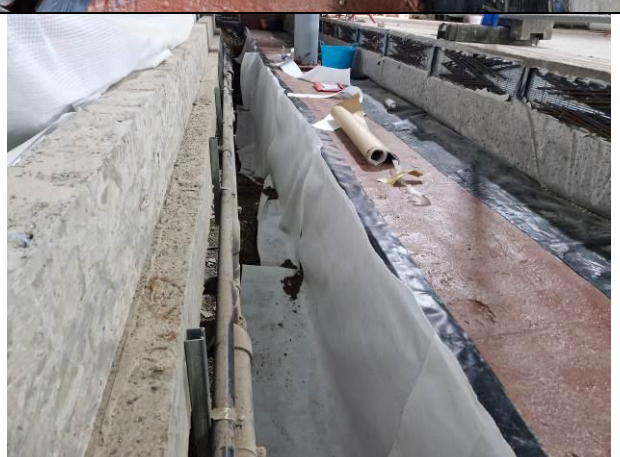
| | <p>Fleece protection layer being installed post-verification to protect membrane during backfilling of the service runs.</p> |
