## Appendix C

# GAS PROTECTION MEASURES VERIFICATION VISUAL INSPECTION RECORD

| Site Name: | Radcliffe Market Chambers Basement | Gas Characteristic Situation: | Basic Radon Only |
| Job Number: | 5238 | Type of development:<br>(Residential/ commercial/ other) | Commercial |

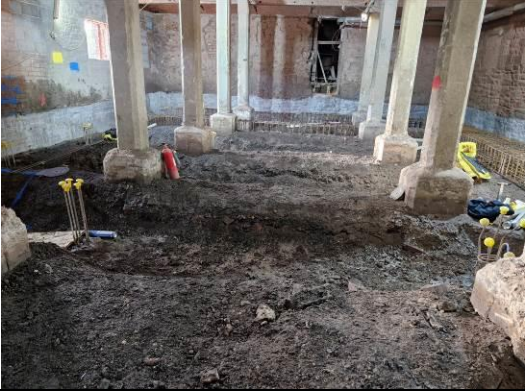
| No. | Item | Comments (see notes) |
|---|---|---|
| | | <i>Photograph showing the first stage of radon protection measures installed for the 'Tomb' area of the Market Hall Basement. SikaDur 32 Epoxy Liquid Barrier (grey) applied to existing walls/ foundations.</i> |

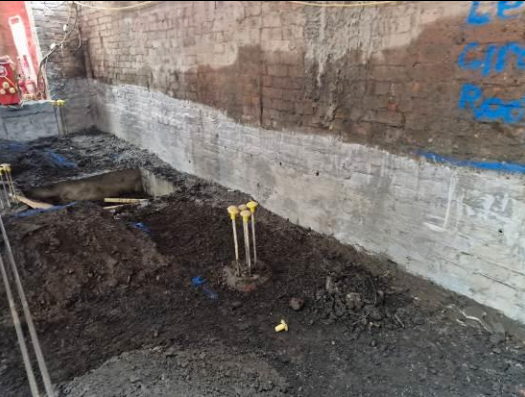
| No. | Item | Comments (see notes) |
|---|---|---|
| | | <i>Photograph showing the first stage of radon protection measures installed for the 'Tomb' area of the Market Hall Basement. SikaDur 32 Epoxy Liquid Barrier (grey) applied to existing walls/ foundations.</i> |

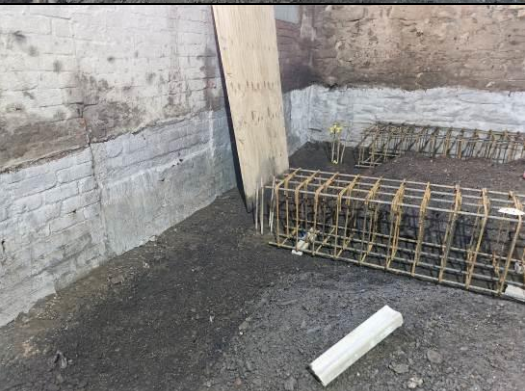
| No. | Item | Comments (see notes) |
|---|---|---|
| | | <i>Photograph showing the first stage of radon protection measures installed for the 'Tomb' area of the Market Hall Basement. SikaDur 32 Epoxy Liquid Barrier (grey) applied to existing walls/ foundations.</i> |

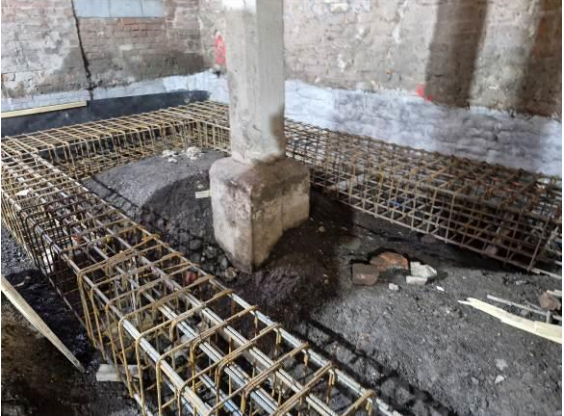
| | <p>Photograph showing the first stage of radon protection measures installed for the 'Tomb' area of the Market Hall Basement. SikaDur 32 Epoxy Liquid Barrier (grey) applied to existing walls/ foundations.</p> |

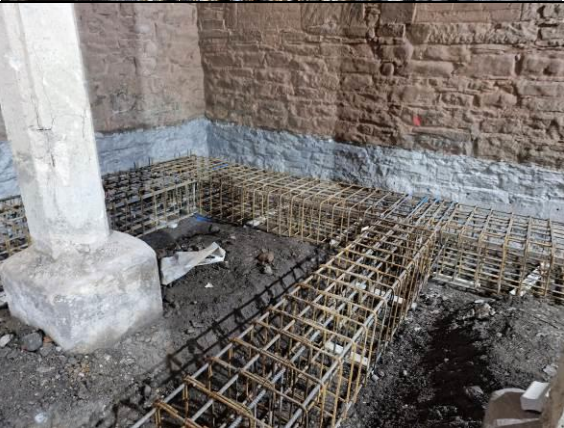
| | <p>Photograph showing the first stage of radon protection measures installed for the 'Tomb' area of the Market Hall Basement. SikaDur 32 Epoxy Liquid Barrier (grey) applied to existing walls/ foundations.</p> |

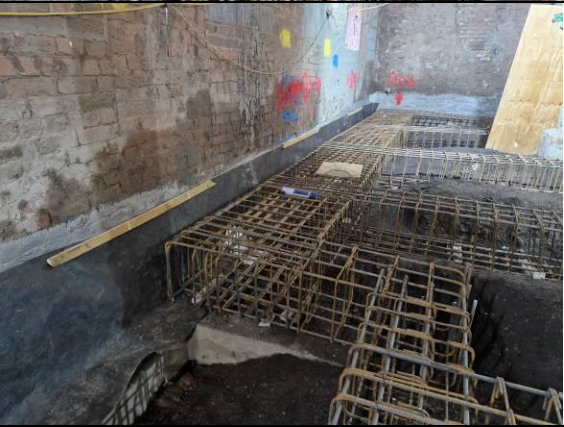
| | <p>Photograph showing the first stage of radon protection measures installed for the 'Tomb' area of the Market Hall Basement. SikaDur 32 Epoxy Liquid Barrier (grey) applied to existing walls/ foundations. Root barrier installed (black).</p> |

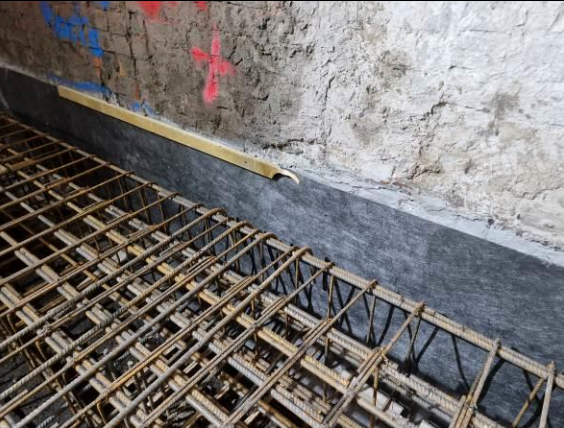
| | <p>Photograph showing the first stage of radon protection measures installed for the 'Tomb' area of the Market Hall Basement. SikaDur 32 Epoxy Liquid Barrier (grey) applied to existing walls/ foundations. Root barrier installed (black).</p> |

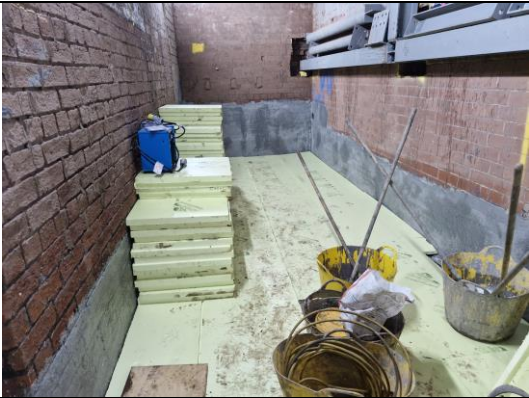
| No. | Item | Comments (see notes) |
|---|---|---|
| | | Photograph showing SikaDur 32 Epoxy Liquid Barrier (grey) applied to existing walls/ foundations in Market Hall Basement chambers. Insulation board being placed on floor prior to membrane being installed. |

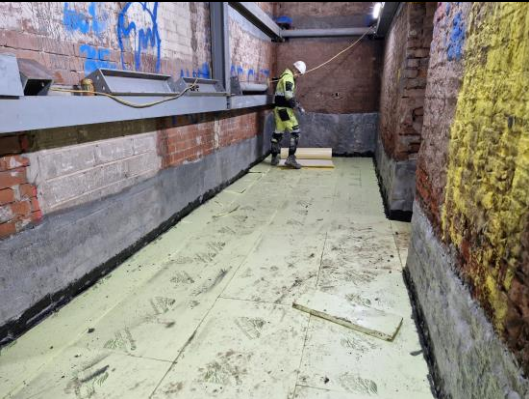
| No. | Item | Comments (see notes) |
|---|---|---|
| | | Photograph showing SikaDur 32 Epoxy Liquid Barrier (grey) applied to existing walls/ foundations in Market Hall Basement chambers. Insulation board being placed on floor prior to membrane being installed. |

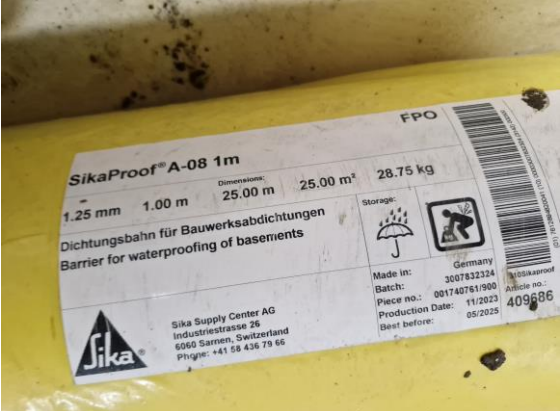
| | <p>Photograph showing roll of SikaProof A-08 Membrane used in Market Hall Basement chambers to form wall to wall radon barrier</p> |

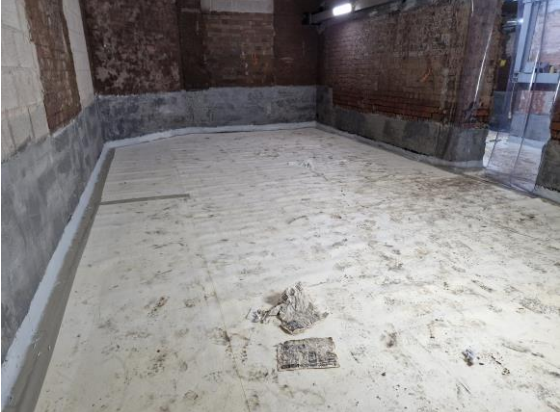
| | <p>Photograph showing SikaProof A-08 Membrane installed in Market Hall Basement chambers to form wall to wall radon barrier, using self-adhesive membrane edge for joints, and SikaProof Tape-150 with Sikadur Combiflex Adhesive used for joints between membrane and SikaDur 32 Epoxy Liquid Barrier on walls.</p> |

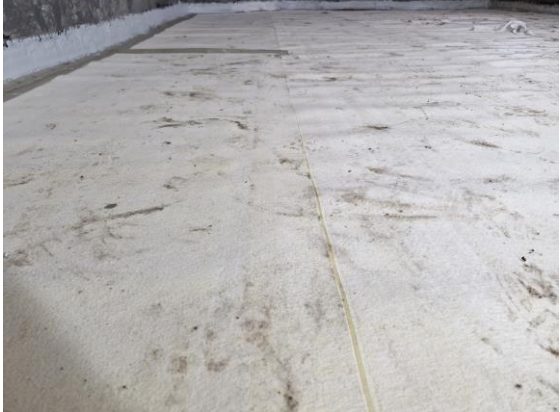
| | <p>Photograph showing SikaProof A-08 Membrane installed in Market Hall Basement chambers to form wall to wall radon barrier, using self-adhesive membrane edge for joints, and SikaProof Tape-150 with Sikadur Combiflex Adhesive used for joints between membrane and SikaDur 32 Epoxy Liquid Barrier on walls.</p> |

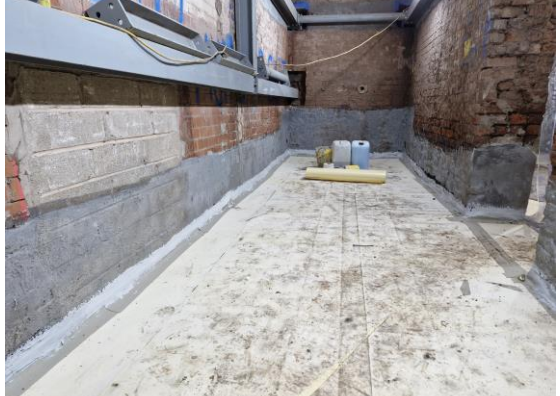
| | <p>Photograph showing SikaProof A-08 Membrane installed in Market Hall Basement chambers to form wall to wall radon barrier, using self-adhesive membrane edge for joints, and SikaProof Tape-150 with Sikadur Combiflex Adhesive used for joints between membrane and SikaDur 32 Epoxy Liquid Barrier on walls.</p> |

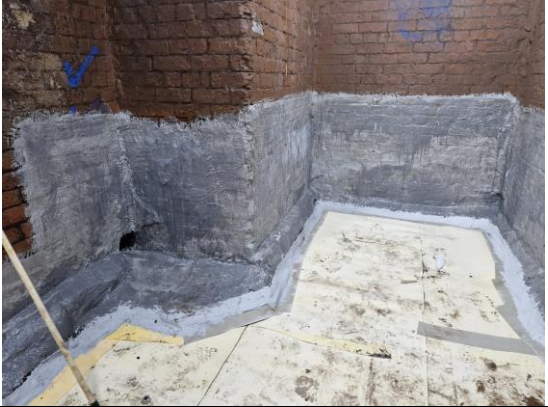
| | <p>Photograph showing SikaProof A-08 Membrane installed in Market Hall Basement chambers to form wall to wall radon barrier, using self-adhesive membrane edge for joints, and SikaProof Tape-150 with Sikadur Combiflex Adhesive used for joints between membrane and SikaDur 32 Epoxy Liquid Barrier on walls.</p> |

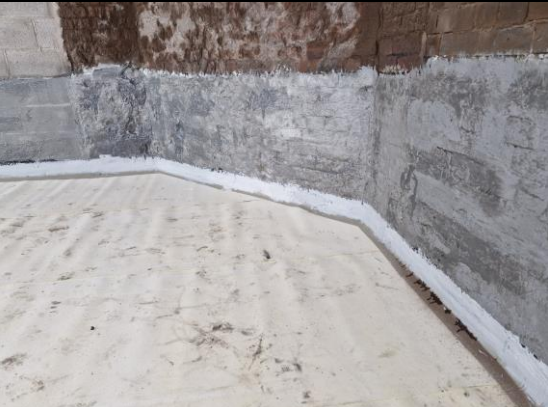
| | <p>Photograph showing SikaProof A-08 Membrane installed in Market Hall Basement chambers to form wall to wall radon barrier, using self-adhesive membrane edge for joints, and SikaProof Tape-150 with Sikadur Combiflex Adhesive used for joints between membrane and SikaDur 32 Epoxy Liquid Barrier on walls.</p> |

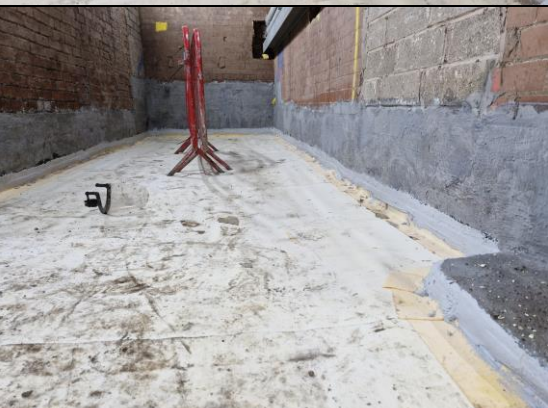
| | <p>Photograph showing SikaProof A-08 Membrane installed in Market Hall Basement chambers to form wall to wall radon barrier, using self-adhesive membrane edge for joints, and SikaProof Tape-150 with Sikadur Combiflex Adhesive used for joints between membrane and SikaDur 32 Epoxy Liquid Barrier on walls.</p> |

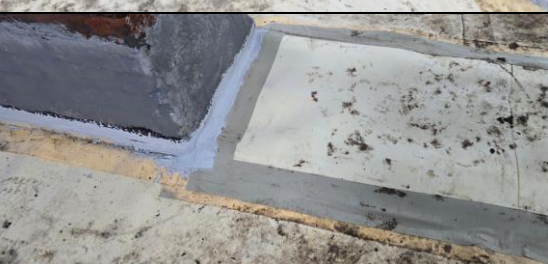
| | <p>Photograph showing SikaProof A-08 Membrane installed in Market Hall Basement chambers at threshold between rooms. Detailing completed with SikaProof Tape-150 with Sikadur Combiflex Adhesive used for joints between membrane and SikaDur 32 Epoxy Liquid Barrier on walls.</p> |

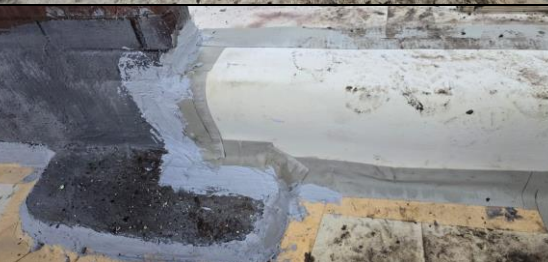
| | <p>Photograph showing SikaProof A-08 Membrane installed in Market Hall Basement chambers at threshold between rooms. Detailing completed with SikaProof Tape-150 with Sikadur Combiflex Adhesive used for joints between membrane and SikaDur 32 Epoxy Liquid Barrier on walls.</p> |

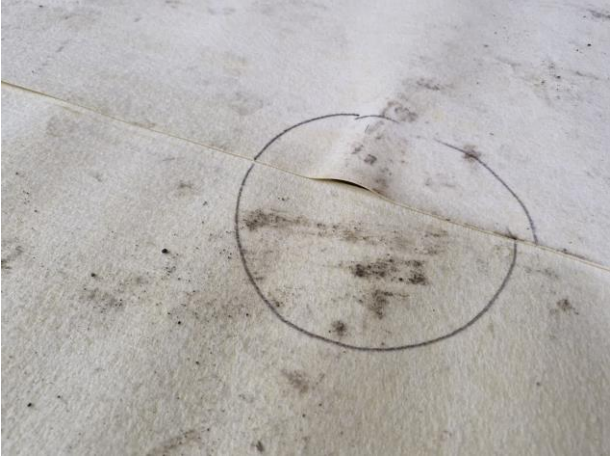
| | <p>Photograph showing failure point identified at self-adhesive edge of SikaProof A-08 Membrane installed in Market Hall Basement chambers.</p> |

Minor repairs required as noted in Section 3.6.

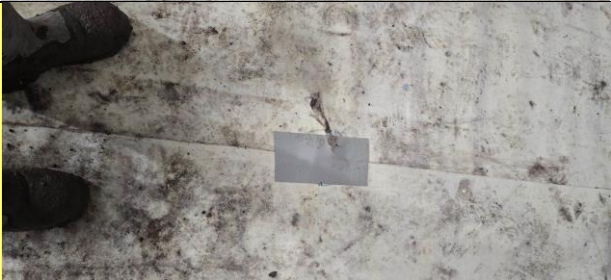
| | <p>Photograph showing identified failure point identified at self-adhesive edge of SikaProof A-08 Membrane repaired using SikaProof Tape-150.</p> |

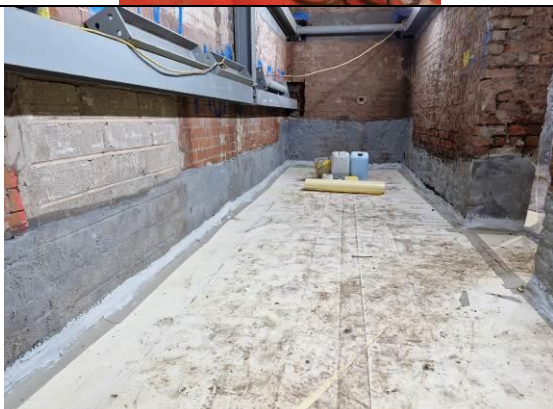
| No. | Item | Comments (see notes) |
|---|---|---|
| | | Photograph showing SikaProof A-08 Membrane installed in Market Hall Basement chambers to form wall to wall radon barrier, using self-adhesive membrane edge for joints, and SikaProof Tape-150 with Sikadur Combiflex Adhesive used for joints between membrane and SikaDur 32 Epoxy Liquid Barrier on walls. |

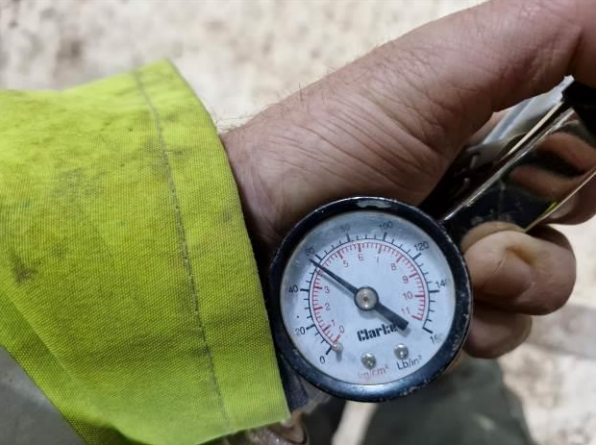
| | <p>Air lance testing of SikaProof A-08 Membrane installed in Market Hall Basement chambers, with pressure gauge showing maintained pressure above minimum of 50psi advocated by ASTM D4437-08:2013.</p> |

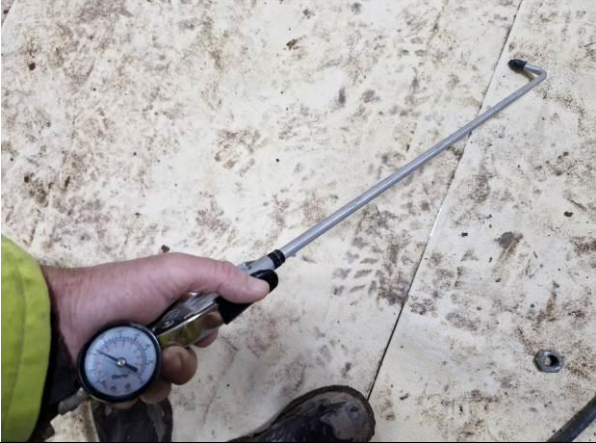
| | <p>Air lance testing of joint between two SikaProof A-08 Membrane sheets installed in Market Hall Basement chambers, with pressure gauge showing maintained pressure above minimum of 50psi advocated by ASTM D4437-08:2013.</p> |

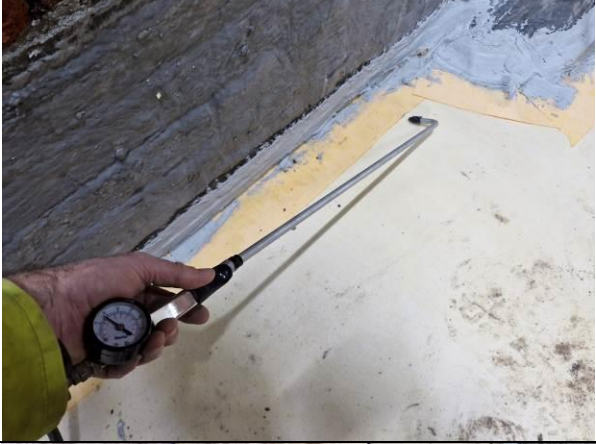
| | <p>Air lance testing of taped joint between SikaProof A-08 Membrane and SikaDur 32 Epoxy Liquid Barrier in Market Hall Basement chambers, with pressure gauge showing maintained pressure above minimum of 50psi advocated by ASTM D4437-08:2013.</p> |

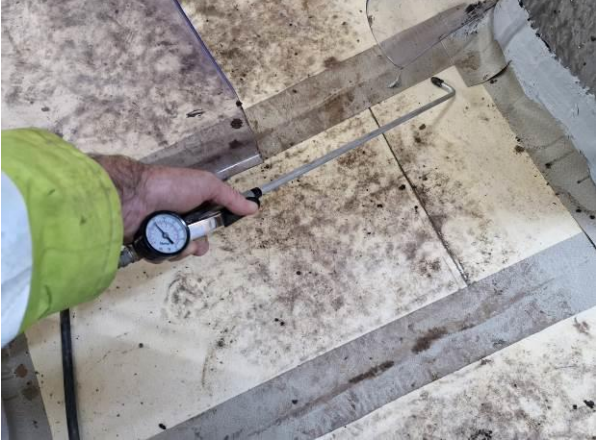
| | <p>Air lance testing of taped joint between SikaProof A-08 Membrane sheets at door way threshold in Market Hall Basement chambers, with pressure gauge showing maintained pressure above minimum of 50psi advocated by ASTM D4437-08:2013.</p> |

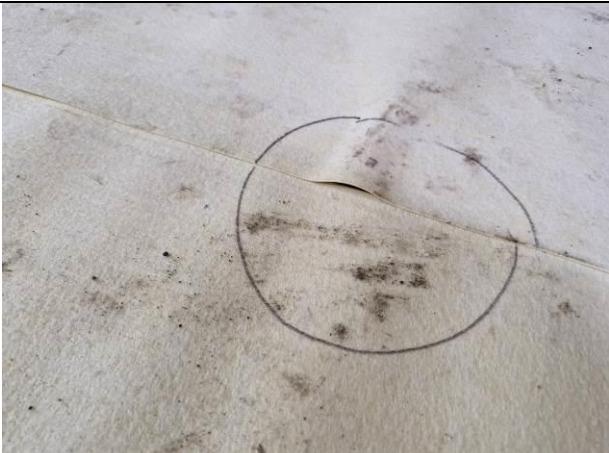
| No. | Item | Comments (see notes) |
|---|---|---|
| 1 | F (S) | F <sub>1</sub> – Creases in the membrane formed an air channel (and therefore incomplete seal) across the self-adhesive membrane joint. Contractor was advised and these were repaired. Remedial works completed by contractor subsequently re-inspected / re-tested and determined to be satisfactory. |

| | <p>Photograph showing failure point (F<sub>1</sub>) identified at self-adhesive edge of SikaProof A-08 Membrane installed in Market Hall Basement chambers.</p> |

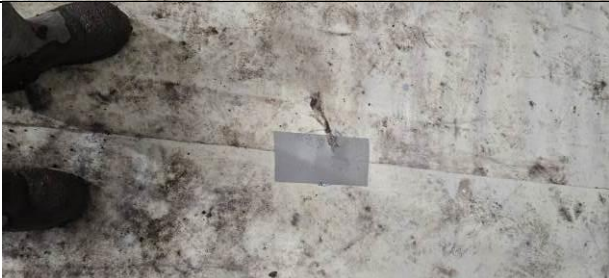
| | <p>Photograph showing identified failure point identified at self-adhesive edge of SikaProof A-08 Membrane repaired using SikaProof Tape-150.</p> |

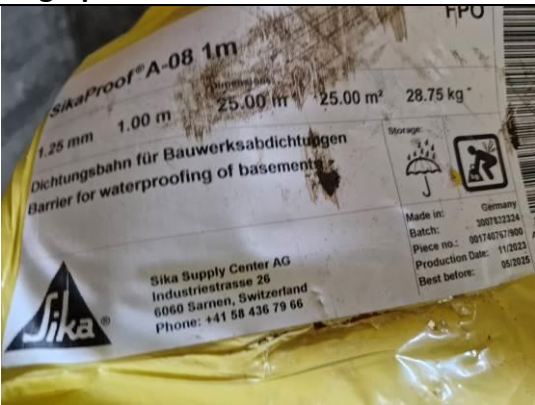
| No. | Item | Comments (see notes) |
|---|---|---|
| | | Photograph showing roll of SikaProof A-08 Membrane used in Market Hall Basement chambers to form wall to wall radon barrier |

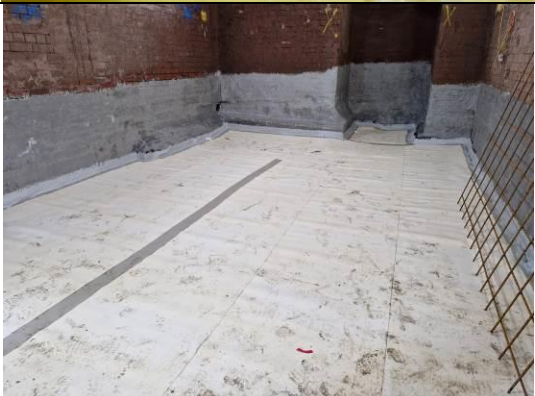
| No. | Item | Comments (see notes) |
|---|---|---|
| | | Photograph showing SikaDur 32 Epoxy Liquid Barrier (grey) applied to existing walls/ foundations. SikaProof A-08 Membrane installed in Market Hall Basement chambers to form wall to wall radon barrier, using self-adhesive membrane edge for joints, and SikaProof Tape-150 with Sikadur Combiflex Adhesive used for joints between membrane and SikaDur 32 Epoxy Liquid Barrier on walls. |

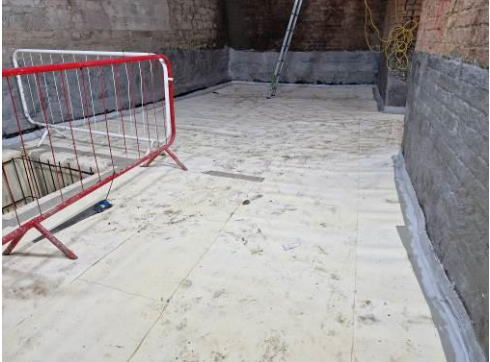
| | <p>Photograph showing SikaDur 32 Epoxy Liquid Barrier (grey) applied to existing walls/foundations. SikaProof A-08 Membrane installed in Market Hall Basement chambers to form wall to wall radon barrier, using self-adhesive membrane edge for joints, and SikaProof Tape-150 with Sikadur Combiflex Adhesive used for joints between membrane and SikaDur 32 Epoxy Liquid Barrier on walls.</p> |

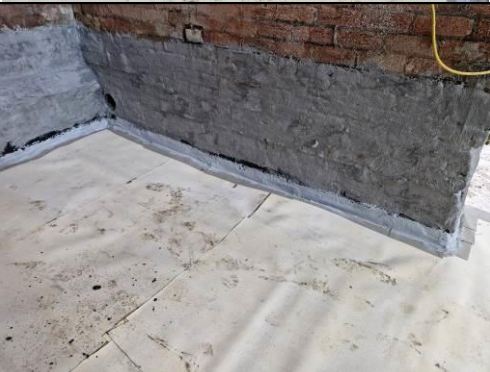
| | <p>Photograph showing SikaProof A-08 Membrane installed in Market Hall Basement chambers to form wall to wall radon barrier, using self-adhesive membrane edge for joints, and SikaProof Tape-150 with Sikadur Combiflex Adhesive used for joints between membrane and SikaDur 32 Epoxy Liquid Barrier on walls.</p> |

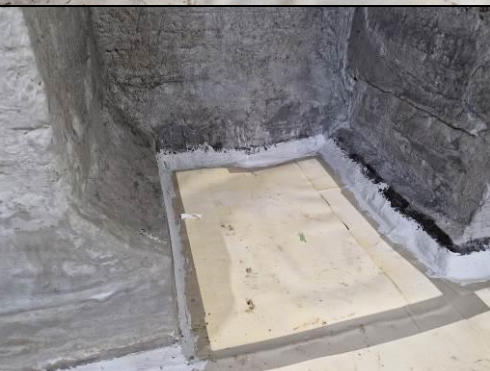
| | <p>Photograph showing SikaProof A-08 Membrane installed in Market Hall Basement chambers to form wall to wall radon barrier. Detailing completed with SikaProof Tape-150 with Sikadur Combiflex Adhesive used for joints between membrane and SikaDur 32 Epoxy Liquid Barrier on walls.</p> |

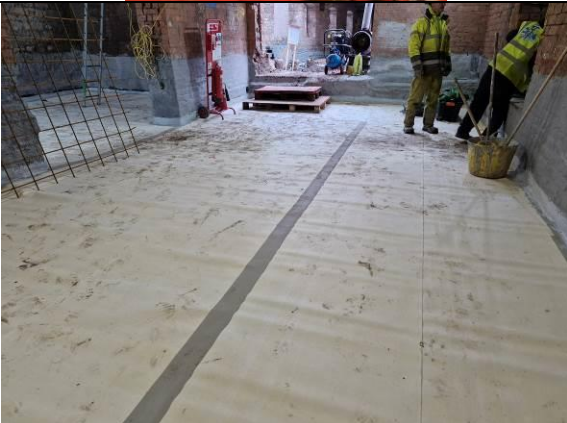
| No. | Item | Comments (see notes) |
|---|---|---|
| | Air lance testing of SikaProof A-08 Membrane installed in Market Hall Basement chambers. | |

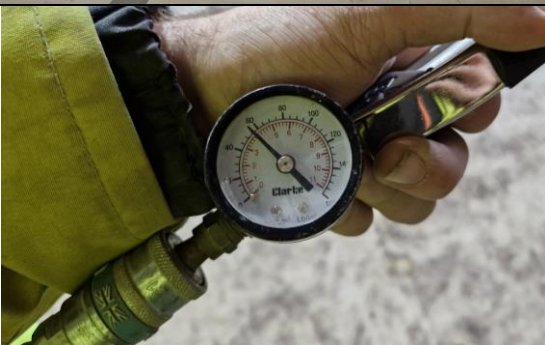
| No. | Item | Comments (see notes) |
|---|---|---|
| | Air lance testing of SikaProof A-08 Membrane installed in Market Hall Basement chambers, with pressure gauge showing maintained pressure above minimum of 50psi advocated by ASTM D4437-08:2013. | |

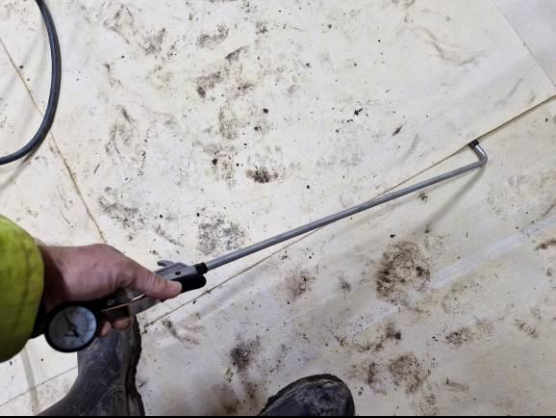
| | <p><i>Air lance testing of joint between two SikaProof A-08 Membrane sheets installed in Market Hall Basement chambers, with pressure gauge showing maintained pressure above minimum of 50psi advocated by ASTM D4437-08:2013.</i></p> |

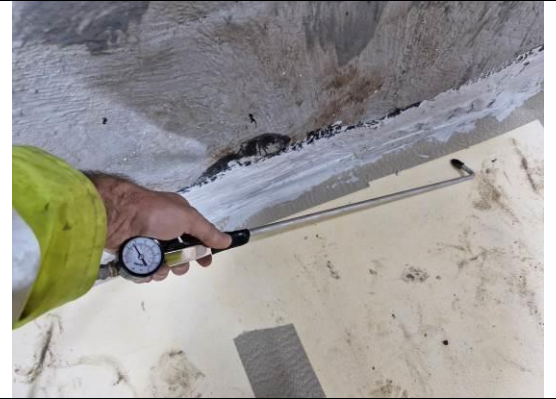
| | <p><i>Air lance testing of taped joint between SikaProof A-08 Membrane and SikaDur 32 Epoxy Liquid Barrier in Market Hall Basement chambers, with pressure gauge showing maintained pressure above minimum of 50psi advocated by ASTM D4437-08:2013.</i></p> |

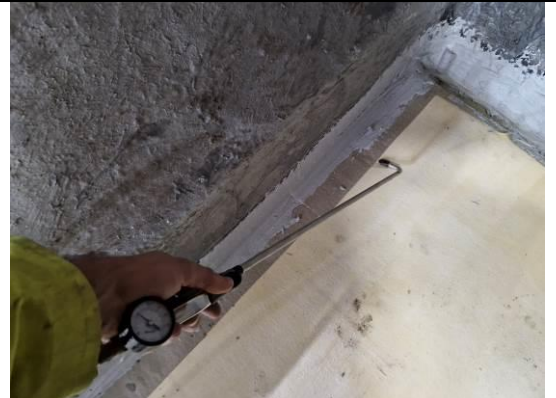
| | <p><i>Air lance testing of taped joint between SikaProof A-08 Membrane and SikaDur 32 Epoxy Liquid Barrier in Market Hall Basement chambers, with pressure gauge showing maintained pressure above minimum of 50psi advocated by ASTM D4437-08:2013.</i></p> |

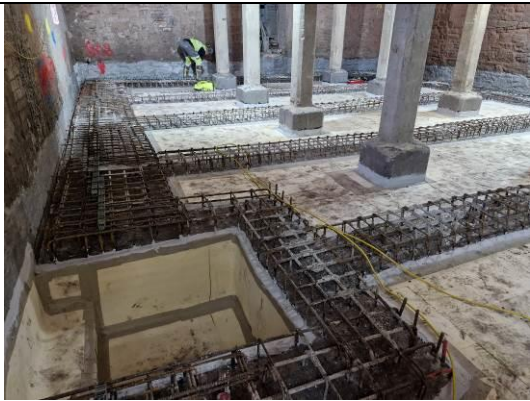
| No. | Item | Comments (see notes) |
|---|---|---|
| | | <i>Photograph showing the 'Tomb' area of the Market Hall Basement, with SikaDur 32 Epoxy Liquid Barrier (grey) applied to existing walls/foundations and applied to new ground beams and stanchion bases. SikaProof A-08 Membrane installed in 'slab' areas between ground beams to form wall to wall radon barrier. Self-adhesive membrane edge for joints, and SikaProof Tape-150 with Sikadur Combiflex Adhesive used for joints between membrane and SikaDur 32 Epoxy Liquid Barrier on stanchion bases and beams.</i> |

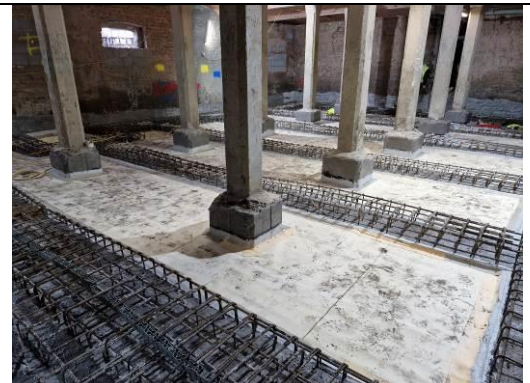
| No. | Item | Comments (see notes) |
|---|---|---|
| | | <i>Photograph showing the 'Tomb' area of the Market Hall Basement, with SikaDur 32 Epoxy Liquid Barrier (grey) applied to existing walls/foundations and applied to new ground beams and stanchion bases. SikaProof A-08 Membrane installed in 'slab' areas between ground beams to form wall to wall radon barrier. Self-adhesive membrane edge for joints, and SikaProof Tape-150 with Sikadur Combiflex Adhesive used for joints between membrane and SikaDur 32 Epoxy Liquid Barrier on stanchion bases and beams.</i> |

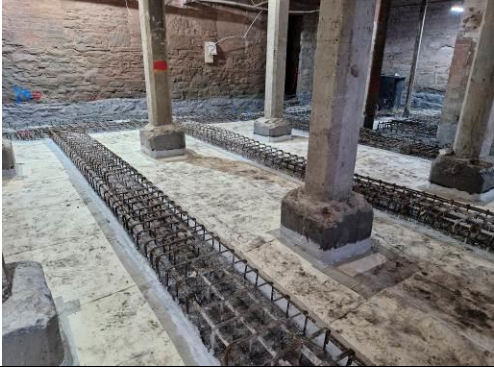
| | <p>Photograph showing the 'Tomb' area of the Market Hall Basement, with SikaDur 32 Epoxy Liquid Barrier (grey) applied to existing walls/foundations and applied to new ground beams and stanchion bases. SikaProof A-08 Membrane installed in 'slab' areas between ground beams to form wall to wall radon barrier. Self-adhesive membrane edge for joints, and SikaProof Tape-150 with Sikadur Combiflex Adhesive used for joints between membrane and SikaDur 32 Epoxy Liquid Barrier on stanchion bases and beams.</p> |

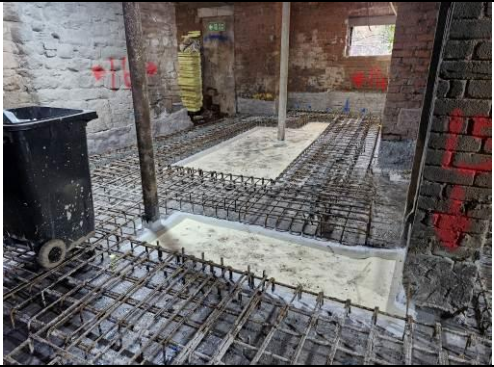
| | <p>Photograph showing the 'Tomb' area of the Market Hall Basement, with SikaDur 32 Epoxy Liquid Barrier (grey) applied to existing walls/foundations and applied to new ground beams and stanchion bases. SikaProof A-08 Membrane installed in 'slab' areas between ground beams to form wall to wall radon barrier. Self-adhesive membrane edge for joints, and SikaProof Tape-150 with Sikadur Combiflex Adhesive used for joints between membrane and SikaDur 32 Epoxy Liquid Barrier on stanchion bases and beams.</p> |

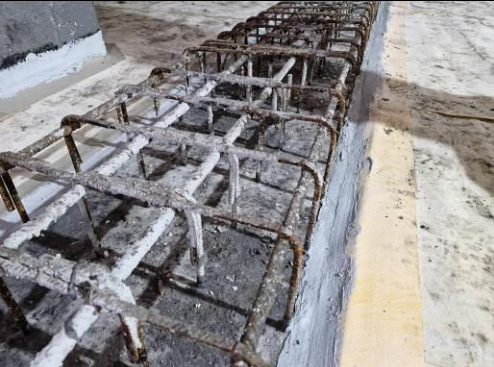
| | <p>Photograph showing the 'Tomb' area of the Market Hall Basement, with SikaDur 32 Epoxy Liquid Barrier (grey) applied to existing walls/foundations and applied to new ground beams and stanchion bases. SikaProof A-08 Membrane installed in 'slab' areas between ground beams to form wall to wall radon barrier. Self-adhesive membrane edge for joints, and SikaProof Tape-150 with Sikadur Combiflex Adhesive used for joints between membrane and SikaDur 32 Epoxy Liquid Barrier on stanchion bases and beams.</p> |

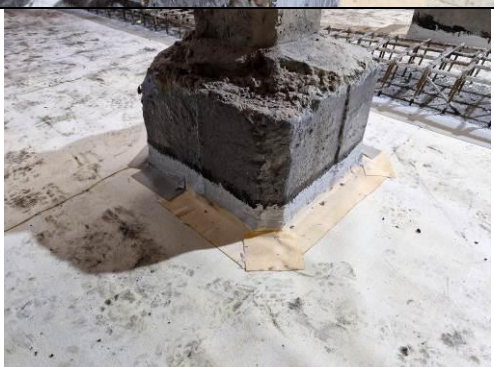
| | <p>Photograph showing the 'Tomb' area of the Market Hall Basement, with SikaDur 32 Epoxy Liquid Barrier (grey) applied to existing walls/foundations and applied to new ground beams and stanchion bases. SikaProof A-08 Membrane installed in 'slab' areas between ground beams to form wall to wall radon barrier. Self-adhesive membrane edge for joints, and SikaProof Tape-150 with Sikadur Combiflex Adhesive used for joints between membrane and SikaDur 32 Epoxy Liquid Barrier on stanchion bases and beams.</p> |

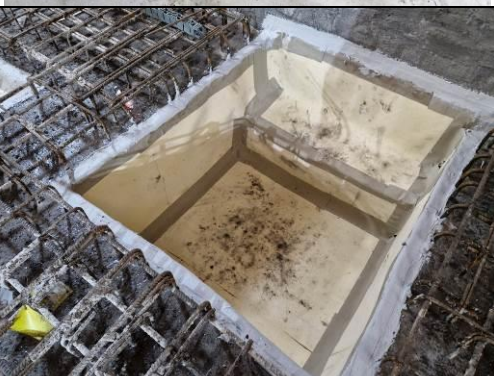
| | <p>Photograph showing SikaProof A-08 Membrane installed in 'Tomb' area of the Market Hall Basement to form wall to wall radon barrier. Detailing completed with SikaProof Tape-150 with Sikadur Combiflex Adhesive used for joints between membrane and SikaDur 32 Epoxy Liquid Barrier on walls.</p> |

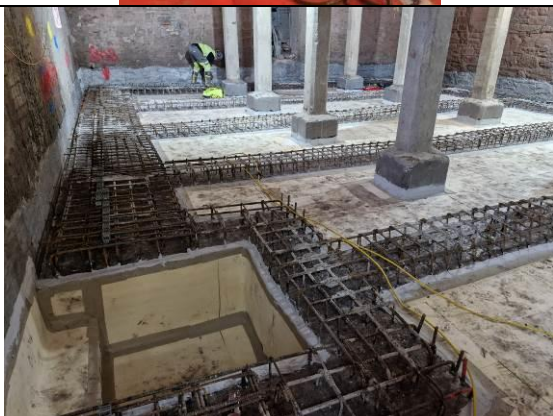
| No. | Item | Comments (see notes) |
|---|---|---|
| | Air lance testing of SikaProof A-08 Membrane installed in 'Tomb area' (Western section) of market hall basement | |

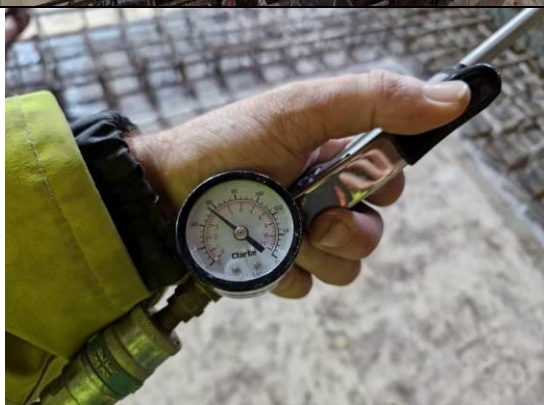
| No. | Item | Comments (see notes) |
|---|---|---|
| | Air lance testing of SikaProof A-08 Membrane installed in 'Tomb area' (Western section) of market hall basement, with pressure gauge showing maintained pressure above minimum of 50psi advocated by ASTM D4437-08:2013. | |

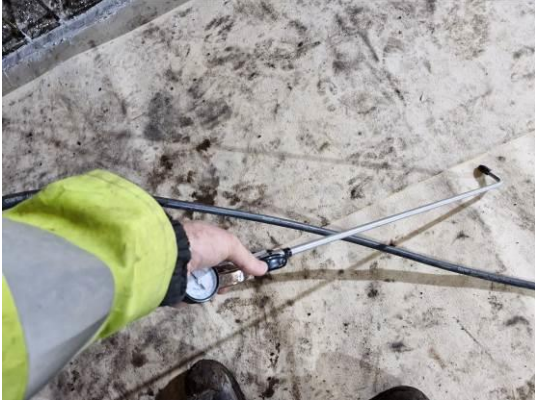
| | <p><i>Air lance testing of joint between two SikaProof A-08 Membrane sheets installed in 'Tomb area' (Western section) of market hall basement, with pressure gauge showing maintained pressure above minimum of 50psi advocated by ASTM D4437-08:2013.</i></p> |

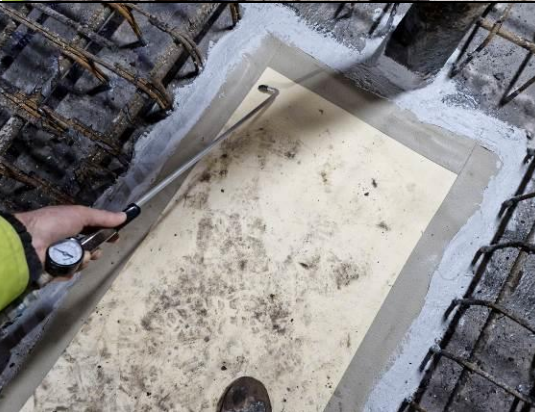
| | <p><i>Air lance testing of taped joint between SikaProof A-08 Membrane and SikaDur 32 Epoxy Liquid Barrier in 'Tomb area' (Western section) of market hall basement, with pressure gauge showing maintained pressure above minimum of 50psi advocated by ASTM D4437-08:2013.</i></p> |

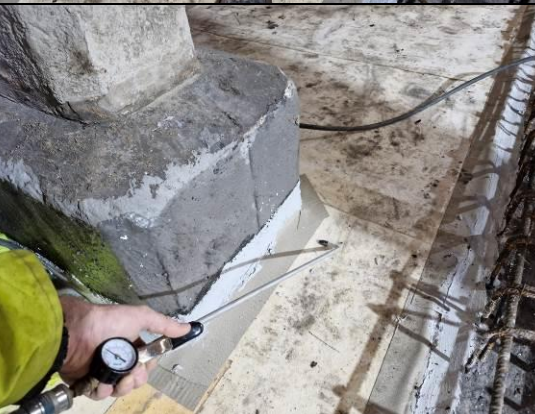
| | <p><i>Air lance testing of taped joint between SikaProof A-08 Membrane and SikaDur 32 Epoxy Liquid Barrier in 'Tomb area' (Western section) of market hall basement, with pressure gauge showing maintained pressure above minimum of 50psi advocated by ASTM D4437-08:2013.</i></p> |

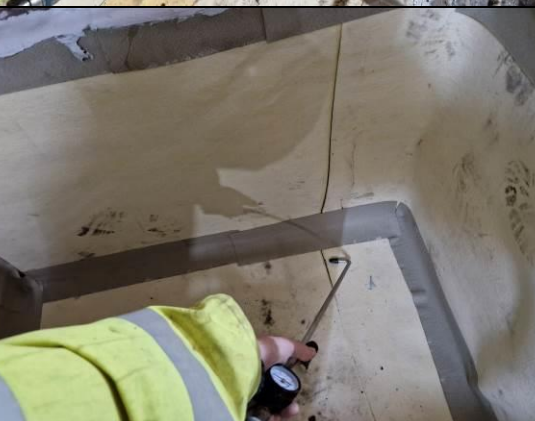
| | <p><i>Air lance testing of joint between two SikaProof A-08 Membrane sheets installed in 'Tomb area' (Western section) of market hall basement, with pressure gauge showing maintained pressure above minimum of 50psi advocated by ASTM D4437-08:2013.</i></p> |

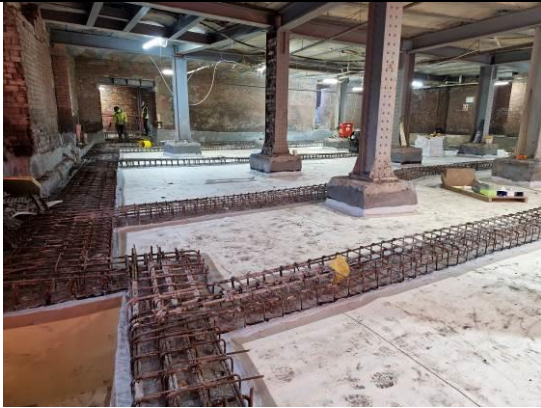
| No. | Item | Comments (see notes) |
|---|---|---|
| | | <i>Photograph showing main event space of the Market Hall Basement, with SikaDur 32 Epoxy Liquid Barrier (grey) applied to existing walls/ foundations and applied to new ground beams and stanchion bases. SikaProof A-08 Membrane installed in 'slab' areas between ground beams to form wall to wall radon barrier. Self-adhesive membrane edge for joints, and SikaProof Tape-150 with Sikadur Combiflex Adhesive used for joints between membrane and SikaDur 32 Epoxy Liquid Barrier on stanchion bases and beams.</i> |

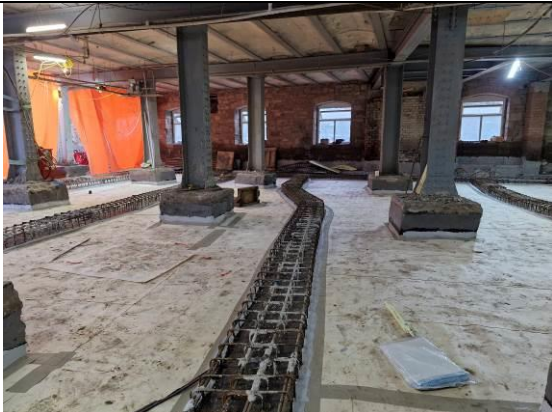
| No. | Item | Comments (see notes) |
|---|---|---|
| | | <i>Photograph showing main event space of the Market Hall Basement, with SikaDur 32 Epoxy Liquid Barrier (grey) applied to existing walls/ foundations and applied to new ground beams and stanchion bases. SikaProof A-08 Membrane installed in 'slab' areas between ground beams to form wall to wall radon barrier. Self-adhesive membrane edge for joints, and SikaProof Tape-150 with Sikadur Combiflex Adhesive used for joints between membrane and SikaDur 32 Epoxy Liquid Barrier on stanchion bases and beams.</i> |

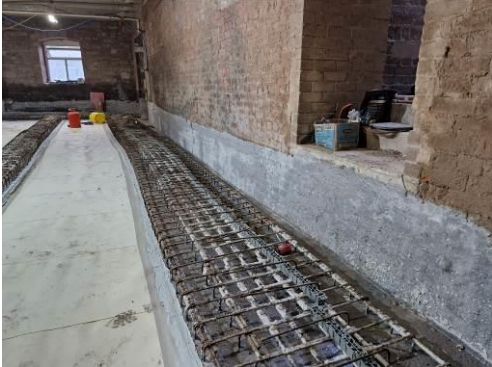
| | <p>Photograph showing main event space of the Market Hall Basement, with SikaDur 32 Epoxy Liquid Barrier (grey) applied to existing walls/foundations and applied to new ground beams and stanchion bases. SikaProof A-08 Membrane installed in 'slab' areas between ground beams to form wall to wall radon barrier. Self-adhesive membrane edge for joints, and SikaProof Tape-150 with Sikadur Combiflex Adhesive used for joints between membrane and SikaDur 32 Epoxy Liquid Barrier on stanchion bases and beams.</p> |

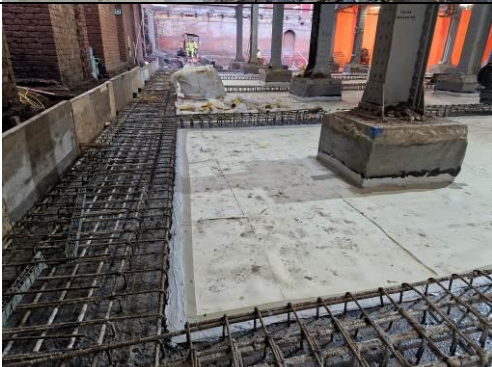
| | <p>Photograph showing main event space of the Market Hall Basement, with SikaDur 32 Epoxy Liquid Barrier (grey) applied to existing walls/foundations and applied to new ground beams and stanchion bases. SikaProof A-08 Membrane installed in 'slab' areas between ground beams to form wall to wall radon barrier. Self-adhesive membrane edge for joints, and SikaProof Tape-150 with Sikadur Combiflex Adhesive used for joints between membrane and SikaDur 32 Epoxy Liquid Barrier on stanchion bases and beams.</p> |

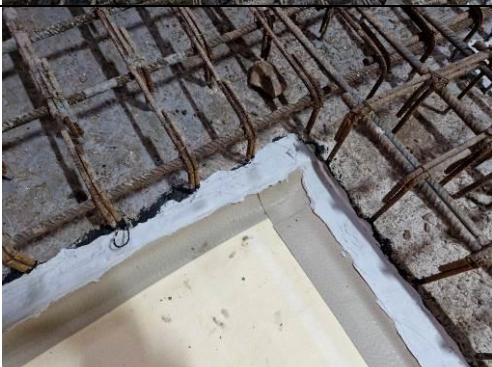
| | <p>Photograph showing main event space of the Market Hall Basement, with SikaDur 32 Epoxy Liquid Barrier (grey) applied to existing walls/foundations and applied to new ground beams and stanchion bases. SikaProof A-08 Membrane installed in 'slab' areas between ground beams to form wall to wall radon barrier. Self-adhesive membrane edge for joints, and SikaProof Tape-150 with Sikadur Combiflex Adhesive used for joints between membrane and SikaDur 32 Epoxy Liquid Barrier on stanchion bases and beams.</p> |

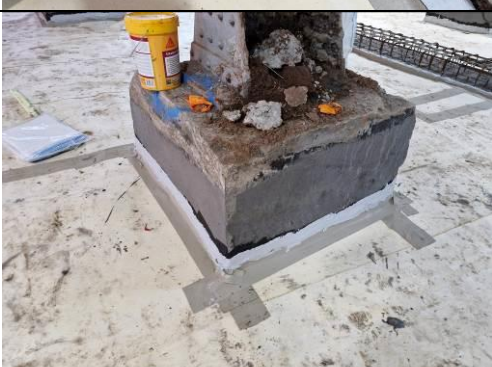
| | <p>Photograph showing main event space of the Market Hall Basement, with SikaDur 32 Epoxy Liquid Barrier (grey) applied to existing walls/foundations and applied to new ground beams and stanchion bases. SikaProof A-08 Membrane installed in 'slab' areas between ground beams to form wall to wall radon barrier. Self-adhesive membrane edge for joints, and SikaProof Tape-150 with Sikadur Combiflex Adhesive used for joints between membrane and SikaDur 32 Epoxy Liquid Barrier on stanchion bases and beams.</p> |

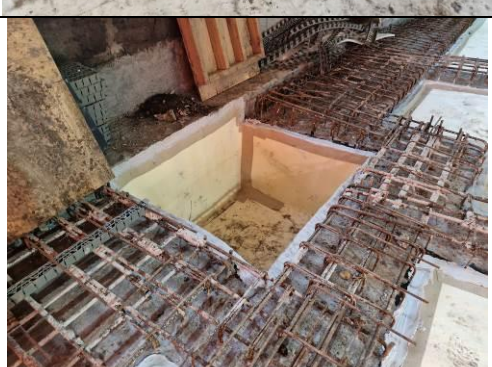
| | <p>Photograph showing SikaProof A-08 Membrane installed in main event space of the Market Hall Basement to form wall to wall radon barrier. Detailing completed with SikaProof Tape-150 with Sikadur Combiflex Adhesive used for joints between membrane and SikaDur 32 Epoxy Liquid Barrier on walls.</p> |
