# Lower Chesham Hall, Chesham Crescent, Bury

## Structural Inspection Report

Job No: 10220221  
Doc Ref: LCH-ZZ-XX-RP-S-0001  
Revision: P02  
Revision Date: 07 March 2022

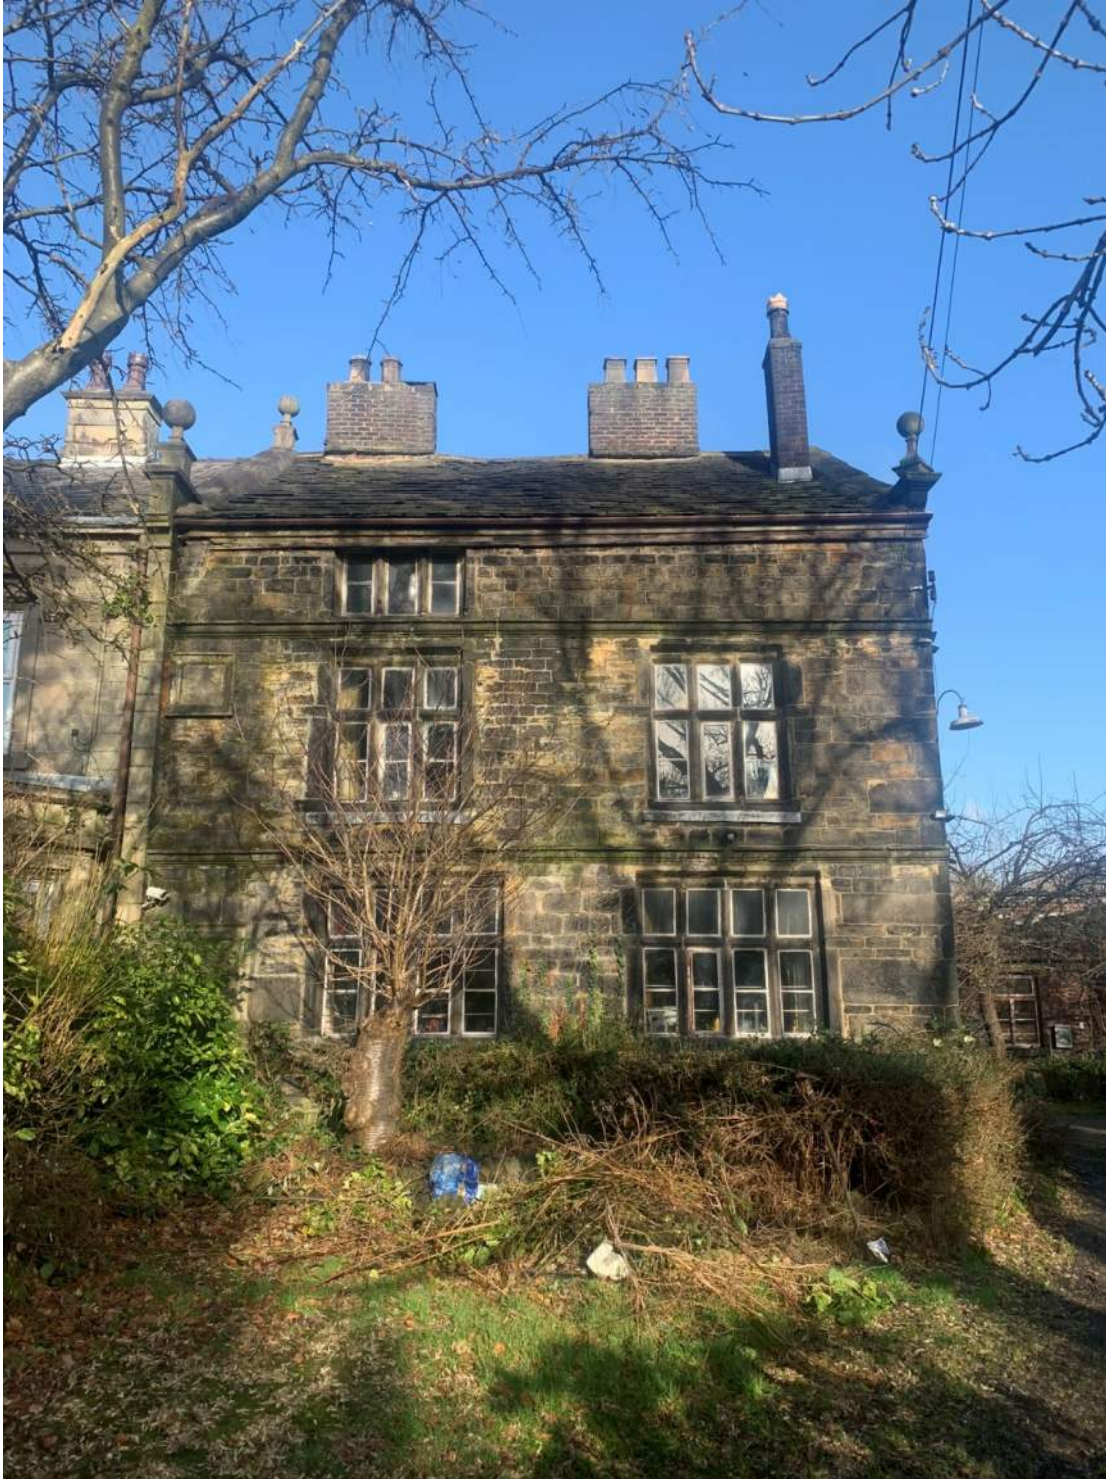
The South Elevation is in relatively good condition. No cracking from structural movement was observed and the walls appeared plumb and true.

There is evidence that significant amounts of water have run down the far western corner of this elevation. As the conditions were dry at the time of the survey it was not clear whether the cascading water was due to current ineffective

guttering, or whether this was a historic defect due to the broken original stone gutter. It is understood there was also an opening in the roof above this location, however this has since been locally repaired to reduce further deterioration internally. A full repair of the roof and guttering should be undertaken to prevent further water ingress and damage. The internal condition of this section of the building is discussed in more detail in 2.1.6.

*Figure 4 Full view of South Elevation*

The walls have undergone widespread repointing with a sand and cement mortar. The mortar joints should be raked out and re-pointed using a lime mortar to allow the walls to be permeable and reduce the levels of damp within the property and also to inhibit the rate of frost damage caused by freeze-thaw cycles.

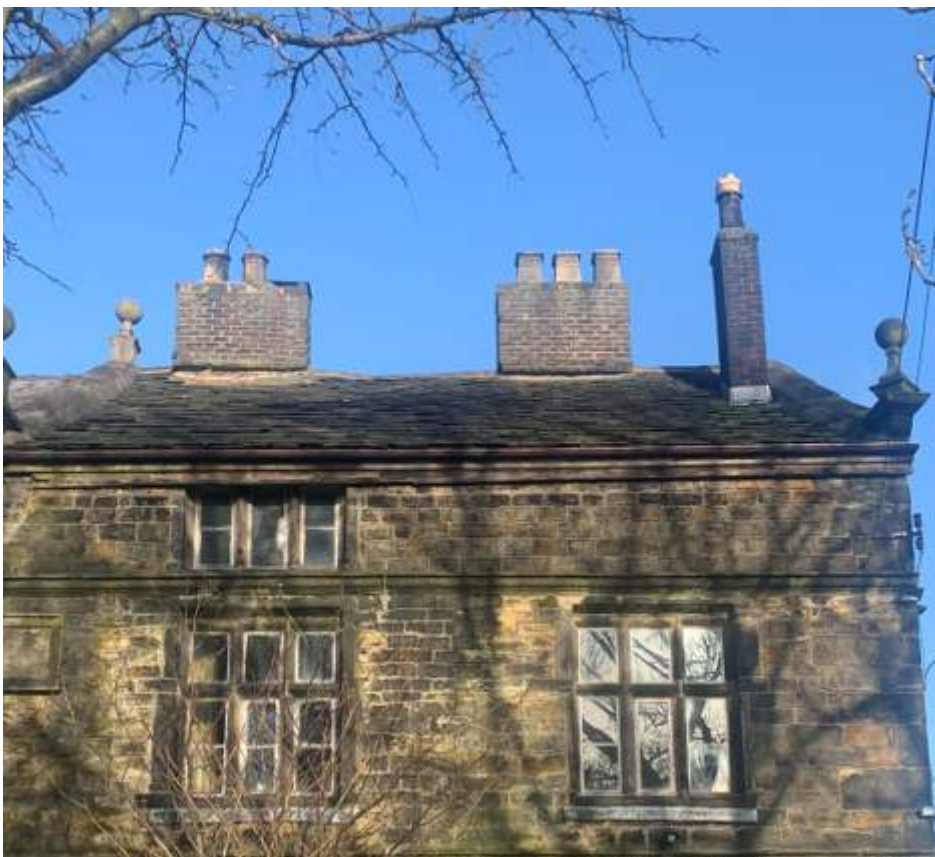
There are three chimney stacks which can be observed from the south elevation. The chimneys were inspected from ground level only, and once scaffolding has been erected it is recommended the chimneys are more closely inspected. The condition of the flues have also not been inspected and all flues should be checked by a suitably qualified GAS SAFE or HETAS engineer. All chimneys are constructed from brick with the oldest two chimneys located along the apex of the building. There are three flues to each of these stacks. It can be seen that the chimneys have been repointed in modern sand cement mortar. There is evidence of sulphate attack to both stacks and this has caused bulging to the rear face of the left hand stack in particular. The bricks should be locally removed and re-set to position. Sulphate attack is caused by the burning of fossil fuels which react with the mortar and cause expansion of the joints.

There is a single chimney stack on the eastern gable end. This is a more recent addition, and it is assumed this was installed during the 1910 alterations. The chimney is constructed from red clay brick. There is evidence of sulphate attack within this chimney which has caused a significant bend and twist to the stack. Given the extent of deformation it is recommended that the chimney is completely dismantled from above roof level and reconstructed. With the installation of a new flue lining, it may not be necessary for the chimney to be re-constructed to the same height, however this reduction would need to be approved by the conservation officer.

*Figure 5 Image showing the three chimneys*

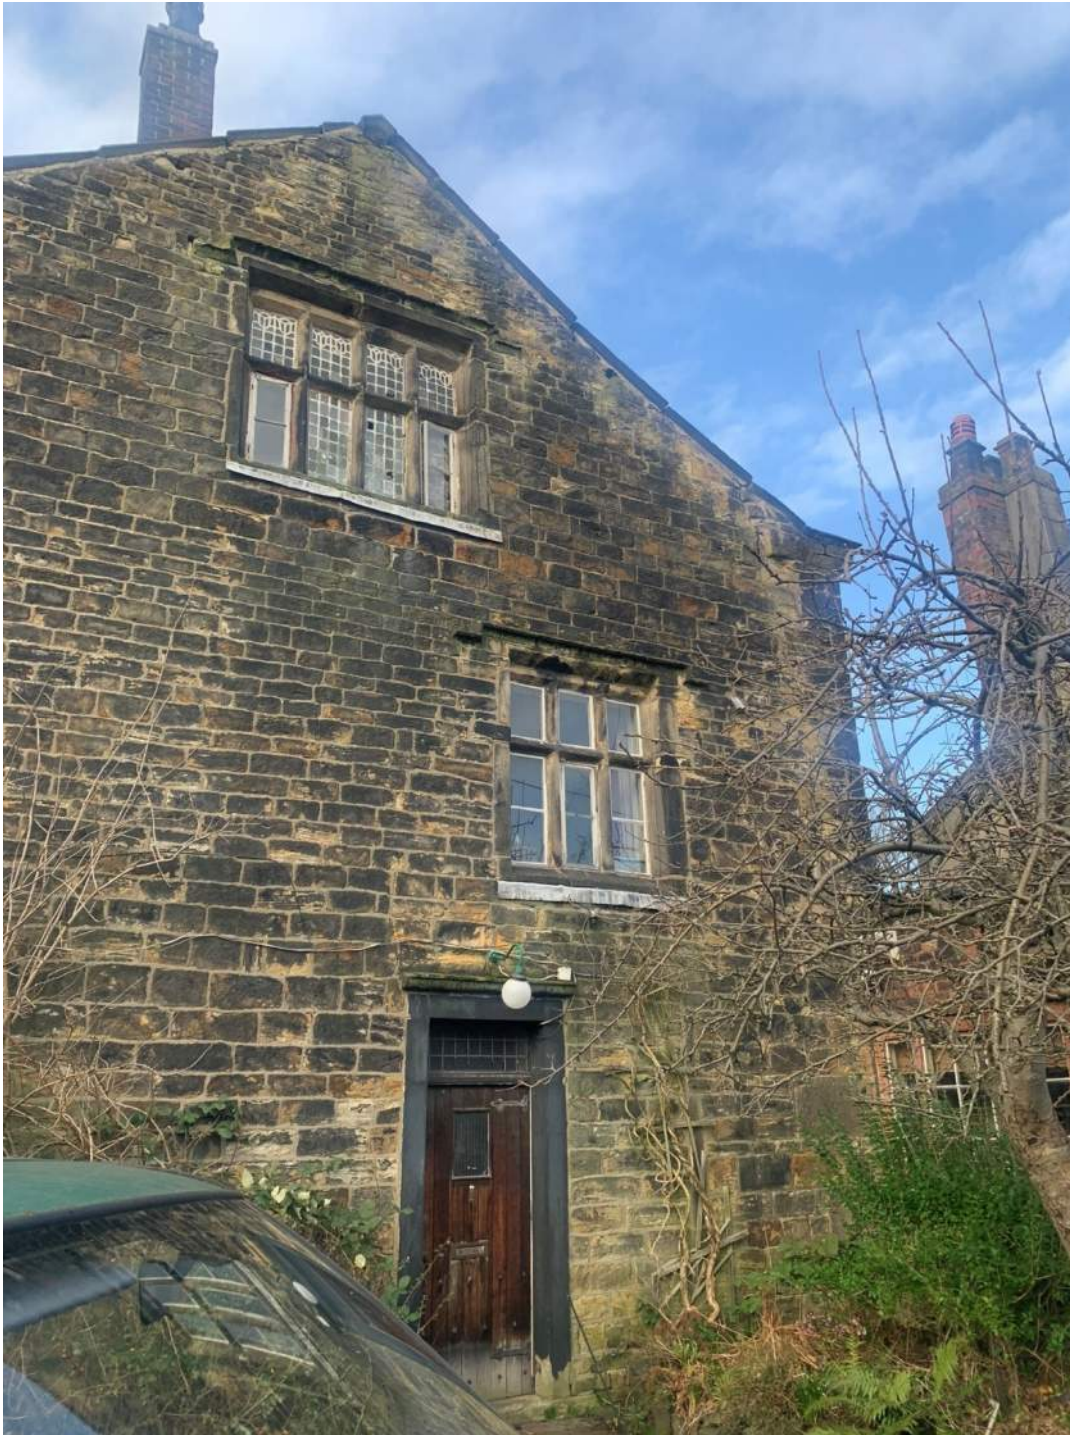
To the eastern elevation, a significant outward bow was observed, with vertical cracking through both the stonework and vertical mortar joints. The most outwardly point of the bow within the wall was located at midpoint between first and second floor levels.

*Figure 6 Image of eastern elevation showing bulge and cracking of stonework*

The bulging and cracking to the wall could be caused by lack of restraint to the floors, or by consolidation or voids within the rubble core, or a combination of the two. Internally the floor joists were observed to run north-south with only a limited number of timber cross beams running east-west. The lack of joists embedded into the limits the restraint that the floor can provide to the end gable wall.

A remedial method of adding restraint between the walls and floors has historically been addressed through the use of cruciform wrought iron wall ties. These however affect the external appearance of the building. In order to achieve a more sympathetic repair, it is recommended that restraint is provided by the following:

- Internal restraint straps installed at regular centres between the timber floor joists and the inner leaf of the walls at each floor level, including the roof.
- Cracked stonework is locally replaced, like for like, with locally sourced stone.
- To the area of cracked and bulging stonework, the inner and outer leaves are tied together using stainless steel, resin fixed rods drilled through, connecting both leaves together. These should be drilled at mortar joint locations to minimise observable repair works as far as practically possible, with the surface over the stainless-steel rod repointed with a lime mortar. The repair should be virtually undetectable externally.

- The stainless-steel rods should also be installed at floor levels, at regular centres, to ensure the internal restraint strap ties also provide restraint to the outer leaf.

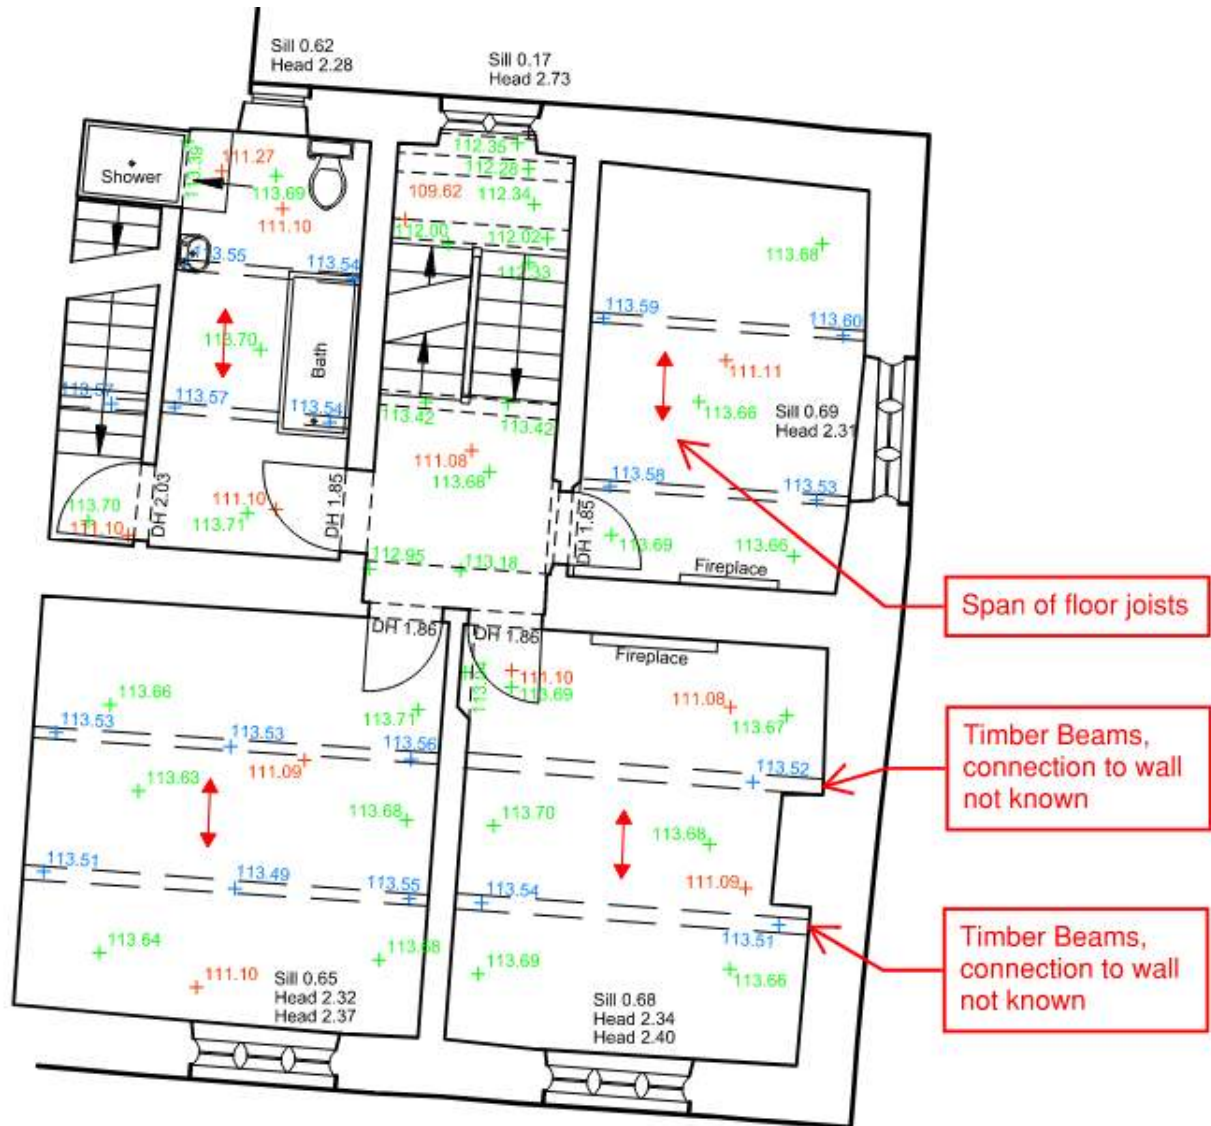
Figure 7 Part plan of first floor showing span of joists

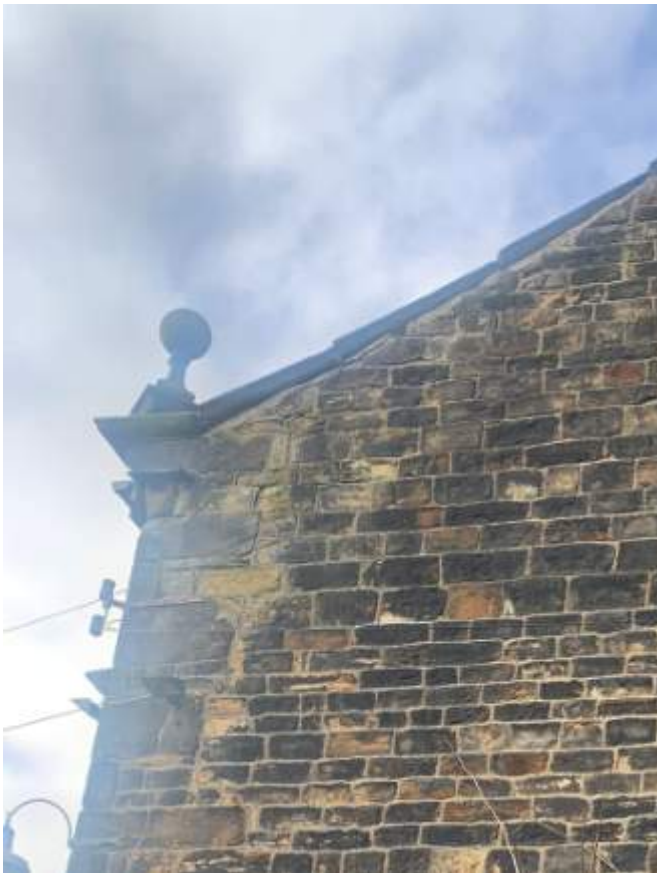
Outward movement of the kneeler on the corner of the south elevation was observed, together with cracking of the mortar joints to the top 1m of the wall, indicating potential movement of the masonry where the front and side elevations are tied together. It is recommended that crack stick bars are installed every other course in this top section of the wall, and that the kneeler is anchored to the masonry wall using a stainless-steel bar resin fixed into the kneeler and top of the wall.

*Figure 8 Cracking in stonework and movement of the kneeler*

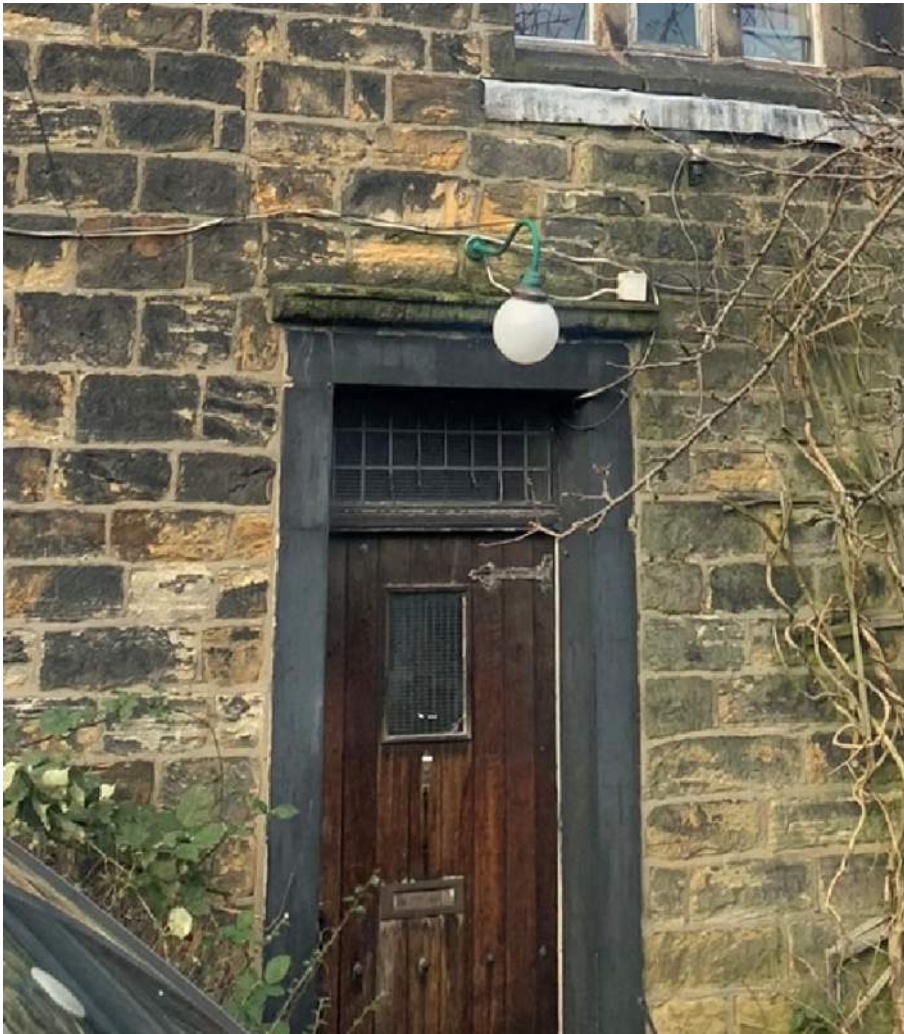
There is a diagonal crack which extends down from the second-floor window to the first-floor window and then down to the centre of the door. The movement could have occurred when the new central door opening was created in this elevation, however a small central crack can also be seen in the stone lintel above the door. The internal finishes should be removed, and investigation undertaken to identify whether the internal timber lintels have rotted and failed.

Figure 9 Cracked stone lintel and diagonal cracking in stonework above

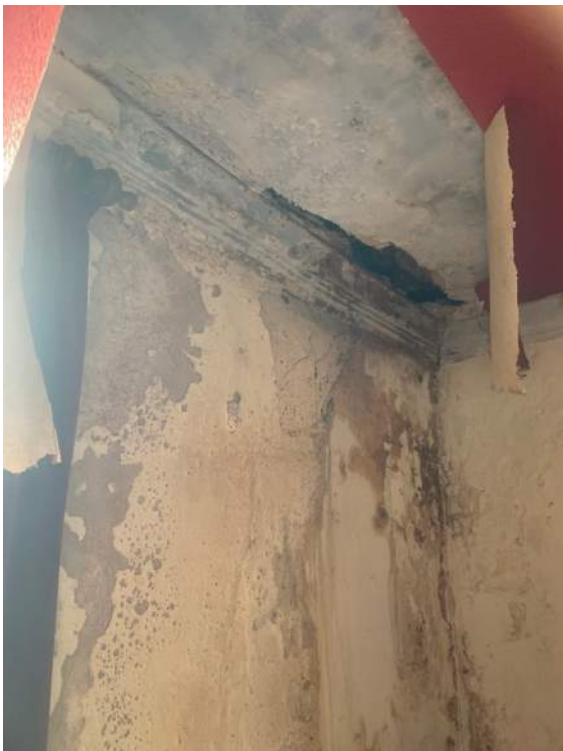
At ground floor level within the sitting room adjacent to the party wall of the care home, significant water ingress was observed which was entered the building through an opening through the roof and from water cascading down the building due to ineffective guttering. The plaster has disintegrated and although the timbers were not inspected at the time of the inspection it is expected that significant decay and potentially rot will have occurred. Following strip out of the finishes / ceilings the timbers should be inspected by a specialist and treated / replaced where required.

*Figure 10 South western corner showing damage from water ingress*

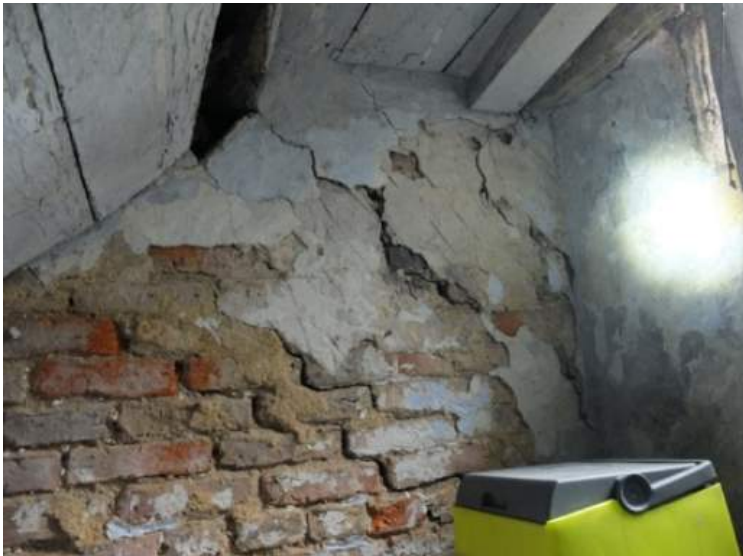
Cracking was observed internally within the cross walls either side of the basement access staircase.

*Figure 12 Cracking to basement cross walls running north south*

The internally finishes should be removed to both these walls to understand the level of defects present. It may be necessary to locally re-build the wall where the timber beam to the dining room is located, to ensure there is adequate bearing support in this location. Decay was noted to the timber bearer for the half landing stair, within the access stair to the basement.

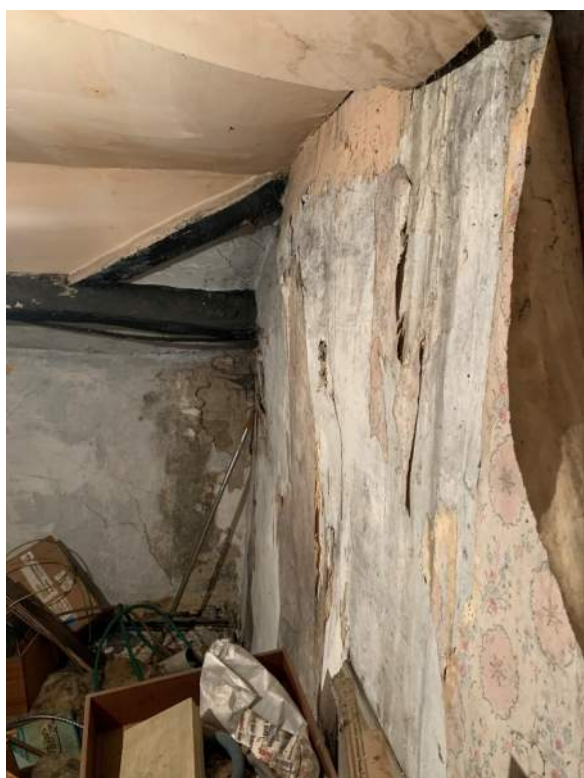
A bulge was noted internally on the rear eastern bedroom within the attic space. This is cognisant with the location where movement was observed externally on the gable end and where, directly below, at ground floor level, alterations to the doorway had been undertaken. It may be that to this location there are voids within the rubble infill and movement has occurred between the two leaves of stonework. The movement is significant, so in this location it is recommended that the roof beams directly over are propped and the wall is locally dismantled and re-built, plumb.

*Figure 13 Significant internal bulge to north eastern bedroom*
