# Stage 1-2 Road Safety Audit

**Bury Old Road, Manchester**

**Unimore Limited**

SLR Project No: 407.064834.00001

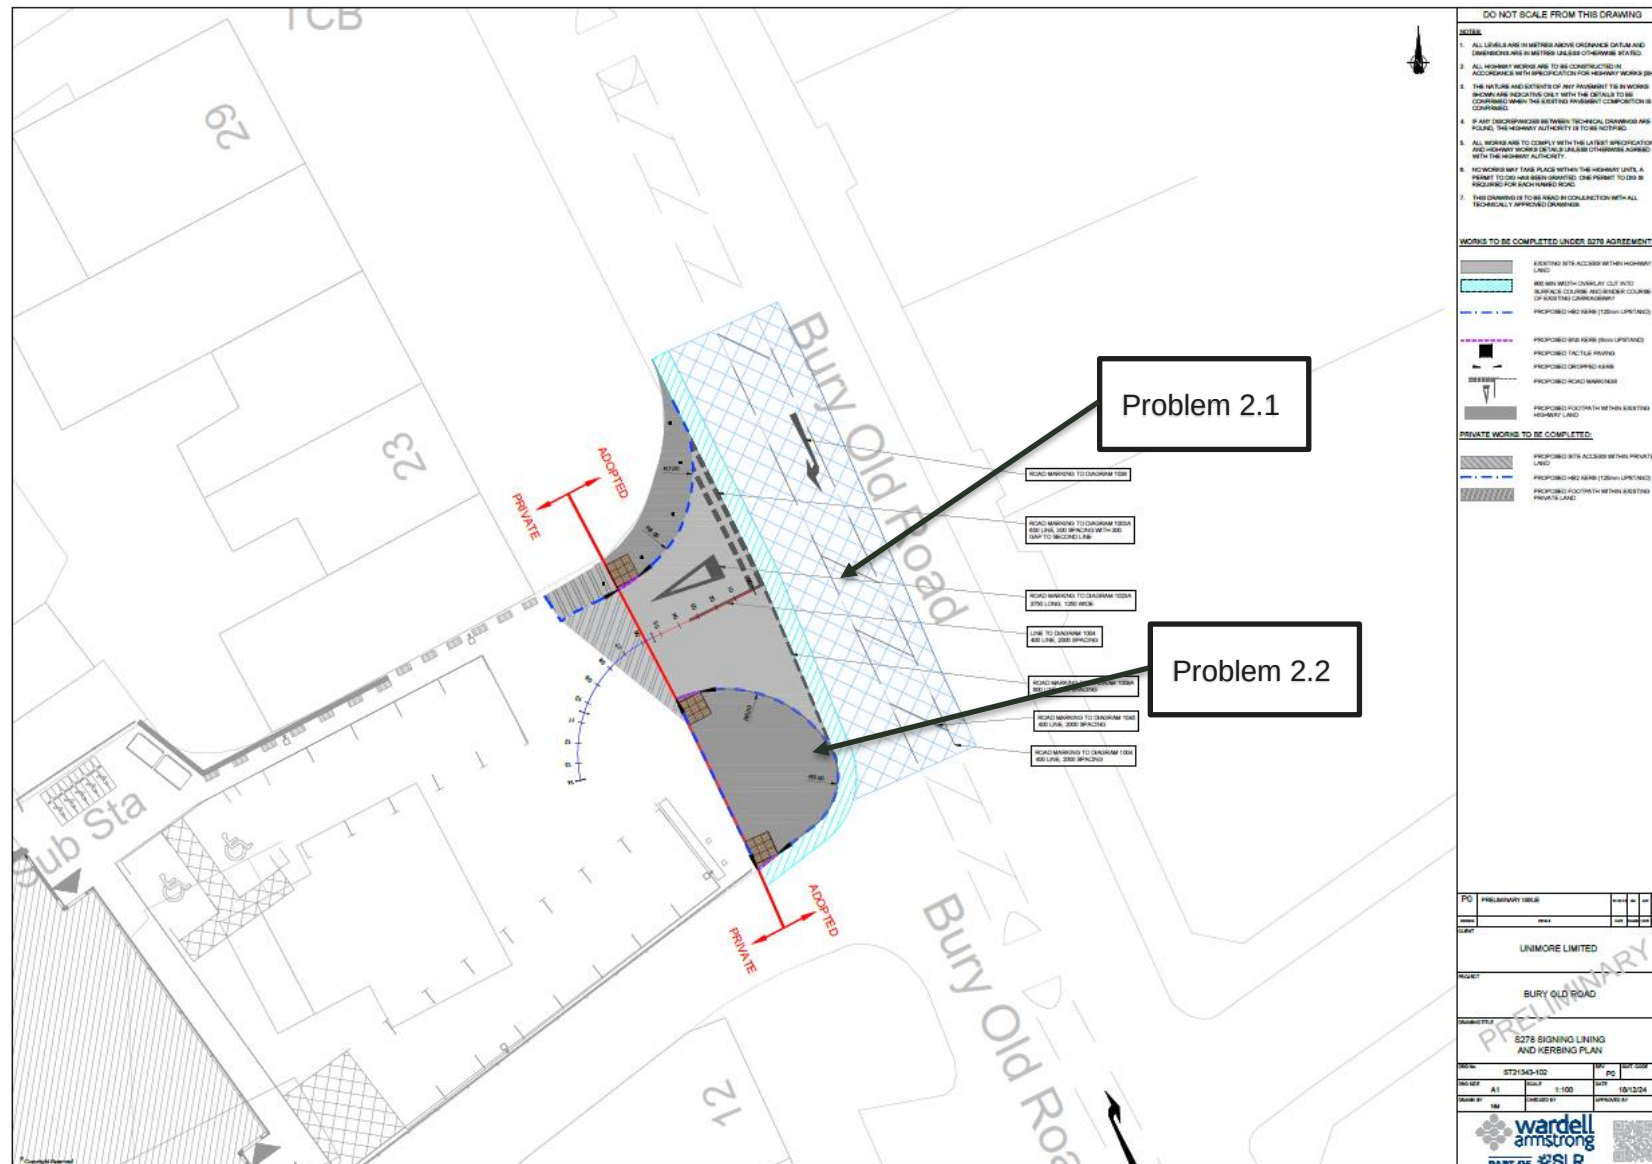
### Drawing No. ST21343-102-P0 - S278 Signing Lining and Kerbing Plan-A1L

Location: Ghost island right turn facility.

Summary: Road marking may lead to overrun of opposing lane on the minor arm potentially causing head on collisions.

Design drawings show road markings for the ghost island right turn appear to terminate the right turn in alignment with the egressing lane on the minor arm. This arrangement may lead to drivers accessing the site, turning too early and overrunning the egress lane of the site junction potentially leading to head on type collisions between vehicles.

Location: Amended traffic island / footway.

Summary: Lack of bollards to prohibit vehicular access may lead to injudicious parking potentially obscuring visibility splay causing side swipe type collisions.

Design drawings do not show any parking prevention measures that are found on junctions surrounding the site access junction. Failure to provide these bollards on the amended traffic island may lead to injudicious parking as was observed during the site visit. This arrangement may in turn lead to the obscuring of the junction visibility splays, potentially causing side swipe type collisions at the junction.

It is recommended that the termination marking for the ghost island right turn be removed to encourage drivers to adopt the correct position in the right turn lane prior to accessing the site.

It is recommended that the appropriate bollards / parking prevention measures are provided on the newly amended traffic island / footway to the south of the site access junction.

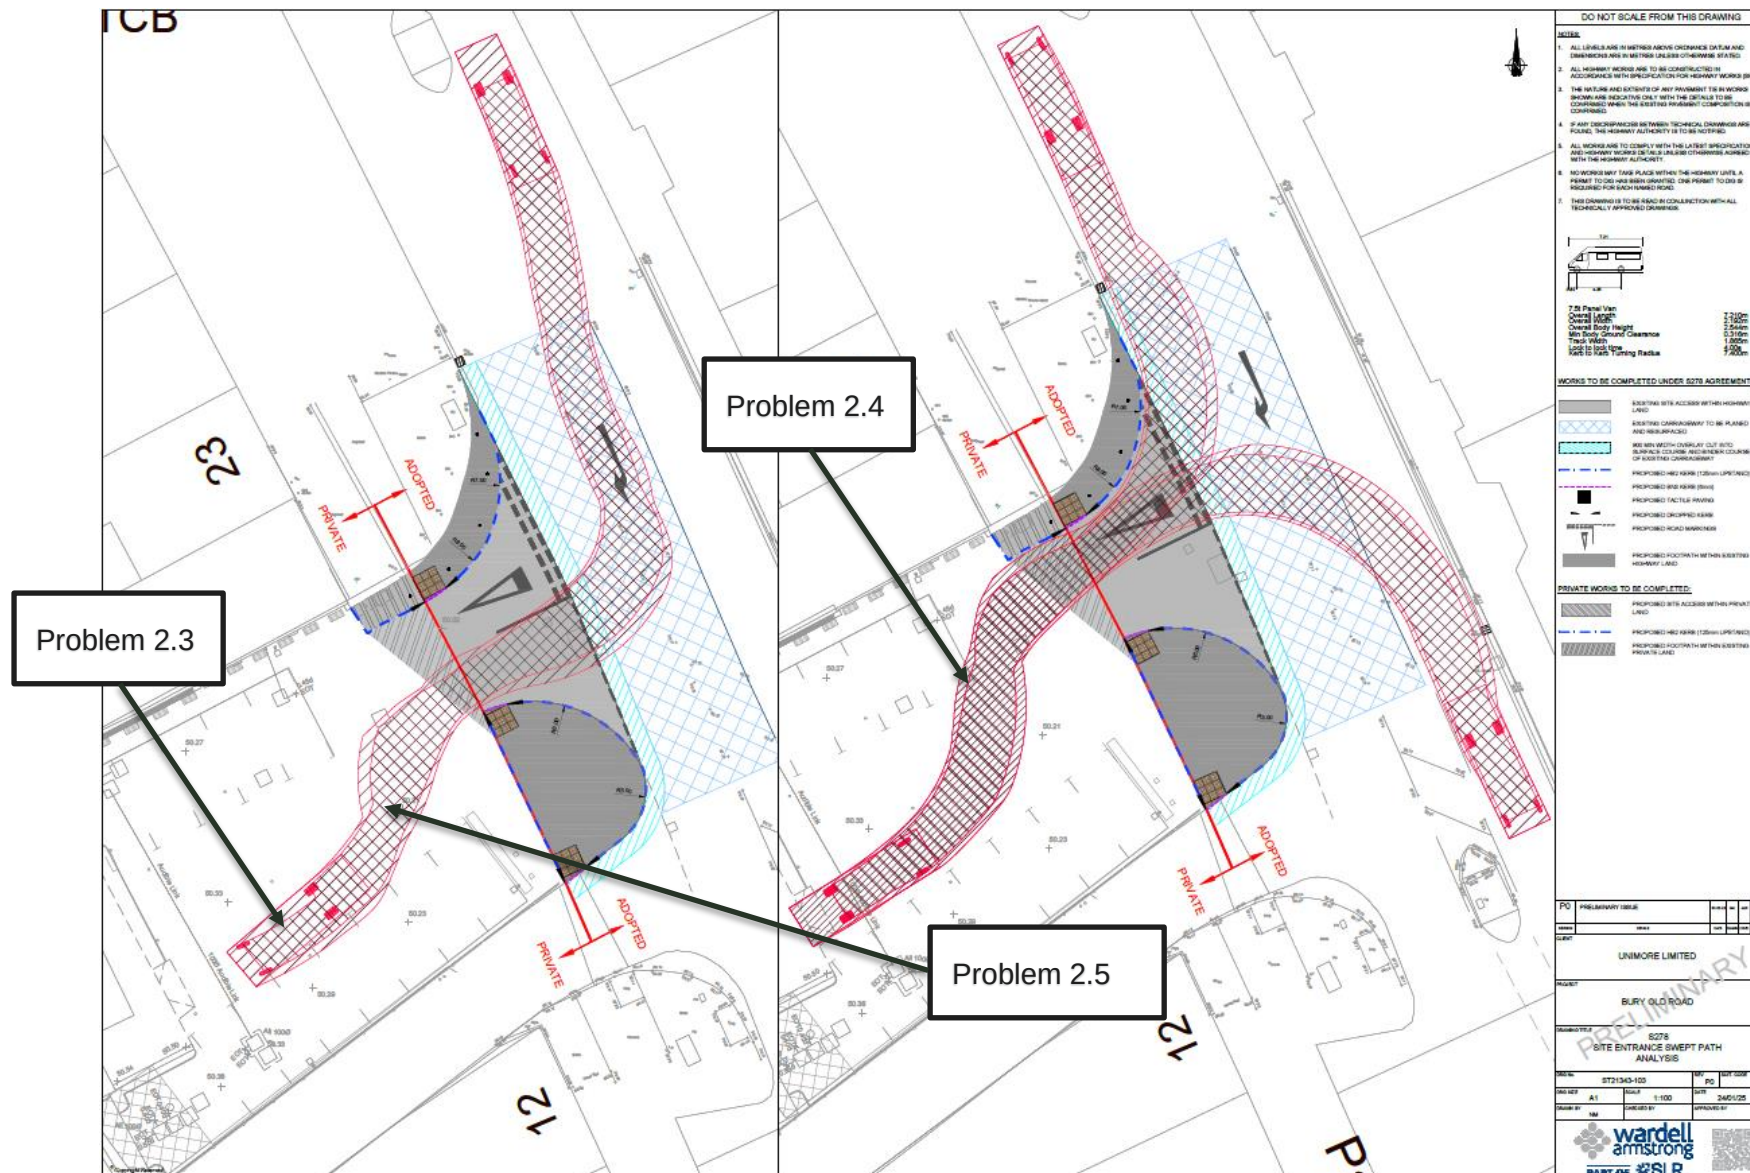
## Drawing No. ST21343-104-P0 - Swept Path Analysis and Visibility Splays-A1L (2)

Location: Internal servicing area.

Summary: Lack of turning area for servicing vehicles may lead to shunt type collisions or collisions between pedestrians and vehicular traffic.

Design drawings do not show an appropriate turning facility for service vehicles. This arrangement may lead to large delivery vehicles reversing back out of the site onto the public highway potentially leading to shunt type collisions, or collisions between reversing vehicles and pedestrians accessing or passing the site access junction.

Summary: Swept path of an egressing vehicle is shown to overrun parking bays which may lead to collisions between vehicles.

Design drawings show the swept path analysis of a service vehicle egressing the site and overrunning a parking bay. This arrangement may lead to collisions between servicing vehicles and those private vehicles either parked or within the process of accessing or egressing the site.

Location: Car park area.

Summary: No swept paths for car parking and the aisle space between the bays does not look sufficient to allow easy reversing out of a space, which may result in cars reversing out onto the public highway potentially leading to shunt type collisions, or collisions between reversing vehicles and pedestrians accessing or passing the site access junction.

It is recommended that the appropriate measures be undertaken to ensure that service vehicles are not required to overrun parking bays in order to access / egress the site in a forward gear. Or that servicing is undertaken out of hours when the car park is not in use.

It is recommended that the appropriate measures be undertaken to ensure that adequate space is provide in the aisle between the bays to enable safe manoeuvring of cars in and out of the designated parking bays. Swept path analysis also needs to be provided.
