# HIGHLIFE

### BURY FUSILIERS MUSEUM - INTERNAL VENTILATION TOWER INSPECTION REPORT

Inspection conducted on: 23 JUNE 2023

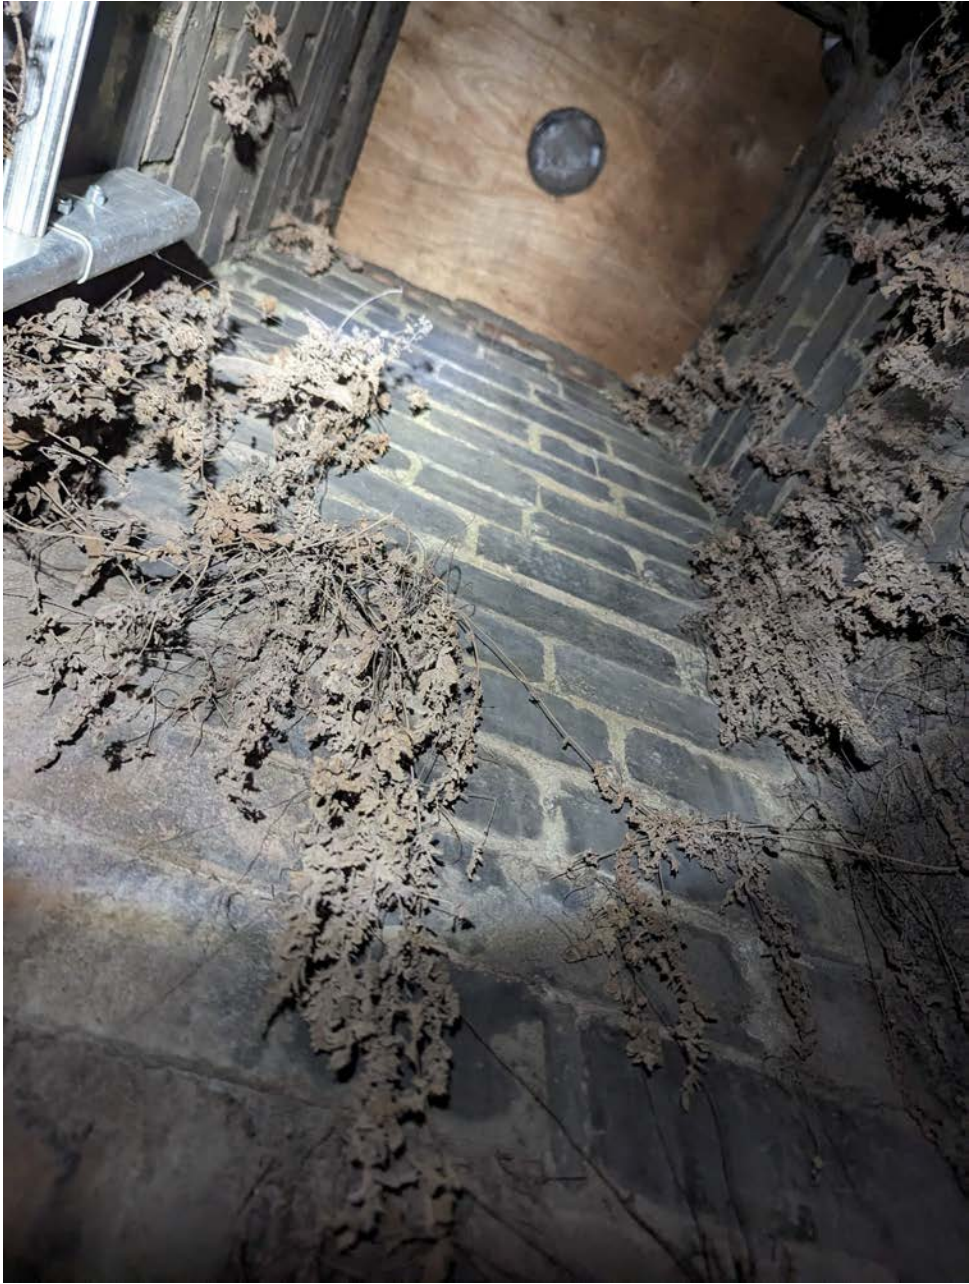
| <i>No.</i> | <i>Location</i> | <i>Description</i> | <i>Proposed Solution</i> |
|---|---|---|---|
| | North shaft | Condition | No signs of water ingress on the roof, plant life is |

| | | | dried and aged but still in place. Brick joints are in good order. |

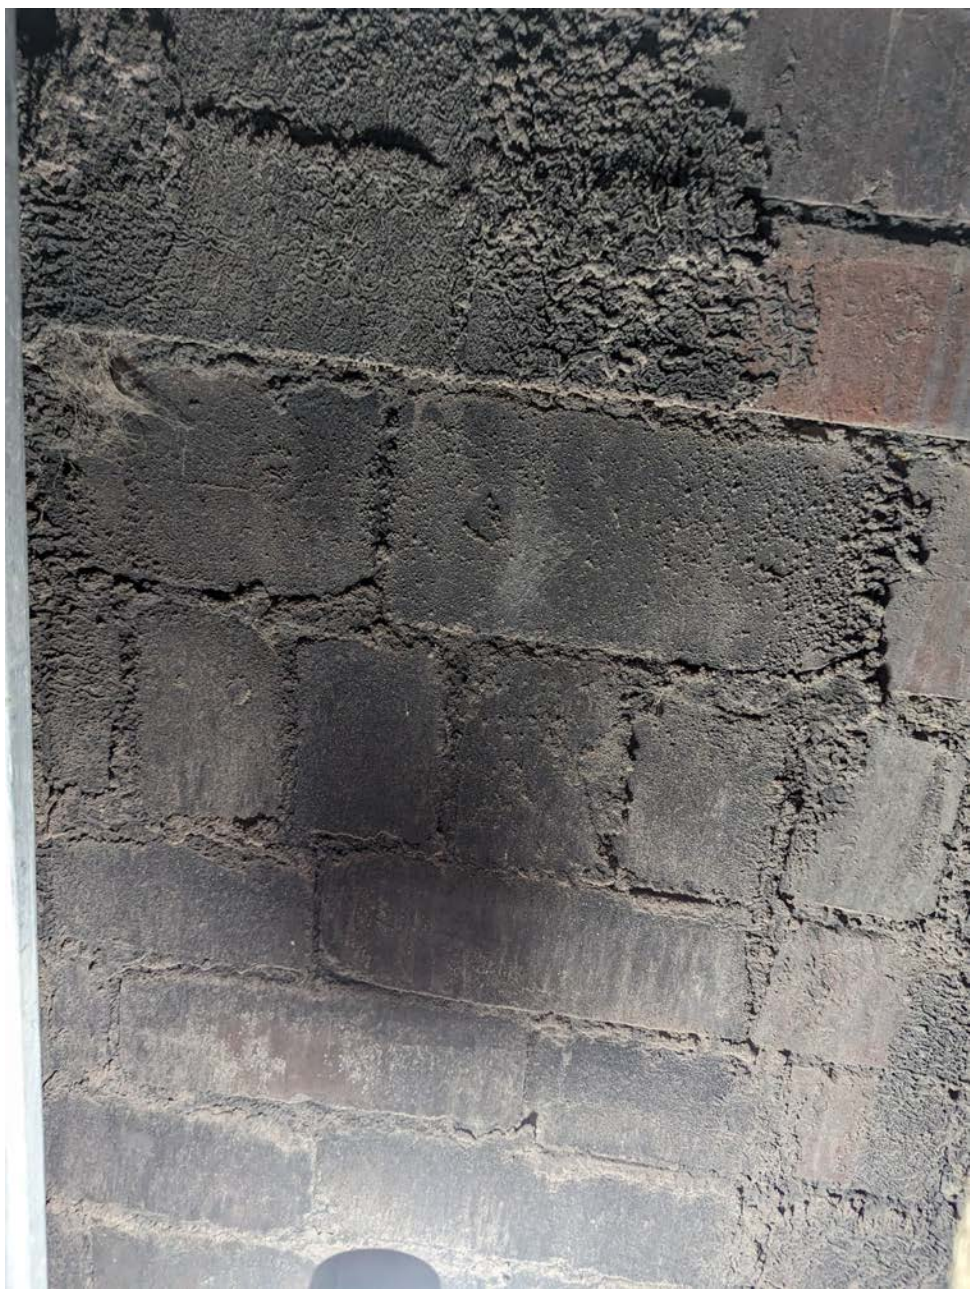
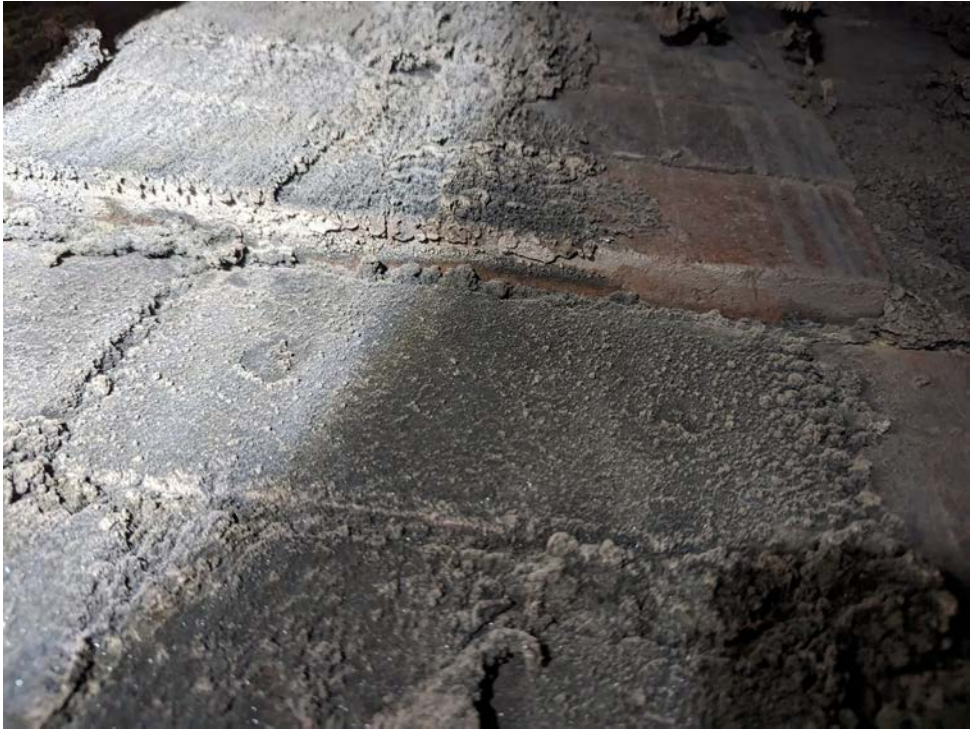
| | North shaft | Brick offset course | The brick course below is level with the top of the louvres, as mentioned in the notes above it is solid and looks to have been in this position since being laid as opposed to more recent bed shifting. East wall only. East wall only, South wall was flat with no offset. |

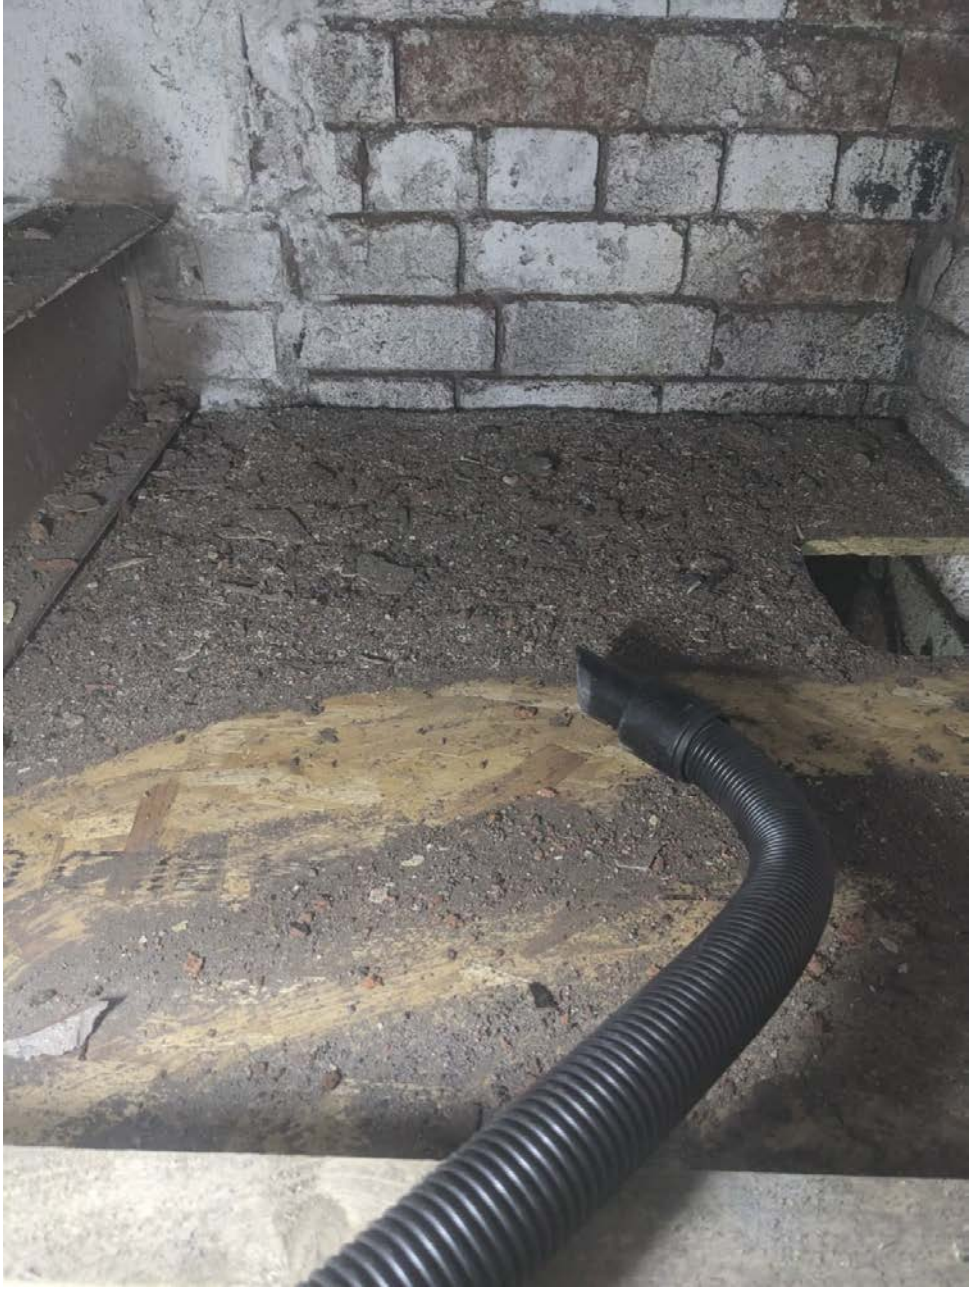
| | North corner top of lift boards. | North corner debris build up. | n/a |

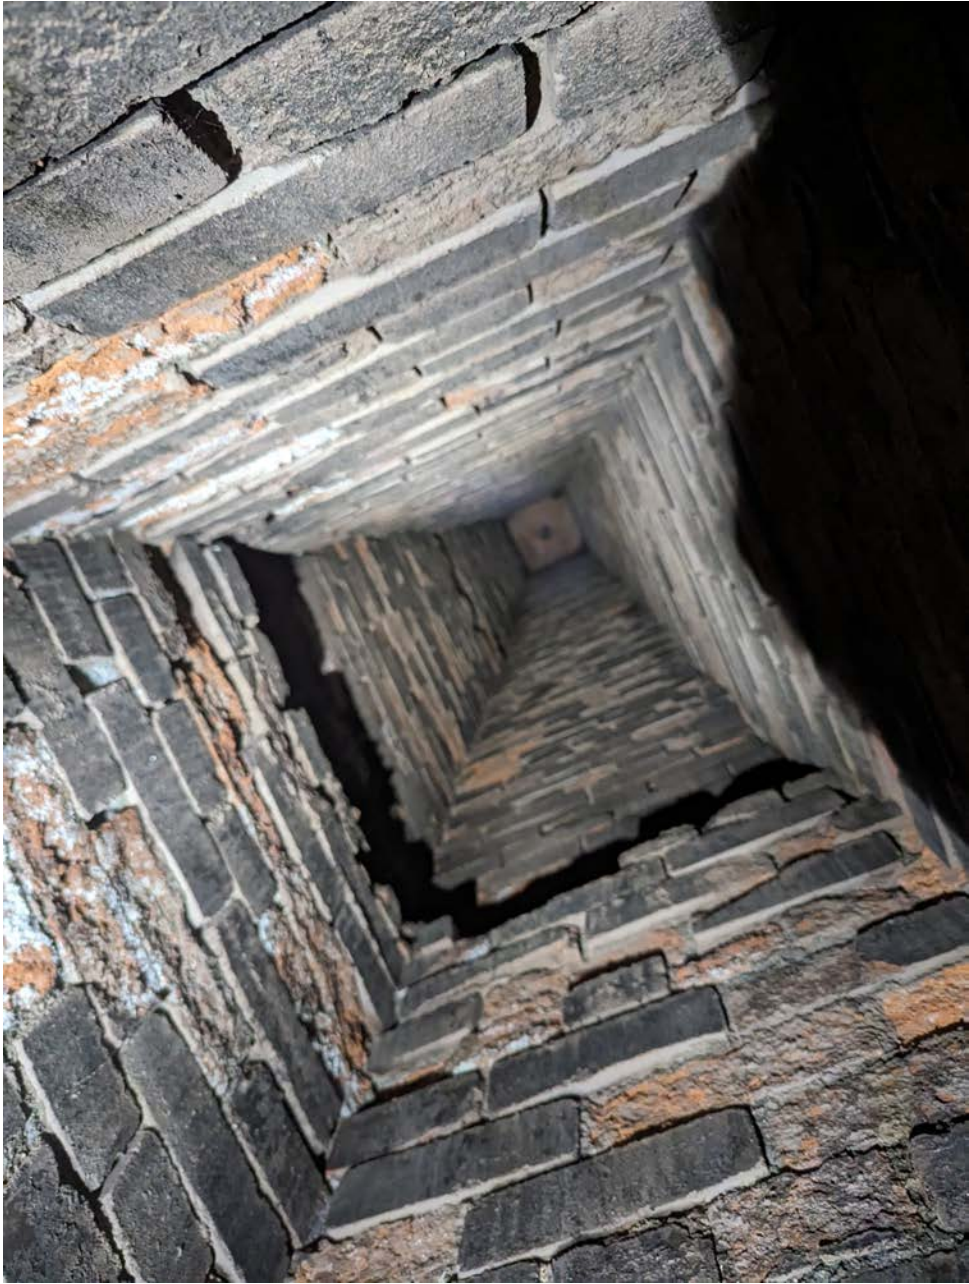
| | North Shaft | Brick face condition | Heavy salt deposits to the lower half in localised areas. Degrading brick faces |

There is a fair amount of salts deposits on the north and west wall which may be due to the general poor state of the pointing and it being a harsher weather side. Equally with

the open jointed jacking of the joins higher up in the louvres there will already be water in the wall which will then be making its way out on the internal face during prolonged periods of wet weather. This would match up with the salt deposits only really going up  $\frac{1}{2}$ - $\frac{2}{3}$ rd of the tower. Above this the brickworks looked dry and protected by the lead roof and good ventilation.

Closing up the jacked joint should help alleviate a lot of the build up of moisture within the wall however there may be a requirement to repoint to help with moisture transfer to the external wall faces. These we would see as a primary repair with a back up if there was still issues with moisture retention due to surface film water/degraded pointing on this elevation.

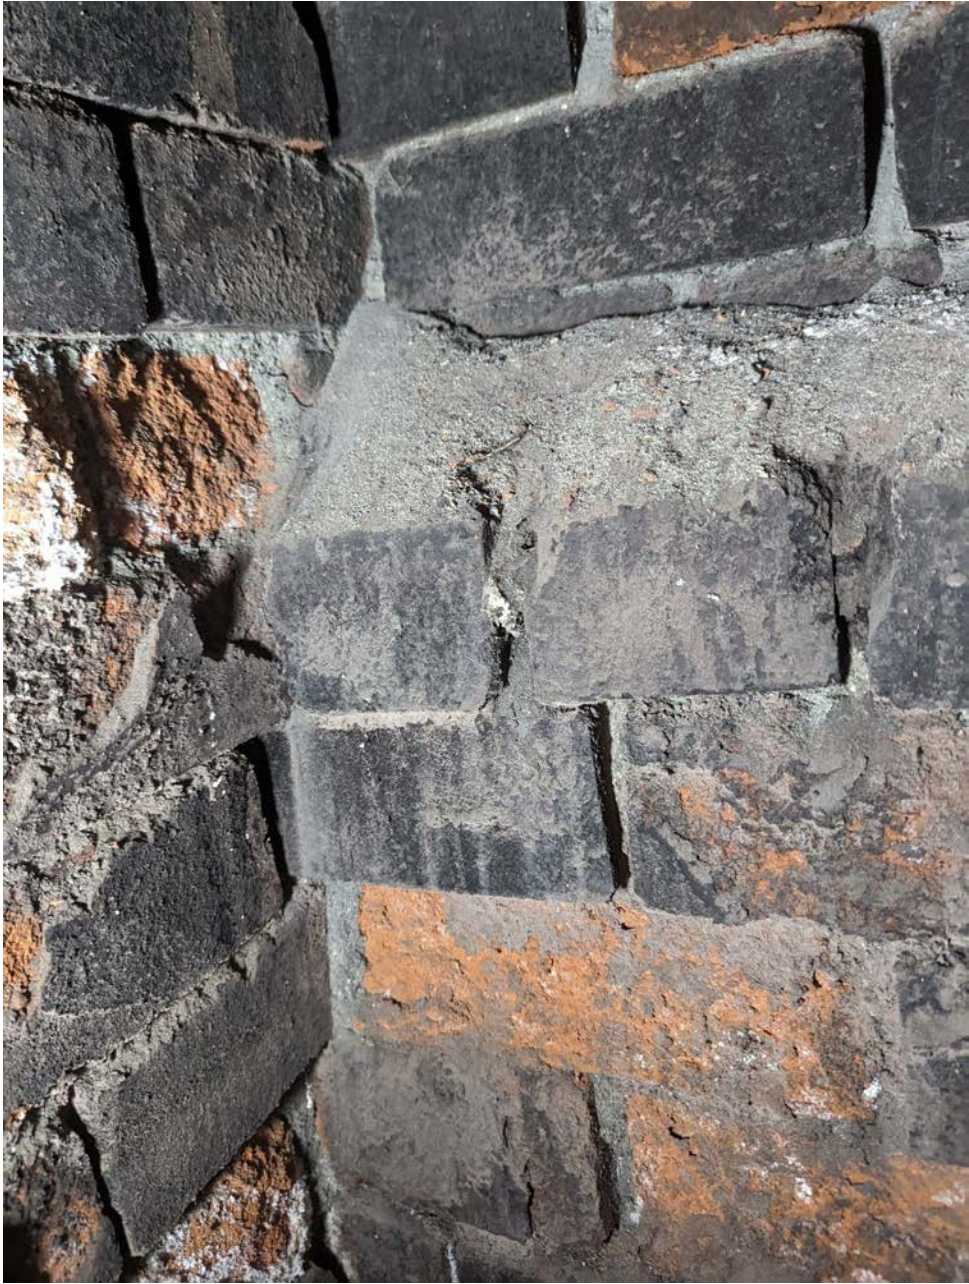
| | North Shaft | Brick face and offset course | Debris build up on offset course that had fallen from above. Offset course at half height. |

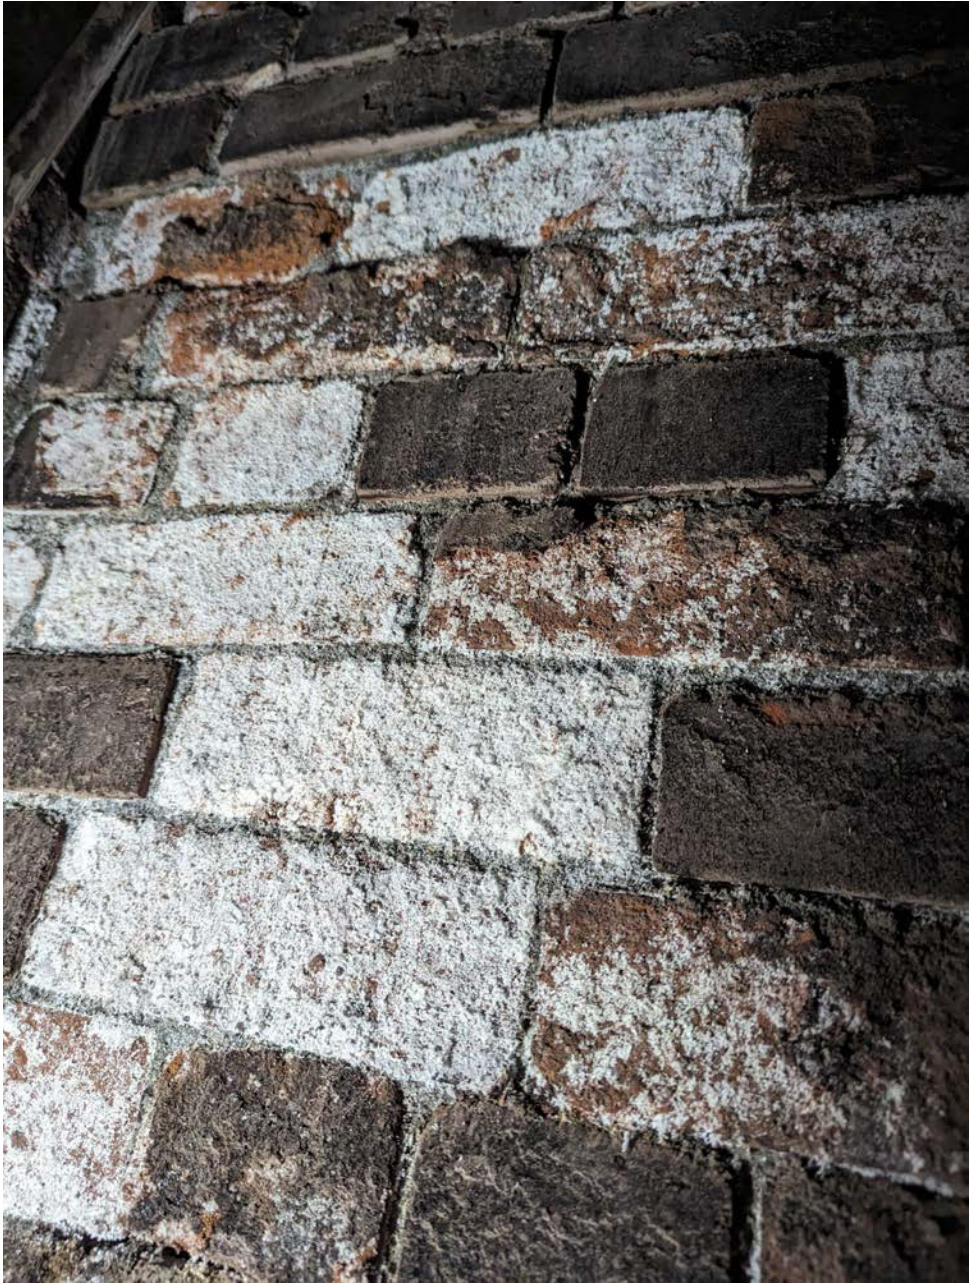
| | North Shaft | Brick face condition | Example of heavy salt build up |

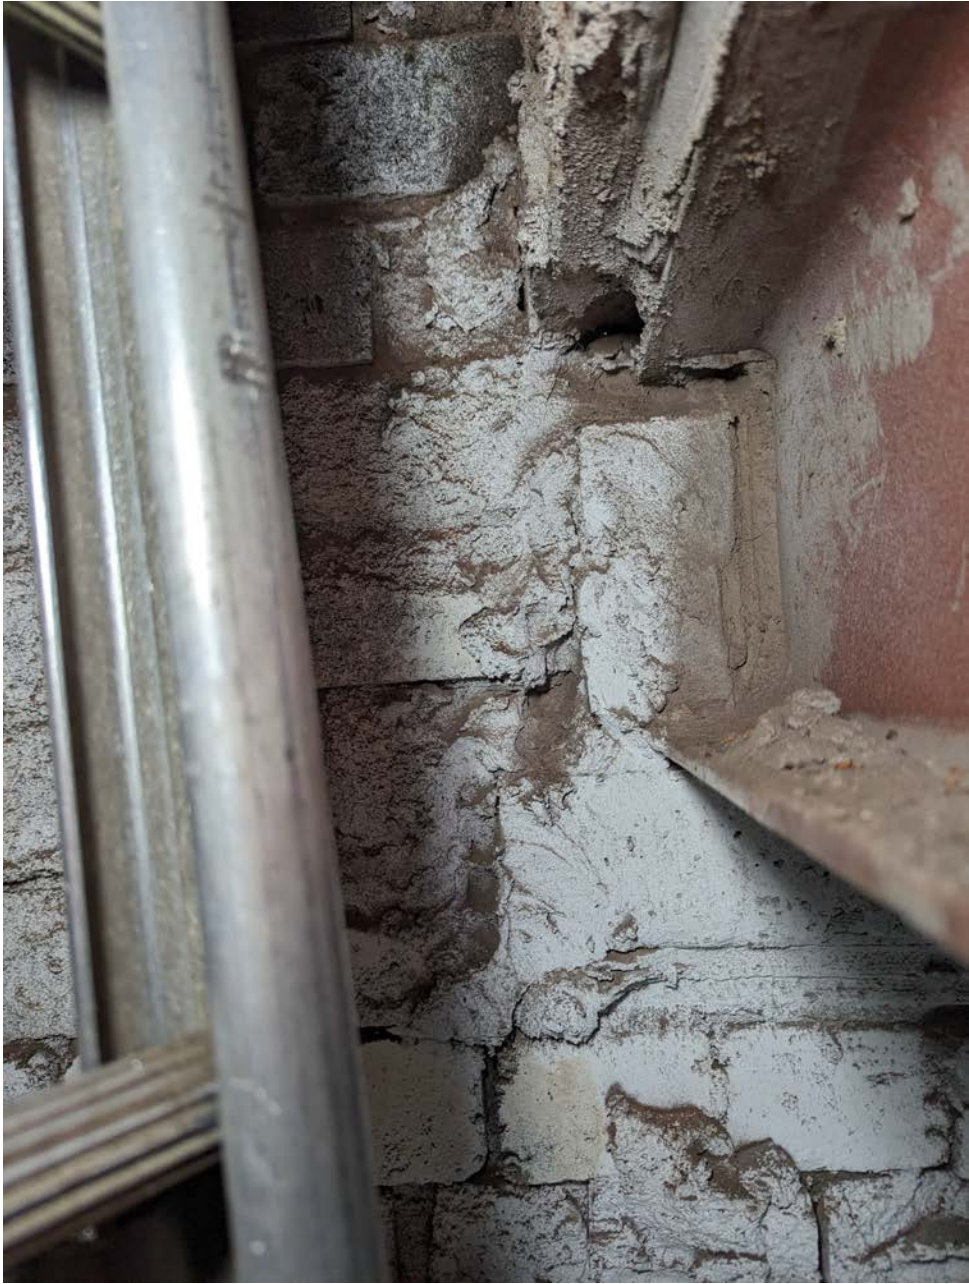
| | North East face | Beam end condition North side | Good condition, minimal localised spots of surface rust. |

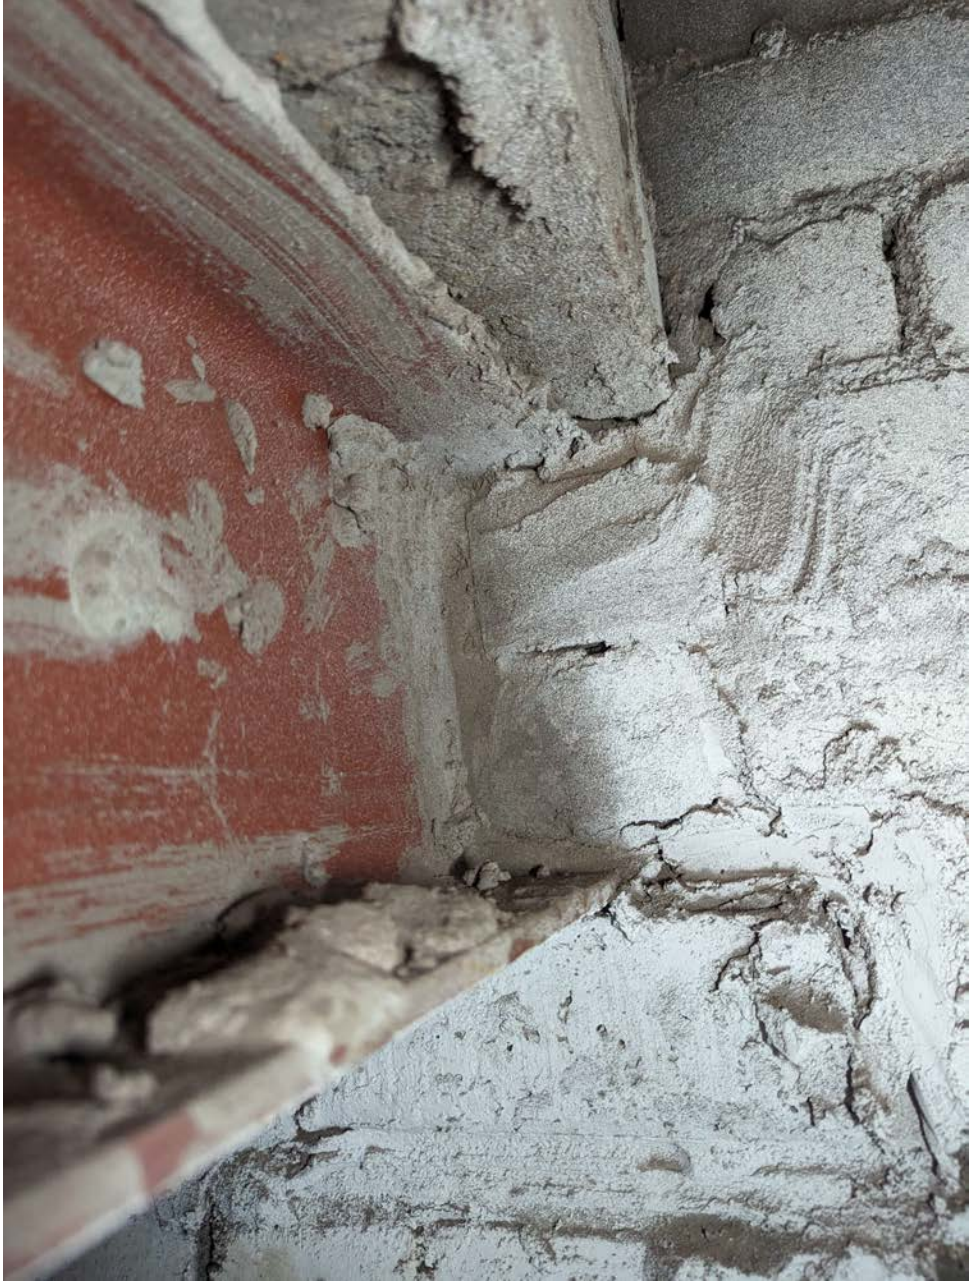
| | North East Face | Beam end condition South side | Good condition |

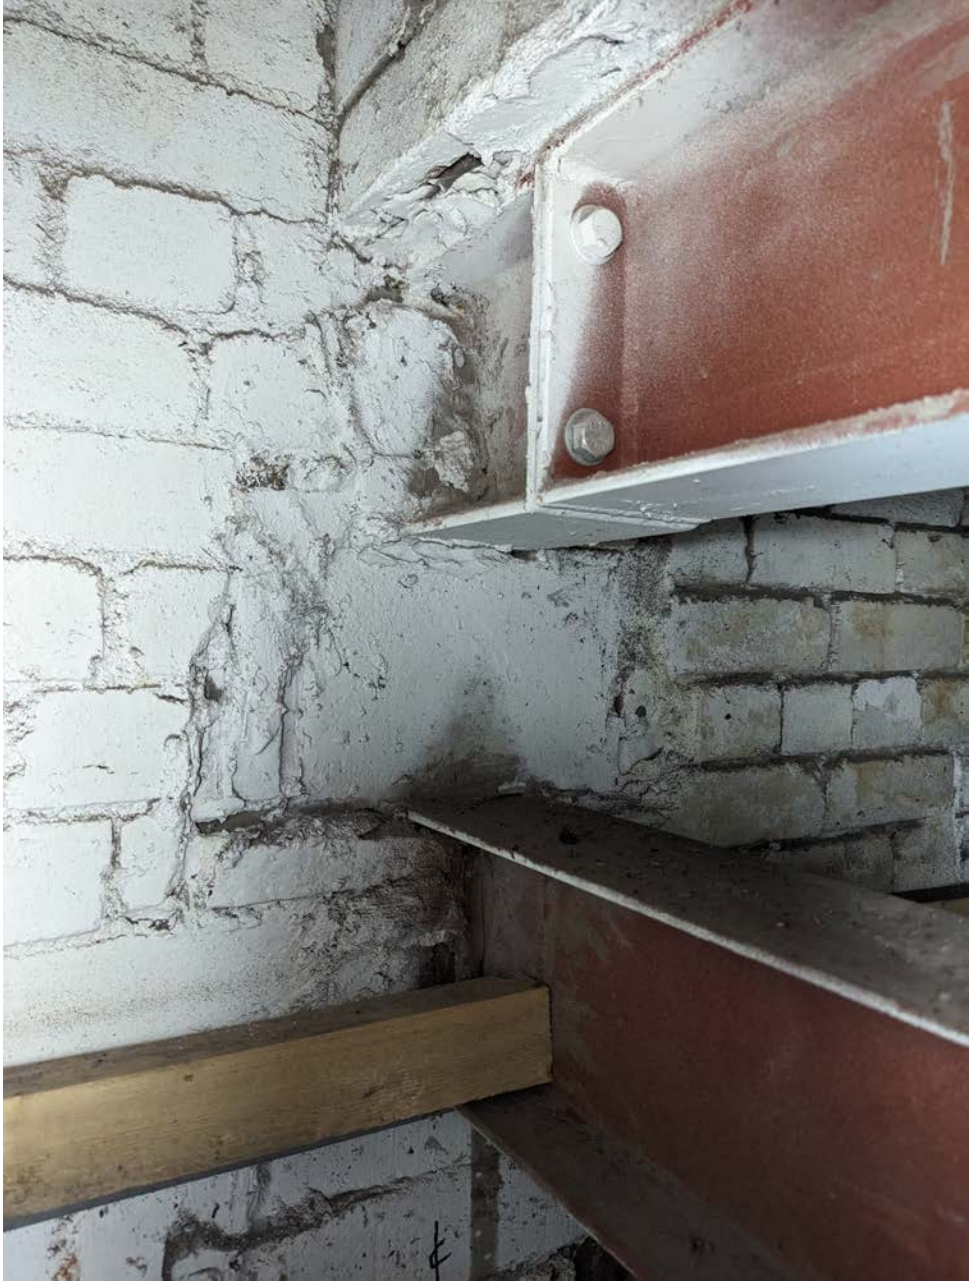
| | South East Face | Beam end condition North side | Good condition, fixings in good condition. |

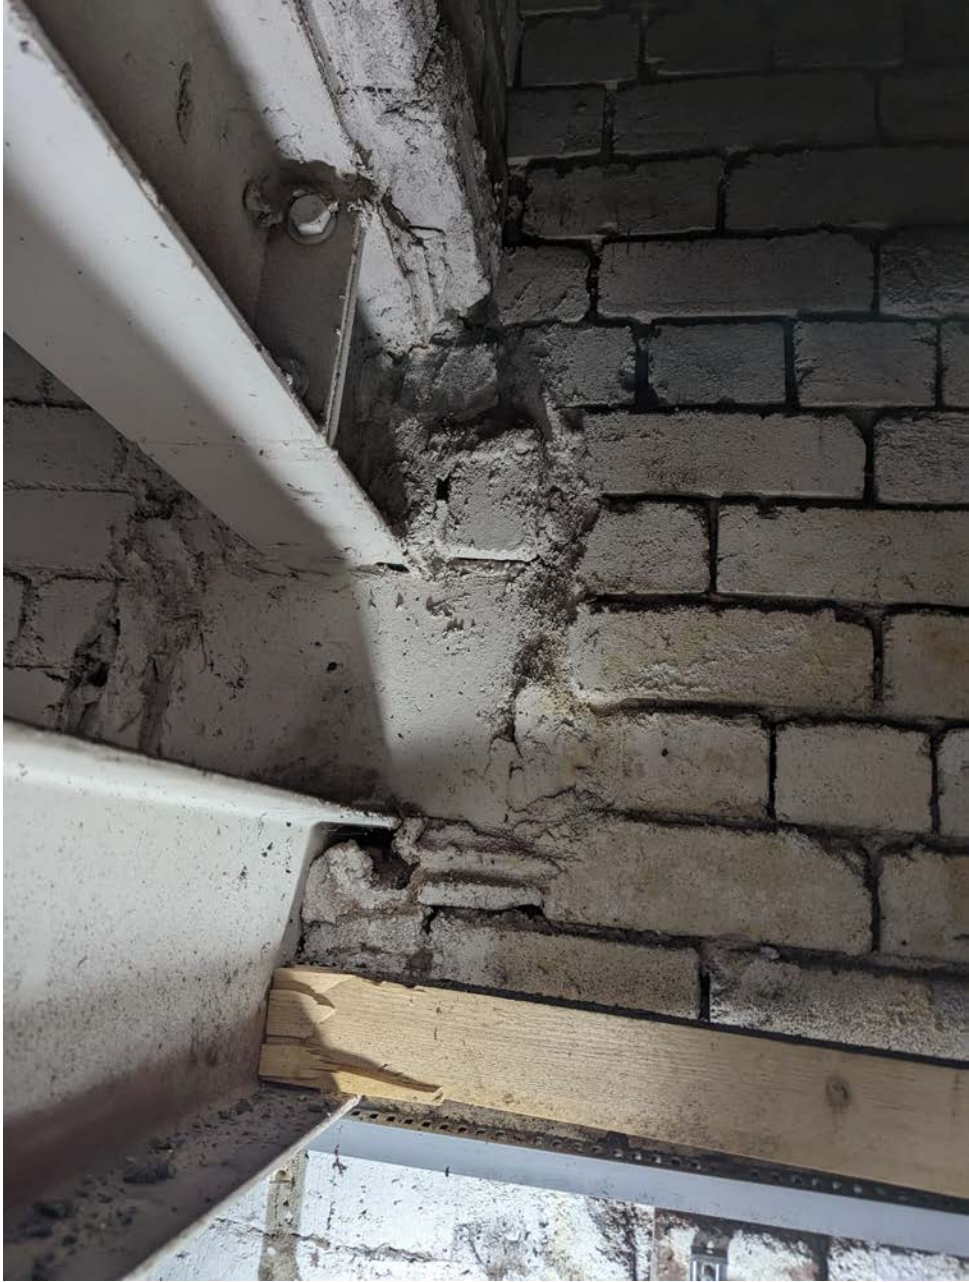
| | South East Face | Beam end condition South side | Good condition, fixings in good condition. |

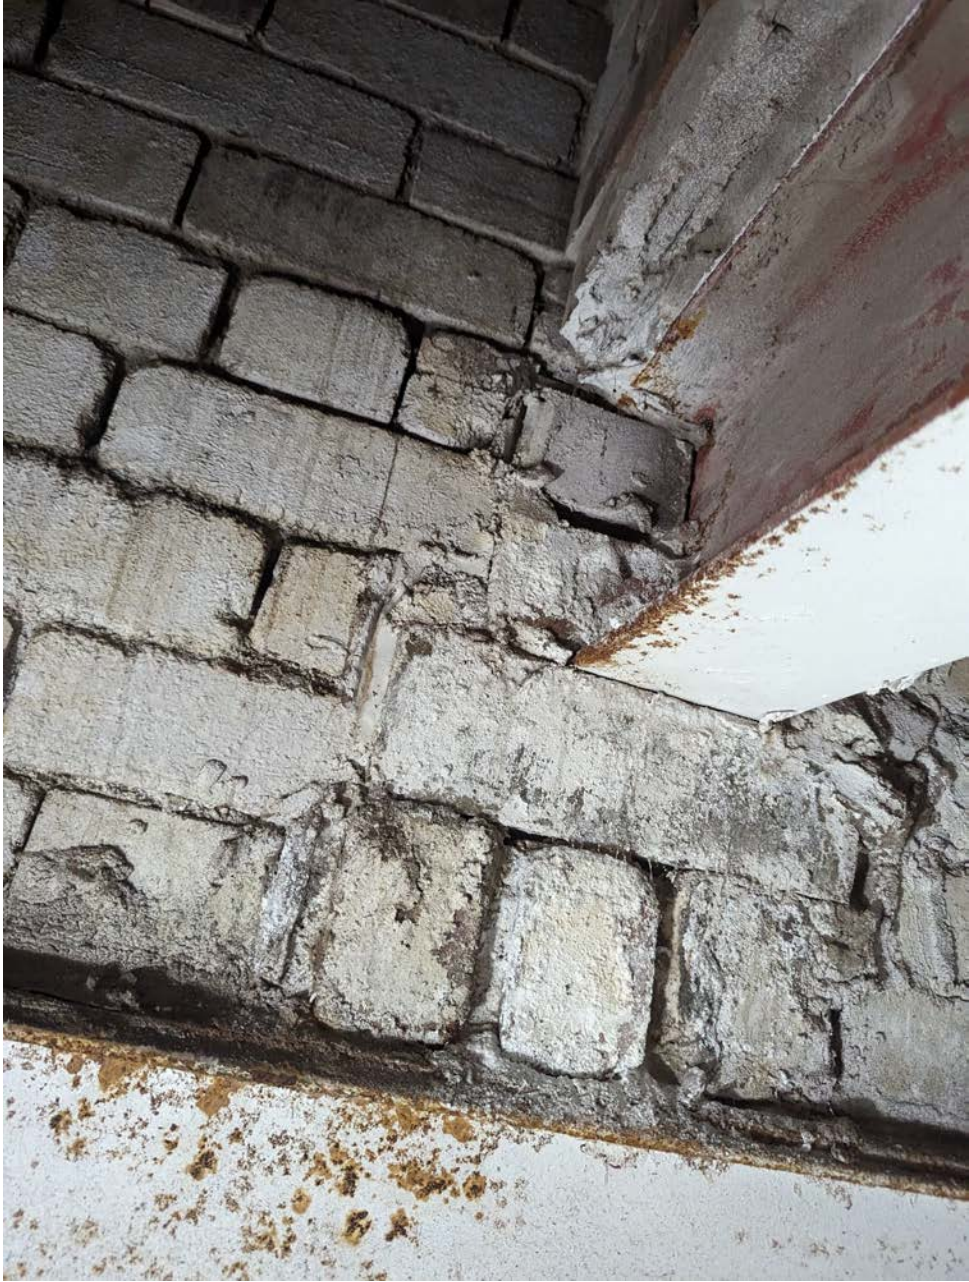
| | South west face | Beam end condition East side | Showing signs of surface rust at the entrance to the wall. Indicating water ingress in this area. Also slight streaking from water on internal face directly above the beam. |

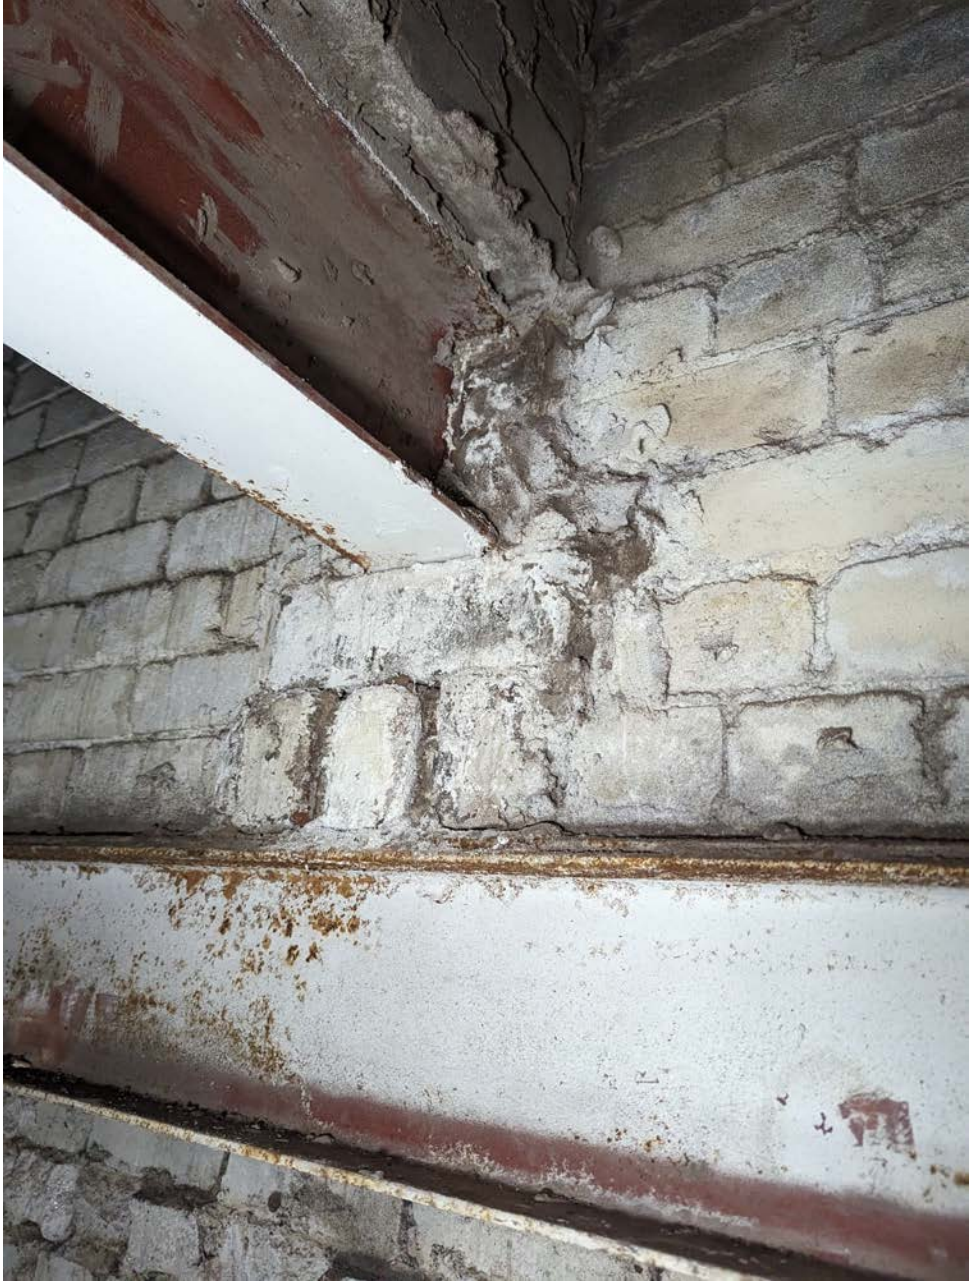
| | South West face | Beam end condition West side and also lintel beam in wall face | Showing signs of water ingress and more general surface rusting showing water ingress along the width of the wall. Streaking can be seen on the left side but not on the right. The left is the side with the external wall identified on the external survey. |

On the most part the internal of the tower is dry and the water is only localised to the south wall where the small wall intersects the tower. The faults of this have been identified on the external survey.

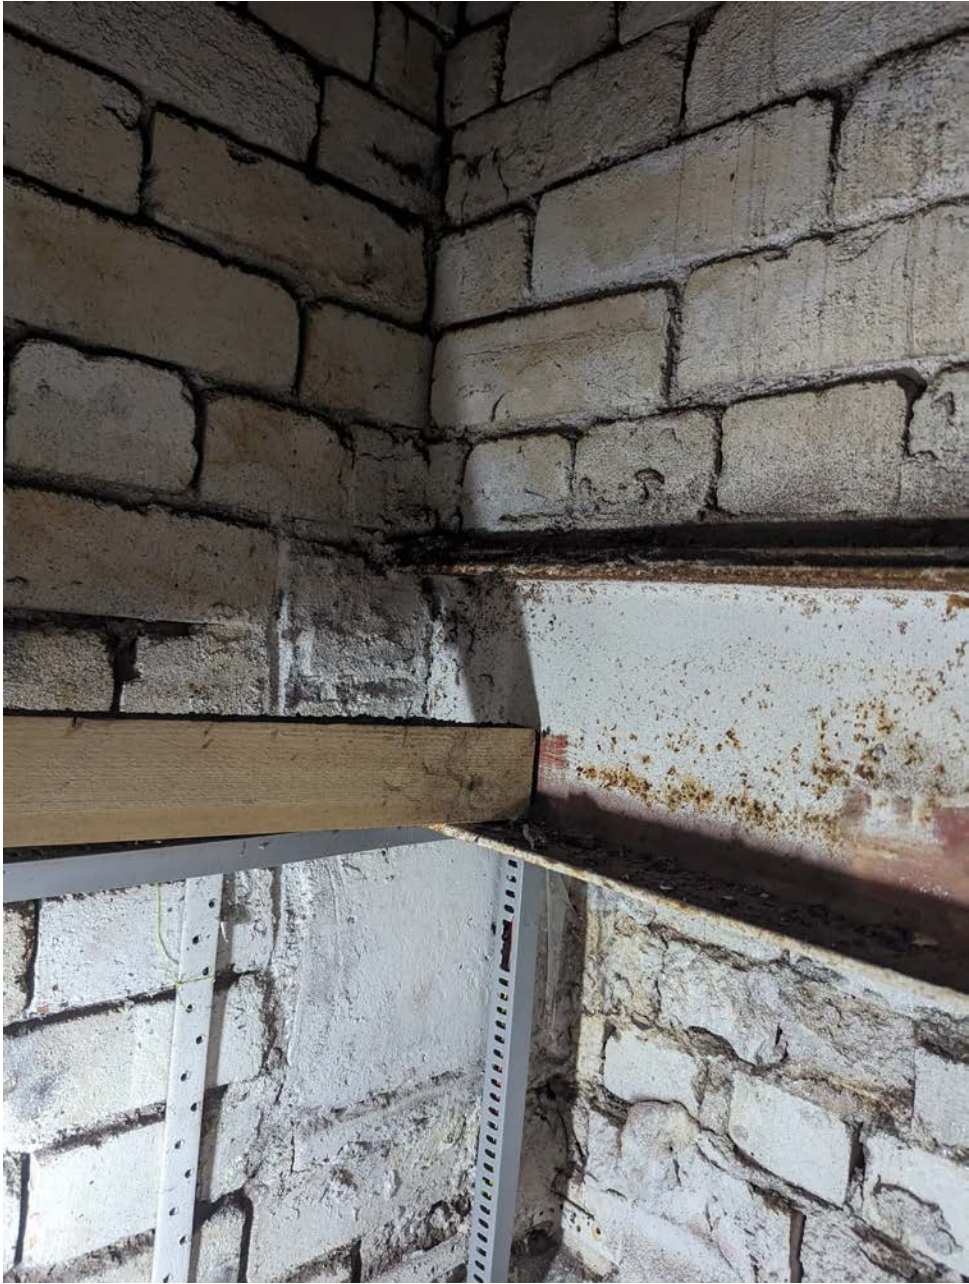
| | South west face | Lintel wall beam East end | Showing signs of general surface rust and beginnings of some delamination.. |

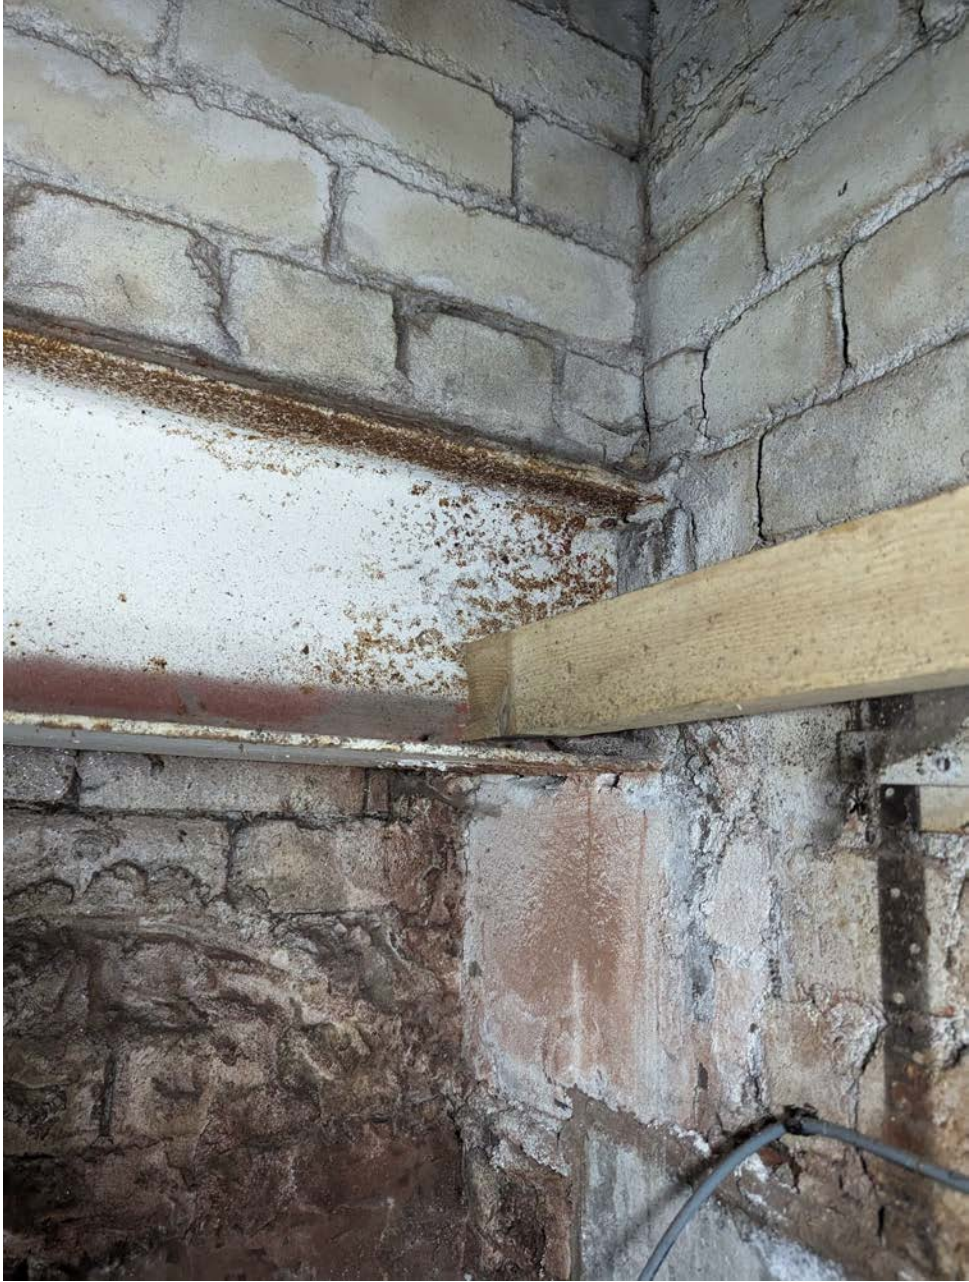
| | South west face | Lintel beam West end | Showing signs of general surface rust and beginnings of some delamination. |

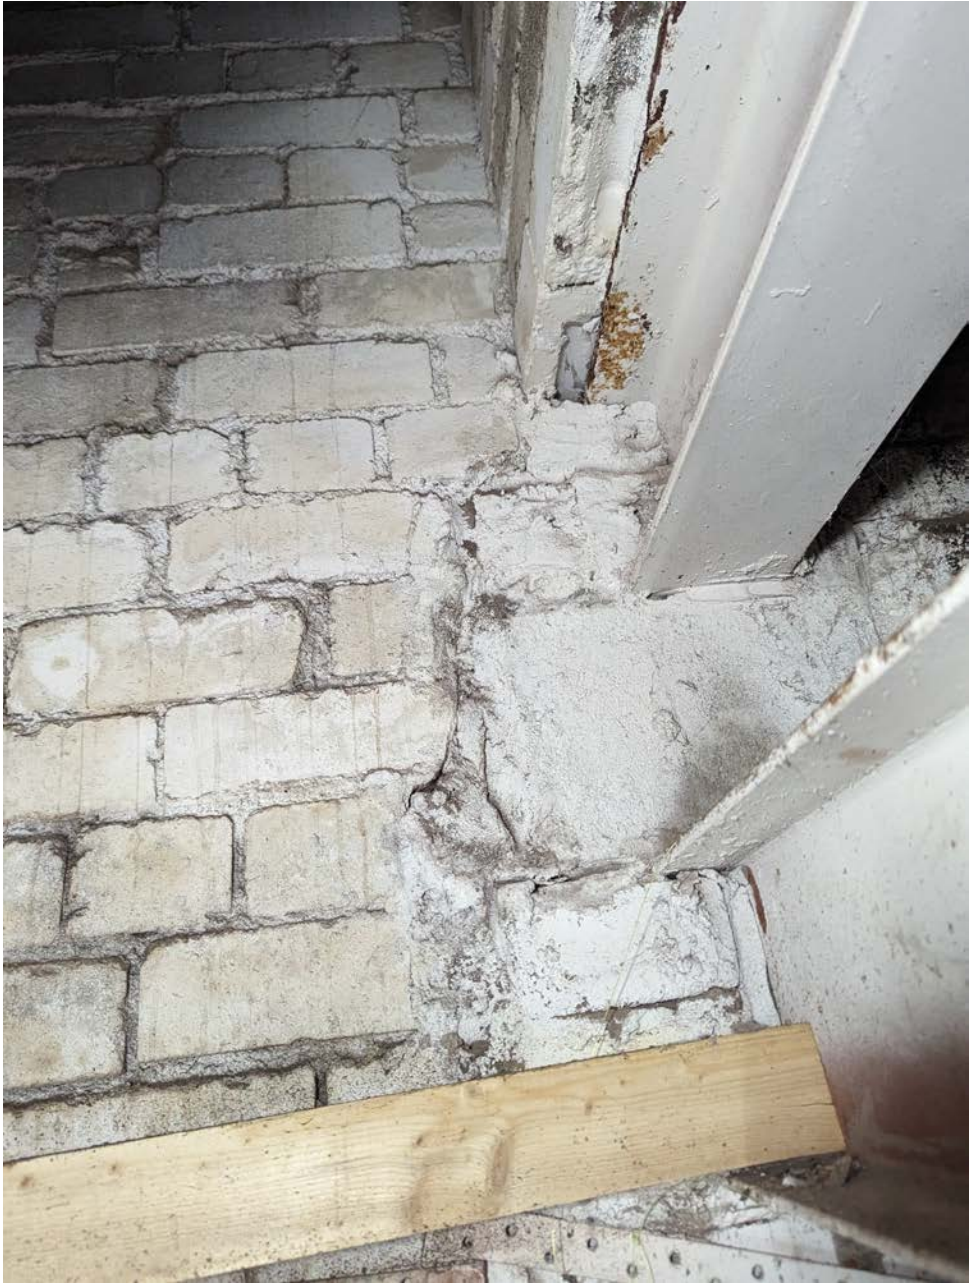
| | North west face | Beam end condition South side | Good condition with signs of localised surface rust |

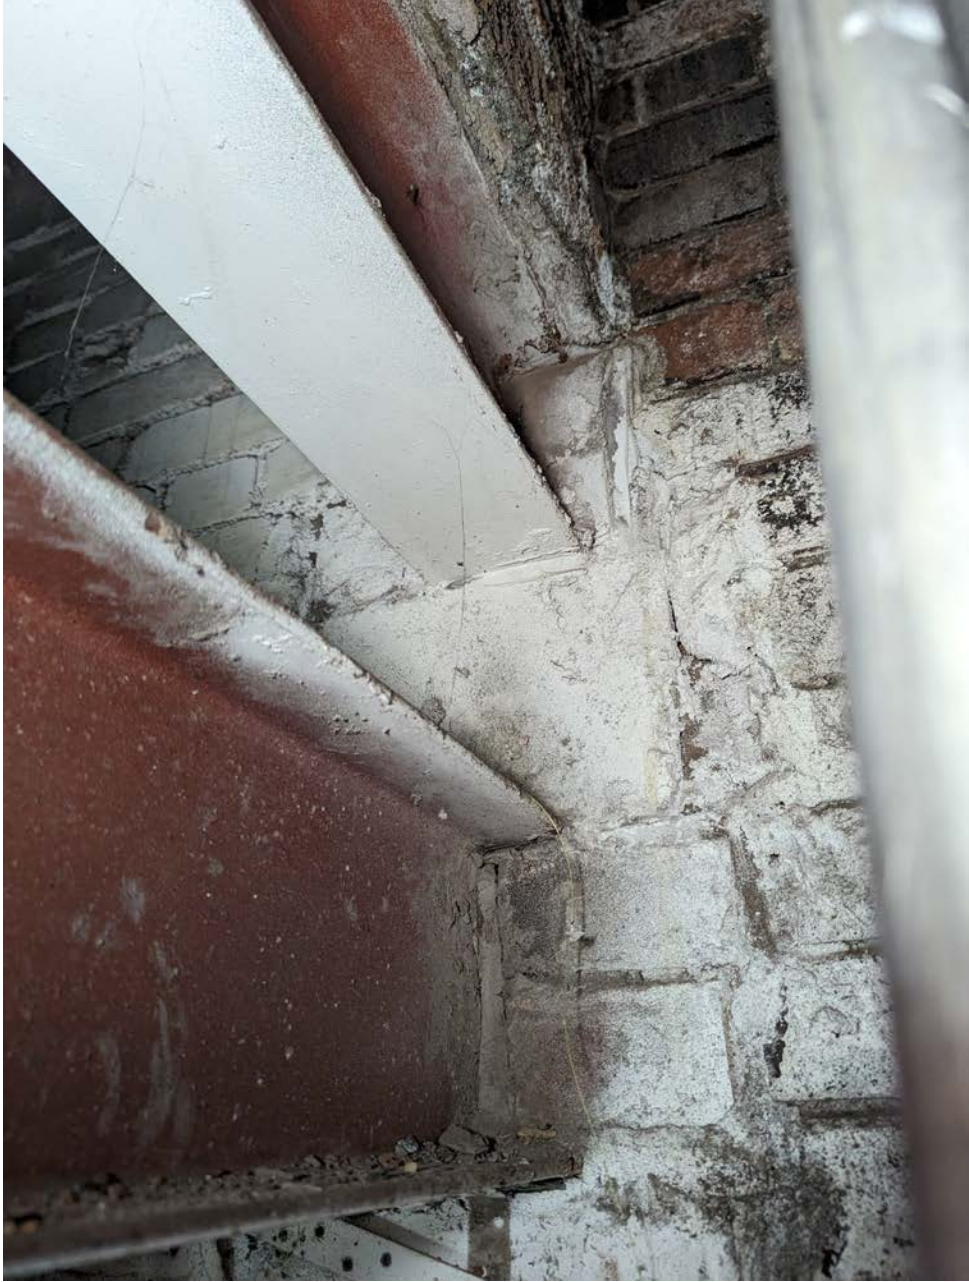
| | North west face | Beam end conditions<br>North side | Good condition with some signs of localised surface rust |

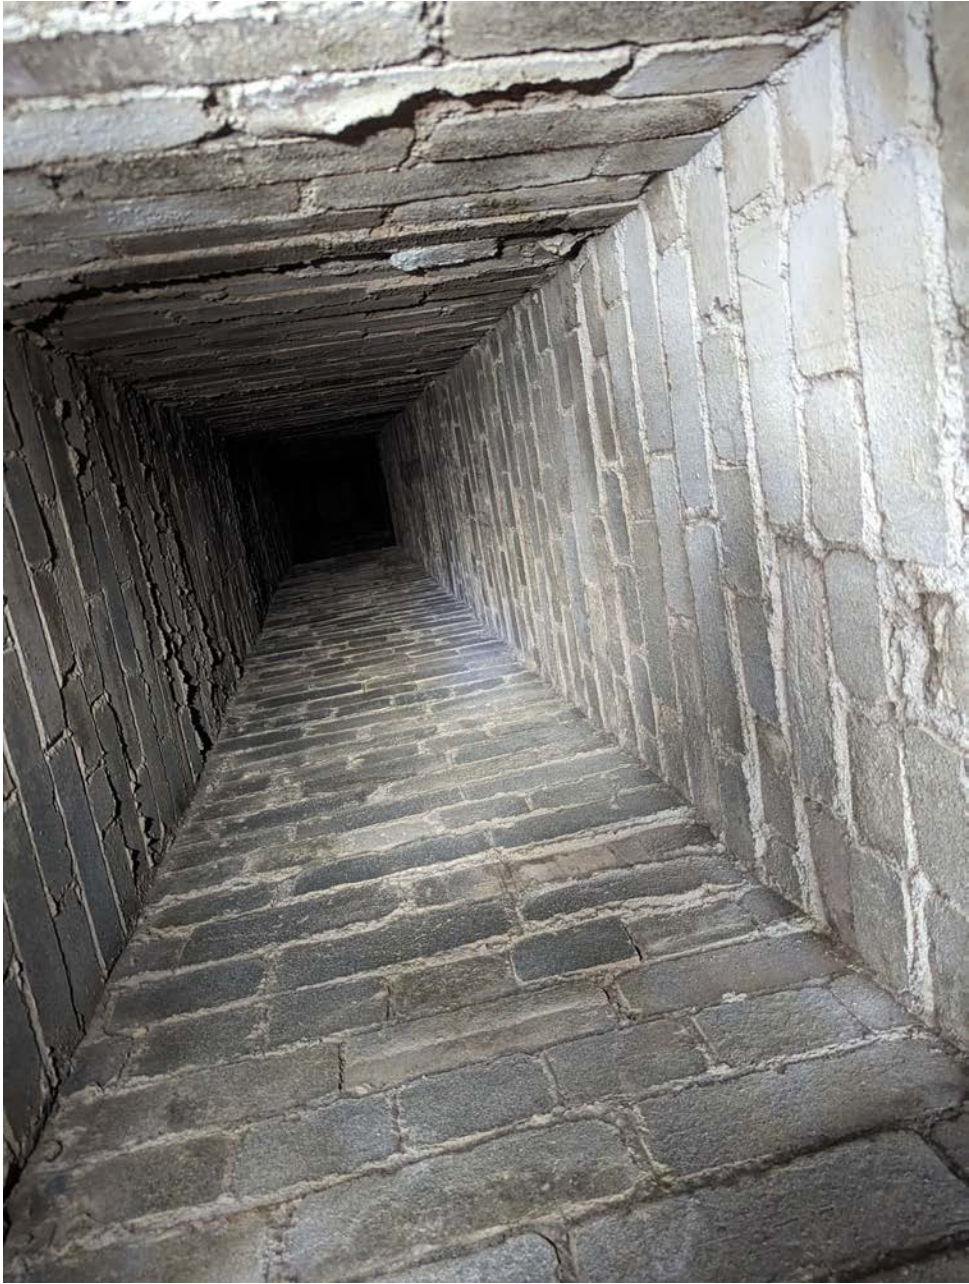
| | West Shaft | West shaft showing small signs of surface exfoliation and brick faces degrading. | |
