# HIGHLIFE

### BURY FUSILIERS MUSEUM - INTERNAL VENTILATION TOWER INSPECTION REPORT

Inspection conducted on: 23 JUNE 2023

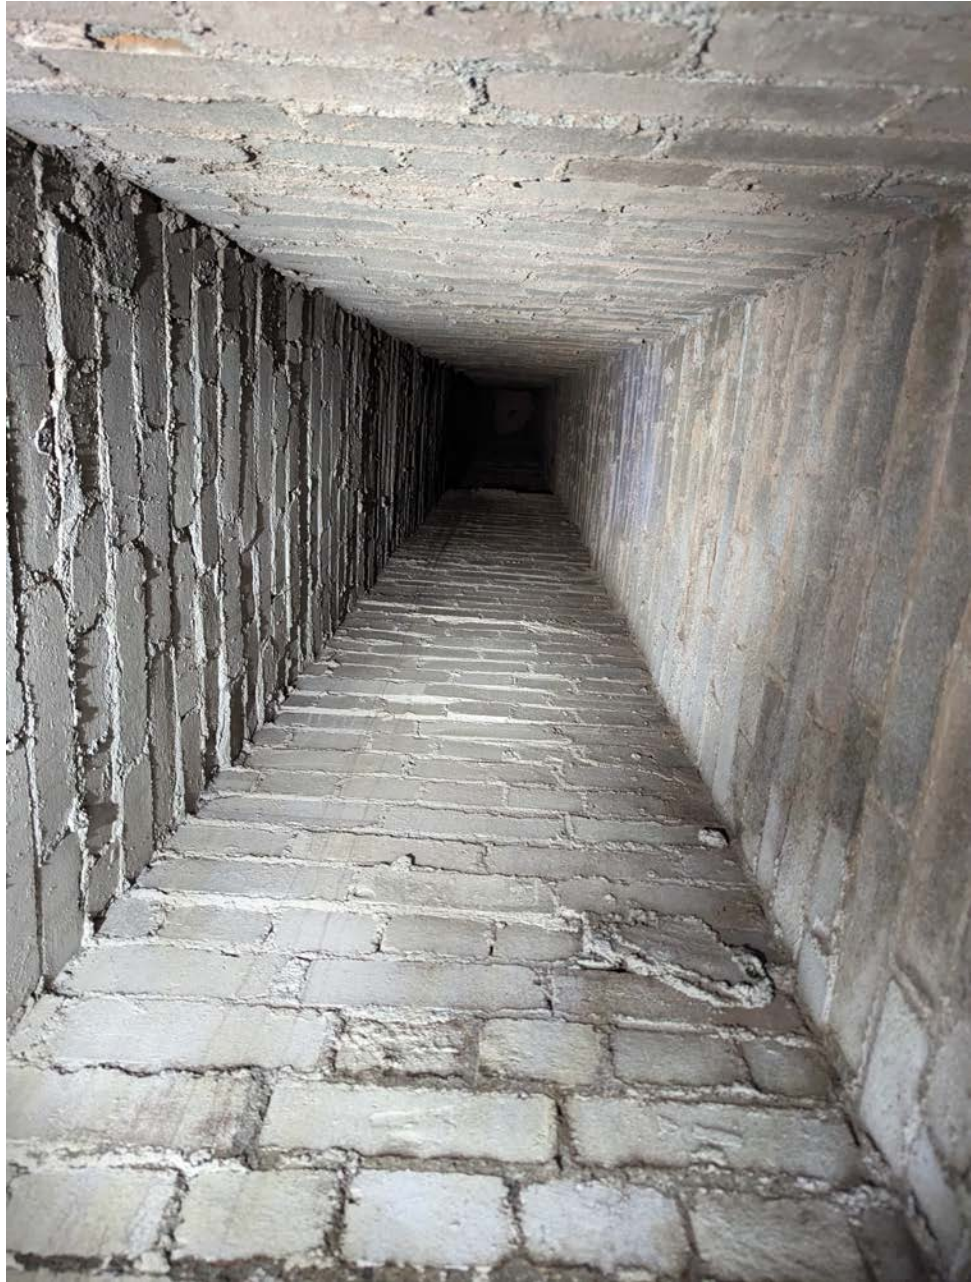
| | East Shaft | East shaft showing little damage to internal brick facing | |
