# HIGHLIFE

### BURY FUSILIERS MUSEUM - VENTILATION TOWER INSPECTION REPORT

Inspection conducted on: 18-19 May 2023

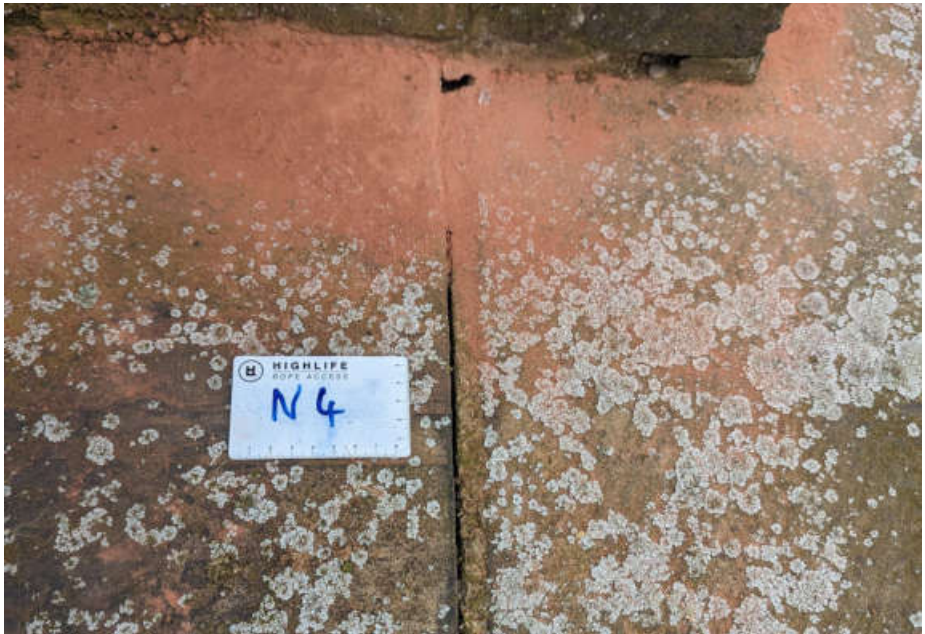
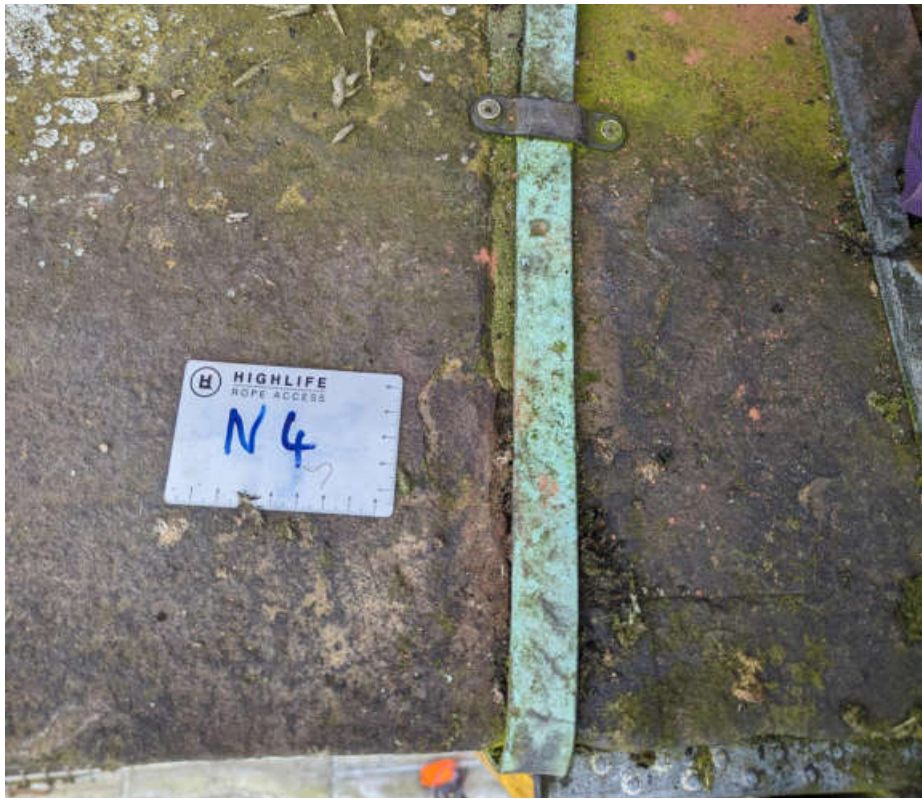
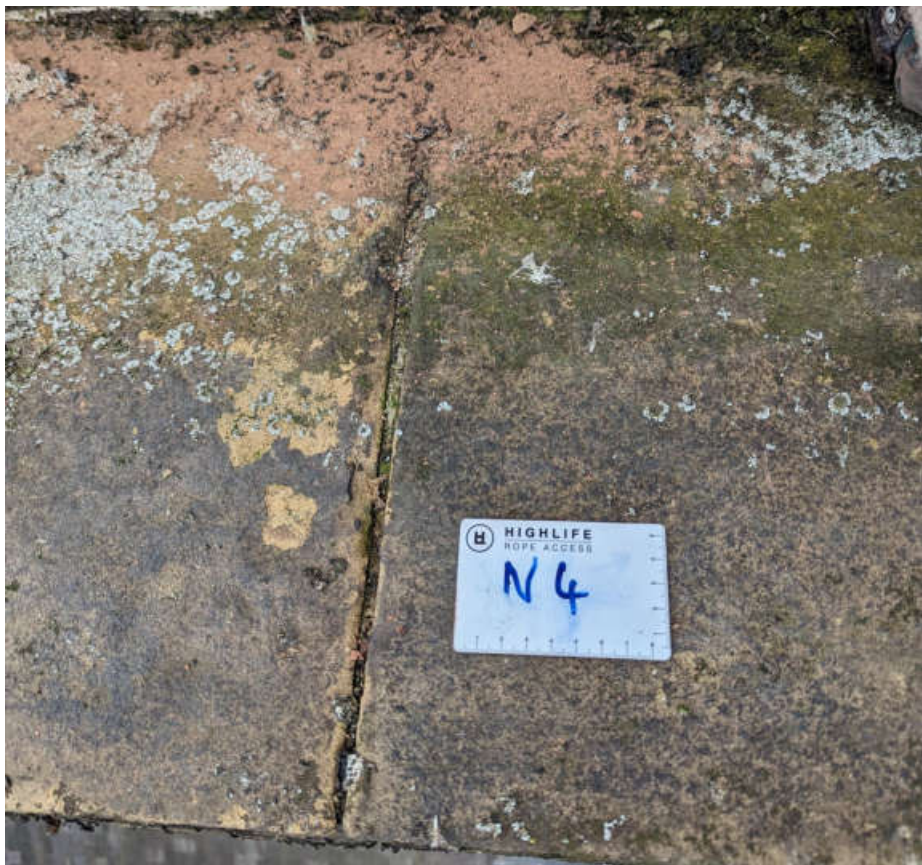
| N4 | Cornice | Open skyward facing perpend joints | Rake out joints and repoint using a suitable mortar. A lead covering on the cornice may be desirable as this could also be used to create a drip - currently there is no drip detail on the bottom edge of the cornice which may cause water to track down the masonry below, and may also be contributing to minor exfoliation on the corbels |

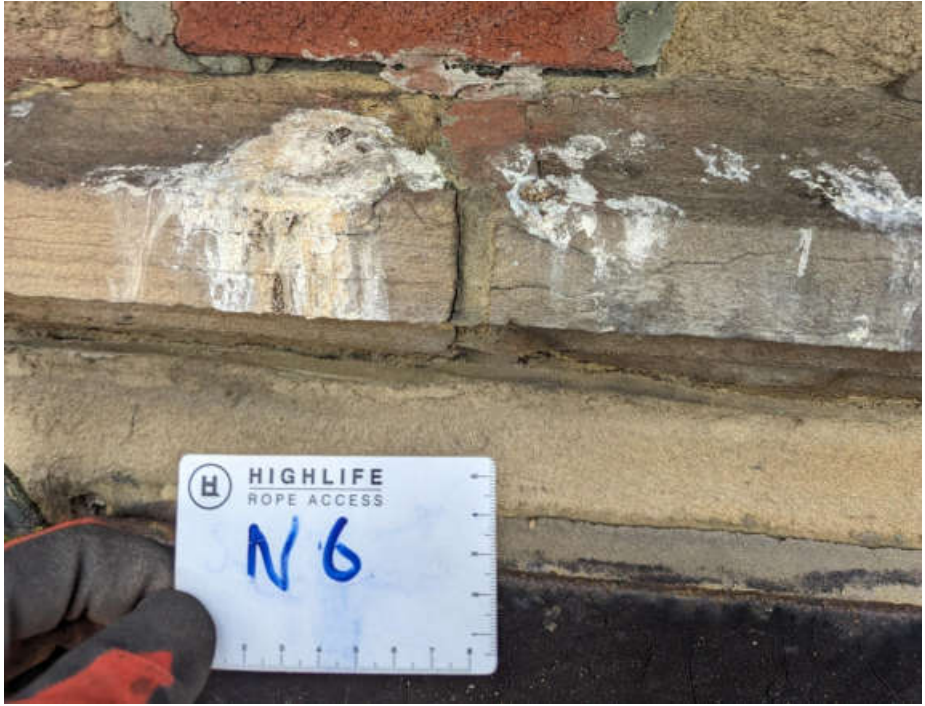
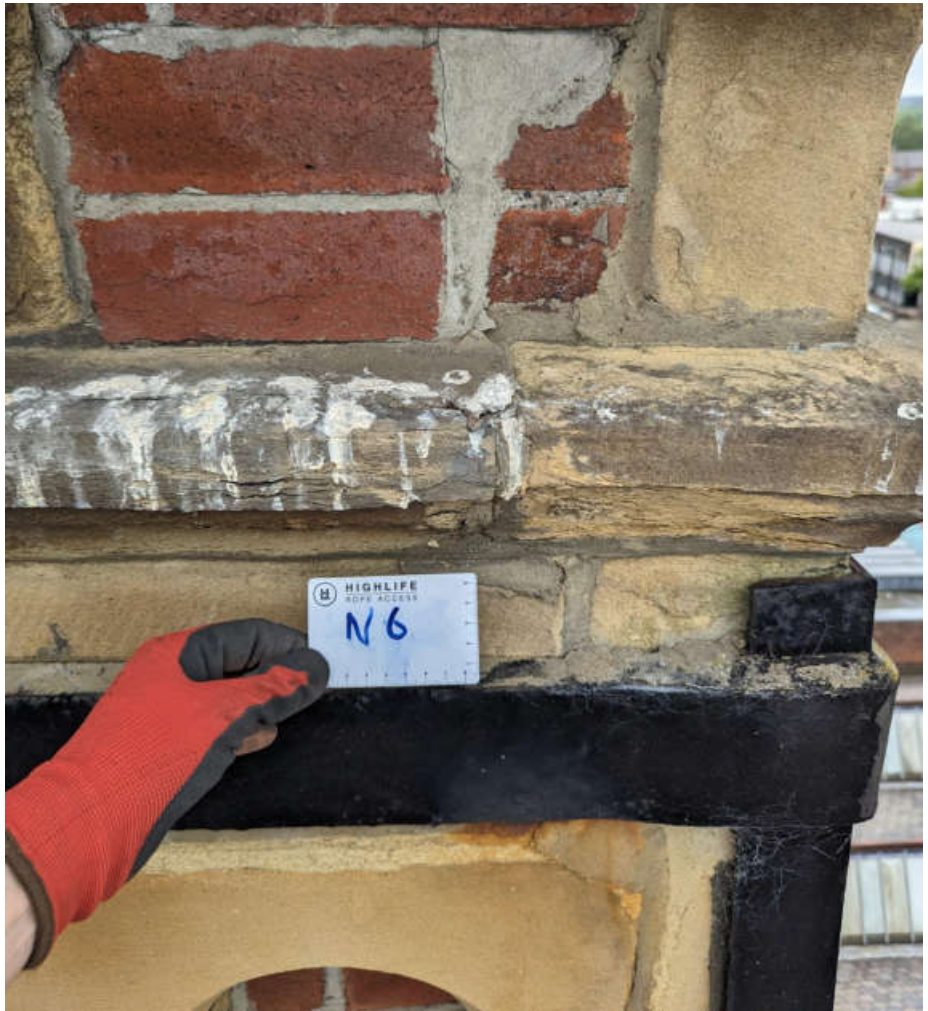
| N6 | Photos | | |

| N6 | String course below corbels | Open skyward facing perpend joints and deterioration of stone | Rake out joints and repoint with a suitable lime mortar. It may be preferable to perform minor mortar repairs to help the string course to shed water |

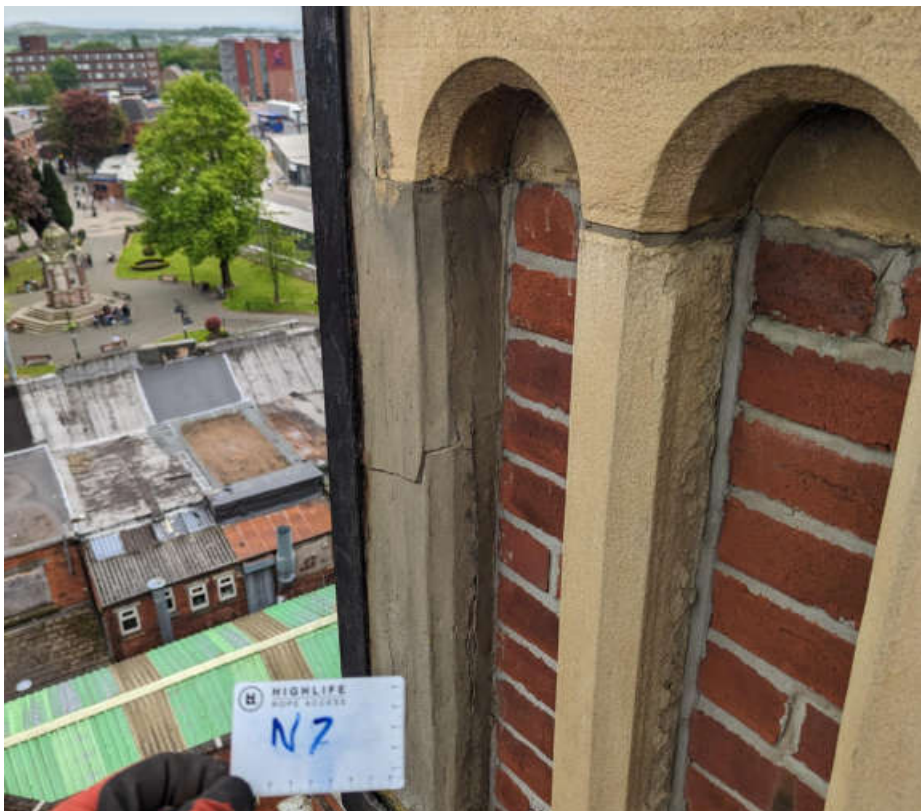
| N7 | Mullions of arched stone details | Deteriorating mortar repairs, stable at the time of inspection | Remove and reinstate mortar repair if high enough priority |

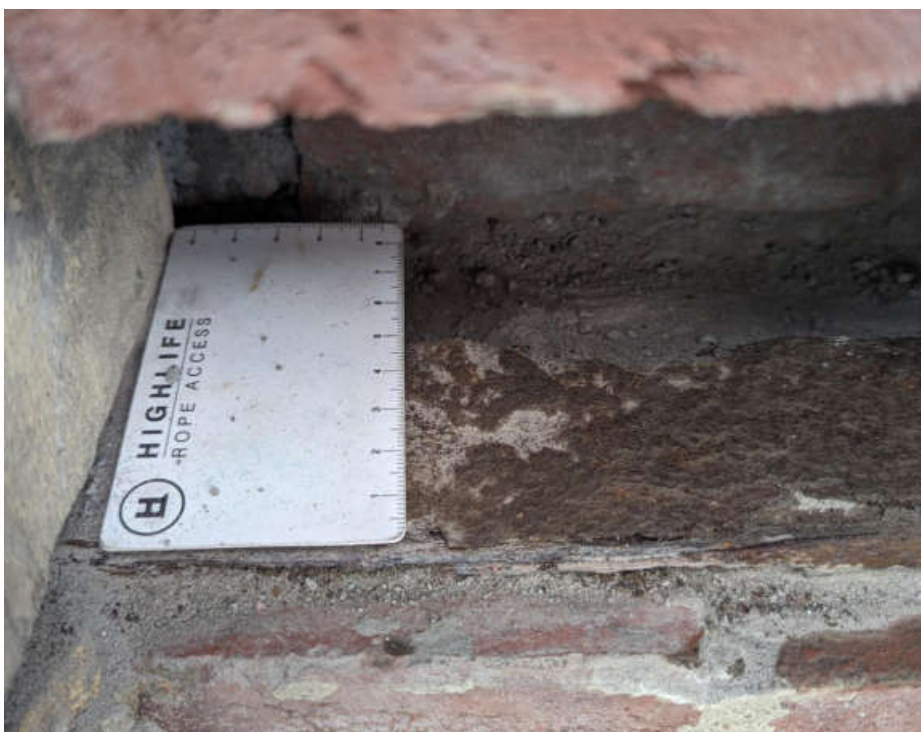
| N8 | Halfway down mullions of arched stone details | <p>Embedded iron bed reinforcement has corroded significantly, jacking up the structure above in the region of 10mm. Possibly the metal cage/ armature boxing in this area was installed to combat this, but the issue will persist until either the corrosion can be stopped or the metalwork removed. Following conversation with architect Rob Chambers an investigation was performed by removing a brick to assess the depth of the bed reinforcement - this was 60mm. A sample of the metal was taken so that it can be assessed</p> | <p>Given the heavily corroded nature of the metal work, our recommendation would be to remove and replace the bed reinforcement. Following our close investigation we feel that this would be fairly straightforward given that it is only one brick deep. This would likely require the temporary removal of a course of bricks. Given that the dowels in the mullions have caused some of the mullions to spall, it may be desirable to also remove these at the same time, which would make removing and replacing the bed reinforcement more straightforward. The solution for removing the dowels would likely involve cutting out a section spanning the joint with the dowel, and indenting some new stone with stainless dowels to secure</p> |

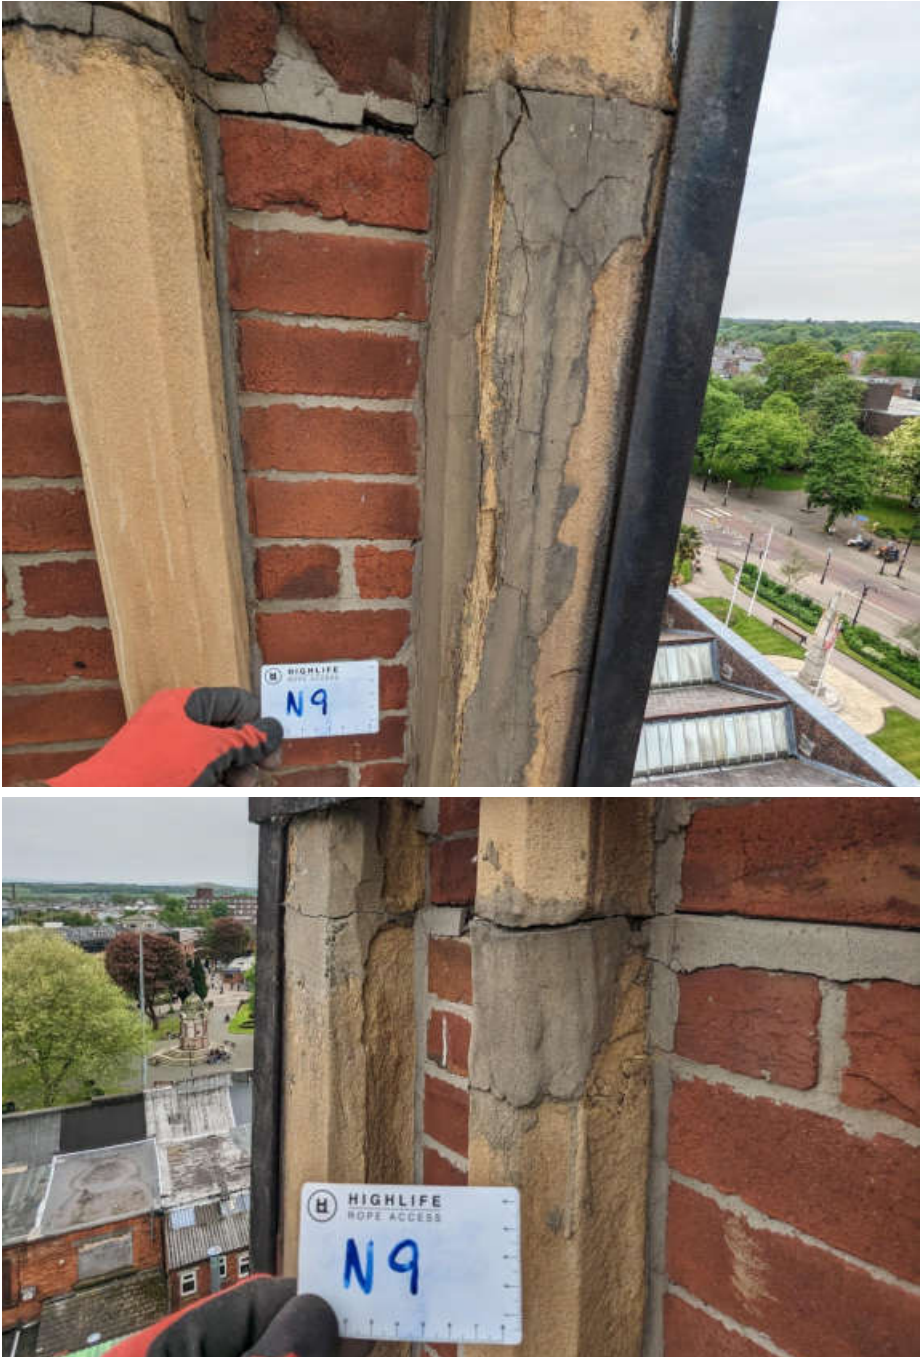
| N9 | Lower mullion section on NW arete | Deteriorating mortar repairs, stable at the time of inspection. Some of these illustrate that the spalled mullions are likely caused by dowels at joints in mullions. | Remove and reinstate mortar repair if high enough priority. It may be necessary to remove dowels as mentioned in N8. This might be achieved by cutting out a section encompassing the dowel and indenting some new stone following installation of the bed reinforcement, with new stainless dowels to secure. |

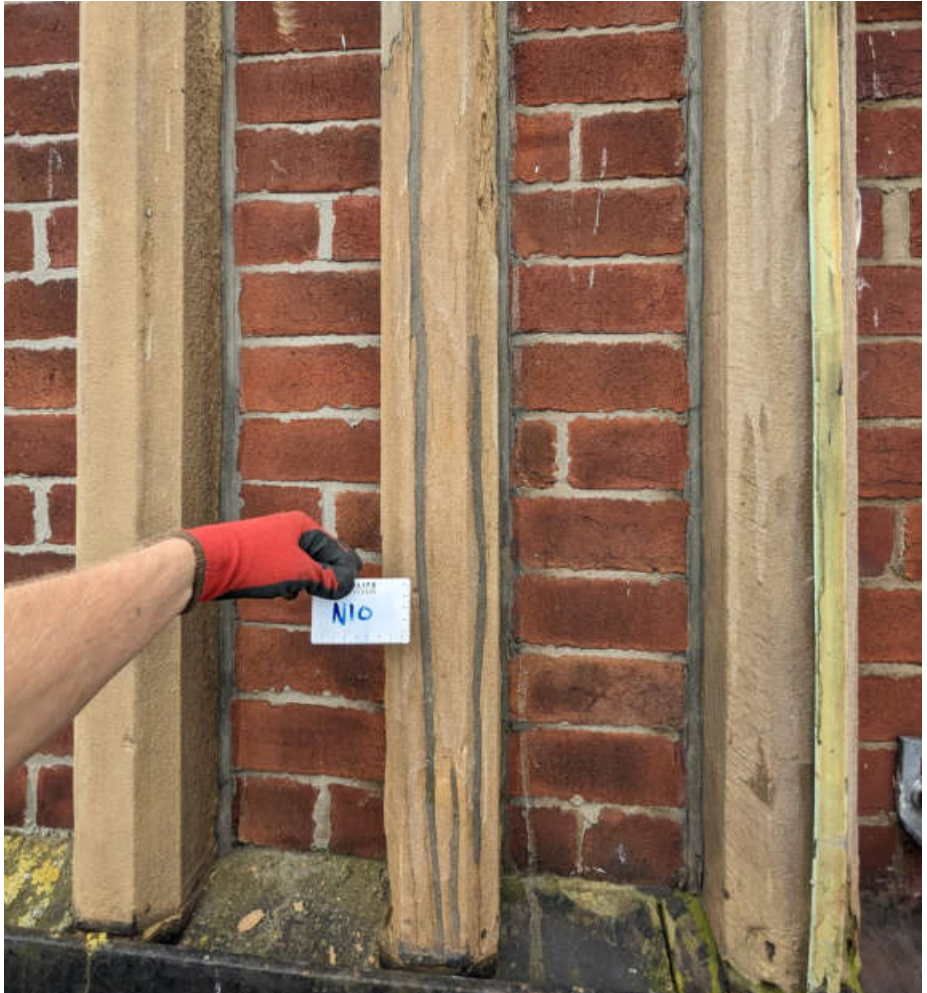
| N10 | Photos | | |

| N10 | Lower mullion section | Long vertical cracks in the mullion have been repointed. Cracks approx 10mm wide | The pointing is in fairly good condition, however if some of the mullions do wind up being indented it may make sense to replace this section. |

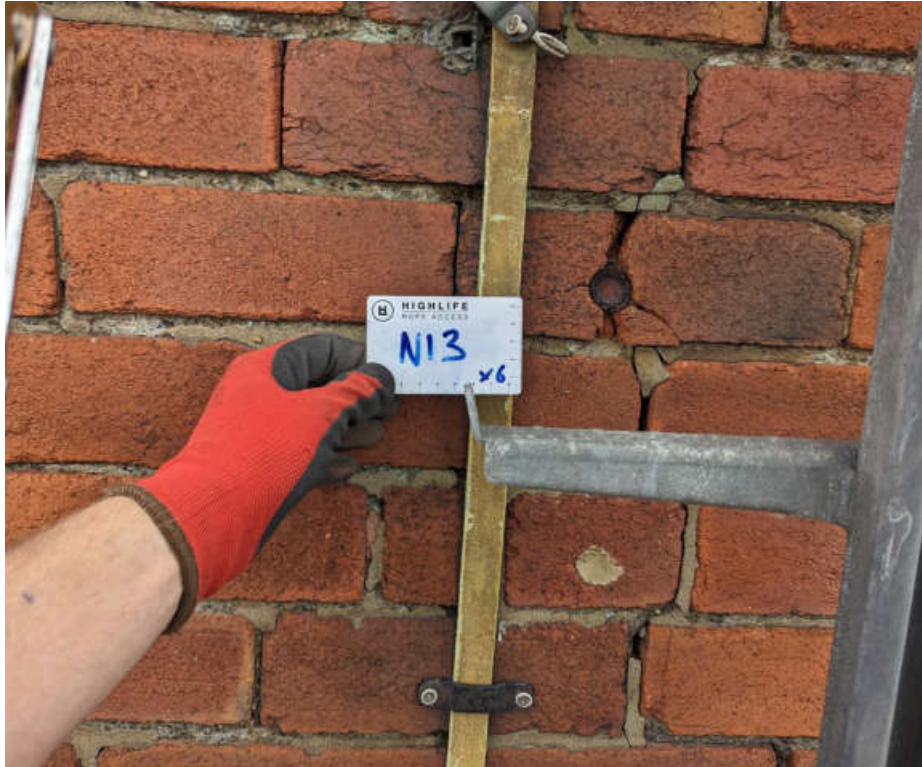
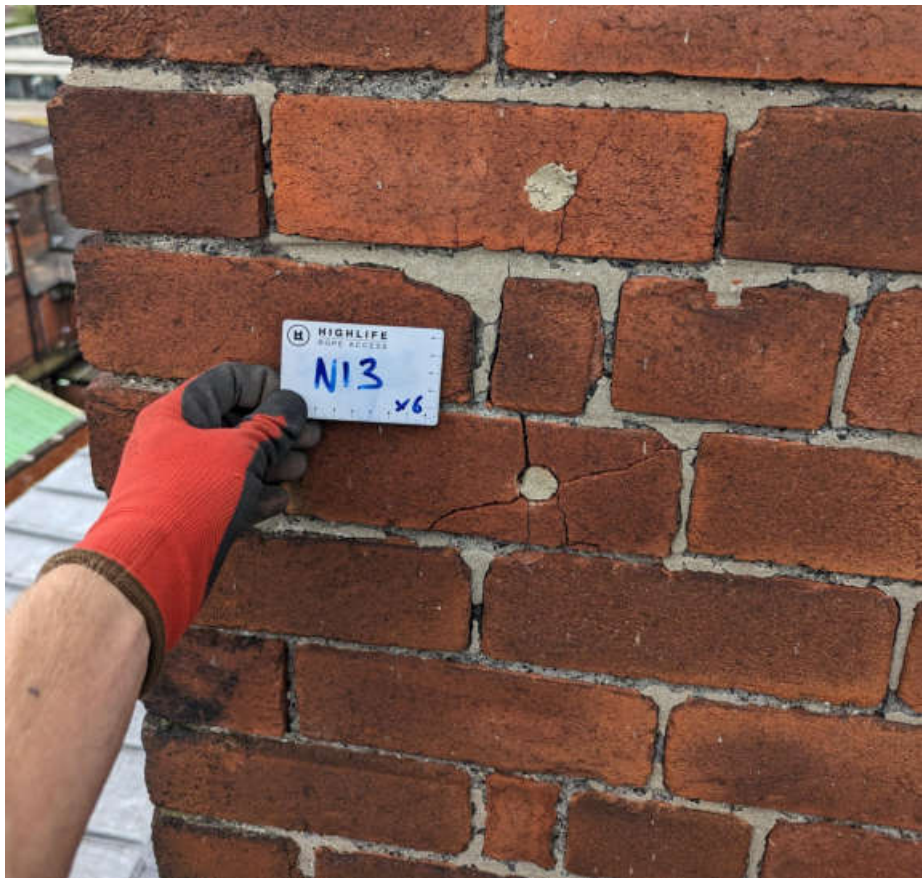
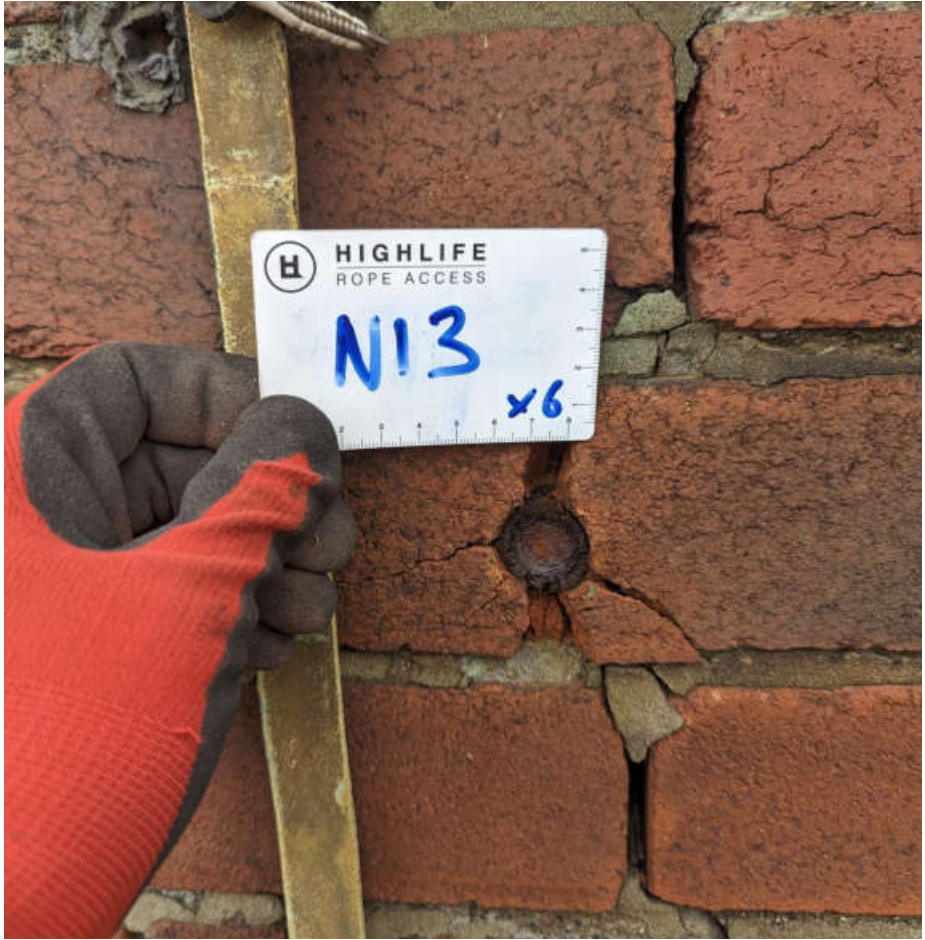
| N13 | Brickwork between sill and stone string course | 6no. Ferrous scaffold fixings. Some of these have corroded and caused the neighboring bricks to split, with cracks as wide as 10mm in places | Replace broken bricks and repoint with a suitable lime mortar. Where bricks are not broken, core out ferrous fixings and point |

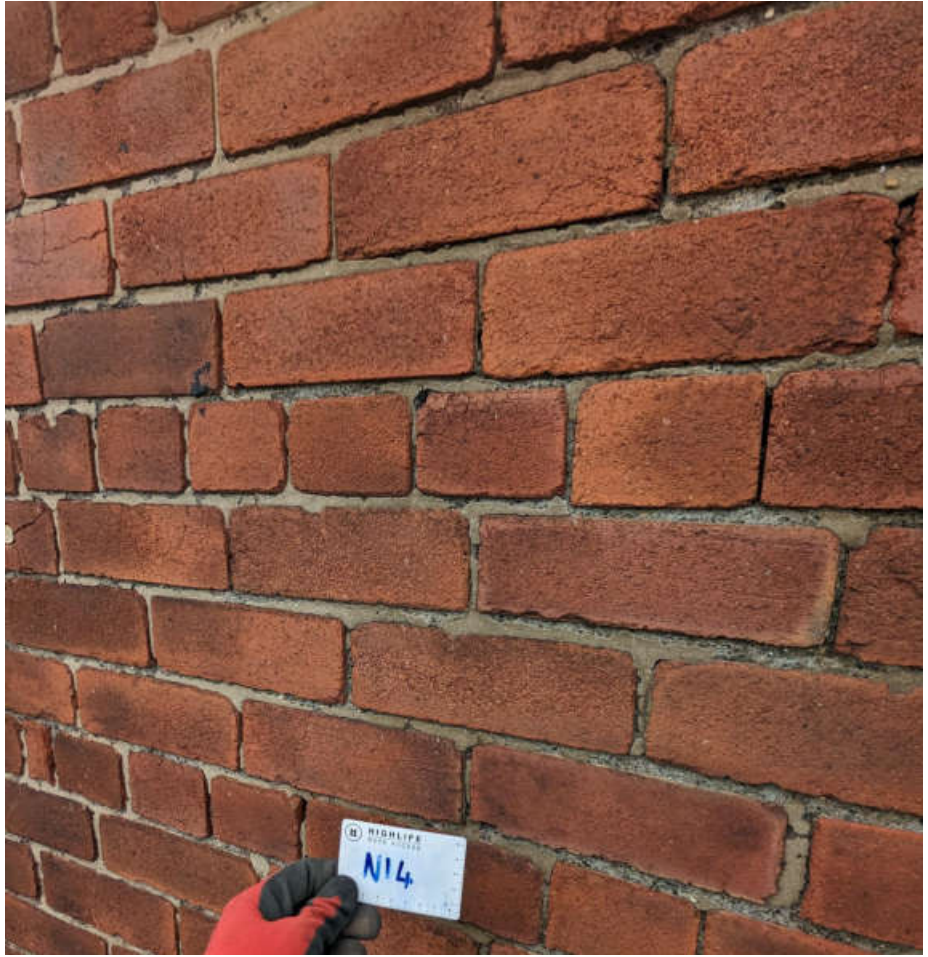
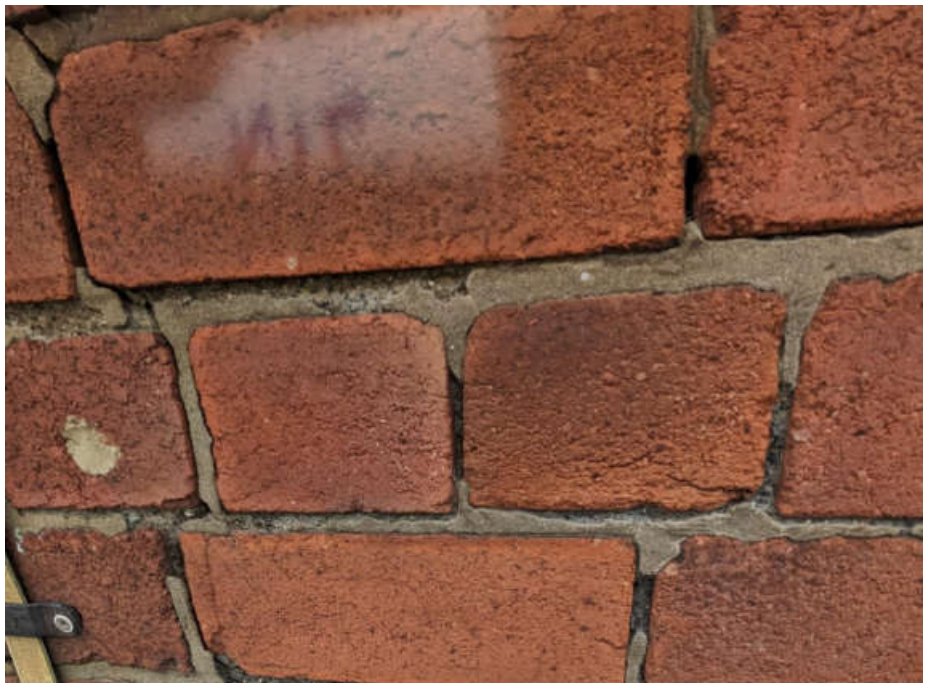
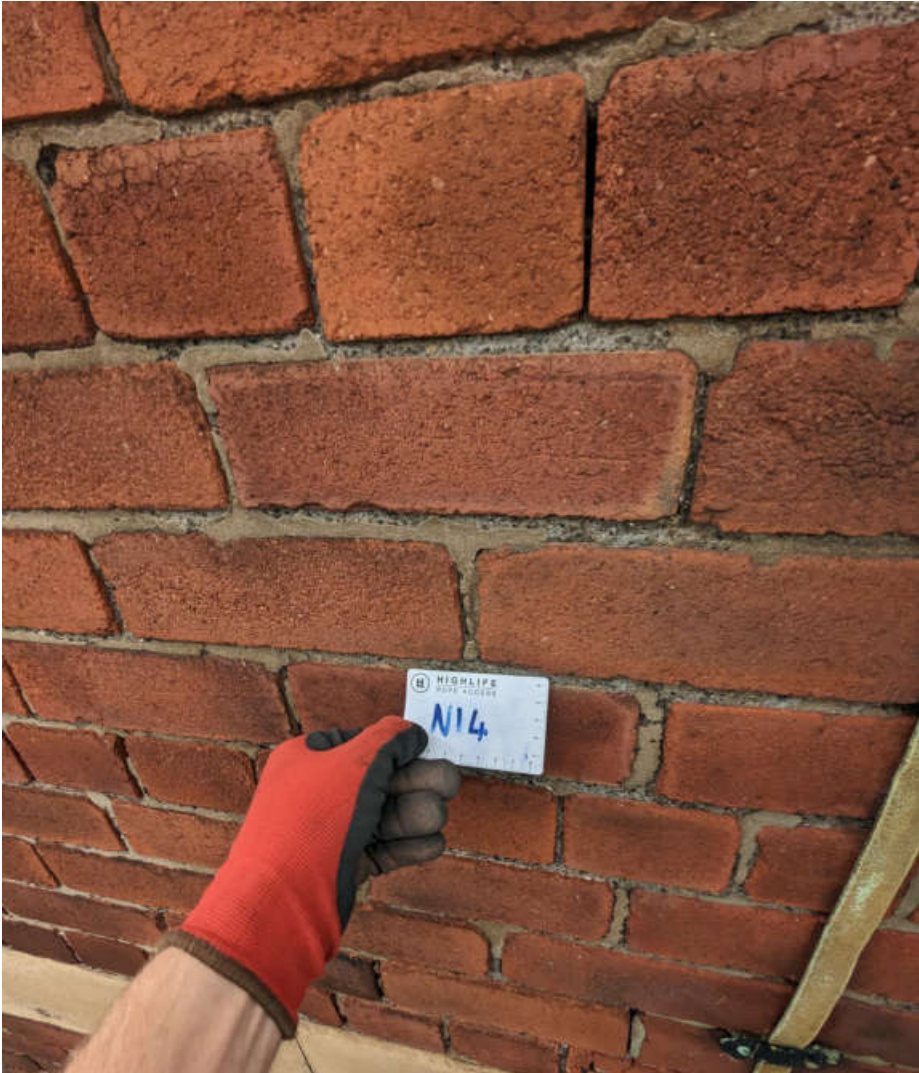
| N14 | Brickwork between sill and stone string course | <p>Photos showing the condition of the pointing, which is mostly in acceptable condition if not slightly recessed, with occasional open perpend joints. Some poor quality cementitious face pointing</p> | <p>Repoint open joints with a suitable lime mortar. Investigate beneath poor quality loose cementitious face pointing</p> |

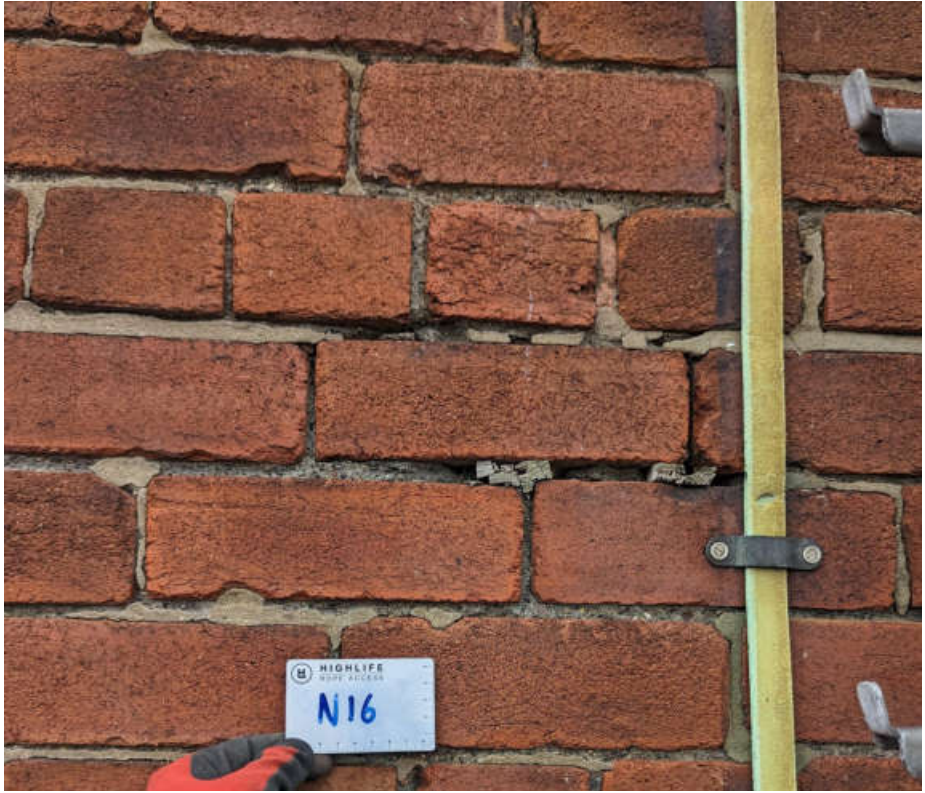
| N16 | Photos | | |

| N16 | Brickwork below stone string course | Photo showing particularly poor area of pointing | Rake out and repoint with a suitable mortar |

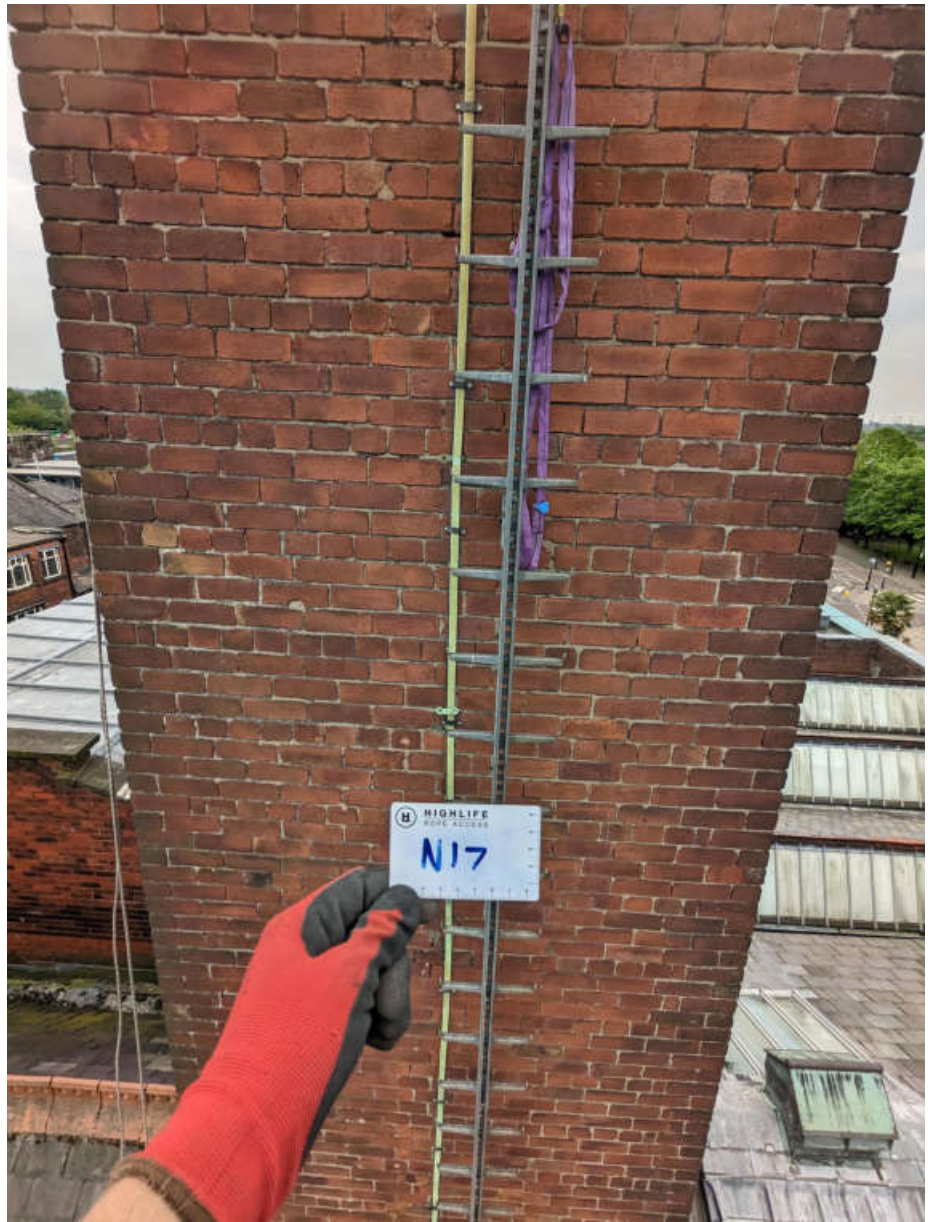
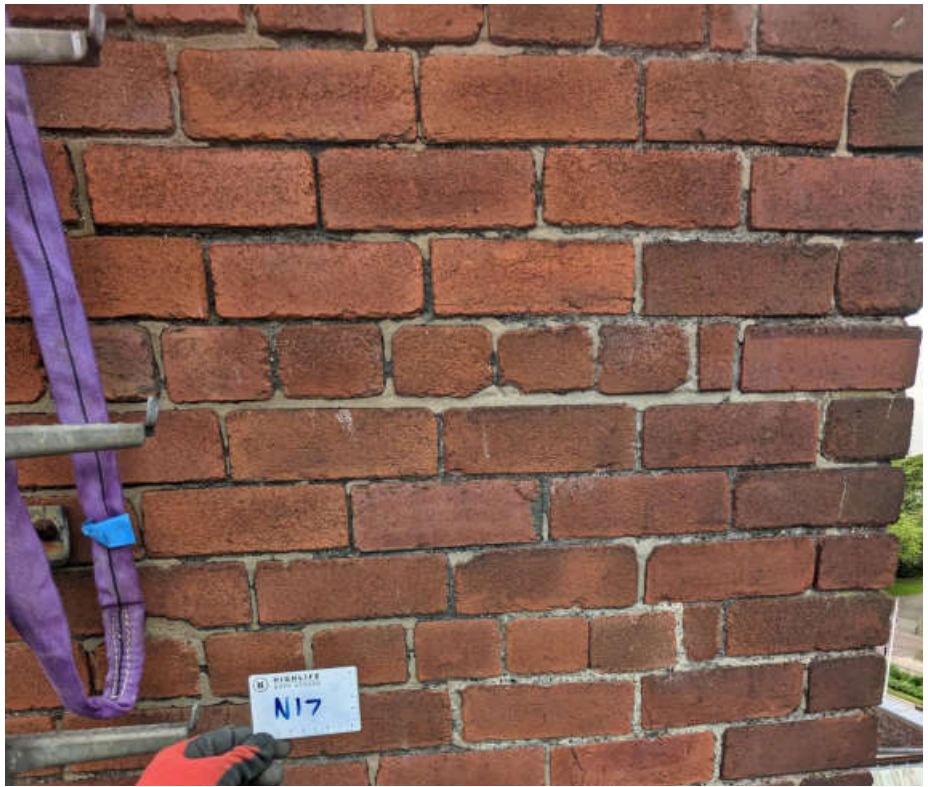
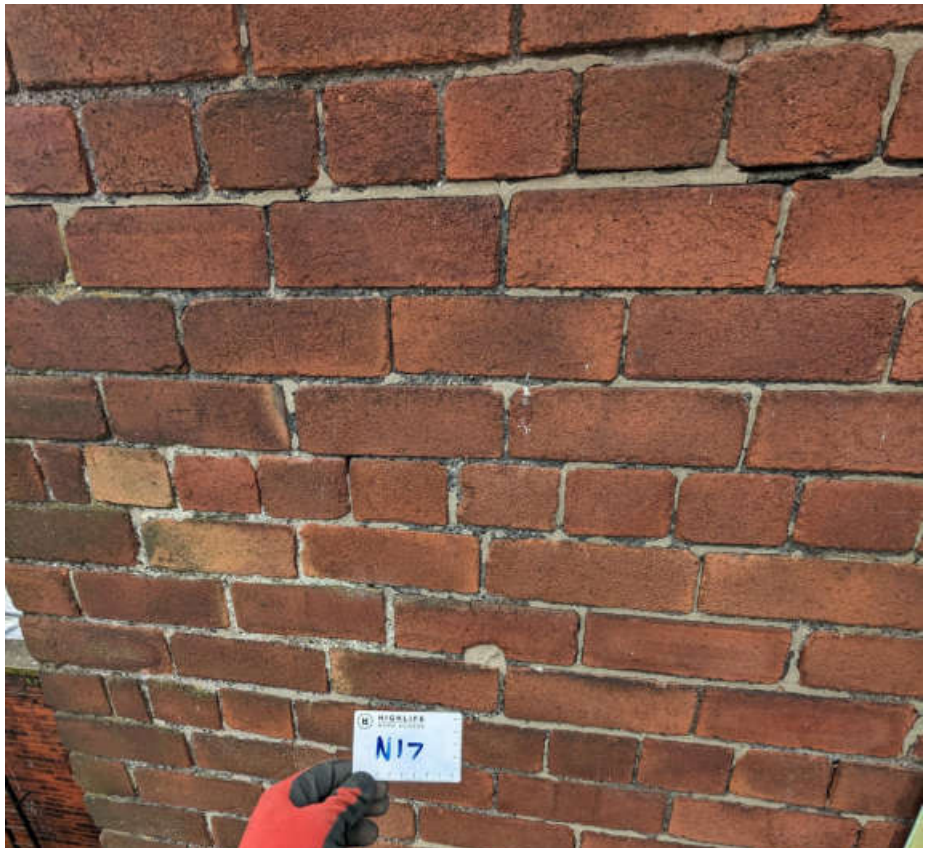
| N17 | Brickwork below stone string course | Photos showing the condition of the pointing, which is mostly in acceptable condition if not slightly recessed, with occasional open perpendicular joints. Some poor quality cementitious face pointing | Repoint open joints with a suitable lime mortar. Investigate beneath poor quality loose cementitious face pointing |

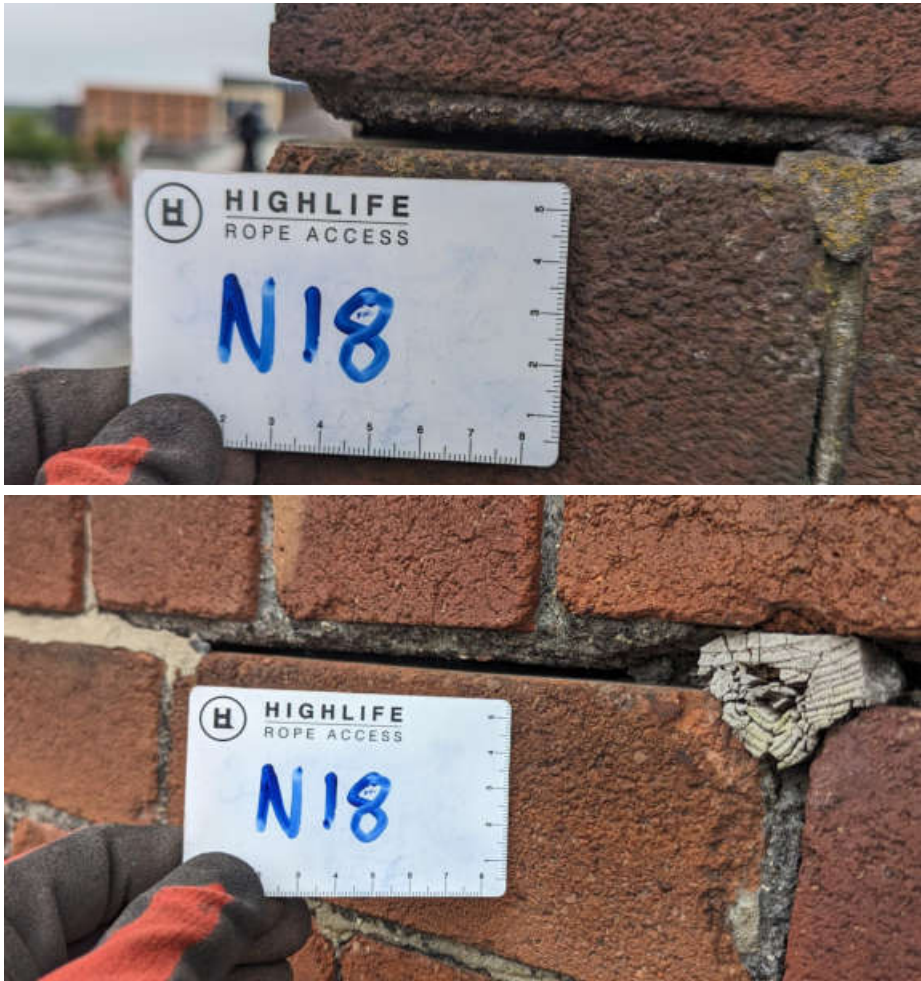
| N18 | Lower brick work | Crack along full length of bed appears to be bed lift, which may indicate further ferrous bed reinforcement, however we could not find evidence of any embedded metal | Given that the damage caused in this instance of bed lift is currently much less consequential than the bed lift further up the tower, it is unlikely that removal would be necessary, and a lower impact method such as cathodic protection might prove adequate if further investigation can prove that there is indeed embedded metalwork |

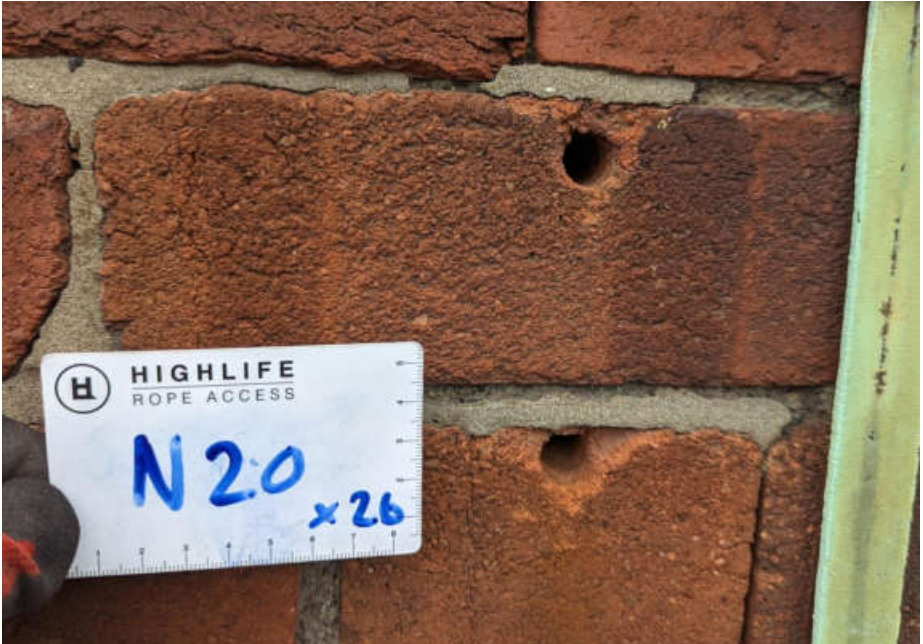
| N20 | Bottom of brick work | Approx 26no. Drill holes in the masonry | Point/ fill holes with a suitable filler/ lime based mortar |

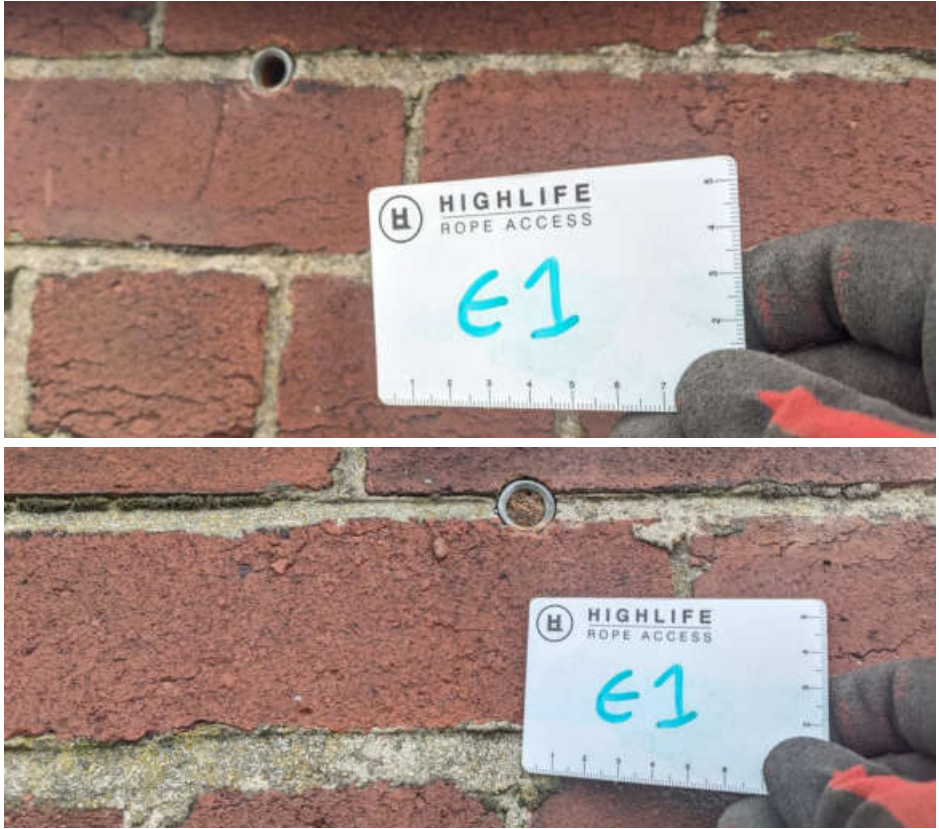
| No. | Location | Description | Proposed Solution |
|---|---|---|---|
| E1 | Brickwork above cornice | Drill holes in brick works with plastic plugs in could be tracking water into the masonry | Repoint the open one if deemed necessary |

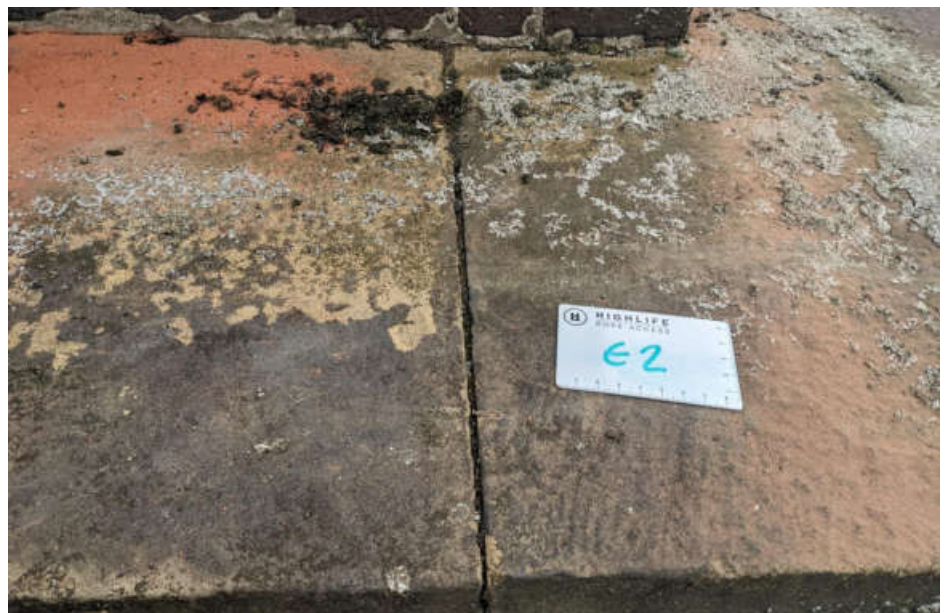
| No. | Location | Description | Proposed Solution |
|---|---|---|---|
| E2 | Cornice | Perpend joints are starting to deteriorate | Rake out joints and repoint using a suitable mortar. A lead covering on the cornice may be desirable as this could also be used to create a drip - currently there is no drip detail on the bottom edge of the cornice which may cause water to track down the masonry below, and may also be contributing to deterioration of the corbels (see E3). |

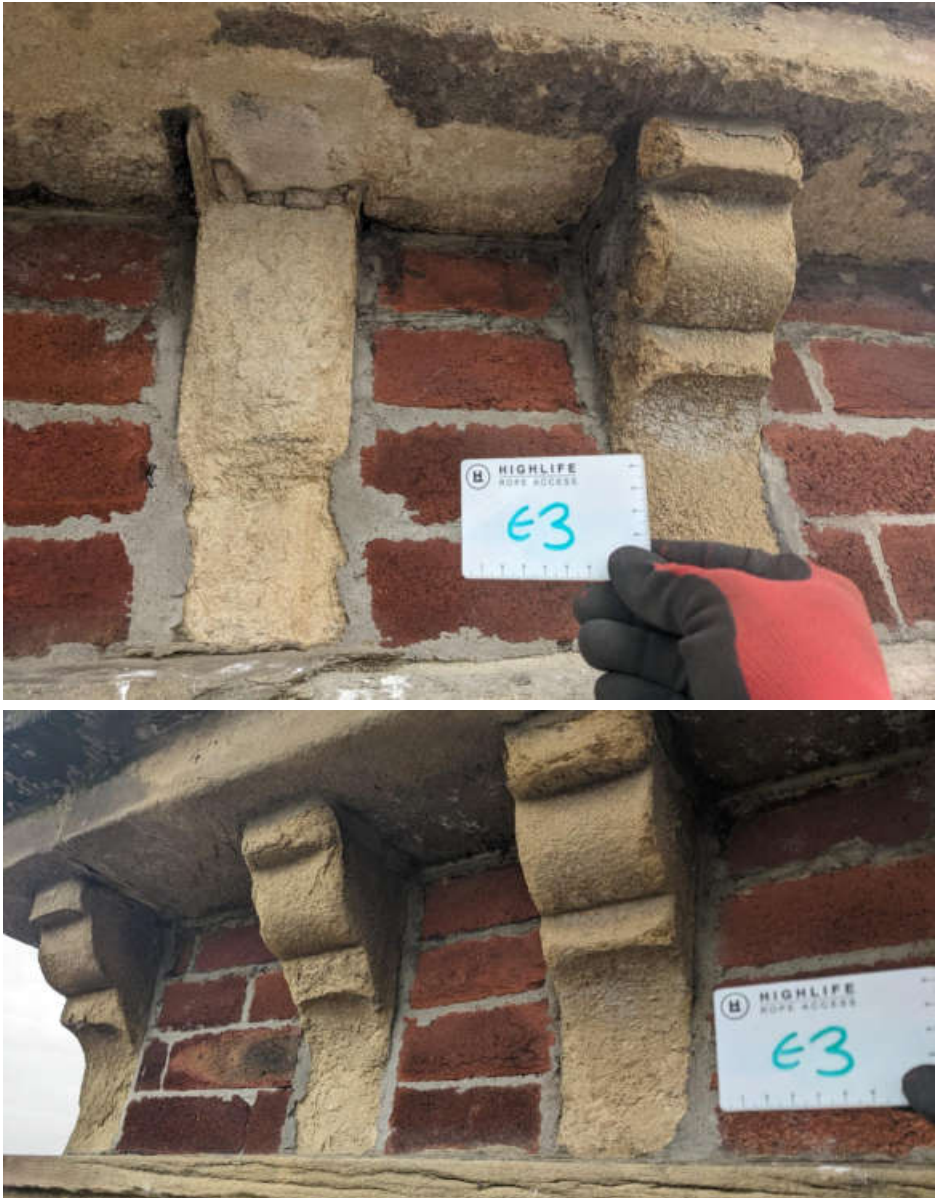
| E3 | Corbels | <p>Heavy deterioration of the corbels on this face, with one missing entirely. This does not seem to be a consequence of corroding metalwork. The cornice above does not have a drip detail and the lip of the cornice is also visibly weathered, therefore it seems likely that water erosion plays a significant role in this weathering</p> | <p>Indenting a new corbel where one is missing may be desirable, however preventing further deterioration of the others may be more pressing. Installation of some sort of drip detail would be a good start, either by installing a lead covering on the cornice above, or cutting a slot into the bottom of the cornice.</p> |
