# HIGHLIFE

### BURY FUSILIERS MUSEUM - VENTILATION TOWER INSPECTION REPORT

Inspection conducted on: 18-19 May 2023

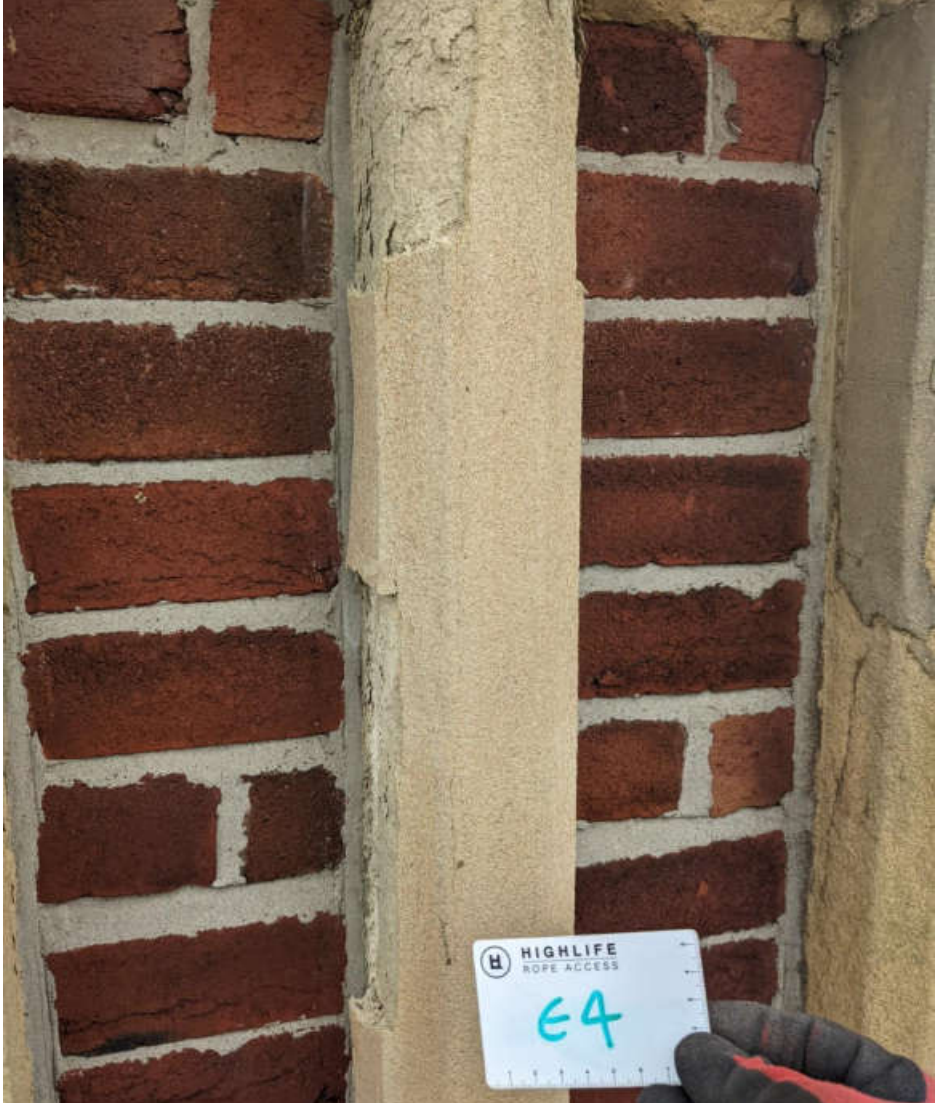
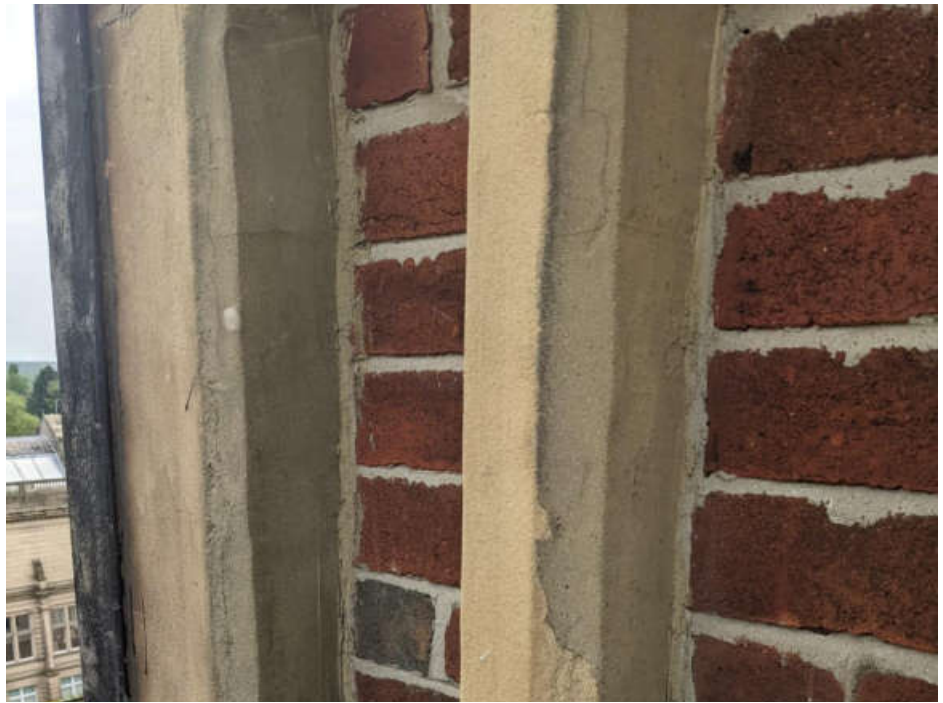
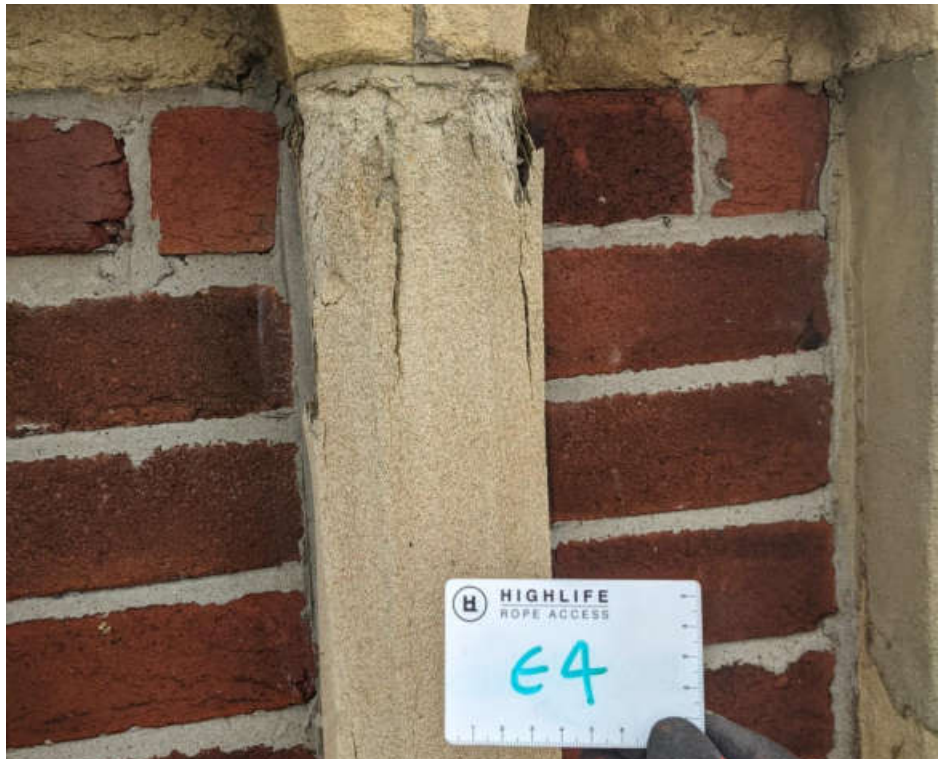
| E4 | Photos | | |

| E4 | Mullions of arched stone details | Some delamination of the stone, loose parts were removed. Historic mortar repairs suggest this is an ongoing issue | Further mortar repairs may be desirable. The old mortar repairs on this face are currently stable |

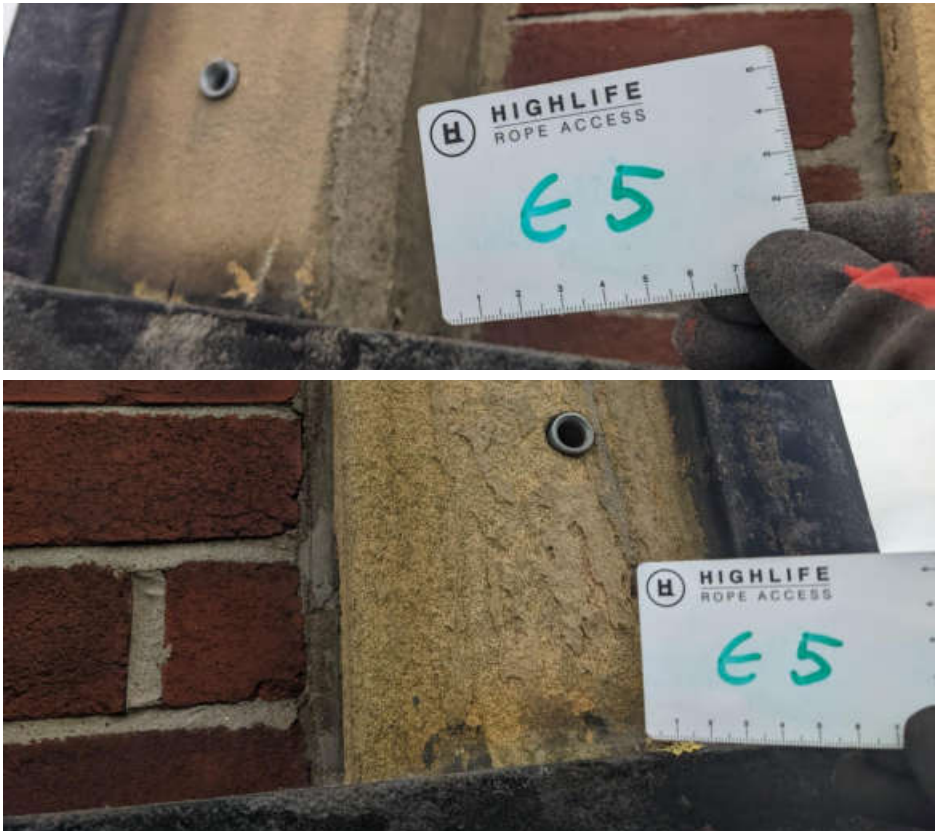
| E5 | Photos | | |

| E5 | Mullions | Drill holes filled with plastic plugs | |

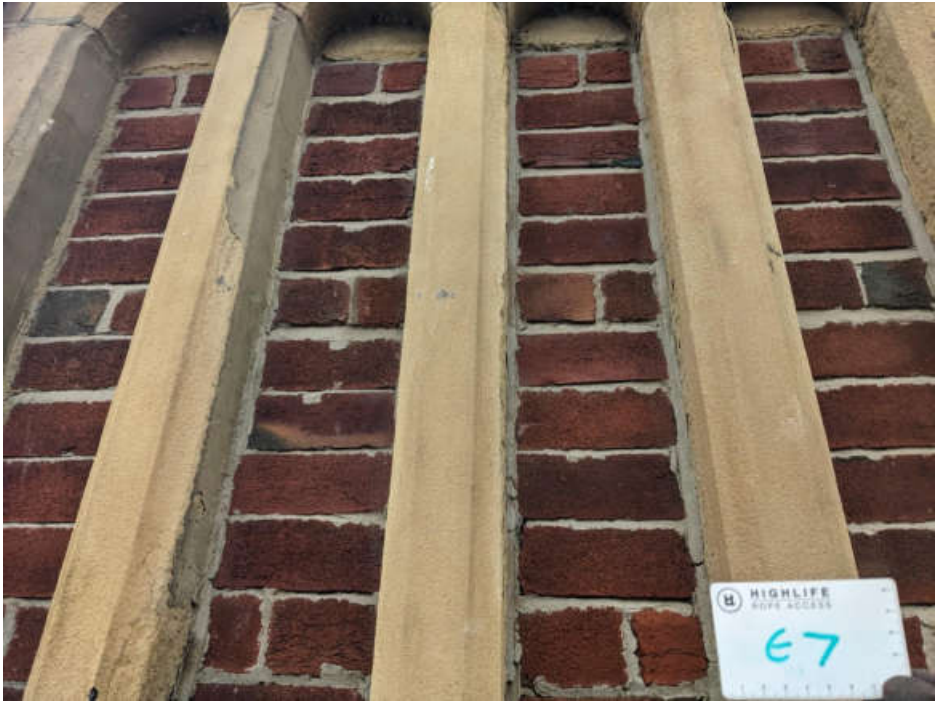
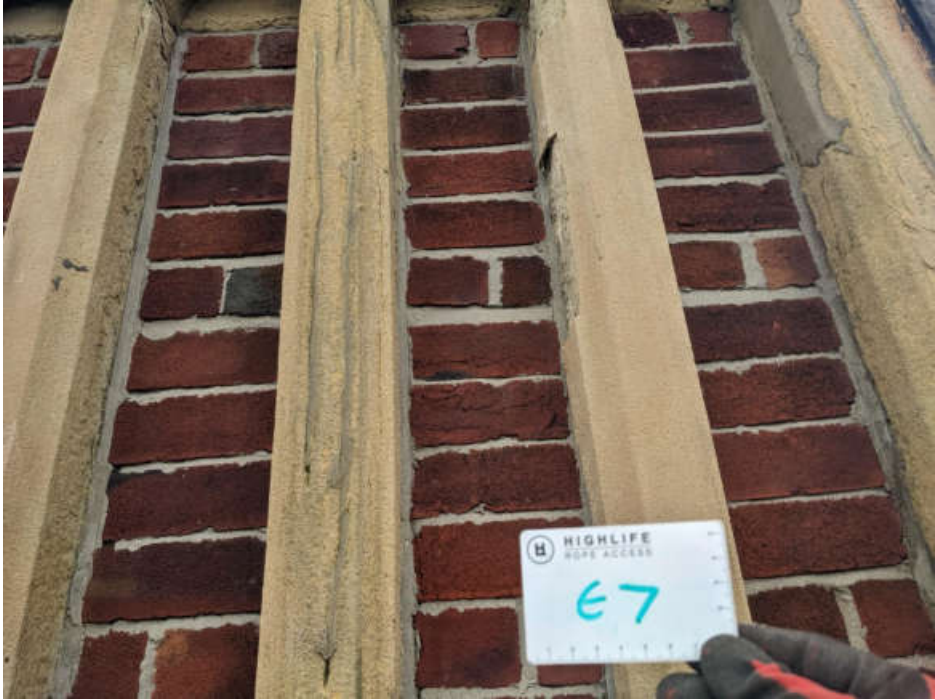
| E7 | Photos | | |

| E7 | Lower section of mullions | <p>Photos to illustrate the condition of lower sections of mullions, one of which has had some long cracks pointed. Also showing condition of the pointing in the brickwork which is acceptable despite being pointed with cementitious mortar</p> | <p>No action needed</p> |

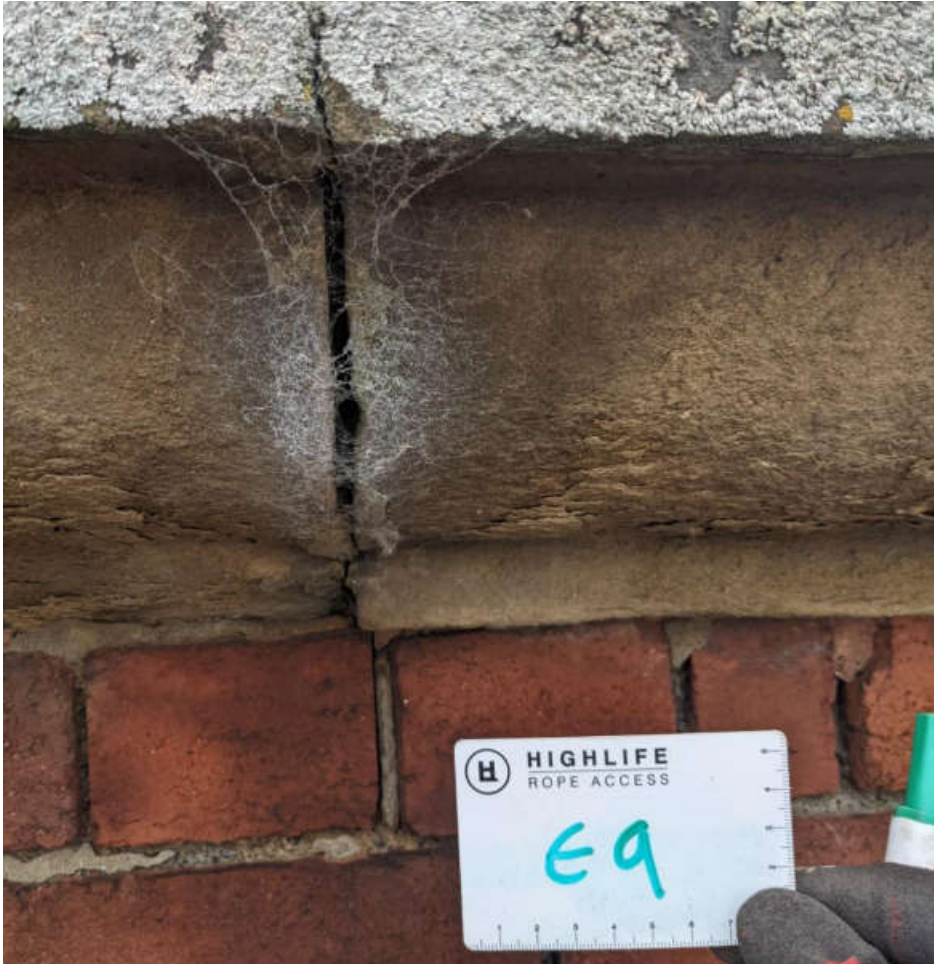
| E9 | Sill below mullions | Open perpend joint on the underside of the sill is potentially tracking water back into the masonry | Rake out joint and repoint using a suitable lime mortar |

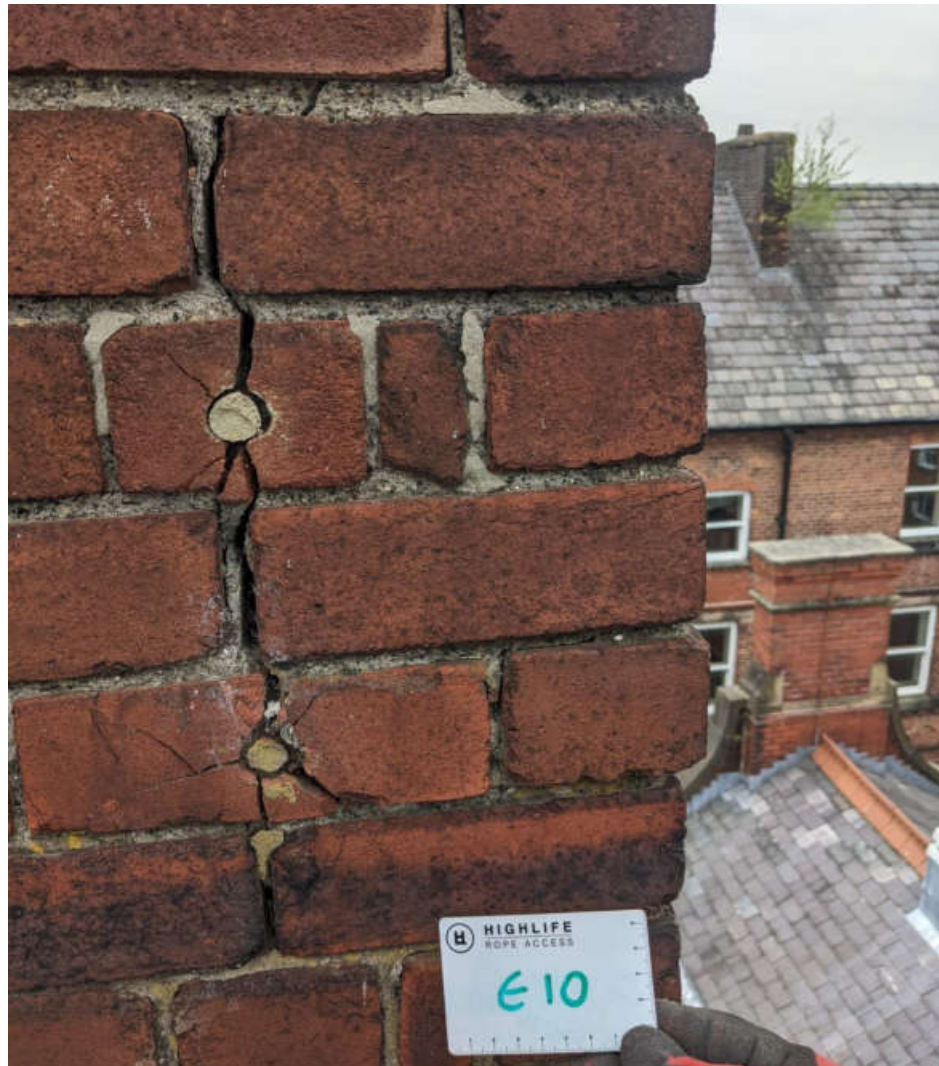
| E10 | Brickwork between mullions and stone string course | 6no. Ferrous scaffolding fixings. Some of these have corroded badly and cracked the surrounding bricks. On the NE arete this has caused significant displacement of several bricks which may compromise the structural integrity of the arete. | Where the bricks are not broken core out the fixings and point with a suitable lime mortar. On the NE arete it may be necessary to replace around 7no. Bricks which have been moved by the corroded ties, or to simply replace the broken bricks and use stainless bed reinforcement to tie the other bricks back into the structure |

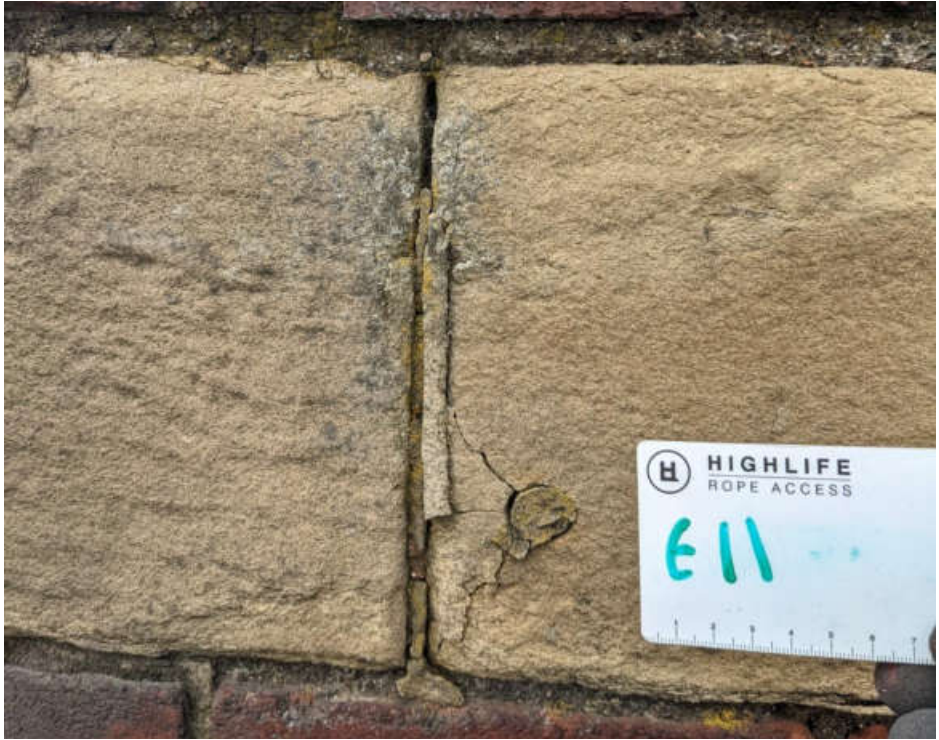
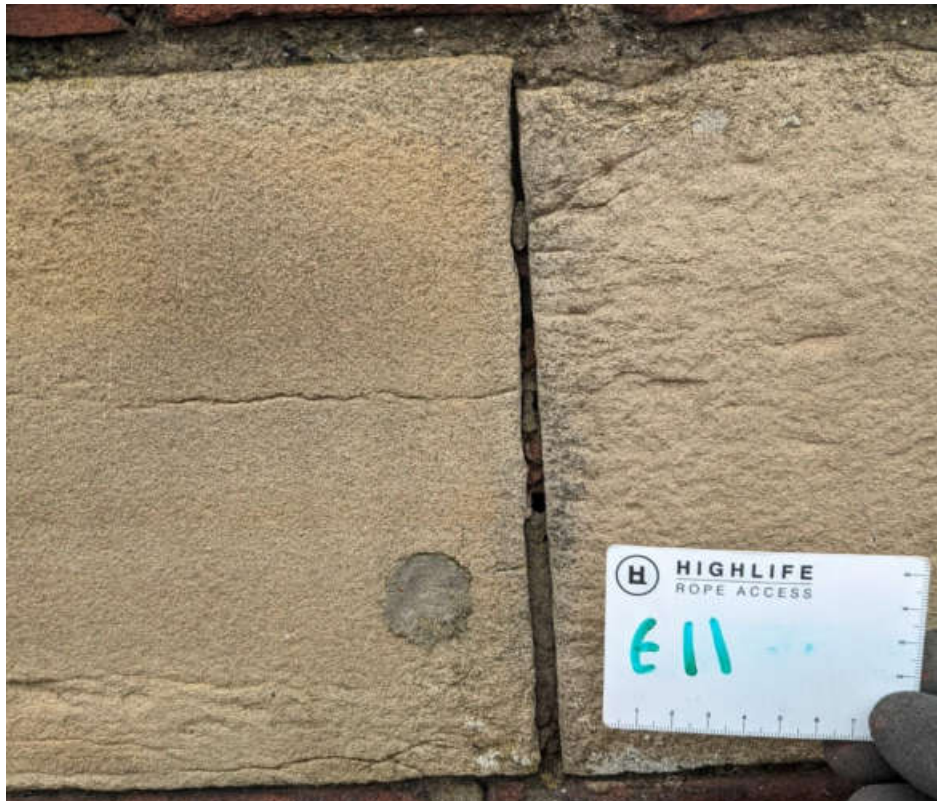
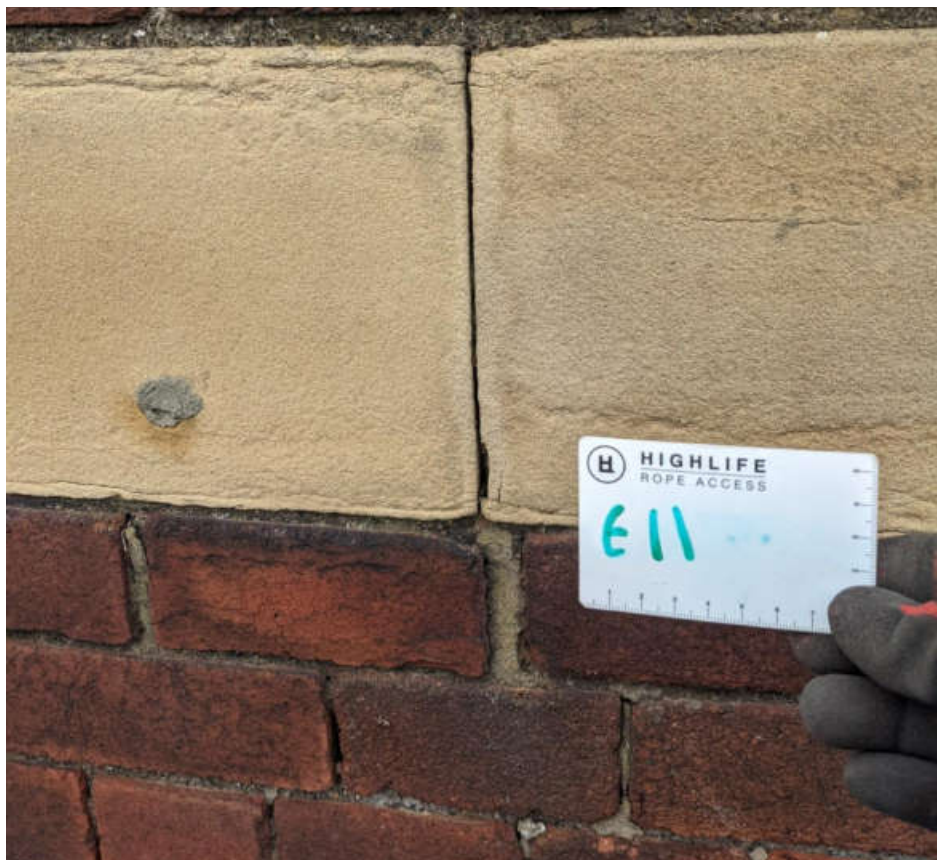
| E11 | Photos | | |

| E11 | Stone string course | Open perpend joints and ferrous scaffolding fixings in the string course | Rake out and repoint perpend joints with a suitable lime mortar. Core out ferrous fixings and repoint. Where the stone has broken a small mortar repair may be desirable |

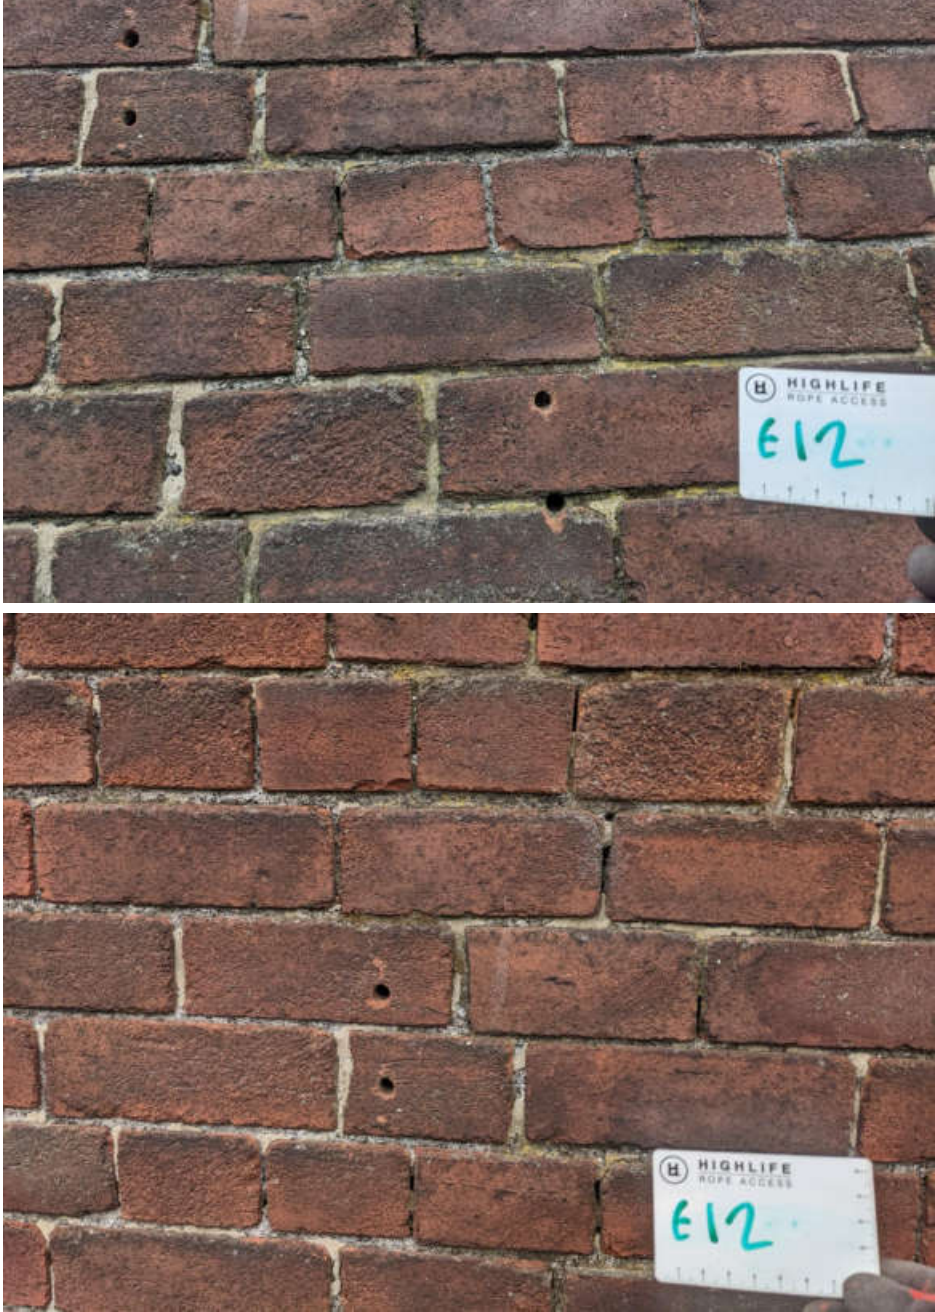
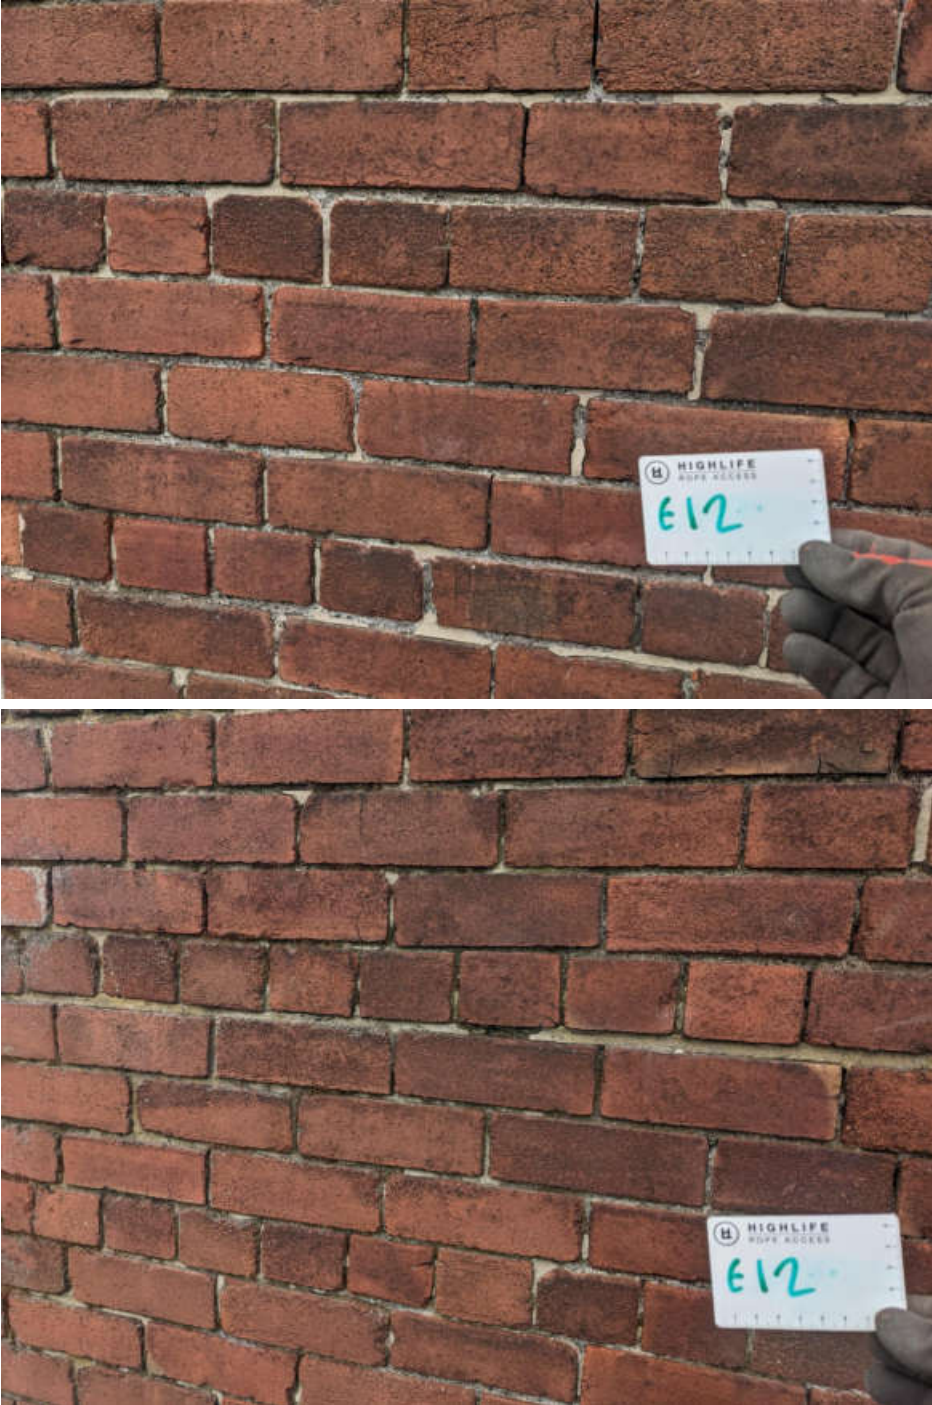
| E12 | Lower brickwork | <p>Photos showing the condition of the pointing which is better than the other faces though still slightly recessed and with occasional open perpend joints. Also approx. 20no. open drill holes which may be tracking water into the building</p> | <p>Point open perpends and drill holes with a suitable lime mortar.</p> |

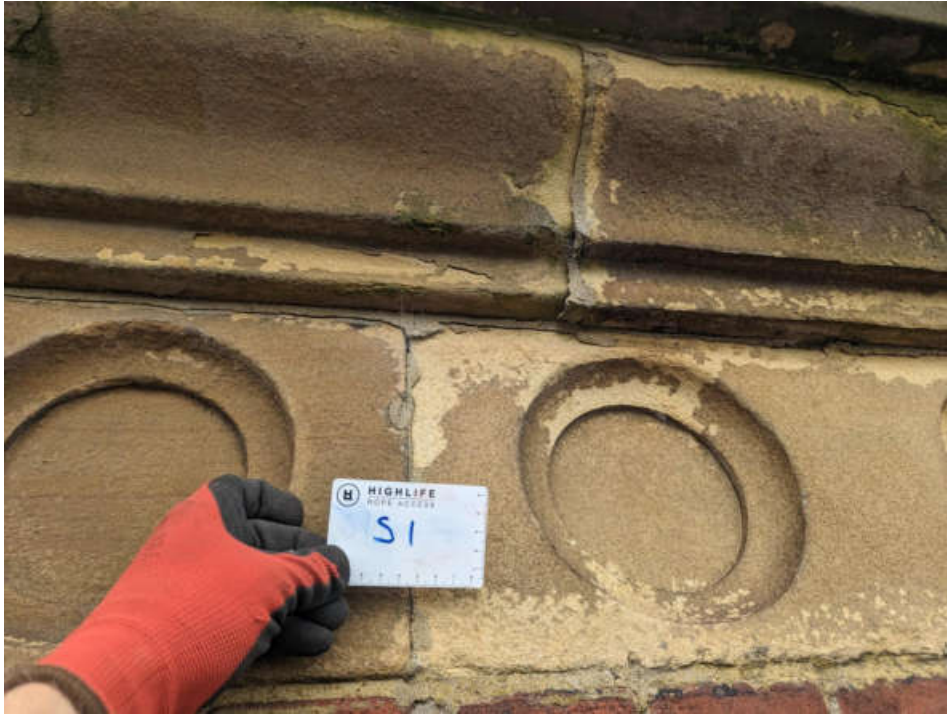
| No. | Location | Description | Proposed Solution |
|---|---|---|---|
| S1 | Photos | | |

| No. | Location | Description | Proposed Solution |
|---|---|---|---|
| S1 | Decorative stone work below roof | Failing pointing | Rake out joints and repoint with suitable lime mortar |

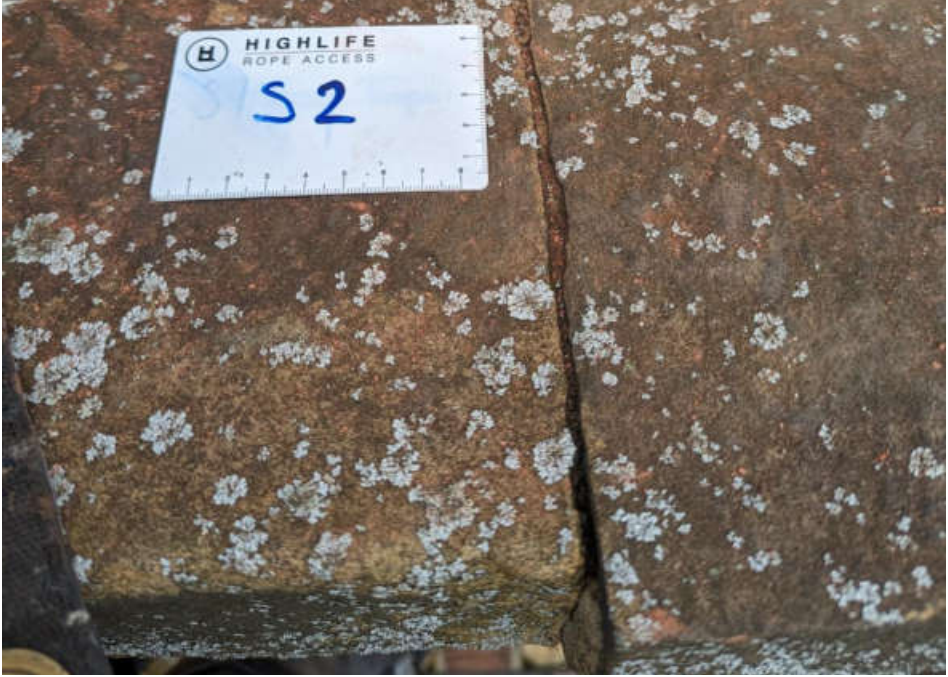
| No. | Location | Description | Proposed Solution |
|---|---|---|---|
| S2 | Photos | | |

| No. | Location | Description | Proposed Solution |
|---|---|---|---|
| S2 | Cornice | Pointing is starting to deteriorate in perpendicular joints | Rake out and repoint with a suitable lime mortar. As per E2 a lead covering may be desirable |

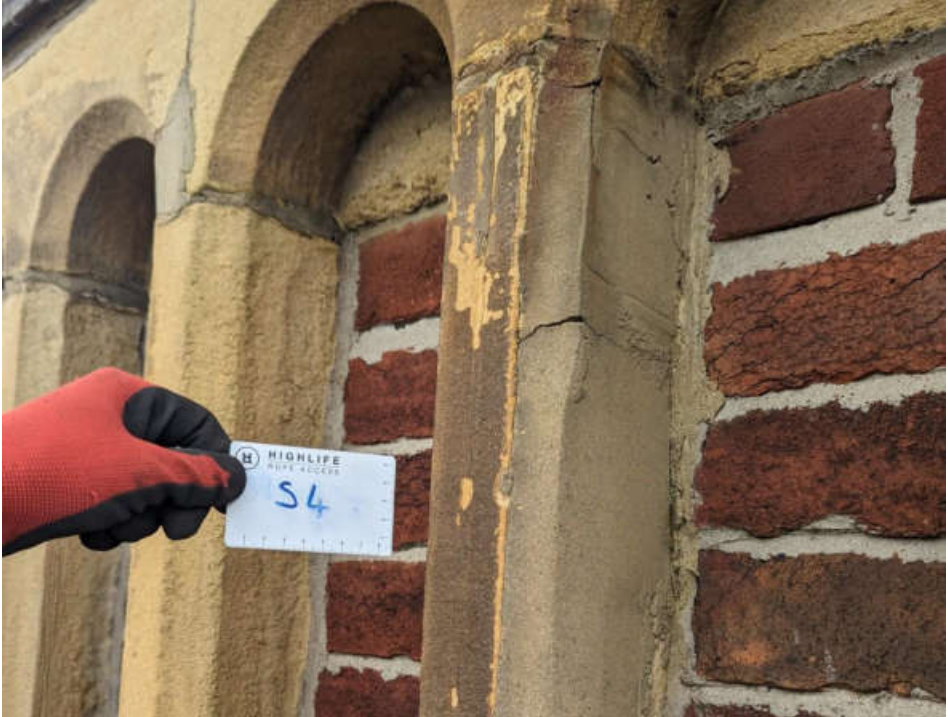
| S4 | Photos | | |

| S4 | Mullions of arched stone details | Large mortar repair is starting to fail, stable at the time of inspection | Remove masonry repair and possibly replace, although if this fault is caused by a ferrous dowel then the issue may well continue |

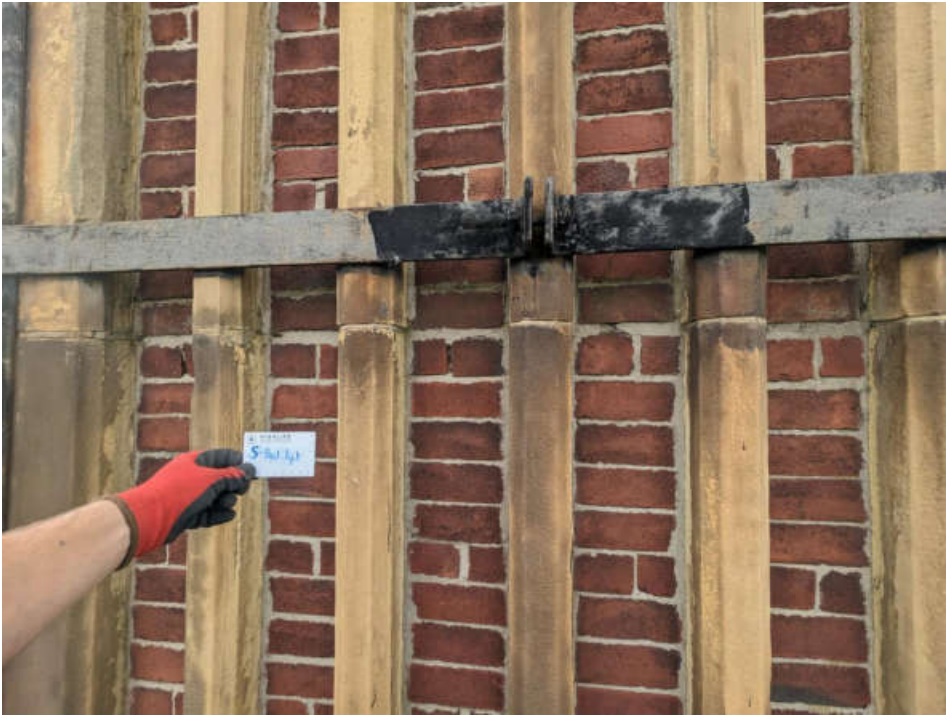
| S5 | Photos | | |

| S5 | Half height on mullions | <p>Photo showing that there does not appear to be any bed lift on the south face where the ferrous bed reinforcement is</p> | <p>Potentially no action needed however if the bed reinforcement is being removed elsewhere it may make sense to give this elevation the same treatment</p> |

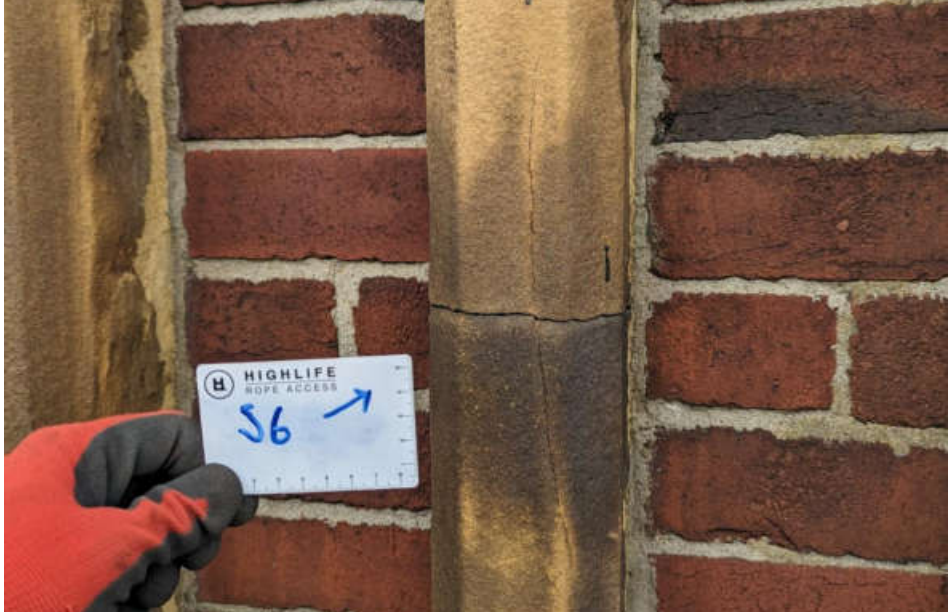
| S6 | Photos | | |

| S6 | Lower section of mullions | Large spall starting to appear, stable at the time of inspection, plus horizontal crack | It may be adequate to try and point this horizontal crack however the cause of this issue is unknown - it could potentially be a consequence of the jacking occurring on the other side of the tower as it seems an unlikely location for a ferrous dowel |

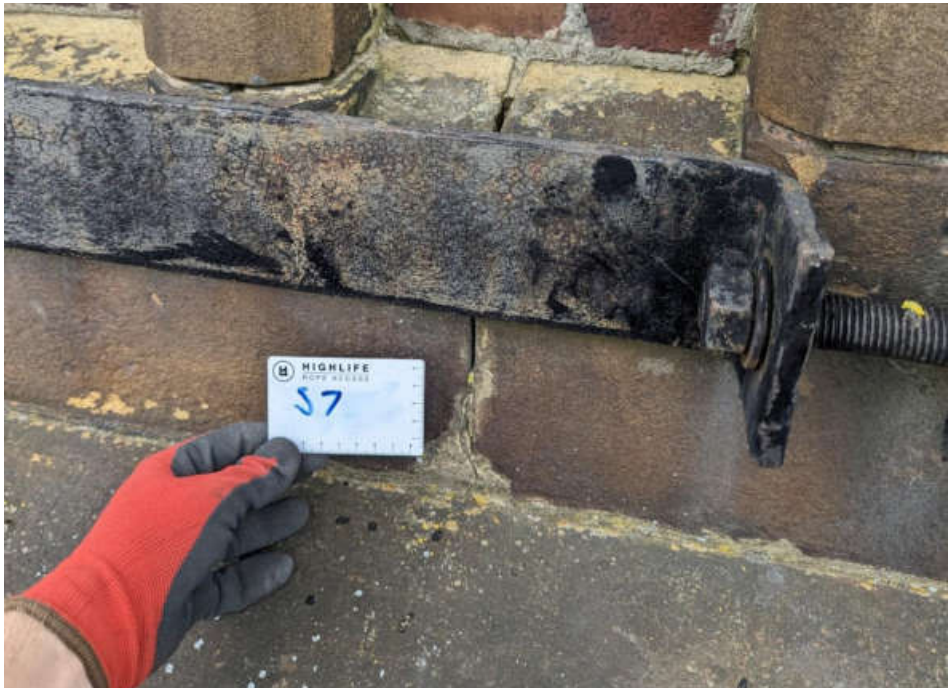
| S7 | Photos | | |

| S7 | Sill at base of mullions | Open perpend joint in sill | Rake out and repoint with a suitable lime mortar |

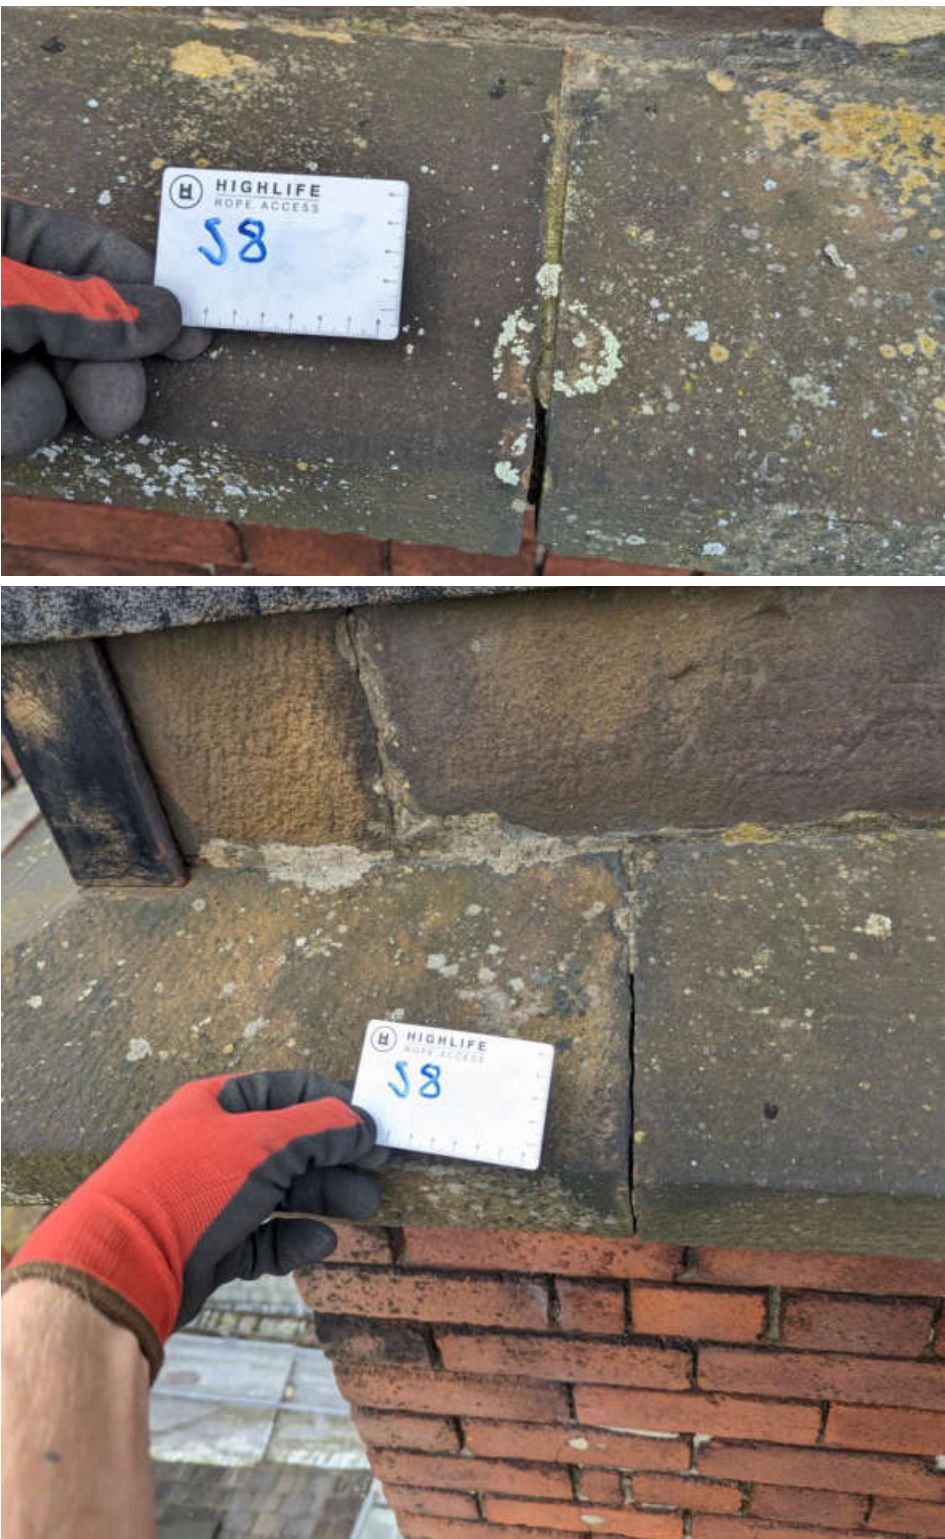
| S8 | Sill/ offset course below mullions | Open perpend joints | Rake out and repoint with a suitable lime mortar |

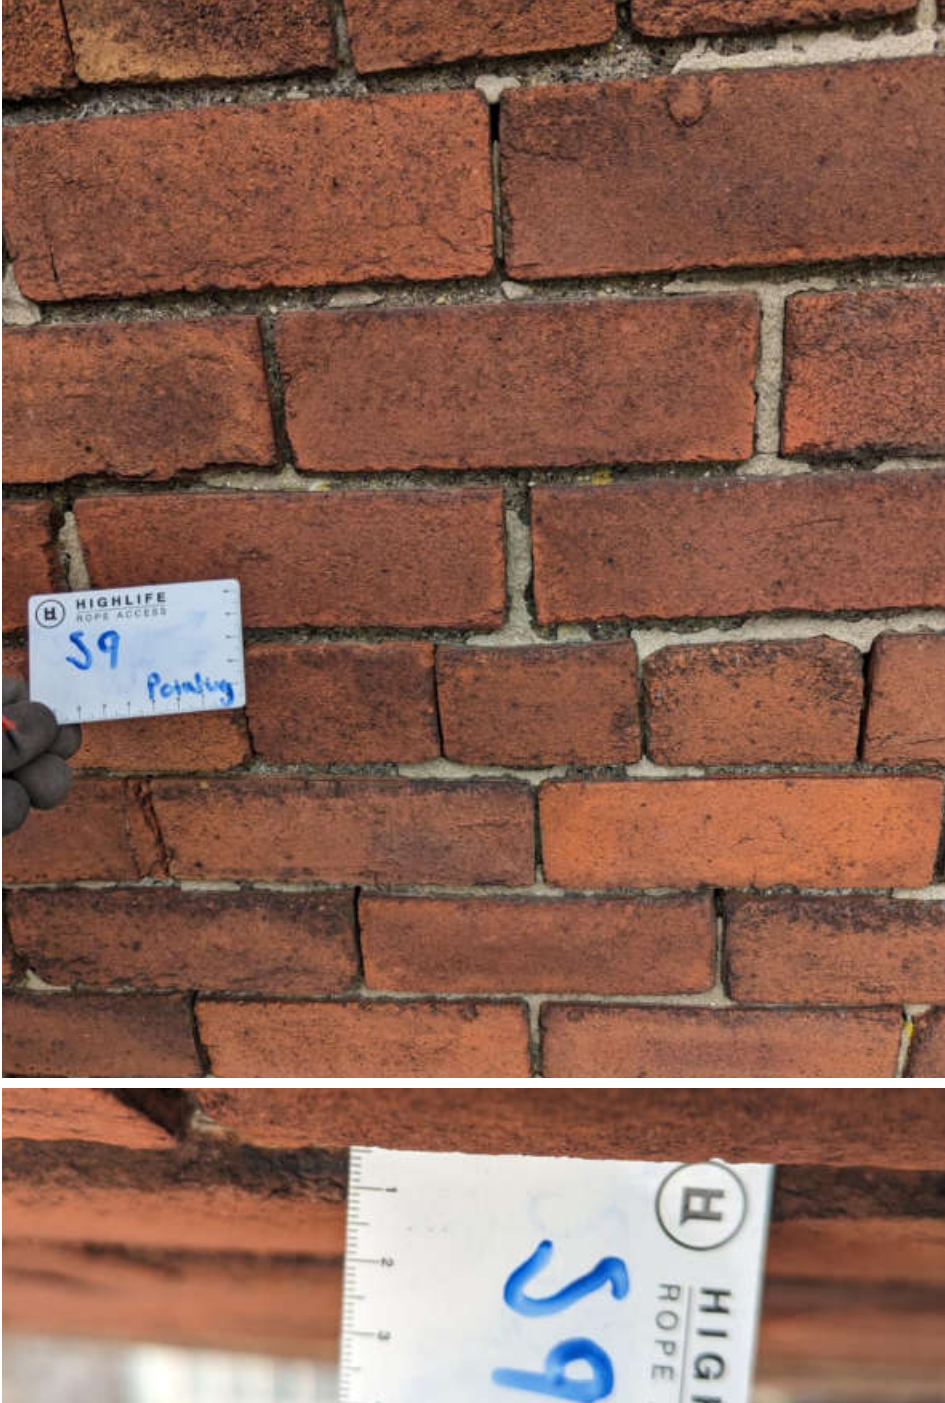
| S9 | Photos | | |

| S9 | Brickwork between sill and stone string course | Photos illustrating condition of pointing which is generally acceptable if not recessed in the region of 10/12mm with occasional open perpend joints | Repoint open perpend joints with a suitable lime mortar |

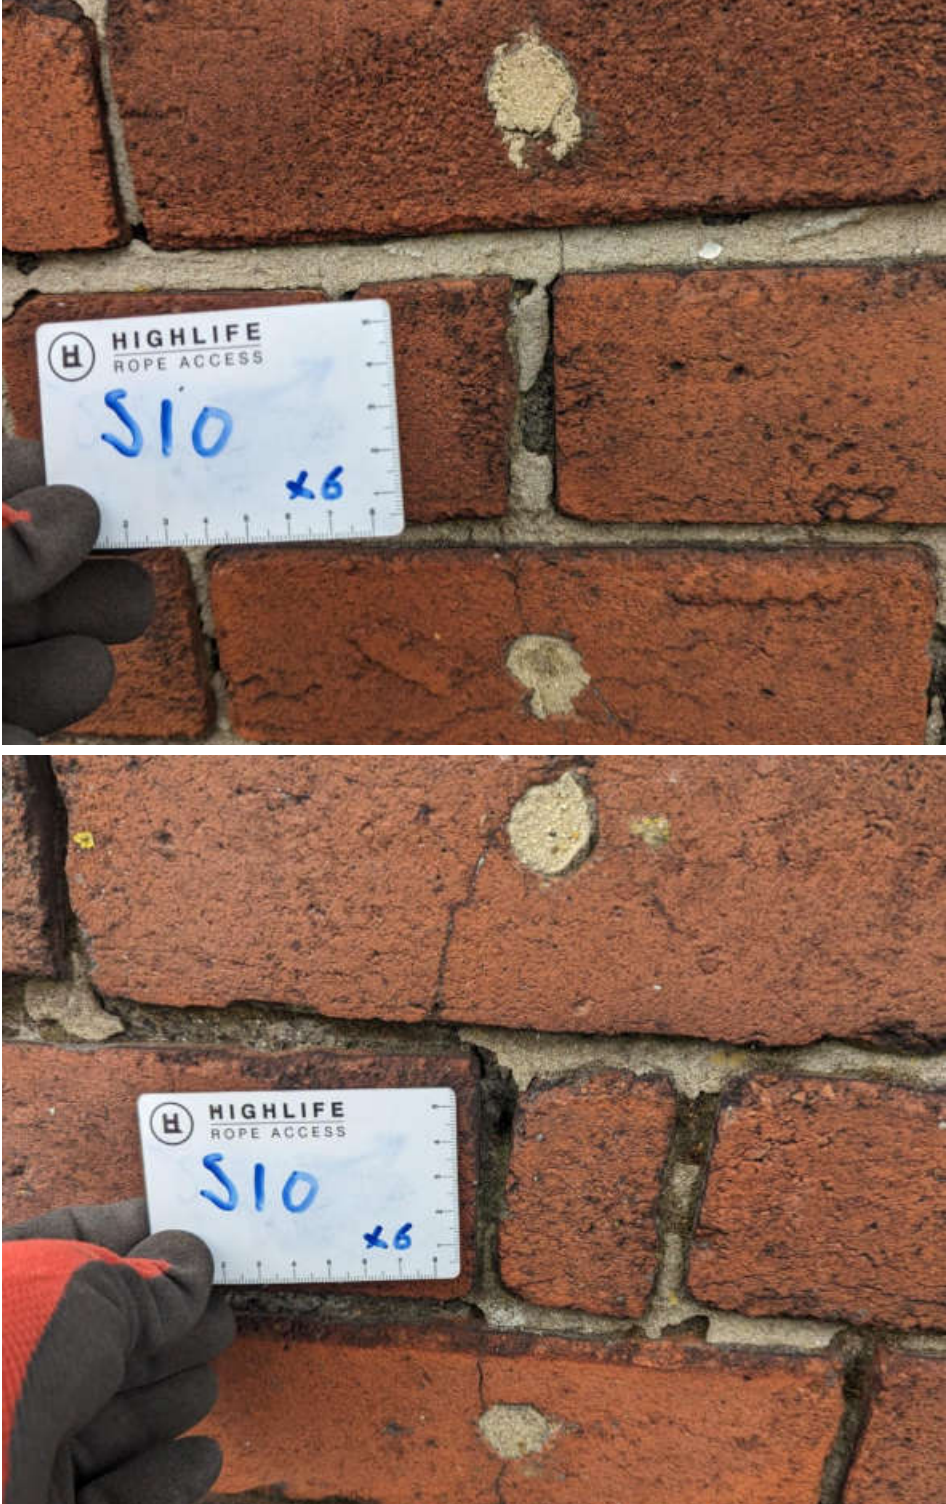
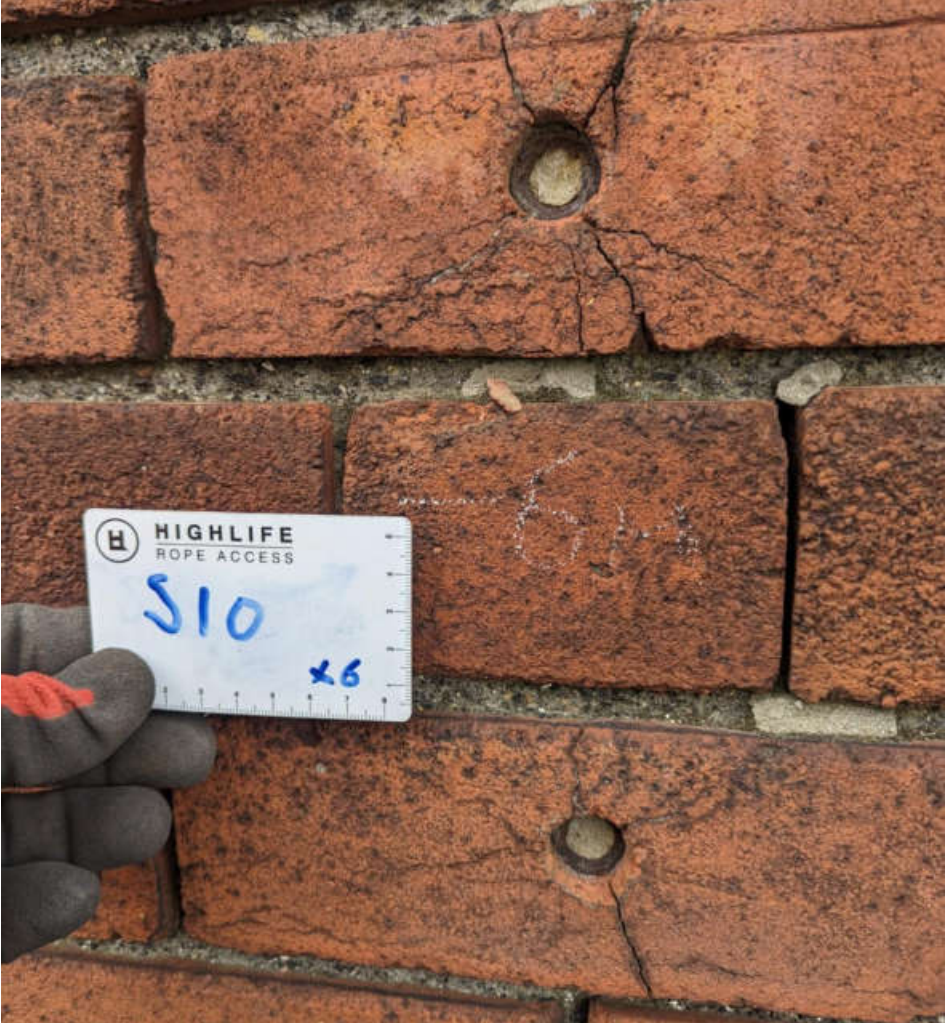
| S10 | Brickwork between sill and stone string course | 6no. Ferrous scaffold fixings. Some have caused the surrounding bricks to crack | Remove and replace broken bricks and repoint with a suitable lime mortar |

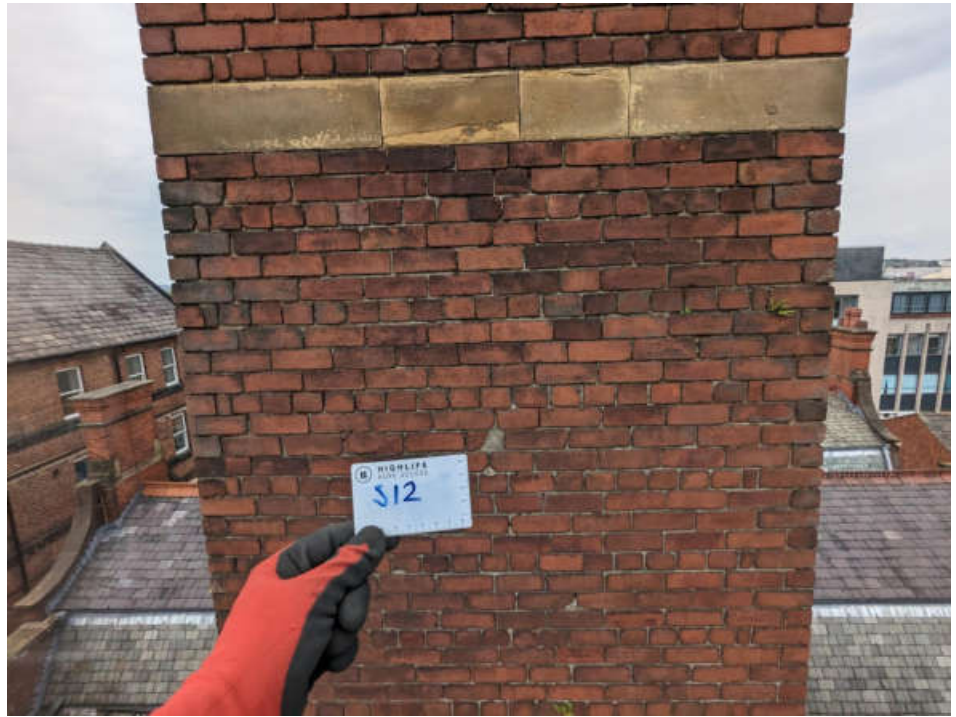
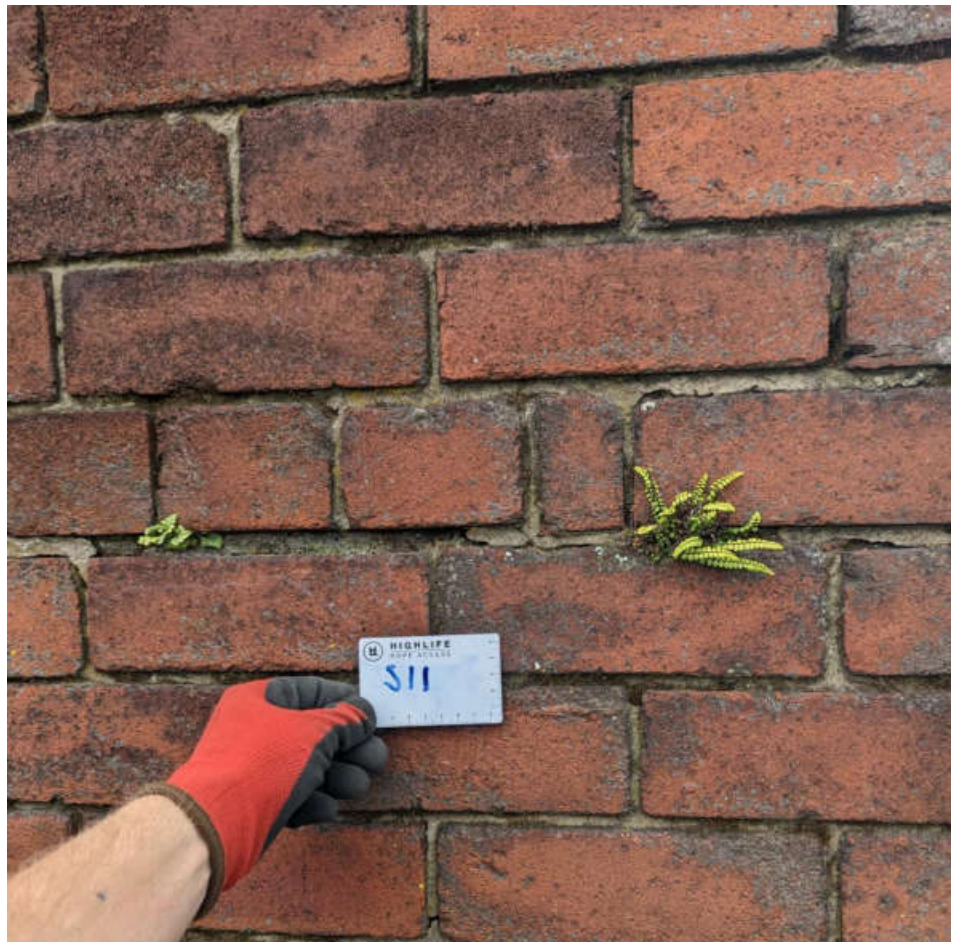
| S12 | Photos | | |

| S12 | Brickwork below string course | Photos illustrating condition of the pointing which is generally acceptable if not slightly recessed, with occasional open perpend joints | Rake out and repoint open perpend joints |
