# HIGHLIFE

### BURY FUSILIERS MUSEUM - VENTILATION TOWER INSPECTION REPORT

Inspection conducted on: 18-19 May 2023

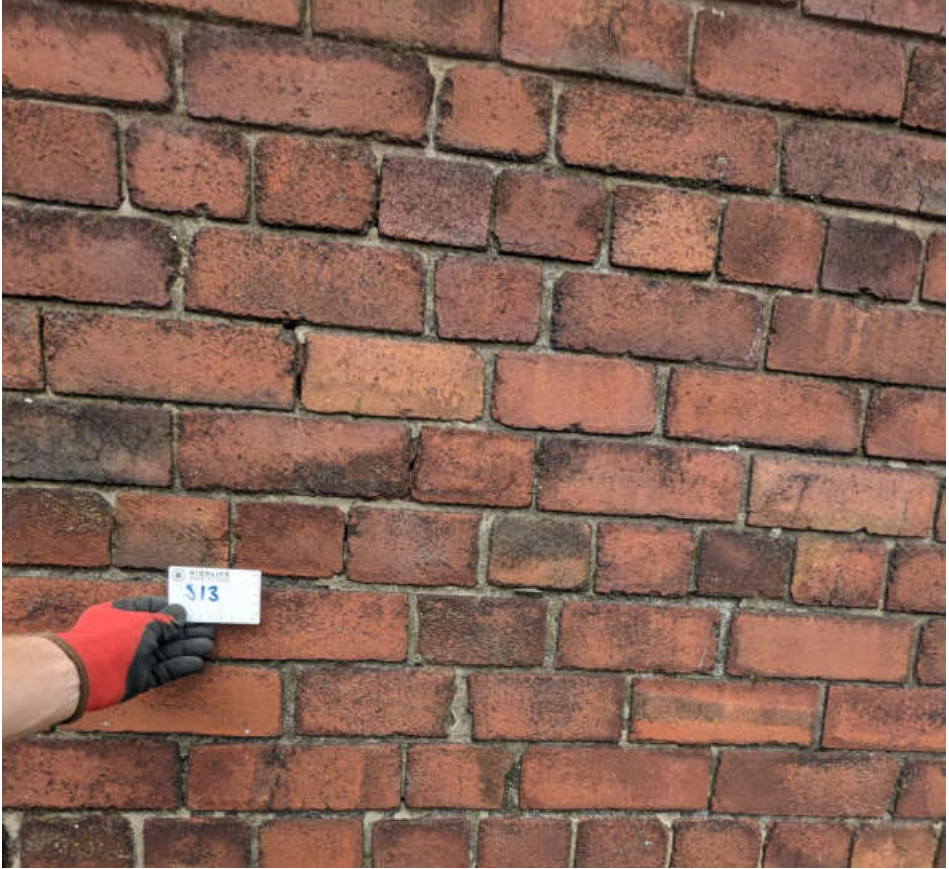
| S13 | Brickwork below string course | Photos illustrating condition of the pointing which is generally acceptable if not slightly recessed, with occasional open perpend joints | Rake out and repoint open perpend joints |

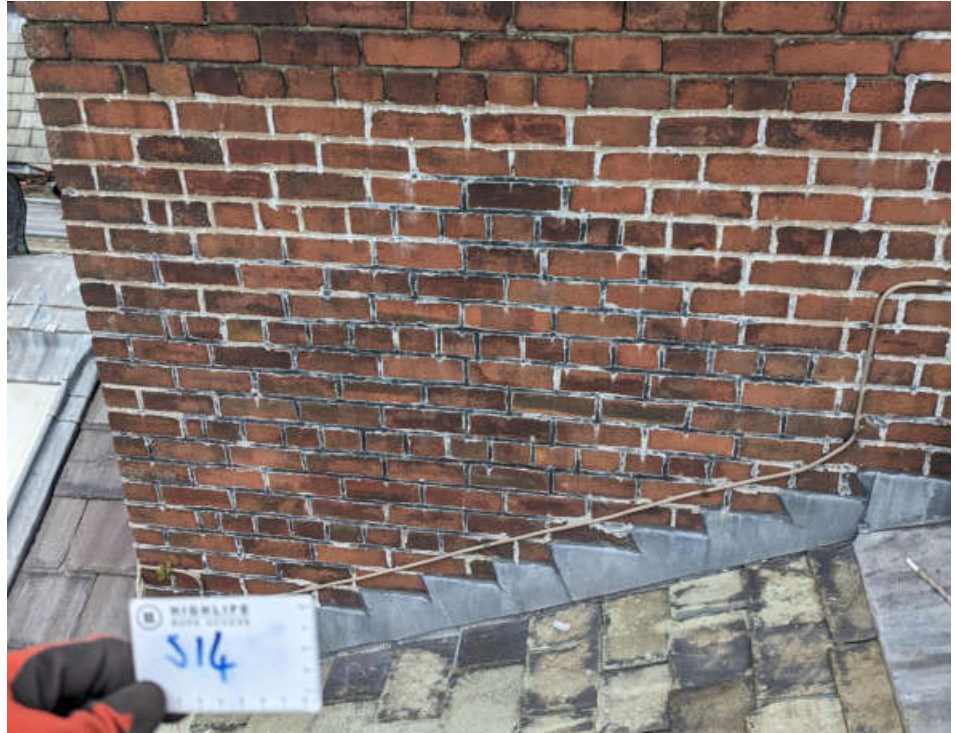
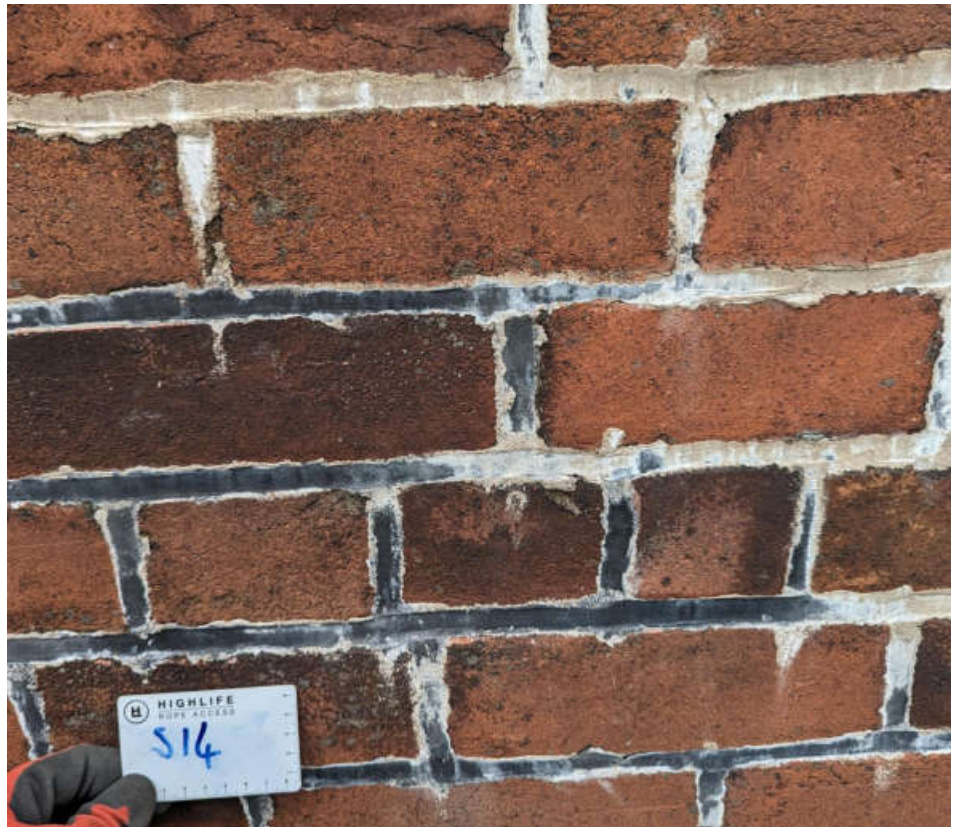
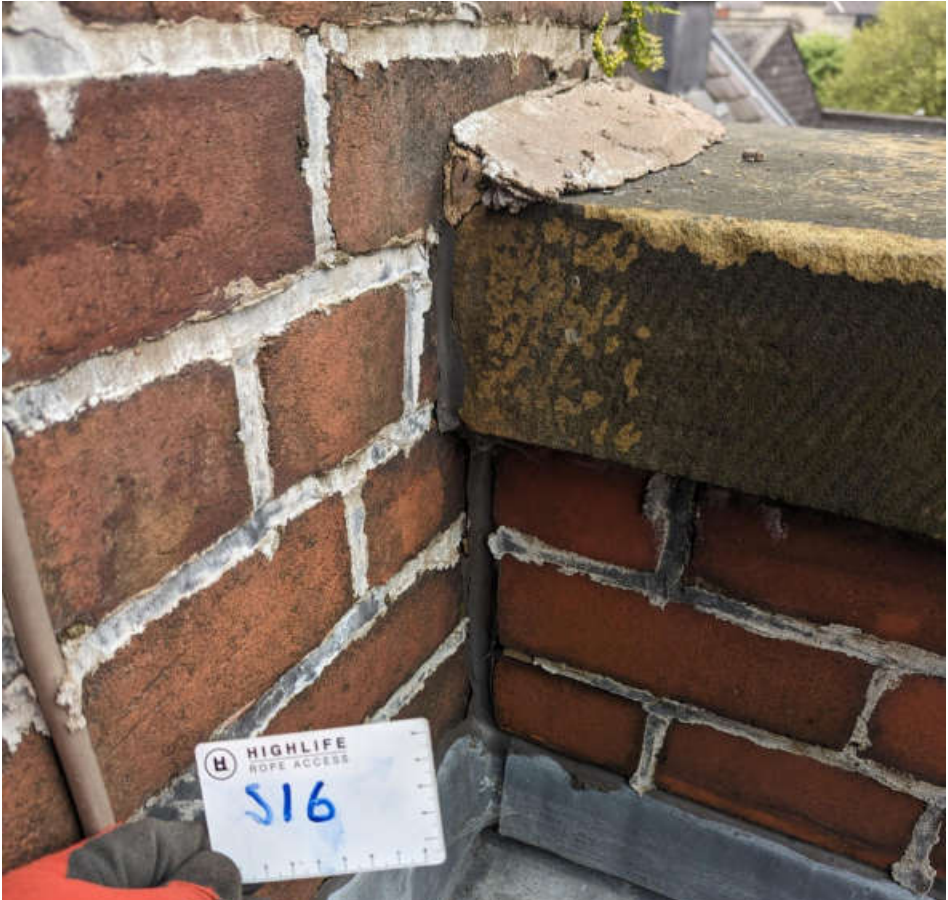
| S14 | Brickwork above roof | Large area of cementitious pointing. Given evidence elsewhere there is good reason to assume that this is poor quality face pointing and may still be contributing to water ingress | This may not be high enough priority but under a belt and braces approach it would be preferable to investigate why this area has had such extensive treatment and potentially repoint with lime mortar. The poor application of cementitious pointing elsewhere suggests that maybe a great job hasn't been done of this area |

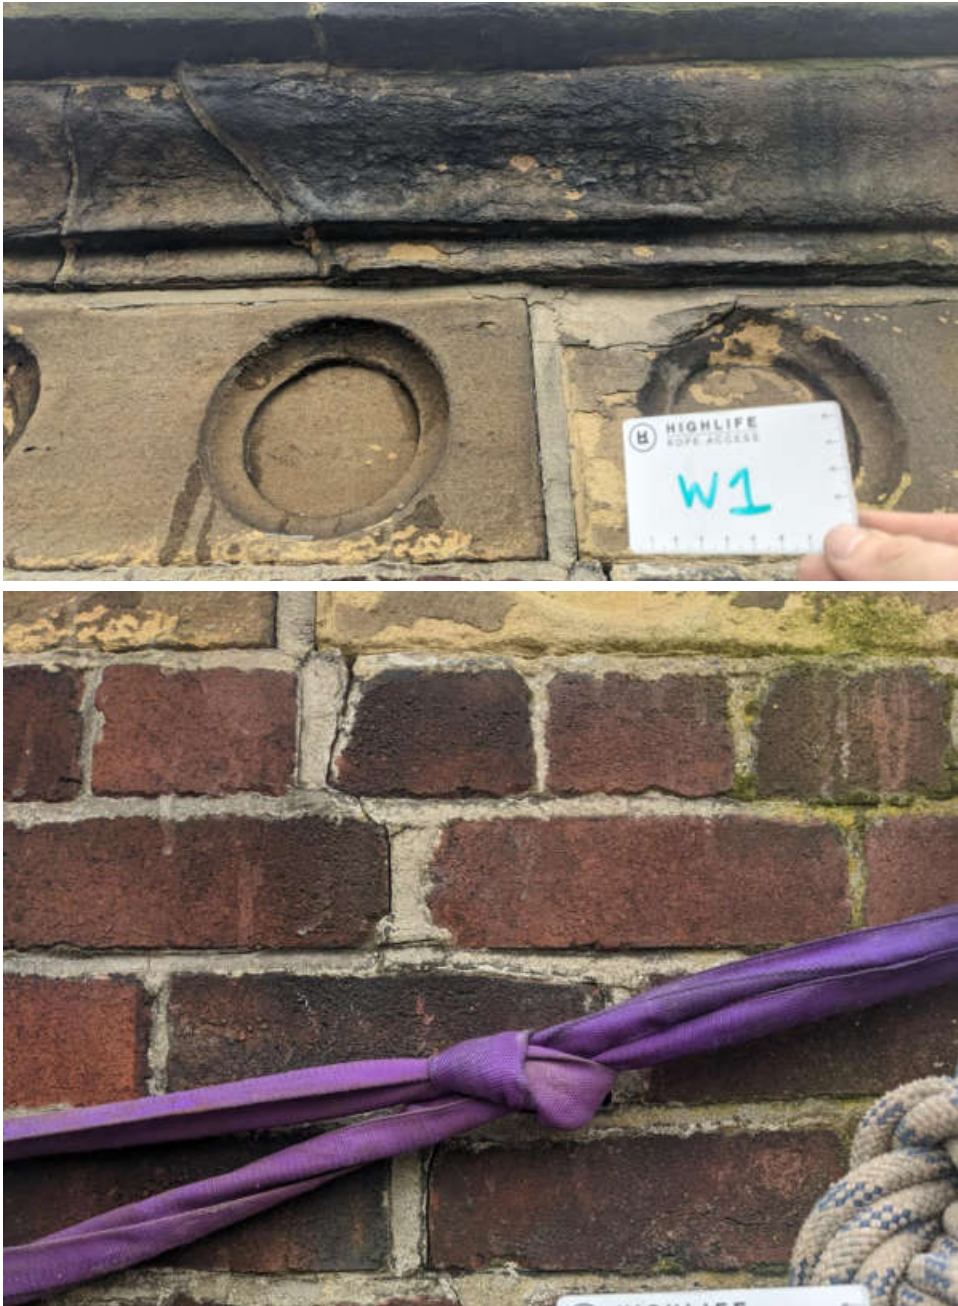
| No. | Location | Description | Proposed Solution |
|---|---|---|---|
| W1 | Photos | | |

| No. | Location | Description | Proposed Solution |
|---|---|---|---|
| W1 | Decorative stone work below roof and brickwork above cornice | A crack in the stonework leads into a stepped crack in the brick work. It is unclear what has caused this | The cracks aren't particularly bad so raking out and repointing may be adequate, alternative some stainless bed reinforcement such as helibar may be used to stitch the crack to prevent further spreading |

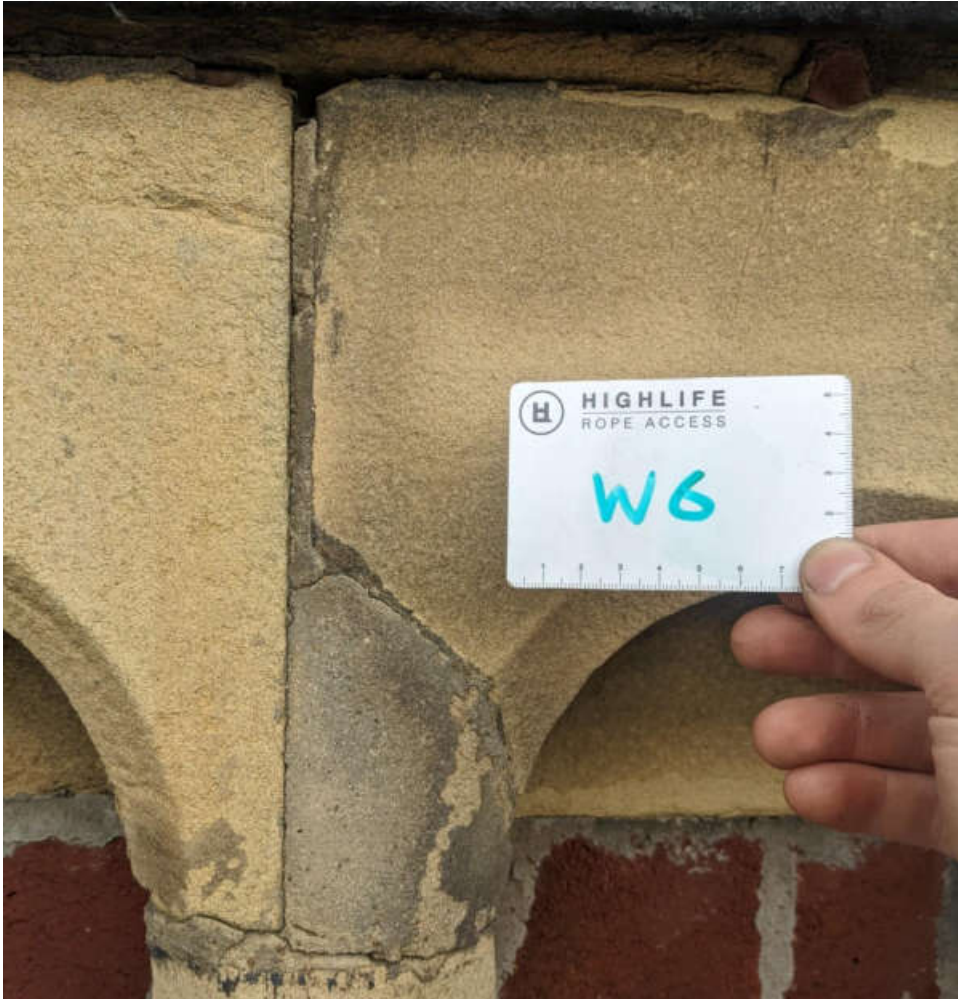
| W6 | Photos | | |

| W6 | Top of arched stone detail | Open joints, and historic mortar repair suggesting further evidence of corroding dowels | Rake out and repoint joints with a suitable lime mortar |

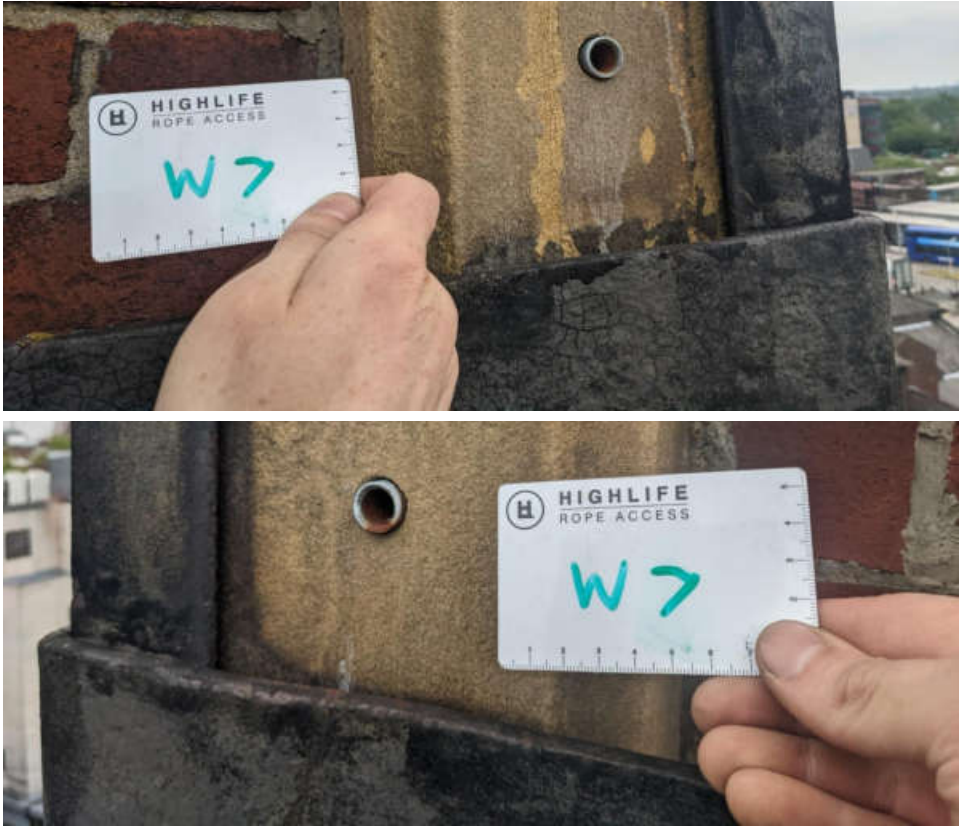
| W7 | Mullions | 2no. Ferrous scaffold fixings | Core out fixings and repoint with a suitable lime mortar |

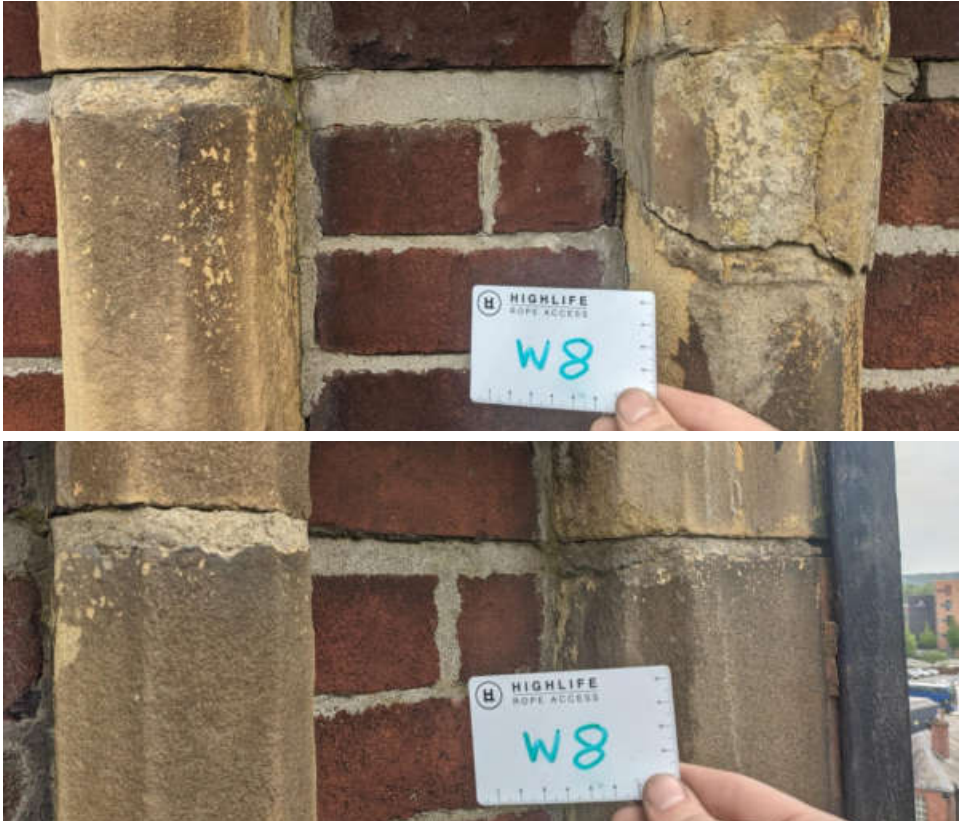
| W8 | Mid height on the mullions | <p>Bed lift from ferrous bed reinforcement as per N8. Photos show that the bed lift decreases from north to south. One photo also shows that one of the ferrous dowels in the mullions is spalling a large section off the mullion. This was stable at the time of inspection</p> | As per N8 |

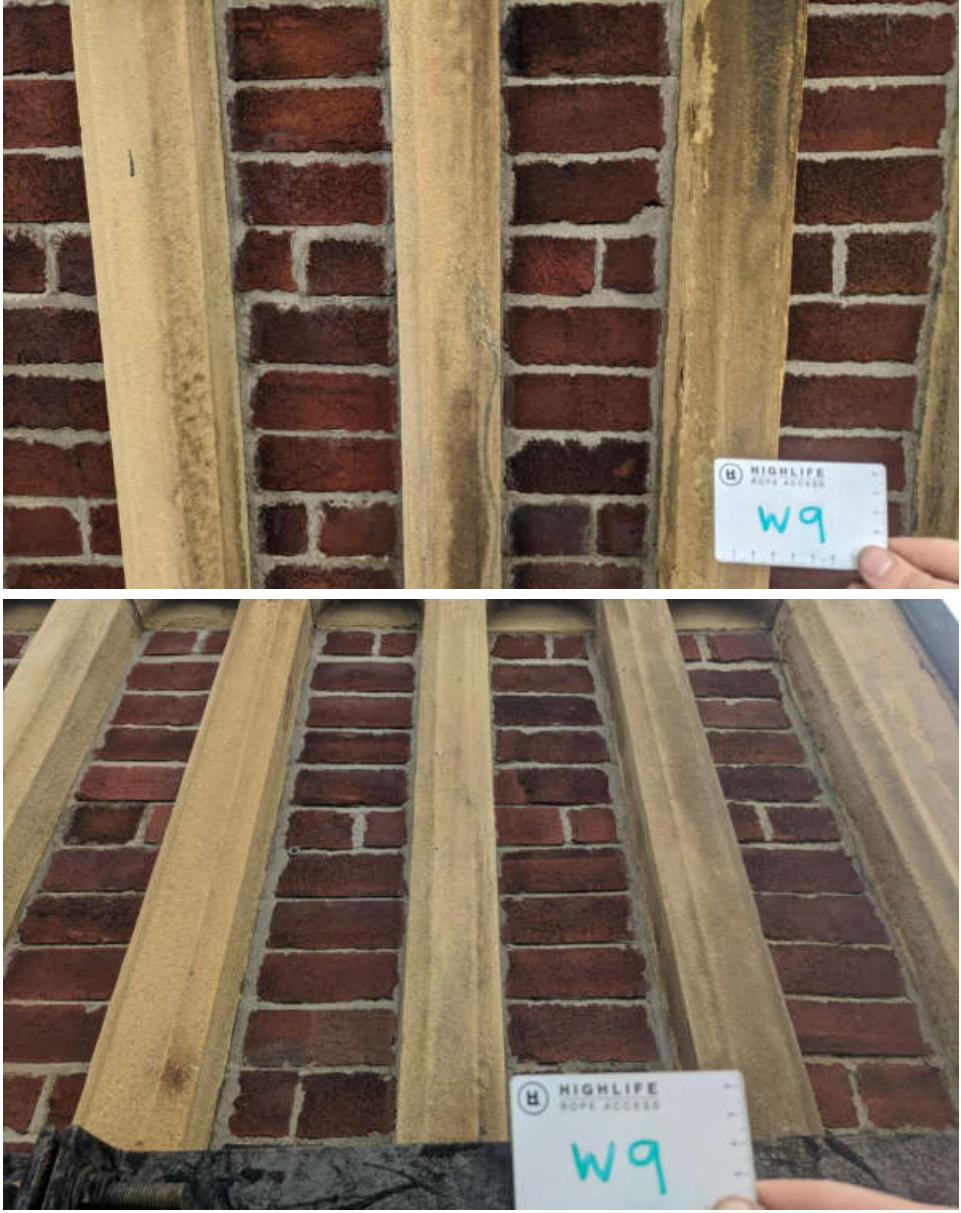
| W9 | Photos | | |

| W9 | Brickwork between the mullions | <p>Photos showing the condition of the brickwork between the mullions which is generally sound, the pointing is cementitious face pointing and is acceptable</p> | <p>No action needed</p> |

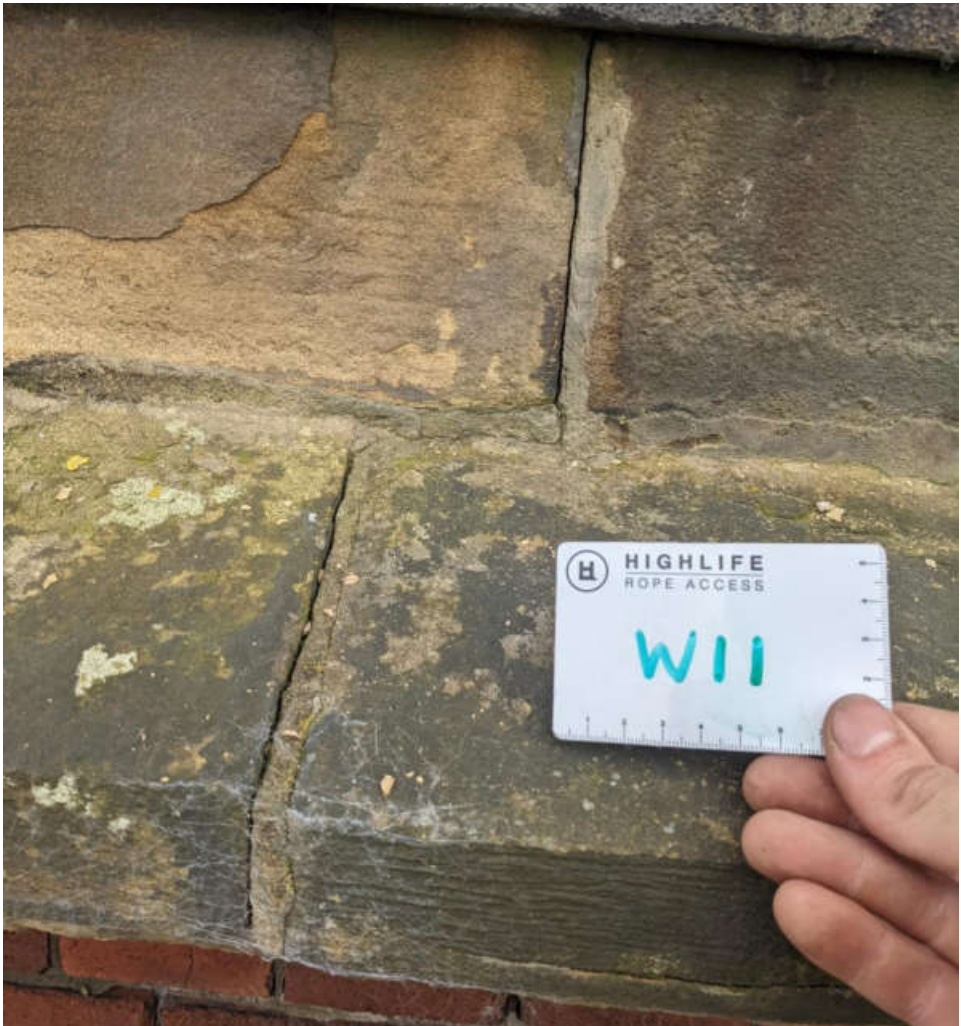
| W11 | Photos | | |

| W11 | Sill/ offset course below mullions | Open perpend and bed in the offset course likely tracking water into the building | Rake out and repoint with a suitable lime mortar |

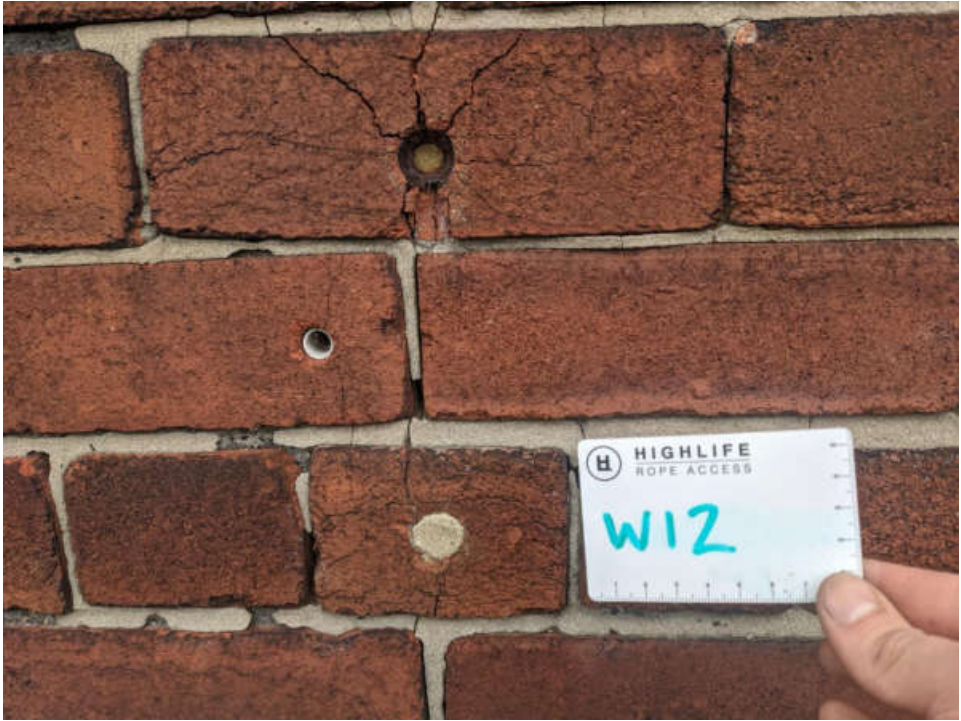
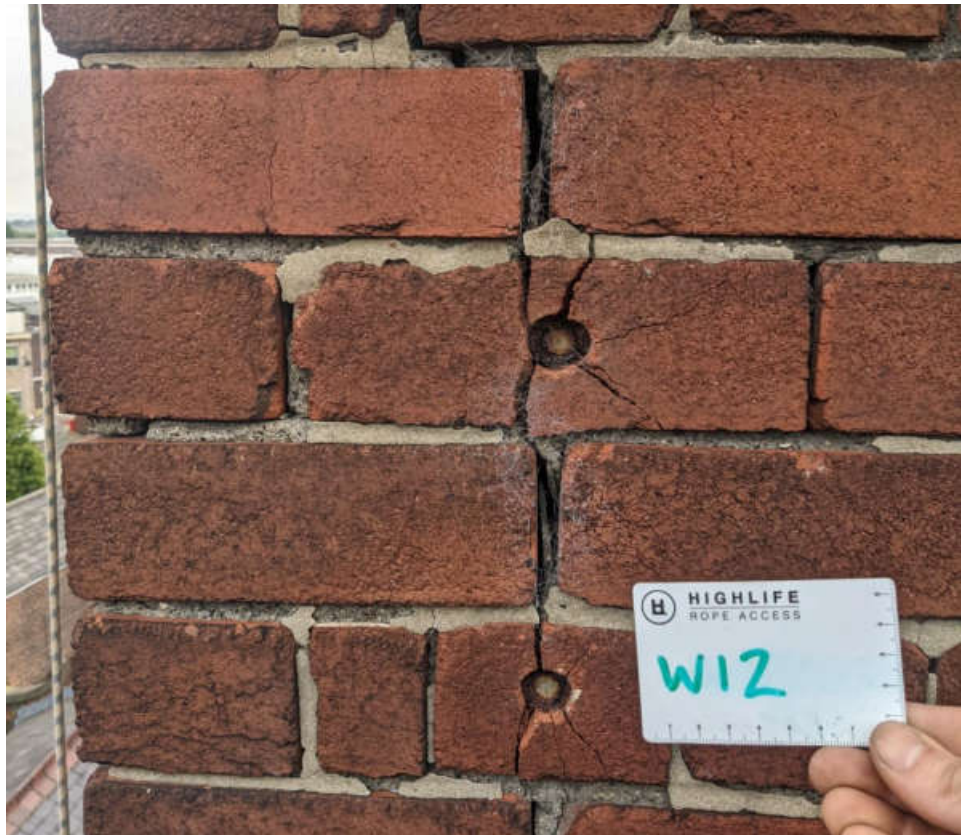
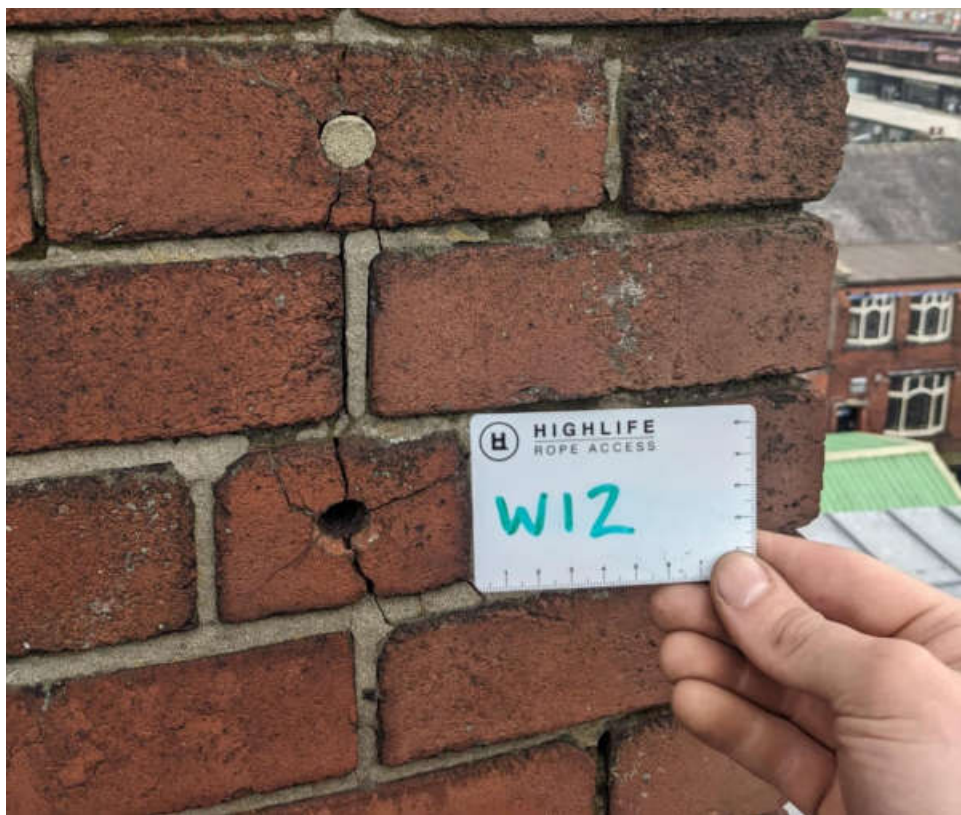
| W12 | Photos | | |

| W12 | Brickwork between sill and stone string course | 6no. Ferrous scaffold fixings, some of which have broken the surrounding bricks | Replace broken bricks and repoint with a suitable lime mortar. Where bricks are not broken core out fixings and repoint |

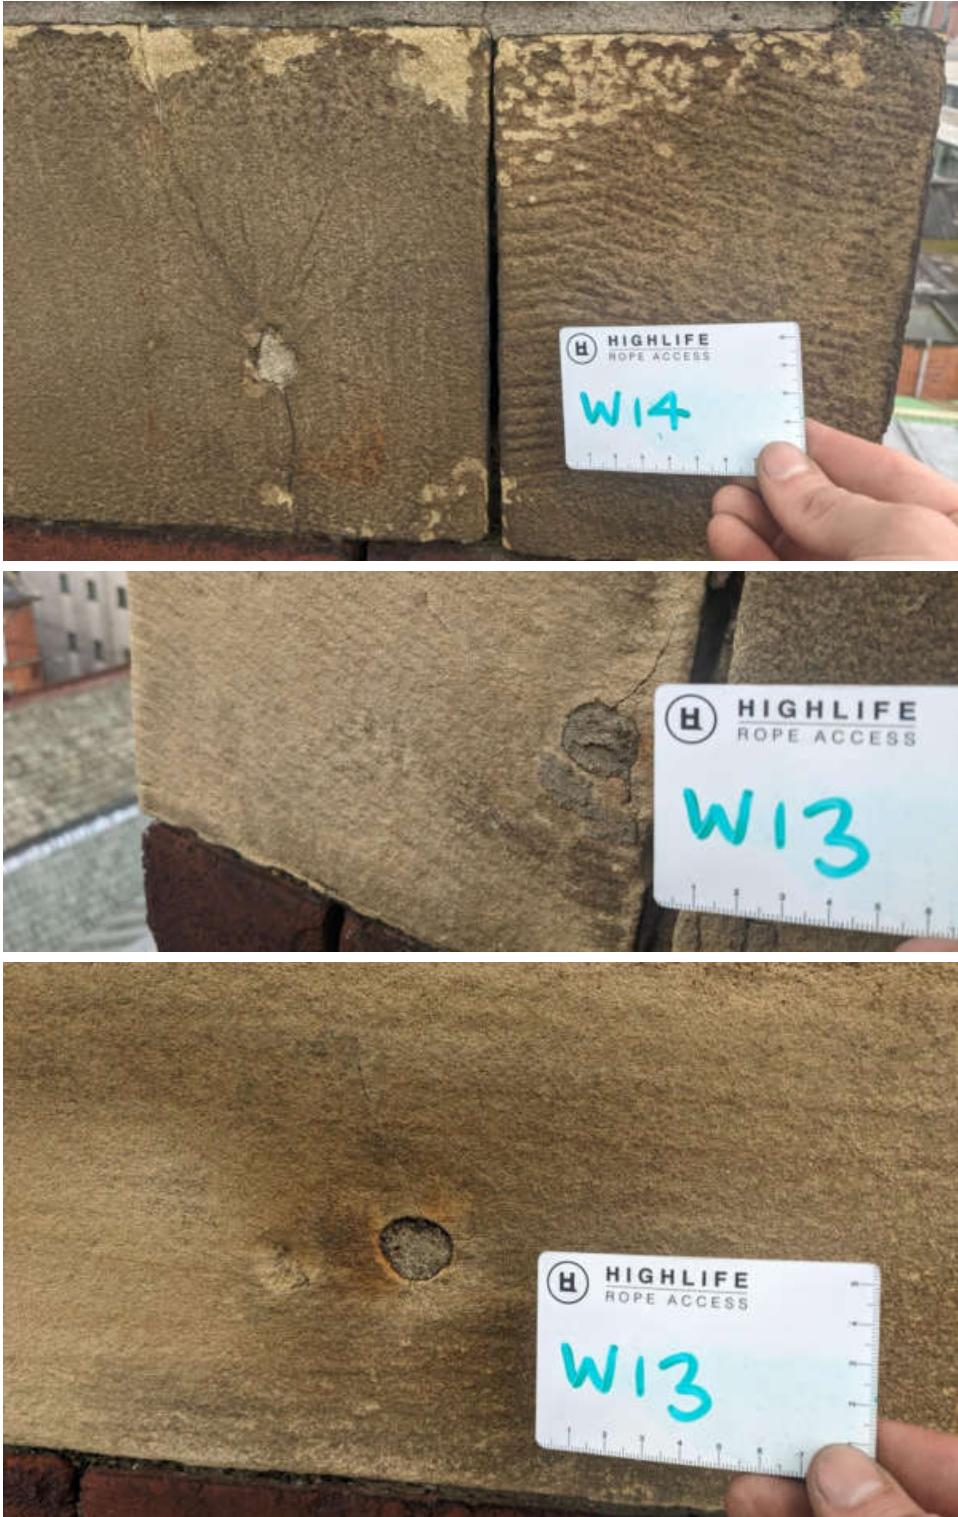
| W13 | Photos | | |

| W13 | String course | 3no. Ferrous scaffold fixings, one of which has caused minor cracking of the stone | Core out fixings and point with a suitable lime mortar |

| W14 | String course | Open perpend joints in string course | Rake out and repoint with a suitable lime mortar |

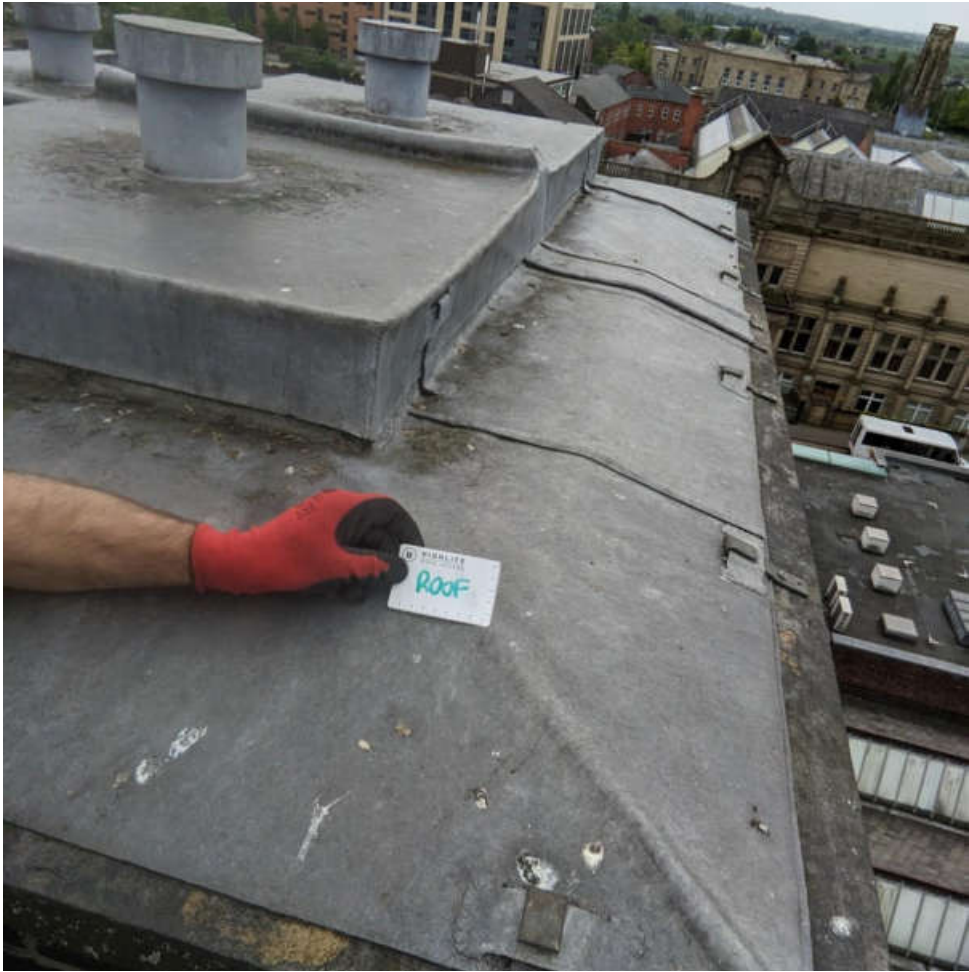
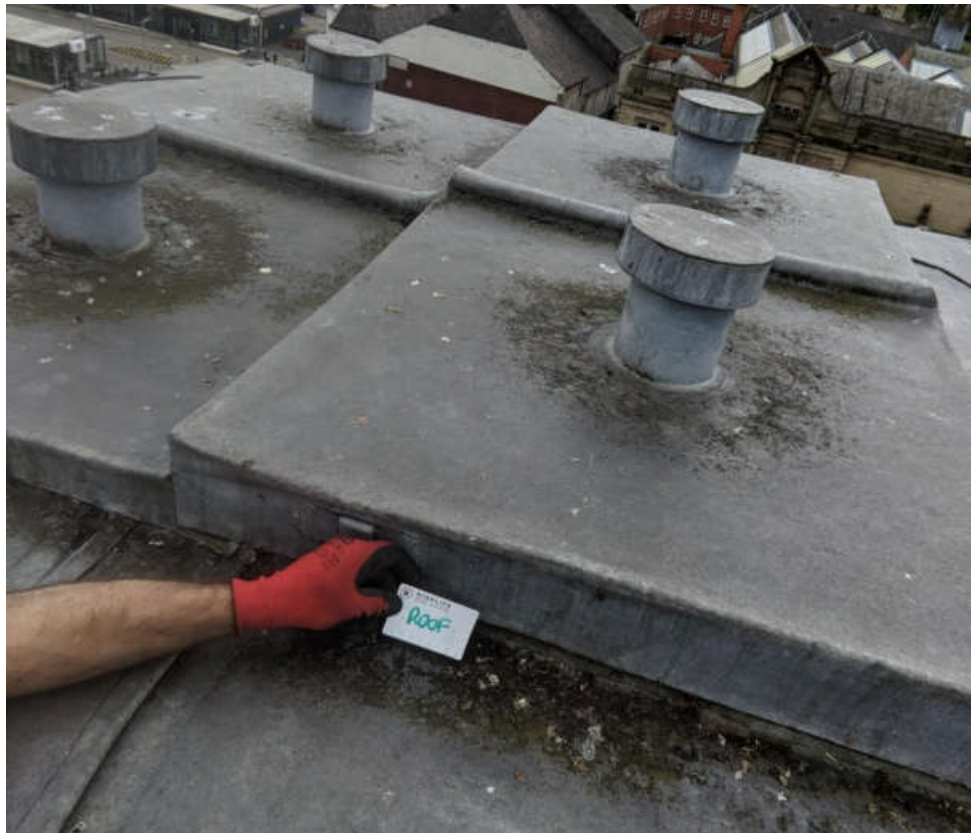
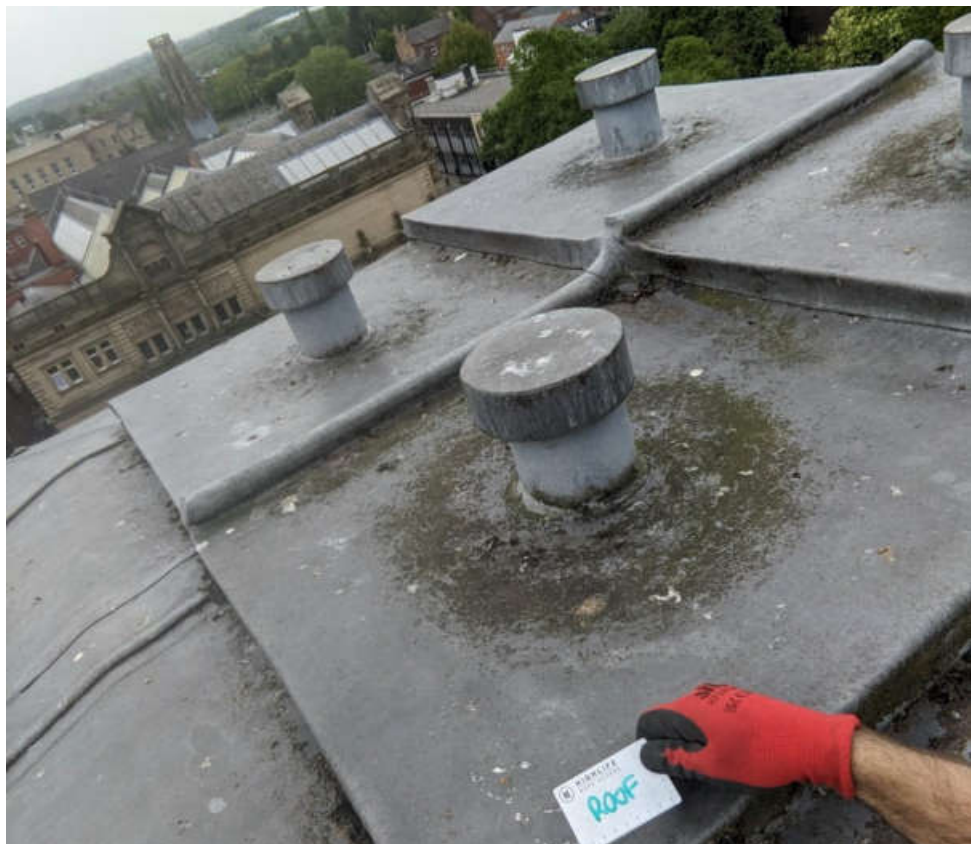
| No. | Location | Description | Proposed Solution |
|---|---|---|---|
| | Roof | The lead roof covering is in very good condition, with no obvious flaws or defects. The only thing that could possibly be considered an issue is that the lead stops around 50mm short of the edge of the roof, however it is highly unlikely that this is actually causing any leaks | No action needed |
