## BURY FUSILIERS MUSEUM

Addendum to Condition Survey  
Chambers Conservation Ltd. (Updated April 2024)

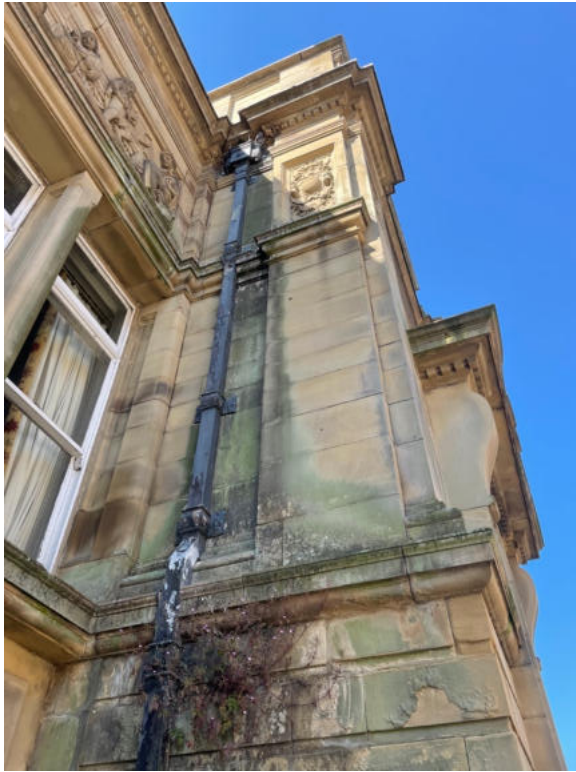
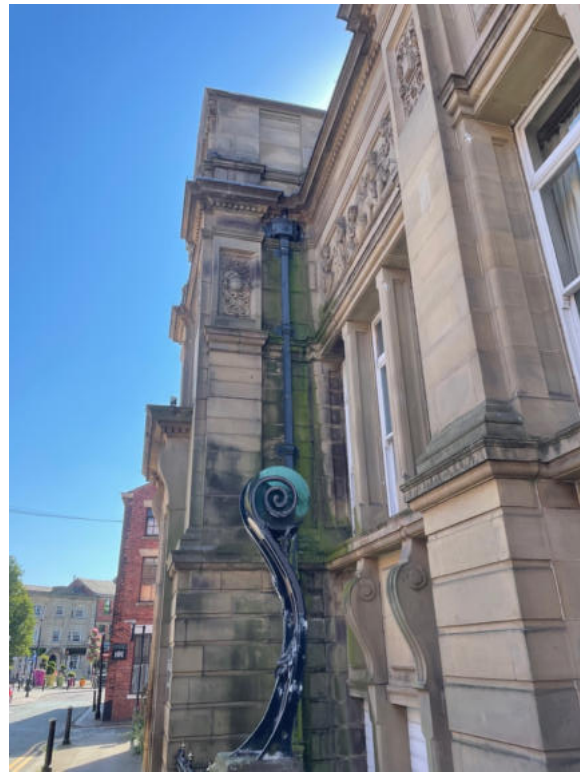
In particular the outlets to Broad Street (see Fig 01) are regularly over-flowing down the external stonework which is starting to cause significant damage to the stonework externally and finishes and joinery internally. Without address this also could result in substantial rot taking hold.

**01** (Area A, right and B, left). Outlets and downpipes to Broad Street. Surcharging and discharging down the face of the ashlar. Causing damage to the stonework (externally) and damp internally. A combined cause of complex discharge arrangements at cornice level, lack of capacity and blockages can be identified as the causes.

There is a need to consider providing additional capacity to the area around the chute, and increased capacity into the hopper and pipe. The hopper and pipe are integrated into the stonework and façade, so increasing the

pipe and hopper capacity would be very damaging to the appearance of the listed building. Improved access for maintenance is, however, required.

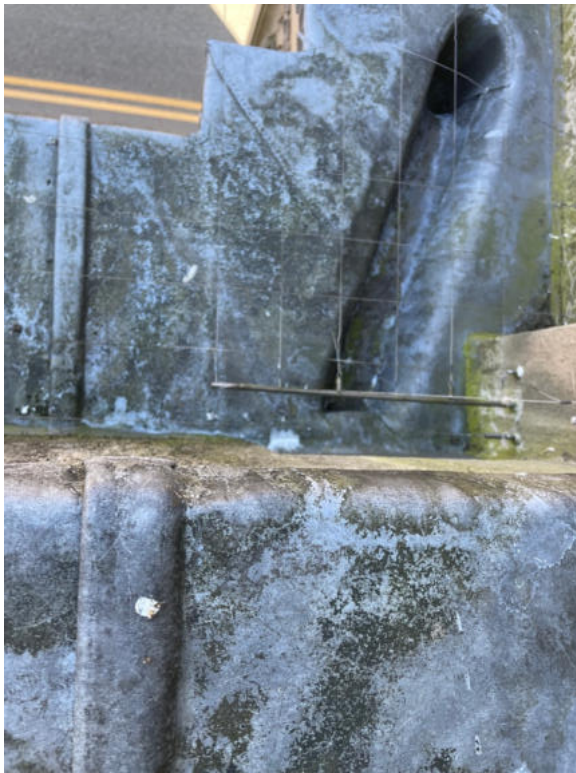
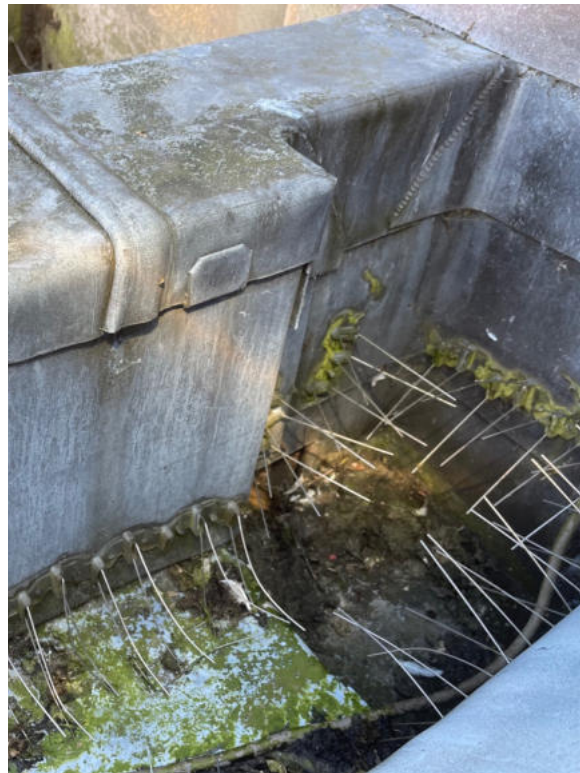
Inspection from above (see Fig 02) shows that the gutter (a fairly standard lead, stepped, parapet gutter) discharges through the blocking course into a very small channel cut into the sky-face of the cornice. Lined in lead, this only provides a very limited capacity and there is no catch-pit or sump to assist in storm conditions. The end result is water discharging over the top of the cornice. The pipes also are vulnerable to blockage, especially as pigeons can gain access to the hoppers. The general evidence of saturation to the stonework suggests the pipe is currently blocked and leaking. It needs to be removed to inspect for cracking to the rear.

**02** Area A (Note, Area B same but mirrored). Lead gutter discharges onto cornice, through channel cut into stone and lined in lead. Capacity is very limited and there is in effect no catch-pit or sump.

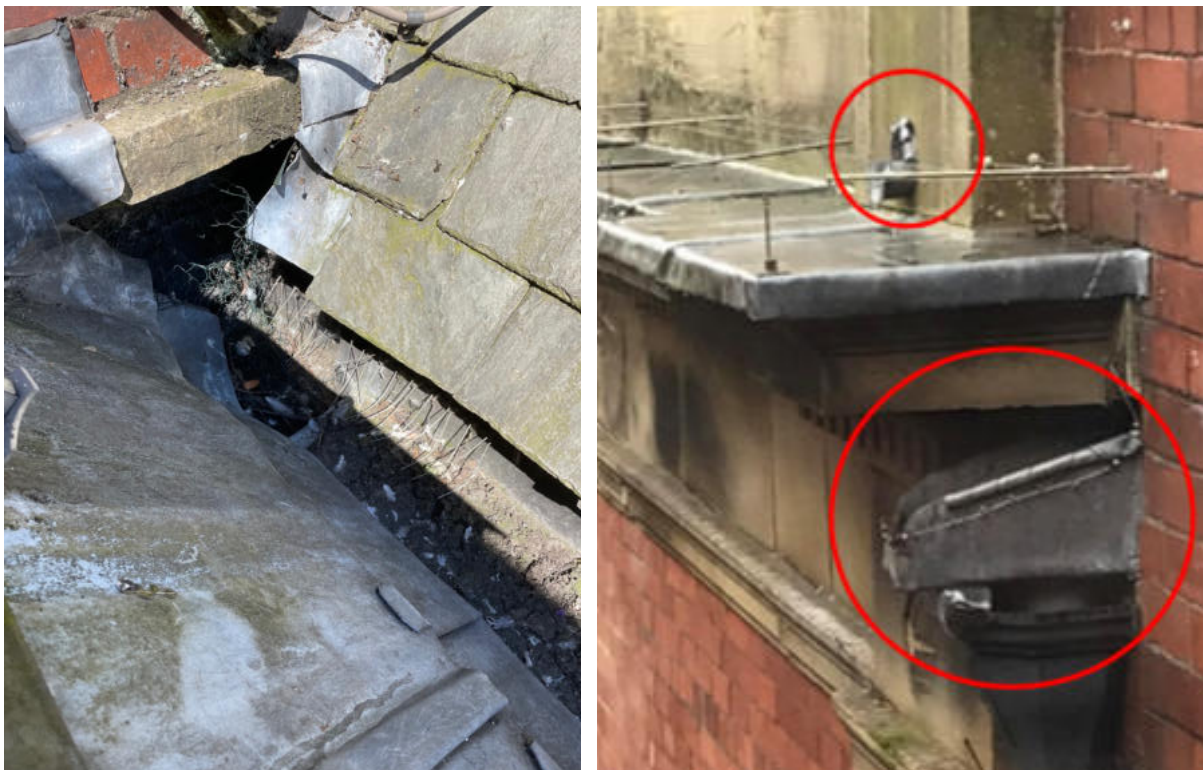
Area C is the discharge point for Gutter 3. This outlet takes a substantial amount of water from two adjacent roof slopes. Identified in AY report, but the outlet configuration was not fully understood, (see illustration 14/15 of AY summary). Water ingress is very evident below the outlet.

Currently the gutter drops into a very small catch-pit with (blocked) overflow. The pipe is then routed internally (concealed) with an off-set to a chute and hopper below. (see Fig03). This is currently very difficult to maintain without external scaffold.

**03** (Area C). View from the gutter above. View from the north-west showing the overflow and hopper (circled).

There is very limited over-flow capacity and the outlet is vulnerable to blockage. It should be possible to increase the catch-pit capacity, with some reconfiguration, and improve access for maintenance to reduce risks to the fabric.

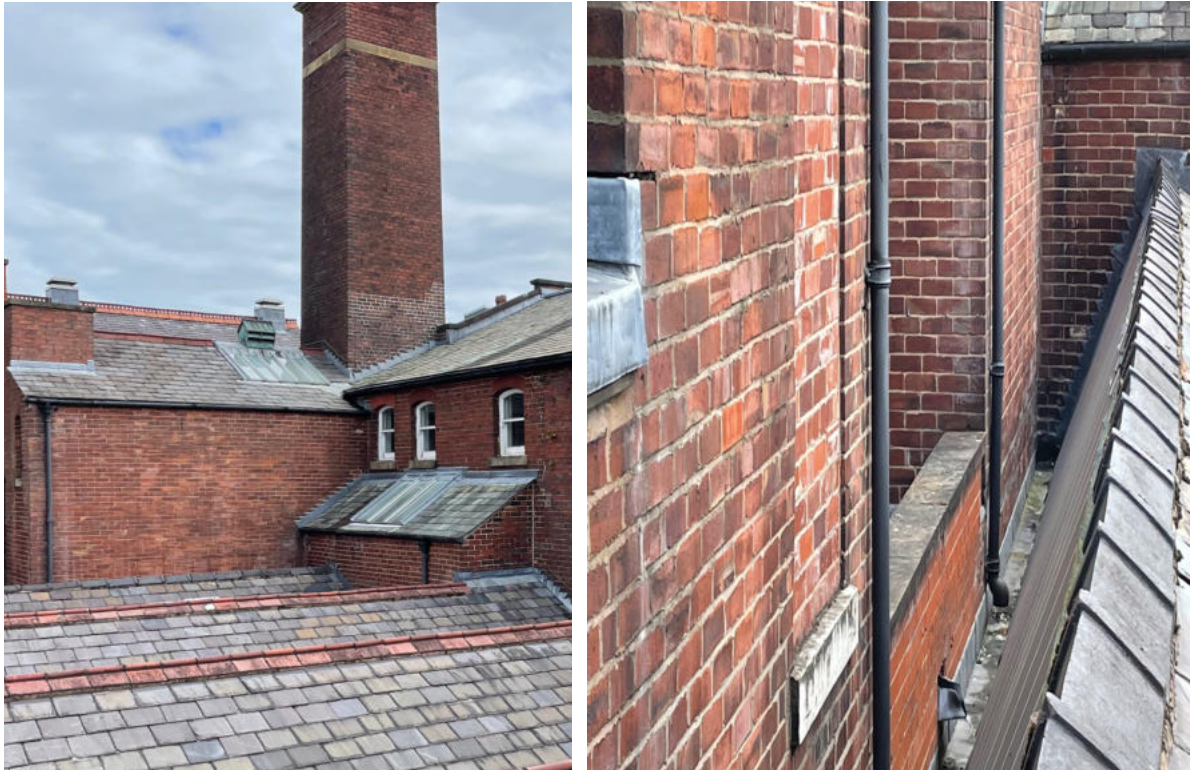
Further areas of water ingress were identified, (above the WC corridor and mezzanine stair S06). This was identified in the AY report (item 4.15, p19), but has noticeably deteriorated subsequently. Gutter 6 and 7 are both misaligned and there is failure in the gutter joints, with consequent saturation of the walls below. A section of rainwater pipe is also missing where gutter 7 discharges into valley gutter 13.

Lead valley gutter (15) has limited capacity (it also takes water from roof 11 via a chute), and inadequate height flashings. There is also misaligned and poor quality brickwork above (this appears to be historic and resulting from the varied dates of construction in this area), this has open joints and is potentially contributing to the damp masonry and plasterwork failure below. This area is identified as Area G on drawing BUFM.01-001.

04 (Area G). General view (left). Close up of view of lead gutter, outlet from roof 11 (left).

The iron gutters need dismantling, joints repairing and re-aligning properly. The lead valley gutter (15) should have increased depth flashings, which could be extended also to protect the brickwork above.

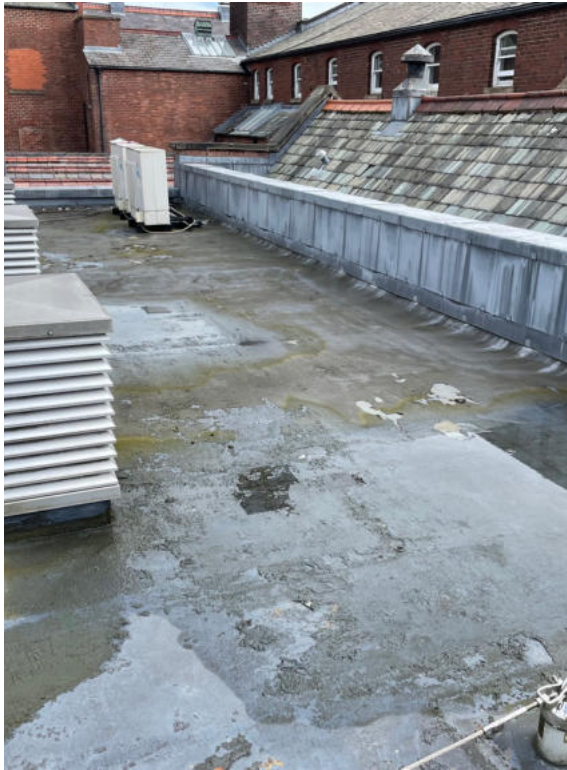
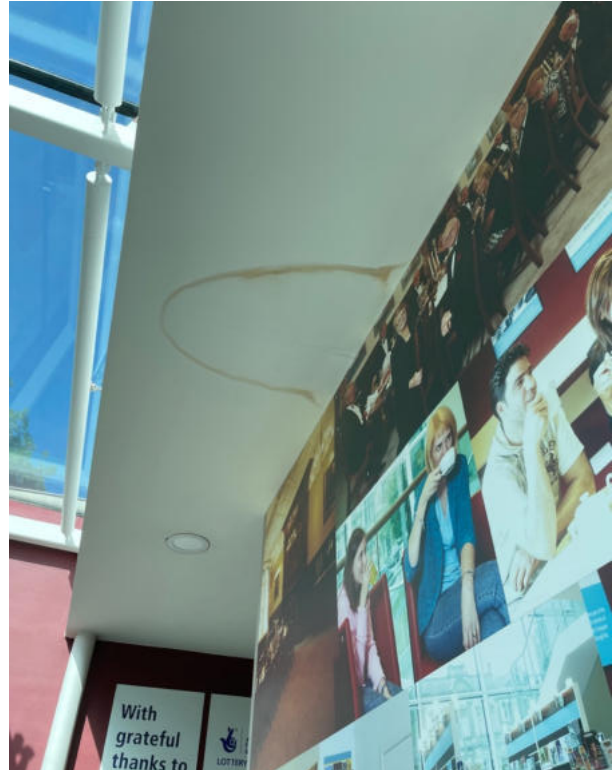
The AY report noted the failure of the modern roofing over the entrance and café. On inspection in August 2022, the roof covering has further failed, and there was widespread evidence of ponding to the surface (through staining as conditions were dry). Water ingress was also evident internally and consequently there is failure in the internal finishes.

The ponding suggests that the roof is not falling properly to the outlets (see Fig 05). The original specification and drawings show a decothane liquid membrane on cut-to-falls insulation. There is widespread evidence of failure in the coating and it is consequently possible the insulation has become wet below, therefore potentially affecting both performance and the falls to the outlets. Patching has been undertaken in a number of locations.

There is also cracking where the liquid extends over the coping to the south-western corner. This isn't currently protected by a flashing, which would significantly improve the detail.

05 (Area F). Evidence of ponding to the flat roof, extensive coating failure and patching. Right, internal water ingress and damage to finishes.

The whole roof is now in need of renewal before significant internal damage occurs. This should preferably be in a membrane rather than liquid applied system, which should offer improved longevity and a more robust finish. Flashings would provide a more robust detail to the south-western parapet.

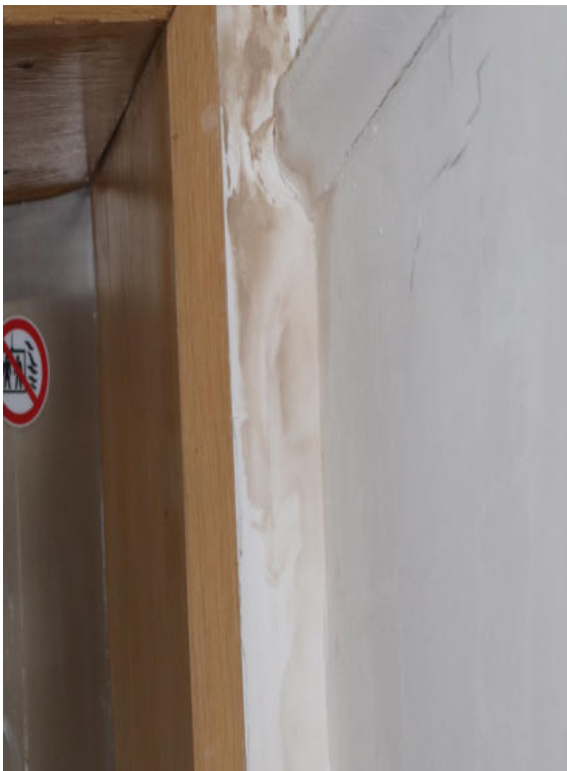
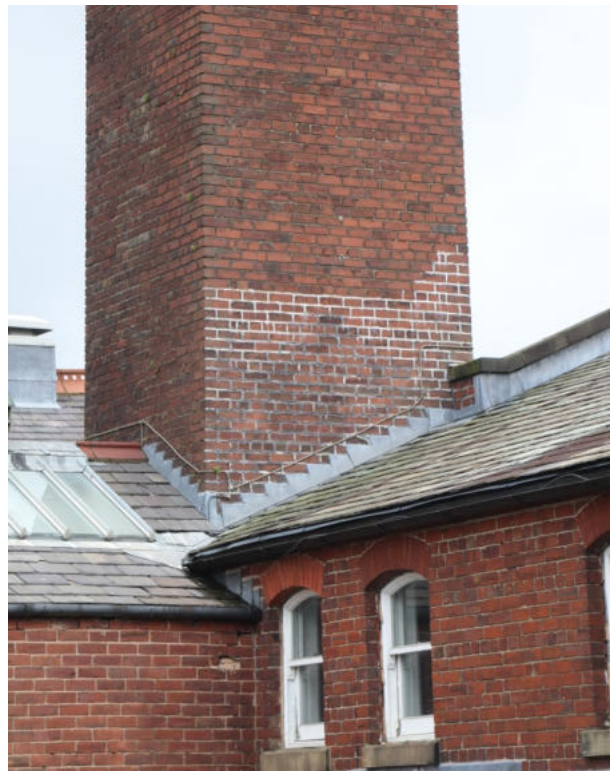
At the time of inspection it was not possible to safely access the interior of the lift shaft to determine the extent of water in the shaft (lift 1), but there remains evidence of some on-going water ingress which is causing damage to finishes (see Fig 06).

06 & 07 (Area D). Damage to finishes from water ingress above lift shaft (lift 1) and recent repointing works, which have made an improvement to the water ingress.

The lift is within a historic ventilation shaft, Some repointing work has been undertaken (see Fig 06), which has (anecdotally) made a difference to the water ingress. It is however evident that the problem remains, and in order to properly determine the cause, a proper high-level inspection, probably using rope access is required, together with a lift-engineer to facilitate the internal inspection. This may determine further high-level works or additional pointing requirements.
