Phase I Geoenvironmental Site Assessment  
Fairways Lodge, Prestwich

Reference: 17-206-R1-1  
Date: September 2023

# PHASE I GEOENVIRONMENTAL SITE ASSESSMENT

Fairways Lodge  
George Street  
Prestwich  
Greater Manchester  
M25 9WS

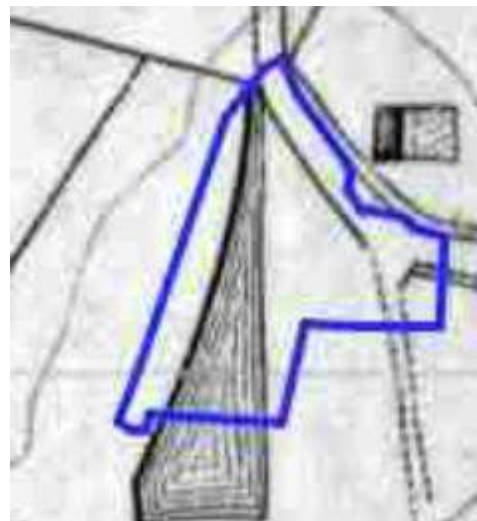
| MAP EDITION | HISTORICAL LAND USE | HISTORICAL MAP EXCERPT |
|---|---|---|
| 1848<br>1:10,560 | A pond/reservoir appears to be located across the majority of the site, likely associated with the Myrtle Grove Dye Works to the south of the site. | |

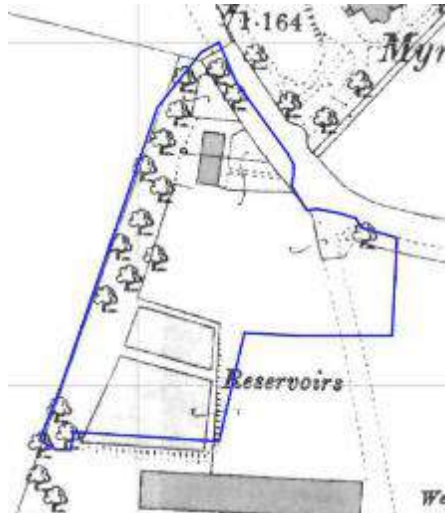
| MAP EDITION | HISTORICAL LAND USE | HISTORICAL MAP EXCERPT |
|---|---|---|
| <p><b>1893</b><br/><b>1:2,500</b></p> | <p>Reservoirs are recorded in the south of the site.</p> <p>A rectangular structure is present in the northern sector.</p> <p>Tracks are present in the north and east of the site.</p> | |

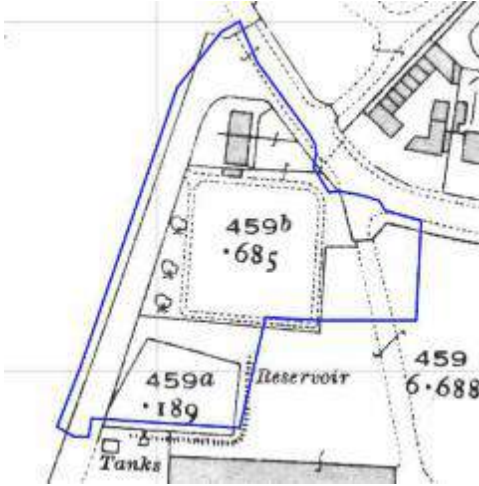
| MAP EDITION | HISTORICAL LAND USE | HISTORICAL MAP EXCERPT |
|---|---|---|
| <p><b>1932</b><br/><b>1:2,500</b></p> | <p>The reservoir furthest north is no longer recorded.</p> <p>A Bowling Green is recorded in the centre of the site with a small Pavilion.</p> <p>Small tanks are recorded at the southern site boundary associated with the adjacent Bleach and Dye Works.</p> | |

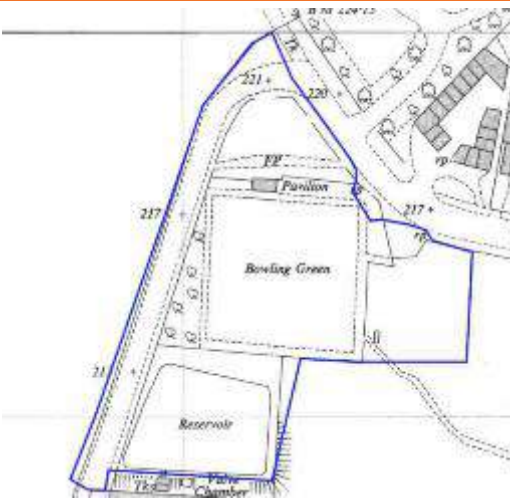
| MAP EDITION | HISTORICAL LAND USE | HISTORICAL MAP EXCERPT |
|---|---|---|
| <p><b>1952</b><br/><b>1:1,250</b></p> | <p>The buildings in the north of the site are no longer present. A footpath is recorded to the north of the Bowling Green.</p> | |

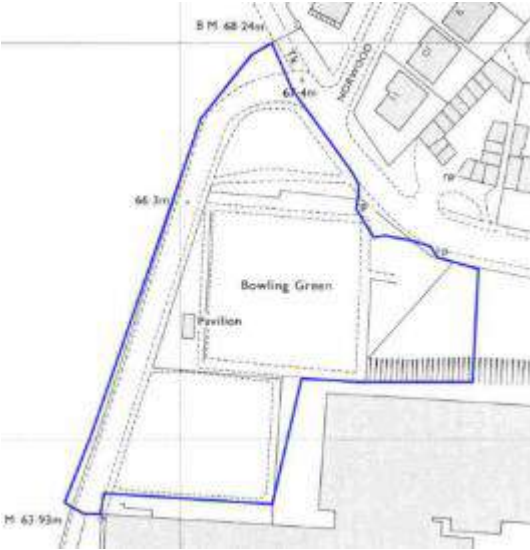
| MAP EDITION | HISTORICAL LAND USE | HISTORICAL MAP EXCERPT |
|---|---|---|
| <p><b>1973</b><br/><b>1:1,250</b></p> | <p>The reservoir in the south appears to have been infilled. A Pavilion is now present to the west of the Bowling Green, rather than to the north.</p> <p>An area of ground workings/land raising is present in the southeast.</p> | |

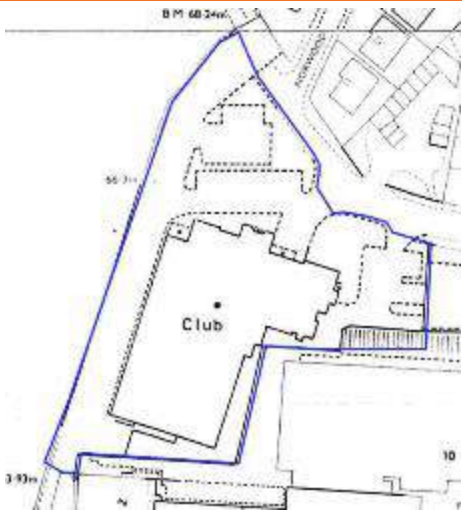
| MAP EDITION | HISTORICAL LAND USE | HISTORICAL MAP EXCERPT |
|---|---|---|
| <p><b>1988</b><br/><b>1:1,250</b></p> | <p>The reservoir in the south has been infilled.</p> <p>The Bowling Green is no longer present and a Club building has been constructed across the majority of the site.</p> | |

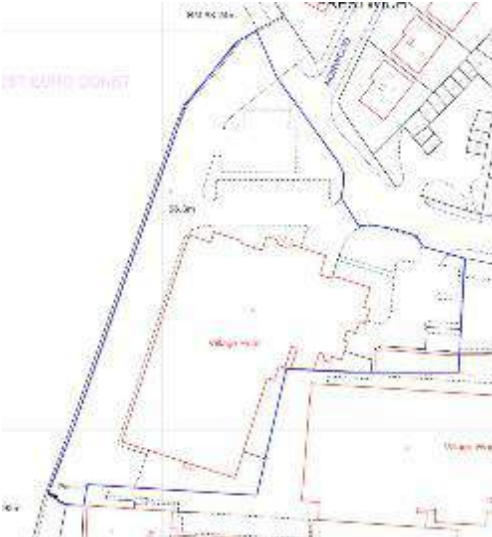
| MAP EDITION | HISTORICAL LAND USE | HISTORICAL MAP EXCERPT |
|---|---|---|
| <p><b>2003</b><br/><b>1:1,250</b></p> | <p>The Club building is now recorded as the Village Hotel.</p> | |

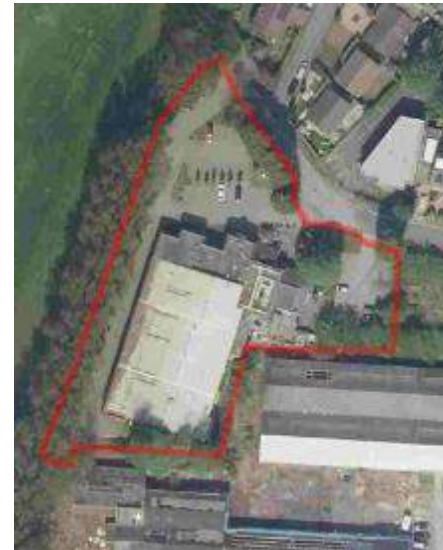
| MAP EDITION | HISTORICAL LAND USE | HISTORICAL MAP EXCERPT |
|---|---|---|
| 2019<br>Aerial<br>Photograph | There are no significant changes. The area to the north of the hotel is utilised as a car park. | |

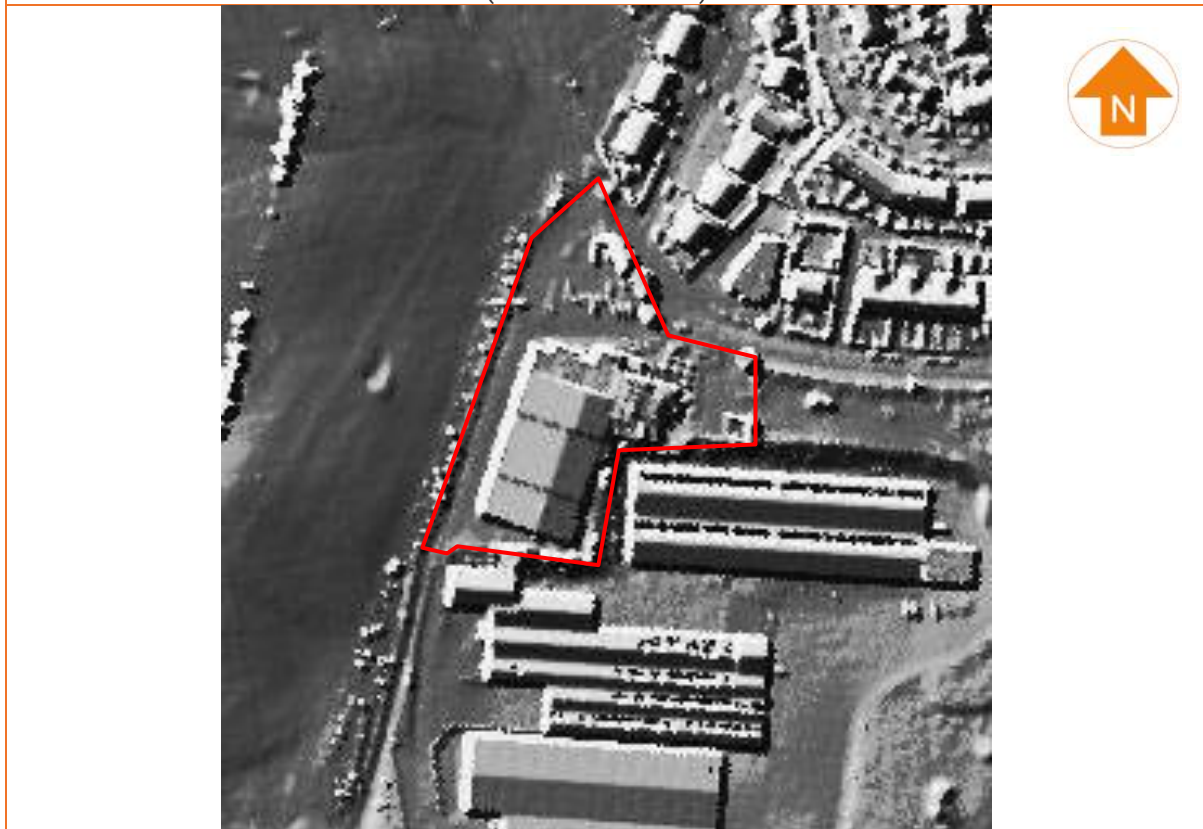
FIGURE 4.1 SURFACE LIDAR DATA (HOUSEPRICES.IO)

It would appear that the placement and upfilling of material will have formed the current site level plateau before the construction of the existing building.

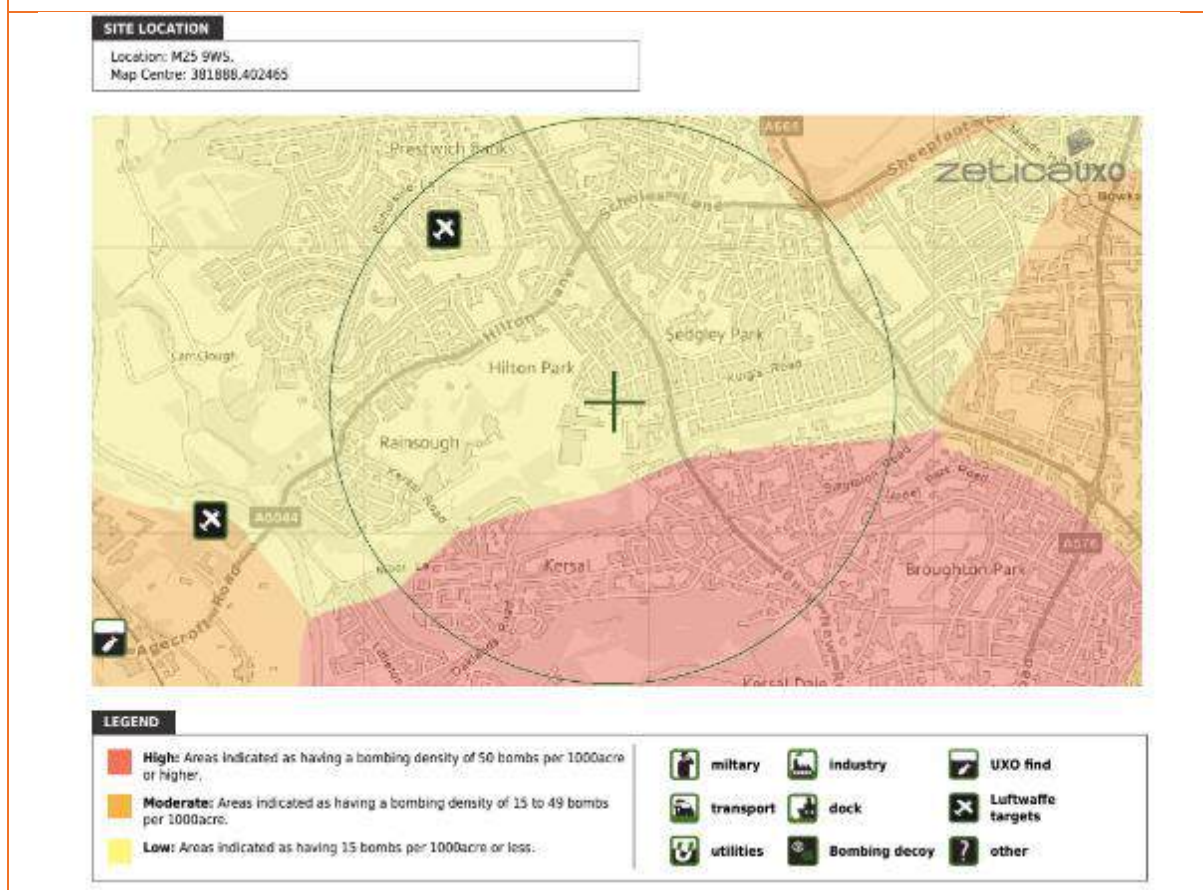
FIGURE 4.4 ZETICA UXO RISK MAP

The regional unexploded bomb risk map from Zetica (2014) indicates that the Site is in an area at low risk from possible unexploded ordnance (UXO) resulting from the Second World War. The Zetica UXO Risk Map is presented in Figure 4.4.
