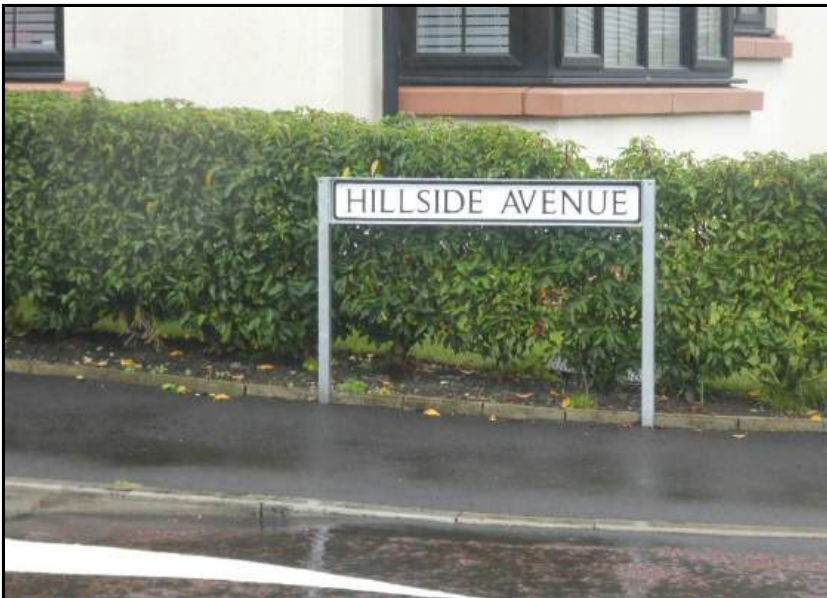
Photograph 1. Hillside Avenue adjoining George Street

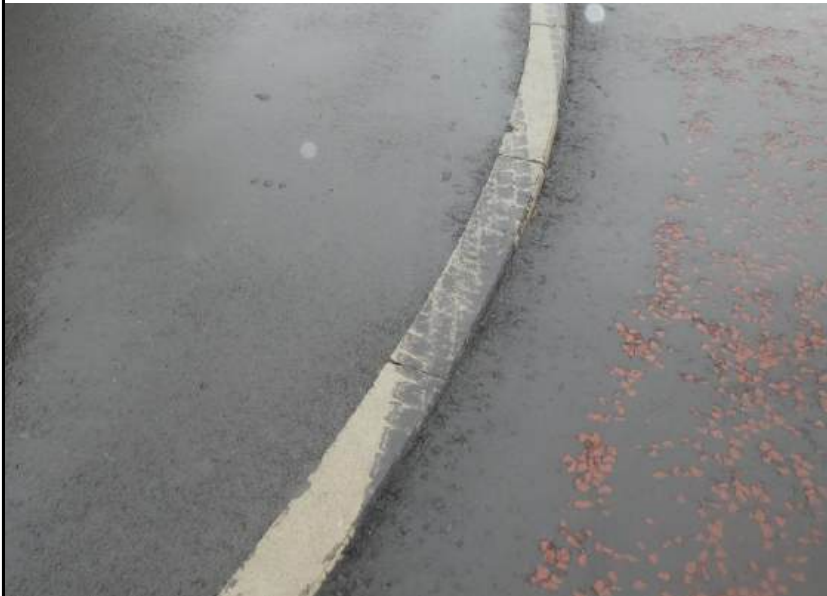
Photograph 3. Kerbing is stained and marked on both sides of the roadway

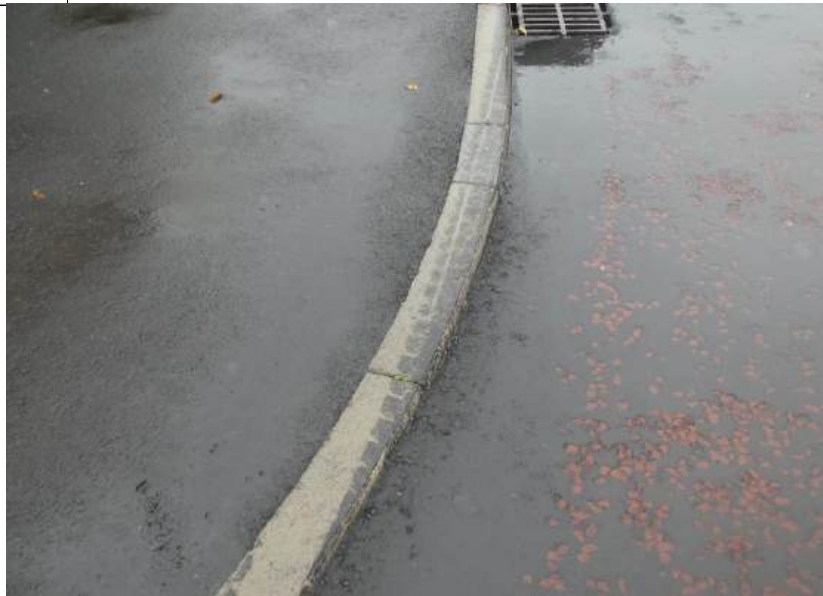
Photograph 4. Kerbing is stained and marked on both sides of the roadway

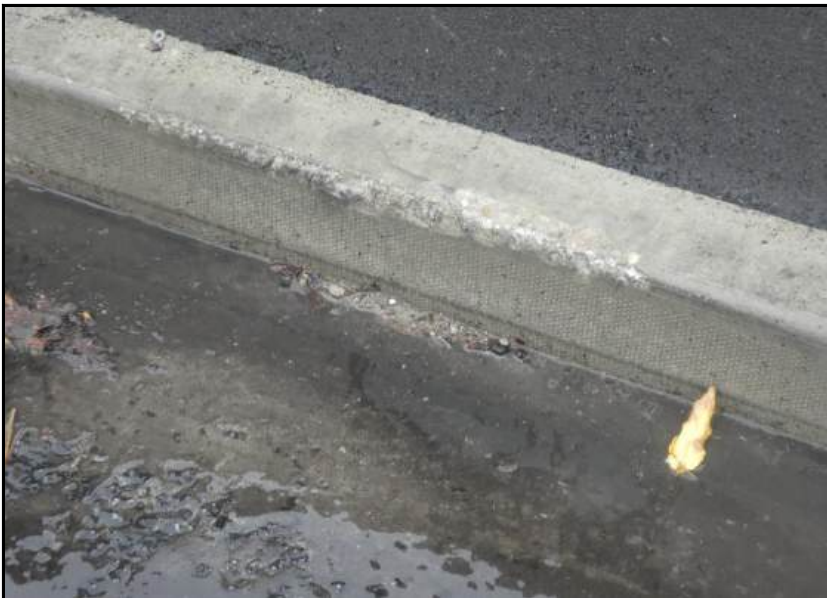
Photograph 5. Localised impact damage to the kerbs

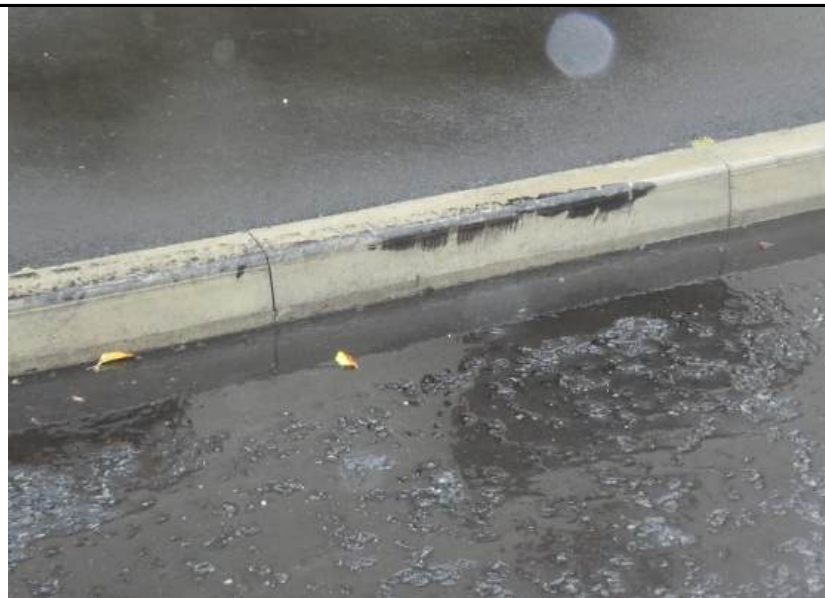
Photograph 6. Staining the kerbing

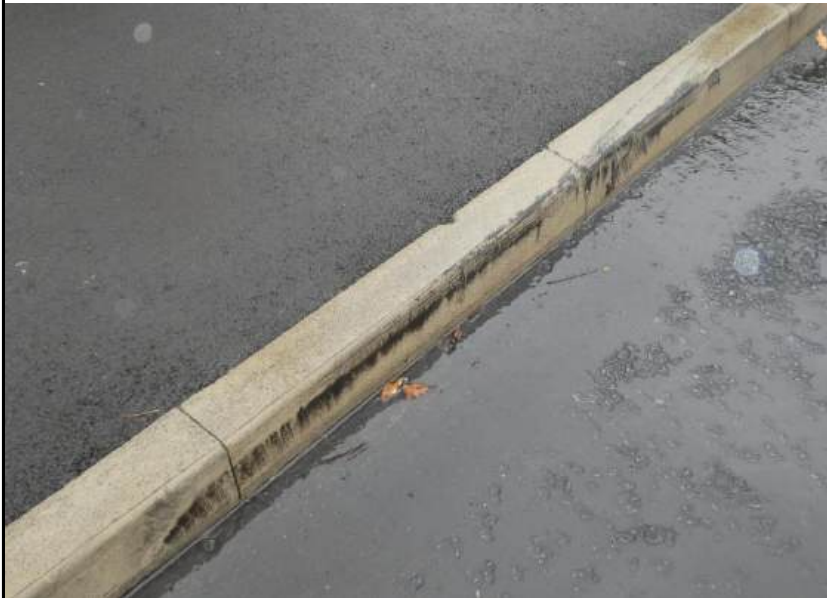
Photograph 7. Staining to the kerbing

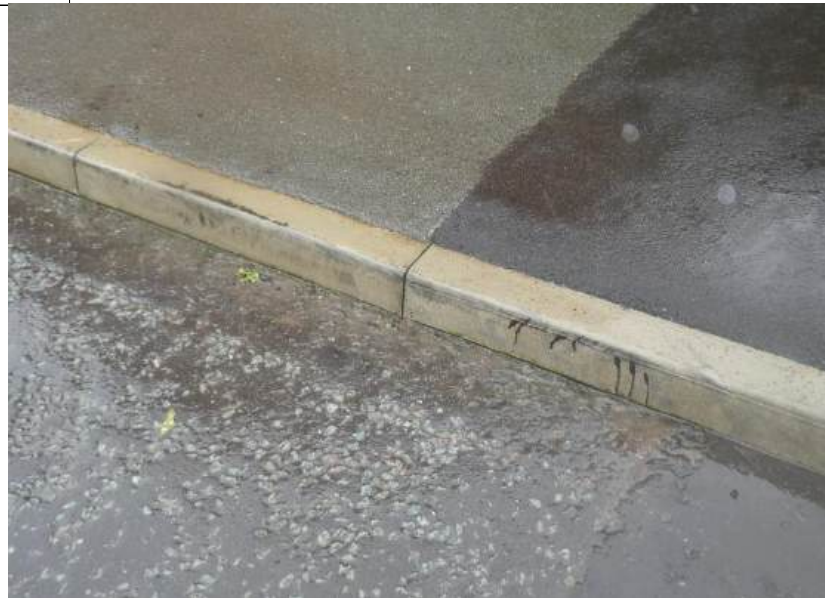
Photograph 8. Staining to the kerbing

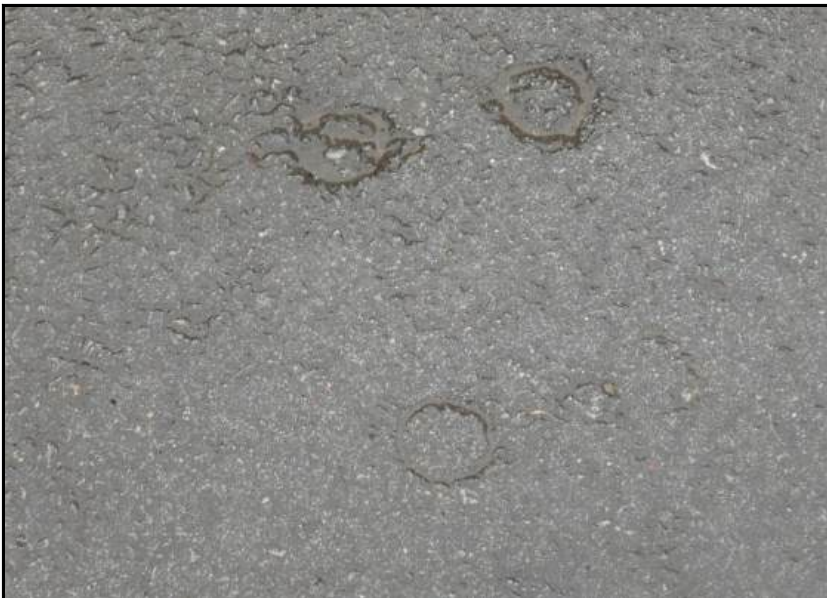
Photograph 9. Localised indentations to footpath areas

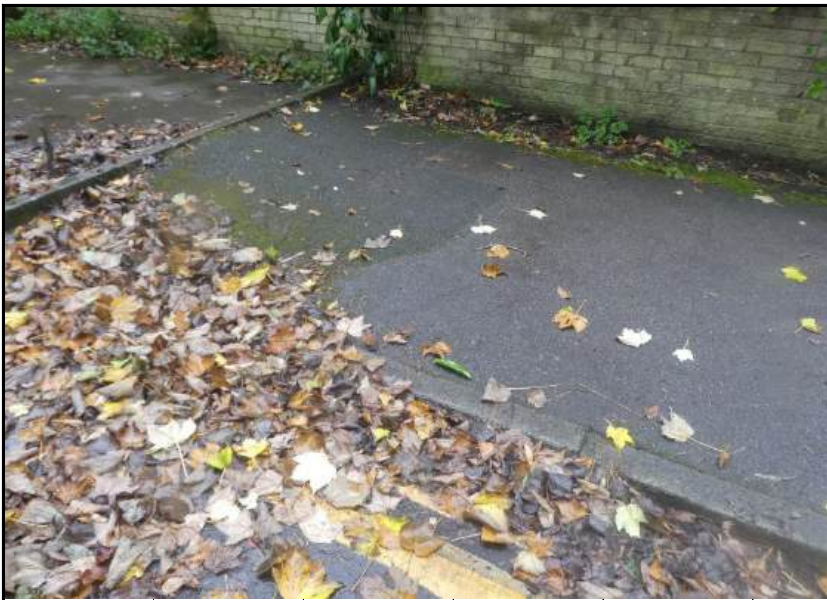
Photograph 13. Tarmacadam surfacing to the footpath

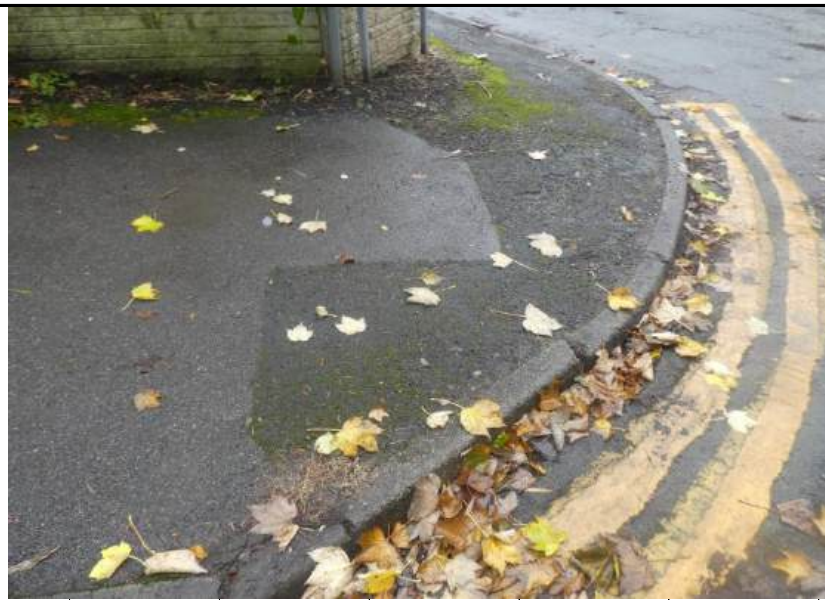
Photograph 14. Localised damage and settlement to the concrete kerbs

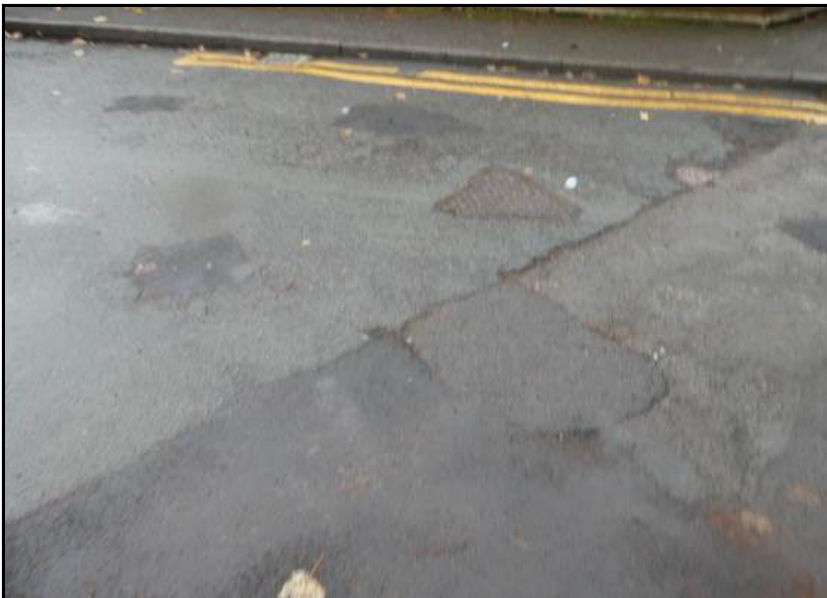
Photograph 17. Localised reinstatement of road surfacing to Norwood junction slightly eroded

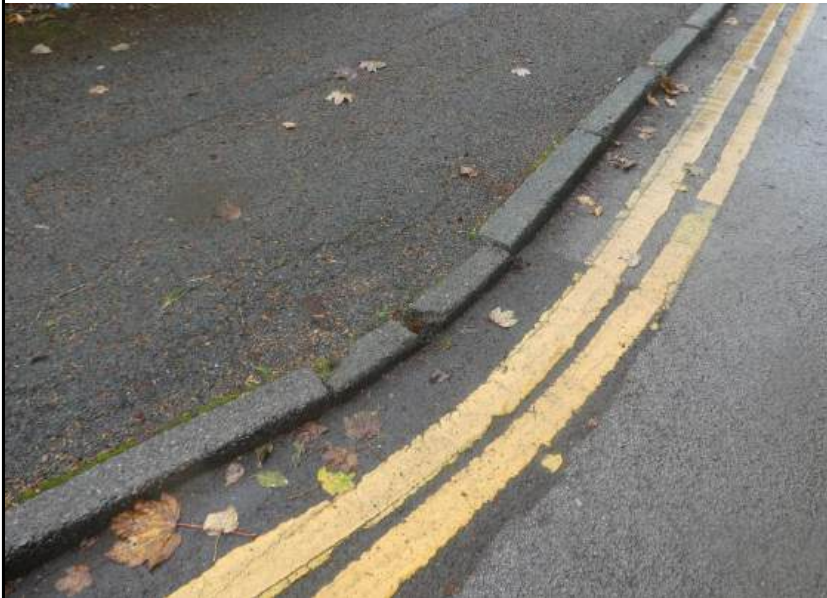
Photograph 19. Damaged and uneven kerbs to Norwood junction

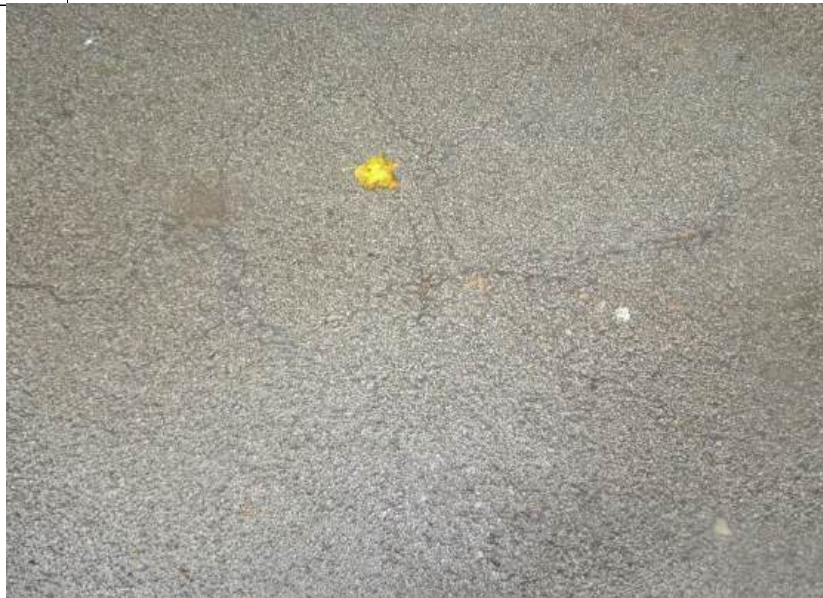
Photograph 20. Localised cracking to road surface

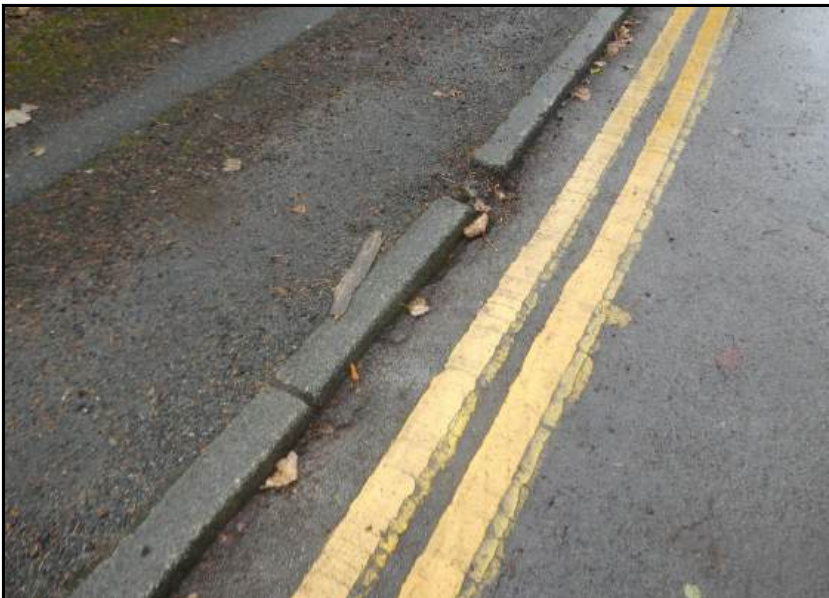
Photograph 21. Uneven and damaged kerb to George Street

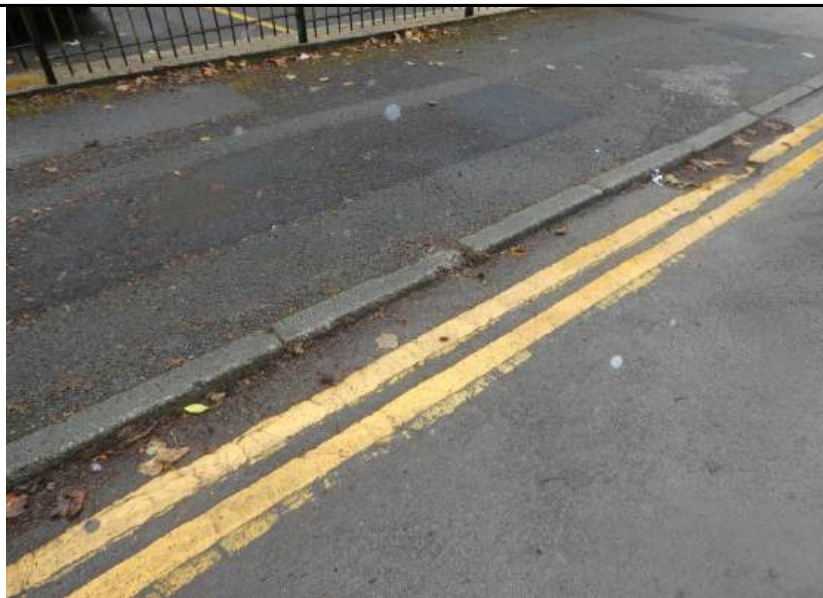
Photograph 22. Uneven and damaged kerb to George Street

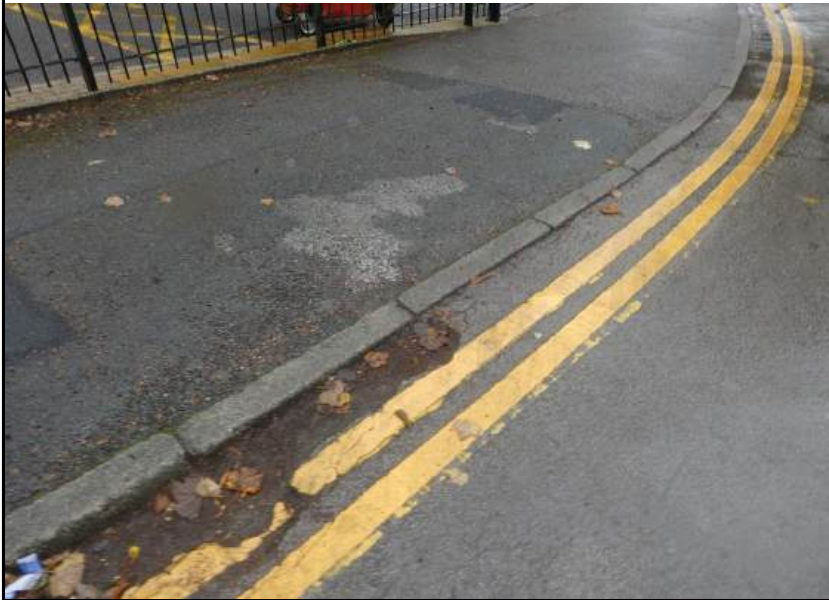
Photograph 23. Uneven and damaged kerb to George Street

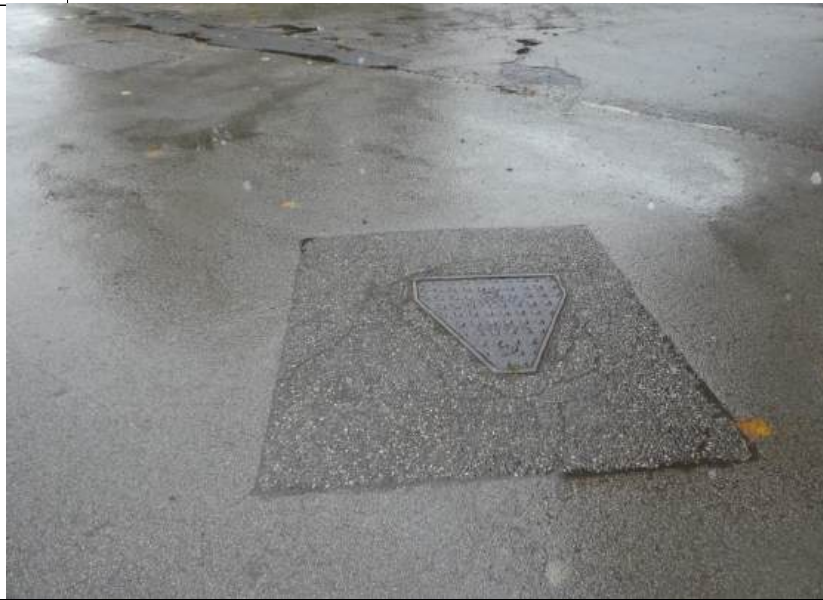
Photograph 24. Reinstatement to inspection chamber cracked and eroding

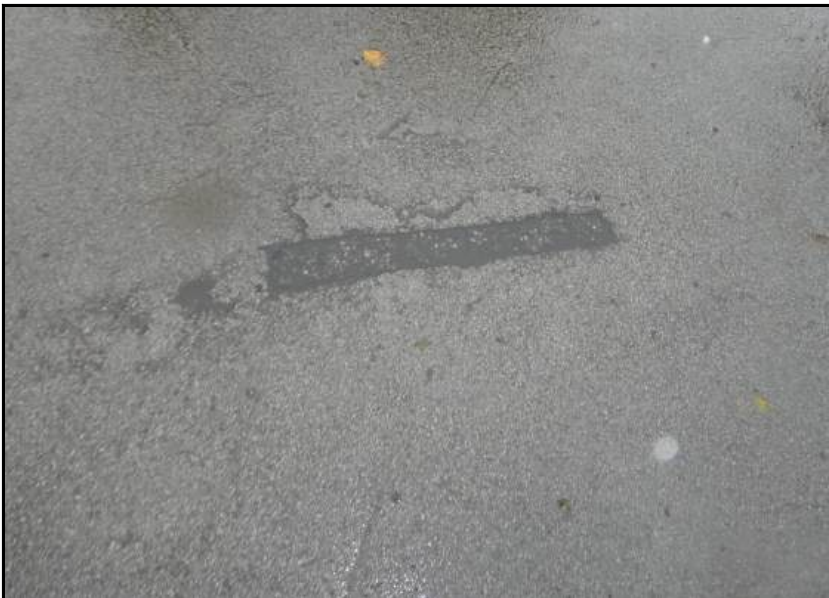
Photograph 25. Localised erosion to surfacing

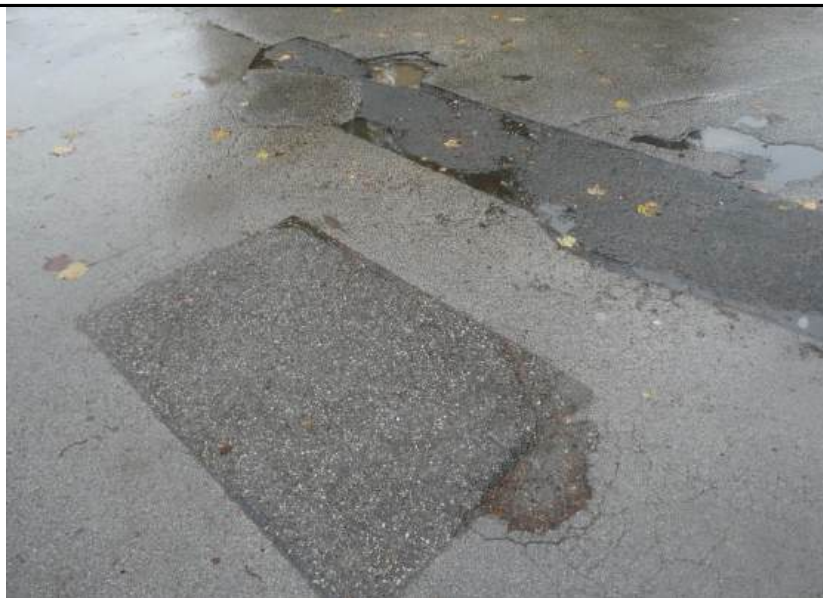
Photograph 26. Reinstated area of surfacing damaged and eroded

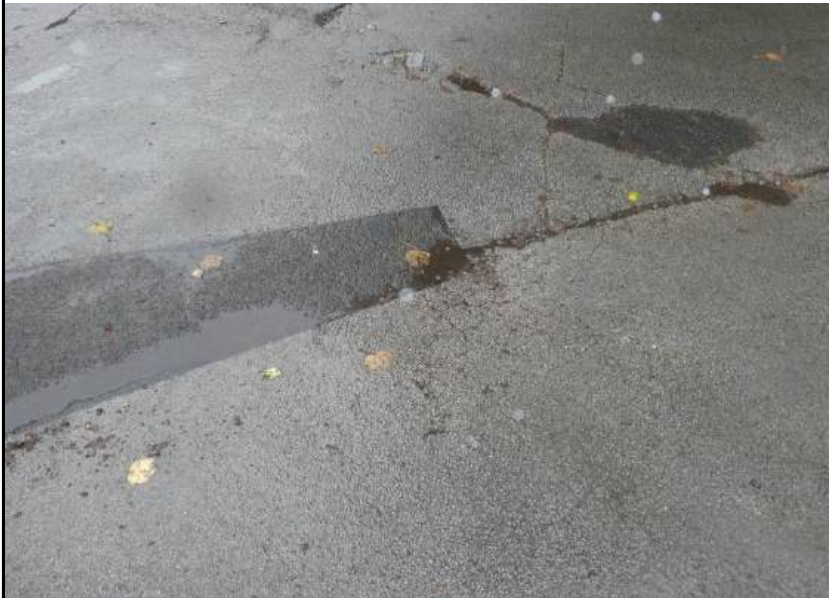
Photograph 27. Reinstated area of surfacing damaged and eroded

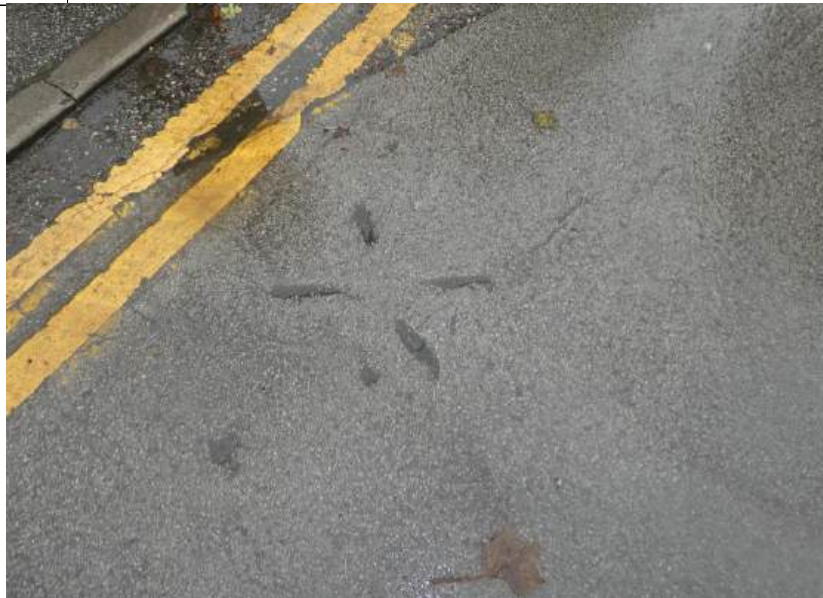
Photograph 28. Localised indentations to road surfacing

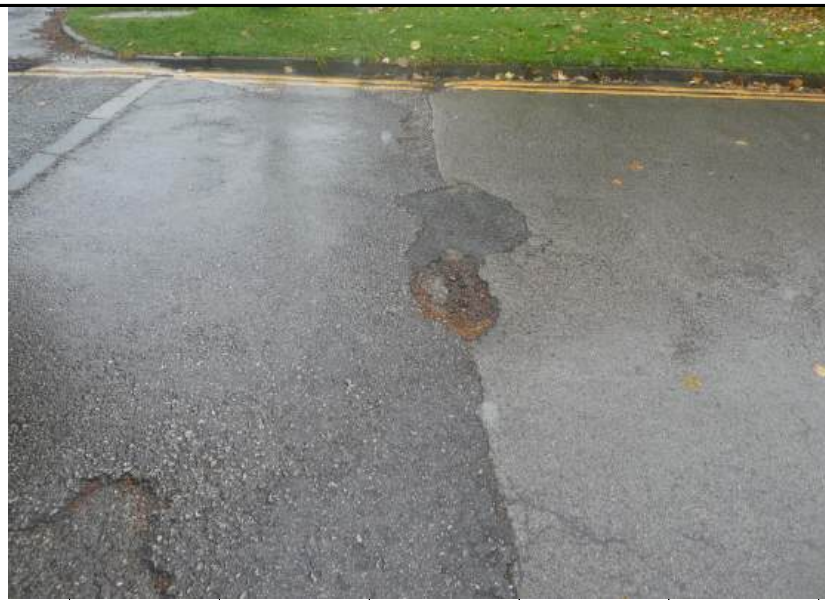
Photograph 30. Localised erosion to surfacing

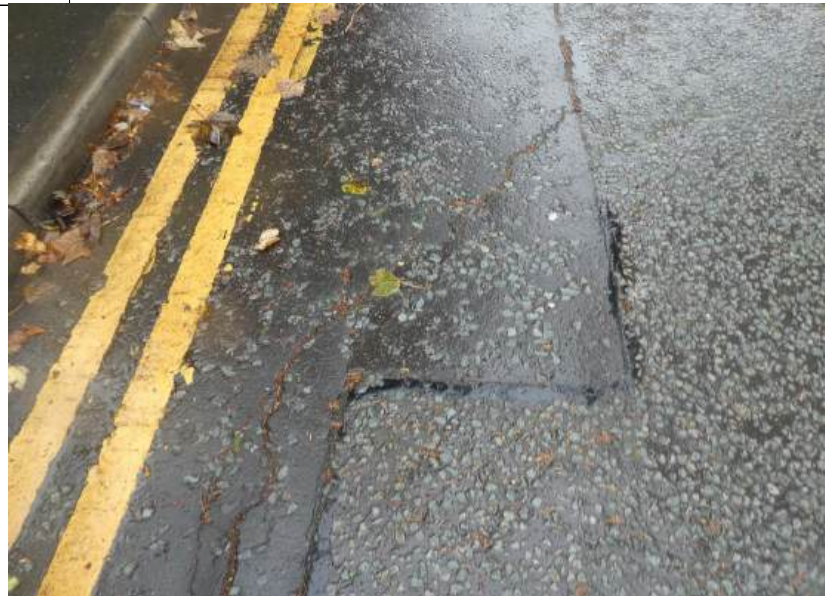
Photograph 36. Cracking to surfacing

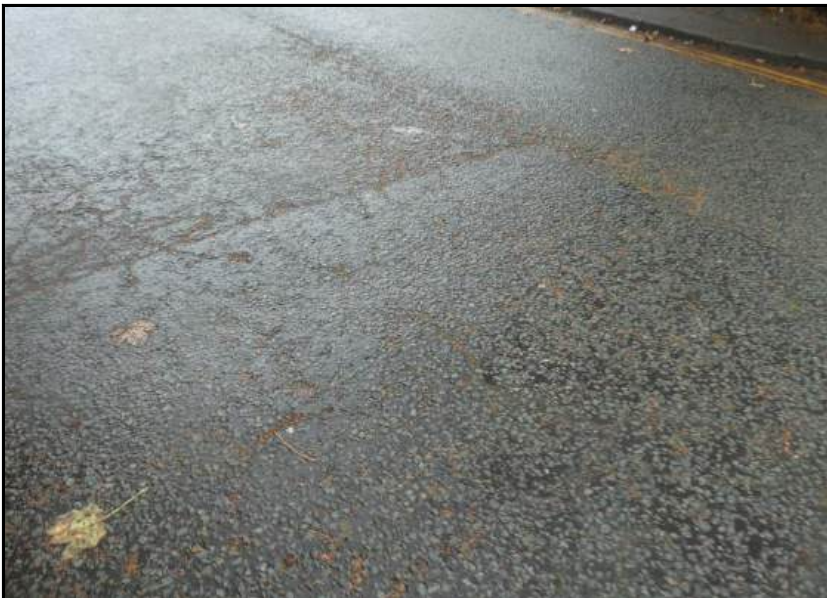
Photograph 37. Erosion of wearing coat of surfacing

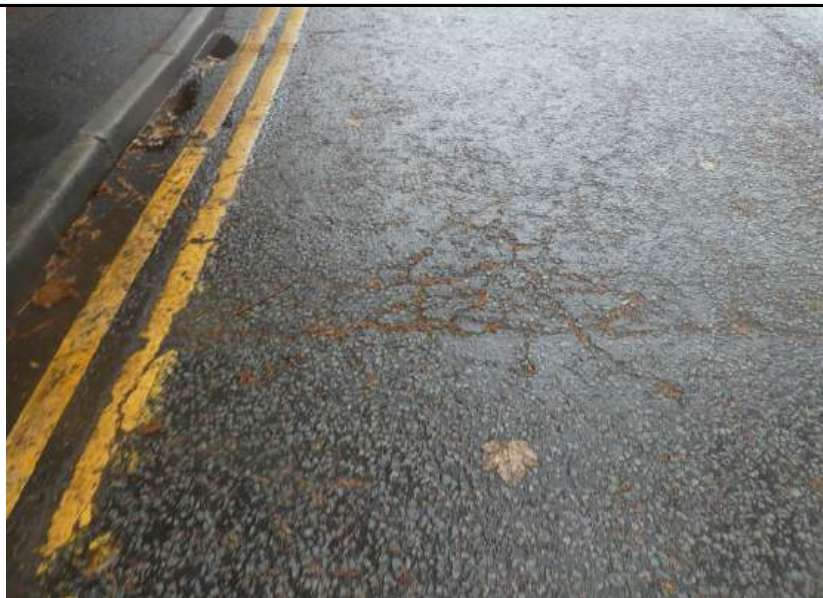
Photograph 38. Badly eroded and cracked surfacing

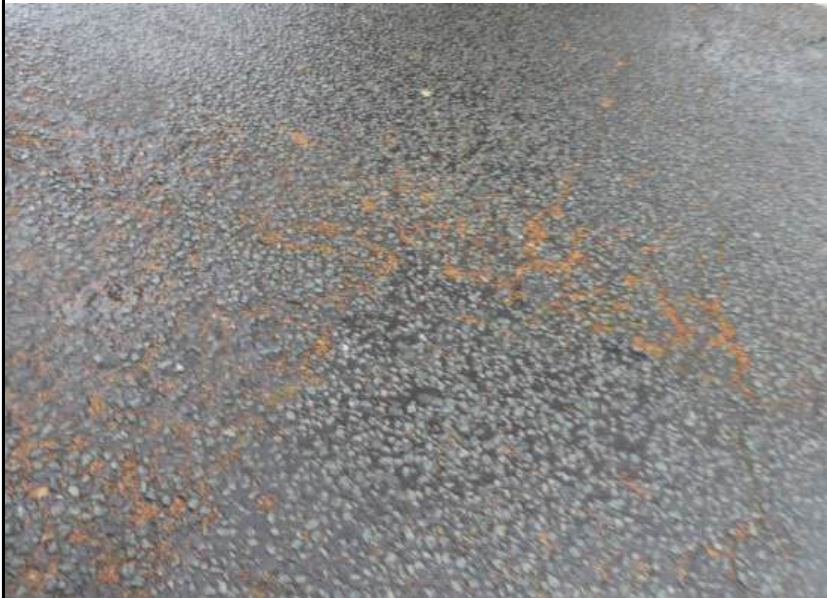
Photograph 39. Badly eroded and cracked surfacing.

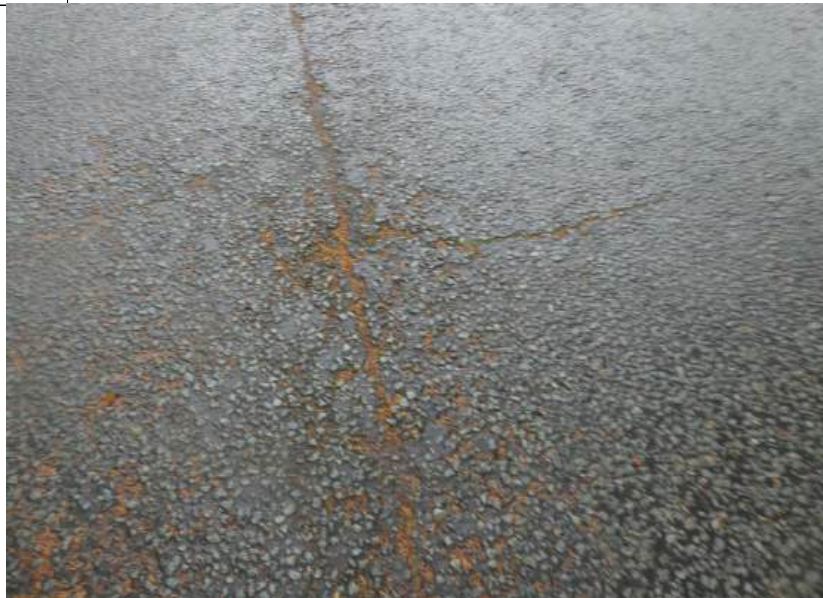
Photograph 40. Badly eroded and cracked surfacing.

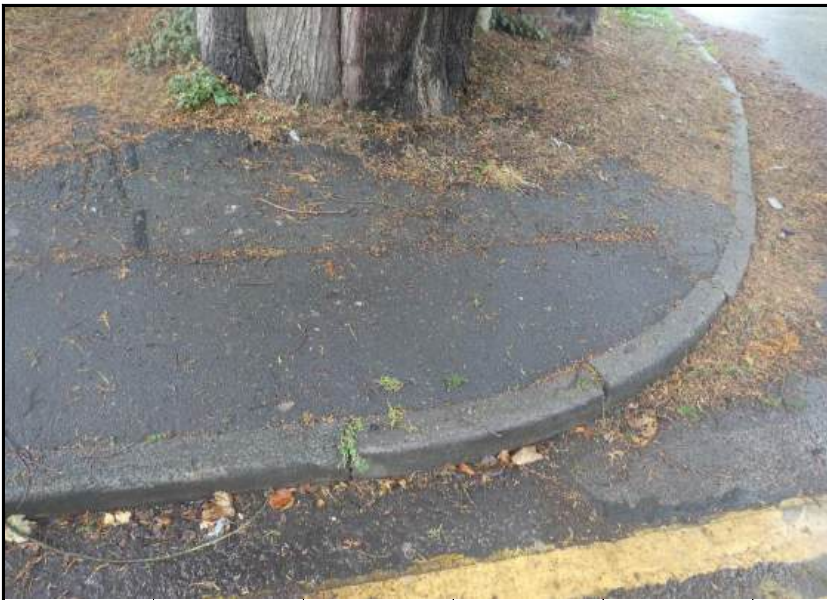
Photograph 41. Damaged and uneven kerbing.

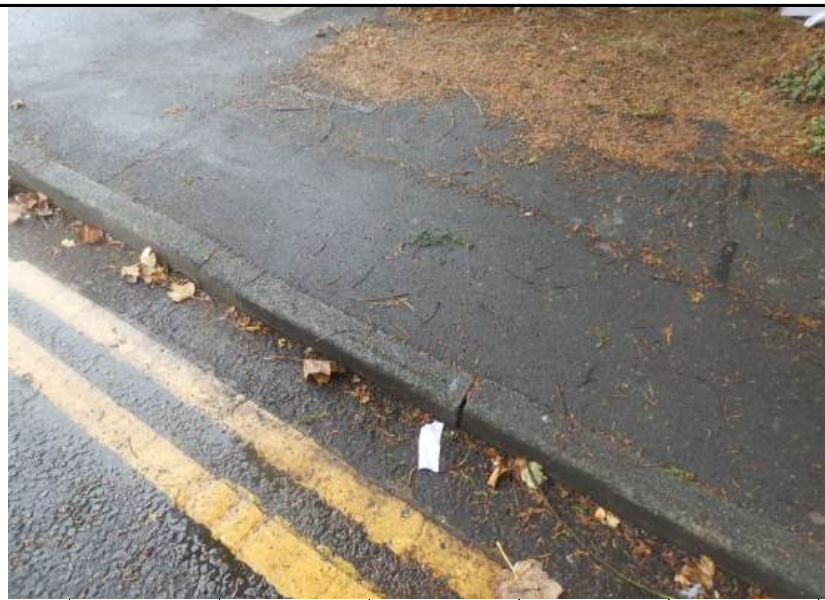
Photograph 42. Uneven kerbing.

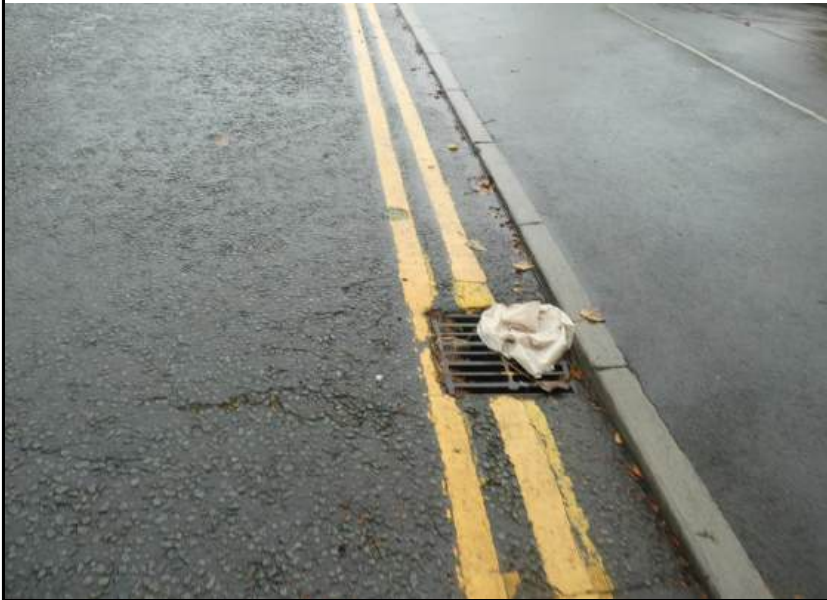
Photograph 43. Localised erosion to surfacing.

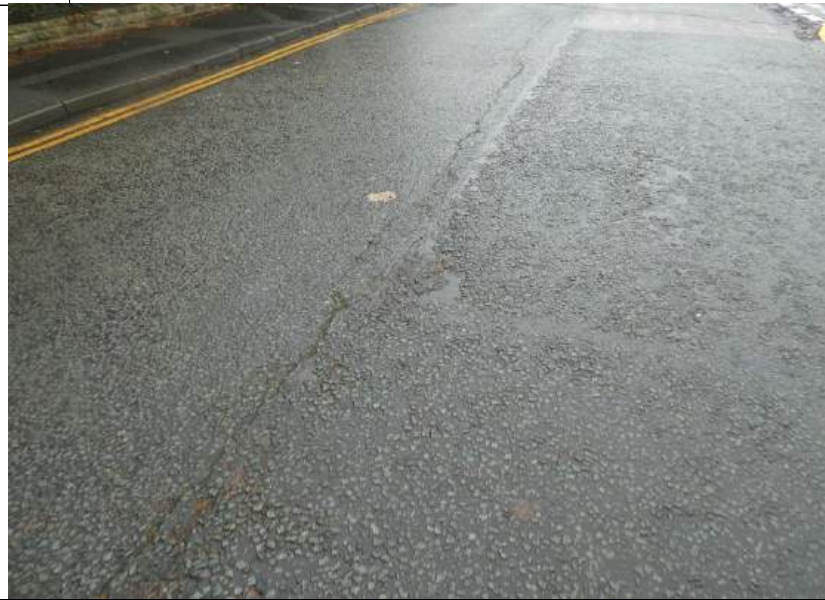
Photograph 44. Cracking to surfacing to centre of roadway.

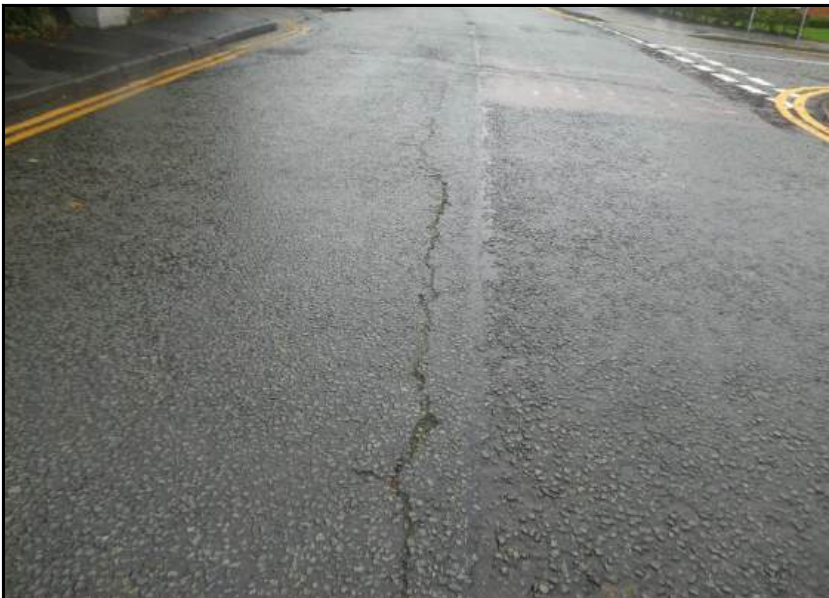
Photograph 45. Cracking to surfacing to centre of roadway.

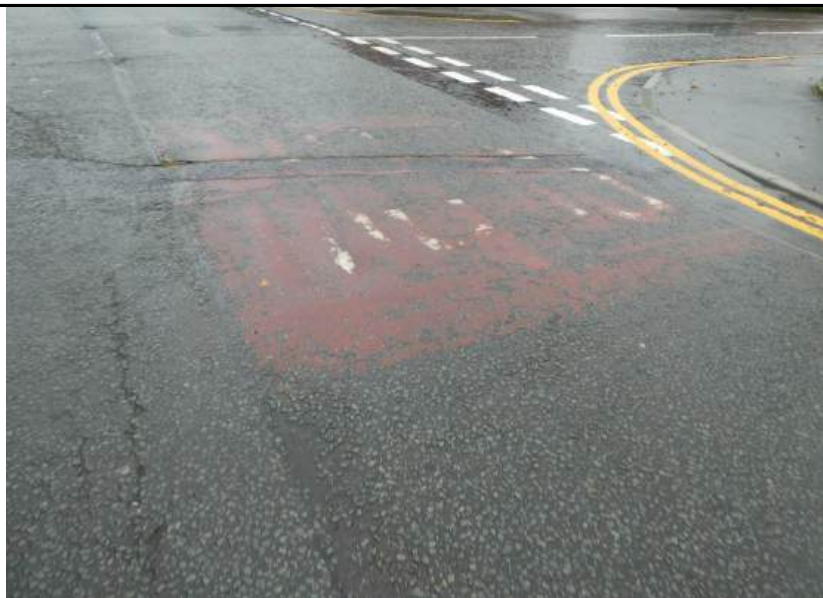
Photograph 46. Cracking to surfacing to centre of roadway.

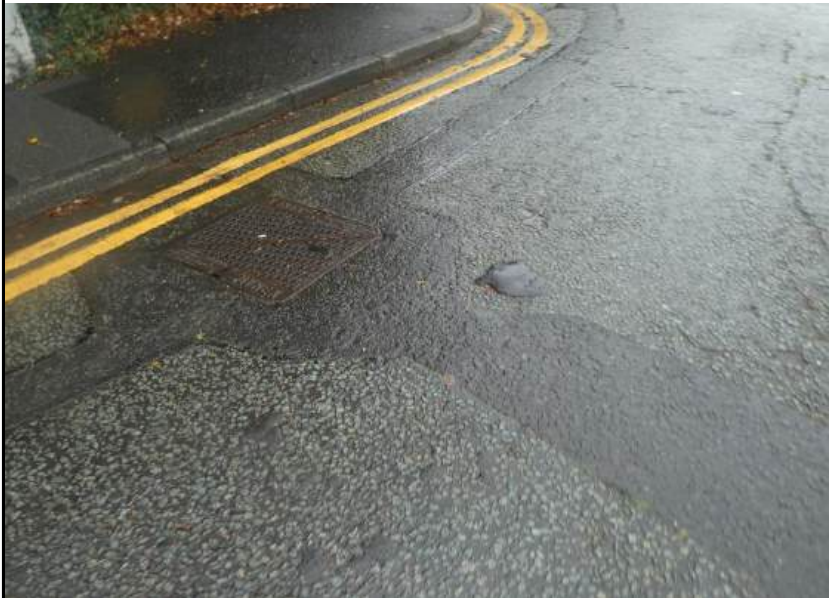
Photograph 47. Localised erosion to surfacing.

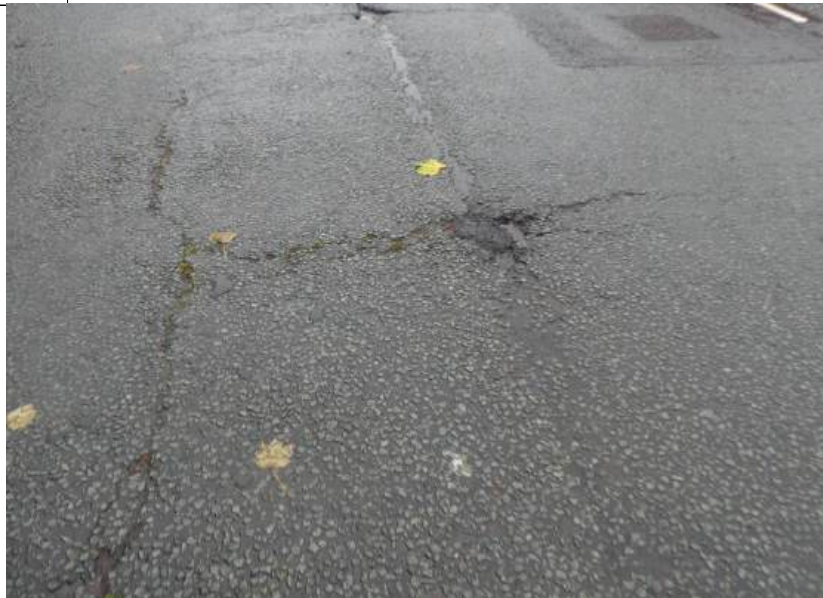
Photograph 48. Cracking and erosion to surfacing.

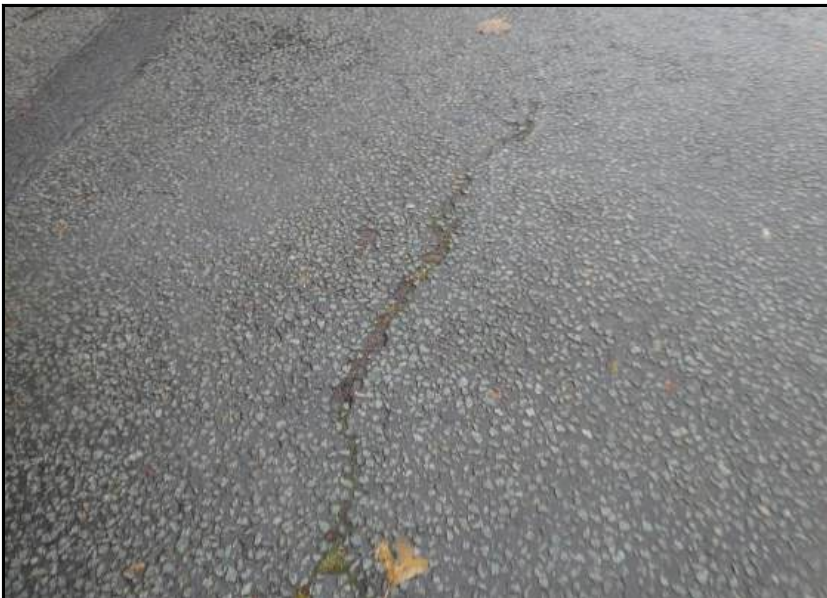
Photograph 49. Cracking and erosion to surfacing.

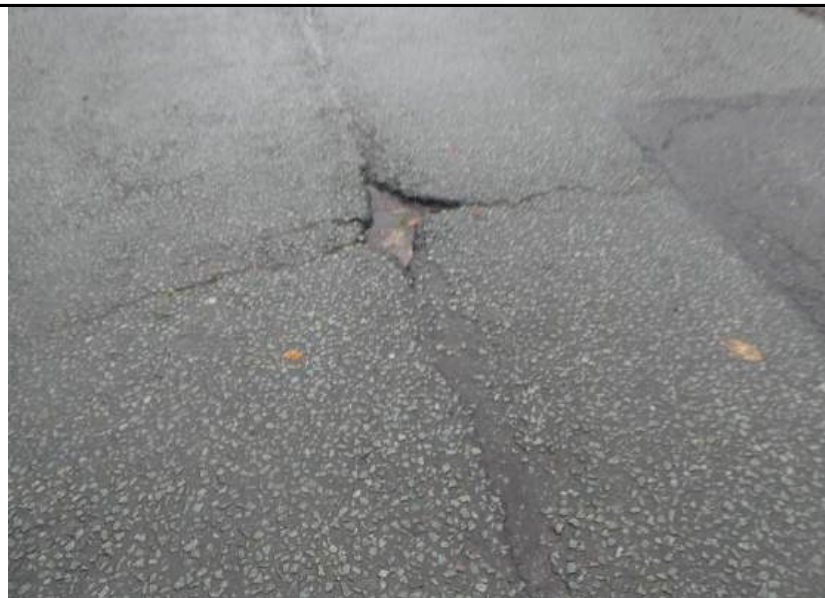
Photograph 50. Cracking and erosion to surfacing.

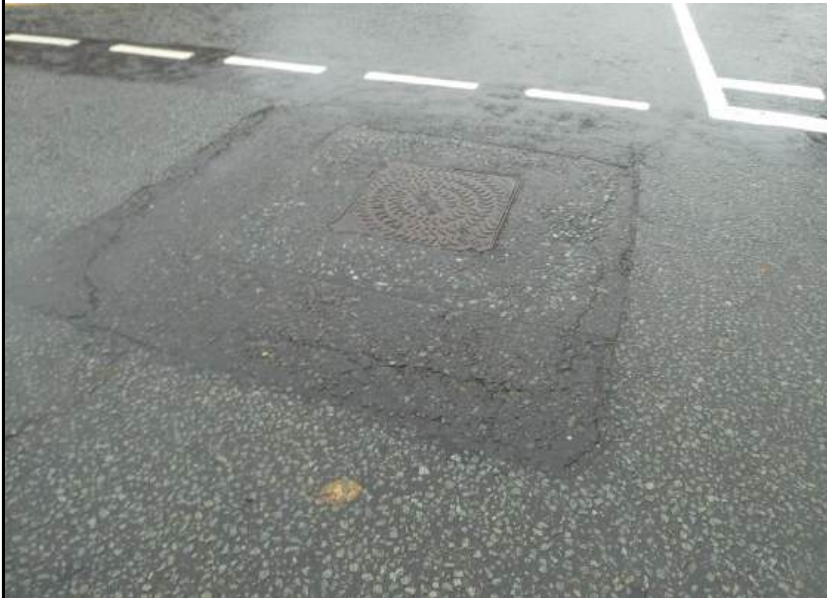
Photograph 51. Cracking and erosion to surfacing.

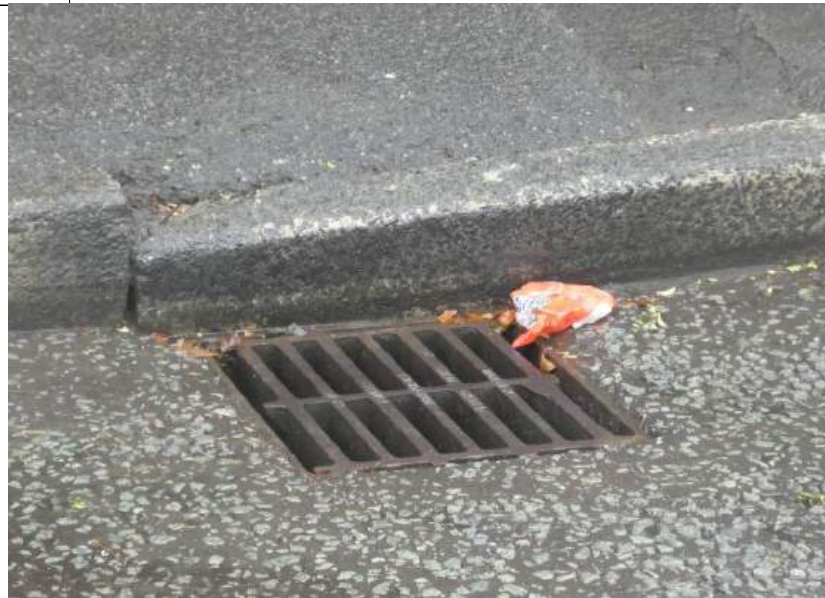
Photograph 52. Uneven kerbs

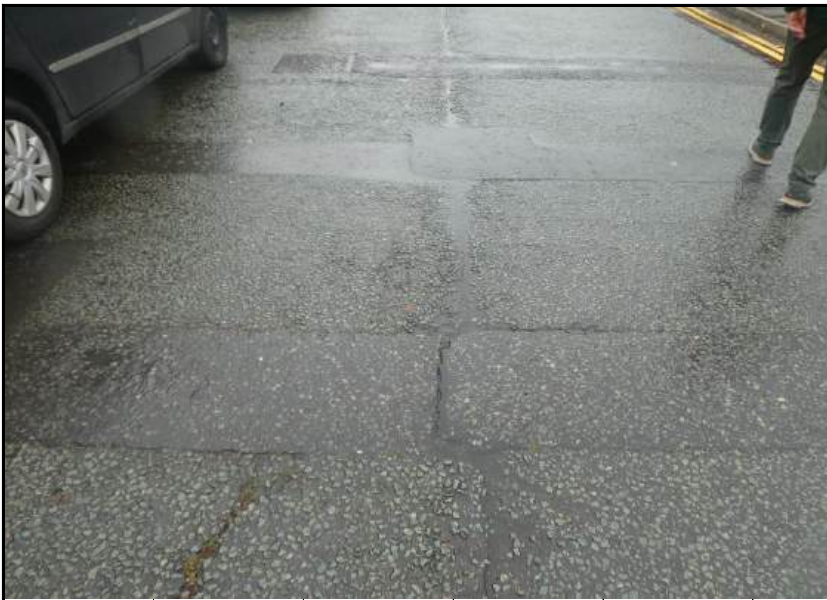
Photograph 53. Cracking to surfacing

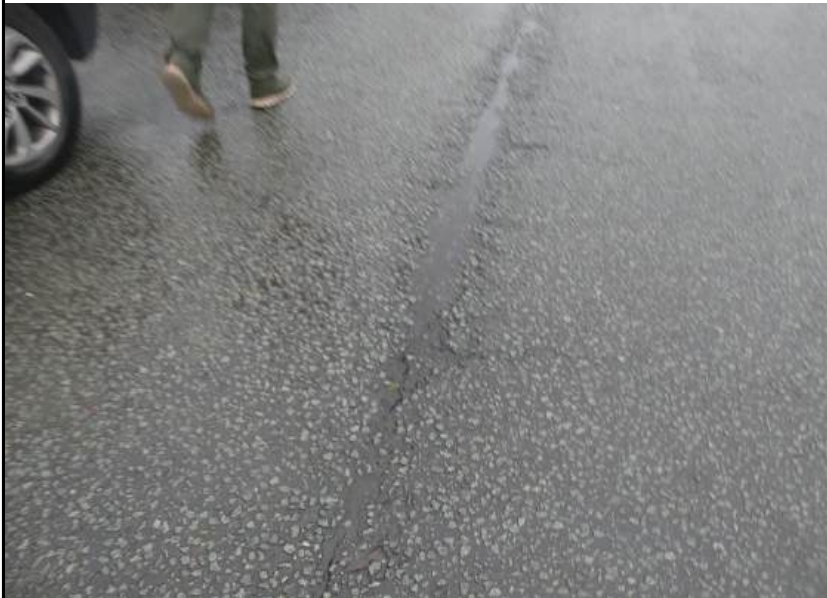
Photograph 59. Erosion to central section of roadway

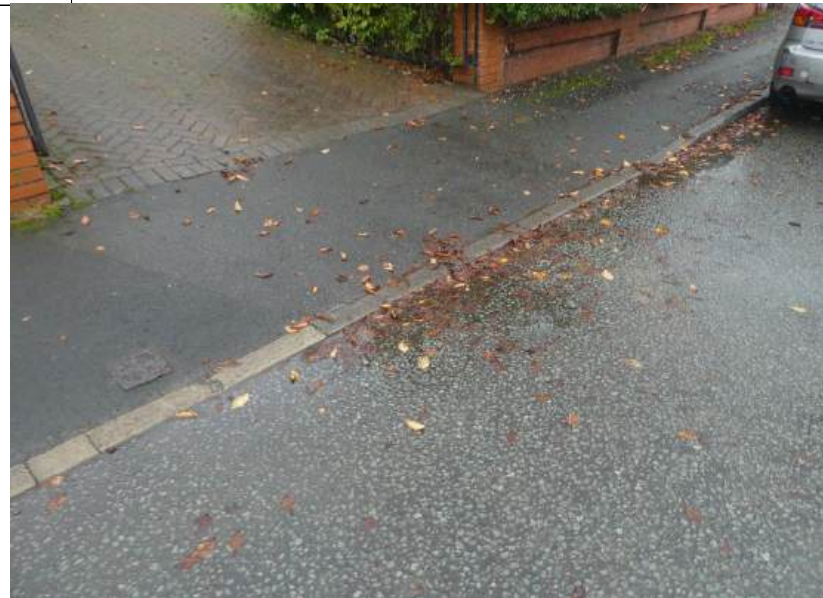
Photograph 60. Localised damage to kerbing

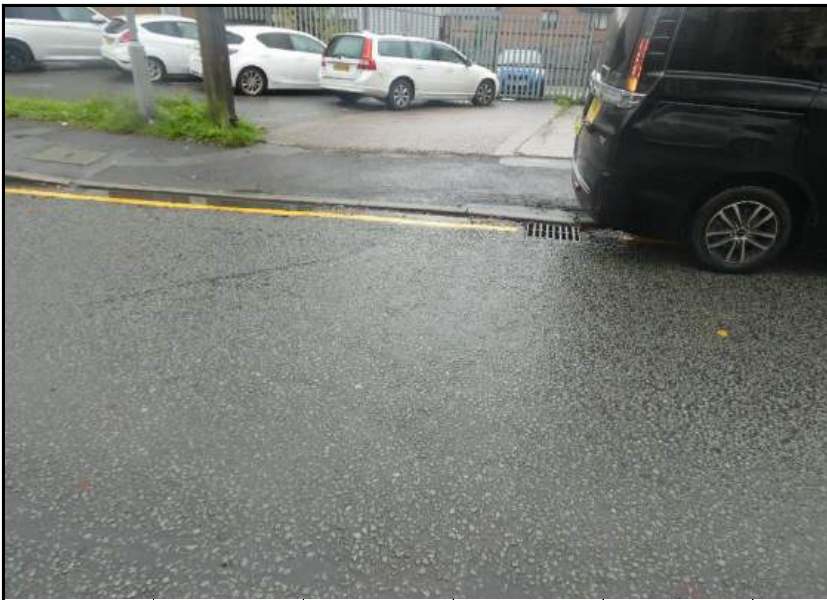
Photograph 61. Minor erosion to surfacing

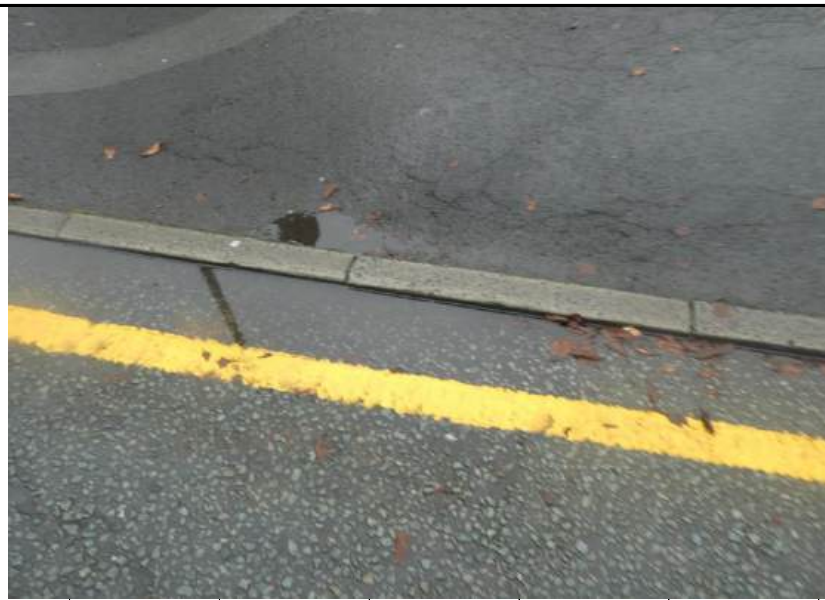
Photograph 62. Erosion to footpath surfacing of junction to business premises

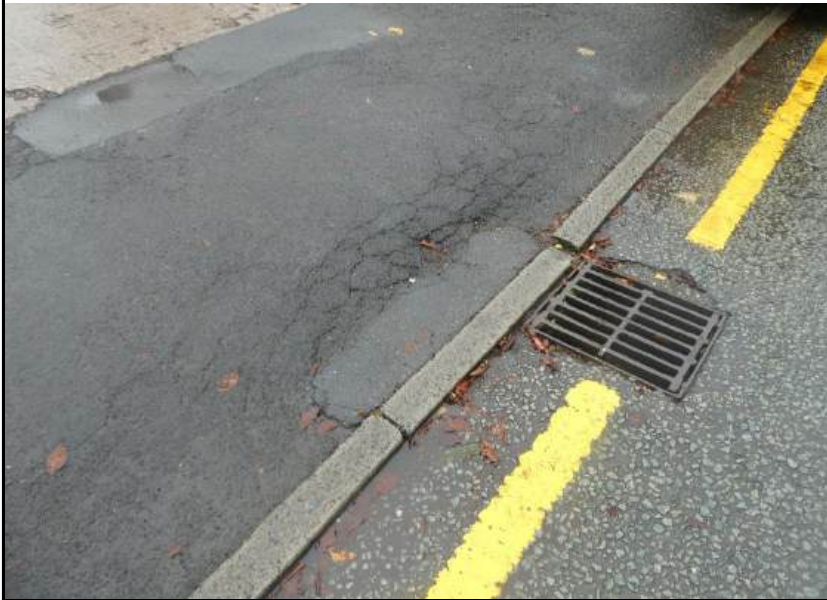
Photograph 63. Erosion to footpath surfacing of junction to business premises
