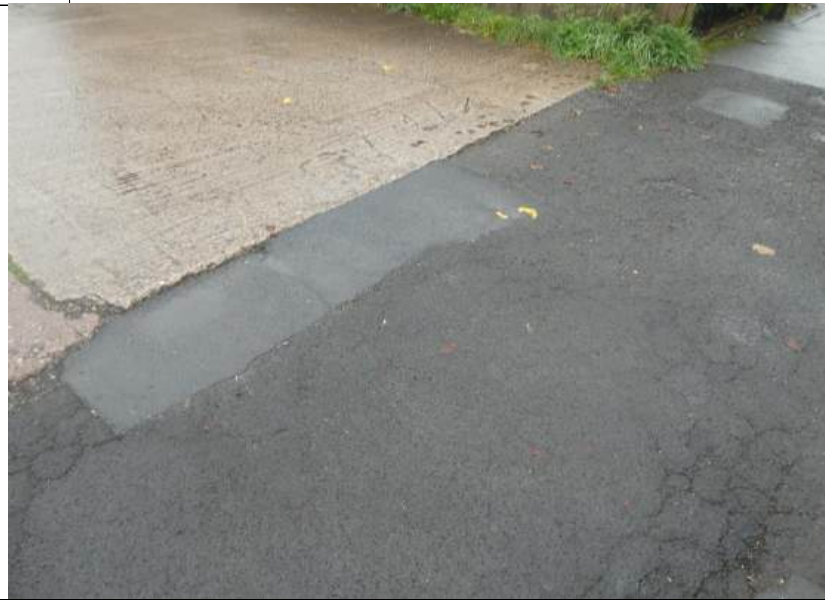
Photograph 64. Erosion to footpath surfacing of junction to business premises

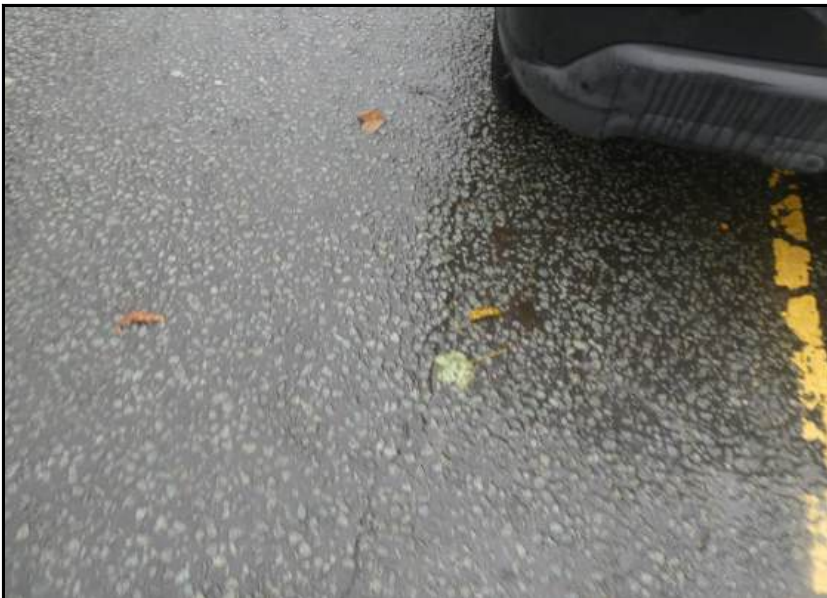
Photograph 69. Cracking to surfacing

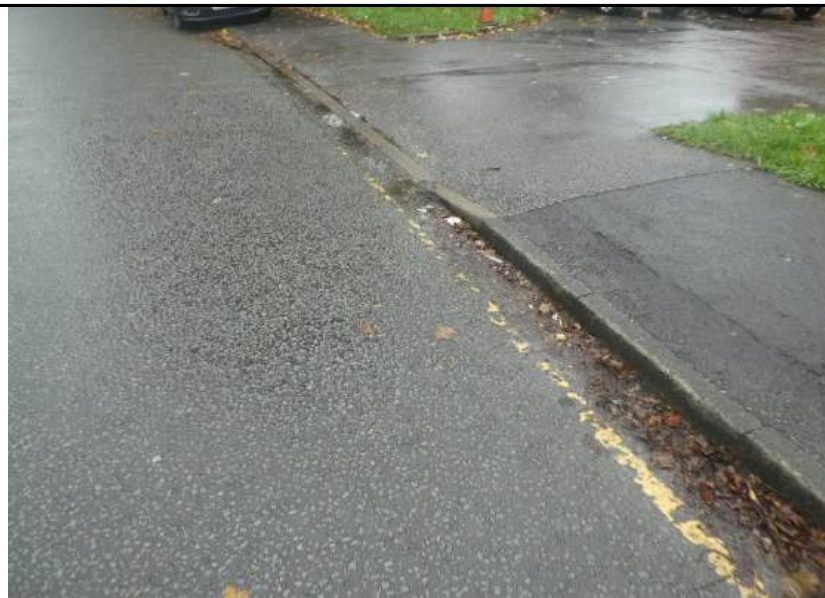
Photograph 70. Erosion to footpath

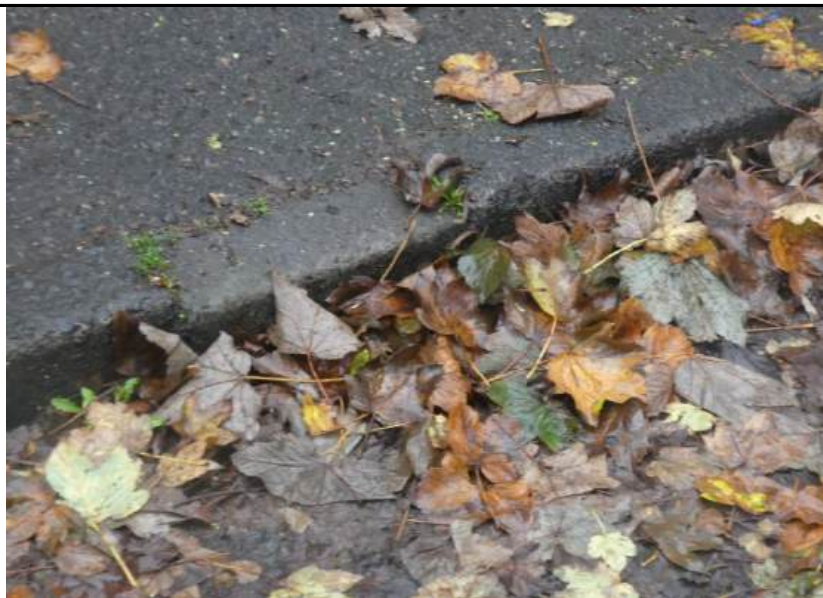
Photograph 74. Uneven kerbs to footpath

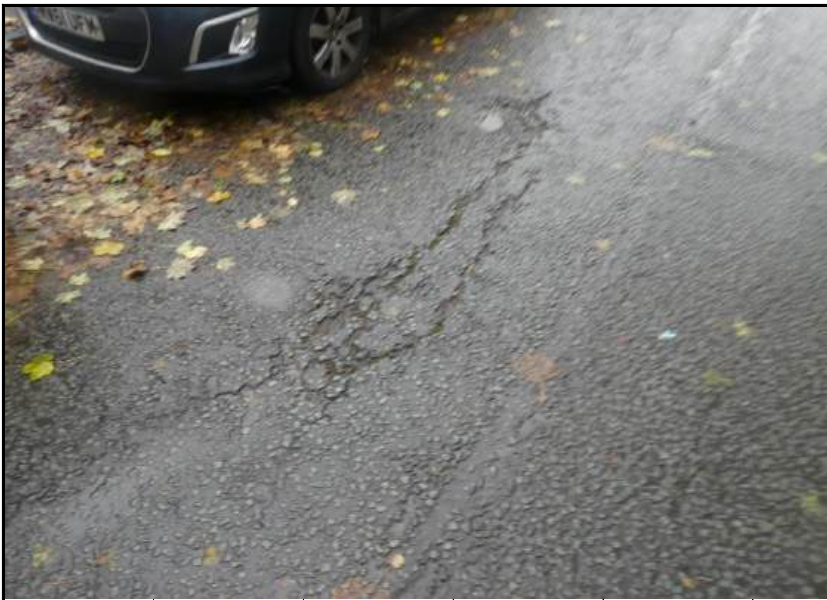
Photograph 77. Localised cracking to surfacing.

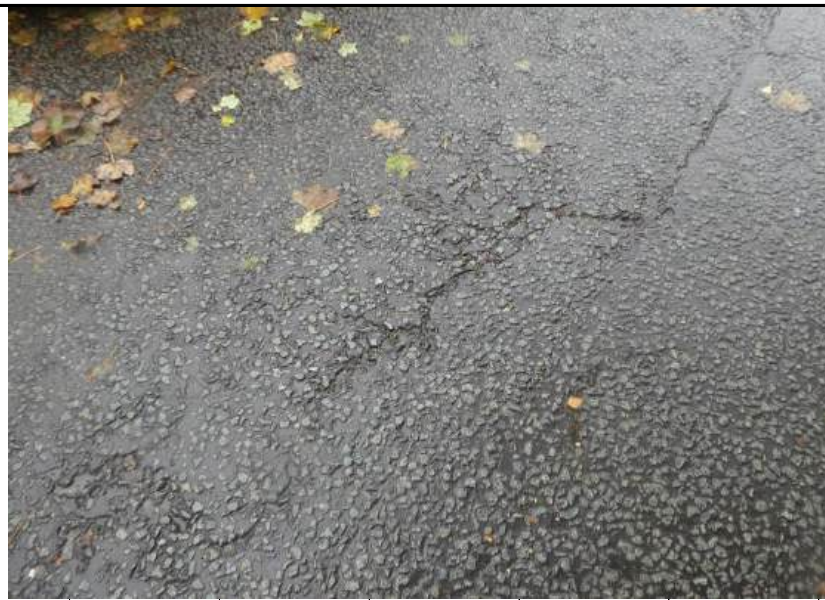
Photograph 78. Localised cracking to surfacing.

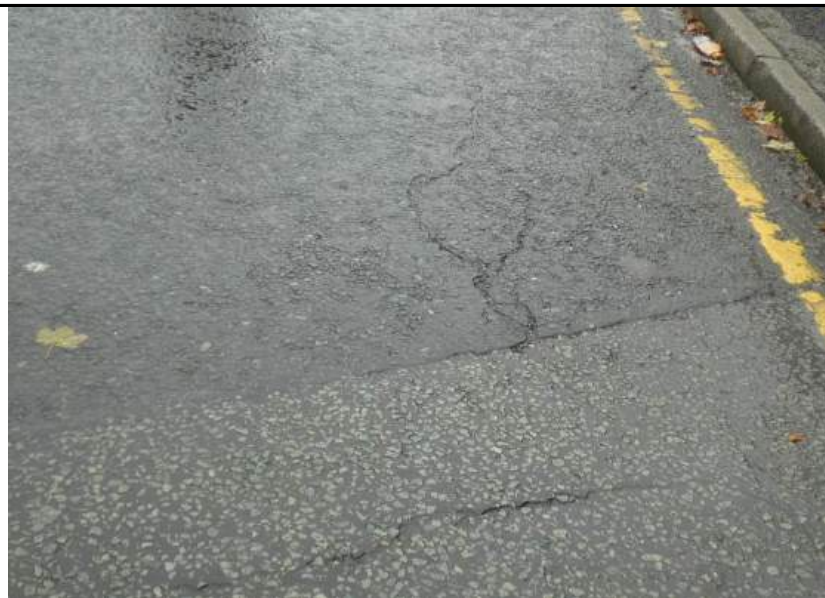
Photograph 82. Localised cracking to road surfacing.

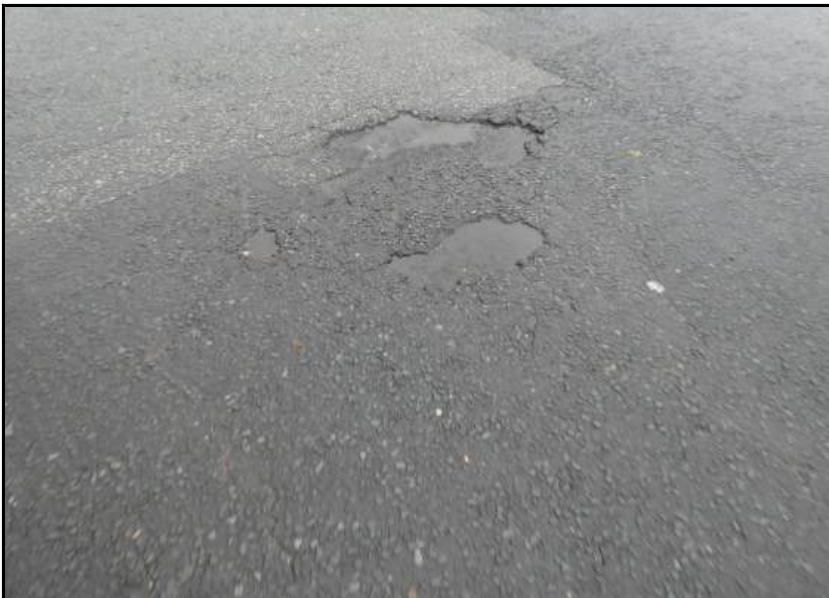
Photograph 89. Localised erosion to surfacing

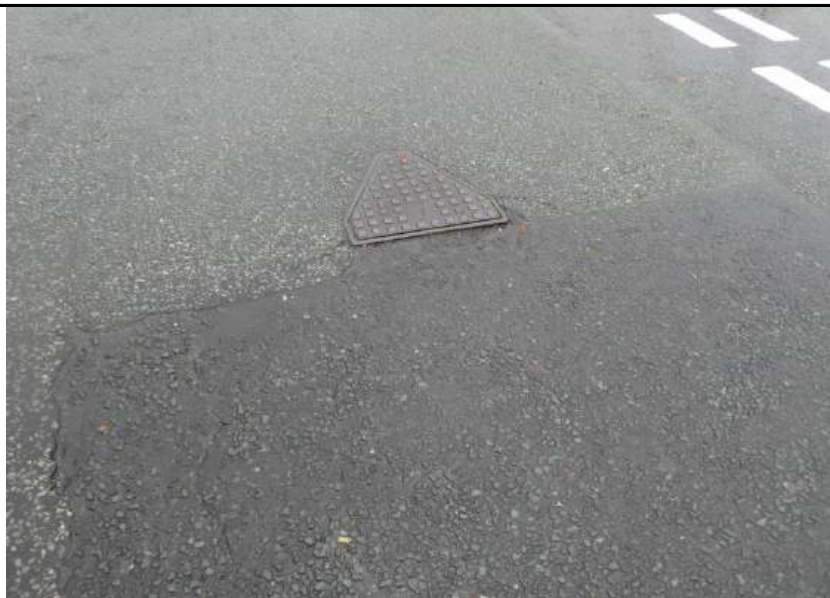
Photograph 90. Localised erosion to surfacing.
