**Report No:** Howard & Seddon/001  
**Report Date:** 12/04/2024  
**Survey Date:** 11/04/2024  
**Lead Surveyor:** Peter Austin

## **Refurbishment and Demolition Asbestos Survey Report for: 23 Ringley Road M45 7LD**

John Alderson & sons Ltd were instructed by **Howard and Seddon** to undertake a Refurbishment and demolition Asbestos Survey Report of, **23 Ringley Road M45 7LD**

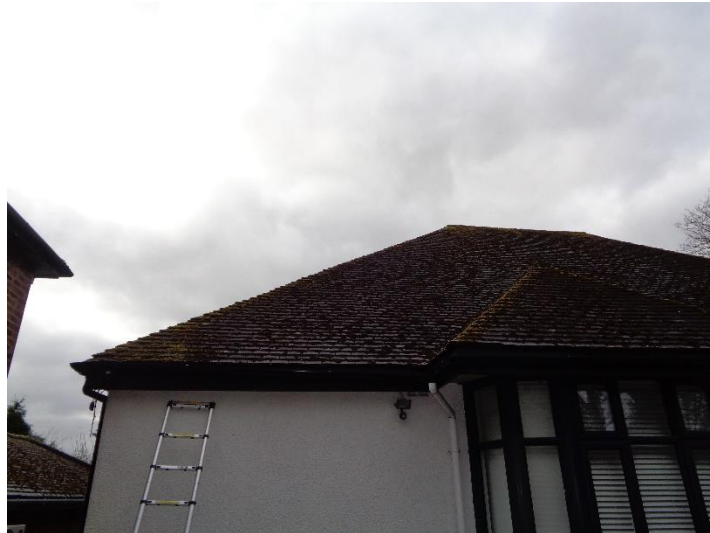
| Location: | Roof | | |

| Product: | Concrete Roof Tiles | | |
| Sample Ref: | S001 P-48427 | Bulk ID: | NAD |
| Comments: | No asbestos detected | | |

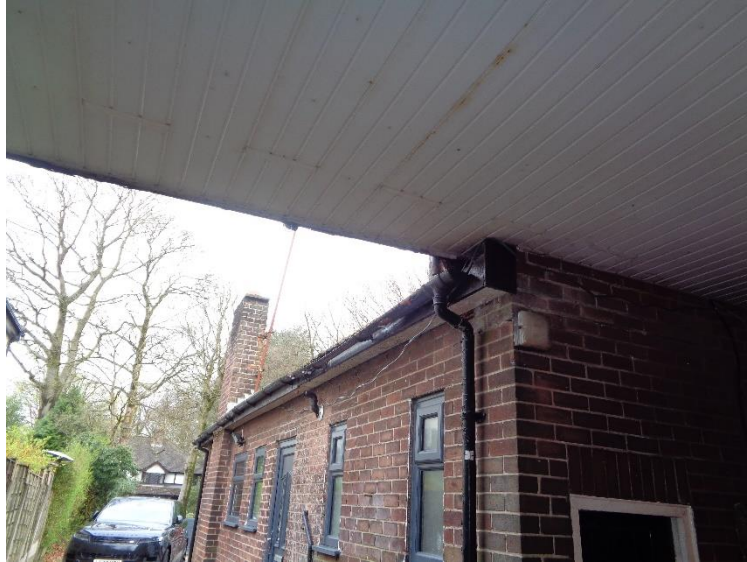
| Location: | Rainwater goods | | |

| Product: | Plastic gutters and downpipes | | |
| Comments: | No suspected asbestos | | |

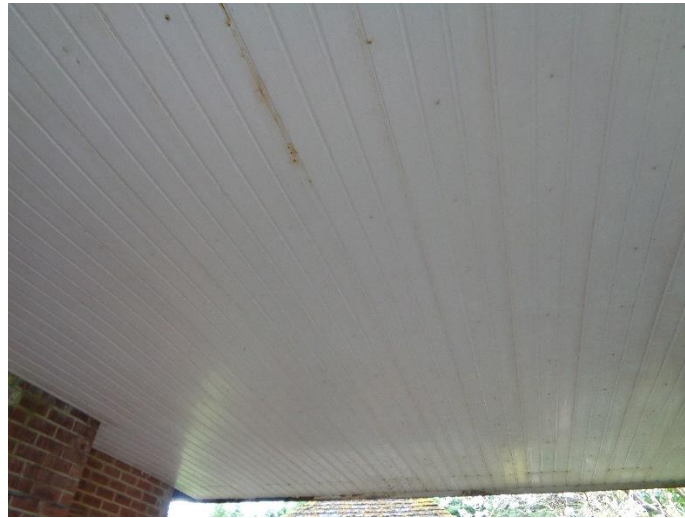
| Location: | Car Port | | |

| Product: | PVC ceiling | | |
| Comments: | No suspected asbestos | | |

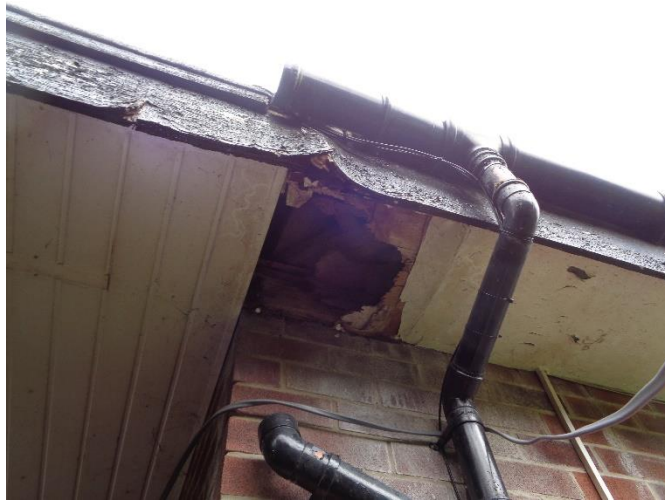
| Location: | Soffits | | |

| Product: | Timber & PVC | | |
| Comments: | No suspected asbestos | | |

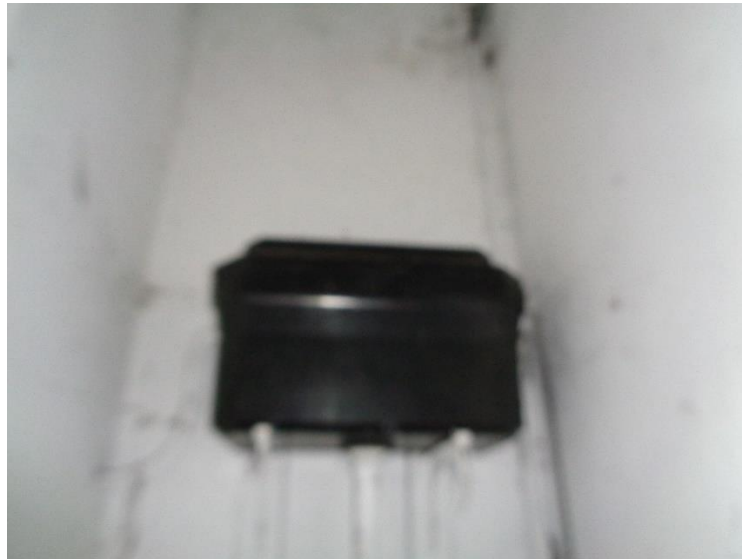
| Location: | Outside toilet | | |

**Toilet seat & Cistern in outside toilet found to contain Amosite asbestos.**

| Product: | Cistern & toilet seat | | |
| Sample Ref: | S001 P-48427 | Bulk ID: | Amosite |

| Sample No. | Client Sample No. | Sample Location | Sample Details | Asbestos Type(s) Present | Analysts Name |
|---|---|---|---|---|---|
| S002 | PA/002 | Outside Toilet | Cistern and Seat - Reinforced Plastics/Composites | Amosite | Varsha Kamireddy |

| Comments: | Recommend removal by licensed contractor | | |

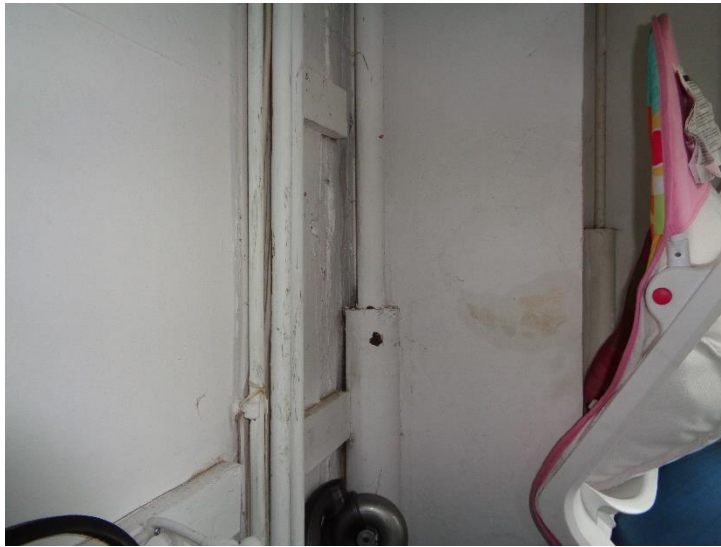
| Location: | Boiler room | | |

| Product: | Pipework insulation | | |
| Sample Ref: | S003 P-48427 | Bulk ID: | NAD |
| Comments: | No asbestos detected | | |

| Sample No. | Client Sample No. | Sample Location | Sample Details | Asbestos Type(s) Present | Analysts Name |
|---|---|---|---|---|---|
| S003 | PA/003 | Boiler Room | Pipe Lagging (Fibrous) | NAD | Varsha Kamireddy |

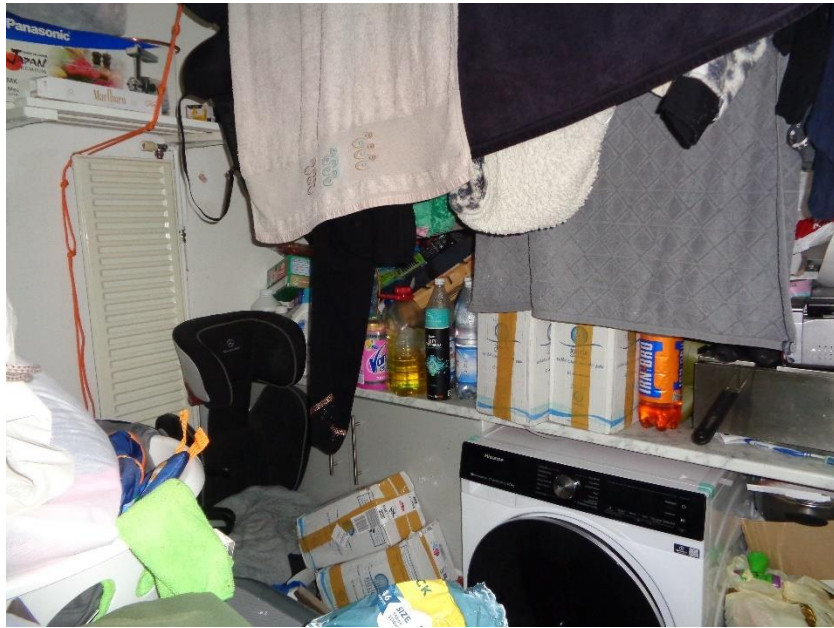
| Location: | Utility room | | |

| Product: | Plaster ceiling | | |
| Comments: | No suspected asbestos | | |

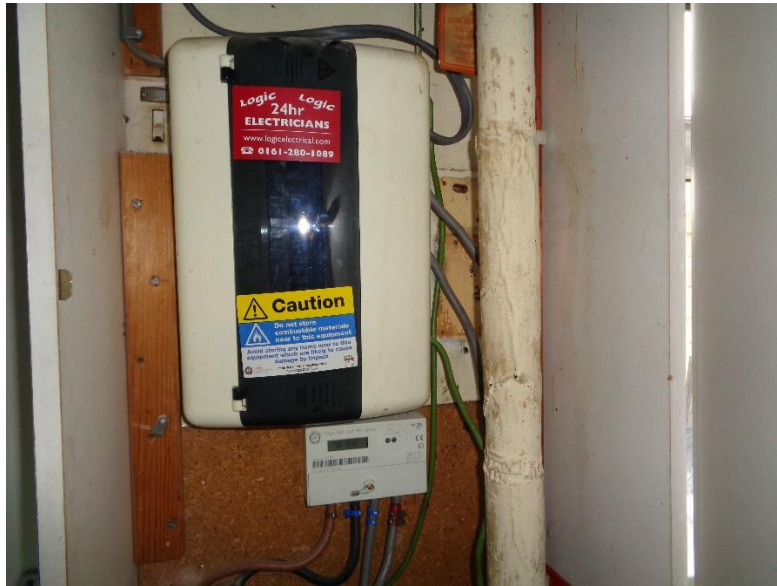
| Location: | Utility room | | |

| Product: | Modern electrics | | |
| Comments: | No suspected asbestos | | |

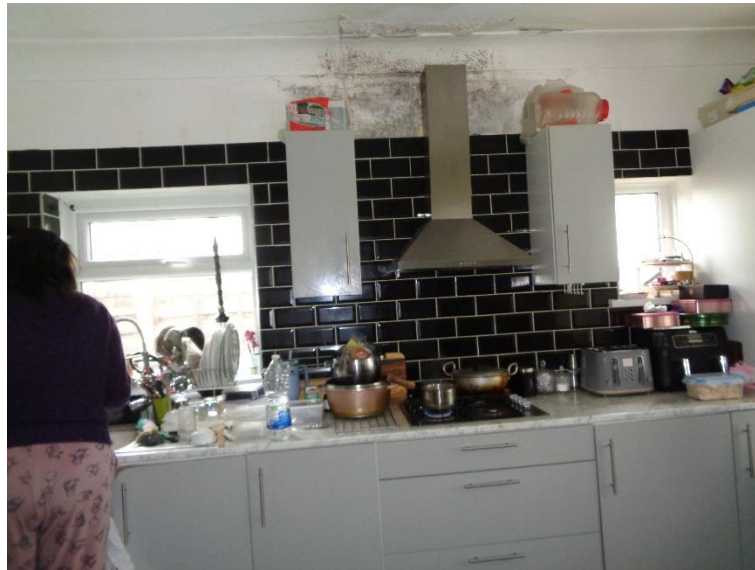
| Location: | Kitchen | | |

| Product: | Brick and plaster walls | | |
| Comments: | No suspected asbestos | | |

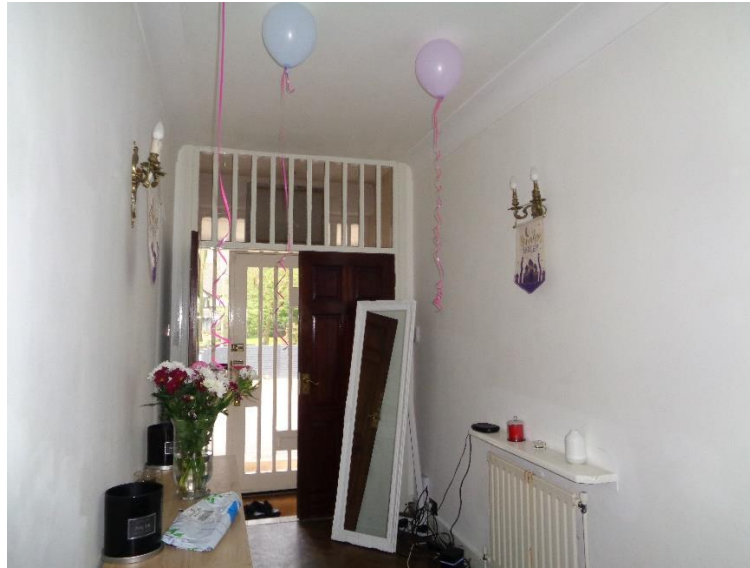
| Location: | Hall | | |

| Product: | Laminate to timber floor | | |
| Comments: | No suspected asbestos | | |

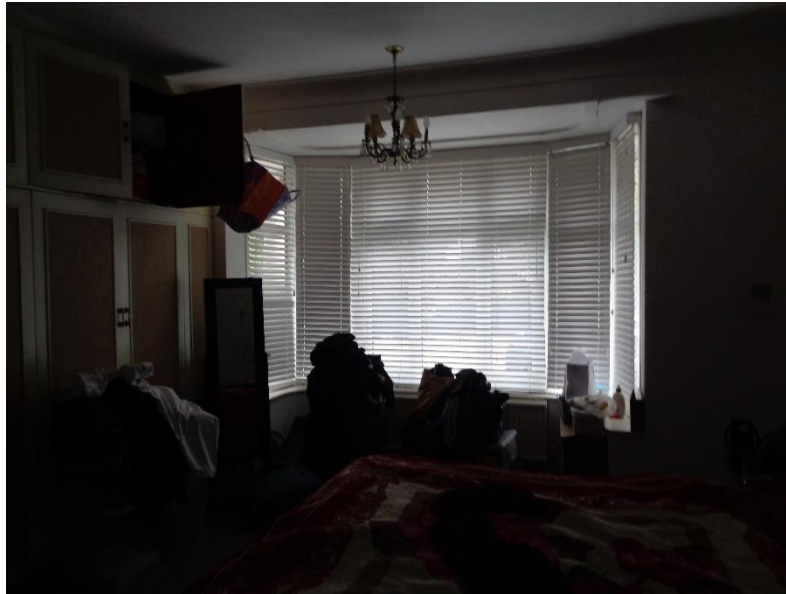
| Location: | Bedroom 1 | | |

| Product: | Carpet to timber floor | | |
| Comments: | No suspected asbestos | | |

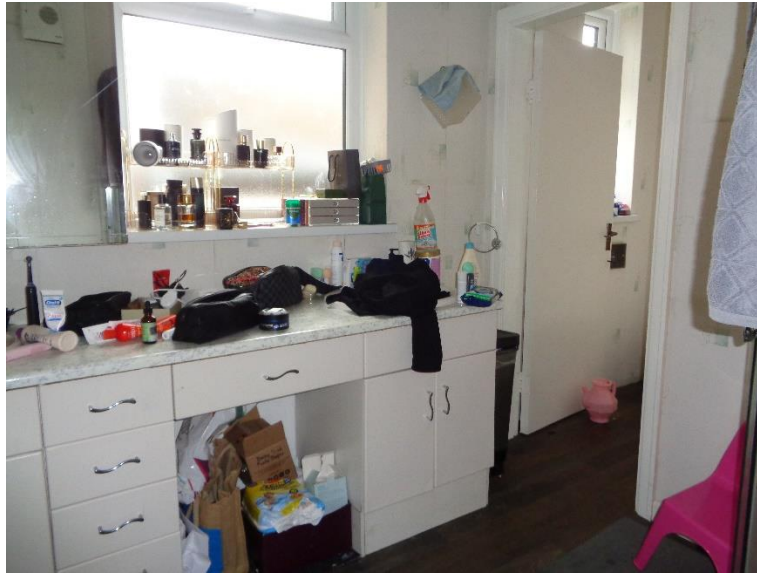
| Location: | Bedroom 1 en-suite | | |

| Product: | Brick and plaster walls | | |
| Comments: | No suspected asbestos | | |

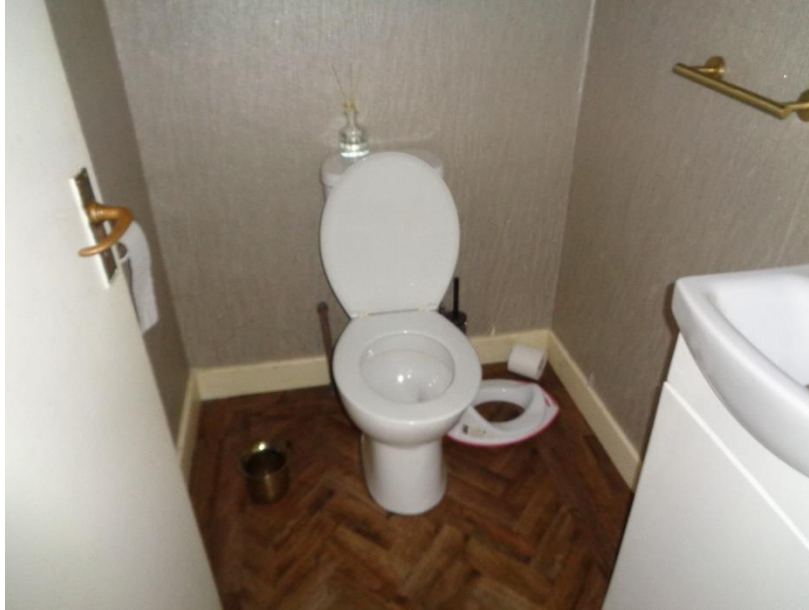
| Location: | Hall toilet | | |

| Product: | Laminate to timber floor | | |
| Comments: | No suspected asbestos | | |

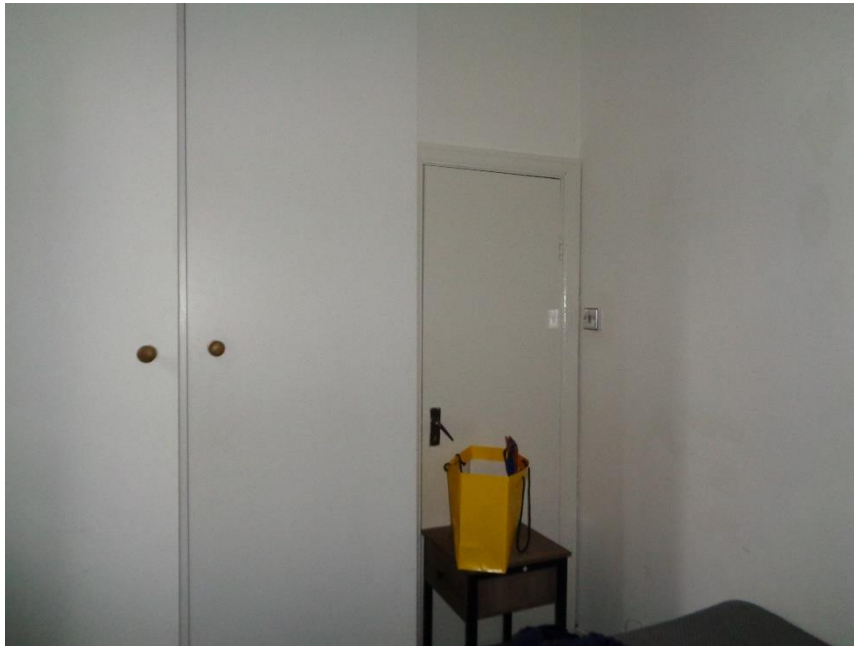
| Location: | Bedroom 2 & ensuite | | |

| Product: | Plaster ceilings | | |
| Comments: | No suspected asbestos | | |

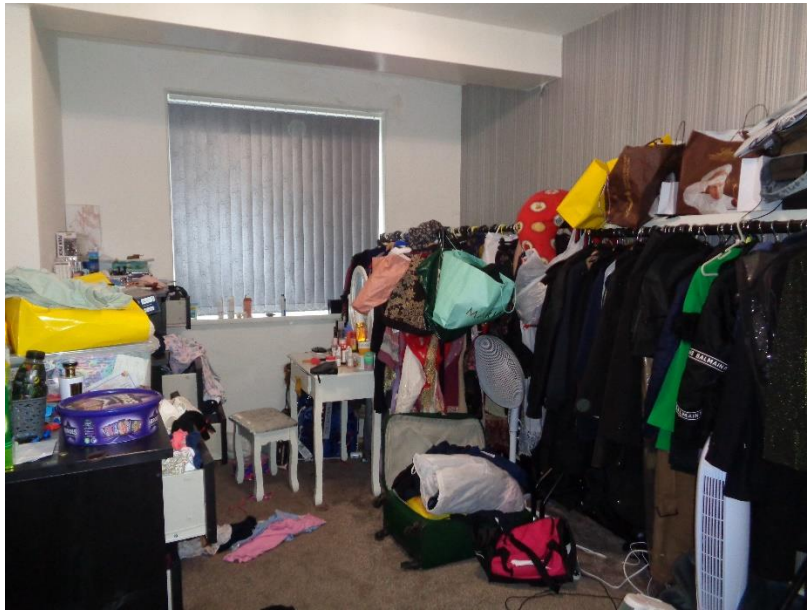
| Location: | Bedroom 3 | | |

| Product: | Carpet to timber floor | | |
| Comments: | No suspected asbestos | | |

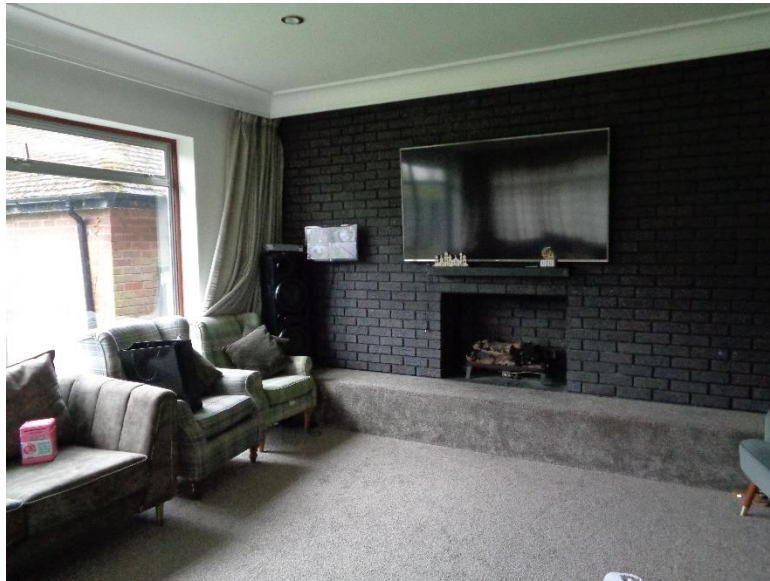
| Location: | Living room / dining room | | |

| Product: | Carpet to timber floor | | |
| Comments: | No suspected asbestos | | |

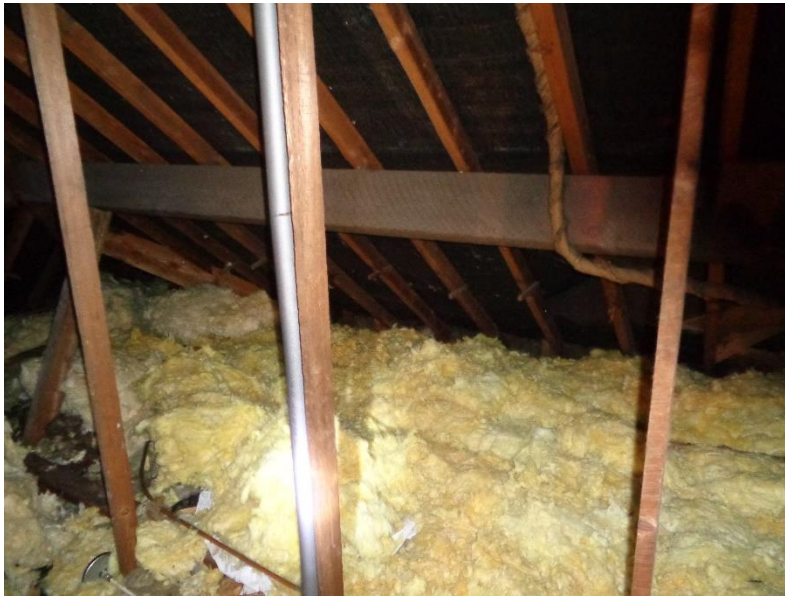
| Location: | Loft | | |

| Product: | Glass fibre loft insulation | | |
| Comments: | No suspected asbestos | | |

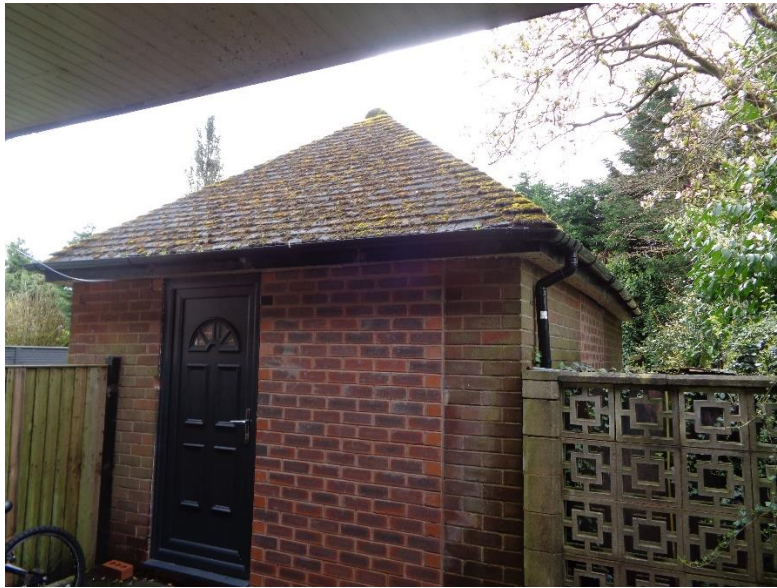
| Location: | Converted garage | | |

| Product: | Concrete roof tiles | | |
| Comments: | No suspected asbestos | | |

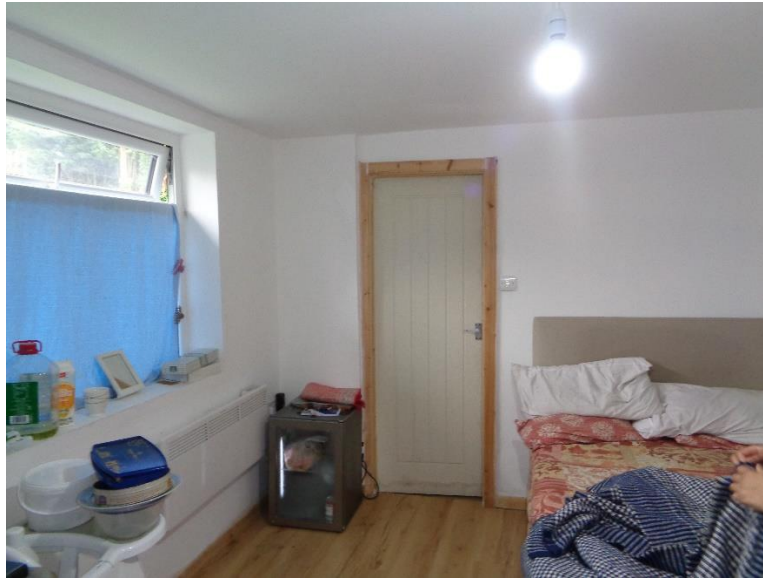
| Location: | Converted garage | | |

| Product: | Plasterboard walls | | |
| Comments: | No suspected asbestos | | |

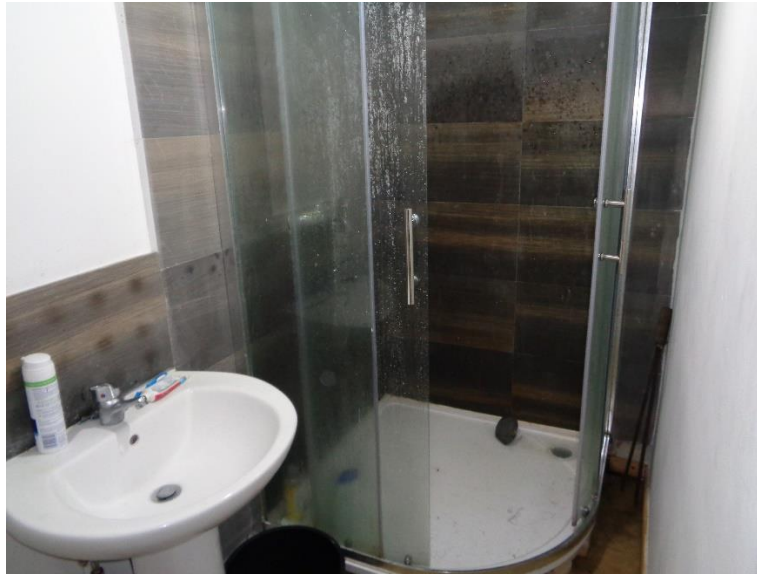
| Location: | Converted garage | | |

| Product: | Laminate walls | | |
| Comments: | No suspected asbestos | | |
