TREE REPORT                      DATE: 10.01.24

Ref: Tree in the neighbouring rear garden at 3 Leyburn Close, Whitefield, Manchester, M45 7UE.

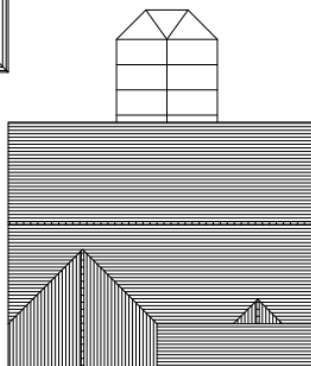
EXISTING SITE PLAN scale 1:50

The tree is a *Fagus Sylvatica* – Beech, and it is protected by TPO number 31. The tree number within that TPO is T8. The trunk is located 4m from the edge of the proposed new building, is 15m tall and 870mm in diameter.

As the dripline is approximately 1m from the closest edge of the potential development and providing the below precautions are carried out, we conclude that the tree should continue to thrive should the works be carried out.

1. **Install Fencing or Barriers:** Erect sturdy fencing or barriers around the tree, marking the tree protection zone (TPZ). This zone should extend at least beyond the drip line of the canopy. This helps prevent heavy machinery, construction materials, and foot traffic from entering the critical root zone.
