**RE: Barn at Meadowcroft Farm, Walshaw, Bury**

I am writing to confirm that we have carried out a visual only site inspection at the above property on 28th September 2022 in order to determine the suitability of the existing barn structure at this property for conversion into a new residential home.

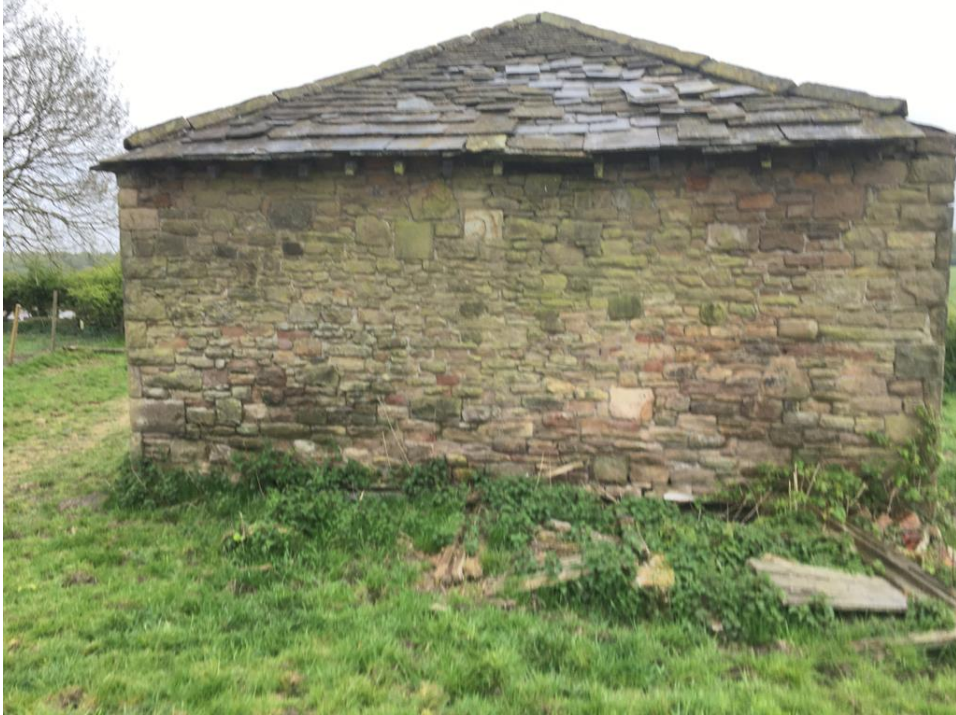
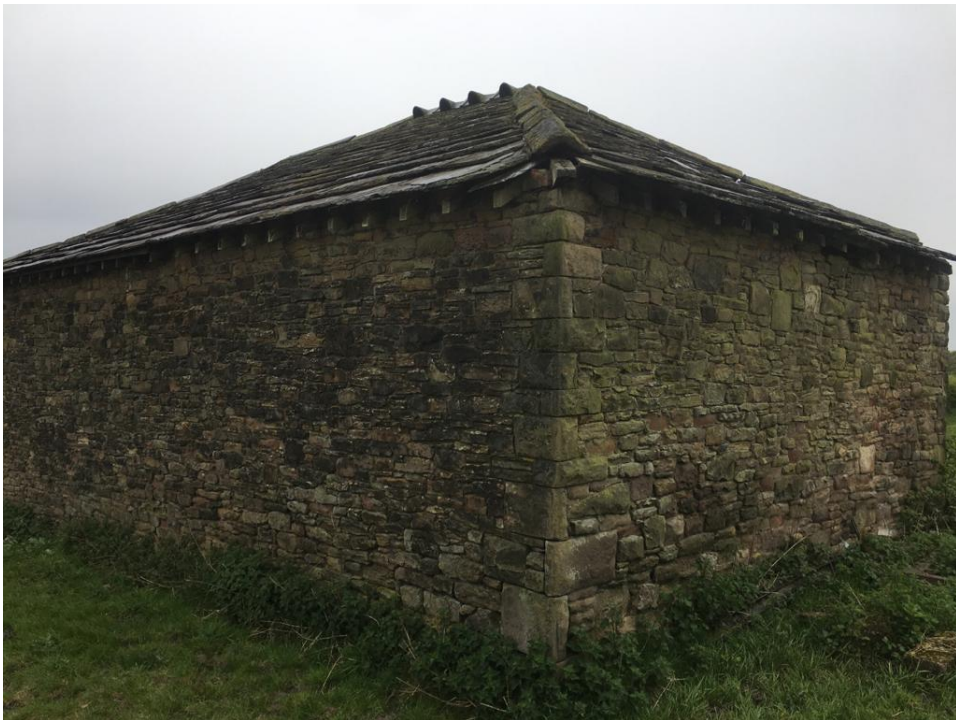
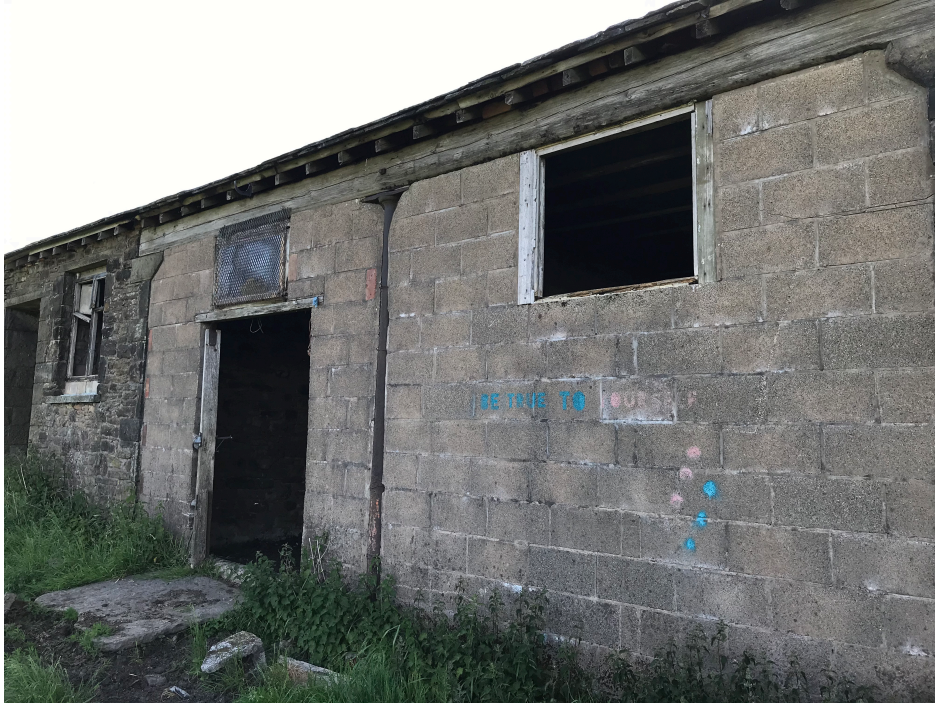
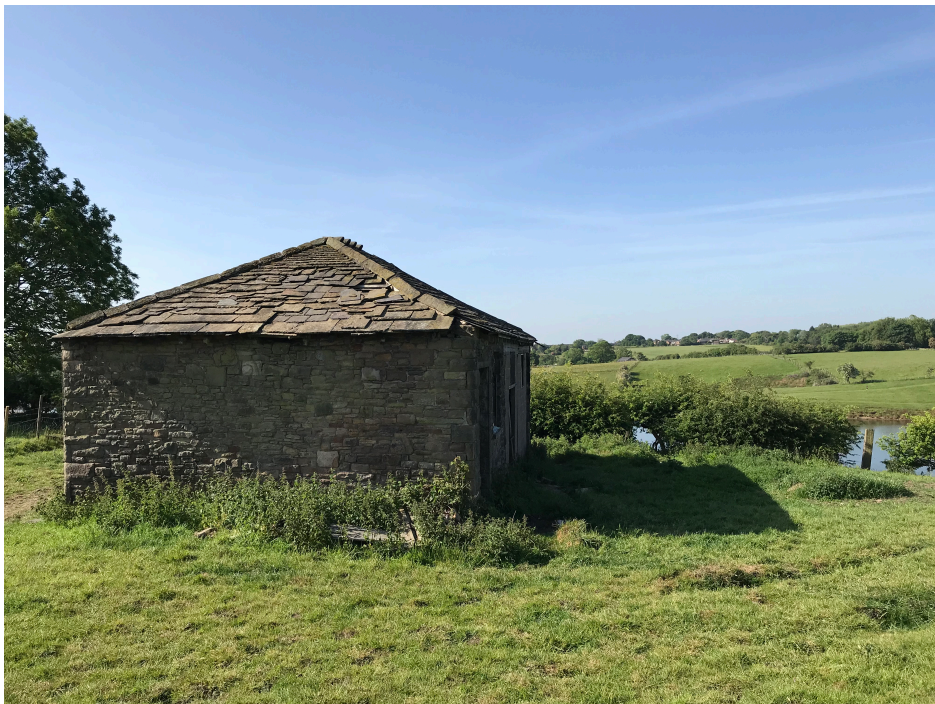
Please find attached below some site photographs taken from our initial site visit, which illustrate the general sound condition of the barn.
