**PROPERTY ADDRESS: Baron St Loco Works, Baron St, Bury BL9 0TY**

**REPORT TYPE: Asbestos Refurbishment/Demolition Survey**

**REPORT NUMBER: B-15727**

**REPORT DATE: 14/11/2017**

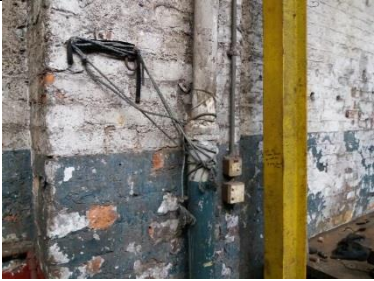
| East Lancs Locomotive Works, Baron St, Bury BL9 | | | | |
|---|---|---|---|---|
| Ground Floor | R002 | Workshop - Down pipe | Down pipe / Cement Product<br>(S005 - No Asbestos<br>Detected) | |

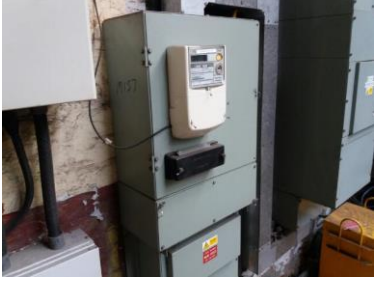
| East Lancs Locomotive Works, Baron St, Bury BL9 | | | | |
|---|---|---|---|---|
| Ground Floor | R002 | Workshop - Electrical box | Electrical box / PVC /<br>Reinforced Plastics (S002 -<br>No Asbestos Detected) | |

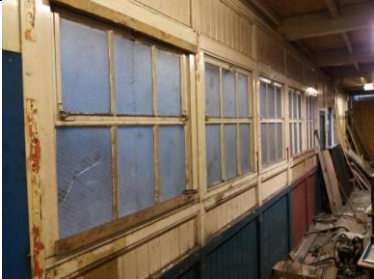
| Ground Floor | R003 | Machine Shop -<br>Window Fames | Window Fames / Bituminous<br>Product (S006 - No Asbestos<br>Detected) | |

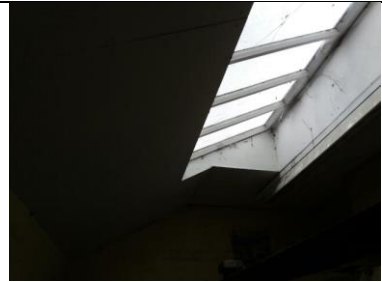
| Ground Floor | R012 | Men's Toilet - Ceiling | Ceiling / Cement Product (S008 - No Asbestos Detected) | |

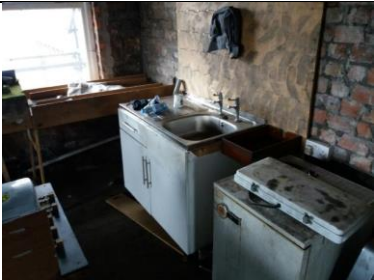
| 1st Floor | R016 | Store - Sink Unit | Sink Unit / Bituminous Product (S009 - No Asbestos Detected) | |

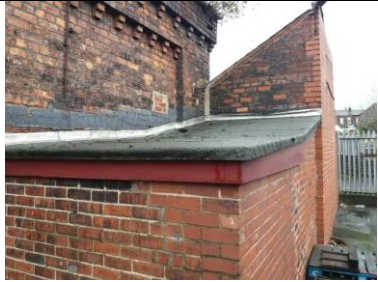
| External | R001 | Roof & Externals - Flat Roof | Flat Roof / Bituminous<br>Product (S001 - No Asbestos<br>Detected) | |

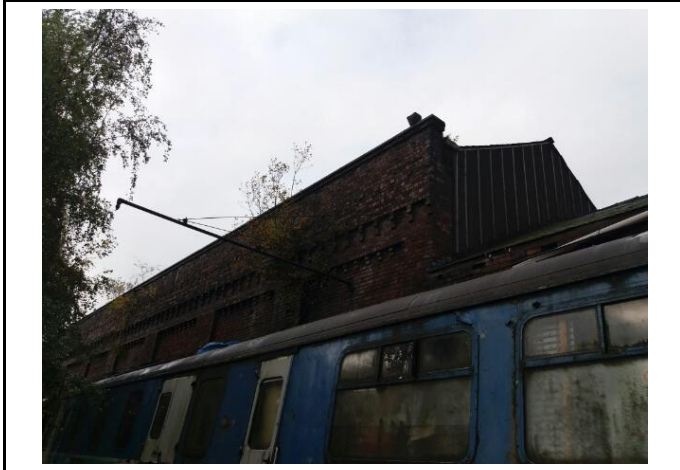
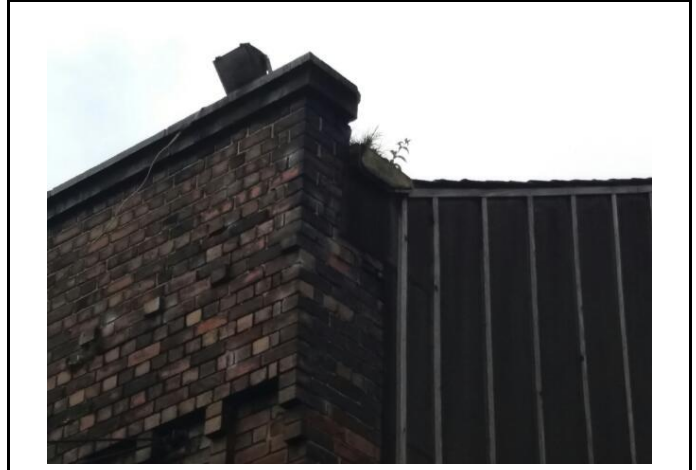
| <b>Ref Number</b> | 147664 |

| East Lancs Locomotive Works, Baron St, Bury BL9 | | | | | |
|---|---|---|---|---|---|
| 147664<br>Strongly Presumed001 | External<br>Roof & Externals<br>R001<br>Box Section Guttering | Cement Product<br>40lin m | Crocidolite | 4 | No Action Required<br>Add to asbestos register and Monitor. |

| ACM | | |
|---|---|---|
| <b>Asbestos Type Description:</b> | Crocidolite | <b>Comments</b><br>High level cement glittering too high to sample. |

| ACTION | | |
|---|---|---|
| <b>Action Types</b> | No action required | <b>Comments / Recommendations</b><br>Add to asbestos register and Monitor. |

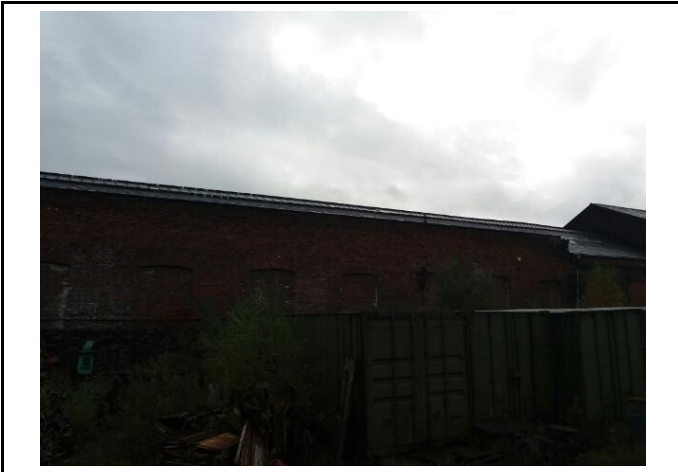
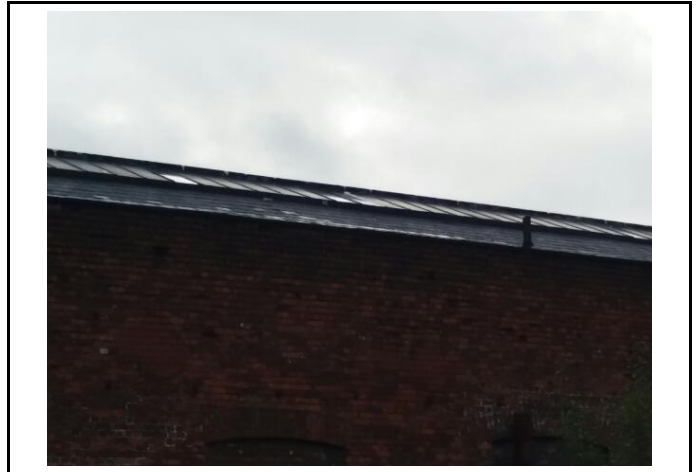
| <b>Ref Number</b> | 147670 |

| East Lancs Locomotive Works, Baron St, Bury BL9 | | | | | |
|---|---|---|---|---|---|
| 147670<br>Strongly Presumed002 | External<br>Roof & Externals<br>R001<br>Skylights | Woven Product<br>180lin m | Chrysotile | 4 | No Action Required<br>Add to asbestos register and Monitor - If this material needs to be removed it will need to be carried out by a licensed contractor. |

| ACM | | |
|---|---|---|
| <b>Asbestos Type Description:</b> | Chrysotile | <b>Comments</b><br>Presumed woven insulation to high level skylights not accessed due to height |

| ACTION | | |
|---|---|---|
| <b>Action Types</b> | No action required | <b>Comments / Recommendations</b><br>Add to asbestos register and Monitor - If this material needs to be removed it will need to be carried out by a licensed contractor. |

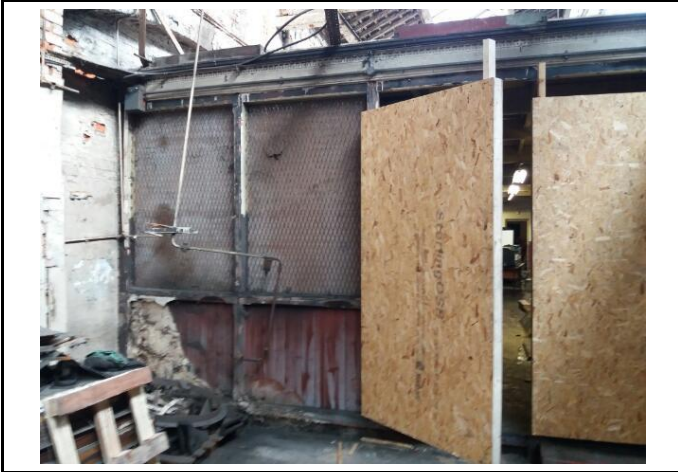
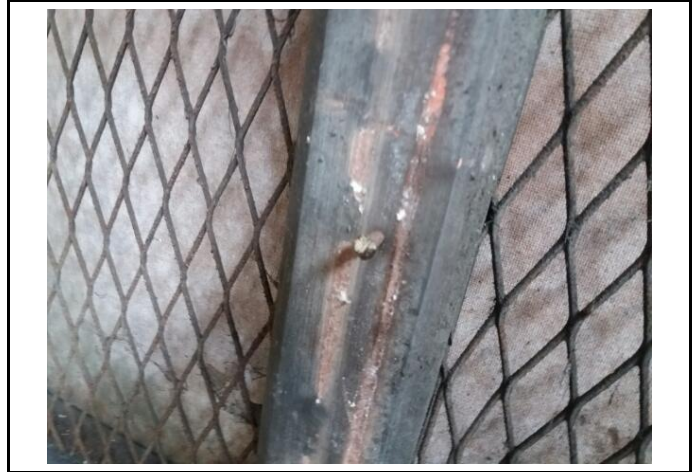
| Ref Number | 147679 |

| East Lancs Locomotive Works, Baron St, Bury BL9 | | | | | |
|---|---|---|---|---|---|
| 147679<br>S003 | Ground Floor<br>Workshop<br>R002<br>wall | Cement Product<br>small amountsm <sup>2</sup> | Chrysotile | 3 | Remove<br>Add to asbestos register and Monitor. |

| ACTION | | |
|---|---|---|
| Action Types | Planned Remedial Action | Comments / Recommendations |

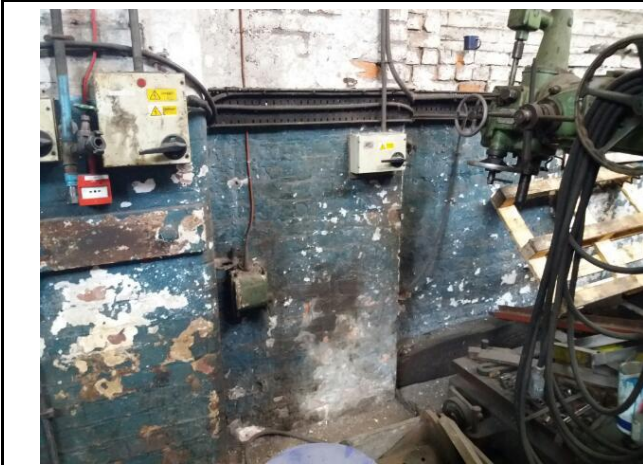
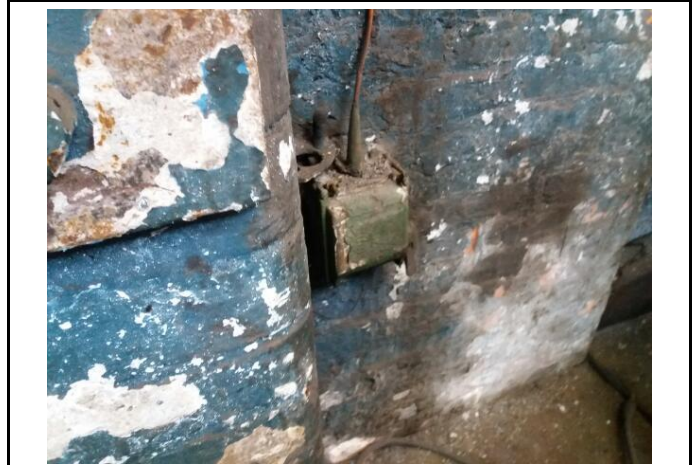
| Ref Number | 147680 |

| East Lancs Locomotive Works, Baron St, Bury BL9 | | | | | |
|---|---|---|---|---|---|
| 147680<br>Strongly Presumed003 | Ground Floor<br>Workshop<br>R002<br>Electrical Box | Woven Product<br>6No | Chrysotile | 4 | No Action Required<br>Add to asbestos register and Monitor - If this material needs to be removed it will need to be carried out by a licensed contractor. |

| ACTION | | |
|---|---|---|
| Action Types | No action required | Comments / Recommendations |

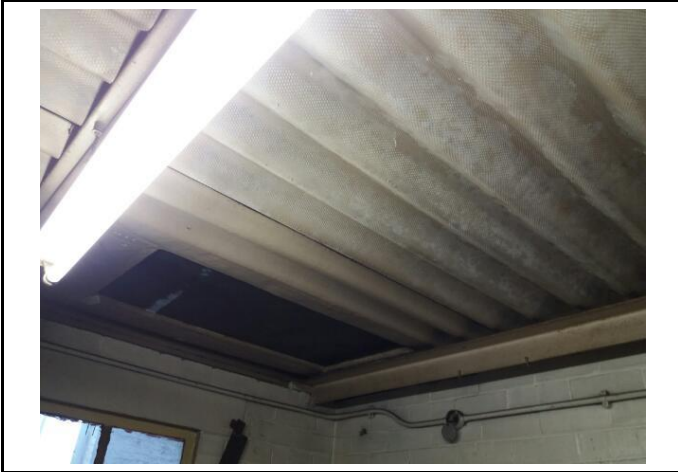
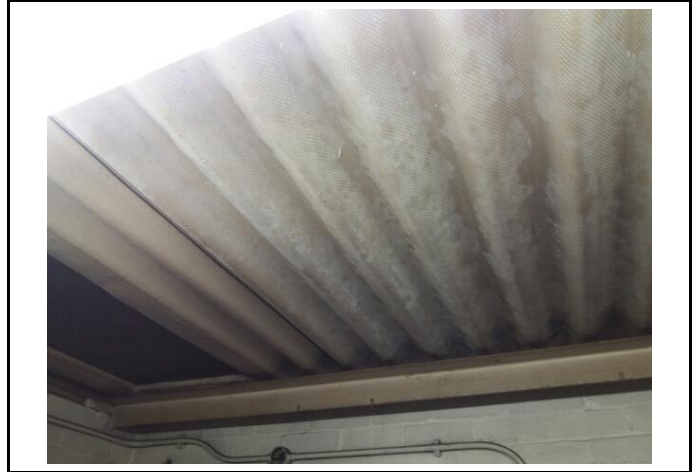
| Ref Number | 147717 |

| East Lancs Locomotive Works, Baron St, Bury BL9 | | | | | |
|---|---|---|---|---|---|
| 147717<br>S007 | Ground Floor<br>Fitters Office<br>R009<br>Ceiling | Cement Product<br>6m <sup>2</sup> | Chrysotile | 2 | No Action Required<br>Add to asbestos register and Monitor. |

| ACTION | | |
|---|---|---|
| Action Types | No action required | Comments / Recommendations |

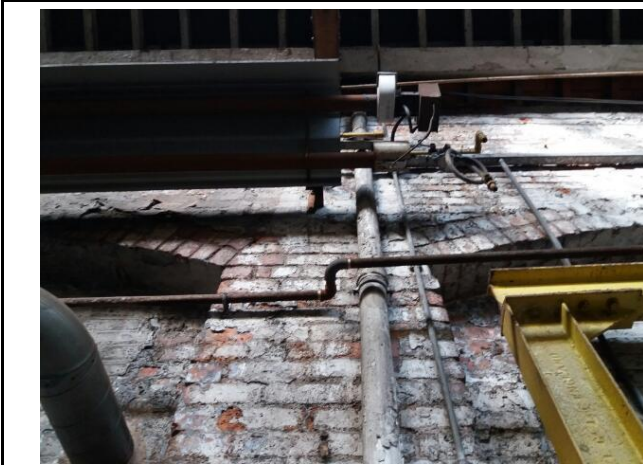
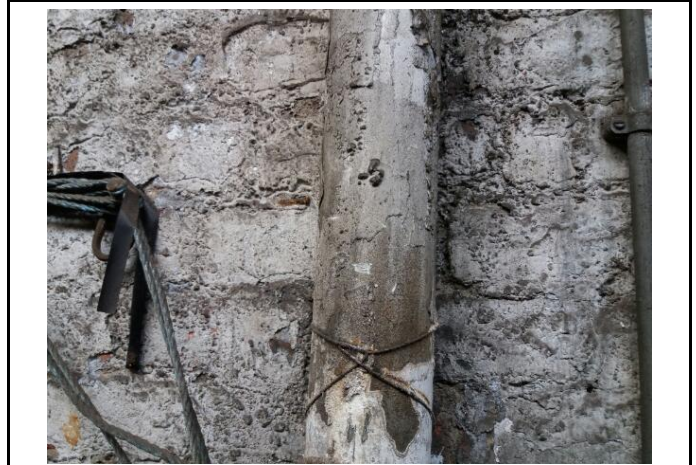
| Ref Number | 147759 |

| East Lancs Locomotive Works, Baron St, Bury BL9 | | | | | |
|---|---|---|---|---|---|
| 147759<br>S004 | Ground Floor<br>Workshop<br>R002<br>Cement down pipe | Cement Product<br>15lin m | Chrysotile | 2 | No Action Required<br>Add to asbestos register and Monitor. |

| ACTION | | |
|---|---|---|
| Action Types | No action required | Comments / Recommendations |
