**Site Tree Appraisal**  
***157 Park Lane, Whitefield M45 7DZ***

**“BS 5837 2012: Trees in Relation to Design, Demolition and Construction – Recommendations”**

Ref: RTS/25102024 01

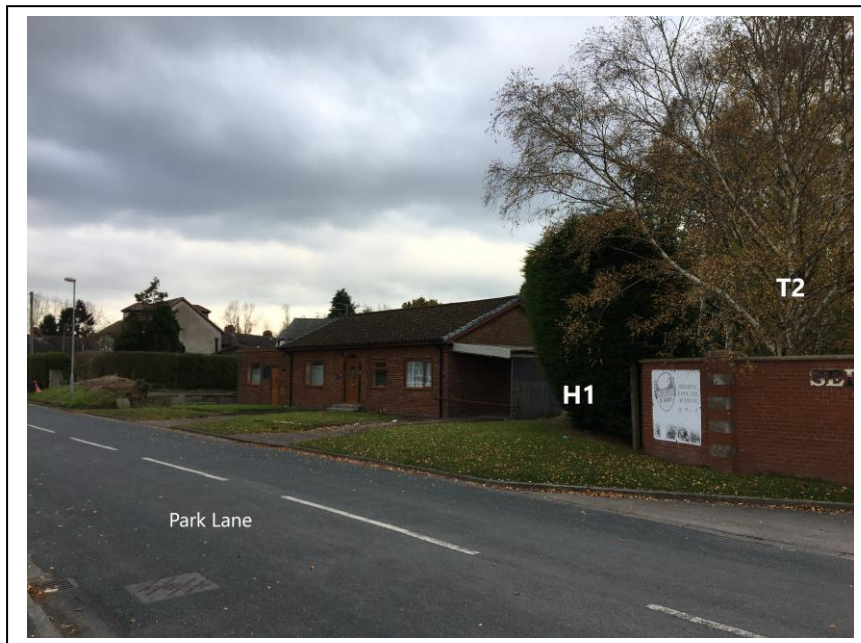
Photo 01:

**2.2 Brief site description:** 157 Park Lane is a detached bungalow on a triangular plot of land that is located towards the southern end of Park Lane (photo 01). The front garden consists of lawn and paved areas. The small triangular rear garden is predominantly lawn area. There are no trees within the gardens of 157 Park Lane, the only trees close to the site are in the neighbouring Rugby Club grounds, adjacent to and beyond the southeast garden boundary.
