| Document Control | | | | |
|---|---|---|---|---|
| Project Name: | | Proffitts | | |
| Report Title: | | Preliminary Roost Assessment Report | | |

- 1.1.1 Avian Ecology Ltd. was commissioned by Proffitts to undertake a Preliminary Roost Assessment (PRA) in relation to the proposed enhancements and landscaping of Whitehead Gardens, Tottington, Bury, BL8 4AL (henceforth referred the 'Site'),

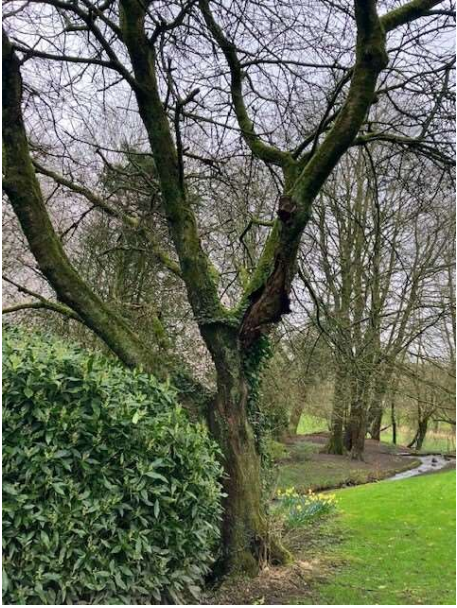
| P1: T4 | P2: T33 |

| Tree ID | Species | Category | Suitability | Development Status | PRF Comments | Photograph |
|---|---|---|---|---|---|---|
| T4 | Prunus sp. | C | Low | Retained | Peeling bark in some areas. | P1 |

| Tree ID | PRF Ref. | PRF Type | Signs of Use | Comments | Photo Ref. (Appendix 1) |
|---|---|---|---|---|---|
| T4 | PRF 1 | Peeling bark | None. | Peeling bark featured on limb, located on the east aspect of the tree. Torching indicated a negative result for presence, although <b>Low</b> potential remains due to suitability of crevice feature. | P1 |

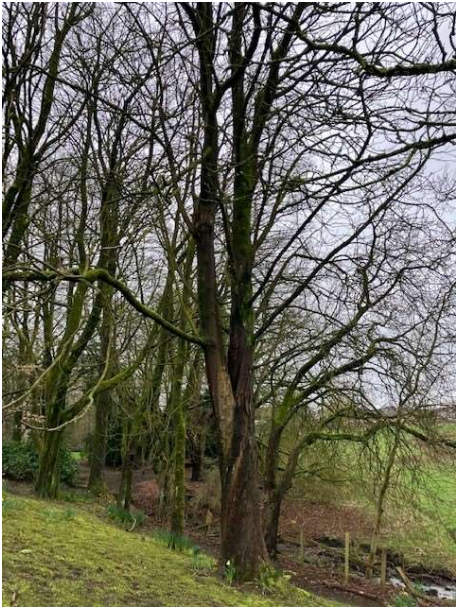
| Tree ID | Species | Category | Suitability | Development Status | PRF Comments | Photograph |
|---|---|---|---|---|---|---|
| T33 | Horse chestnut | B | Low | Retained | Peeling bark throughout. | P2 |

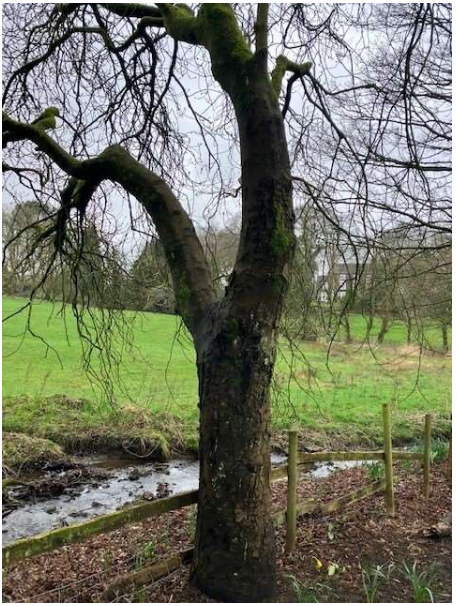
| P3: T34 | P4: T36 |

| Tree ID | Species | Category | Suitability | Development Status | PRF Comments | Photograph |
|---|---|---|---|---|---|---|
| T34 | Horse chestnut | C | Low | Retained | Peeling bark mainly concentrated relatively low. | P3 |

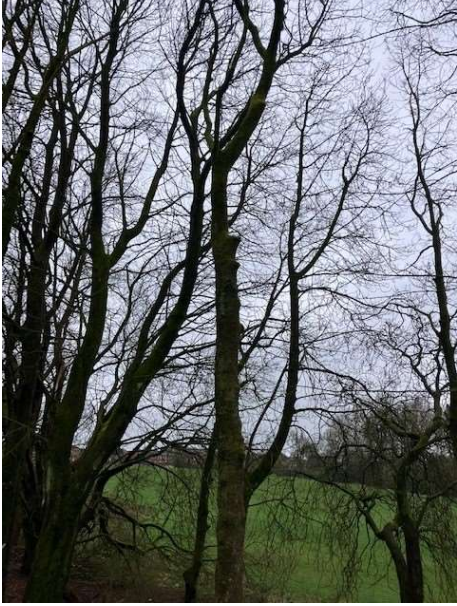
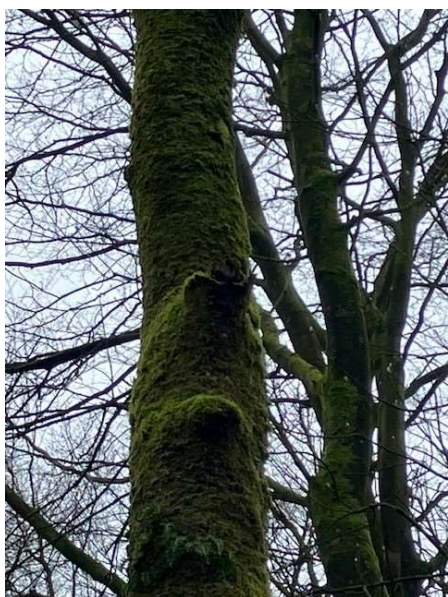
P5: T36

| Tree ID | Species | Category | Suitability | Development Status | PRF Comments | Photograph |
|---|---|---|---|---|---|---|
| T36 | Sycamore | D | Low | Felled | Potential PRF not visible from ground, approximately 15m high, northern aspect. | P4-P5 |

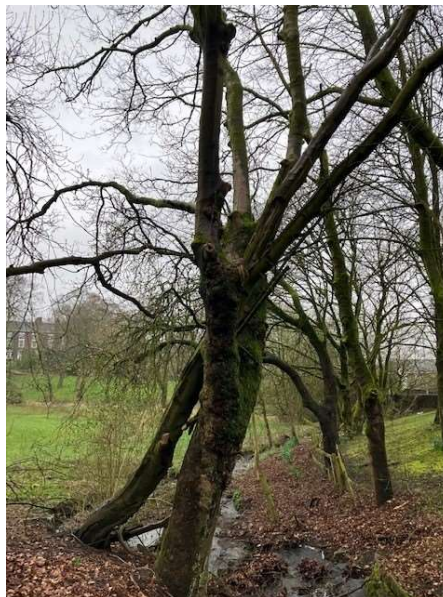
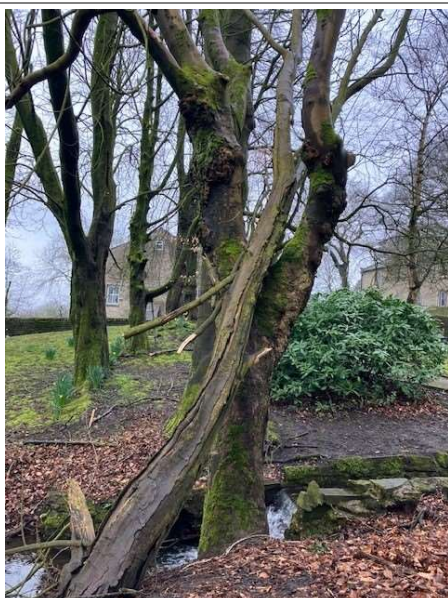
P6: T44

| Tree ID | Species | Category | Suitability | Development Status | PRF Comments | Photograph |
|---|---|---|---|---|---|---|
| T44 | Sycamore | D | Moderate | Felled | Two trunks; peeling bark and knots present, potential PRFs but non-accessible - second trunk more rotted. | P6-P7 |

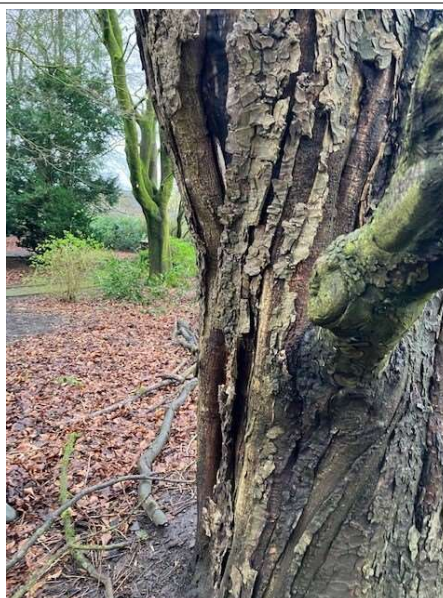
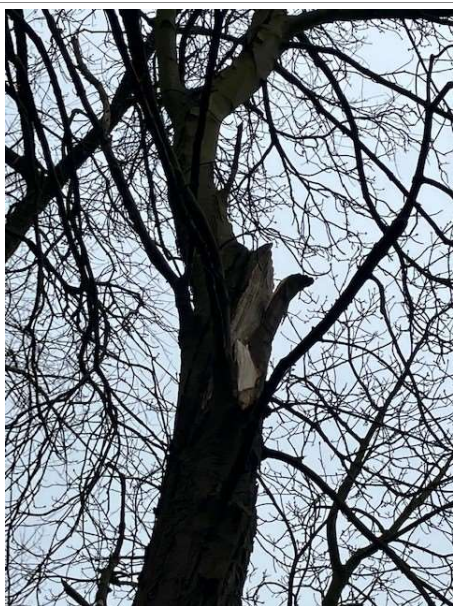
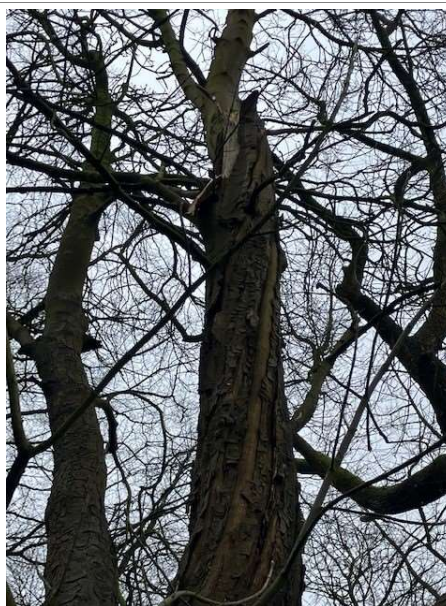
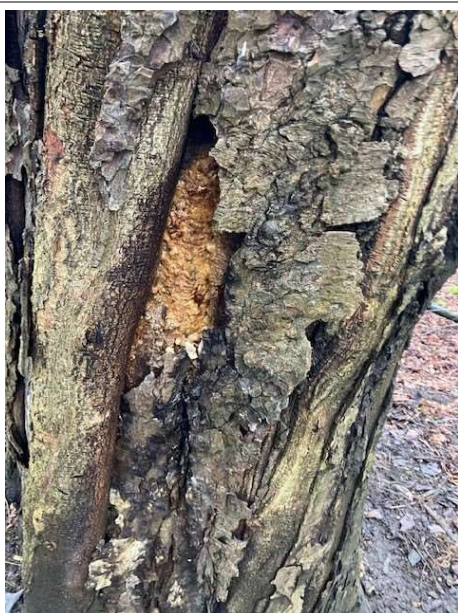
P8: T47

| Tree ID | Species | Category | Suitability | Development Status | PRF Comments | Photograph |
|---|---|---|---|---|---|---|
| T47 | Horse chestnut | B | High | Retained | Peeling bark, cracks and broken limbs (most significant at approximately 15m high, southeast aspect. | P8-P11 |

| Tree ID | PRF Ref. | PRF Type | Signs of Use | Comments | Photo Ref. (Appendix 1) |
|---|---|---|---|---|---|
| T47 | PRF 7 | Various | None. | Wet, visible exposed rot where bark has broken away, some crevice potential but internal conditions appear unsuitable. Various other cracks and PRFS located at height which were non-accessible (T47 remains as <b>High</b> potential). | <b>P8-P11</b> |

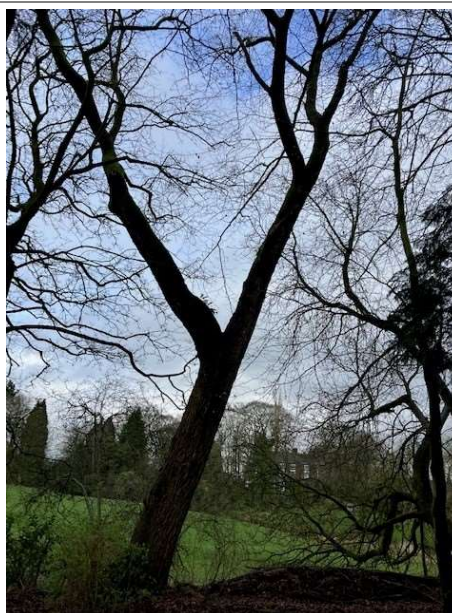
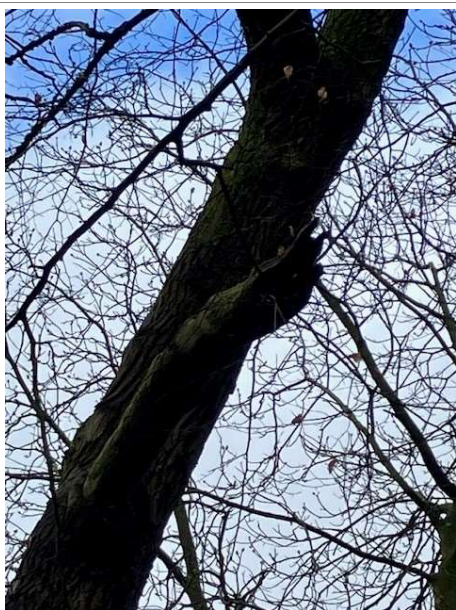
P12: T49

| Tree ID | Species | Category | Suitability | Development Status | PRF Comments | Photograph |
|---|---|---|---|---|---|---|
| T49 | Black poplar (hybrid) | B | High | Retained | Cracks in bark, broken limbs, most significant approximately 15m high at southeast aspect. | P12-P13 |

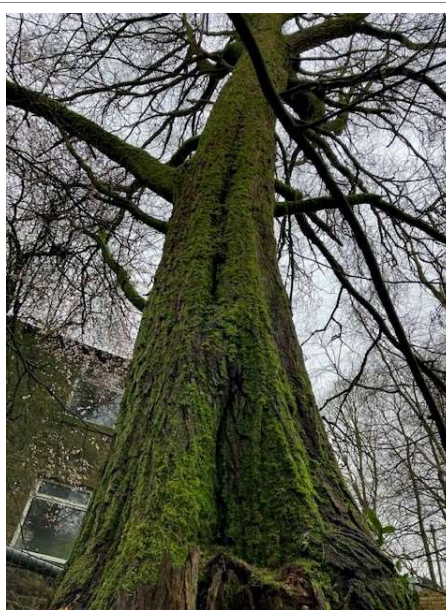
P14: T78

| Tree ID | Species | Category | Suitability | Development Status | PRF Comments | Photograph |
|---|---|---|---|---|---|---|
| <b>T78</b> | Crack willow | C | Moderate | Felled | Crack/tear running from base of tree located on north aspect. Tear at base checked - negative for presence at time of survey, higher crack non-accessible. | <b>P14-P15</b> |

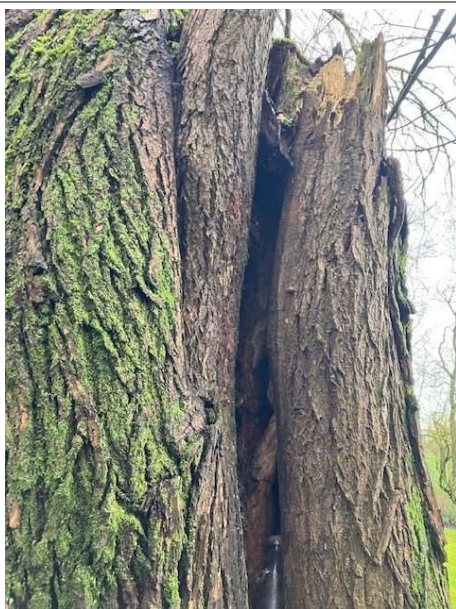
P15: T78

| Tree ID | PRF Ref. | PRF Type | Signs of Use | Comments | Photo Ref. (Appendix 1) |
|---|---|---|---|---|---|
| T78 | PRF 11 | Crevice | None. | Crack/wound within trunk close to base of tree on north aspect. Internal conditions relatively wet, litter also wedged within. Endoscopy revealed feature forms numerous cracks/crevices extending in various direction, with angles/orientation making the feature difficult to inspect | <b>P15</b> |

| Tree ID | PRF Ref. | PRF Type | Signs of Use | Comments | Photo Ref. (Appendix 1) |
|---|---|---|---|---|---|
| | | | | completely. Additional PRF present at elevation located on north aspect, appears to be a split/wound in trunk, although non-accessible. PRA remains <b>Low</b> potential in light of non-surveyed features. | |

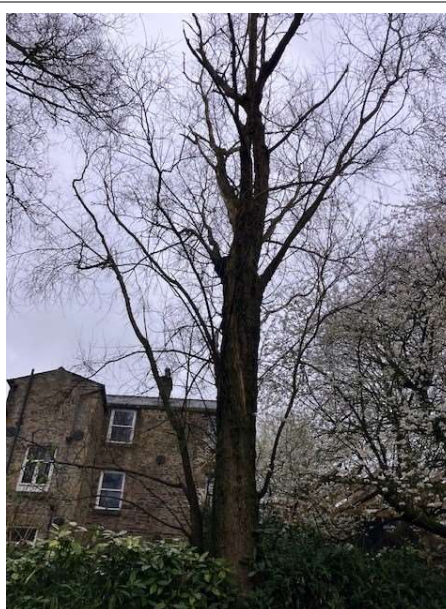
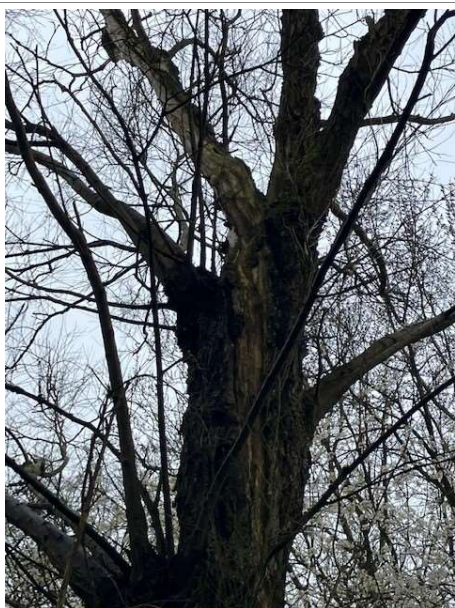
P16: T80

| Tree ID | Species | Category | Suitability | Development Status | PRF Comments | Photograph |
|---|---|---|---|---|---|---|
| <b>T80</b> | Crack willow | D | Moderate | Felled | Deep crack/wound located on trunk at elevation, present on northeast aspect. | <b>P16-P17</b> |

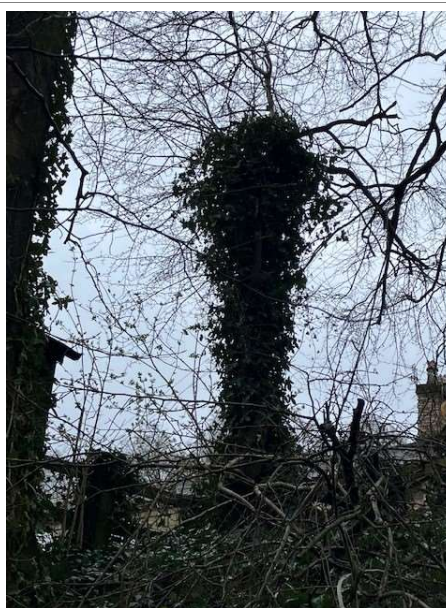
P18: T93

| Tree ID | Species | Category | Suitability | Development Status | PRF Comments | Photograph |
|---|---|---|---|---|---|---|
| <b>T93</b> | Hawthorn | D | Moderate | Felled | Ivy covered but inaccessible. Potential for concealed features. | <b>P18</b> |

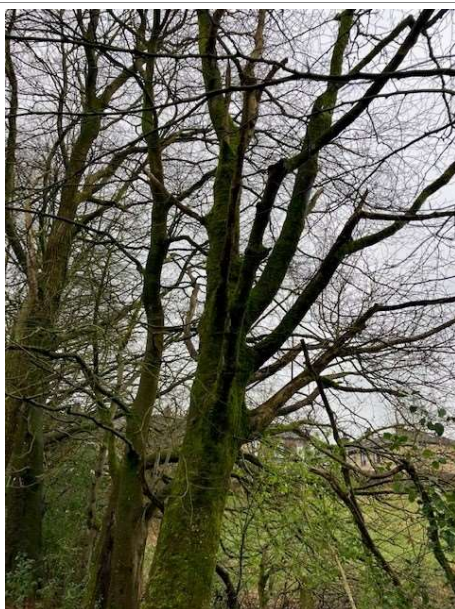
P19: T114

| Tree ID | Species | Category | Suitability | Development Status | PRF Comments | Photograph |
|---|---|---|---|---|---|---|
| <b>T114</b> | Sycamore | D | Low | Felled | Cracked branch, located on west aspect, non-accessible. | <b>P19</b> |

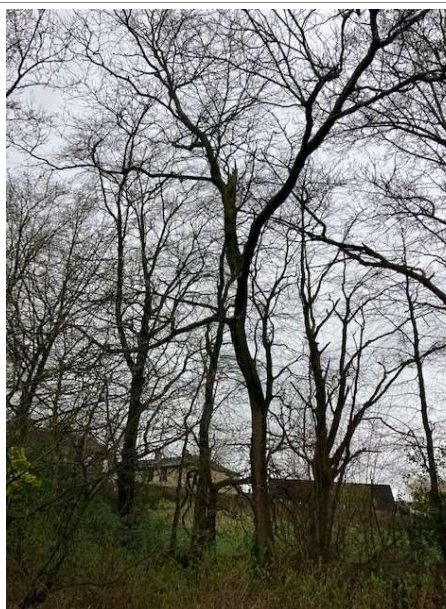
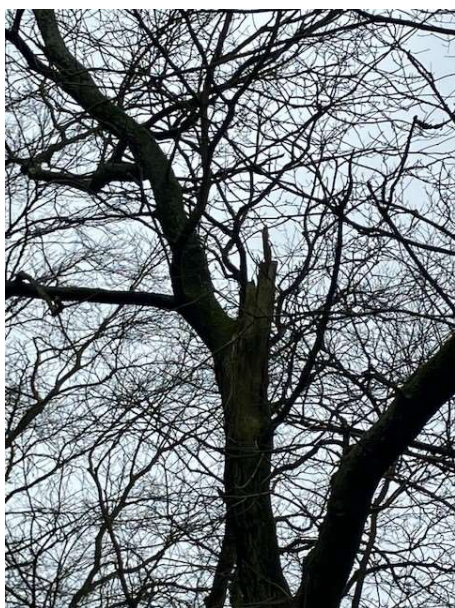
P20: T115

| Tree ID | Species | Category | Suitability | Development Status | PRF Comments | Photograph |
|---|---|---|---|---|---|---|
| <b>T115</b> | Crack willow | C | Low | Crowned | Split limb approximately 18m high, but facing upward and possibly exposed to elements. | <b>P20-P21</b> |

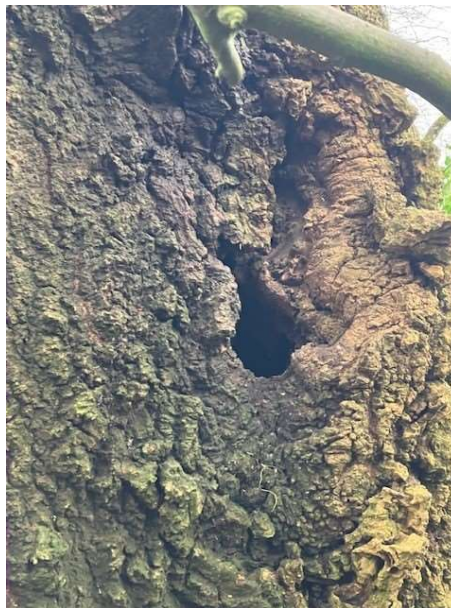
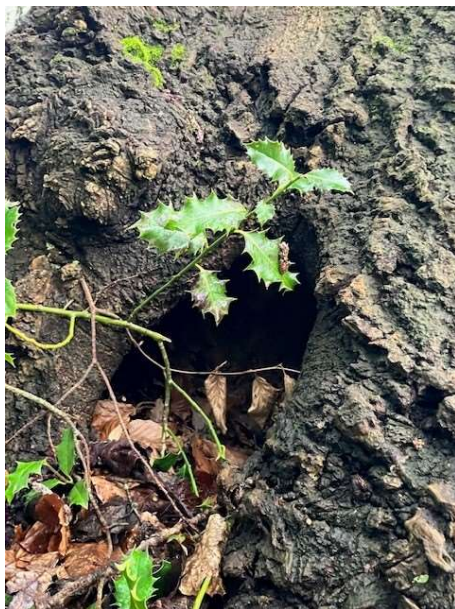
P22: T117

| Tree ID | Species | Category | Suitability | Development Status | PRF Comments | Photograph |
|---|---|---|---|---|---|---|
| <b>T117</b> | Aspen | B | Moderate | Crowned | Butt-rots and hollow cavities at base, possible hollow trunk, multiple cracks in limbs, and present cavity on northwest aspect of trunk approximately 3m high. Cavities checked but appeared to be negative for presence, although feature appeared to extend beyond scope of equipment. | <b>P22-P23</b> |

| Tree ID | PRF Ref. | PRF Type | Signs of Use | Comments | Photo Ref. (Appendix 1) |
|---|---|---|---|---|---|
| T117 | PRF 12 | Butt rot | None. | Butt-rot cavities at base on southeast aspect, appears to open into large void upwards within trunk (suggests potential hollowing, with cavity extending beyond scope of endoscope). Retains <b>Moderate</b> potential. | <b>P22-P23</b> |

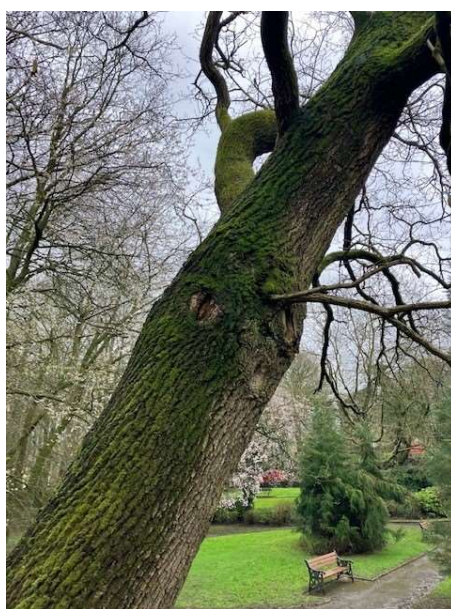
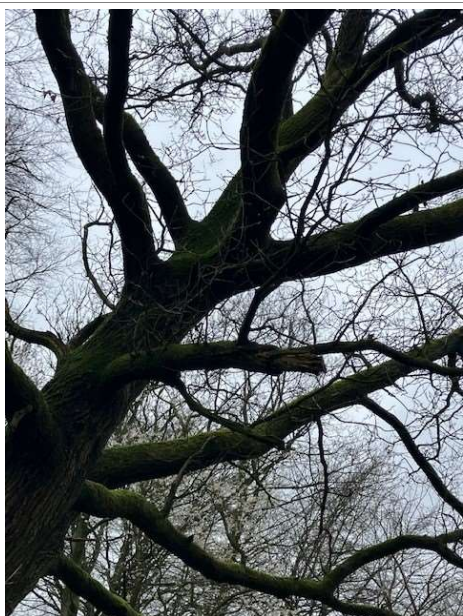
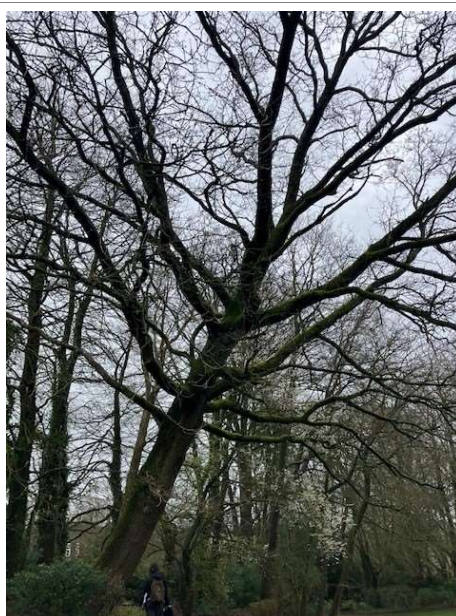
P24: T125

| Tree ID | Species | Category | Suitability | Development Status | PRF Comments | Photograph |
|---|---|---|---|---|---|---|
| <b>T125</b> | English oak | B | Moderate | Crowned | Many broken limbs at height, non-accessible. Superficial wounds closer to base, all of which were unsuitable upon being checked. | <b>P24-P26</b> |

| Tree ID | PRF Ref. | PRF Type | Signs of Use | Comments | Photo Ref. (Appendix 1) |
|---|---|---|---|---|---|
| T125 | PRF 15 | Rot hole and crevices | None. | Superficial rot holes/wounds present at lower elevation on southwest aspect, although none formed viable cavities suitable for roosting. However, multiple cracks and broken limbs observed at height which were non-accessible. Given unknown status of outstanding features and apparent age of tree, <b>Moderate</b> potential retained. | <b>P24-P26</b> |

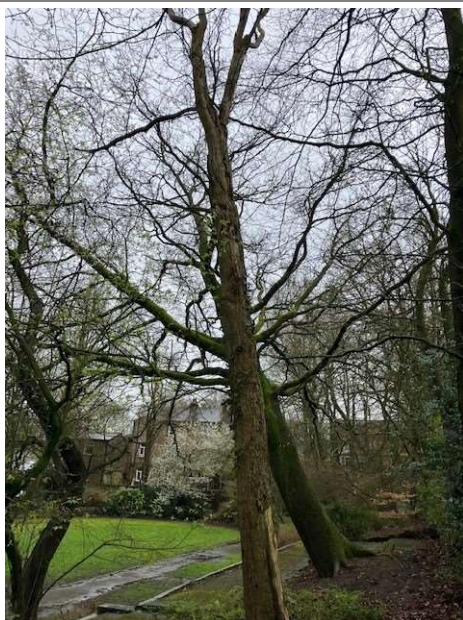
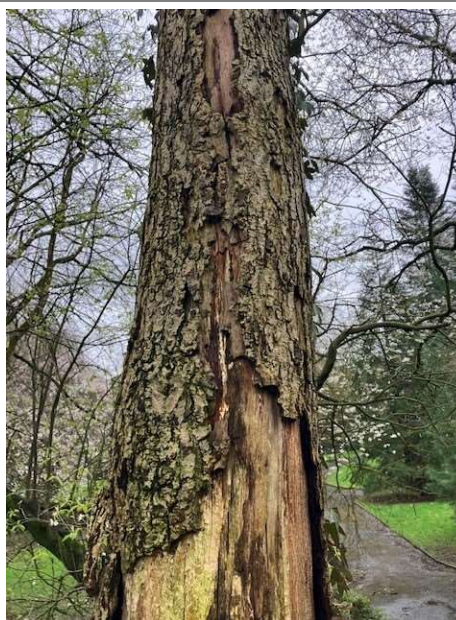
P27: T128

| Tree ID | Species | Category | Suitability | Development Status | PRF Comments | Photograph |
|---|---|---|---|---|---|---|
| <b>T128</b> | Crack willow | D | Low | Felled | Splitting bark throughout trunk, and split limb roughly 20m in height. | <b>P27-P28</b> |

| Tree ID | PRF Ref. | PRF Type | Signs of Use | Comments | Photo Ref. (Appendix 1) |
|---|---|---|---|---|---|
| T128 | PRF 16 | Peeling bark/cracked limb | None. | Large areas of broken/peeling bark present on northwest aspect, forming suitable crevice space. Appeared to be negative for the bat presence upon inspection at the time of survey. Additional crack/broken limb features present at apex, although non-accessible at elevation. <b>Low</b> potential for T128 retained in light of outstanding PRFs present. | <b>P27-P28</b> |

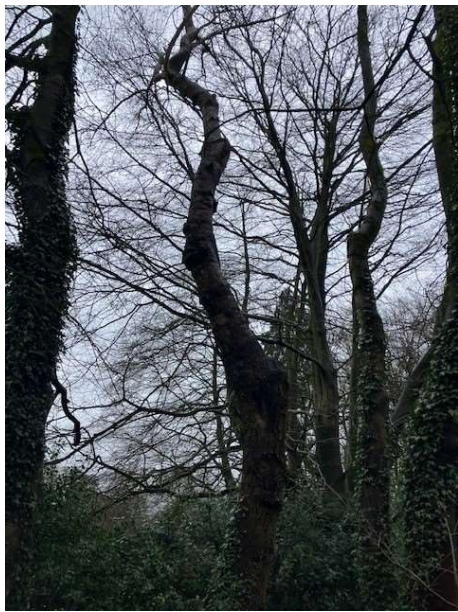
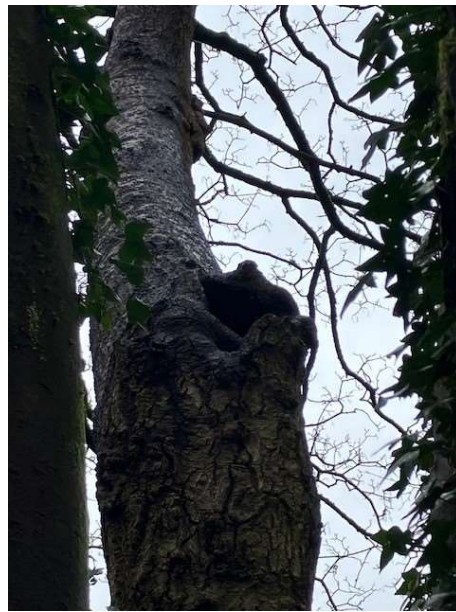
P29: T135

| Tree ID | Species | Category | Suitability | Development Status | PRF Comments | Photograph |
|---|---|---|---|---|---|---|
| T135 | Salix sp. | C | Moderate | Felled | Large cavity on northeast aspect, located approximately 4m in height. Non-accessible. | P29-P30 |

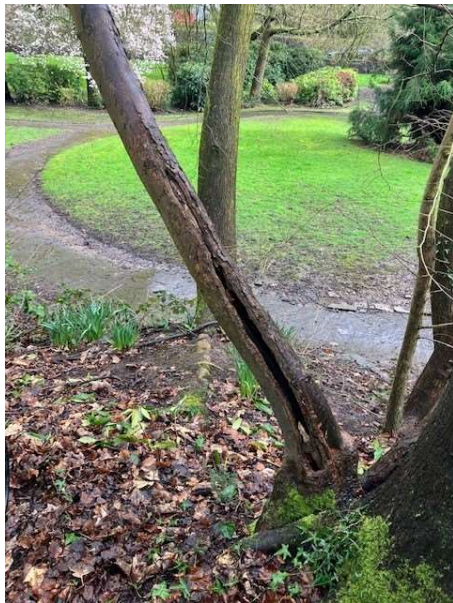
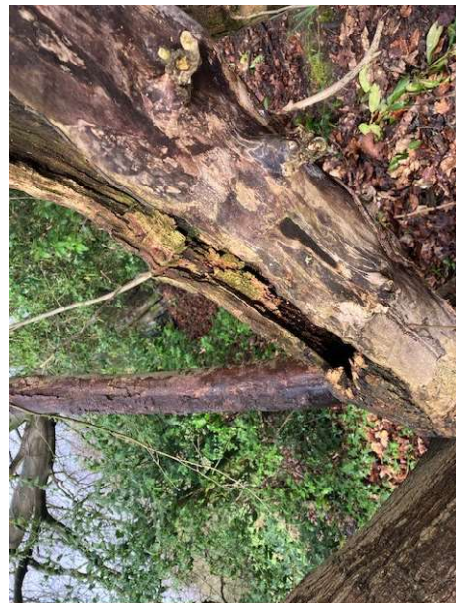
P31: T138

| Tree ID | Species | Category | Suitability | Development Status | PRF Comments | Photograph |
|---|---|---|---|---|---|---|
| T138 | Ulmus sp. | D | Low | Retained | A broken limb and large rot-wound present close to base, negative for presence at time of survey, but potential noted. | P31-P32 |

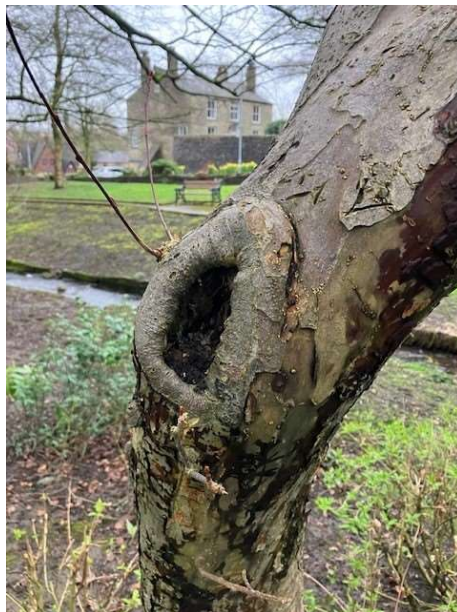
P34: PRF 3; T13

| Tree ID | PRF Ref. | PRF Type | Signs of Use | Comments | Photo Ref. (Appendix 1) |
|---|---|---|---|---|---|
| T13 | PRF 3 | Holes | None. | Three rot holes/wounds located on northwest and east aspects. Shallow and considered superficial; all features considered unsuitable overall, with T13 assessed as having <b>Negligible</b> potential post inspection. | <b>P34</b> |

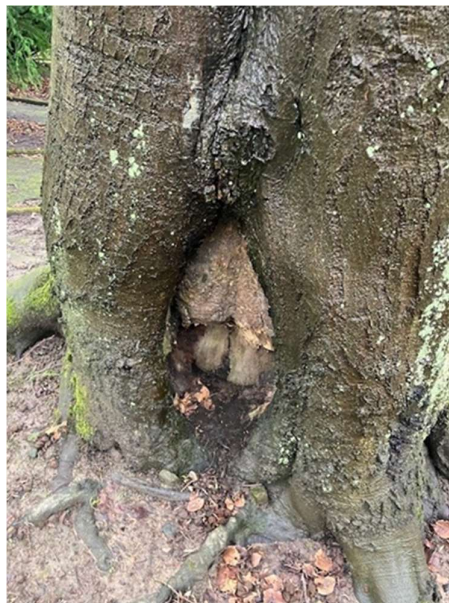
P36: PRF 5; T17

| Tree ID | PRF Ref. | PRF Type | Signs of Use | Comments | Photo Ref. (Appendix 1) |
|---|---|---|---|---|---|
| T17 | PRF 5 | Butt-rot | None. | Superficial butt-rot feature at base of tree on southeast aspect; no crevice/void spaces formed by features so deemed unsuitable as roosting feature. T17 assessed as having Negligible potential overall. | <b>P36</b> |

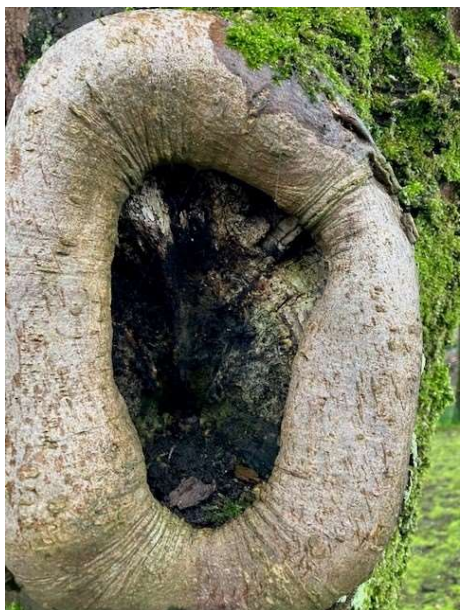
P37: PRF 6; T37

| Tree ID | PRF Ref. | PRF Type | Signs of Use | Comments | Photo Ref. (Appendix 1) |
|---|---|---|---|---|---|
| T37 | PRF 6 | Rot and crevices | None. | Superficial rot/wounds present at low elevation, all shallow and unsuitable as roosting features upon inspection. Larger feature present on east aspect which suggests potential; from ground, but revealed to be superficial (P37). <b>P37</b> assessed as <b>Negligible</b> overall. | <b>P37</b> |

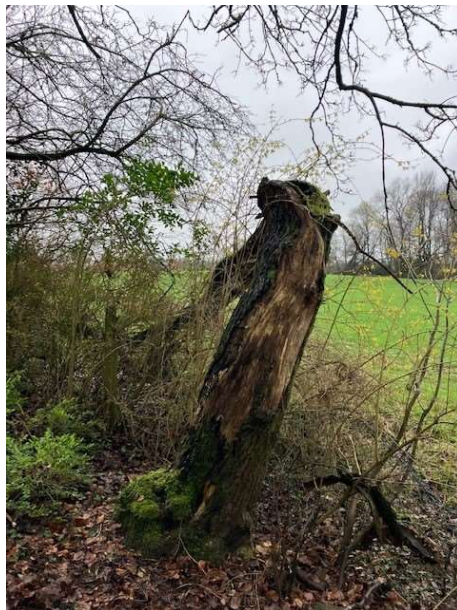
P38: PRF 8; T52

| Tree ID | PRF Ref. | PRF Type | Signs of Use | Comments | Photo Ref. (Appendix 1) |
|---|---|---|---|---|---|
| T52 | PRF 8 | Crack | None. | Tree bent, with crack in trunk forming a potential feature, although upon inspection no crevices/voids had formed considered to be suitable as roosting features. Feature also oriented upwards and exposed to elements, subsequently assessed as unsuitable, T52 considered to have <b>Negligible</b> potential overall. | <b>P38</b> |

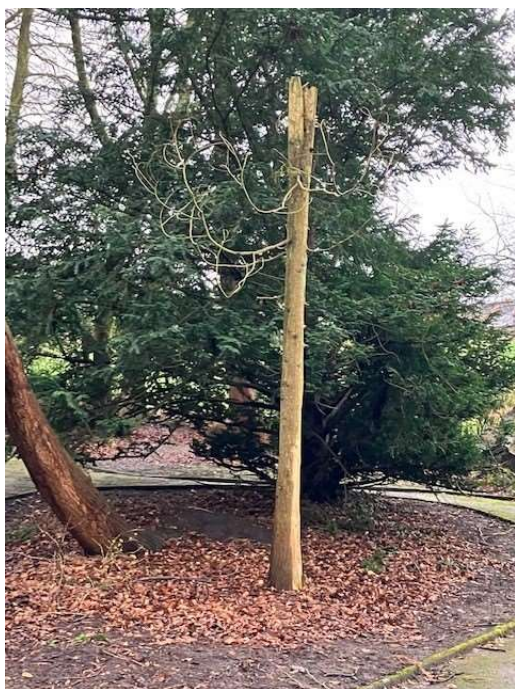
P39: PRF 9; T55

| Tree ID | PRF Ref. | PRF Type | Signs of Use | Comments | Photo Ref. (Appendix 1) |
|---|---|---|---|---|---|
| T55 | PRF 9 | Crack | None. | Dead trunk, primarily stripped of bark with some remains, although not considered to form suitable features. Crack at apex of trunk examined but revealed to be superficial. T55 was assessed as having <b>Negligible</b> potential overall. | <b>P39</b> |

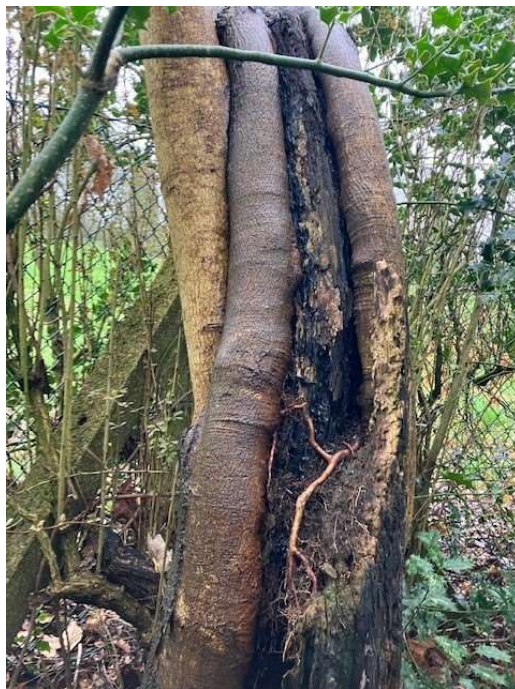
P40: PRF 10; T61

| Tree ID | PRF Ref. | PRF Type | Signs of Use | Comments | Photo Ref. (Appendix 1) |
|---|---|---|---|---|---|
| T61 | PRF 10 | Crevice | None. | Superficial wound present on south aspect; feature did not form any viable crevice or void spaces, and was considered unsuitable. T61 was assessed as having <b>Negligible</b> potential overall. | <b>P40</b> |

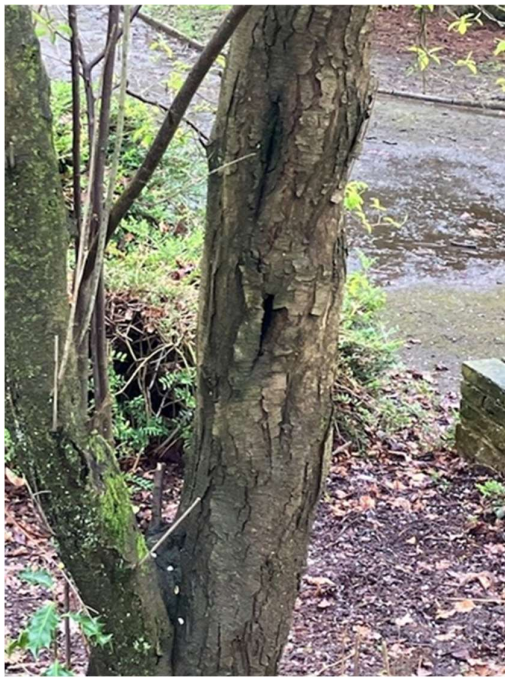
P41: PRF 17; T129

| Tree ID | PRF Ref. | PRF Type | Signs of Use | Comments | Photo Ref. (Appendix 1) |
|---|---|---|---|---|---|
| T129 | PRF 17 | Small void | None. | Small superficial rot holes present on northwest elevation, upon inspection shallow and unsuitable as a roosting feature. T129 was assessed as having <b>Negligible</b> potential overall. | <b>P41</b> |

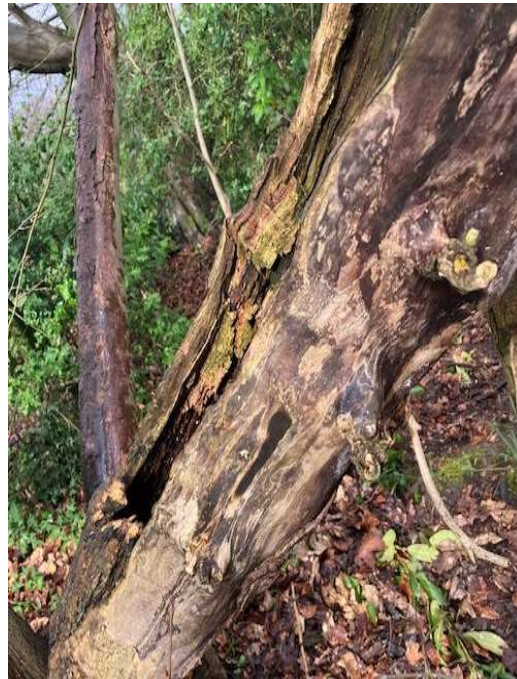
P42: PRF 18; T138

| Tree ID | PRF Ref. | PRF Type | Signs of Use | Comments | Photo Ref. (Appendix 1) |
|---|---|---|---|---|---|
| T138 | PRF 18 | Rot cavities | None. | Large wounds/rot cavities present on two limbs present at base of tree. Both confirmed to be negative for the presence of | <b>P43</b> |

| Tree ID | PRF Ref. | PRF Type | Signs of Use | Comments | Photo Ref. (Appendix 1) |
|---|---|---|---|---|---|
| | | | | roosting bats at the time of survey, although features considered viable. Tree retains <b>Low</b> roosting potential, although not scheduled to be directly impacted during proposed works. | |
