CBRE  
**Radcliffe Town Centre**  
Constraints Desk Study

RAD-ARP-RP-CG-0001

Issue 2 | 12 April 2021

Purpose of visit Preliminary site inspection as part of a constraints study

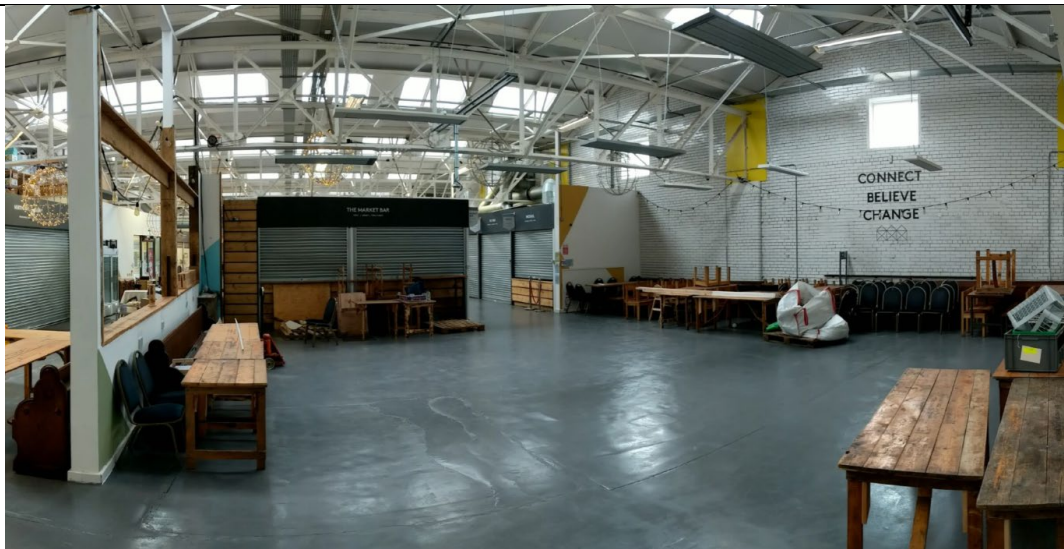
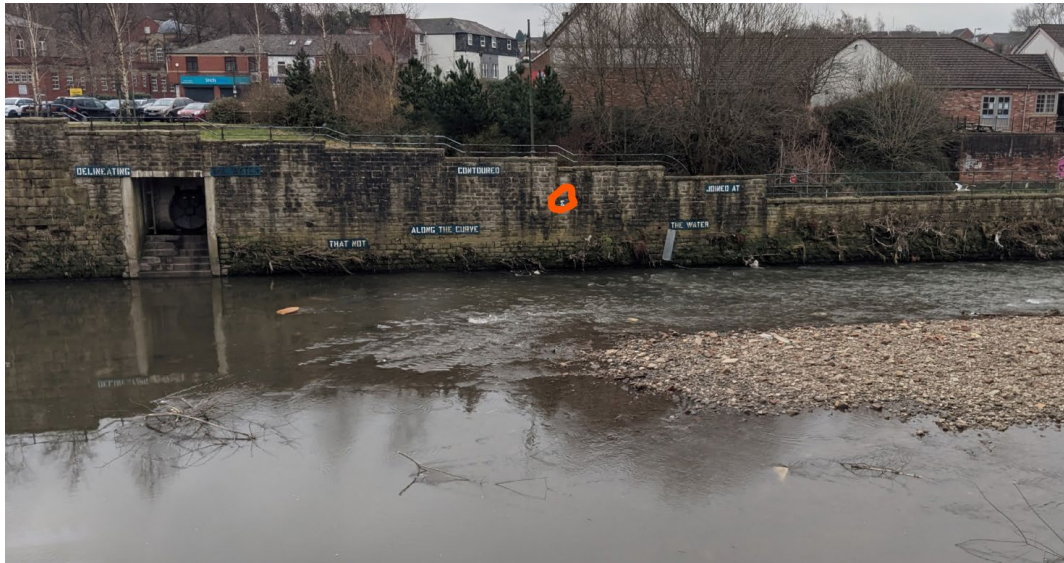
| Notes | Action by |
|---|---|
| <p>Western edge of market building, looking east</p> <p>View of south bank of river from the market observation window – RD confirms that when the river level is at the circled level this is an indicator of significant basement flooding.</p> | |

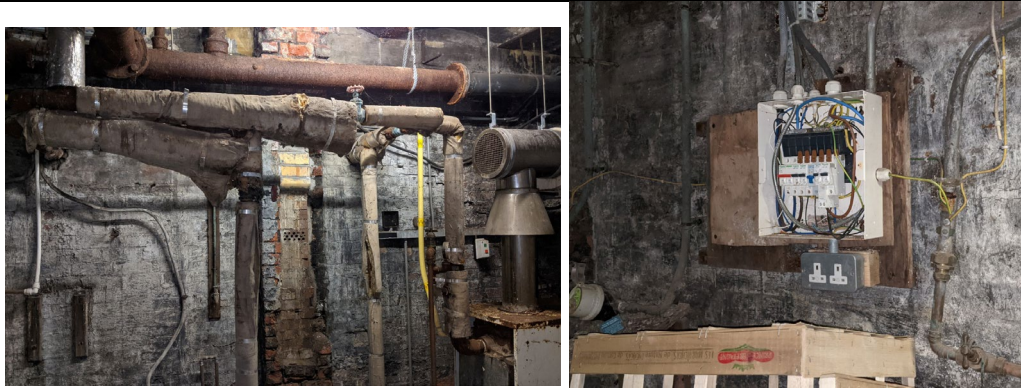
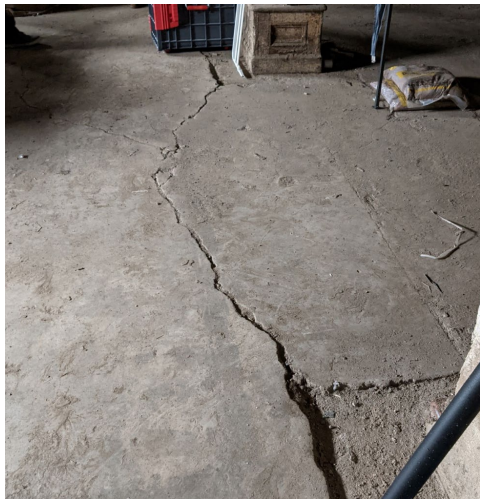
The basement floor was visibly damaged in places. The floor was cracked and distorted which may be indicative of vertical groundwater pressure which exceeds the floor slab strength during these flood events.

| Notes | Action by |
|---|---|
| <p>Main chamber – Evidence of cracking in the concrete floor, floor levels locally distorted.</p> <p>Floor to window sill height on river side approx. 0.75m</p> <p>Reported to be a former snooker hall. Remains of a bar area are present.</p> <p>Some vaulted areas present on north side of basement and evidence of water entry from above possibly from the external paved area.</p> | |

- Repairs to known cracks in areas of leakage;
- Repairs to, replacement of, or blocking up of windows which are known to allow river water into the basement;
- Re-pointing of the external wall where appropriate; and
- Sealing of redundant drainage (such as foul connections) in the basement.

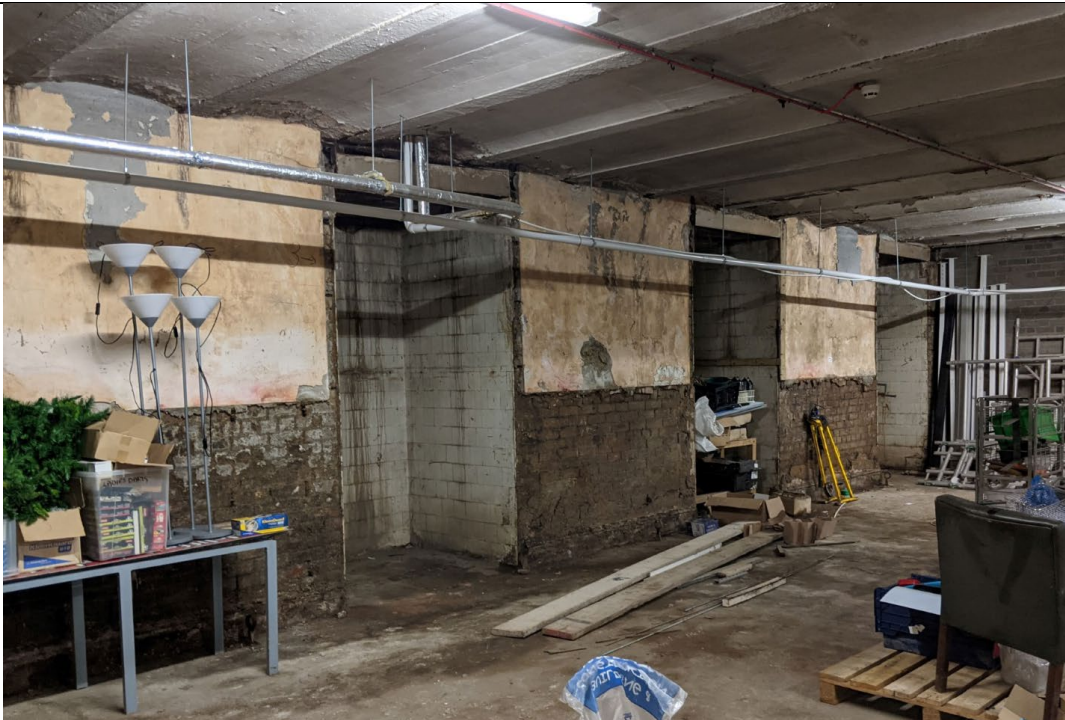
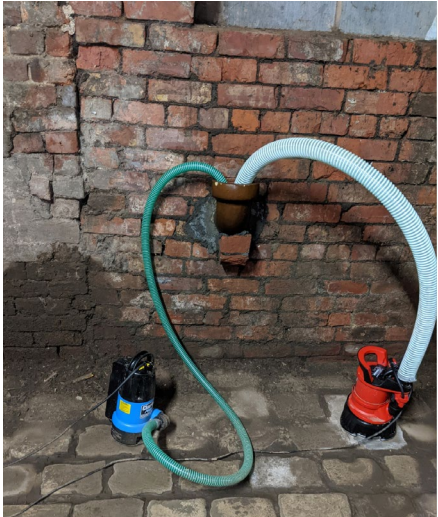
| Notes | Action by |
|---|---|
| <p>Walking to the west, basement enters a slightly lower are with a stone set floor. A pair of water pumps has been placed which activate once water reached a level of 3 inches and appears to discharge through the river wall.</p> | |

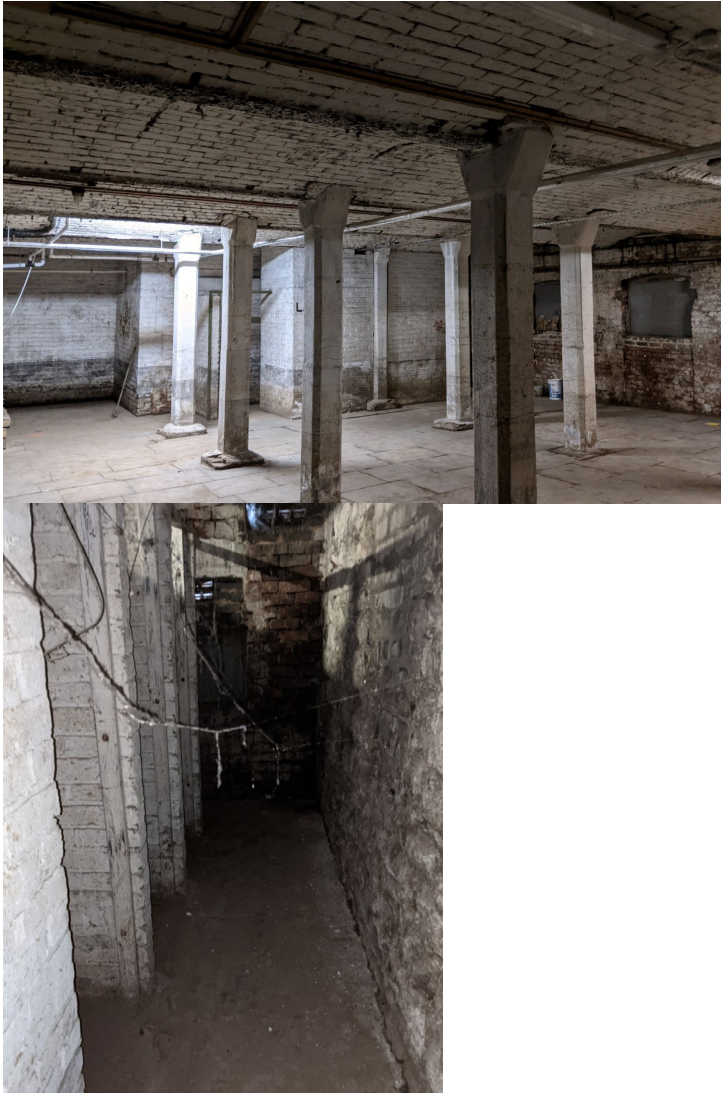
| Notes | Action by |
|---|---|
| <p>Further to the west, the basement enters a former air raid shelter with concrete columns supporting a vaulted brick arch ceiling. Two toilet structures present one either side of this room. Stone slab floor slopes from west to east. Window sills blocked with concrete building blocks but height from floor to window sills 1.05m in west and 1.3m in east.</p> <p>General – Evidence of structural damage/cracking up to 20mm. Some structural tell tales present. RD believed that the council may have some reports.</p> | <p>[POST VISIT<br/>– Survey<br/>obtained within<br/>a structural</p> |

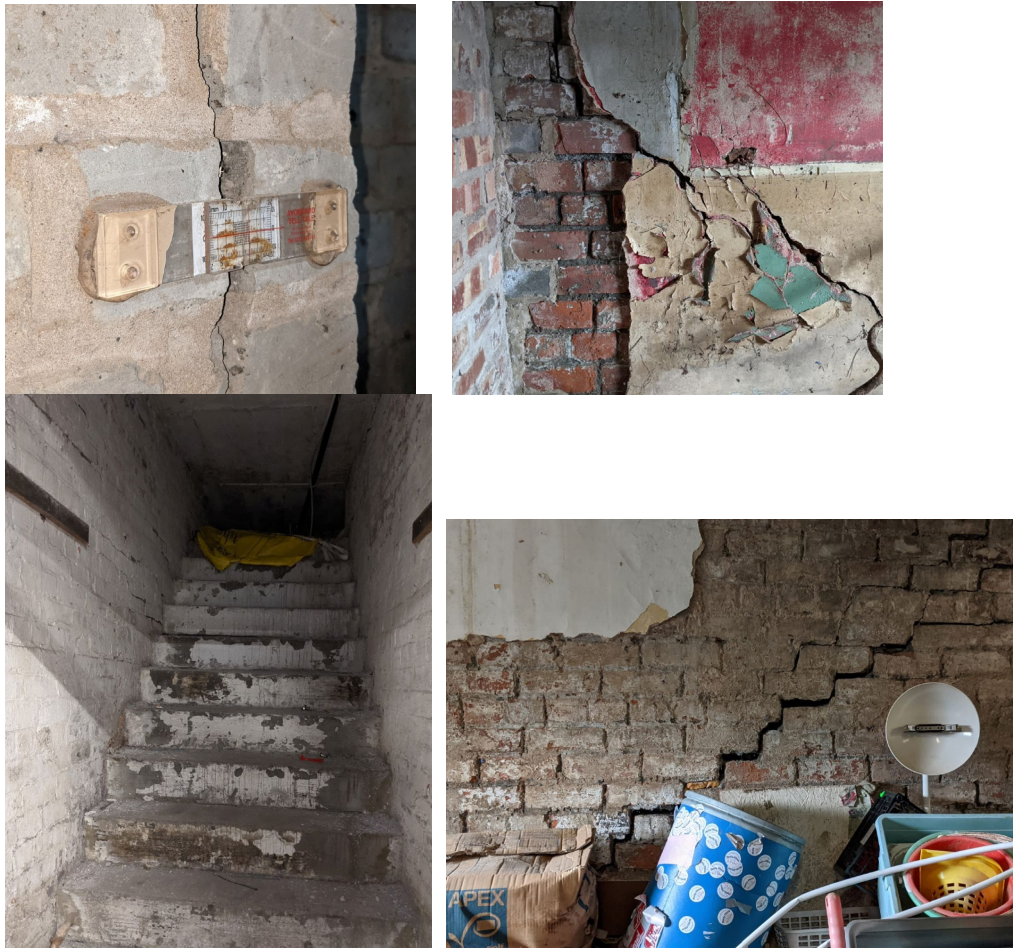
| Notes | Action by |
|---|---|
| <p>Several blocked off staircases – opportunity to reopen these</p> | <p>report. To be reviewed]</p> <p>Check with client as to availability of any structural reports on market incl monitoring. If not available then structural survey recommended. [POST VISIT – Structural report obtained. To be reviewed]</p> |

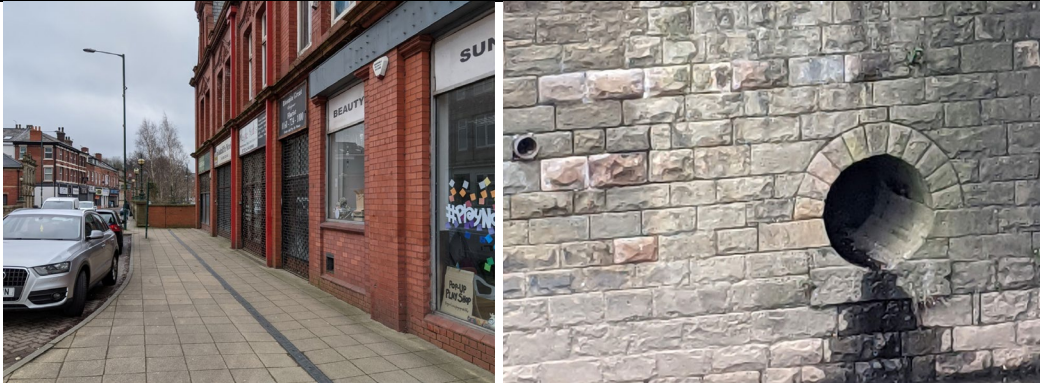
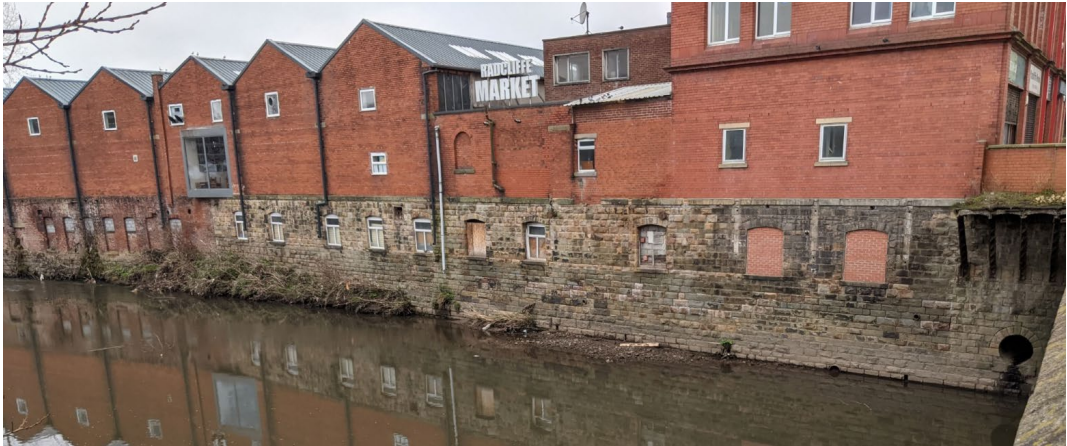
| Notes | Action by |
|---|---|
| <p>Southern façade of market showing window elevations within stone walled basement with brick construction over. Note large diam pipe in wall on right of photo.</p> | |

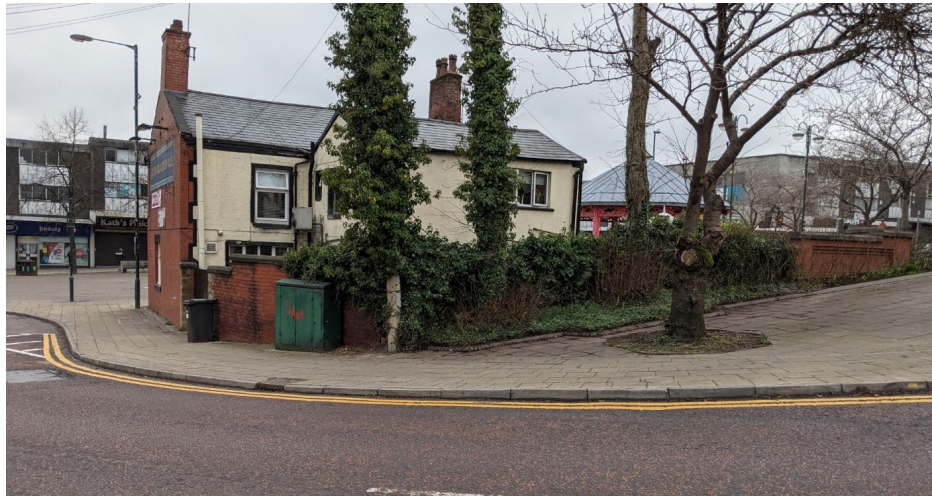
| Notes | Action by |
|---|---|
| <p>Looking west to Bridge Tavern – Ground levels reducing from north to south</p> | |
