# Highway Condition Report

## Stopes Road, Little Lever – S278 Highway Improvements

### Taylor Wimpey Manchester

27 August 2024

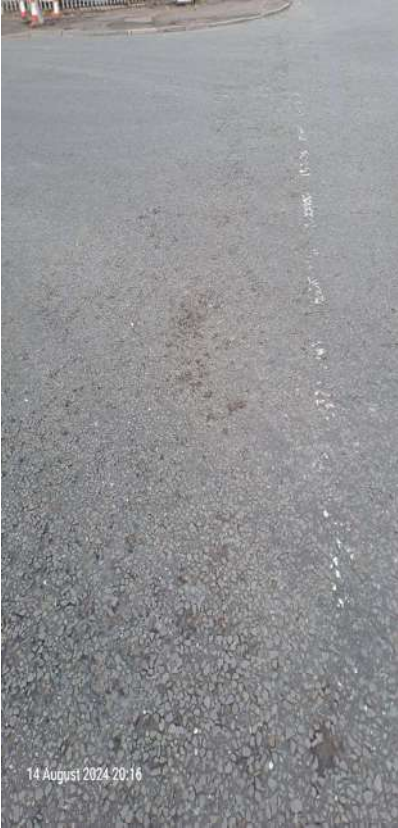
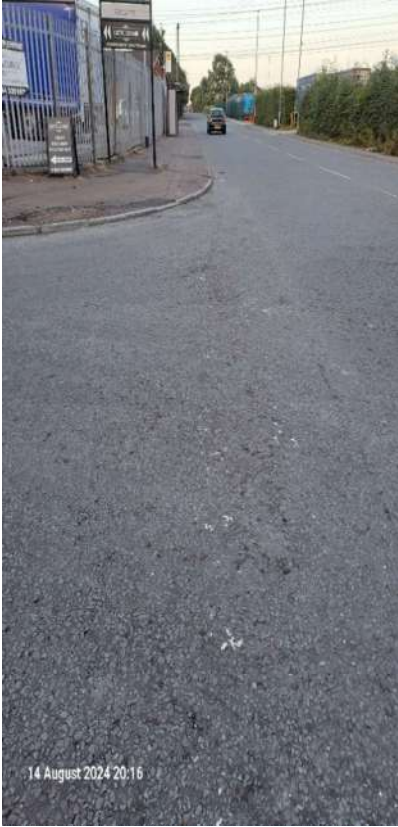
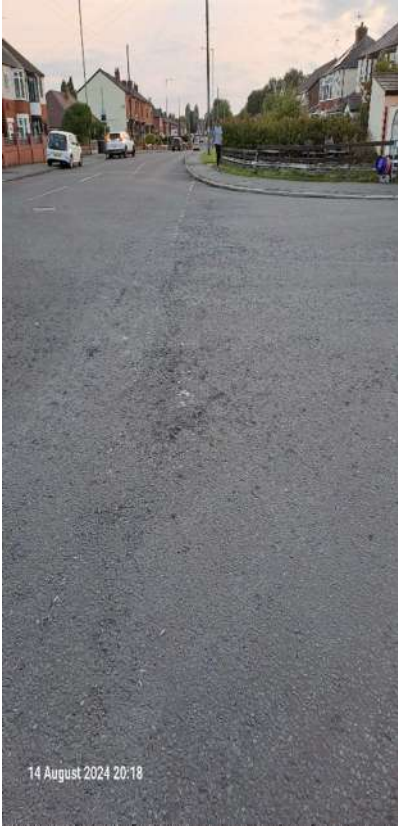
**Photographs 1 to 8** show the existing highway defects within the area of the entrance to Stopes Road. Photographs 1, 2, and 3 indicate damage to the wearing course across the front of the access, where pockets of the aggregate and binder have failed to create small holes / indentations in the road surface.

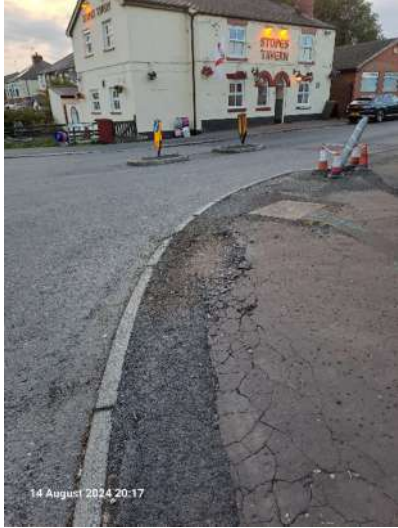
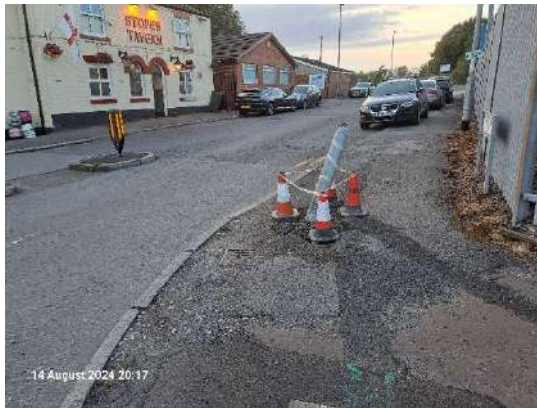
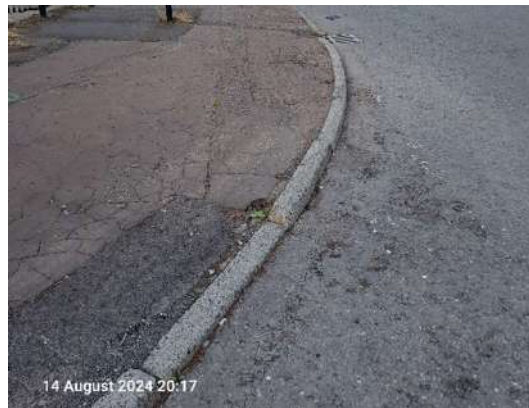
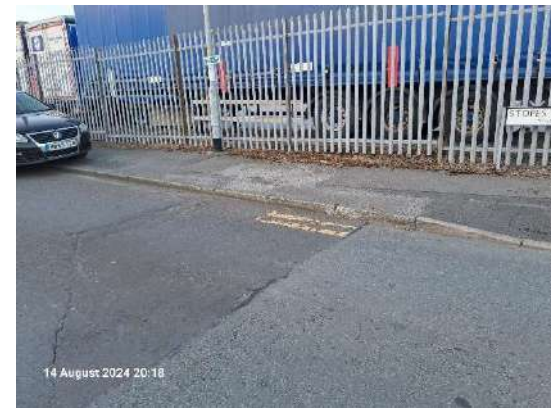
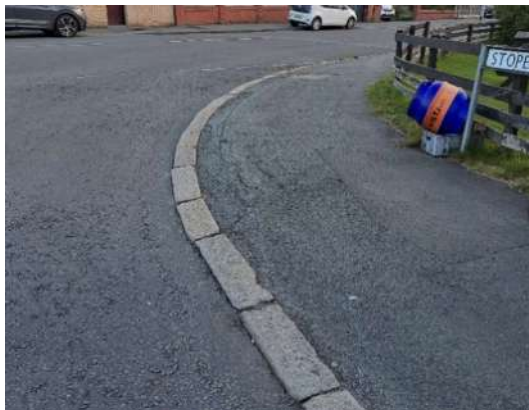
**Photographs 4 to 8** highlight a significant amount of damage to the existing kerbs and footways within the bellmouth area. Areas of the footway surface have completely failed, kerbs are chipped and become dislodged from the concrete foundation. There are also many kerbs which have an inadequate upstand (particularly around the entry radius), which could possibly be due to overrun by HGV's.

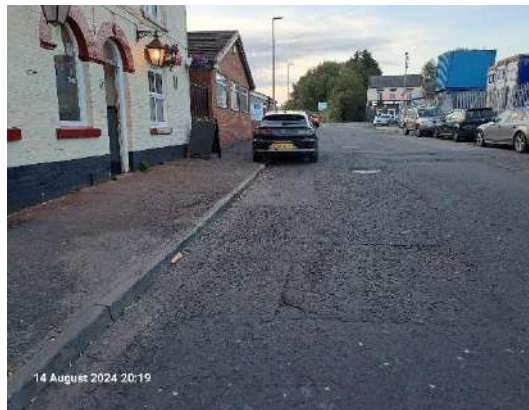
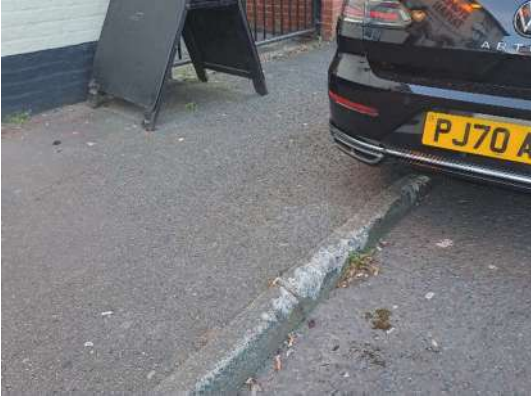
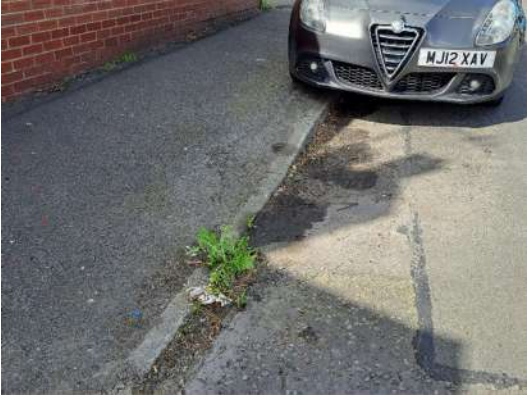
**Photographs 9 to 14** - Moving further north along Stopes Road to the area outside the "Stopes Tavern" pub, again there is damage to the footway where the surface has deteriorated, and sections of the kerb surface are worn away (**refer to photographs 9, 11, and 11a**)

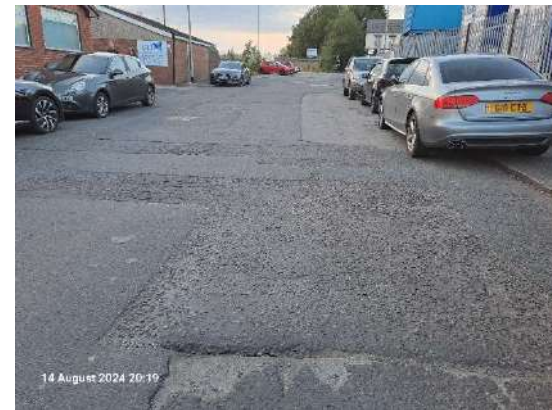
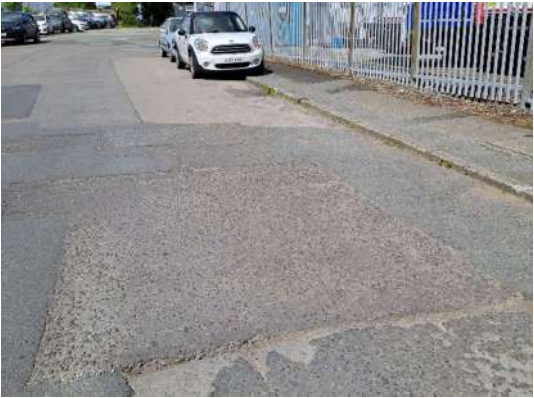
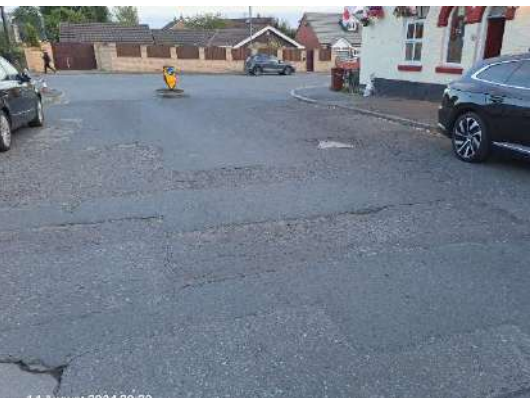
The carriageway is in a poor condition - there are sections of patch resurfacing / repair which have cracking, settlement, and failure of the surface. (**refer to photographs 10, 10a, and 13**)

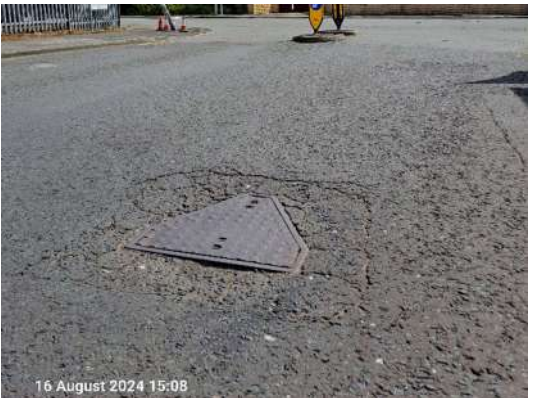
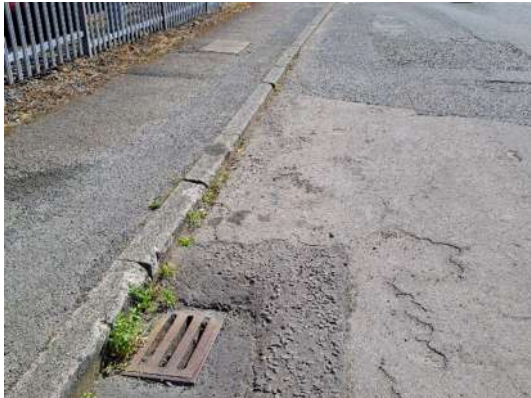
There is damage to an existing manhole cover within the carriageway and gully on the east side channel. Both have been subject to settlement, with the manhole cover level and one side of the gully being significantly lower than the surrounding road surface. The CCTV drainage survey shall confirm whether these issues have been caused by damage to the existing sewer or simply failure of the cover / frame bedding arrangement. (**refer to photograph 12, and 14**)

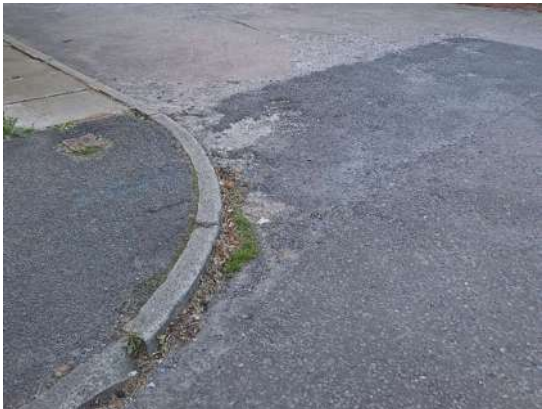
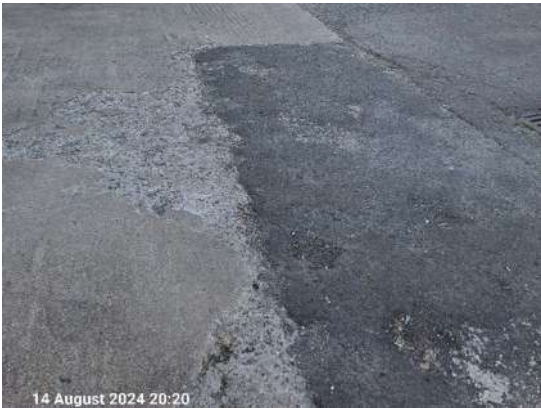
**Photographs 15 and 16** illustrates the damage to the carriageway within the entrance to GLD properties, where the thin layer of Asphalt at the front of the access has broken away in parts and sections of the concrete construction surface (further into the access) has worn away to expose the aggregates of the concrete.

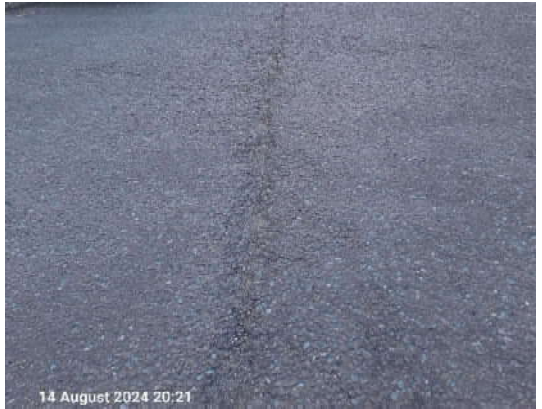
**Photograph 17** shows what appears to be the failure of a joint within the road surface, the likely cause being water ingress and expansion during colder periods.

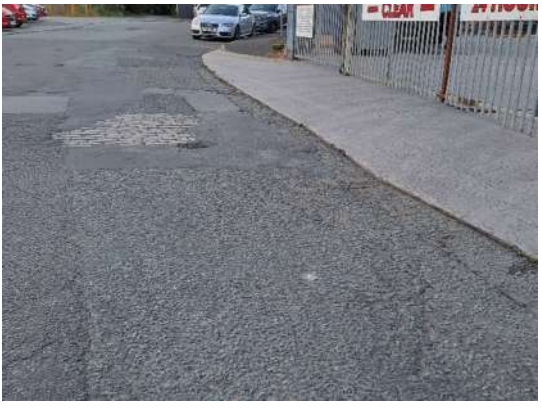
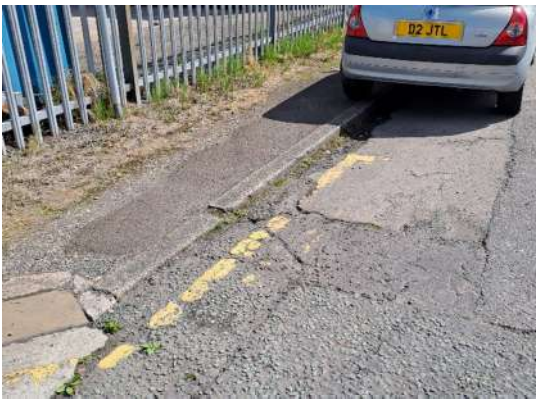
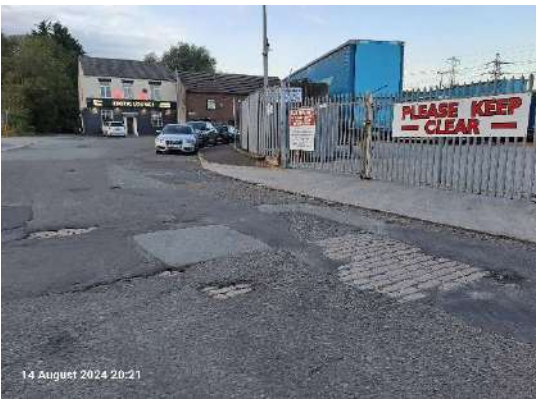
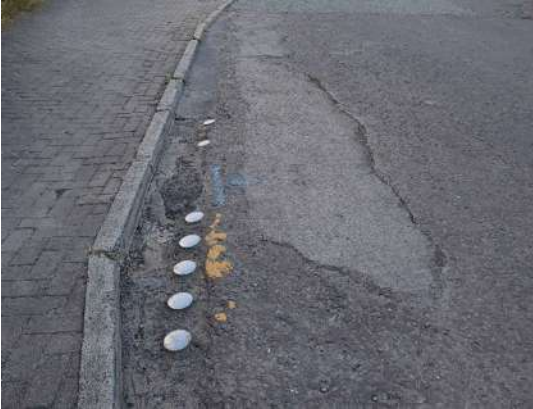
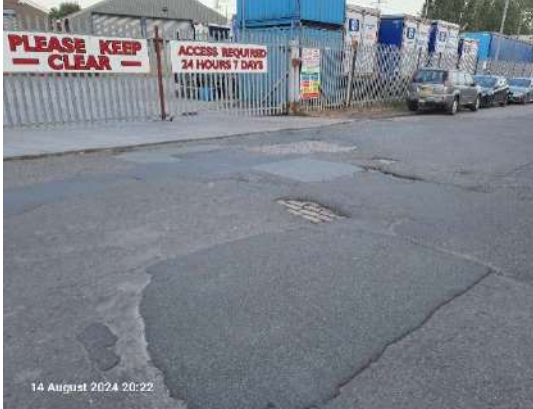
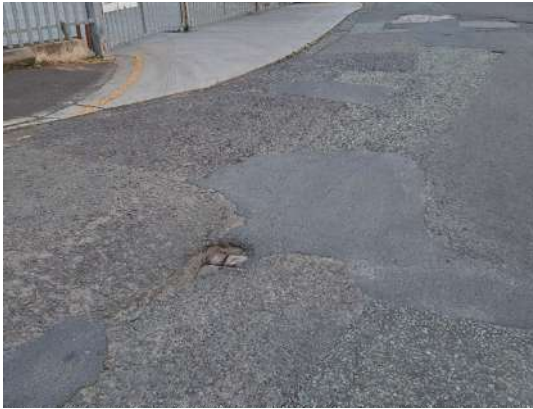
**Photographs 18 to 22** demonstrate the extremely poor condition of the carriageway in the vicinity of the entrance to J O Transport Ltd. There are many instances where the carriageway surface has completely worn away to expose the old cobblestone construction below. There also appears to be have been various sections of patch repairs undertaken over the years, as it is evident that there are various sections of different types of surface course material across the area.

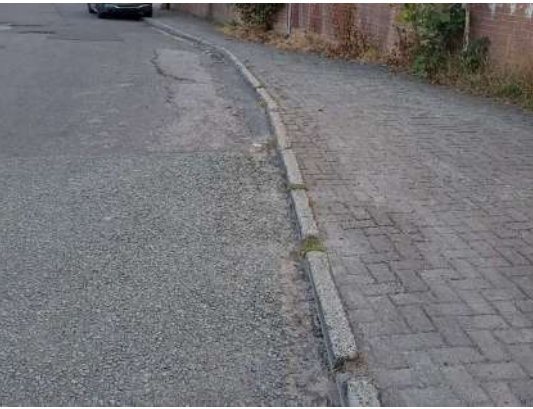
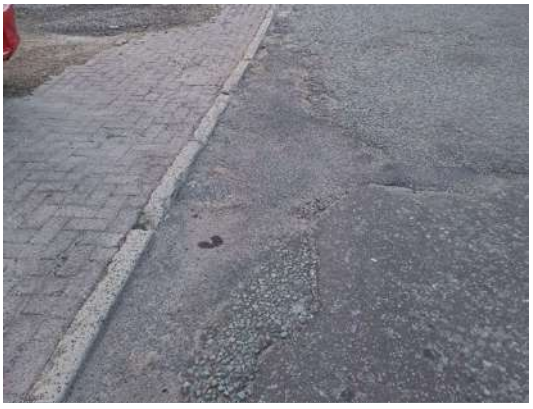
**Photographs 23 & 24** have been taken to indicate the level of damage to the kerbs and footways. Both images show the poor condition of the kerbs, footways, and carriageway along the channel (which has been repaired at some stage).

The kerbs in this area are in extremely poor condition where, unsurprising due this being a former industrial access, many kerbs have cracked, moved, and completely failed in some cases as a result vehicles overrunning them. There is also significant damage to the carriageway along the channel along the front of the kerb, which appears to have been repaired at some point. (refer to photographs 24, 29, 30, 31).

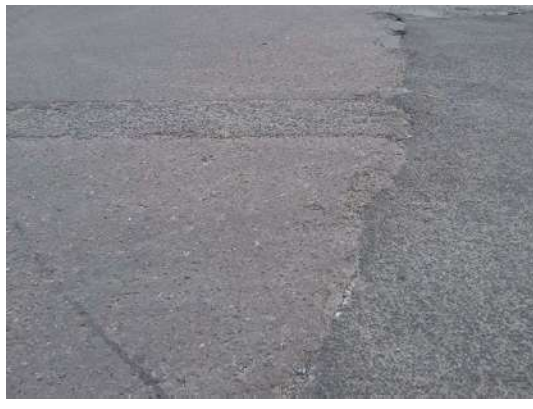
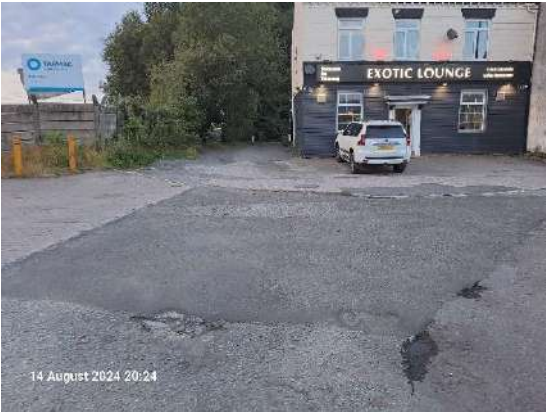
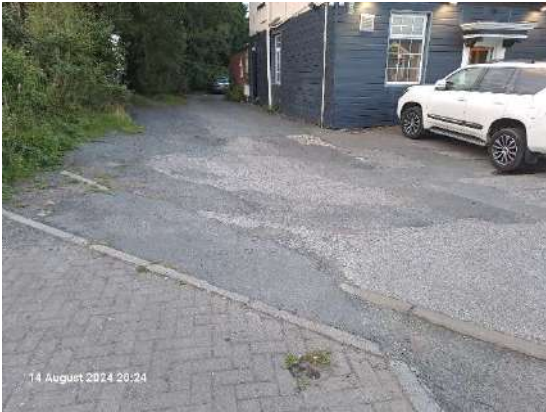
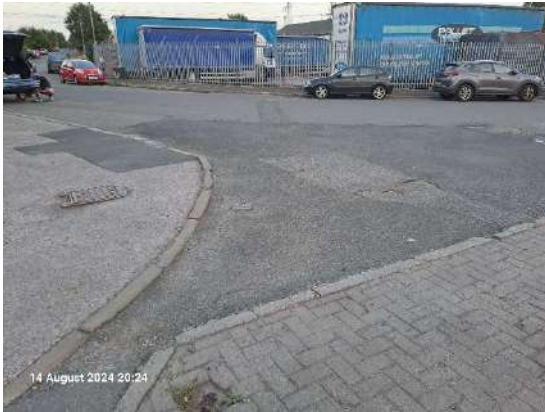
The images taken highlight patchwork repair and utilities trench scarring / reinstatement across the carriageway, all of which are insufficiently jointed to prevent water ingress and potentially future and more significant damage to the road structure. (refer to photographs 24 to 28).

As with other areas along Stopes Road covered thus far in this survey report, there are many areas where there are holes and cracks in the surface. (refer to photograph 26 as an example)

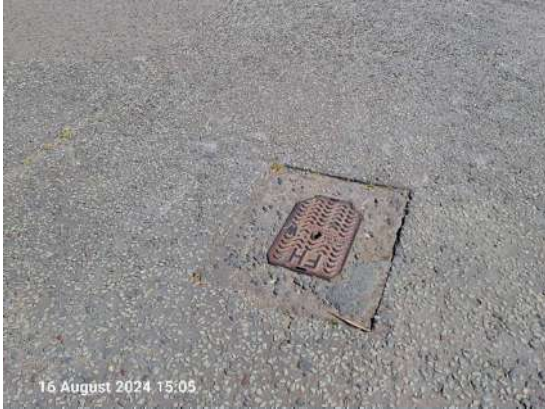
**Photograph 39** illustrates failure of the surface course reinstatement around a fire hydrant chamber that has been installed more recently than the surrounding carriageway. **Photographs 41 & 42** show longitudinal cracking to the road surface, surface patch repairs, and again utilities trench scars (which are present along the length of Stopes Rd from No.150 to the gas governor to the east).

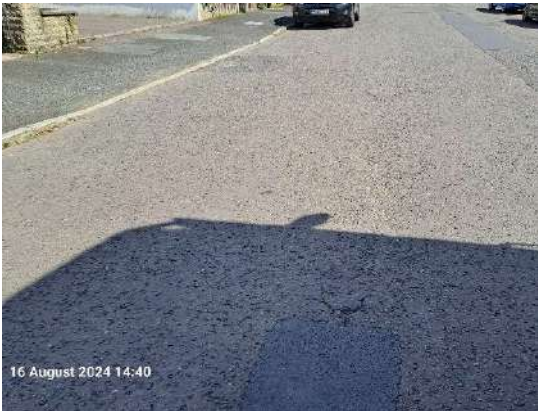
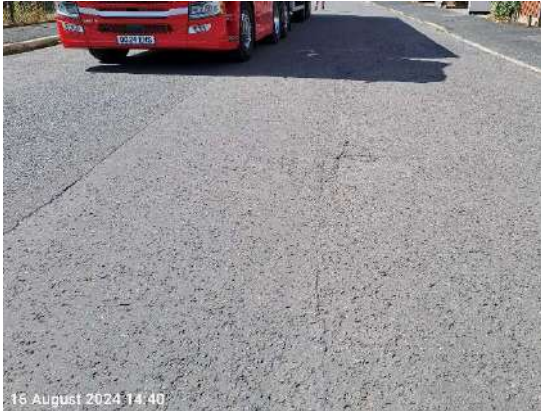
**Photographs 39 to 42** show damage to the carriageway in the vicinity of the existing access to 'Aurora Foods'. The entrance area itself is in poor condition, with deterioration of the road surface along the channel / joint resulting in an uneven channel profile (which may result in poor drainage and surface ponding). The utilities trench scar across the access is showing signs deterioration and there is a section where the binder is worn down to expose the aggregates within the road surface.

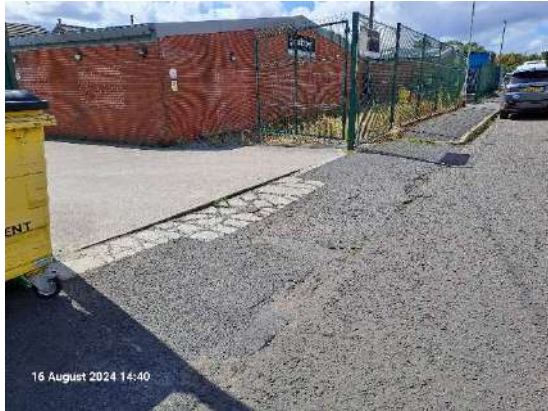
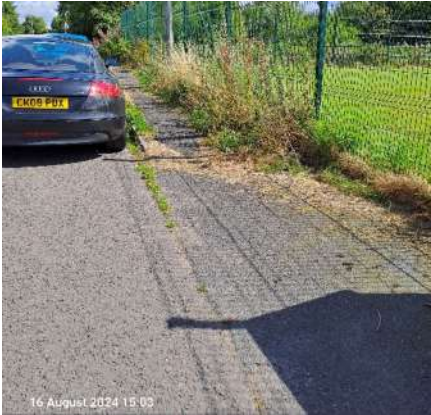
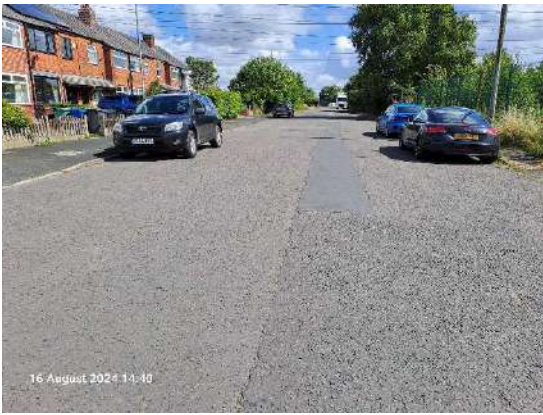
**Photographs 43 to 45** indicate the condition of the highway at the existing access to 'gowallpaper' business. The entrance area is in very poor condition with a range of defects evident.

- There is a significant amount of cracking to the road surface across the access.

- Complete failure of the road surface along the joint at the front of the access.
- There is a patch of concrete which has failed – with substantial cracking and settlement illustrated by the photographs.

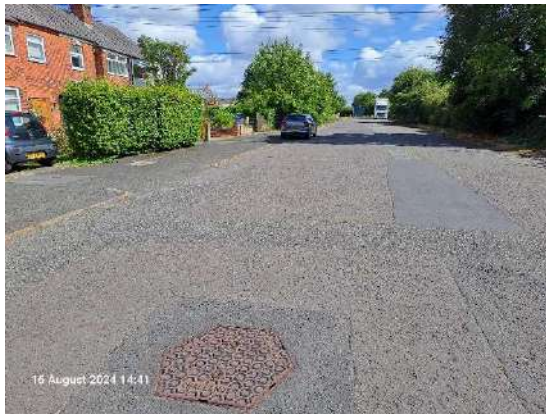
**Photographs 44 to 46** illustrate utilities trench scarring, surface patch repairs referred to earlier in this report. They also highlight the damage to the road surface course, where the asphalt binder appears to have deteriorated in places thus resulting in the aggregate being more exposed than acceptable levels. To the east of the access there is a substantial amount of weeds and grass along the kerb / channel and back of footway, which is likely to have caused damage to the footway construction. This continues further east up to a dis-used access, which has become severely overgrown with vegetation (**refer to photograph 50**).

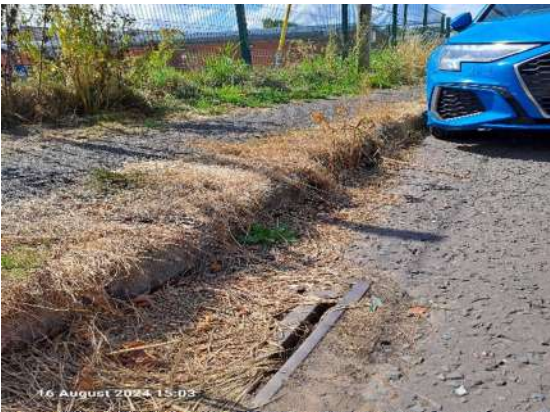
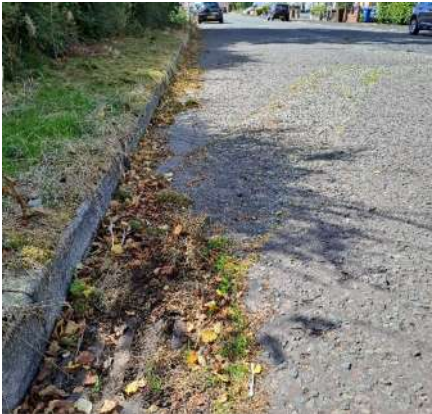
**Photographs 47 and 53** show existing gullies located on the south side of Stopes Road that are completely blocked and were not visible during the site walkover due to being covered with grass. The drainage of surface water from the highway will undoubtedly be affected. **Photograph 53** also further highlights the issue with weed and moss growth within the carriageway area along Stopes Road.

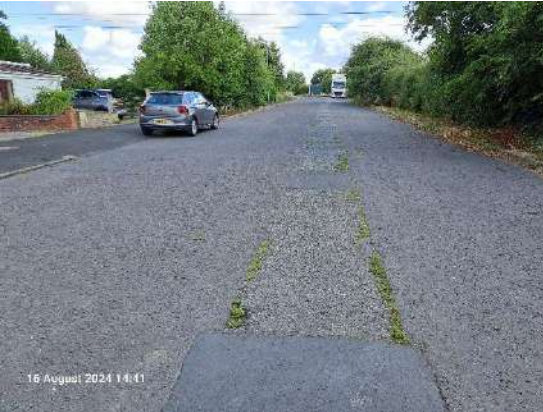
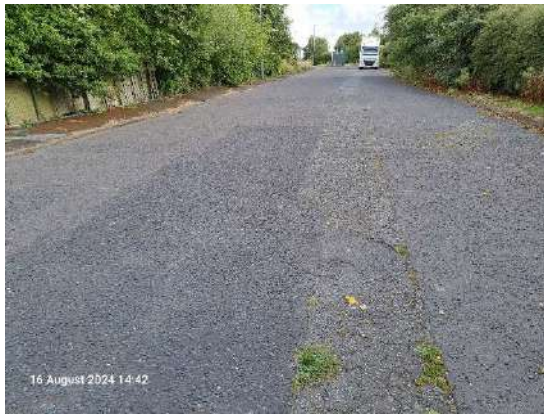
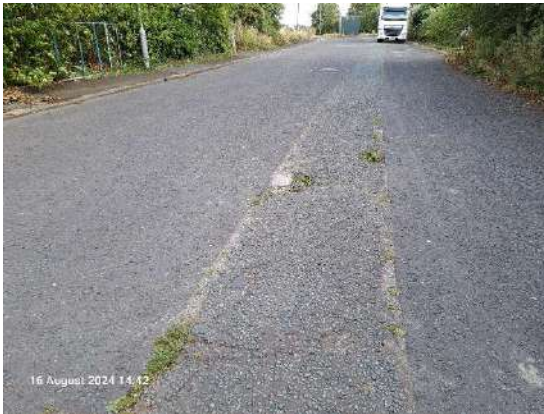
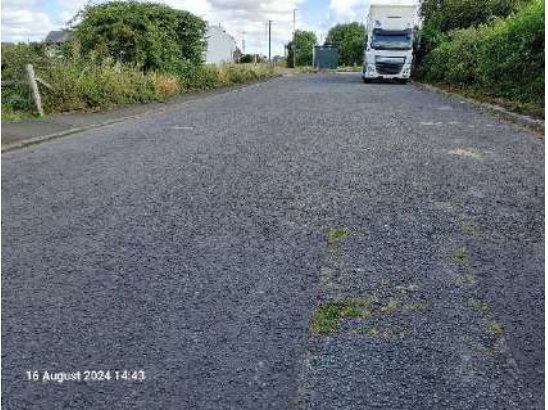
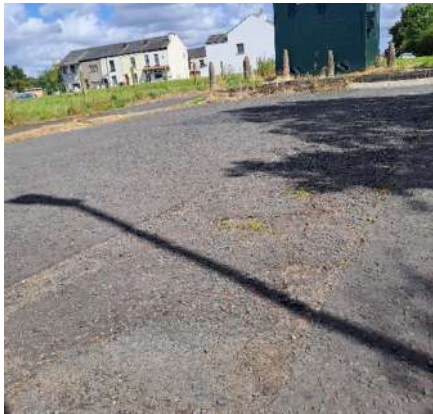
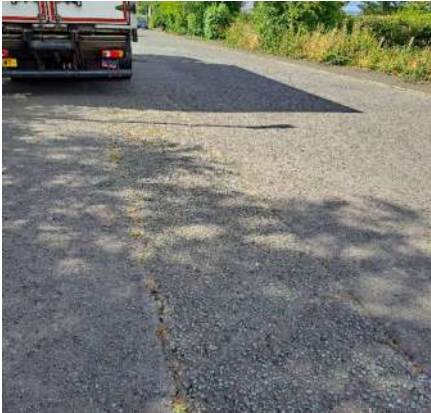
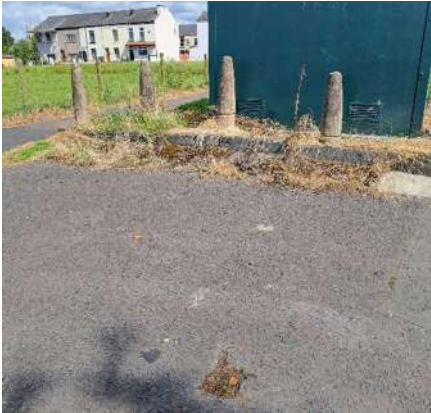
Photographs 48,51,54,56,61,62,63 provide further examples of the poor condition of the carriageway resulting from the utilities trench reinstatement undertaken along along the length of Stopes Rd from No.150 to the gas governor to the east.

There are numerous instances where grass / weeds have formed either along the edge / joint of the trench reinstatement or within sections where the road surface has failed and broken away.

As can be seen in the images taken, there are also many instances where the joint / surface has failed and broken away along the edges of the utilities trench reinstatement, which will

only deteriorate further over time due to surface water ingress and winter weather conditions.

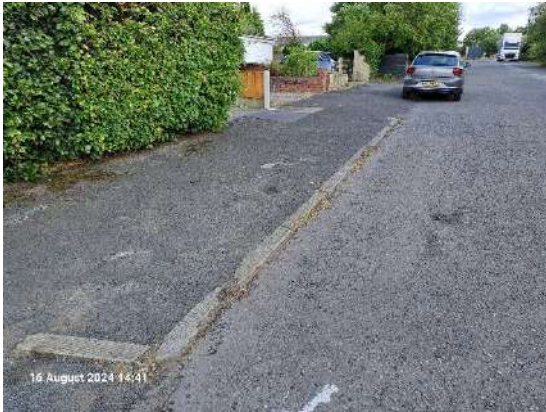
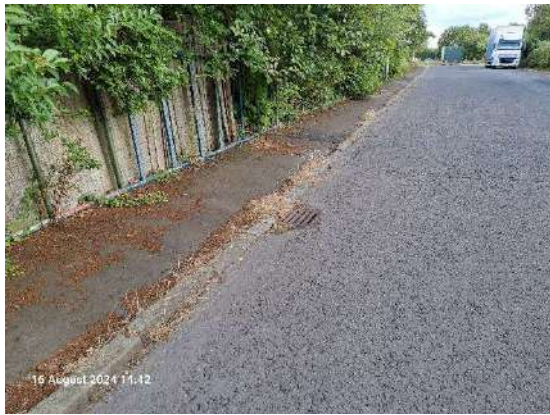
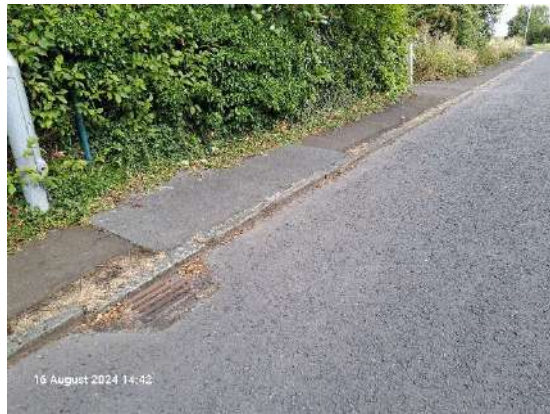
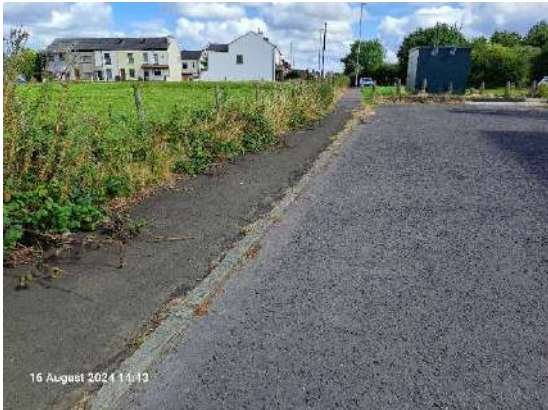
**Photographs 49,52,55,57,58,60** highlight the condition of the existing kerbs and footway along the northern side of Stopes Road, from property No.98 up to the end of the road in the vicinity of the gas governor.

In these areas the kerbs generally have a very shallow upstand, many have settled / moved significantly, and some have deteriorated to a point where sections of the kerb have broken away.

- A rough / course surface finish in parts.
- Cracking and settlement of the footway.
- An uneven surface with surface patching / scarring from trench reinstatement.
- A significant amount of grass covering the footway.
- Sections of the footway surface that have failed and broken / worn away.

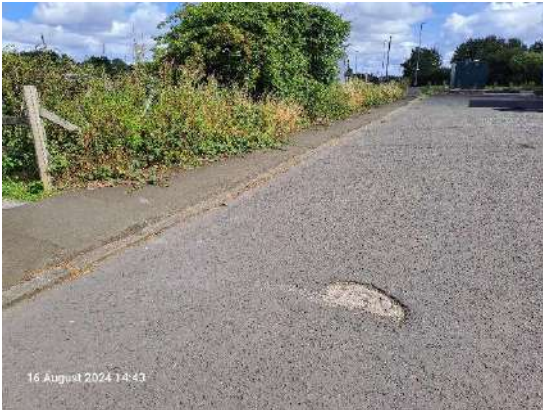
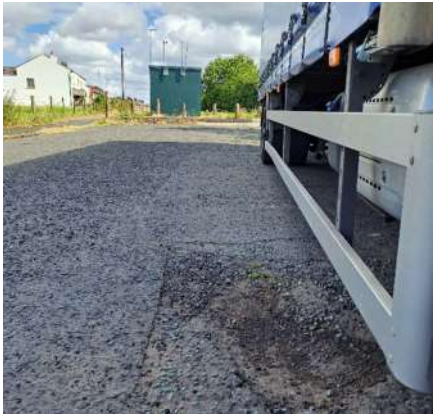
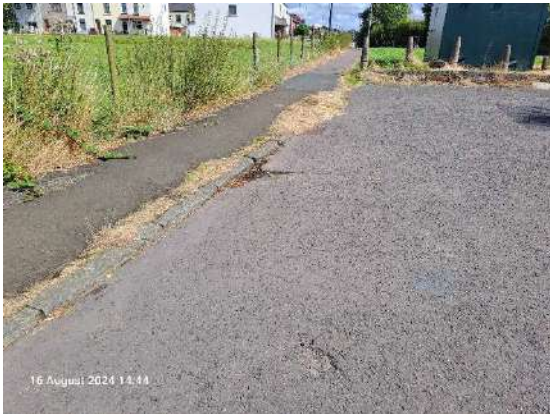
Photographs 57,59,60,63 highlight further damaged areas to the carriageway at the western end of Stopes Road, where patches of the road surface have completely failed and broken away. These areas will get worse over time and will spread over a larger area if left untreated, as surface water will penetrate beneath the surrounding road surface and resulting in further damage caused by freezing / expansion.

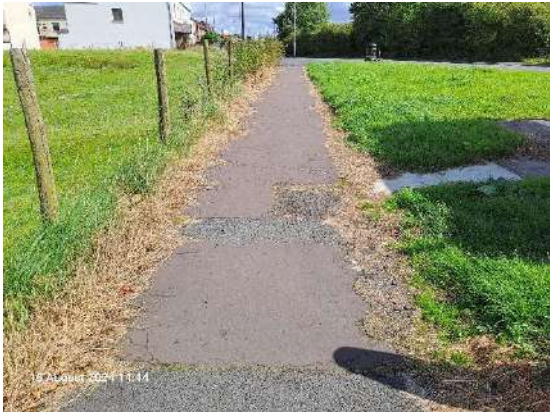
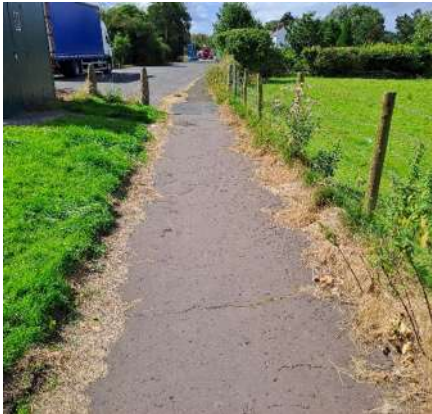
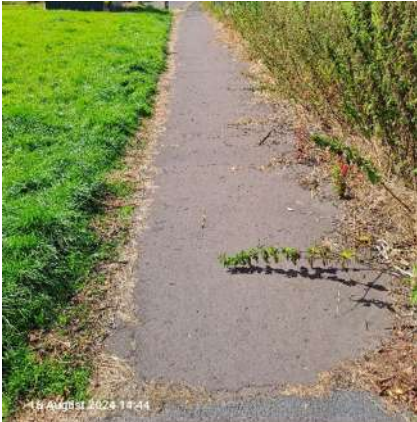
Photographs 64 to 66 show the footpath link at this location, which was seen to be in reasonable condition when compared to other areas of Stopes Road. However, there is a small section of the footpath which has failed / broken away (refer to photograph 65) and again there are areas of what appear to be utilities trench reinstatement.

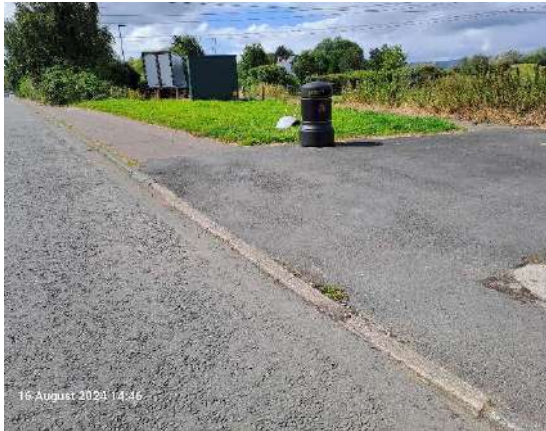
Moving further along the footpath towards the dropped kerb access to the west on the A6053, there is cracking to the footway surface and there is a buildup of grass along the edges but there doesn't seem to be any signs of significant damage (though this could be covered by the grass). Refer to Photographs 66 and 67.
