**SITE VISIT REPORT 15220-HYD-XX-XX-SVR-GE-1018**

**SHEET NO.: 6 of 18**

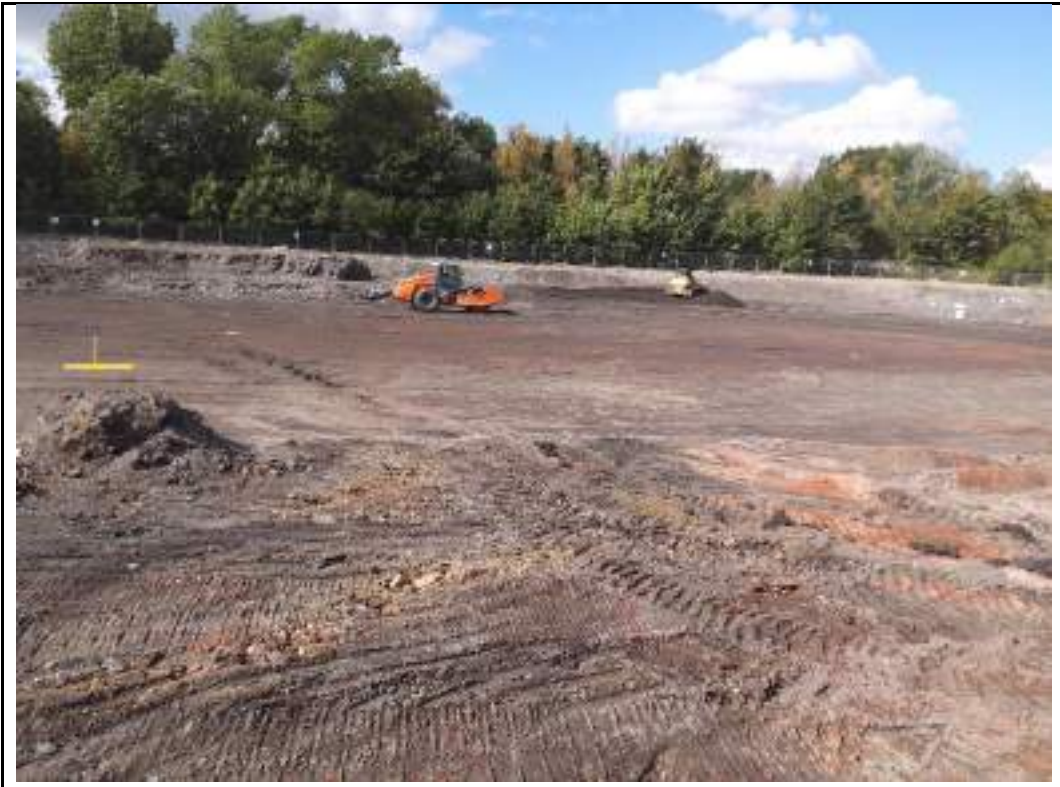
Photograph 9: Proof rolling and backfilling in western part of the site

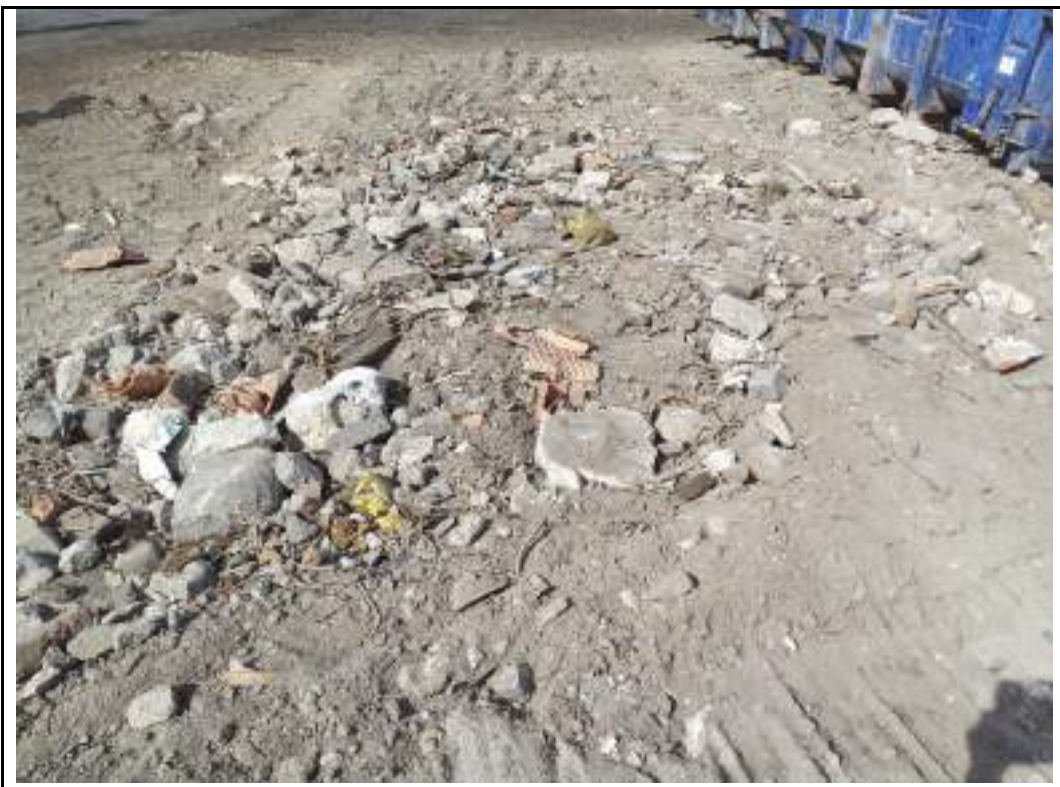
Photograph 10: Deleterious materials in central part of the site.

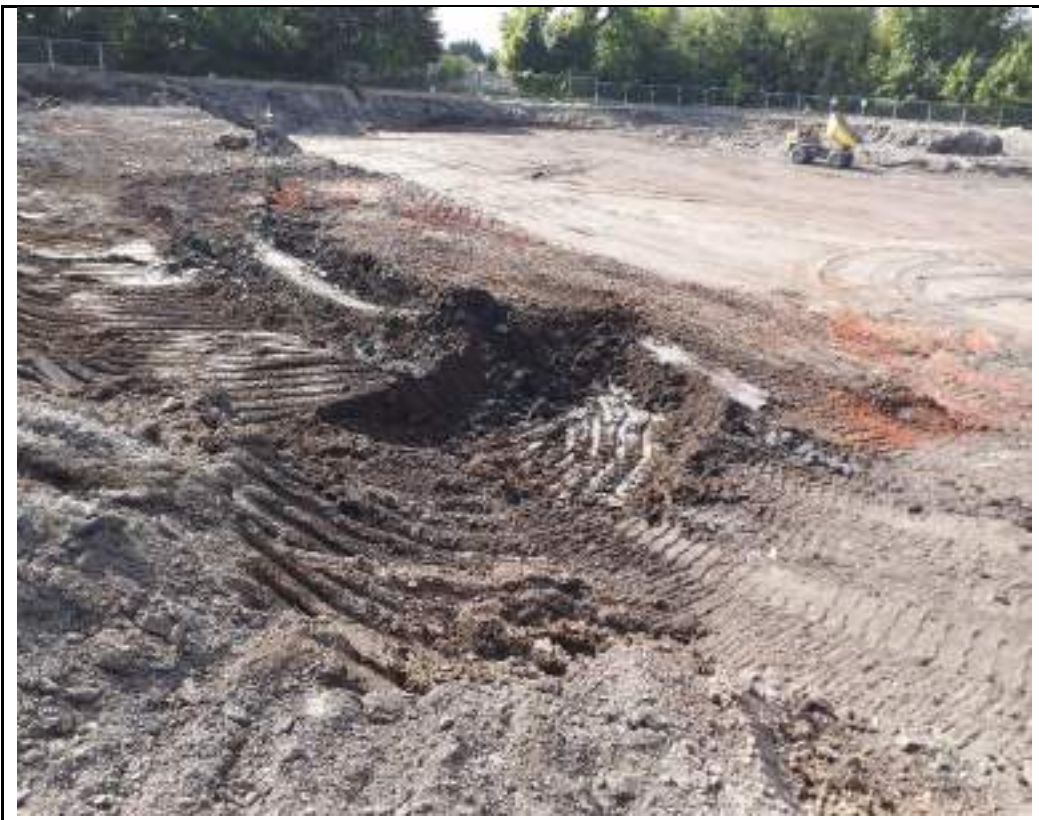
Photograph 110: Soft spot in excavation in southern part of the site.

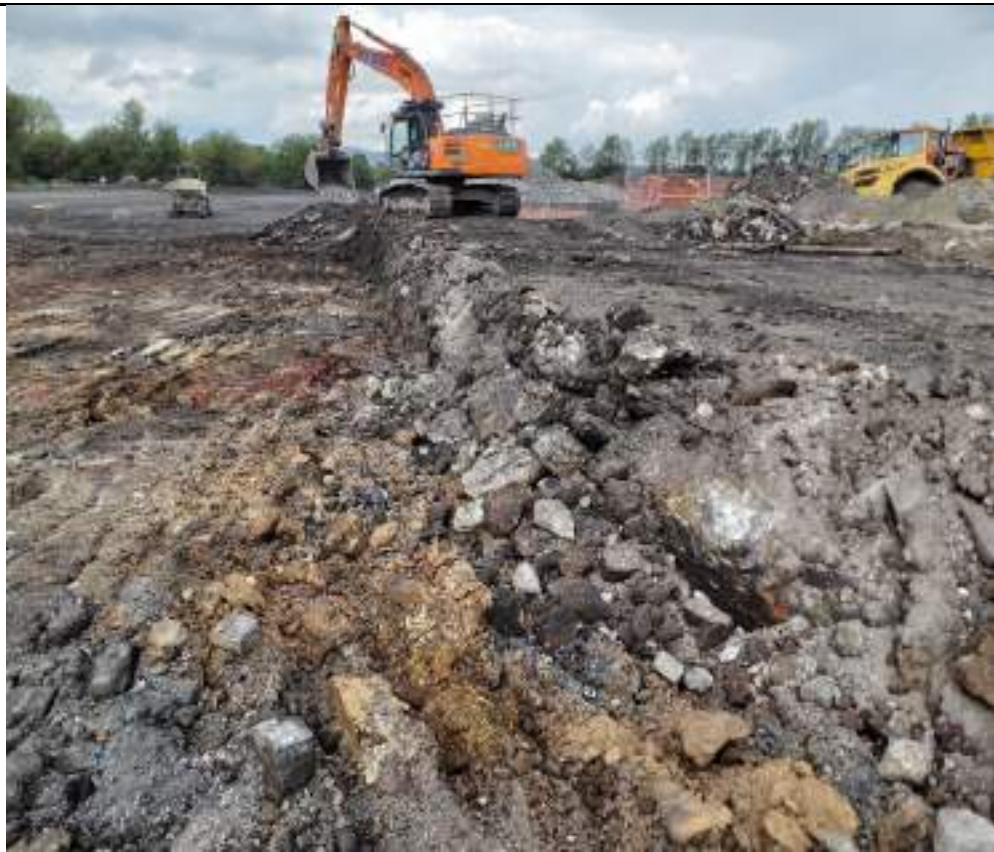
Photograph 8: Deleterious materials in excavation in southeastern part of the site.

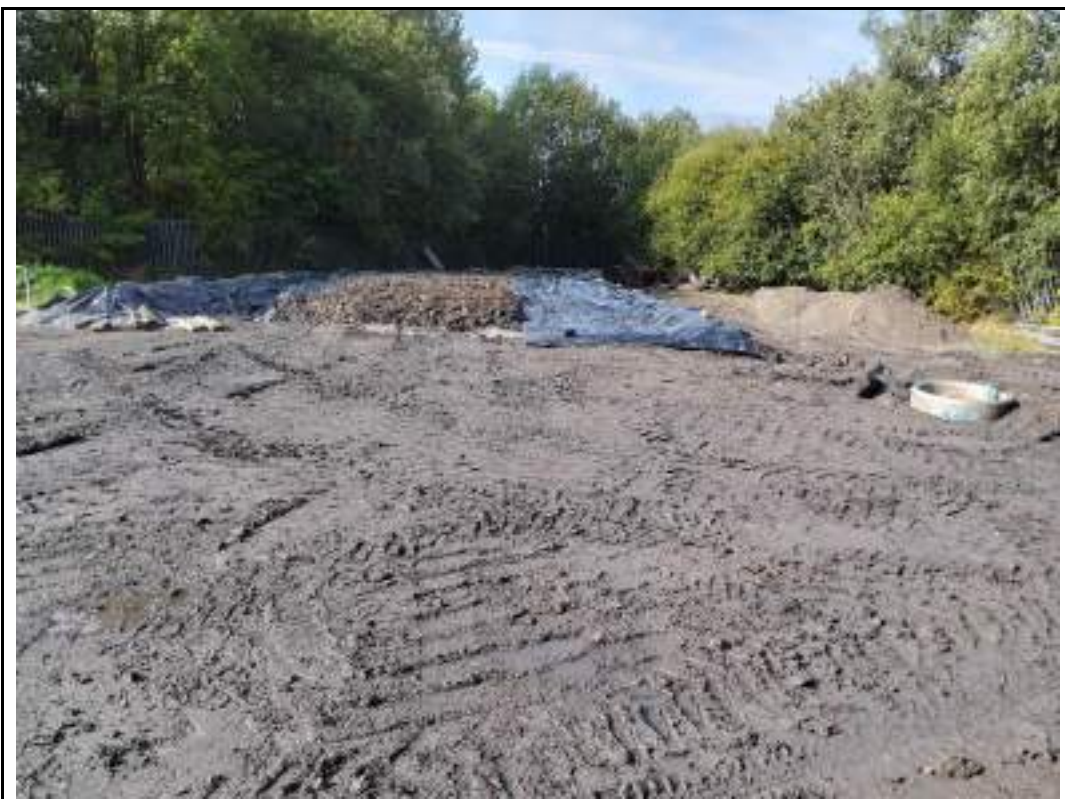
Photograph 110: Stockpile of potentially TPH contaminated material in northeast of the site.  
Material from excavation in southeastern part of the site.

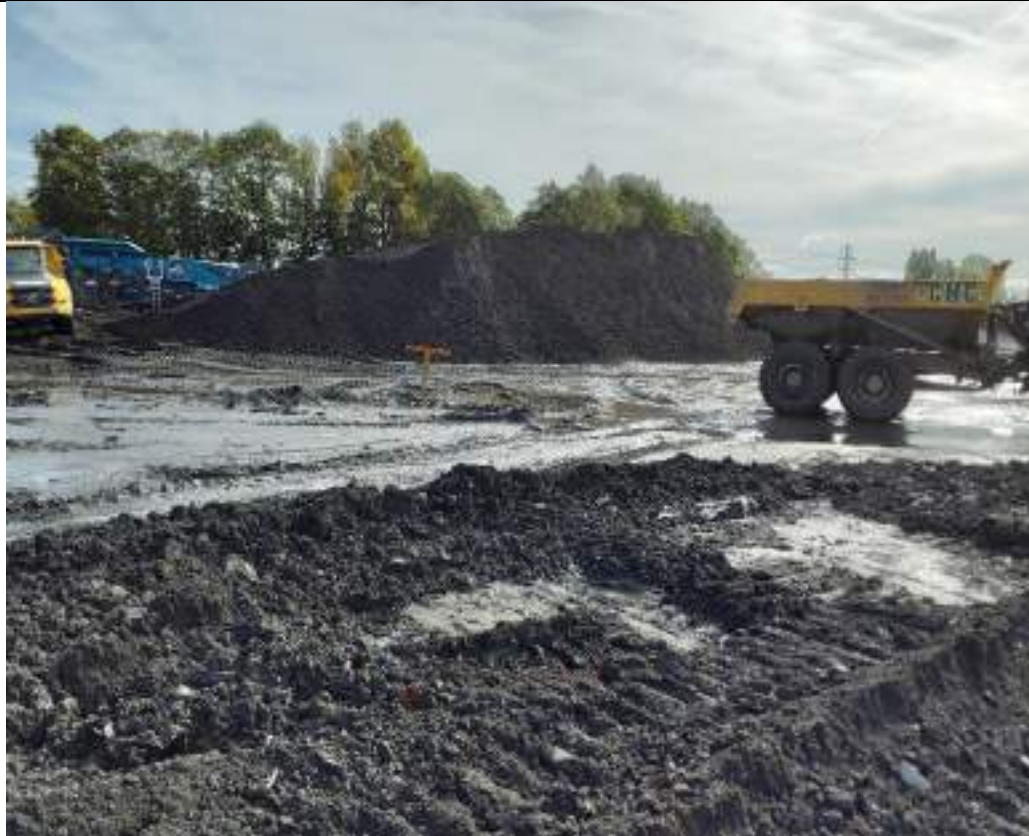
Photograph 25: Stockpile of undersize material from screener in northeast of the site.

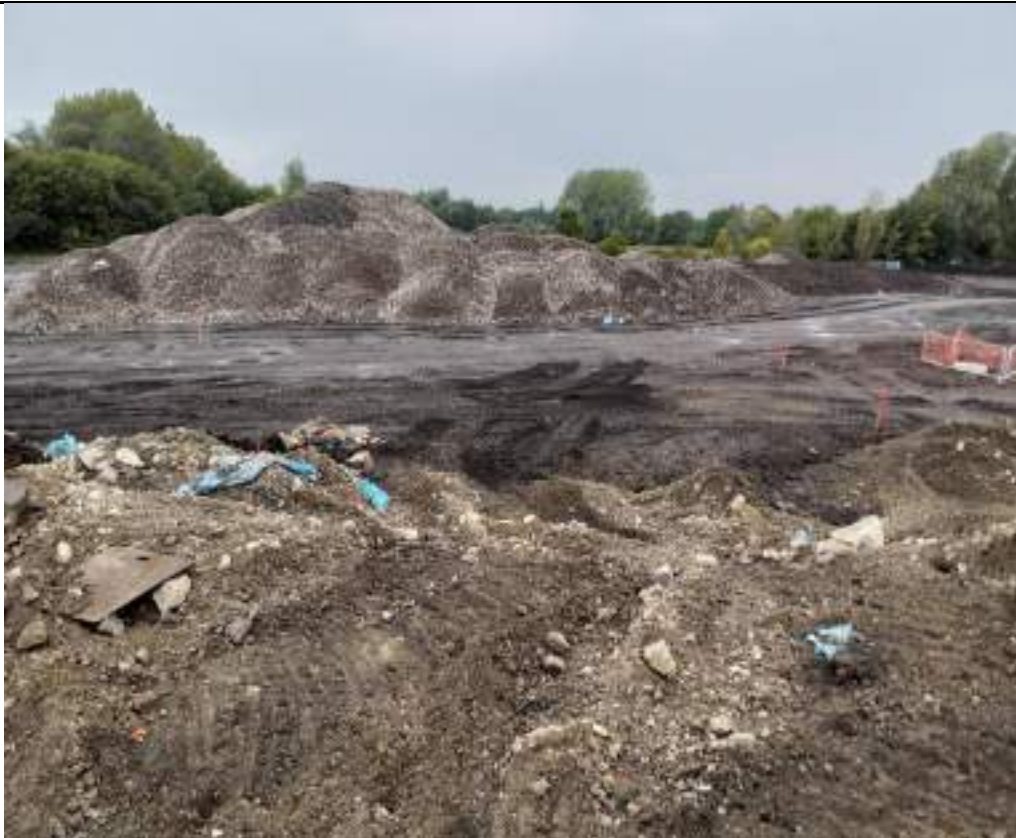
Photograph 136: Stockpile of crushed material in northwestern part of the site.

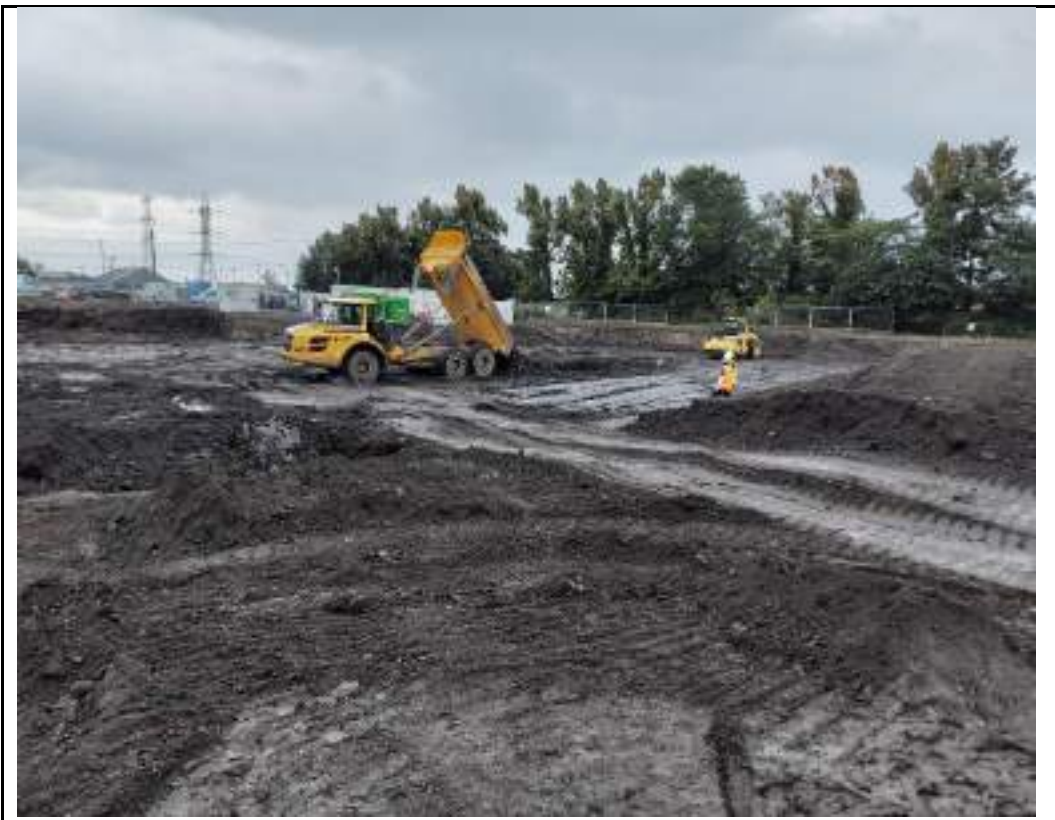
Photograph 12: Backfilling of soft spot excavation using crushed bricks as starter layer

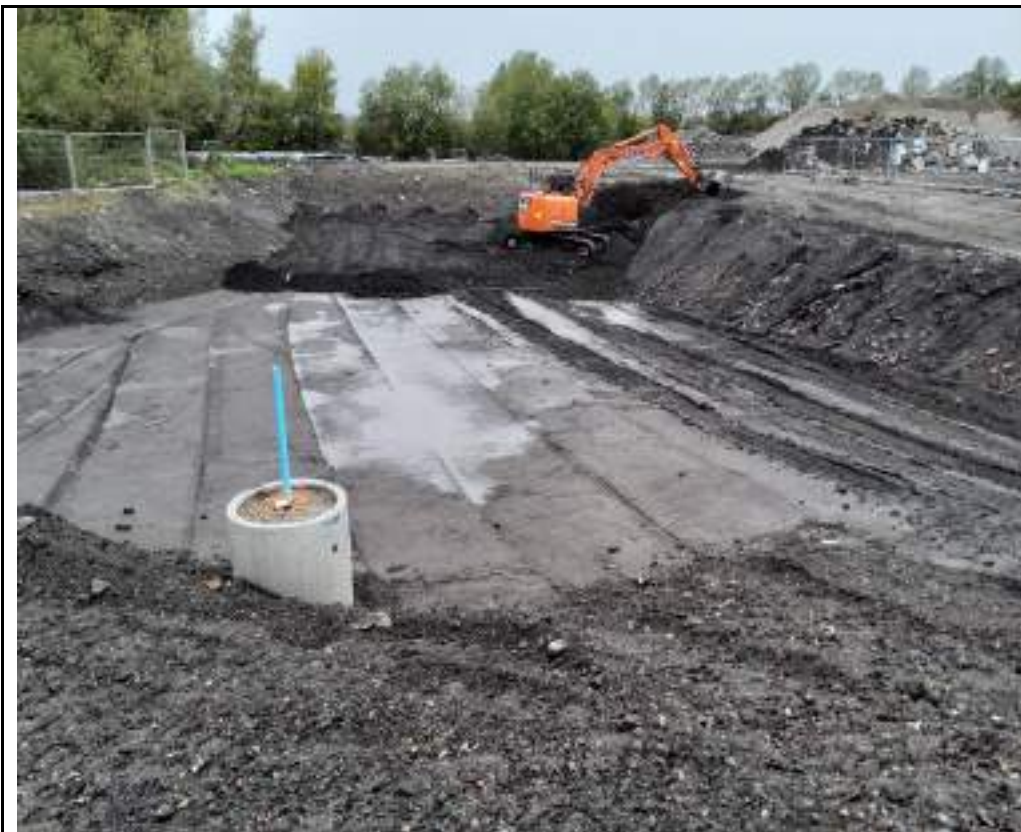
Photograph 12: Backfilling western part of the site using material from excavation in the west.

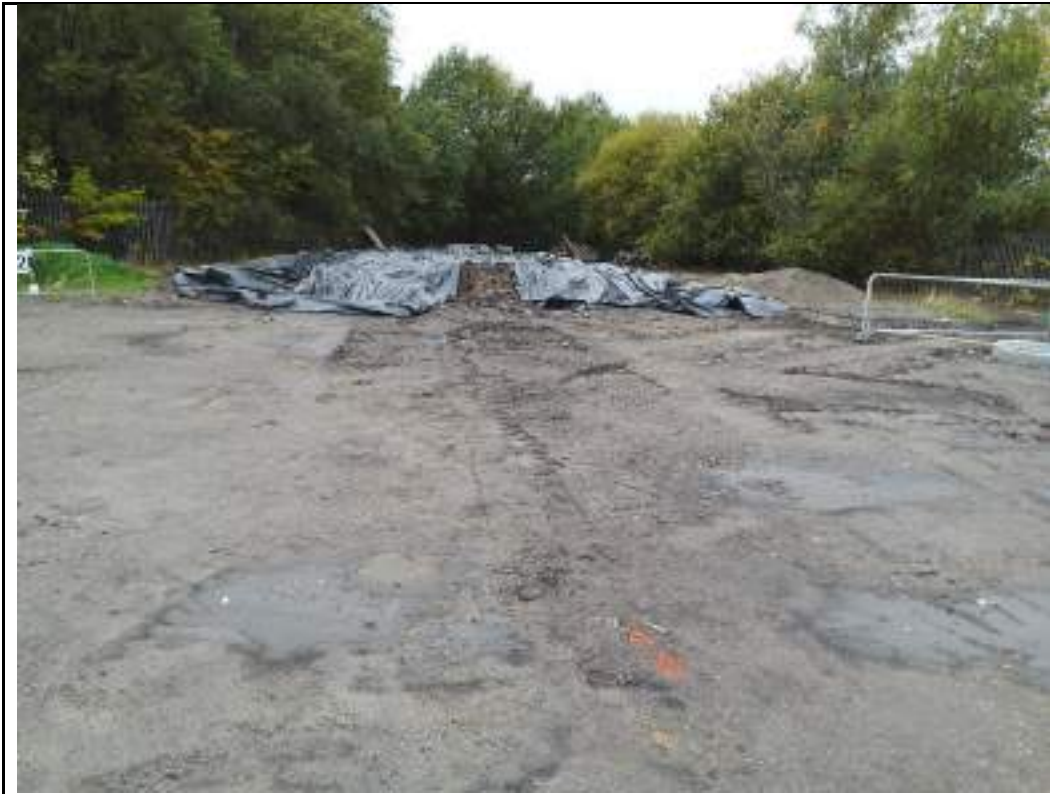
Photograph 15: Stockpile of TPH contaminated material in western part of the site.

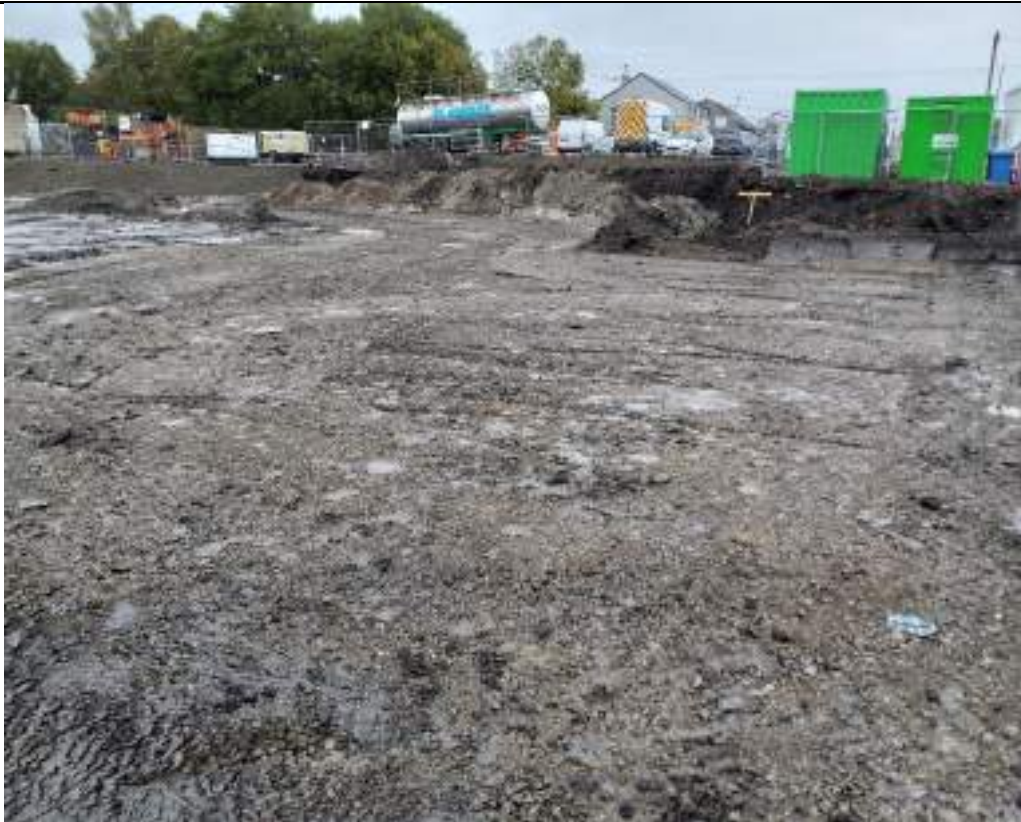
Photograph 20: Soft spot area backfilled with engineered fill in southern part of the site.

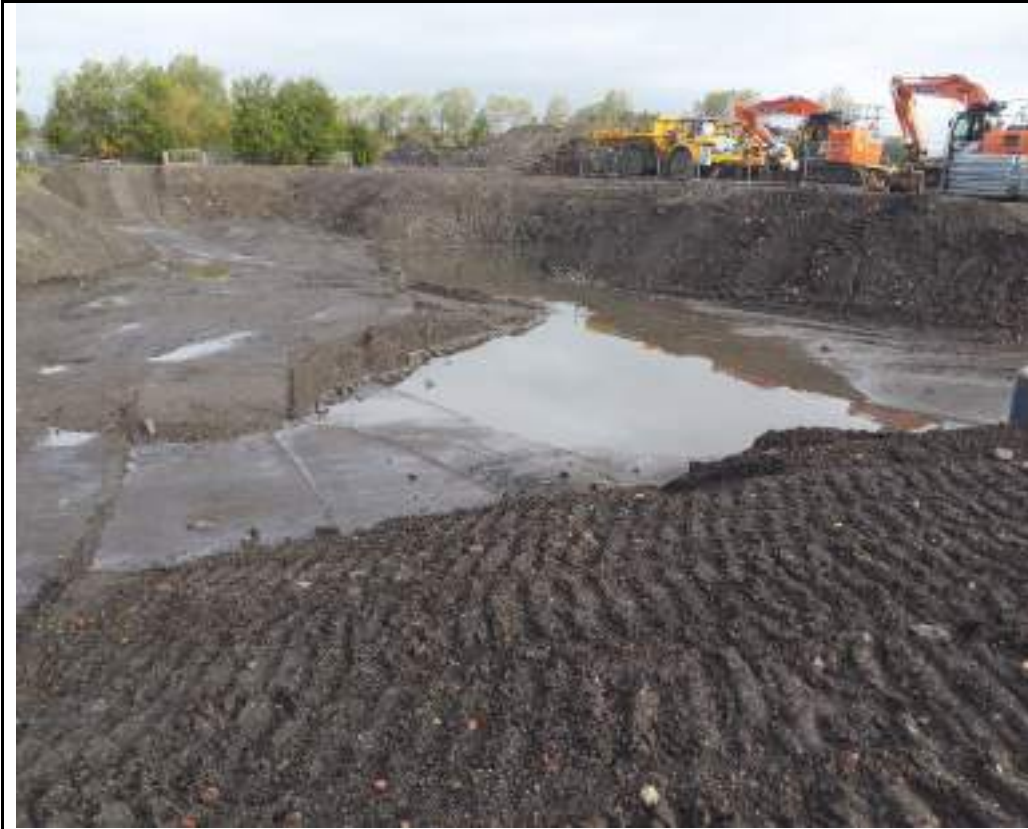
Photograph 17: Standing water in excavation for abstraction well in western part of the site.

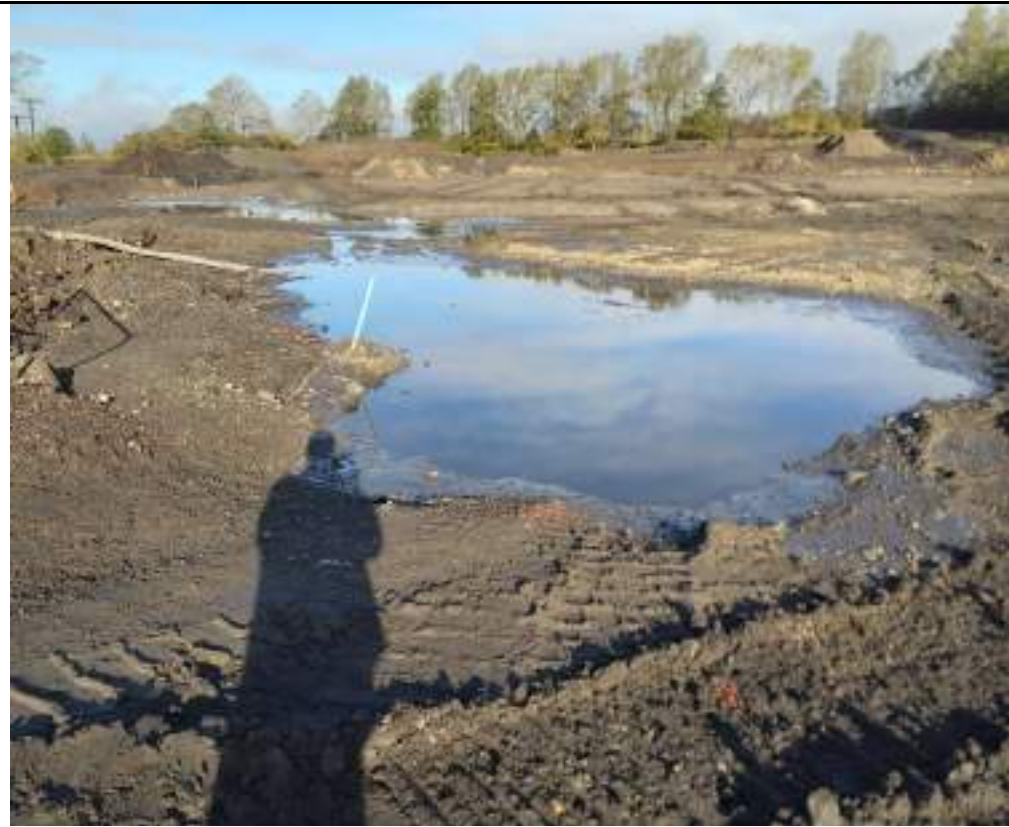
Photograph 9: Standing water in northern part of the site.

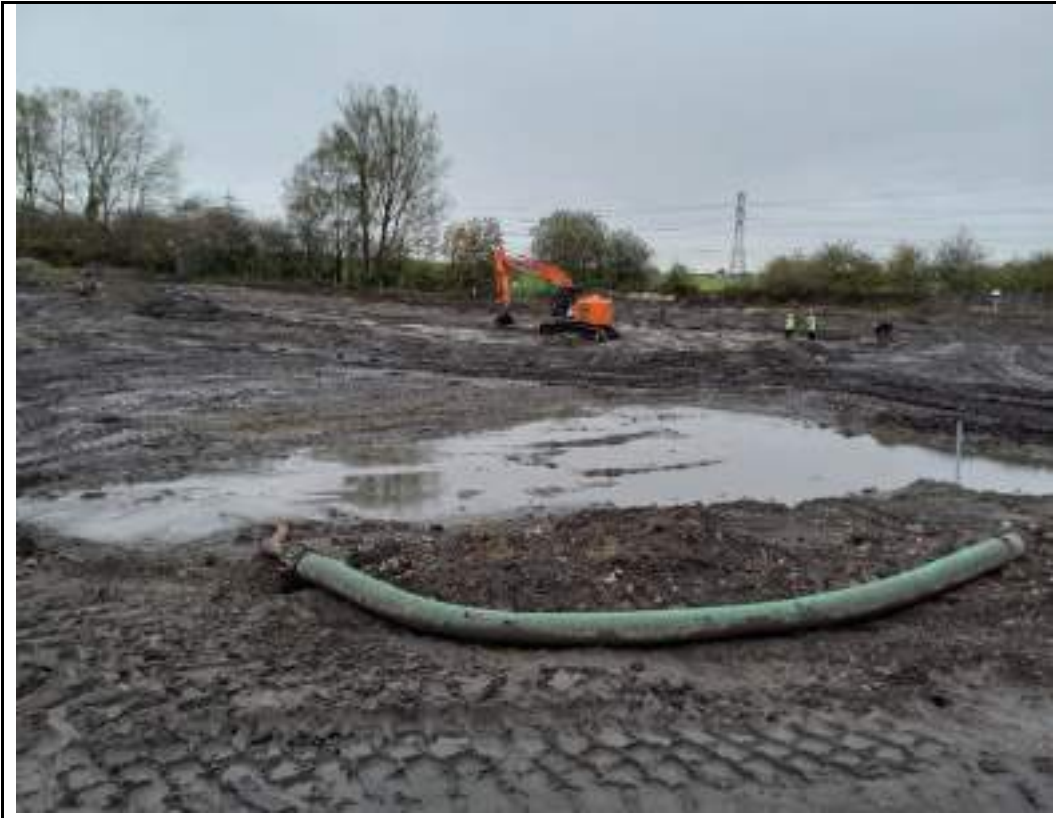
Photograph 9: Standing water in northern part of the site.

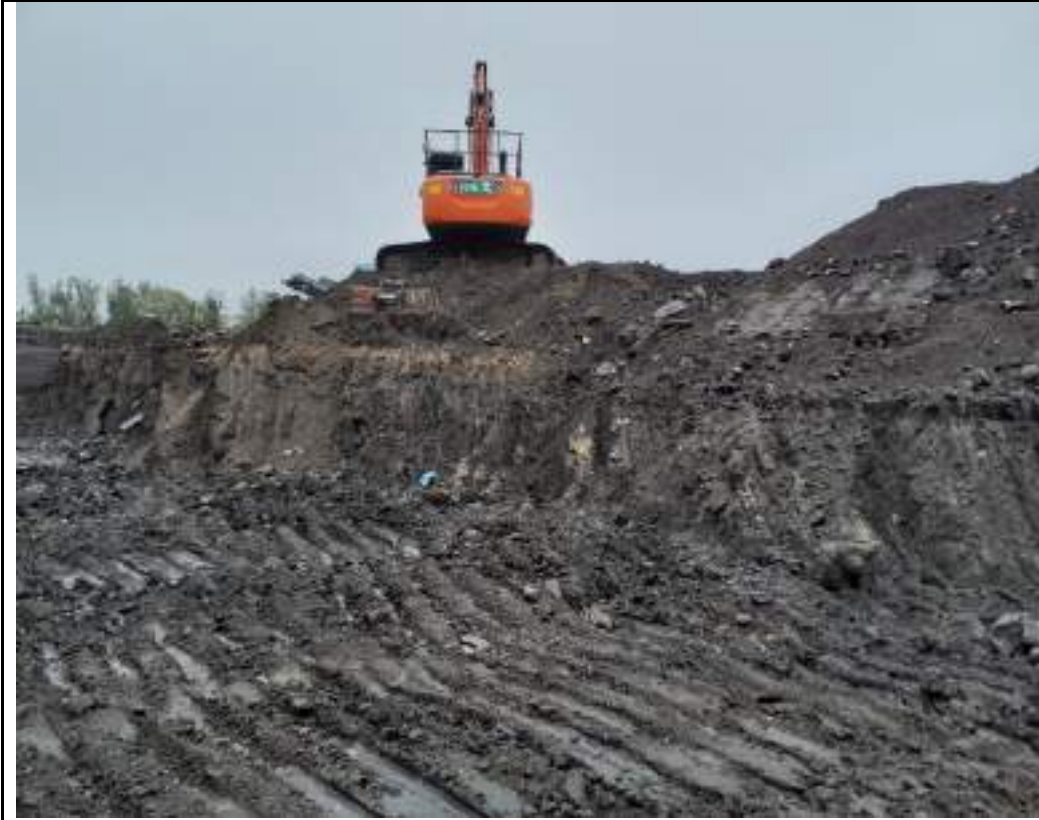
Photograph 15: Unbattered excavation in northeastern part of the site.

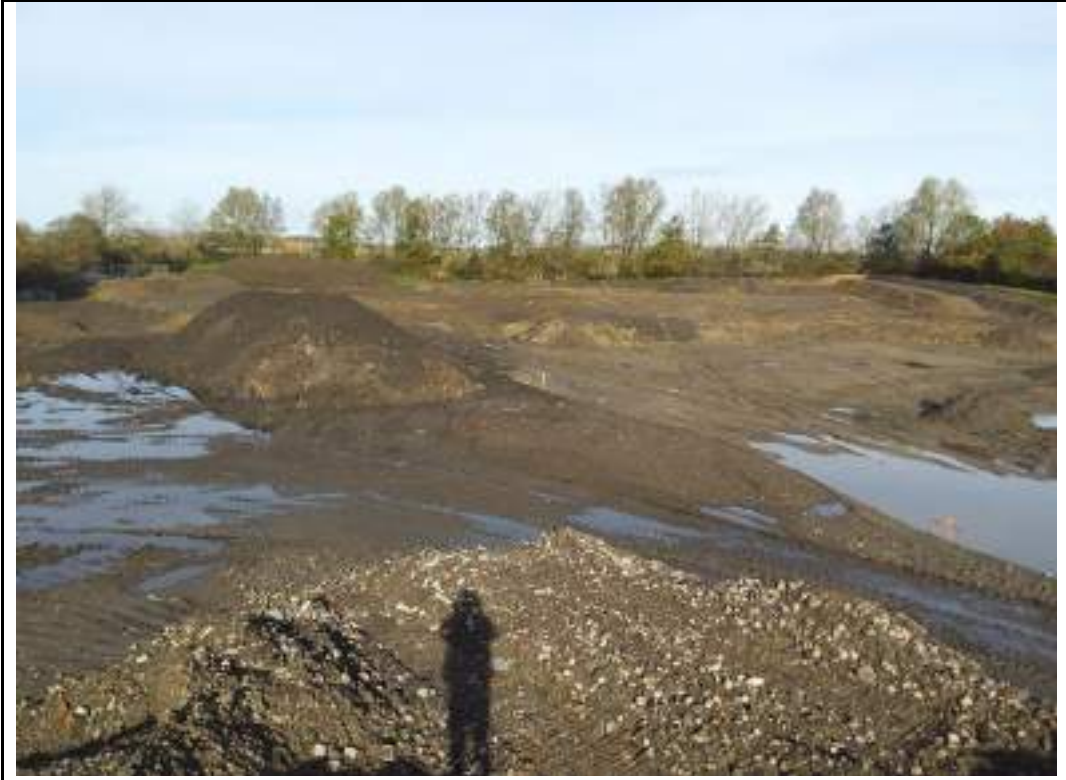
Photograph 15: Overview of stockpiles of unsuitable materials in northern part of the site.
