| SITE VISIT REPORT 15220-HYD-XX-XX-SVR-GE-1035 | | SHEET NO.: 1 of 20 | |
| Project: Stopes Road, Bolton | | Date: 09/11/22 | |
| Client: Harworth | | Weather: Cloudy | |
| Doc Ref: 15220-HYD-XX-XX-SVR-GE-1035 | | Status & Revision: S2 – P1 | |

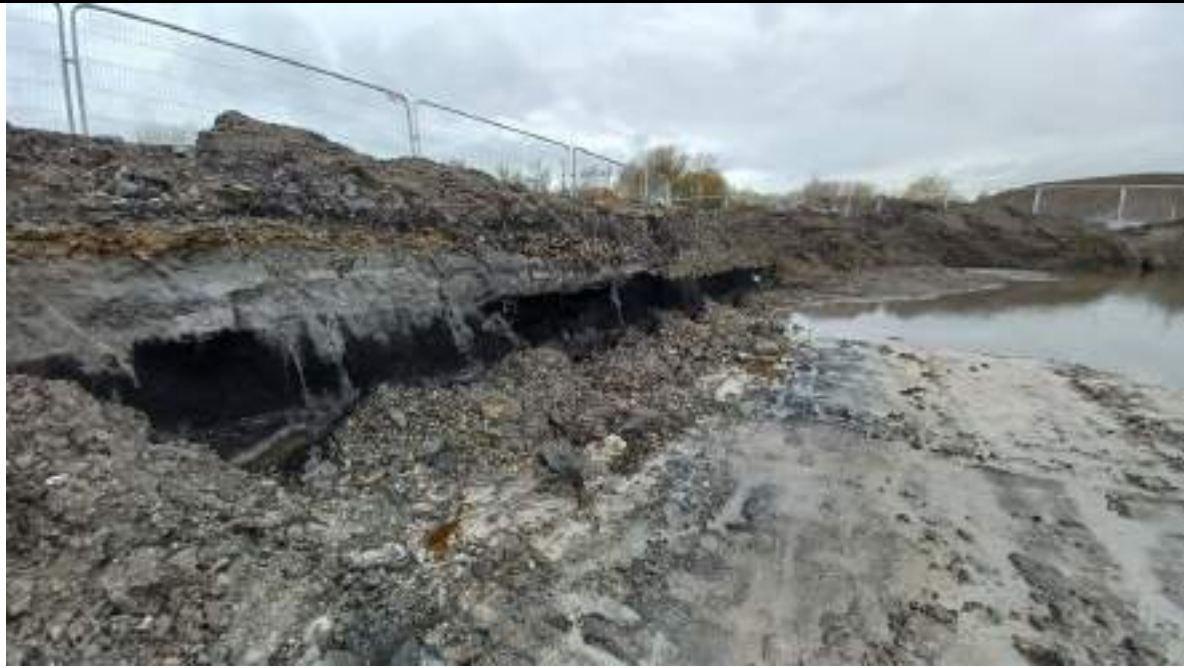
Photograph 5: Some steep excavations noted. Recommend reducing and battering back prior to winter shutdown

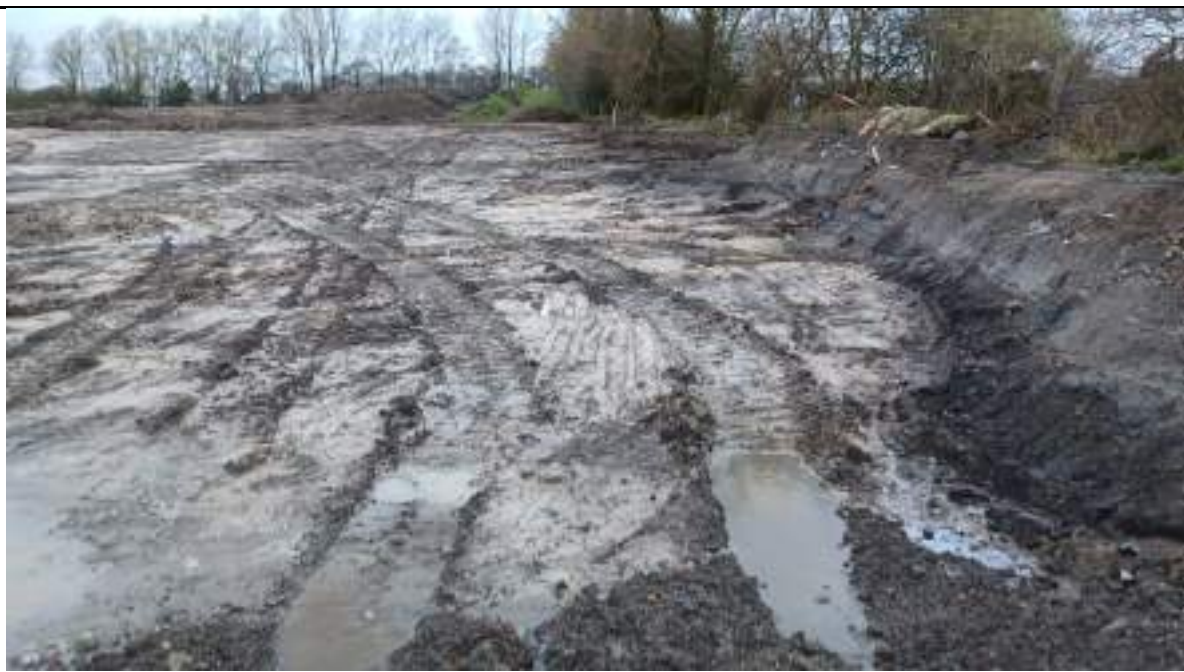
Photograph 6: Natural soils exposed at surface during over-dig.

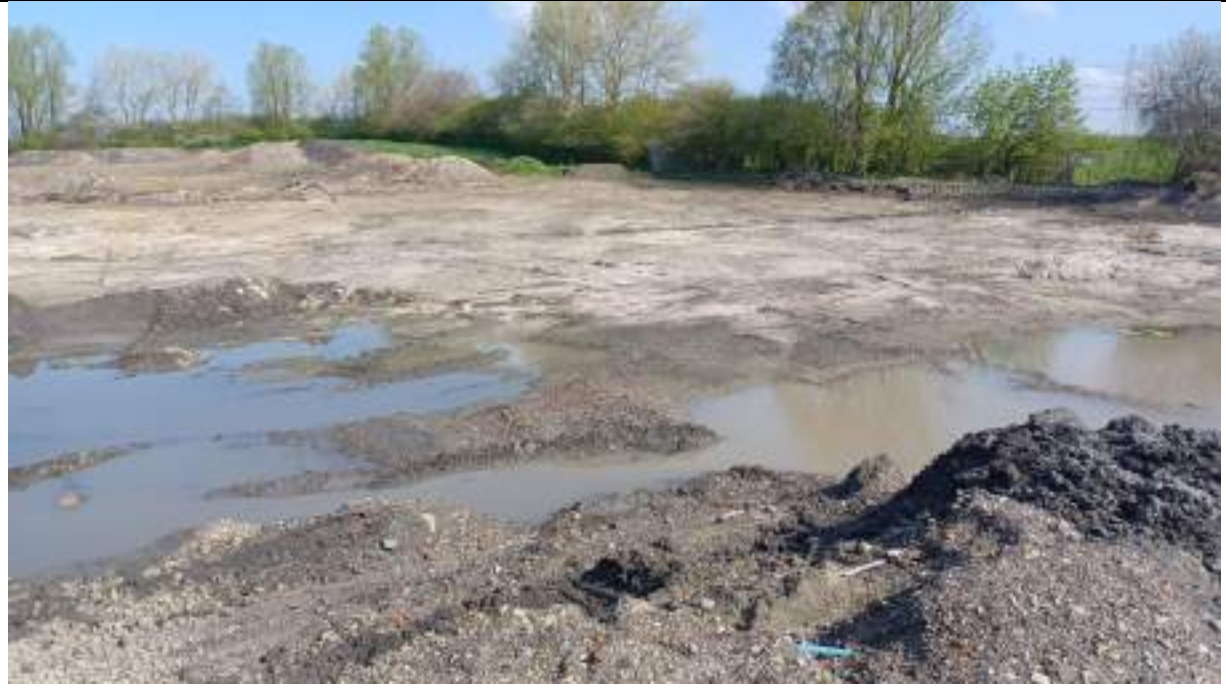
Photograph 5: Cut area in the northeast corner of the site. Some standing water observed

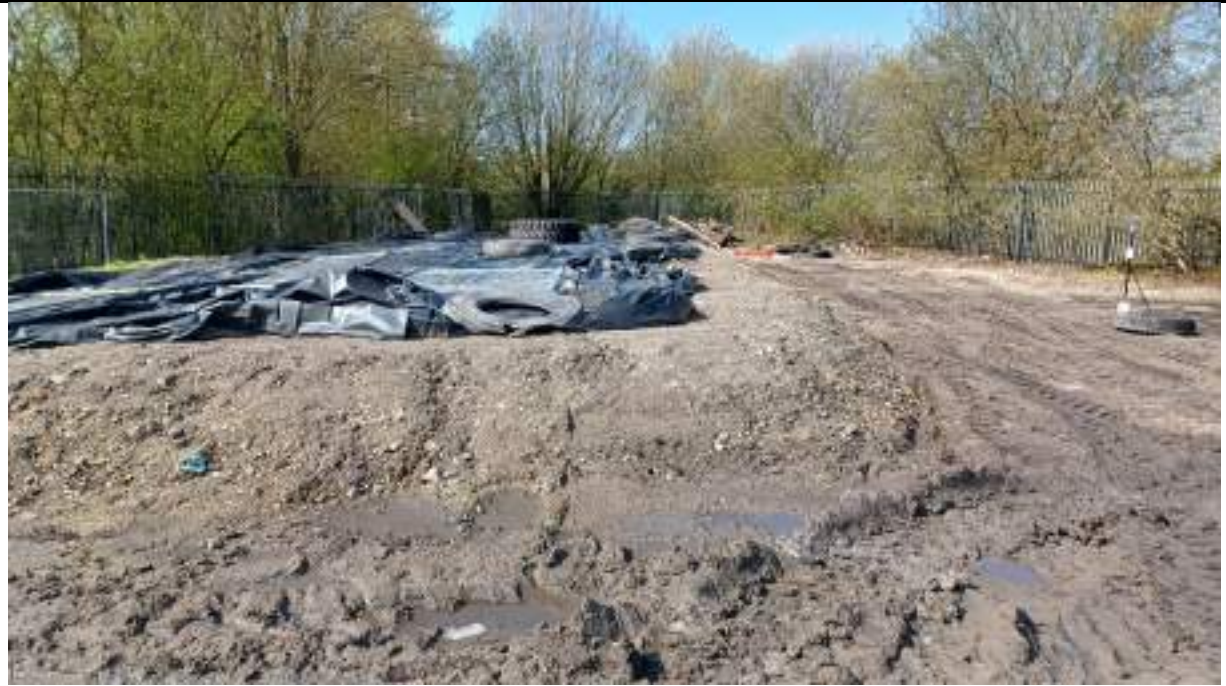
Photograph 6: Hotspot 7 stockpile in eastern corner of site. Awaiting the results of testing to confirm suitability

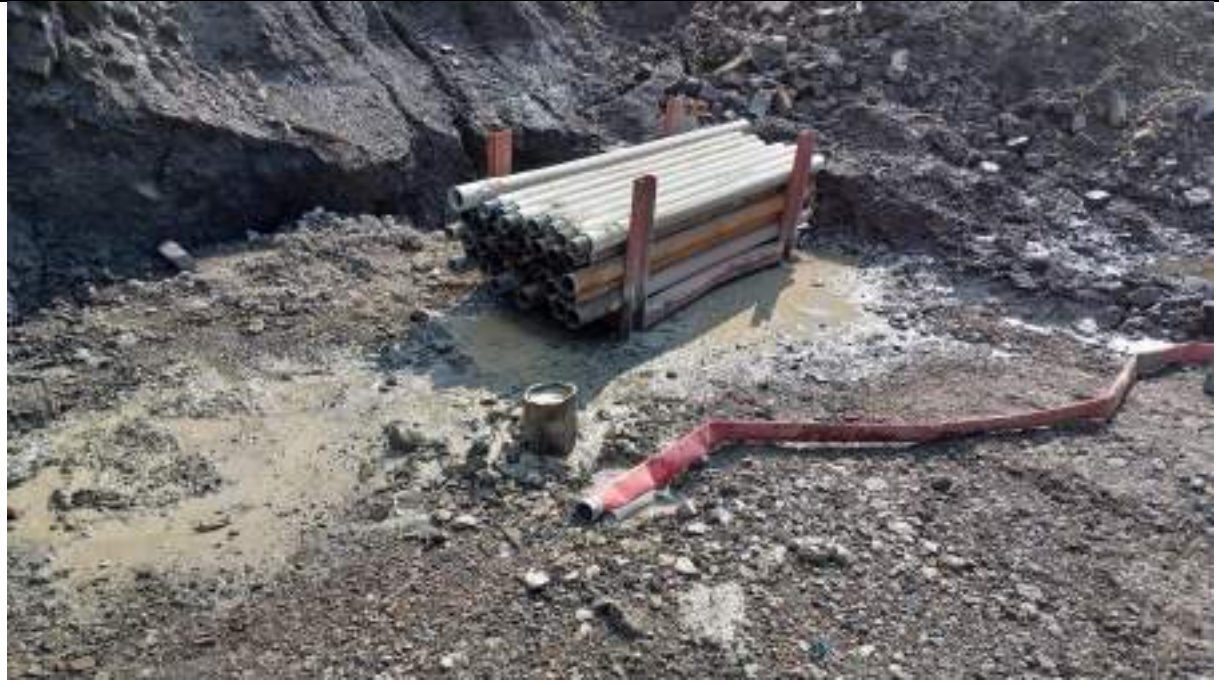
Photograph 7: Grouting complete for the observed borehole in the northwest of the site.

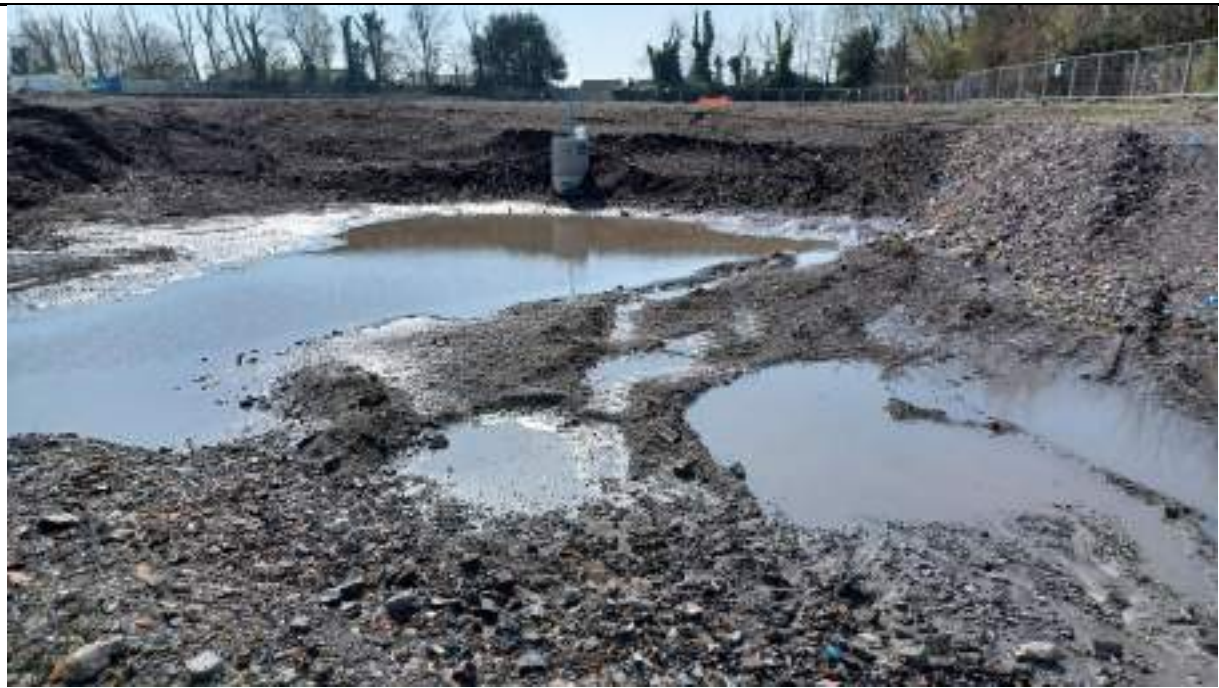
Photograph 8: Standing water in the centre east of the site. Water to be pumped out prior to filling

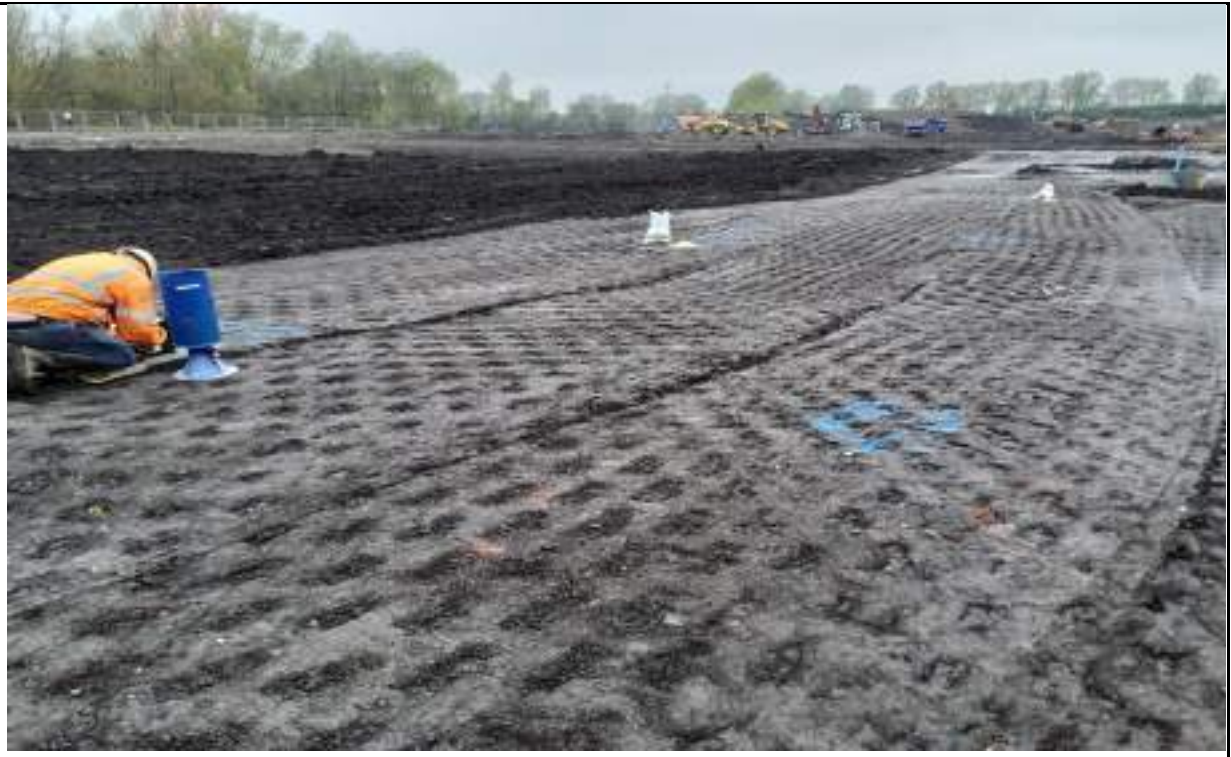
Photograph 2: Sand Replacement Density test on placed fill in the south.

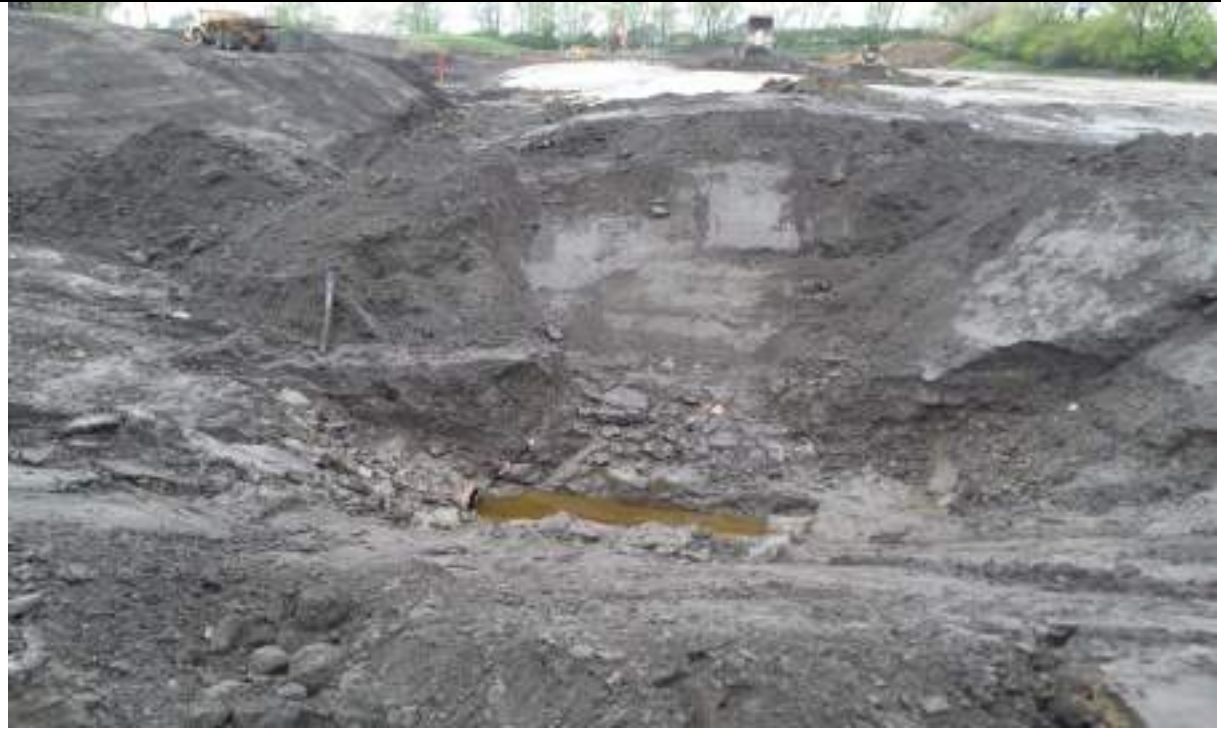
Photograph 5: Damaged drainage pipe in excavation in the centre east.

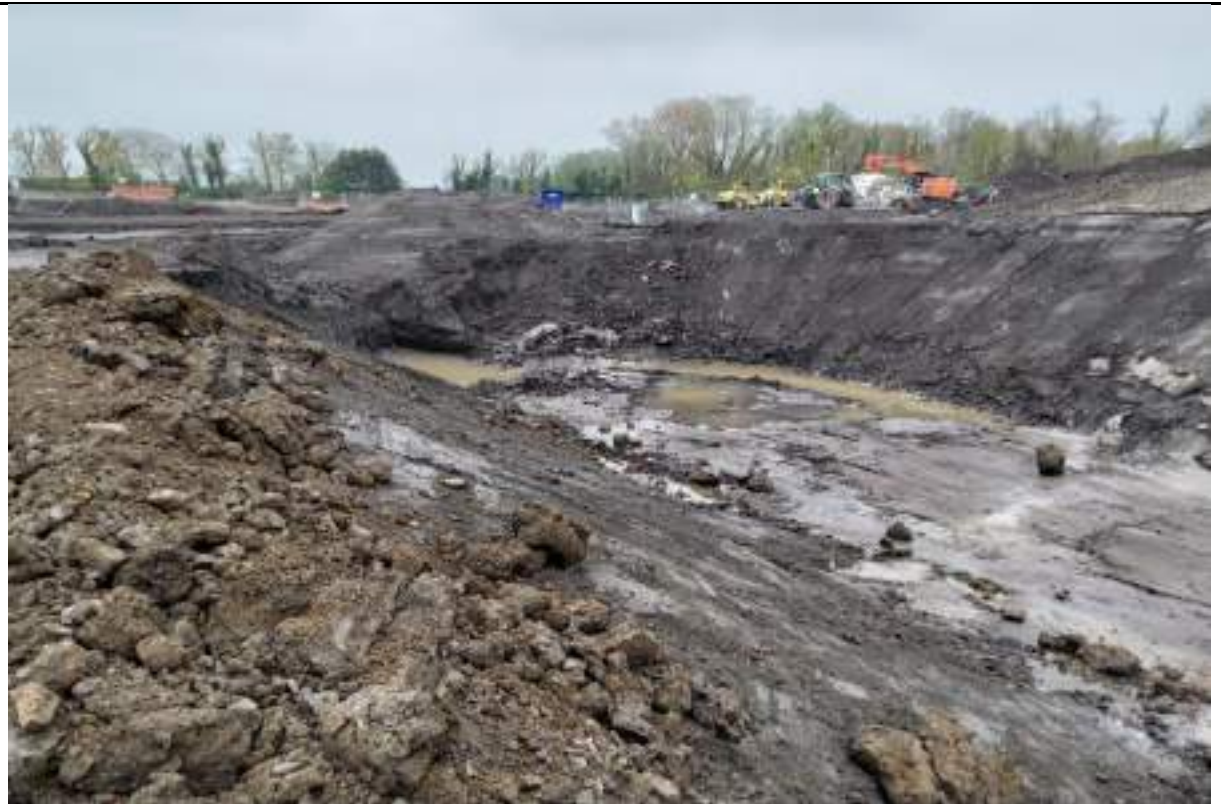
Photograph 6: Standing water in excavation in the centre east.

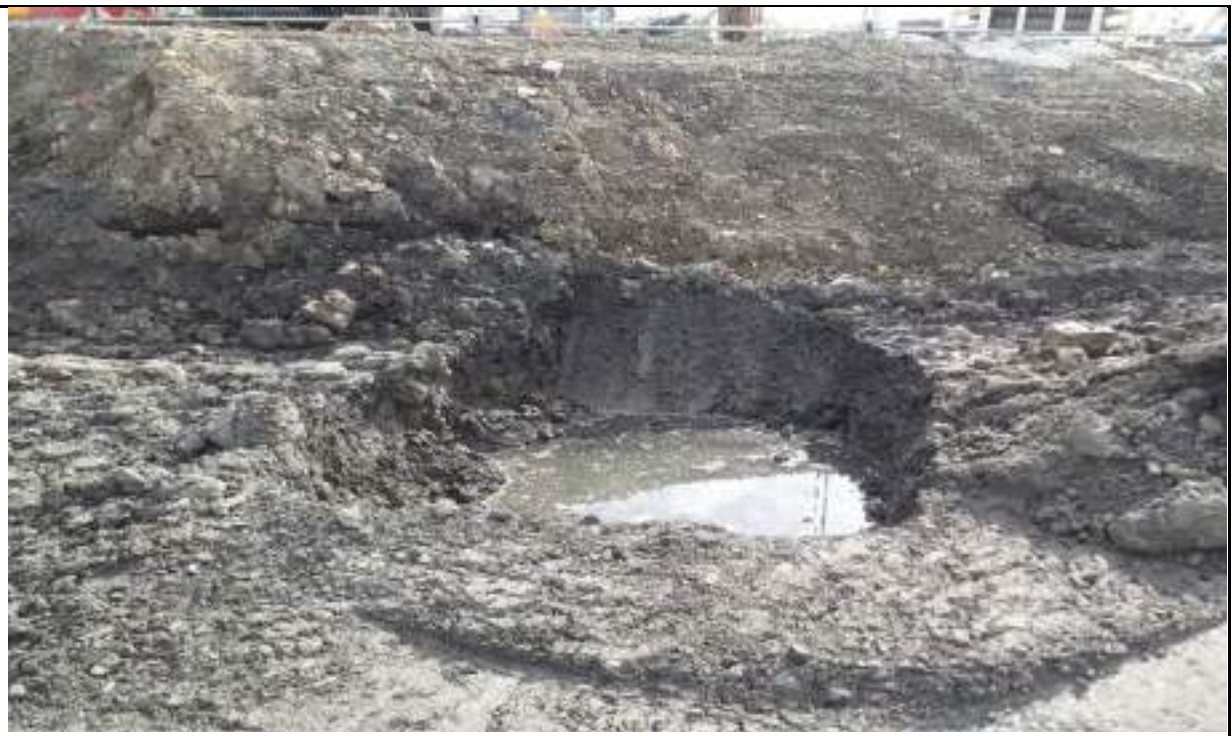
Photograph 12: Trial pit for groundwater monitoring in the centre south. Water observed in three trial pits in the centre south.

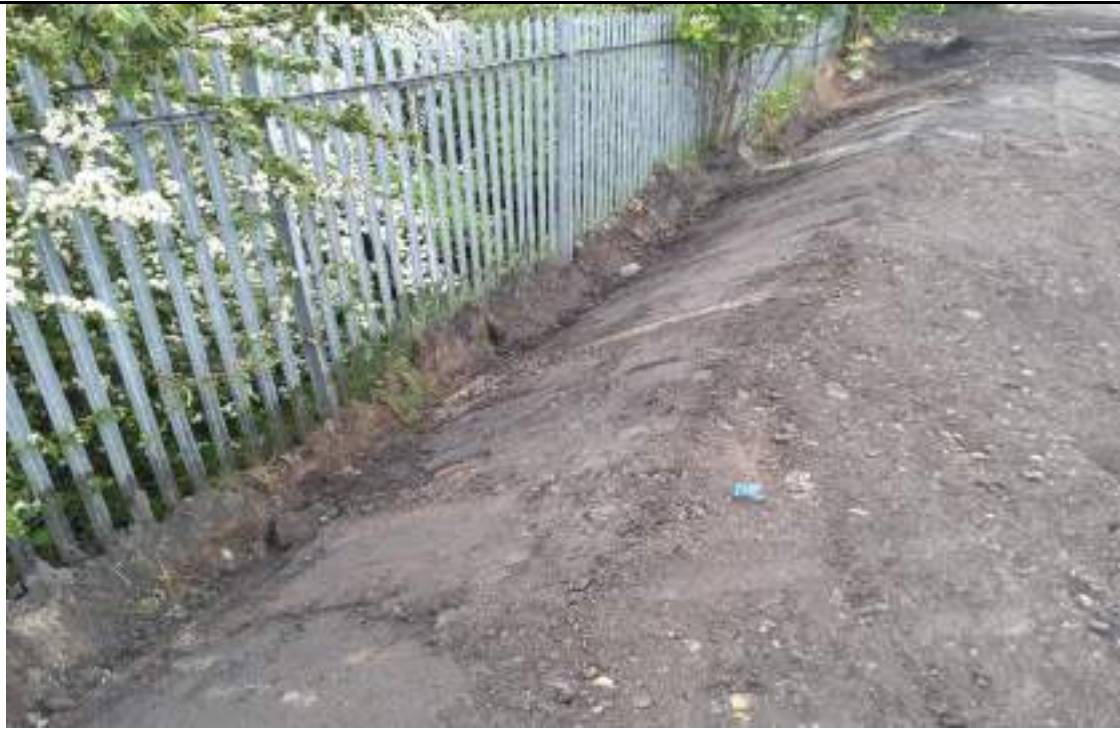
Photograph 9: Slope of battered fill next to slope of the adjacent land in the northwest seems quit deep and unsafe.

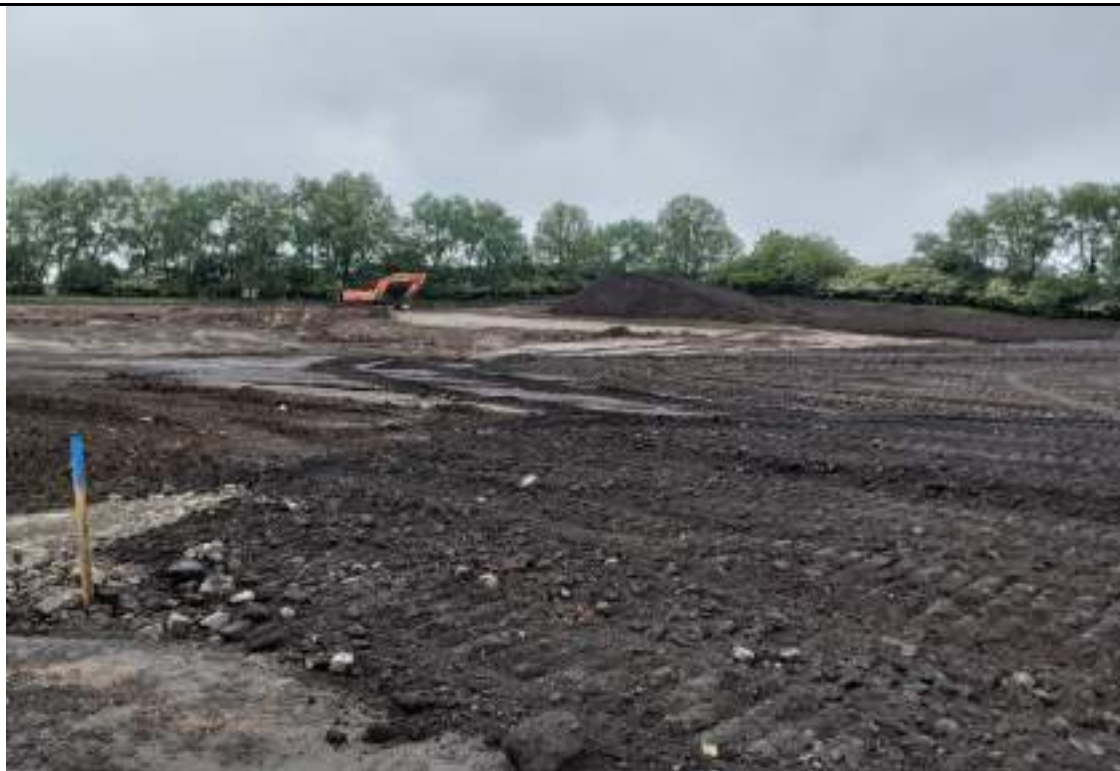
Photograph 10: Excavator trimming backfilled borrow pit.

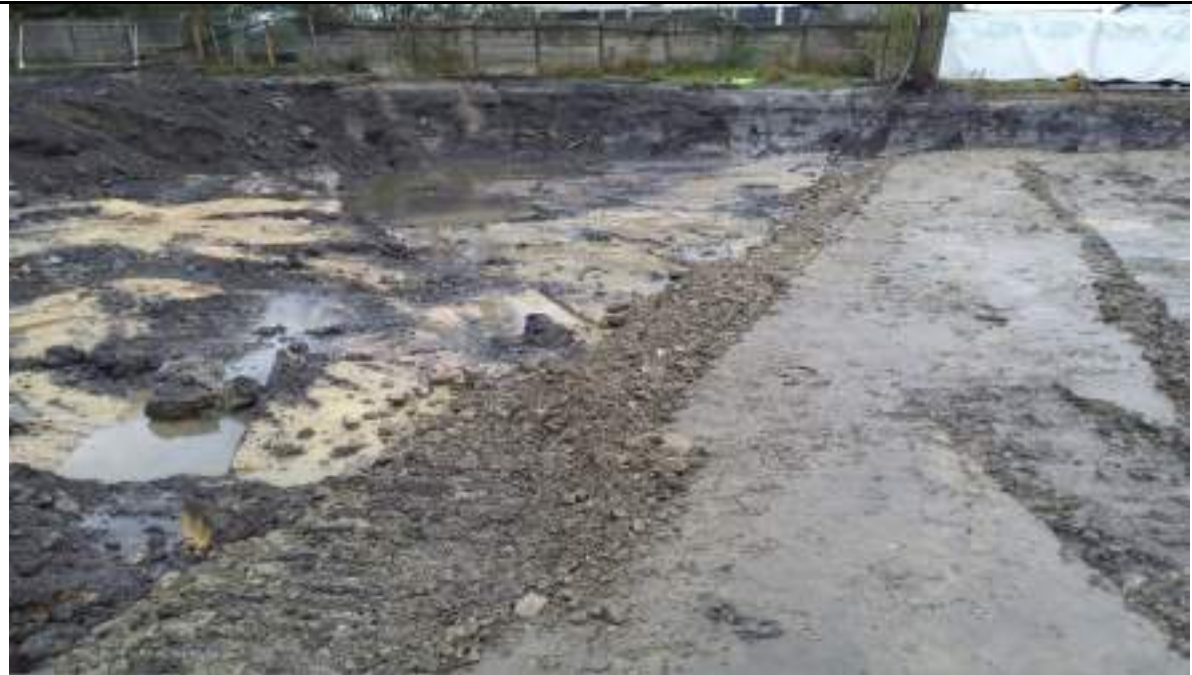
Photograph 1: Excavation of Potentially TPH contaminated Made Ground in the location of shaft no.7. Glacial till at the base of the excavation observed. 6F5 material placed in the southern part to provide running layer.

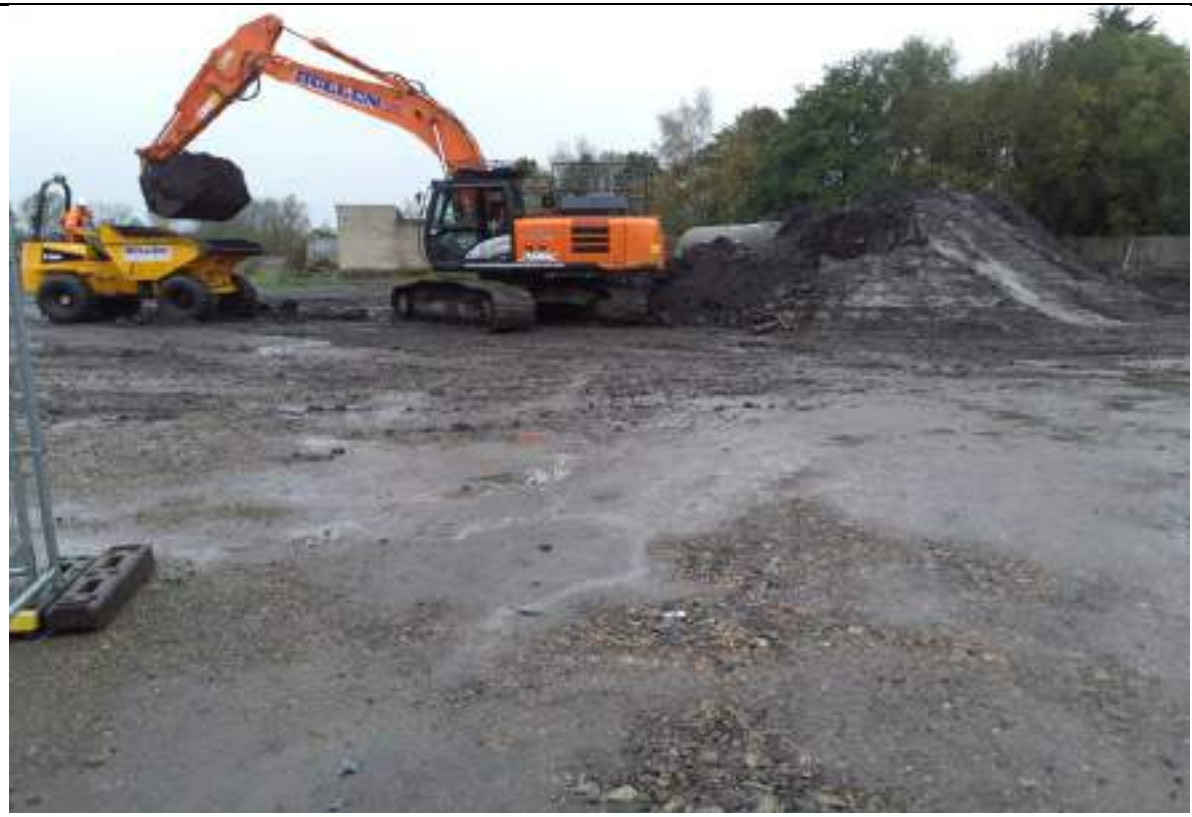
Photograph 2: Stockpile of potentially TPH contaminated material excavated from location of shaft no.7.

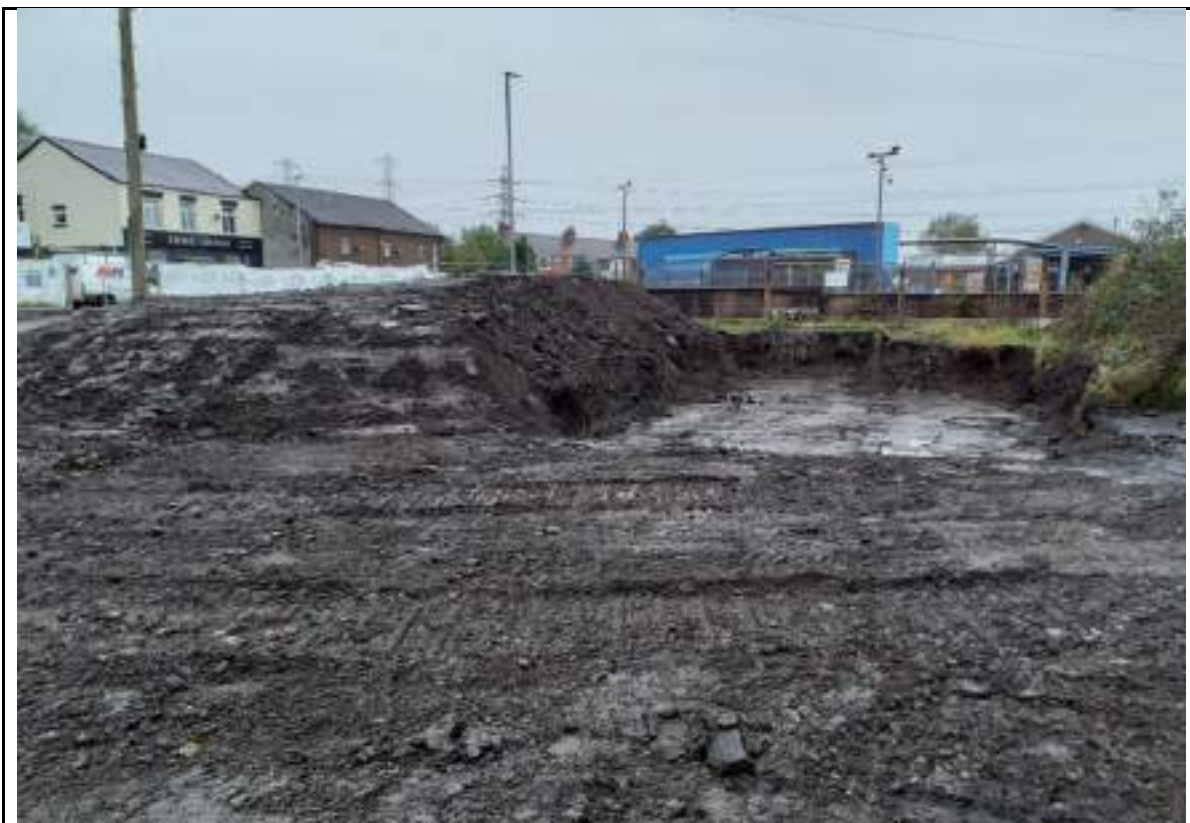
Photograph 4: Excavation of Made Ground in the location of shaft no.8. Material has high moisture content.
