Final V1 Dated: 4<sup>th</sup> June 2024

WCS Project Reference: P5090  
Bury MBC Listed Building Consent Reference: 70507

Plant Farm, Cross Lane, Ramsbottom, Bury BL8 4LY

Further submission following application for Listed Building Consent for internal refurbishment works

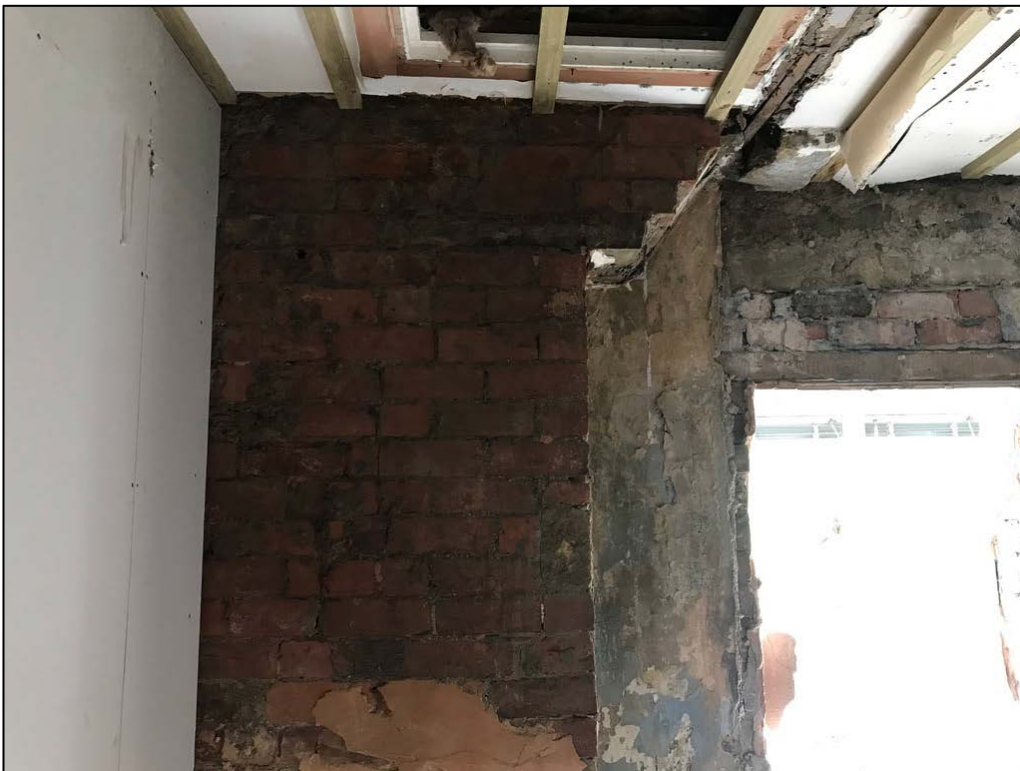
- 2.1 The property has three chimney stacks which are of replacement modern construction comprising Staffordshire Blue engineering brick laid in cement mortar. For the avoidance of doubt, no historic fabric is present, and the chimney stacks are not considered to be of any heritage significance.
- 2.2 The chimney stacks are in acceptable structural condition with no major structural defects evident. Significant water ingress is however visible internally beneath the south chimney stack, and this appears to correspond to a defective lead flashing directly above the affected area (Photographs 5.1, 5.2).
- 2.3 There are a range of more minor defects visible to the central and northern chimney stacks including moss growth indicative of mortar deterioration, and partial loss of the mortar flaunchings at the apex

5.1 Saturated brickwork beneath southern chimney caused by defective flashing.

- Careful lifting of adjacent stone flags around chimney stack bases and replacement of all lead flashings, replacement of modern breathable roofing membrane where damaged. Replacement of all lead flashings in Code 4 lead, suitably detailed and treated with patination oil, pointed into the chimney stack brickwork using a cement-based mortar as detailed above.

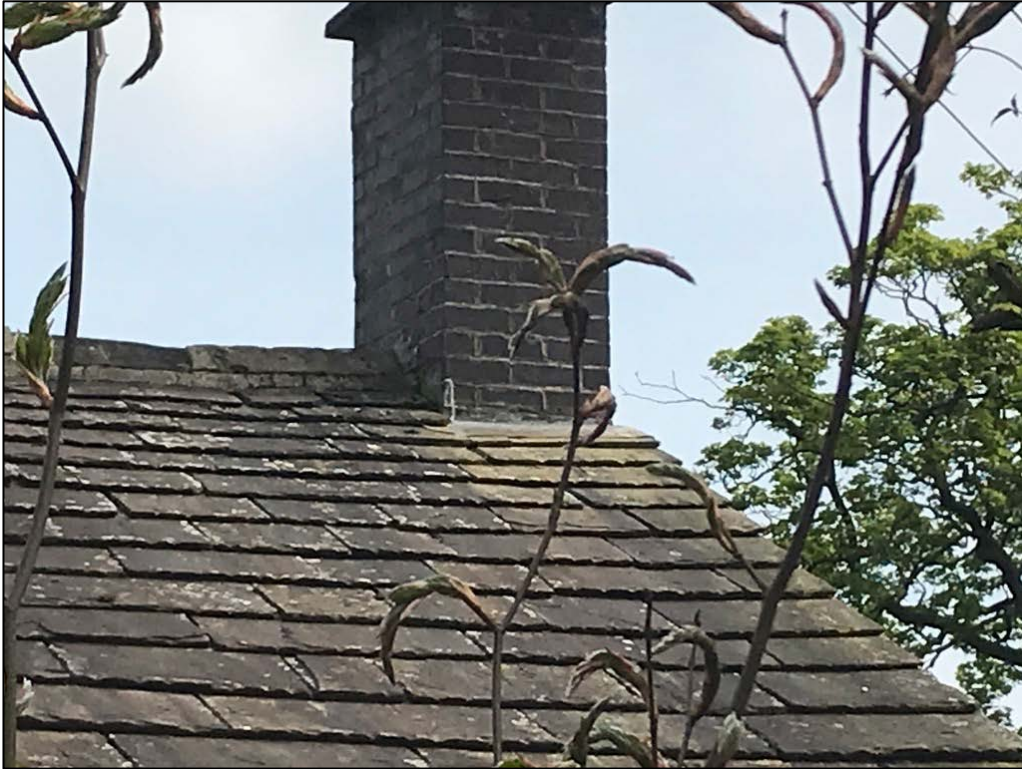
5.2 Evidence of defective flashing to exterior of southern chimney stack.

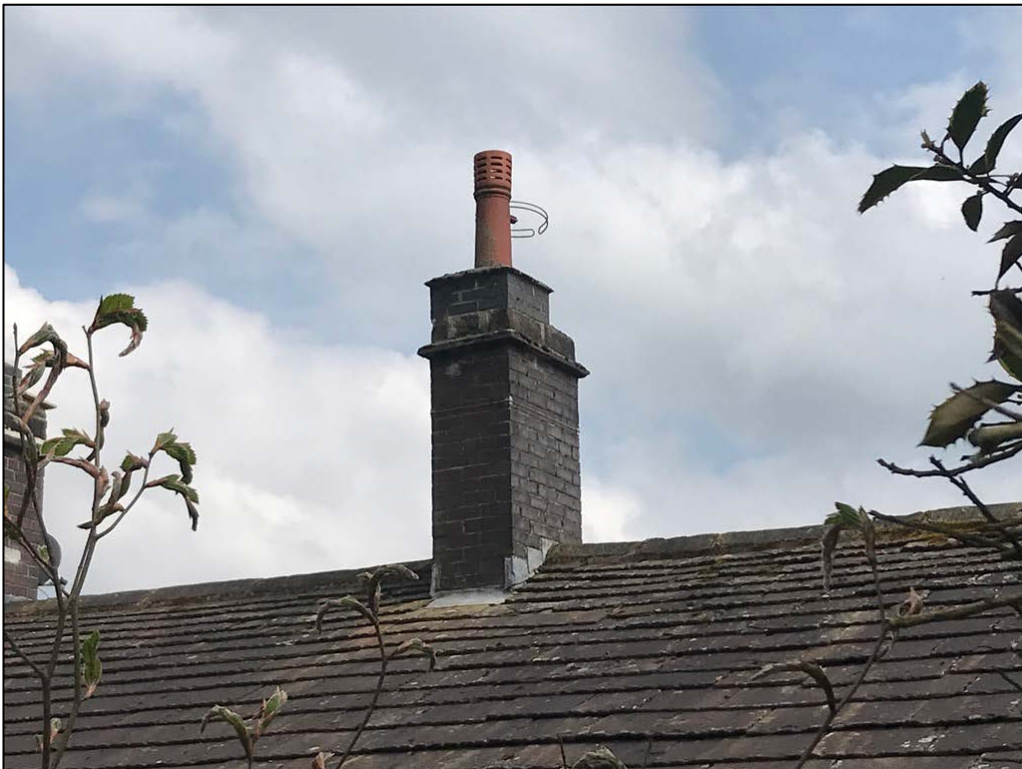
of the structures. In addition, the chimney pots are not capped and there is a risk of direct water ingress into the flues beneath (Photographs 5.3 and 5.4).

5.3 Uncapped chimney pot and moss growth visible to central chimney stack.

- Provision of scaffold access using capped scaffold poles to avoid accidental damage to original stonework.
- Capping of redundant chimney flues to prevent water ingress using a suitable traditional red terracotta capping detail.

- Removal of moss and replacement of damaged mortar pointing and flaunching to all chimney stacks, using cement-based mortar. Note: cement-based mortar is proposed in this area as the chimney stack materials are modern replacements not suited to the use of lime-based mortars. Staffordshire blue engineering brick is an exceptionally hard material and would not be suitable to receive a soft lime-based mortar.

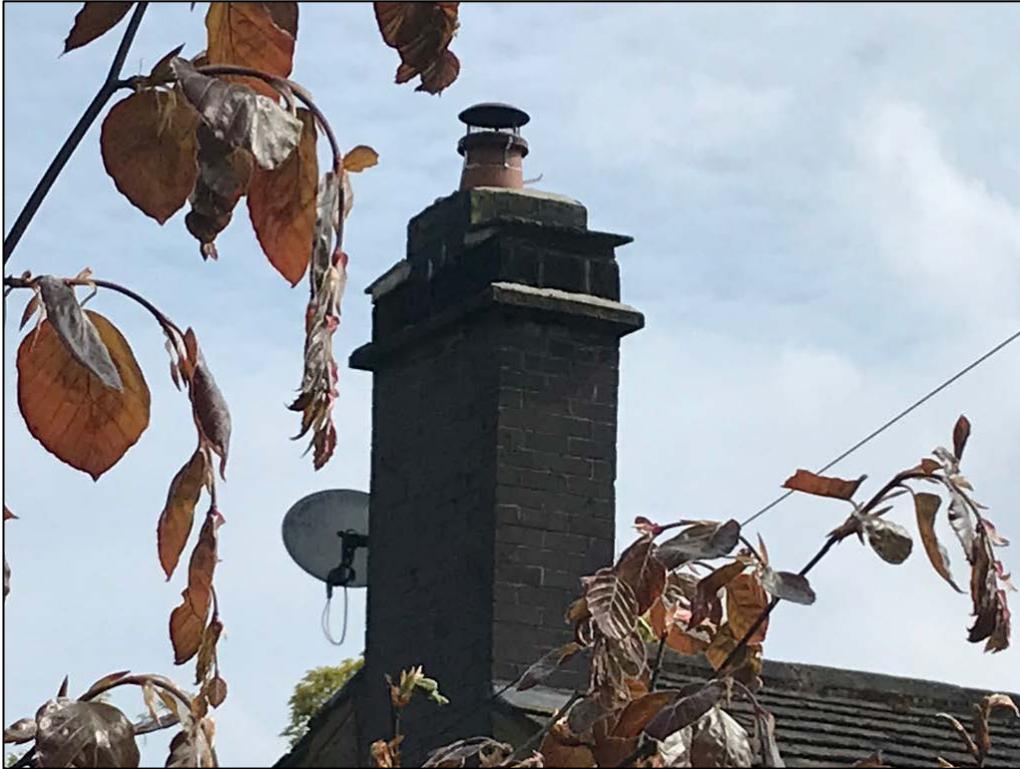
5.4 Incomplete mortar flaunching and moss growth to northern chimney stack.

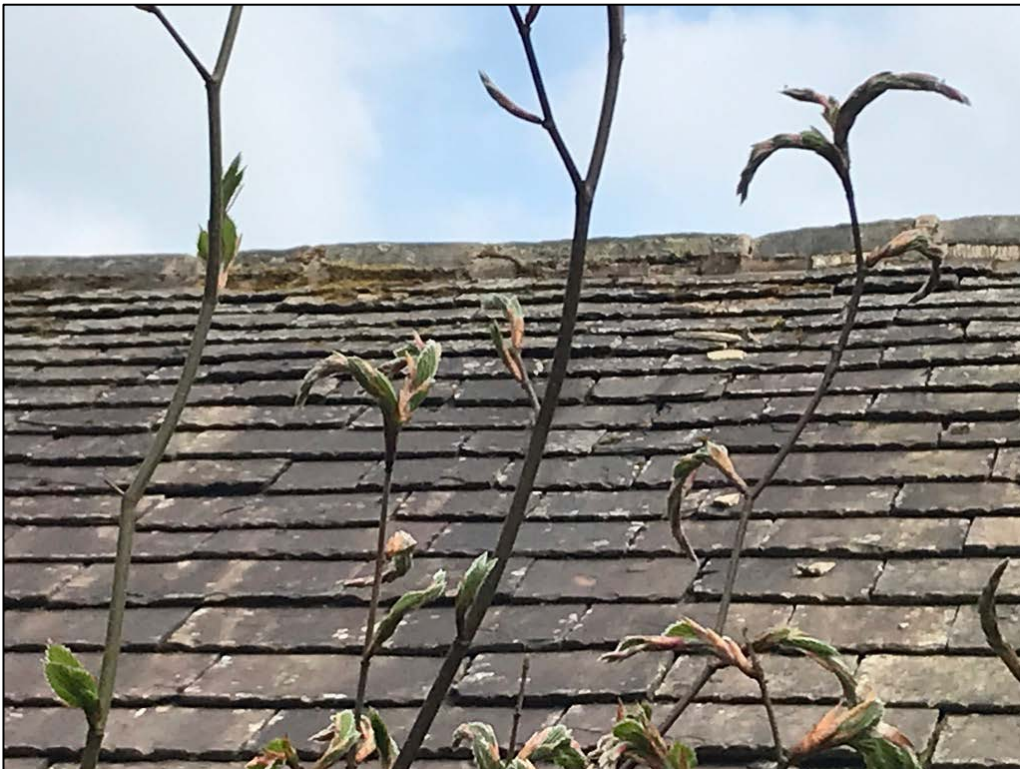
2.5 The roof coverings are in acceptable structural condition with no major defects evident. There is however evidence of moss growth and mortar deterioration to the stone ridge capping and there is potential for water ingress as a result (Photograph 5.5).

5.5 Damaged pointing and moss growth to stone ridge capping.

- Careful lifting of stone ridge cappings, removal of moss and cement-based mortar. Careful cleaning (at ground level) of cement-based mortar residue from stone ridge cappings using handheld tools only to avoid damage.

- Re-setting of stone ridge cappings, bedded and pointed in a traditional lime-based mortar, not gauged with cement or other additives. Lime-based mortar to have a gently brushed finish to expose the aggregate and give a suitable appearance, to avoid a smooth over-finished pointing style. Lime-based mortar to be allowed to dry carefully over three to four days covered with wet hessian matting, to prevent excessively rapid drying and consequent failure.

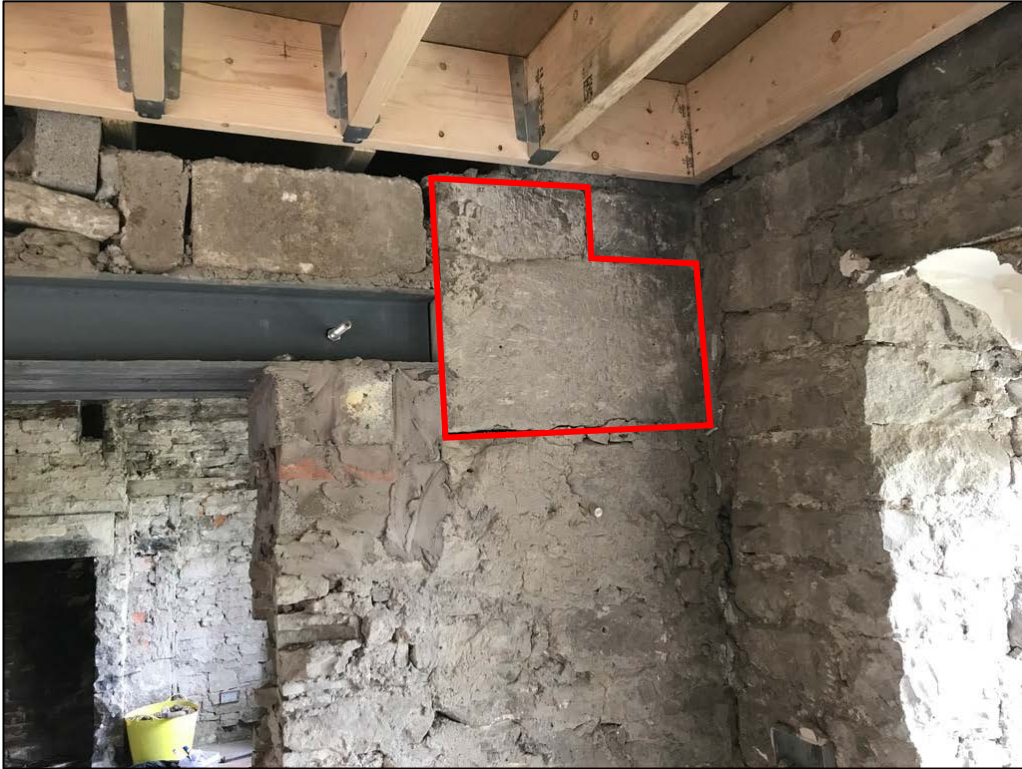
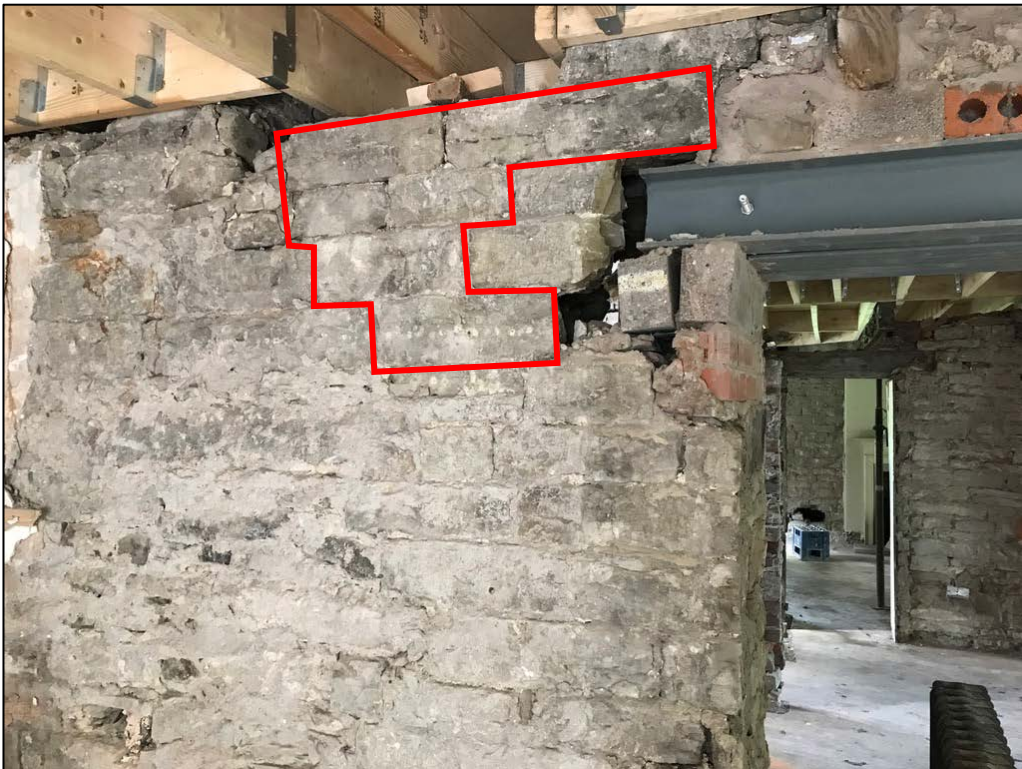
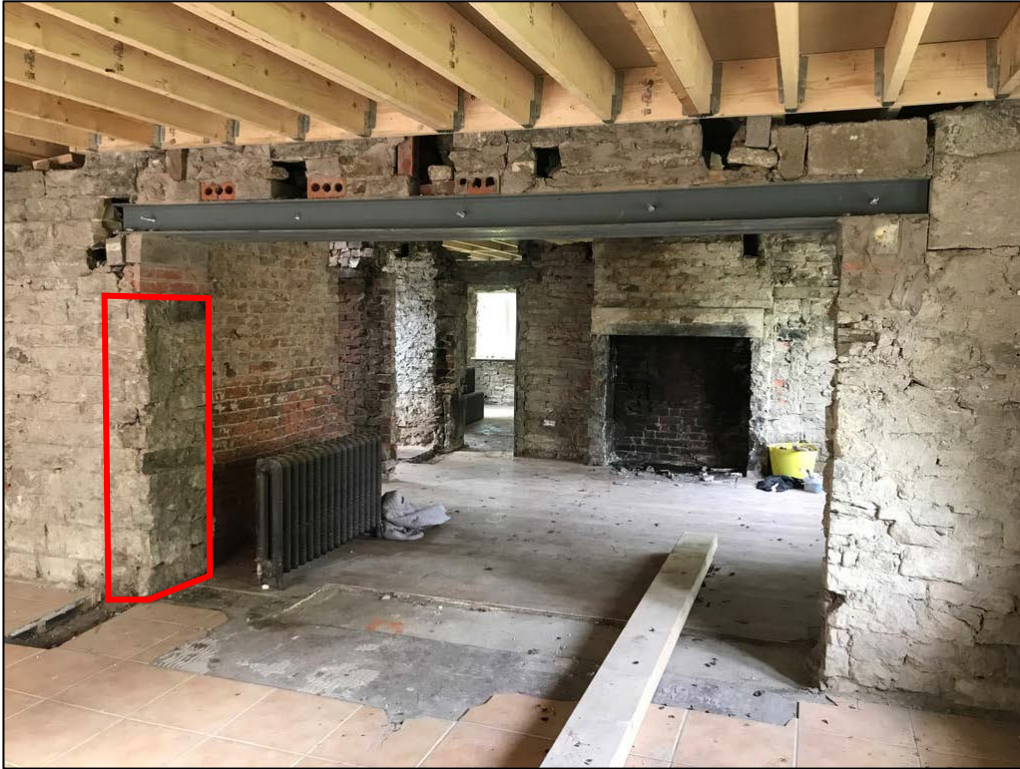
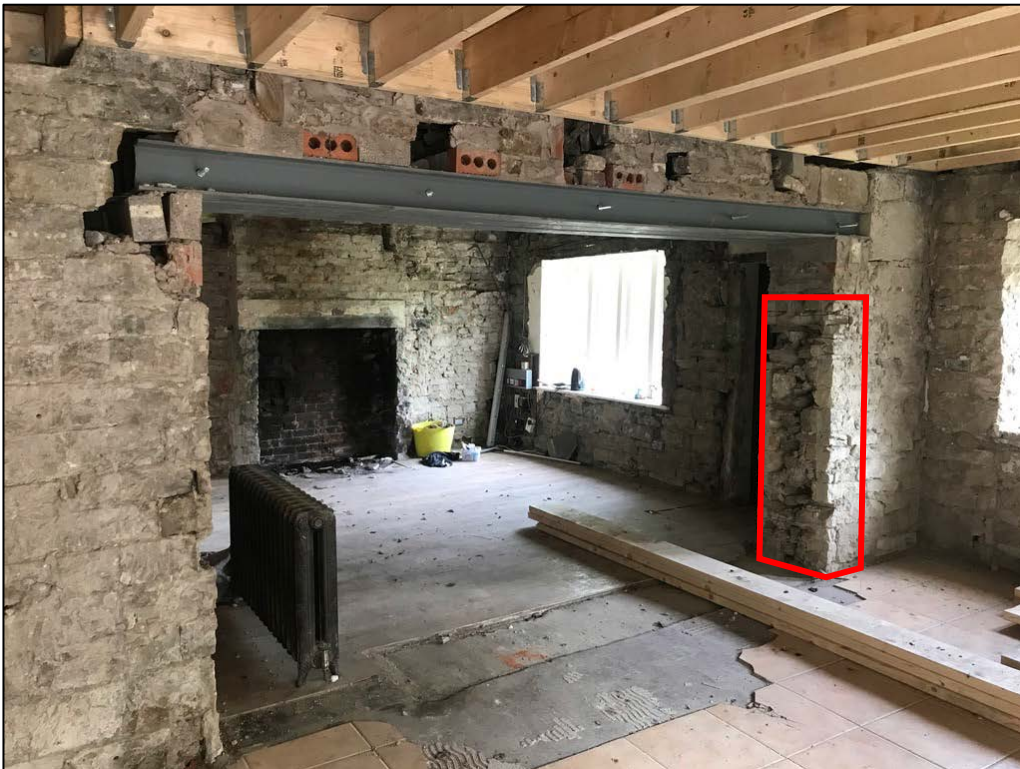
- 3.2 The statutory consultee response from HB&P and the subsequent LPA officer comments indicate a concern regarding the legibility of the remaining sections of the former external wall to either side of the newly formed structural opening. The advice provided encourages the retention of clear visual evidence of the wall's age and previous function following the refurbishment works.

5.6 Proposed exposed stone section (1) to remain visible within former external wall of c. 1739.

5.7 Proposed exposed stone section (2) to remain visible within former external wall of c. 1739.

5.8 Proposed exposed stone section (3) to remain visible within former external wall of c. 1739.

5.9 Proposed exposed stone section (4) to remain visible within former external wall of c. 1739.

- 3.4 In order to ensure the desired legibility, however, it is proposed that sections of suitably well-dressed stone should be left exposed and visible as shown within the mark up below. This will include both individual dressed stones and the left- and right- hand side vertical reveals of the new opening (marked-up Photographs 5.6, 5.7, 5.8, and 5.9).

- 3.5 The plaster will be finished neatly around the exposed stone sections, with a plain chamfered plaster reveal detail between the plaster surface and recessed stone surfaces.

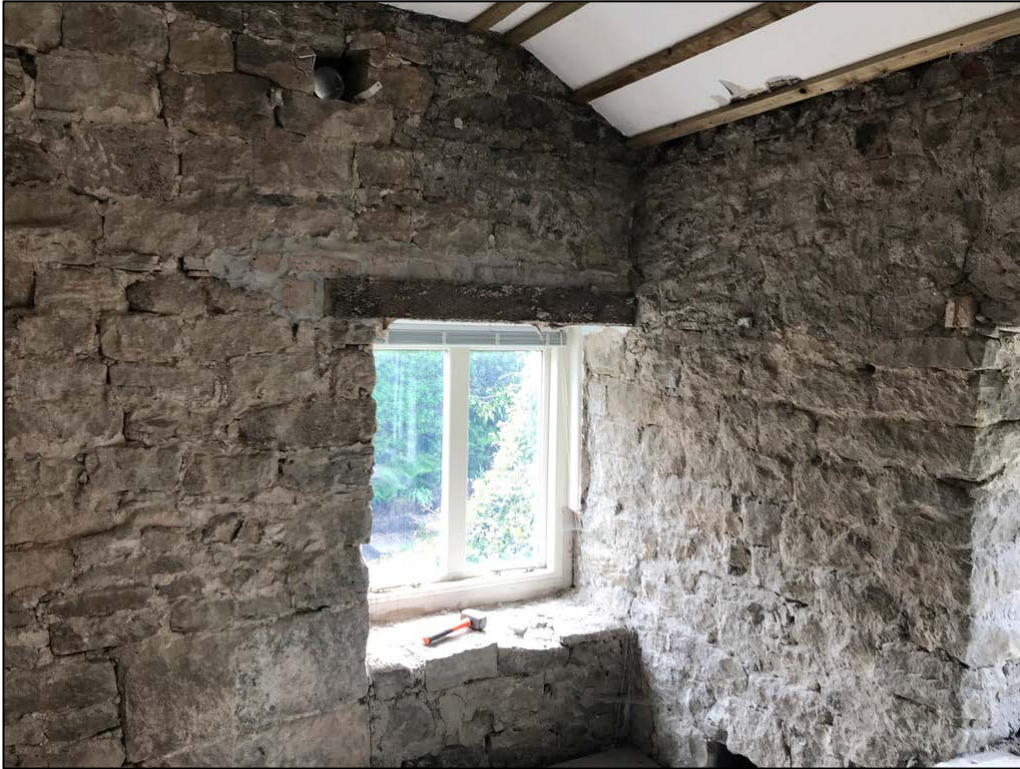
- 4.4 Based upon a visual inspection at the time of the survey, in this case the condition of the above ground external walls following removal of earlier cement-based plaster applications appears to be relatively good for their age and type. There is no significant visual evidence of water ingress through the external walls and the stonework appears to have dried well over time (Photograph 5.10).

5.10 Natural stone faces of external walls generally dry with no major water ingress above ground.

- Plastering internally throughout to the main above ground external walls using Limelite plaster. This is a proprietary lime-based plastering system comprising Easy Bond (primer and keying aid), Limelite Renovating Plaster (undercoat) and Limelite High Impact Finishing Plaster (topcoat). The system provides a suitable level of workability and reliability whilst allowing for breathability to protect the fabric of the building.

- Provision of ongoing maintenance to the main above ground external walls to minimise the risk of water ingress, including but not limited to prompt repair of any defects to rainwater goods and weathering details, removal of moss and algal growth to the main walls, re-pointing as required in lime based mortar and control of ground level vegetation.

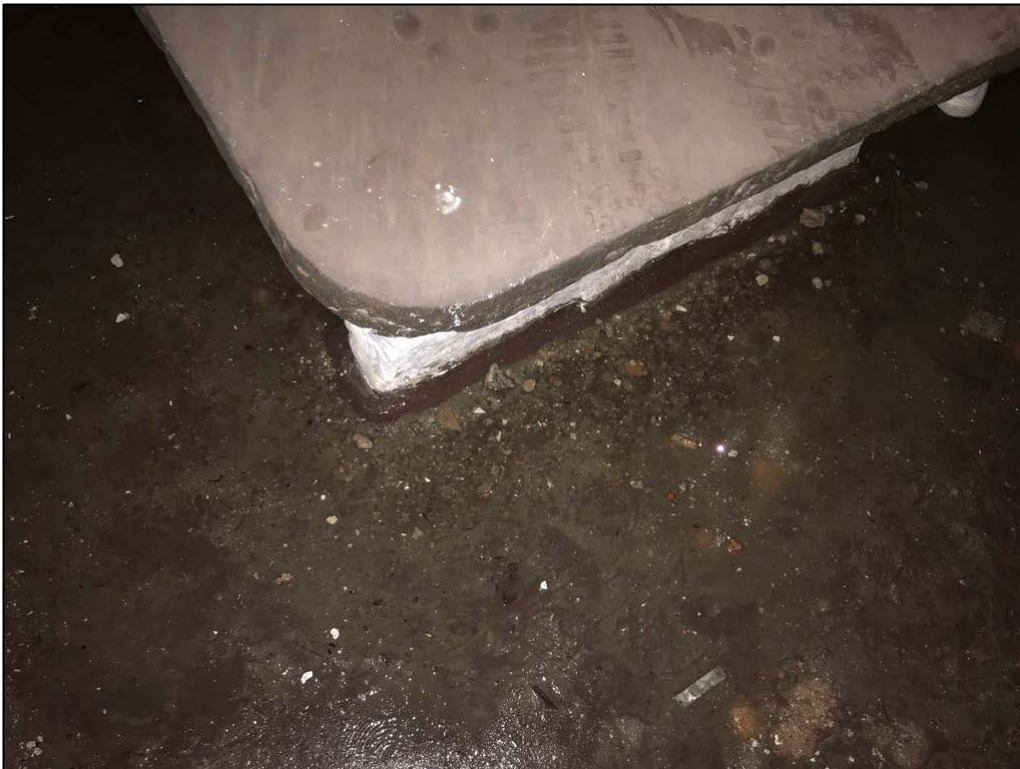
- 4.5 To the partially below-ground walls of the cellar to the rear of the property, there is significant water ingress and the walls are wet to the touch. At ground level within the cellar there is considerable water ingress, and standing water was observed at the time of the survey (Photograph 5.11).

5.11 Significant water ingress to cellar area with standing water visible at ground level.

- Provision of a new proprietary tanking system to the cellar area, comprising an insulated plasterboard system with a suitably robust waterproof membrane and integrated channel drainage system. This approach will necessitate the removal and making good to a new level floor of the existing stone table structure within the cellar, to avoid hydrostatic pressure causing water to enter the structure and the wider internal environment via this route.

- The proprietary tanking system will be installed by a suitably qualified tanking sub-contractor who will provide full written and drawn details of the system proposed. A Guarantee will be provided to the applicant on completion of the works. Building Control permission will be required for the works. This is because the habitable area of the property and its thermal envelope will be extended into the basement area on completion of the tanking works.

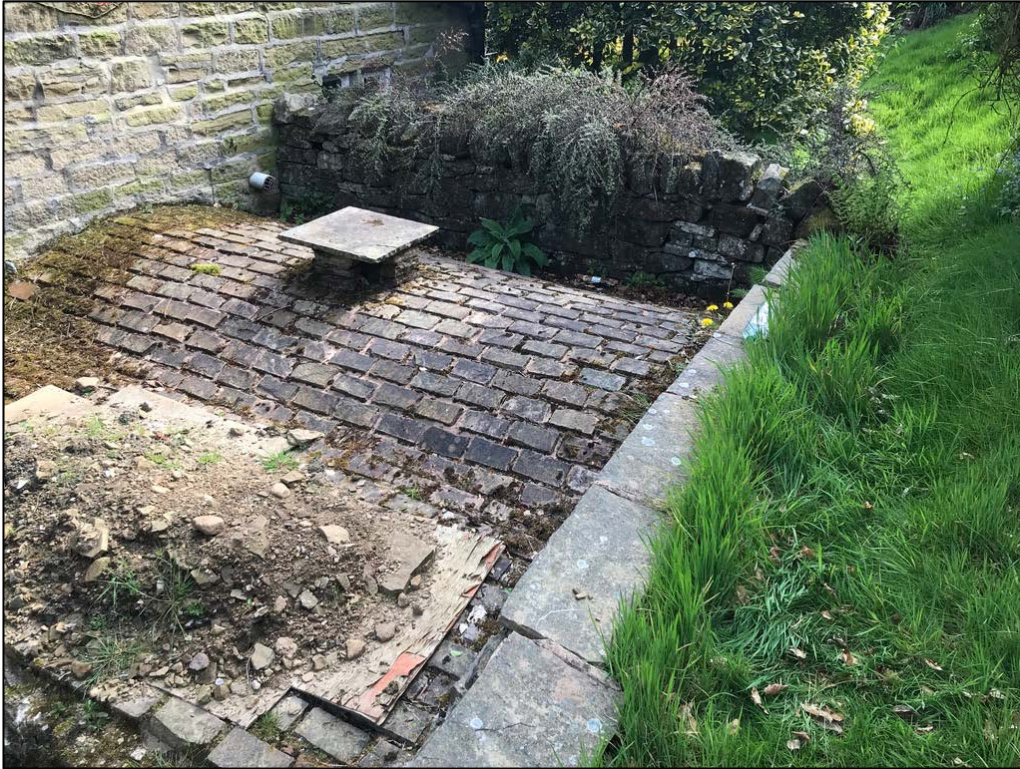
- 4.6 As identified within the Heritage Assessment, parts of the cellar construction appear to be of 20<sup>th</sup> century date and this is confirmed by the use of modern stone setts to the roof structure which is visible externally (Photograph 5.12).

- 4.7 A number of defects were identified externally to the cellar roof and walls including moss and vegetation growth and loss of pointing, all of which will contribute to the water ingress seen internally. The design of the roof also allows water to pool between the stone setts due to the recessed pointing style used (Photograph 5.13).

5.12 Modern stone setts to cellar roof. Defects including moss and vegetation growth, pointing loss.

- Repair and ongoing maintenance of the partially below-ground walls and roof of the cellar structure, including control of vegetation throughout the area, removal of moss growth, re-pointing in cement mortar to damaged areas, and completion of additional pointing to the stone

setts to a flush pointing profile to prevent water pooling between the setts. Note that cement-based mortar is suitable for use in this instance as the external structure and roofing setts of the cellar are of later 20<sup>th</sup> century date and modern construction.

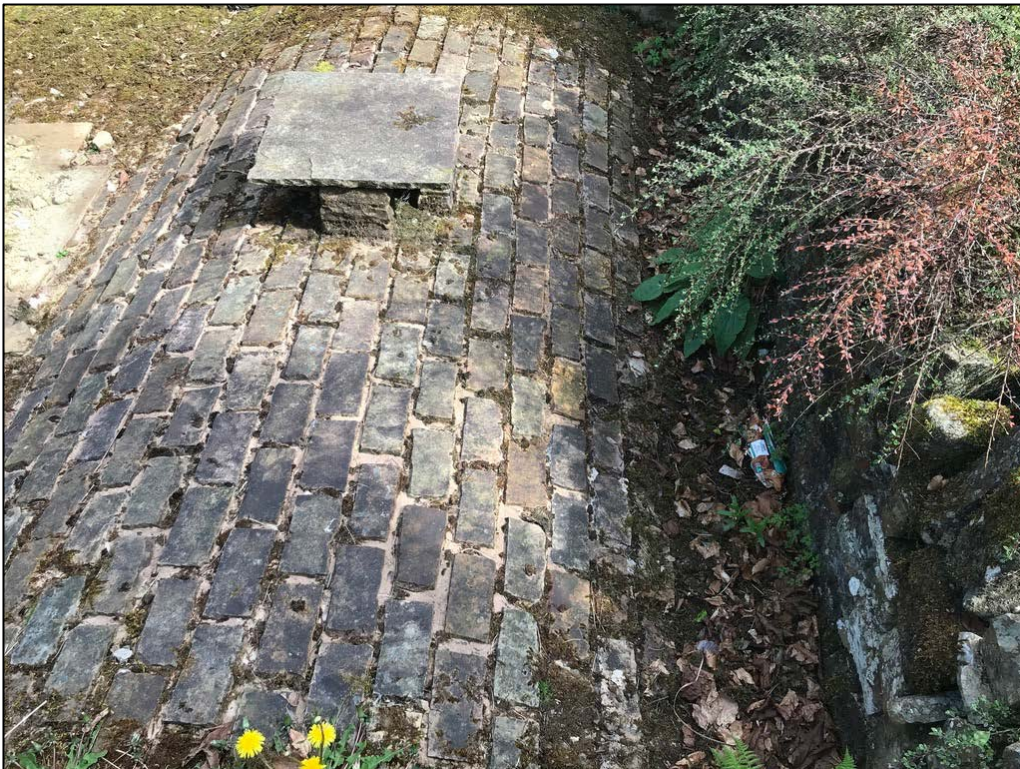
5.13 Recessed pointing style to modern stone setts allows water to pool between setts.

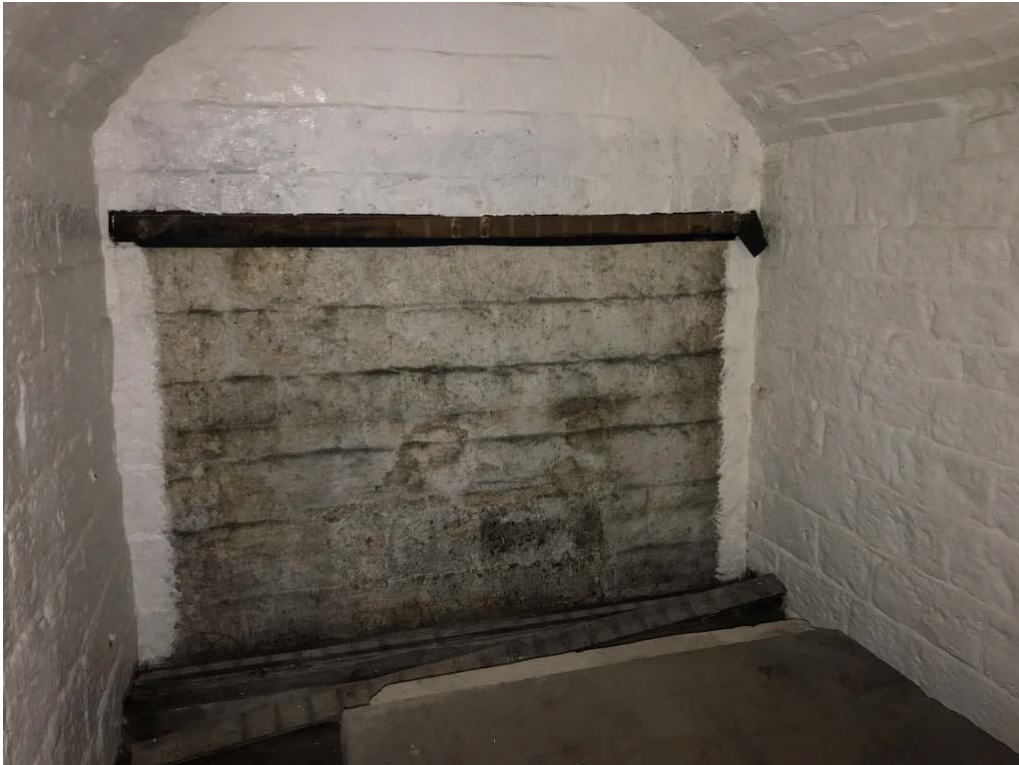
- 4.8 Notwithstanding the modern roof construction of the cellar, the lower parts of the internal walls appear to be of greater age when viewed internally. The walls have been constructed of hand tooled stonework, although this may be partially reconstructed (Photograph 5.14). The central table to the cellar may also be of some historic interest. There is a further niche to the north cellar wall which is of reclaimed stone and is of modern construction and no historic interest (Photograph 5.15).

5.14 Partially historic stonework within lower sections of cellar walls.

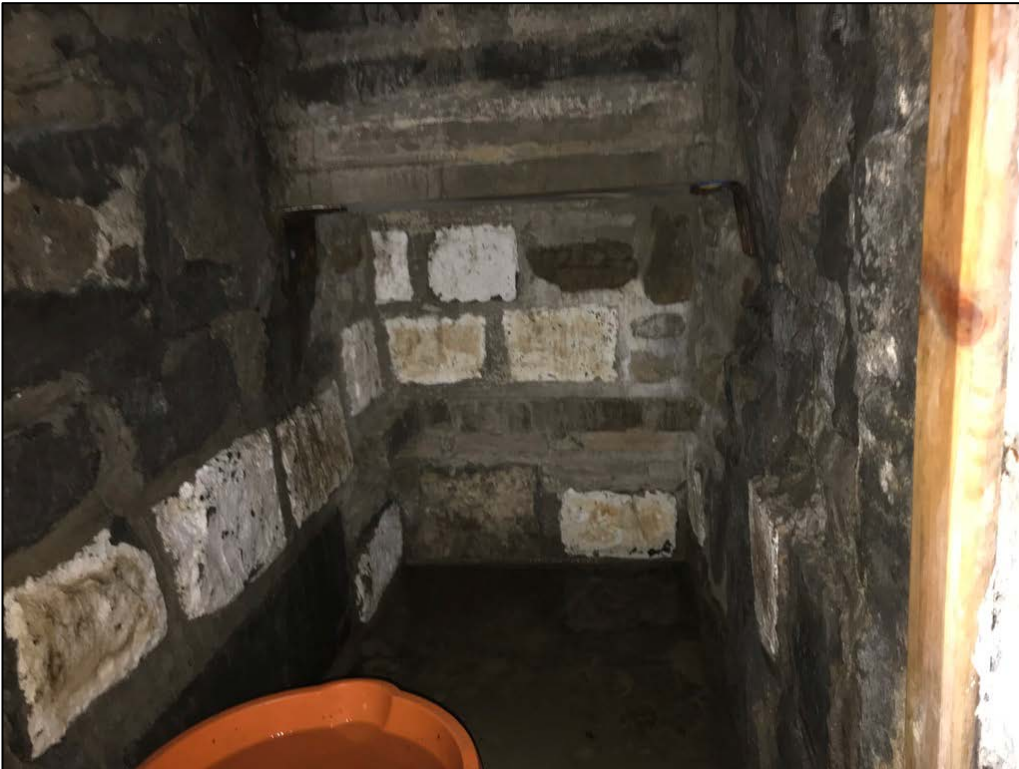
5.15 Modern niche within cellar.
