# Trees and Construction

## BS5837:2012 Tree Survey, Arboricultural Impact Assessment & Method Statement

**Site:** 2 Cliff Ave, Summerseat, BL9 5NE

**Ref:** 20543.23 / A1\_AIA

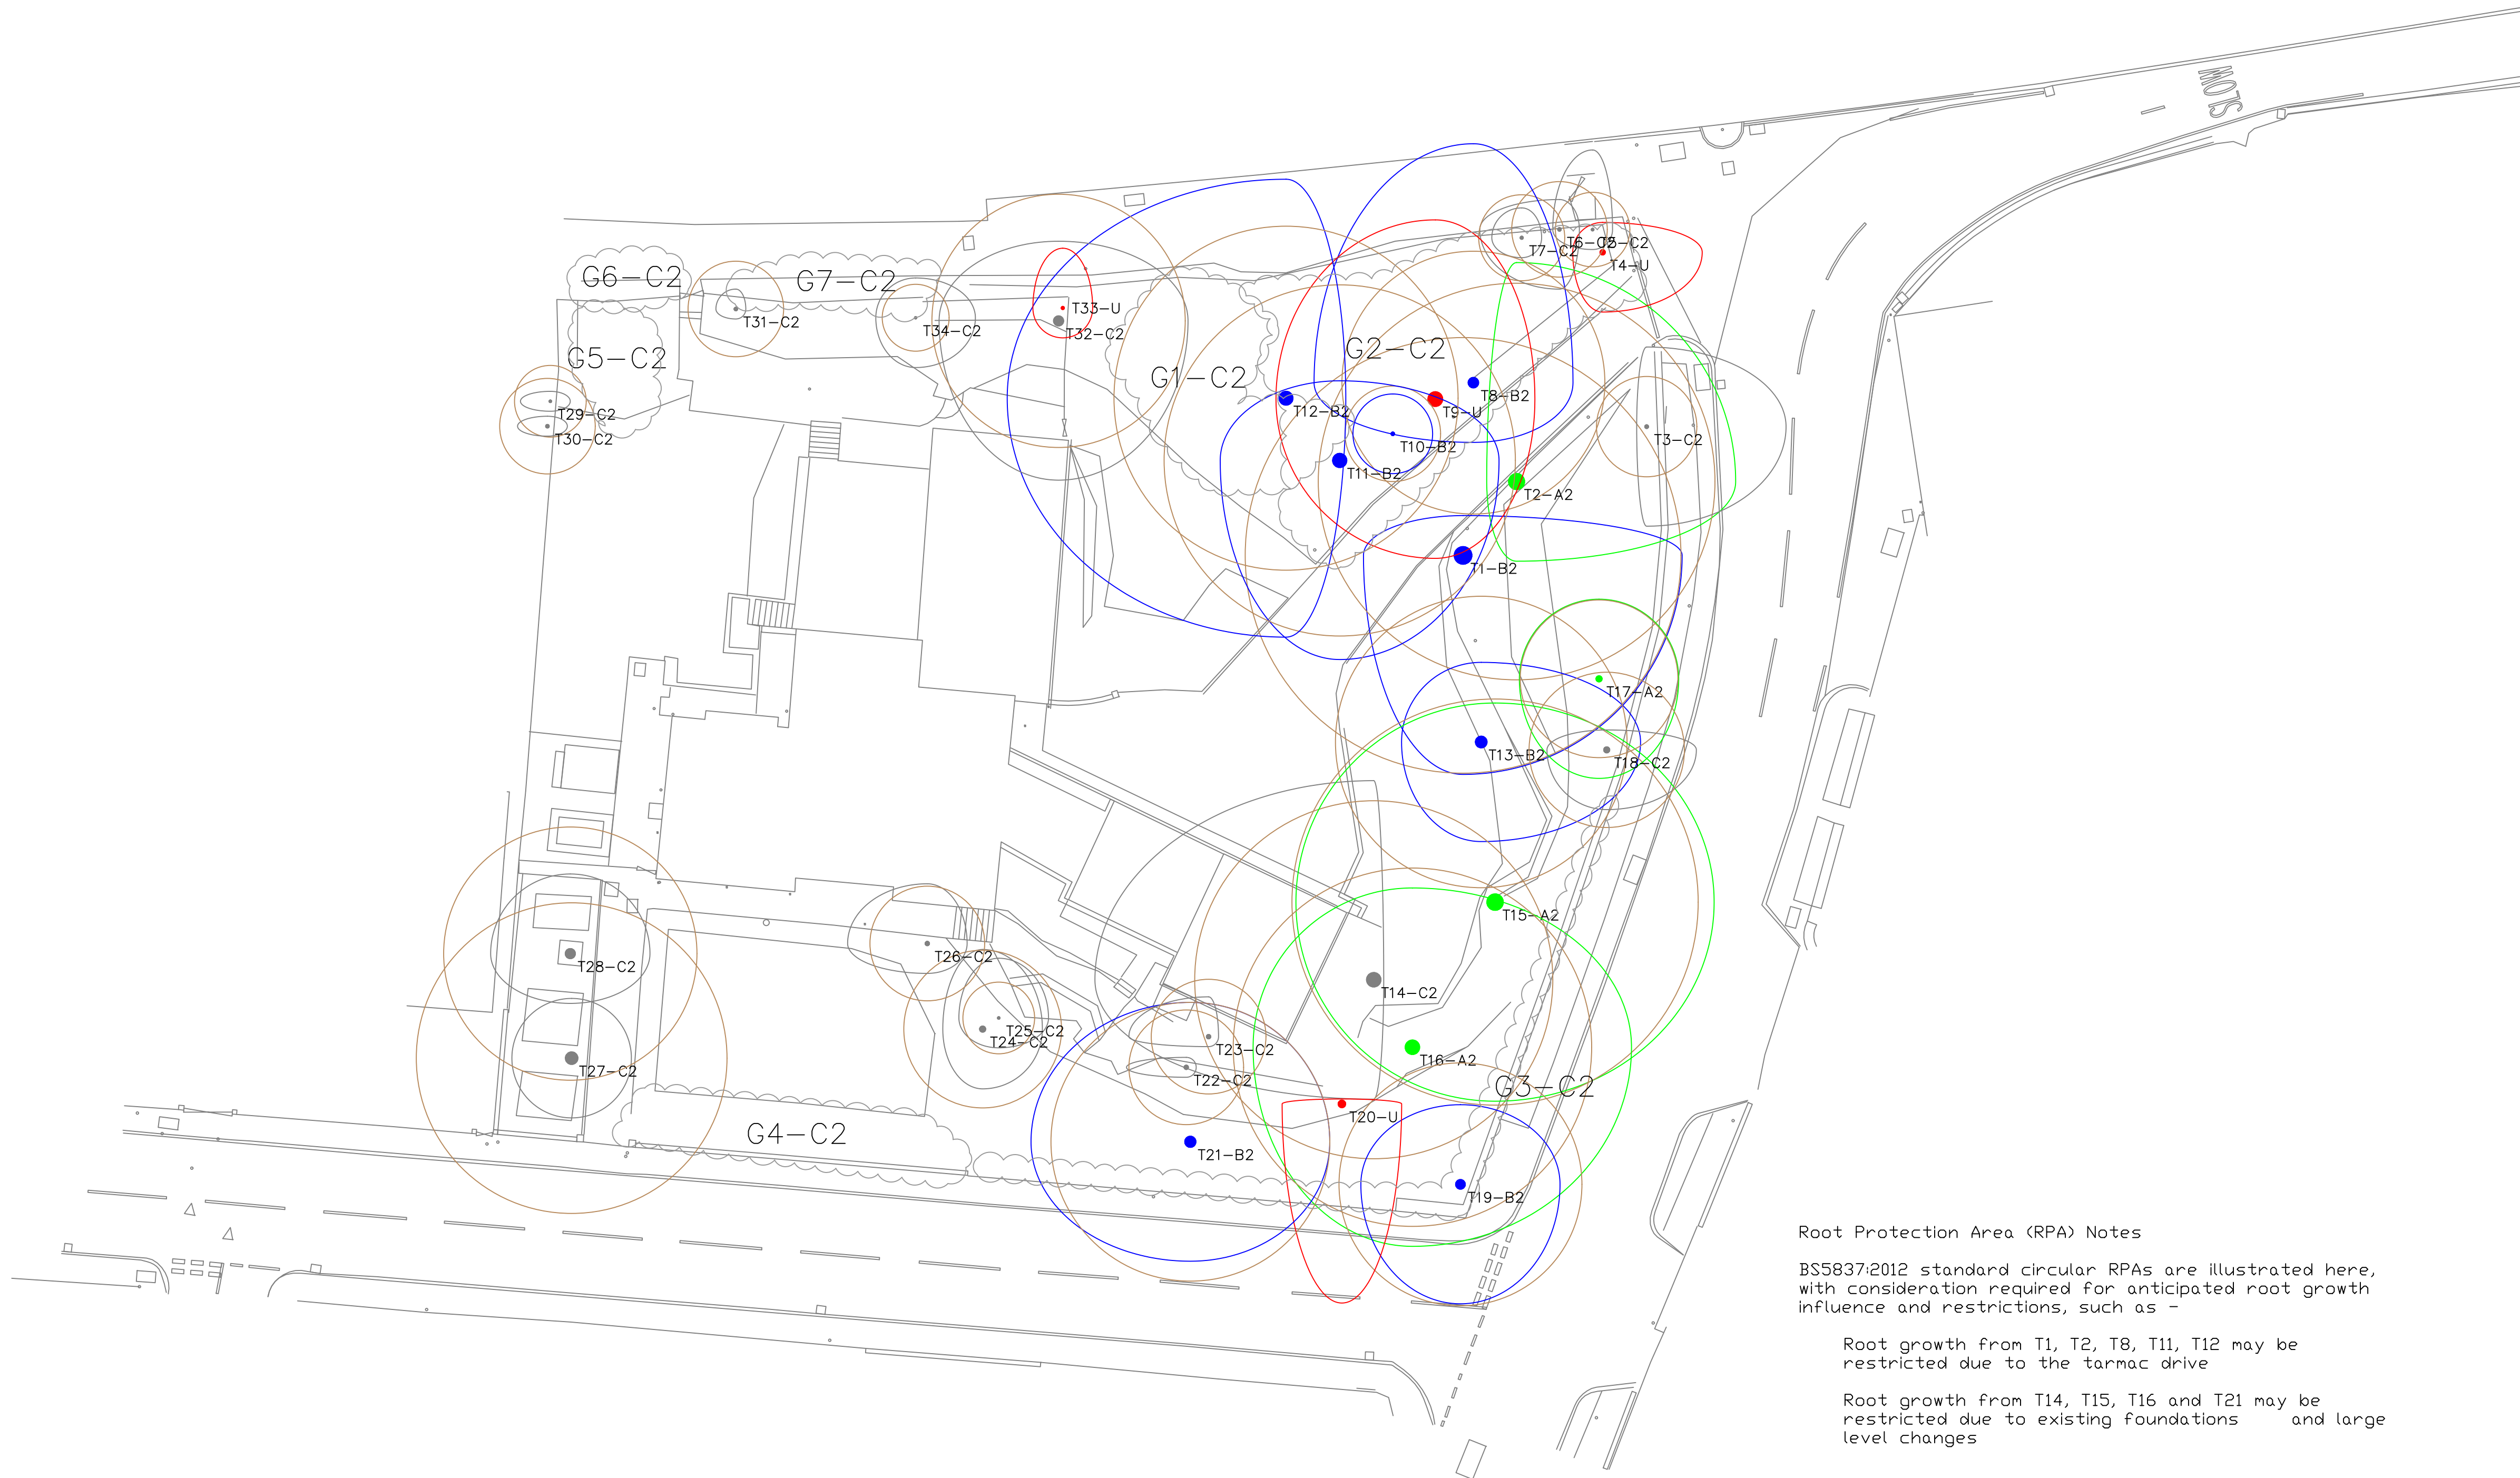
Root growth from T14, T15, T16 and T21 may be restricted due to existing foundations and large level changes

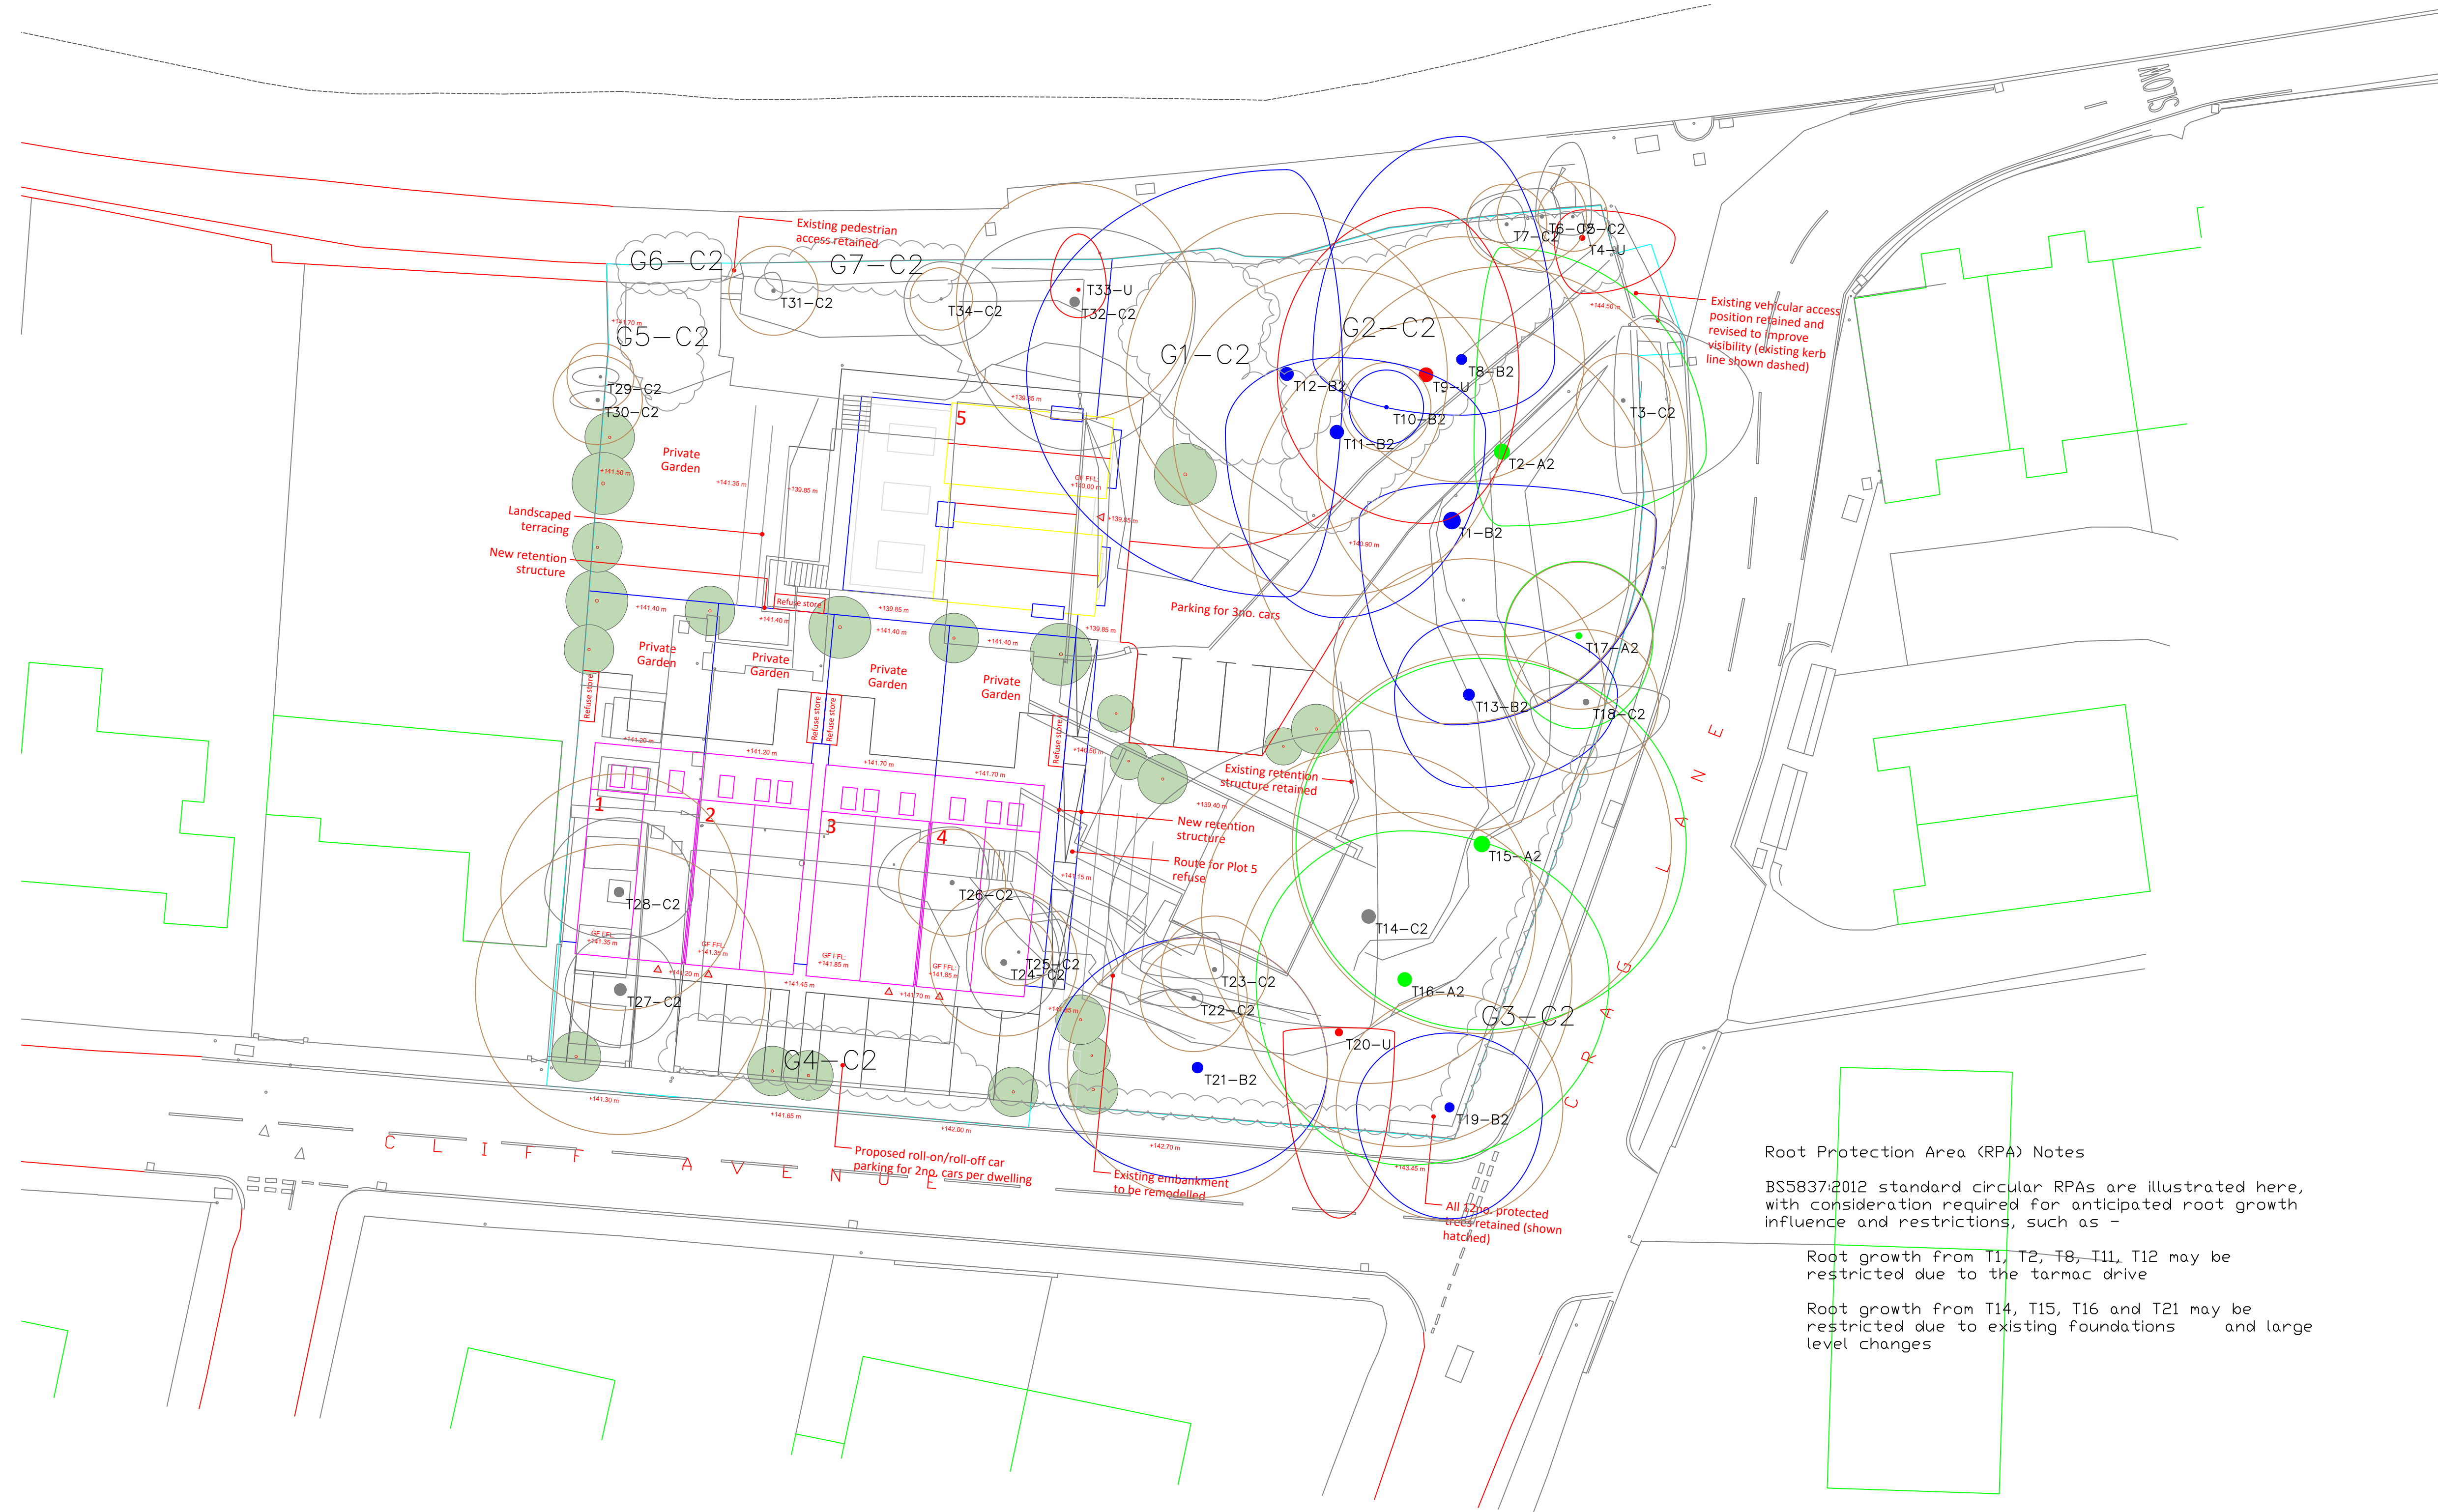
Root growth from T14, T15, T16 and T21 may be restricted due to existing foundations and large level changes
