**SPURR HOUSE, POLE LANE, BURY**  
**HIGHWAY DILAPIDATION SURVEY**

| 1 | <b>Pole Lane - Junction with Parr Lane</b> |

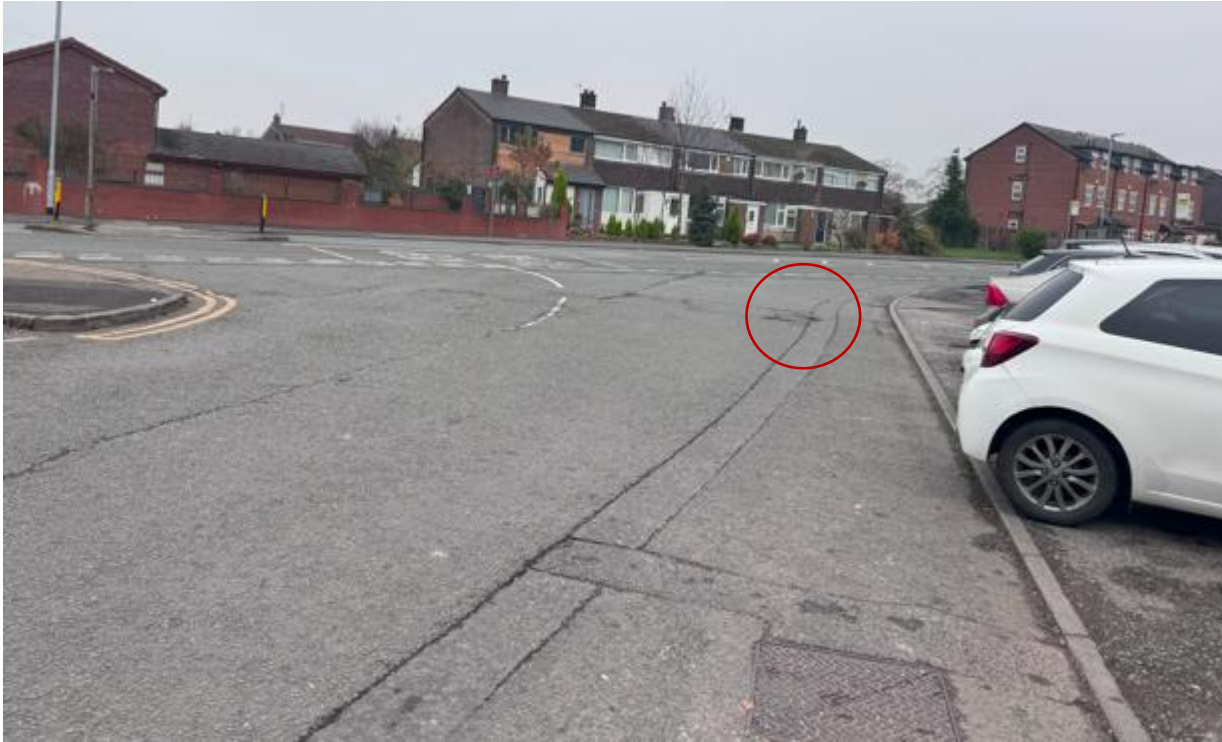
| 1.1 | <p>Pothole in the junction (circled), cracks down the middle of the road. Re surfaced trench areas settled.</p> <p>1.1</p> |

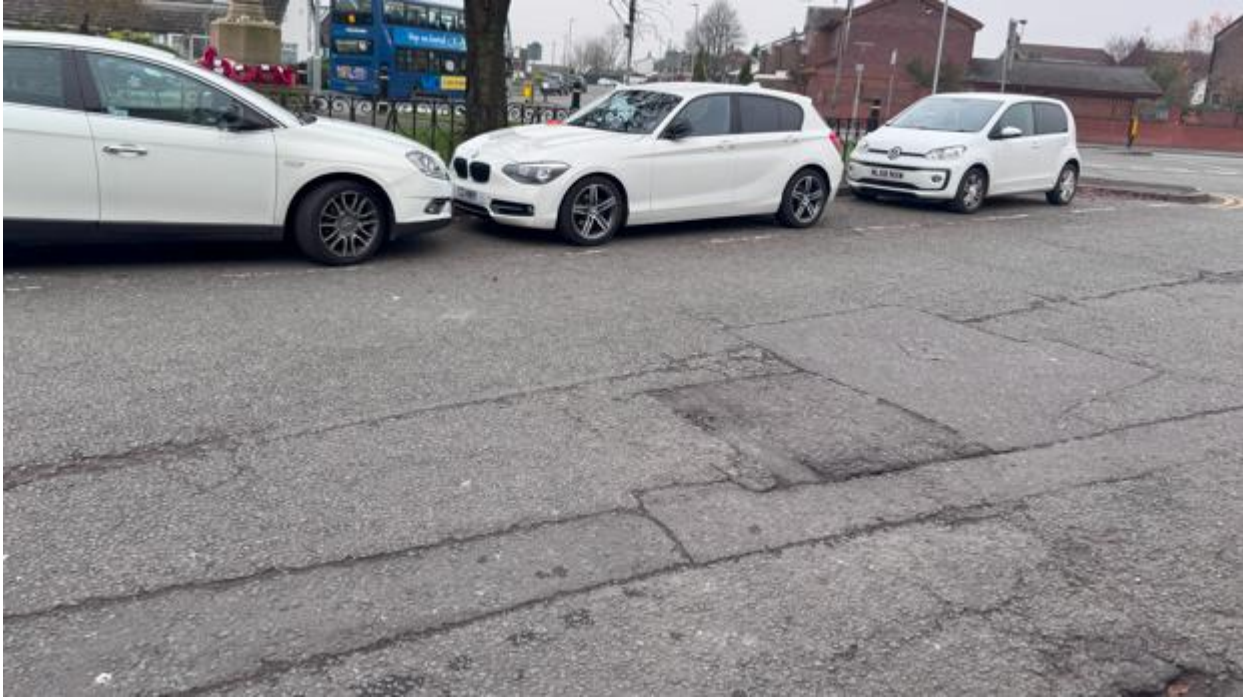
| 1.2 | <p>Multiple areas resurfaced causing erosion on edges, crack down centre and faded white parking bay markings.</p> <p>1.2</p> |

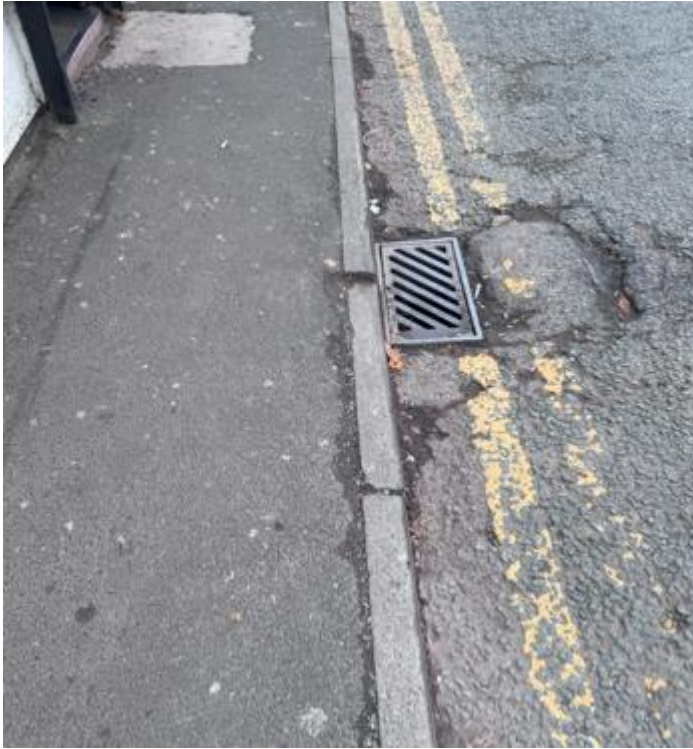
| <p>1.3</p> | <p>Kerbs un even and bad condition, yellow markings faded, ironwork protruding and surface failure around gully.</p> <p>1.3</p> |

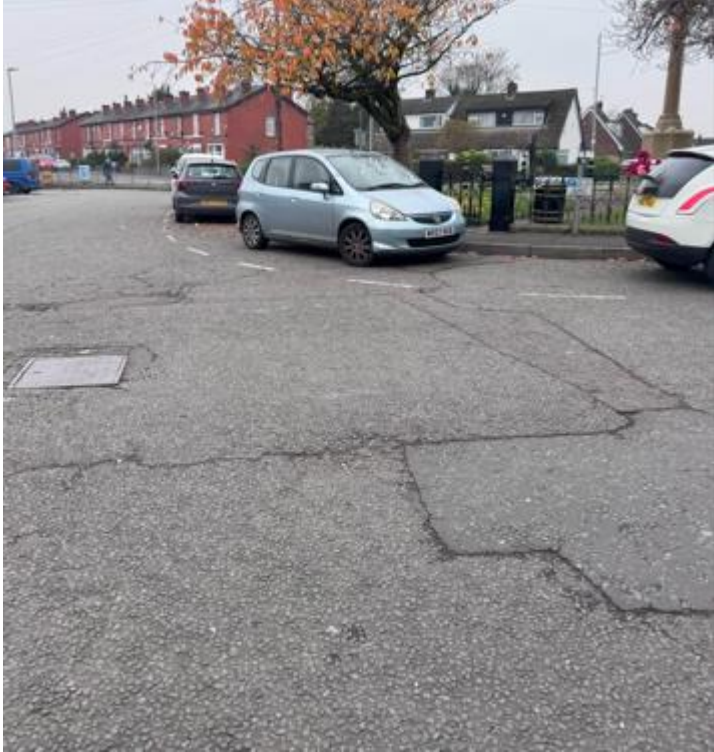
| <p>1.4</p> | <p>Re surfaced areas seem depressed, ironwork protruding with carack around causing depressions, cracks though the centre of the road.</p> <p>1.4</p> |

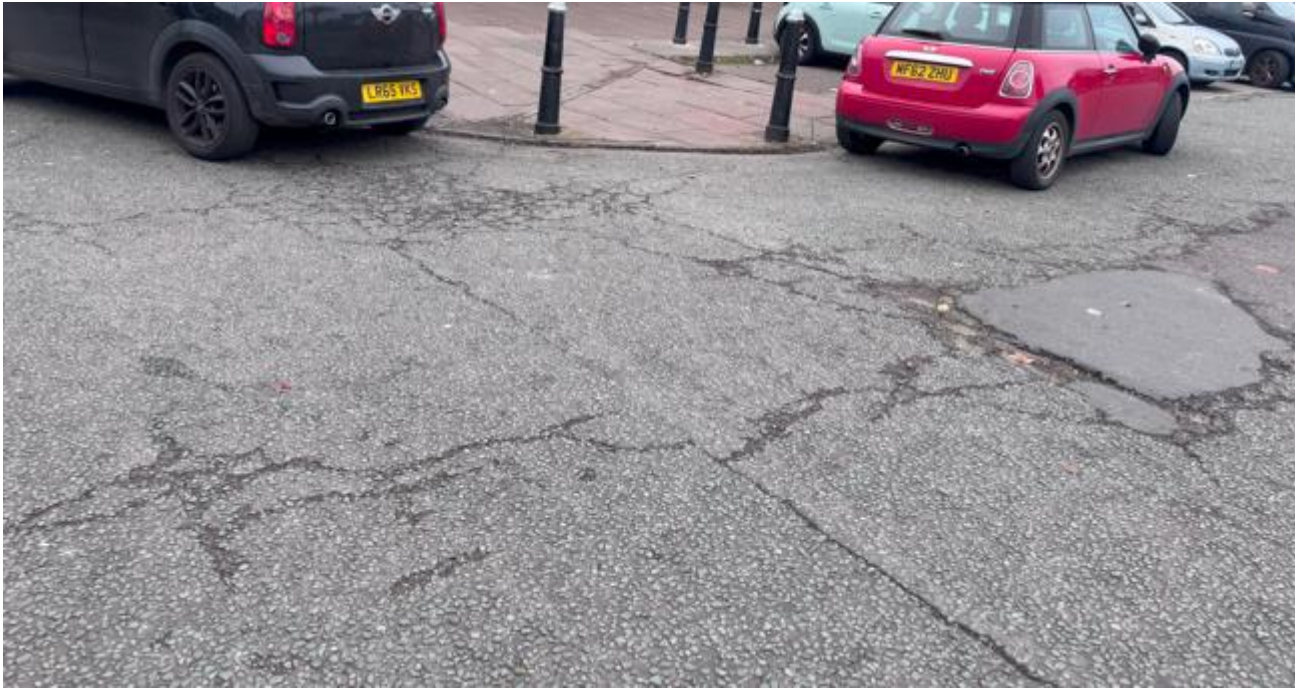
| <p>1.5</p> | <p>Resurfaced area starting to come up, pothole formed from edges. Settlement issue causing large amount of cracking.</p> <p>1.5</p> |

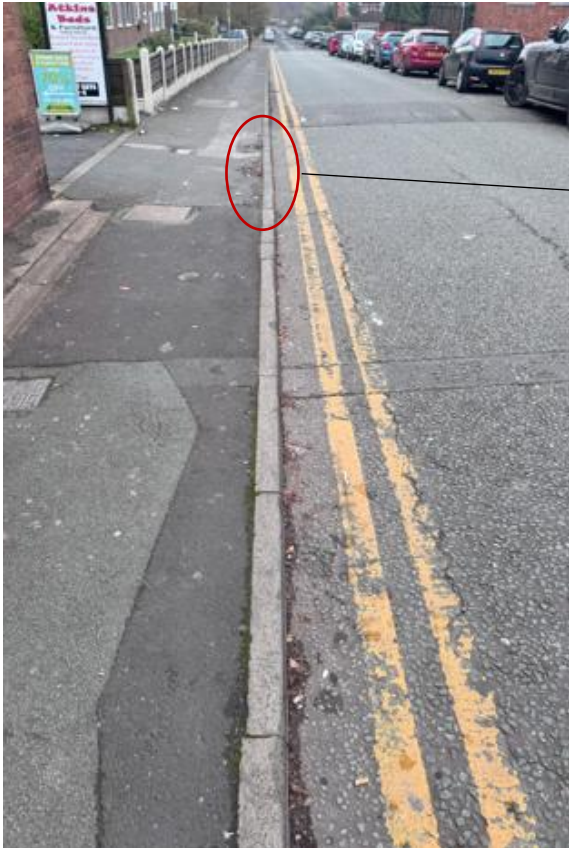
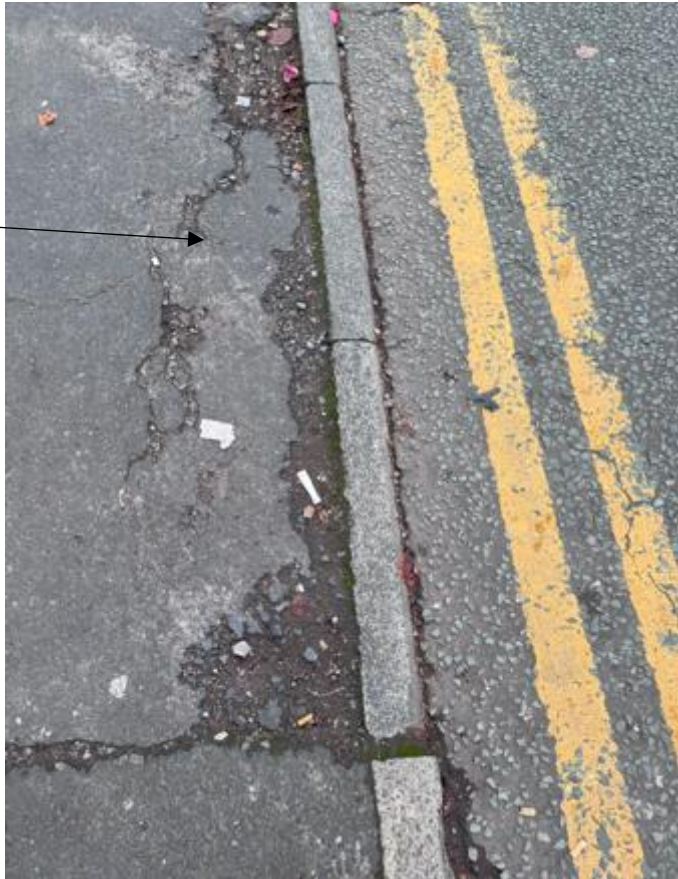
| <p>1.6</p> | <p>Faded yellow lines – kerbing damaged, cracks down length of lining. Crack down centre of the road</p> <div style="display: flex; justify-content: space-around;"> </div> <div style="display: flex; justify-content: space-around;"> <p>1.6.1</p> <p>1.6.2</p> </div> |

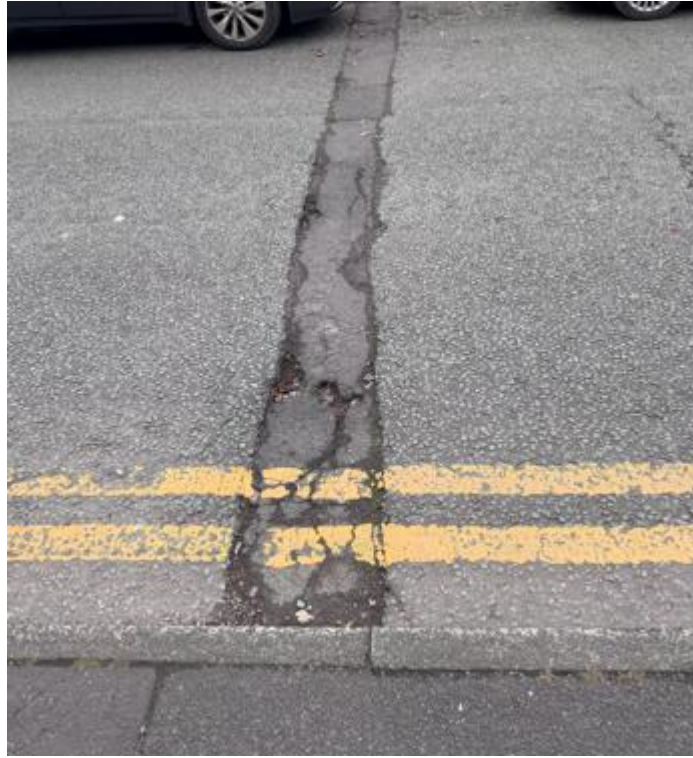
1.9

Old trench resurfacing is crumbling and cracked

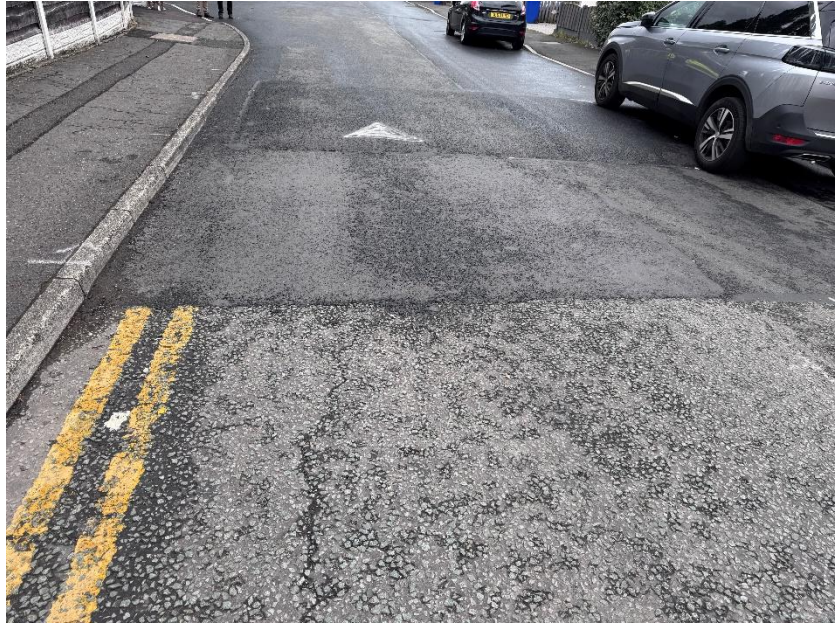
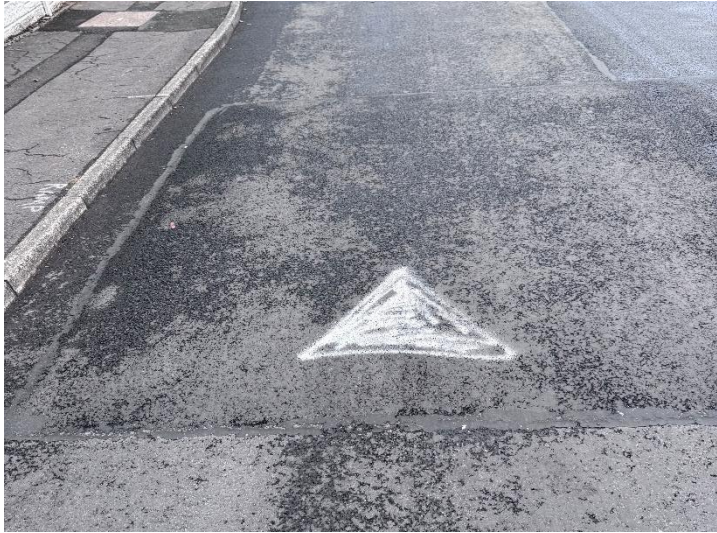
| 2.3 | <p>Road hump – white lining faded and road marking not implemented yet, existing speed bump updated.</p> <div data-bbox="332 298 1113 882"> </div> <div data-bbox="1193 321 1863 819"> </div> |

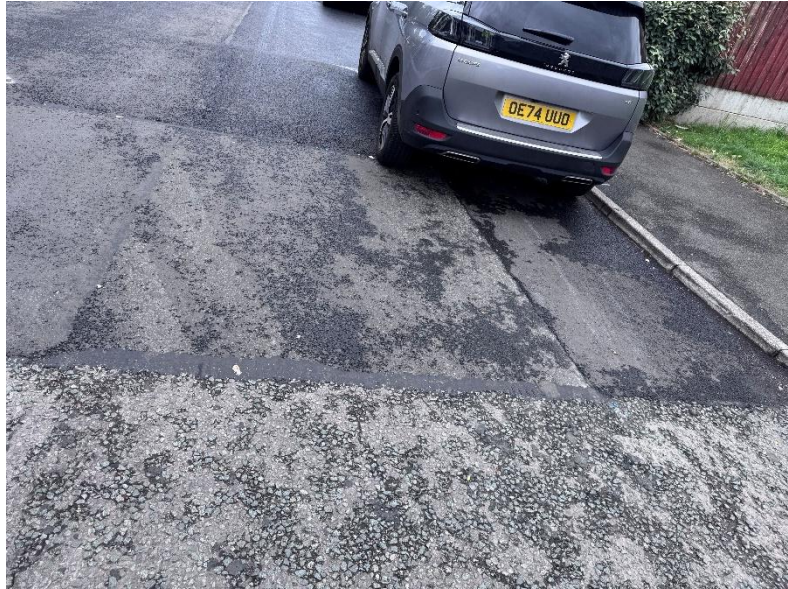
| 2.4 | <p>Top surface course worn sown , resurfacing is crumbled.</p> <div data-bbox="317 987 1053 1537"> </div> |

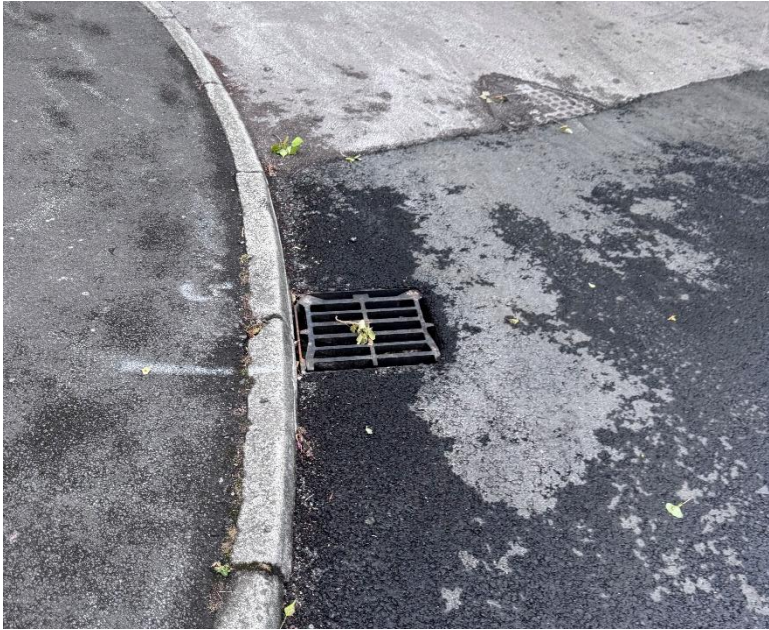
| 2.5 | <p>Junction tie in surface shown.</p> |

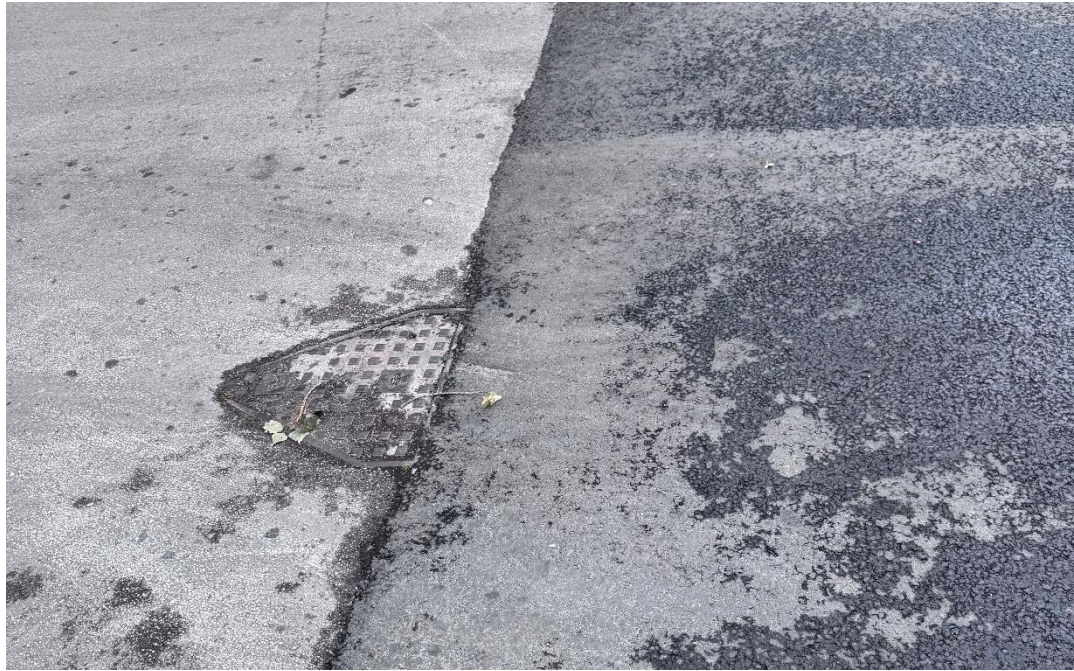
| 2.6 | <p>Junction tie in surface deteriorated, multiple re surfacing and patches, surface course very worn, protruding ironwork.</p> |

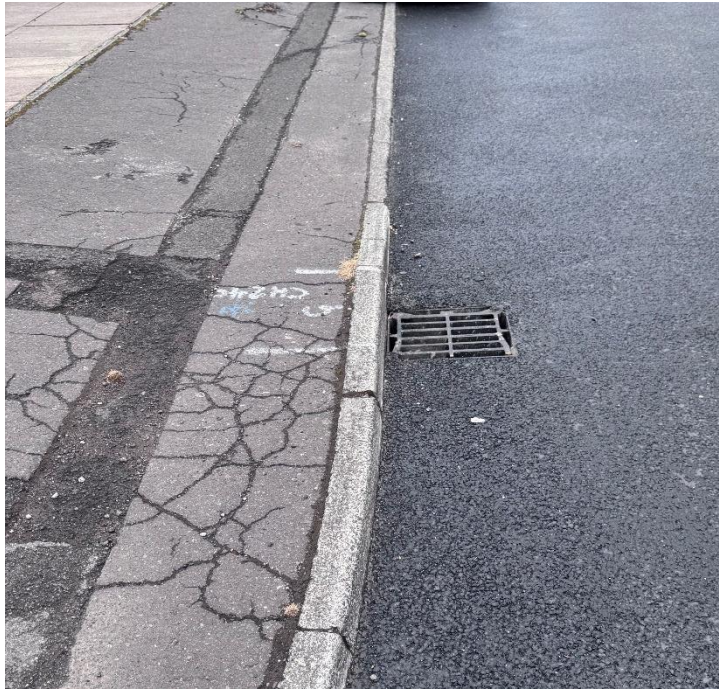
| 2.7 | <p>Pedestrian footway surface badly worn with cracks.</p> |

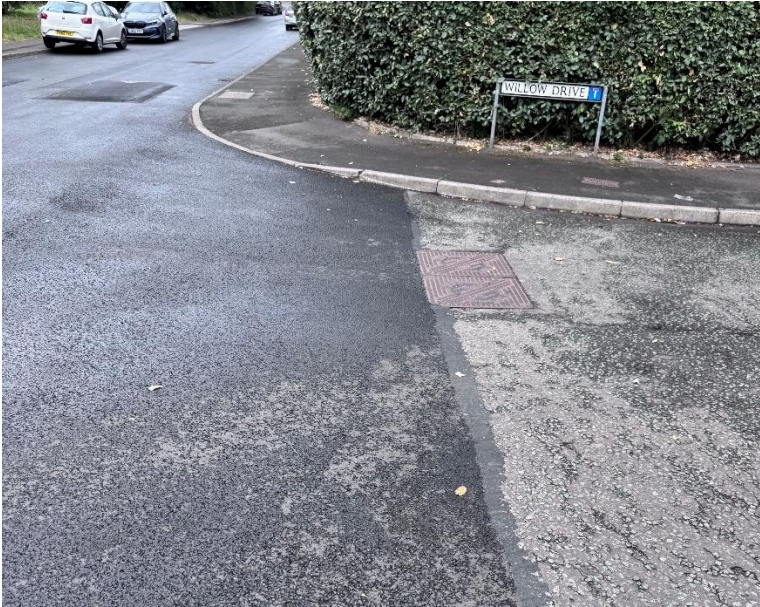
| 2.8 | <p>Road not level at junction tie in of Willow Drive.</p> |

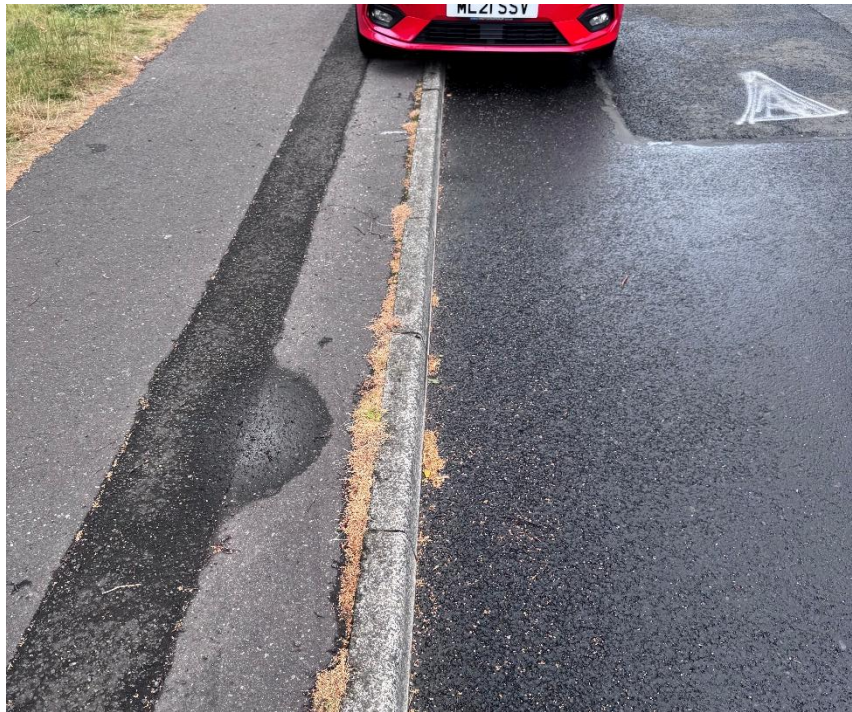
| 2.9 | <p>Vegetation between footway and road on kerbs, multiple surfacing on footway.</p> |

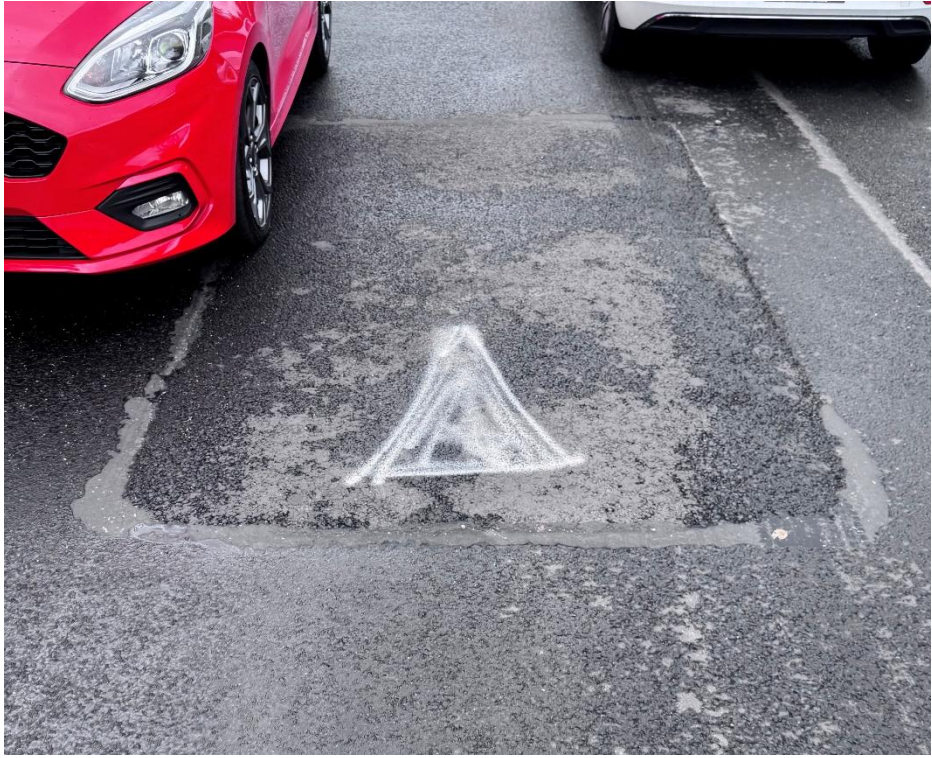
| 2.10 | <p>Speed bump – Temporary white arrow marking.</p> |

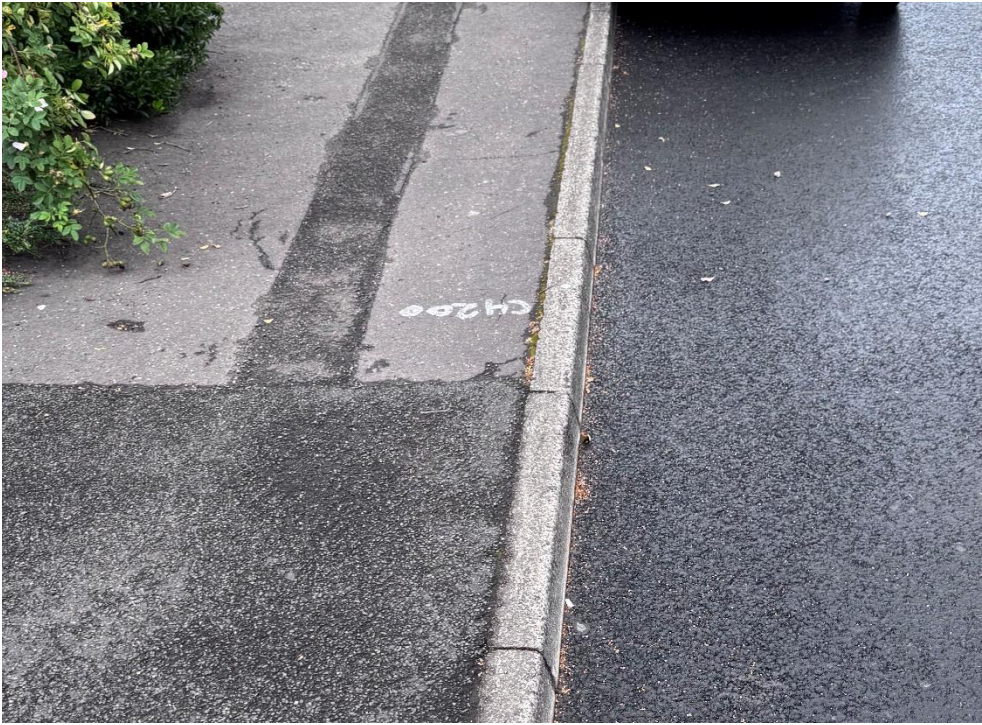
| 2.11 | <p>Original Surface work down, staggered footpath.</p> |

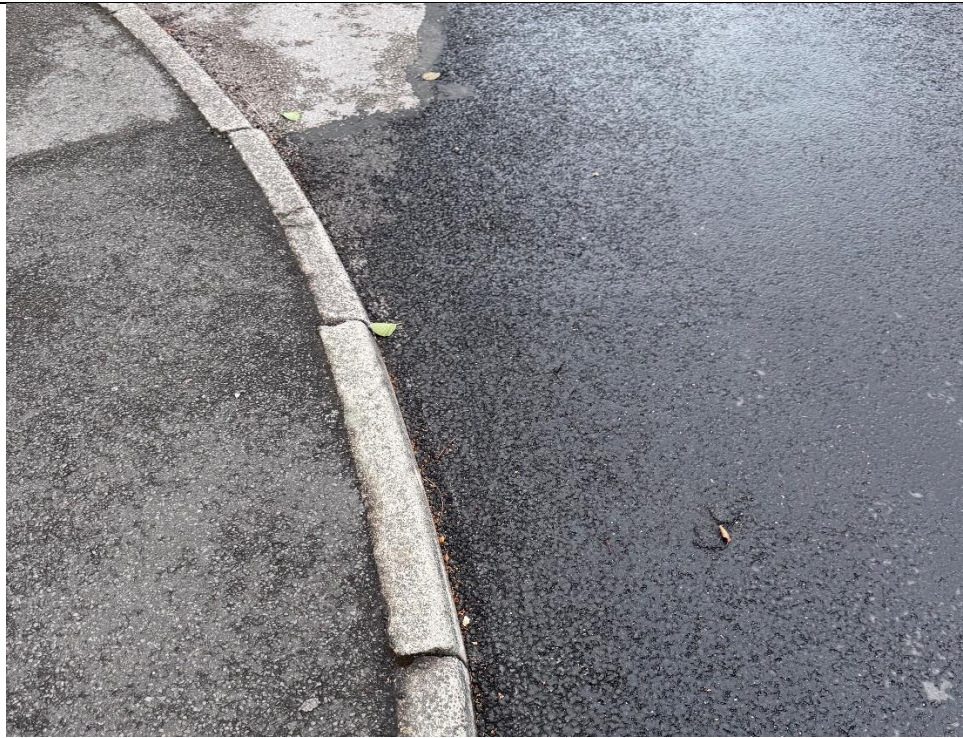
| 2.12 | <p>Staggered and uneven kerbs on radius.</p> |

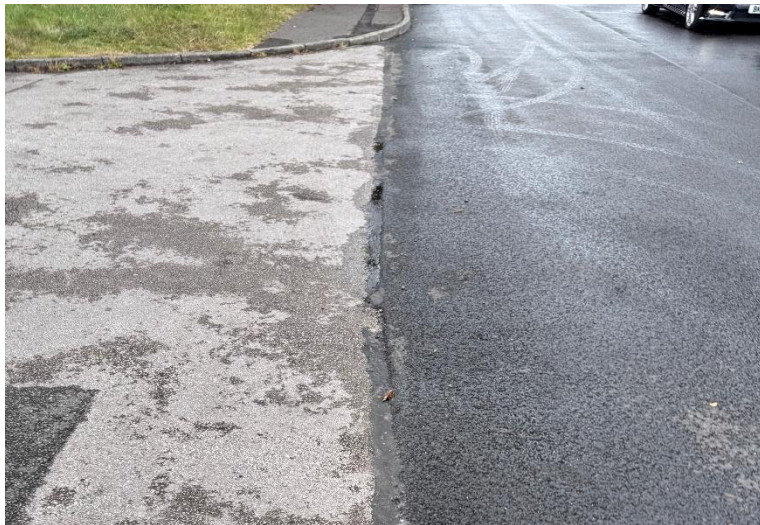
2.13

Existing Junction condition

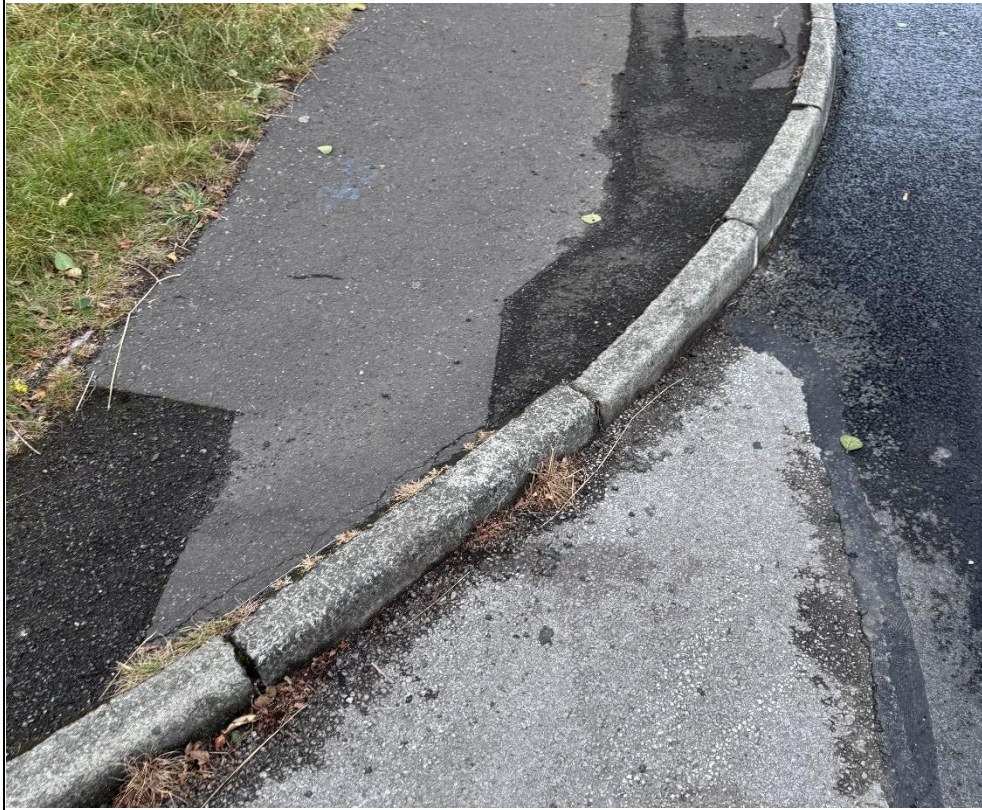
2.14

Kerbline staggered.
